FIELD TESTING OF REMOTE SENSOR GAS LEAK DETECTION SYSTEMS

FINAL REPORT

SwRI[®] Project No. 18.10485

December 2004

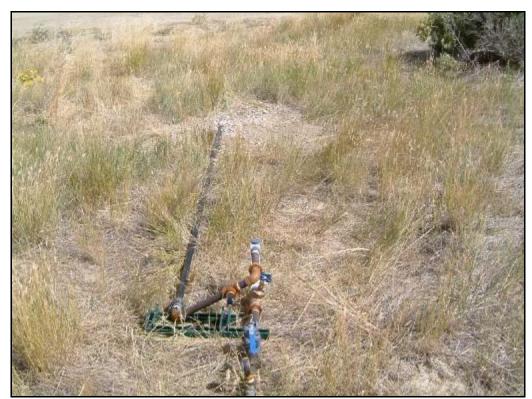
Site 1 – Underground leak outlet is roughly 10 feet from rotometer location (in gravel area).

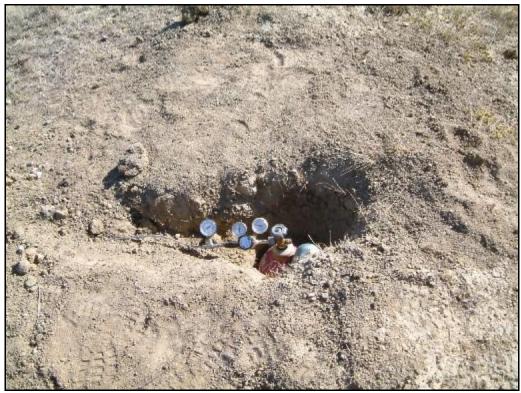
Site 2A - View of bottle and regulator (typical of all bottle fed leaks; 2A through 2E).

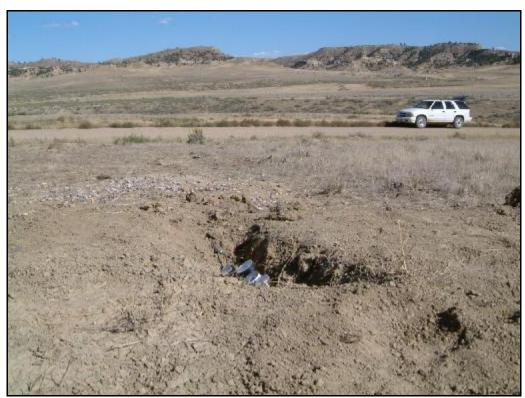
Site 2A – View from leak site to road. Underground leak located in the gravel area approximately 8 feet from bottle location.

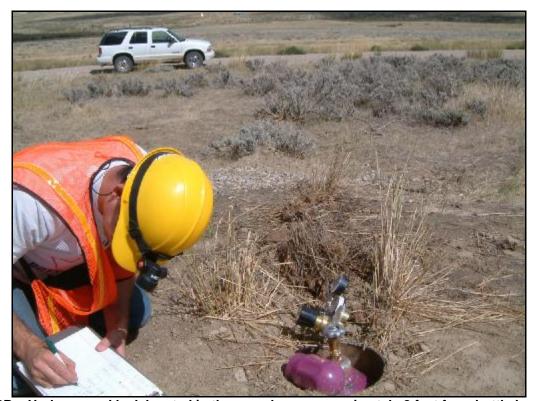
Site 2B – Underground leak located in the gravel area approximately 8 feet from bottle location.

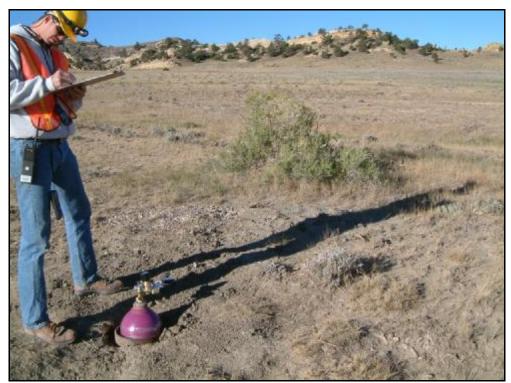
Site 2C – Underground leak located in gravel area approximately 8 feet from bottle location.

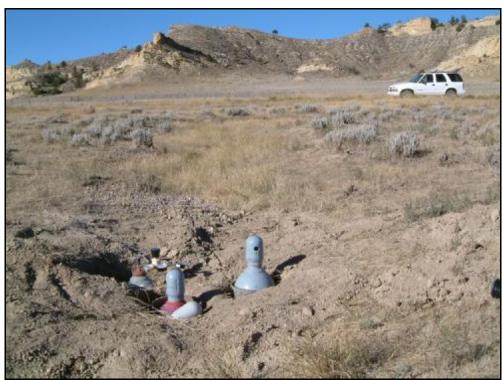
Site 2D/Site 1F – Three bottles (two with methane only, one with methane/ethane mix).
Underground leak located in the gravel area approximately 8 feet from bottle location. Vehicle located on the road.

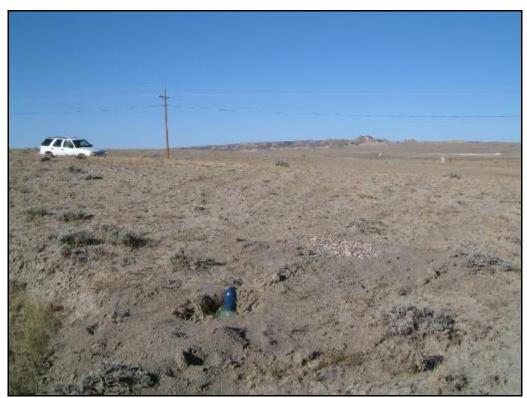
Site 2E – Underground leak located in the gravel area approximately 8 feet from bottle location. Vehicle located on the road.

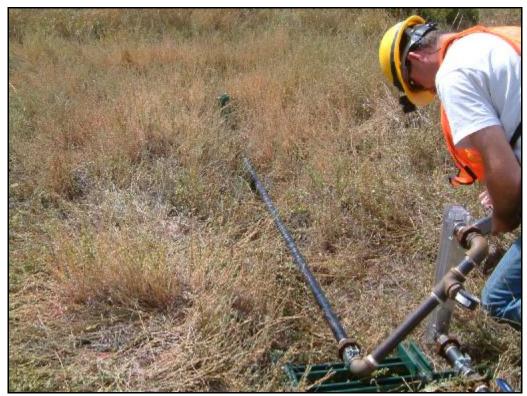
Site 3 – Aboveground leak at the end of the 10-foot long pipe.

At the aboveground leak site (Leak Site 3), the pipe connected to the rotameter assembly was laid on the ground and ended in an upward-facing elbow (and flame arrestor). See drawing 18-10485-400 located in Appendix C.

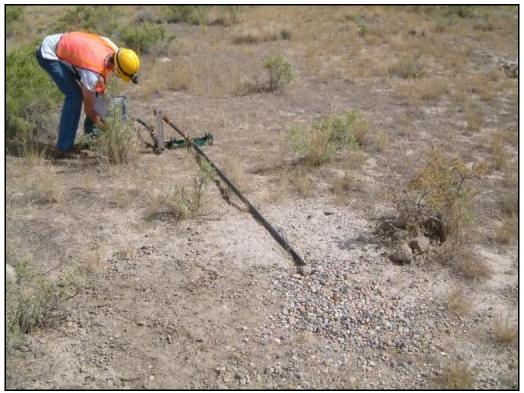
Site 4 – Underground leak emitting through gravel.

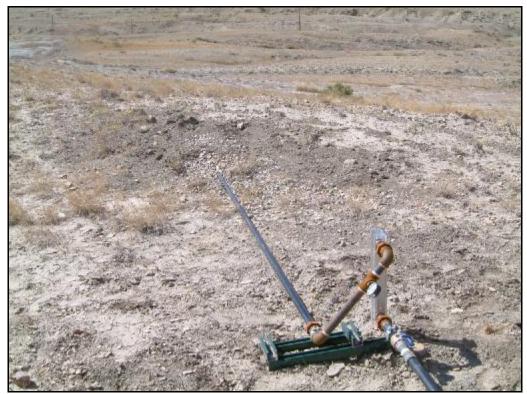
Site 6 – View at the top of the hill. Underground leak at gravel located approximately 10 feet from the rotometer.

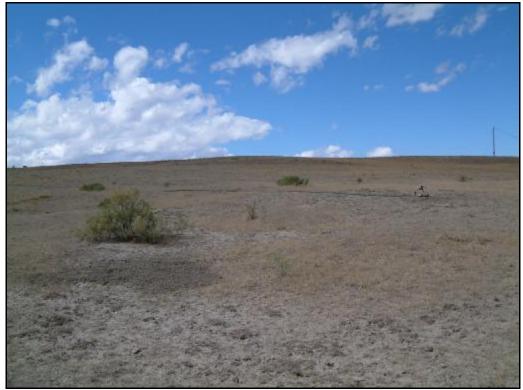
Site P1 – Underground leak. Directionally drilled such that the leak emits under greasewood bush located approximately 20 feet from rotometer.

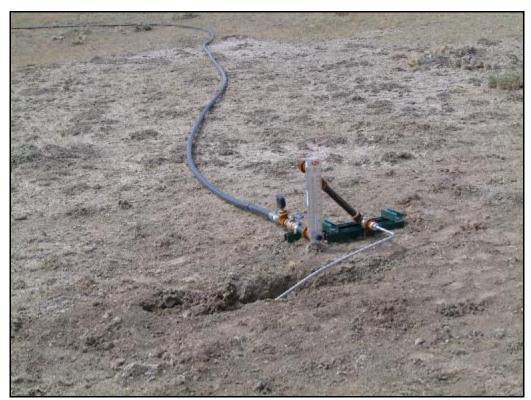
Site P1 – Detail of tubing entering the ground.

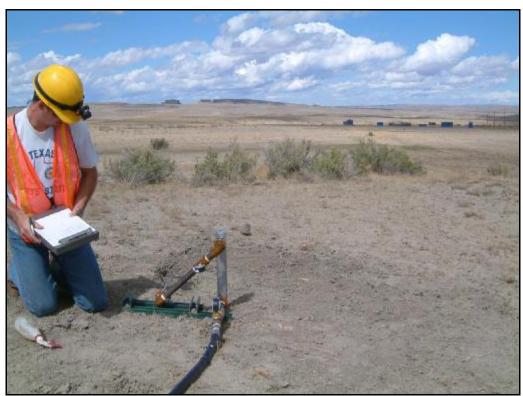
Site P2 – View of leak site and vegetation. The gas leak emits underground near the middle of the greasewood bushes.

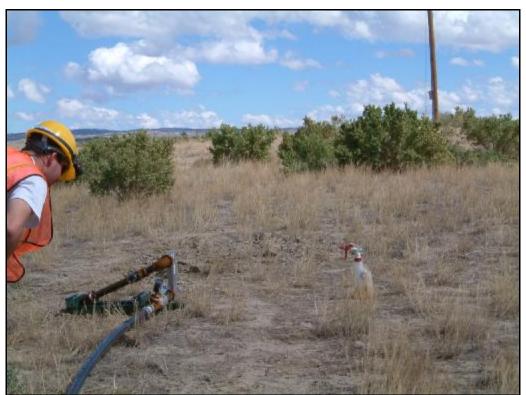
Site P3 – View of leak site and vegetation. The gas leak emits near the middle of the greasewood bushes.

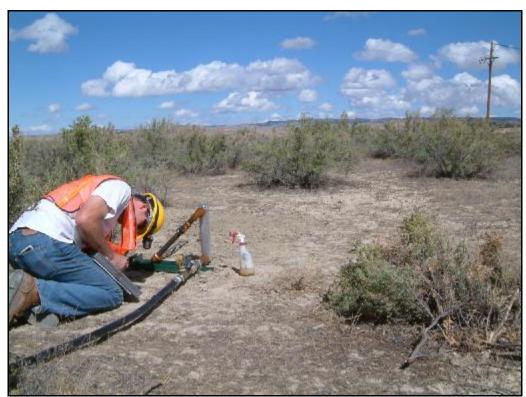
Site P4- View of leak site and vegetation. The gas leak emits near the middle of the greasewood bushes in the center of the picture.

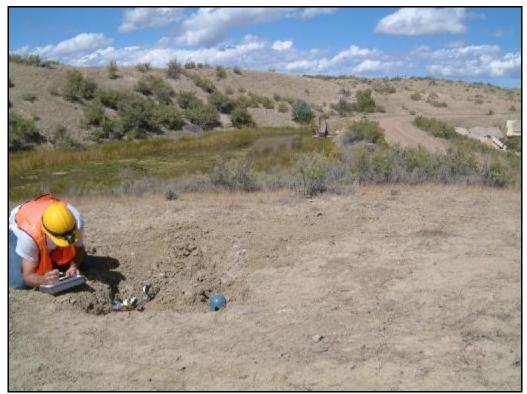
Site P5 – View of site and vegetation. The leak emits beneath the greasewood bushes in the middle of the picture.

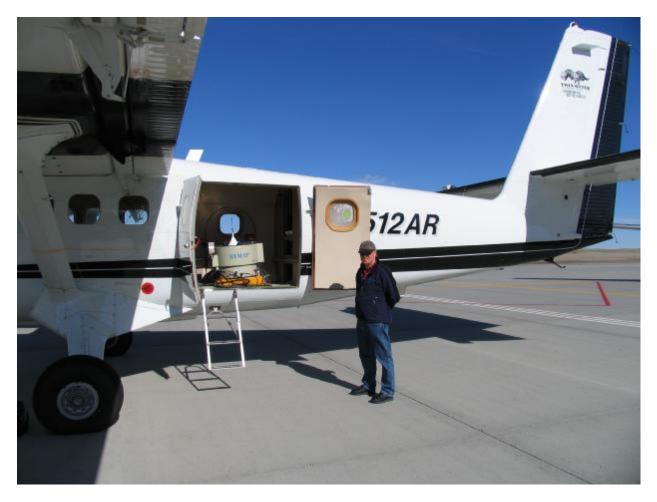
The hyperspectral imaging spectrometer is mounted in a Twin Otter aircraft, which has ca view hole cut in the bottom of the plane. The sensor is mounted on a stabilizing platform, which contains an inertial measuring unit (IMU). The stabilizing platform maintains the sensor axis angle with respect to the earth below in spite of the motions of the aircraft. The stabilizing platform and sensor combination are mounted over the hole in the bottom of the aircraft. The sensor and the stabilizing platform are controlled be a computer which is rack mounted in the plane near the sensor stabilizing platform combination. The photo in Figure 1 below shows the sensor as white labeled HyMap and the stabilizing platform, which is yellow inside the Twin Otter. The HyVista sensor operator, Mike Hornibrook, is standing at the open hatch doors.

Figure 1 The HyMap sensor is white sitting on the stabilizing platform that is yellow inside the Twin Otter manned aircraft. Mike Hornibrook who is the HyVista operator is shown standing outside side the hatch doors.

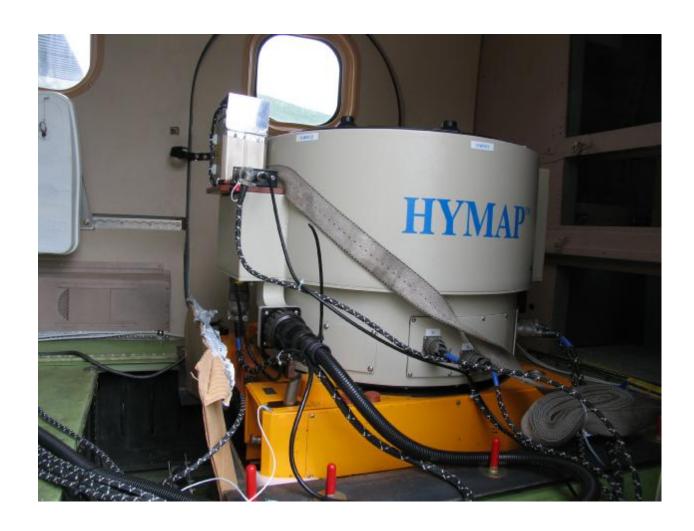
The computer that controls the sensor and stores the imaging spectrometer data and the stabilizing platform orientation information can be seen in the second figure.

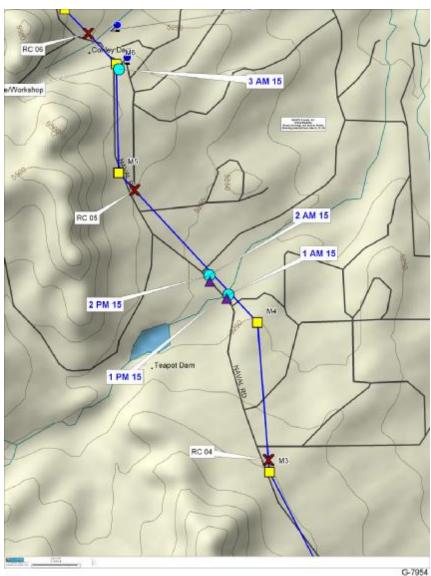
Again we present in Section 3 the position of the survey vehicle, not the position of the leak origin. We will continue our analysis of the recorded column concentrations to search for small leaks. The RMLD exhibited a good ability to resolve two leaks close together as shown in Figure 8.

Figure 8. Positions of two adjacent leaks present both Wednesday AM and PM show resolving power.
