# Role of Coatings in Direct Assessment and Risk Analysis

Jenny Been  
NOVA Research and Technology Centre  
Calgary, Alberta

*OPS Workshop on Advanced Coatings R&D, June 9-10, 2005*

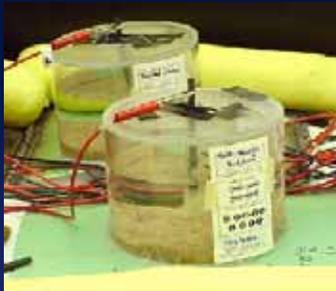
- ✓ 0.4 to 6.0 mm holidays
- ✓ 15 cm dia. coating area
- ✓ 1.5 L volume
- ✓ 300 cm<sup>3</sup> sand (to restrict mixing)

- Solutions:
  - ✓ Fresh Water
  - ✓ Sand
  - ✓ Salt Slough
  - ✓ Clay
- -0.85 to -3.0 V
- RT and 60 C
- 1 - 18 months

- Measurements included potential, current, EIS, CD area

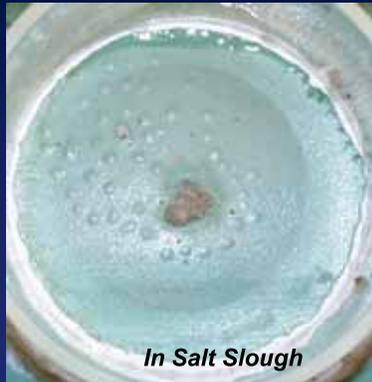
- A 60 C temperature increased the coating permeability, where the passage of water and current through the coating was facilitated by high osmotic pressure gradients
- Blister formation may result in continuous disbondment with blisters turning to new pinholes

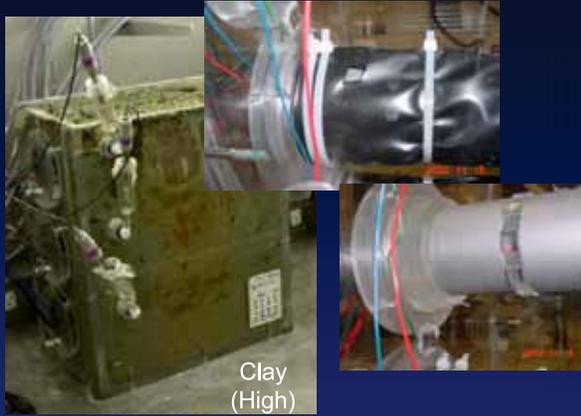
- Dilute near-neutral pH SCC environment, CO<sub>2</sub>
- 3 soils in 3 Plexiglas soil boxes
- Exposed for ~18 months
- Anaerobic chamber: 5% CO<sub>2</sub> / N<sub>2</sub>
- 3 PE coated CS pipe assemblies in each box
- 1 cm<sup>2</sup> holiday was cut into the coating
- CP potential was applied
- Measurements included potential, current along the pipe assembly, pH and dissolved CO<sub>2</sub>.

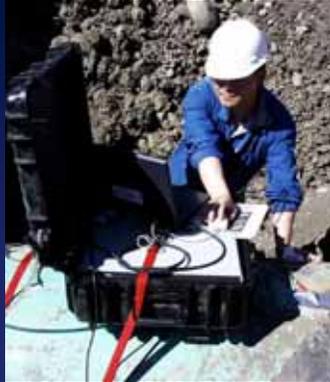
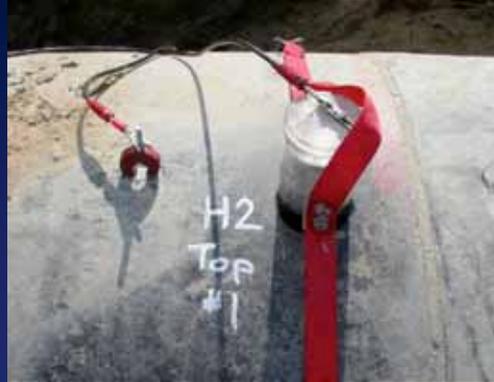
- Visual inspection and holiday detection
- Electrochemical Impedance Spectroscopy (EIS) can be used to assess coating condition

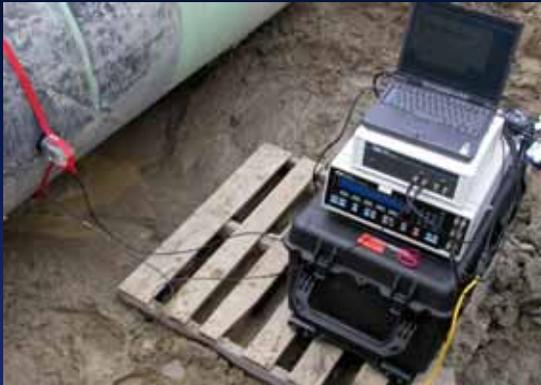
- dielectric interface enhances the capabilities of the FRA to yield valid low frequency data
- 2-electrode system
- no liquid electrolyte
- EISPlus measurements were made
- Belt can be replaced with a magnet
- HPCC coating was in excellent condition after 11 y of service
