Report on the Test Results of the
Handheld Pipe Locator
Demonstration May 2009

October 2009

**REPORT ON THE TEST RESULTS OF THE HANDHELD PIPE LOCATOR
DEMONSTRATION**

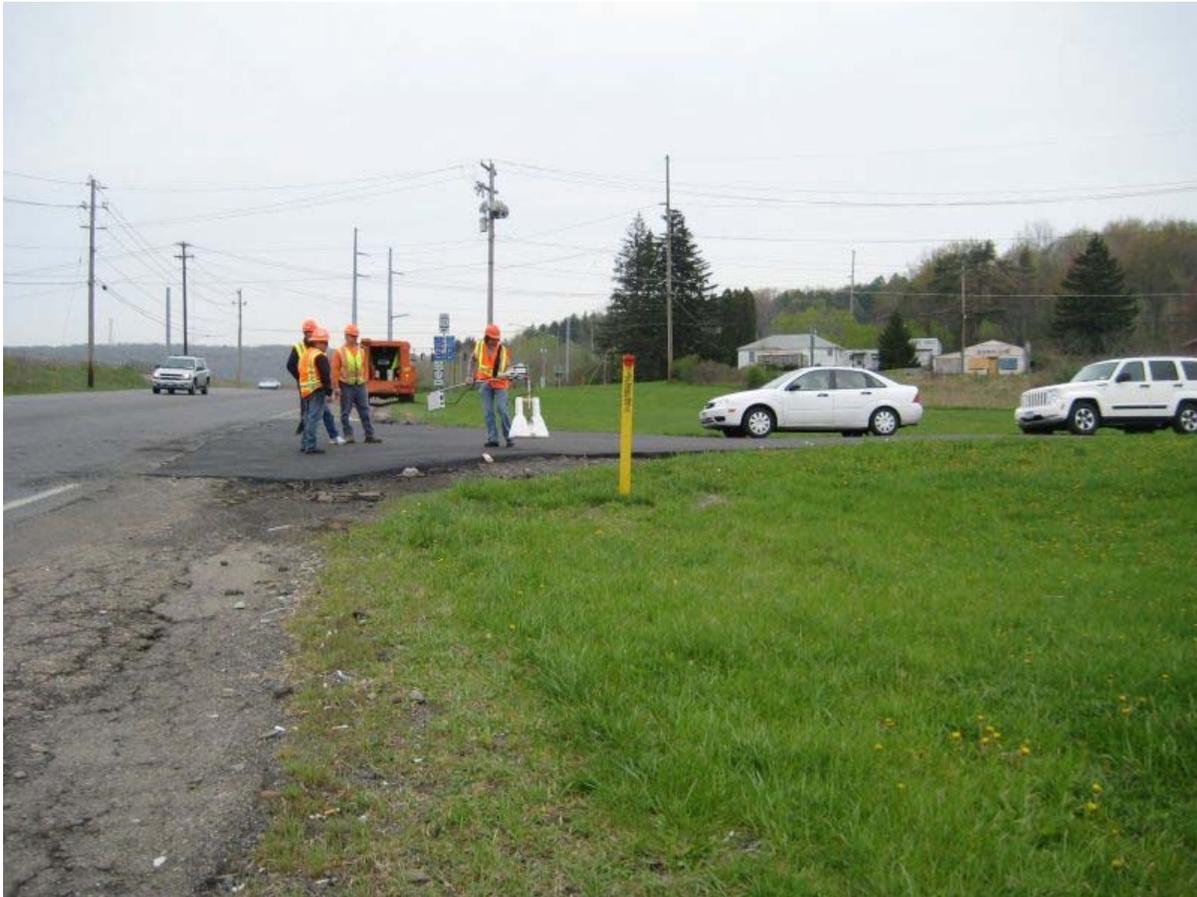
Site 1

8.1 SITE 1 (NYSEG)

<u>Date:</u>	<u>Time:</u>	<u>Town</u>	<u>Site Name</u>
May 4 th 2009 – Day 1	Am	Binghamton	Corporate Drive
<u>Handheld unit Version:</u>	<u>Number of Pipes:</u>	<u>Pipe Material:</u>	<u>Pipe Size(s):</u>
Bistatic	1	Possible PE	Unknown
<u>Surface Conditions:</u>	<u>Soil Type/Condition:</u>	<u>Weather:</u>	<u>Verification Method:</u>
Grass	Mixed	Overcast	None

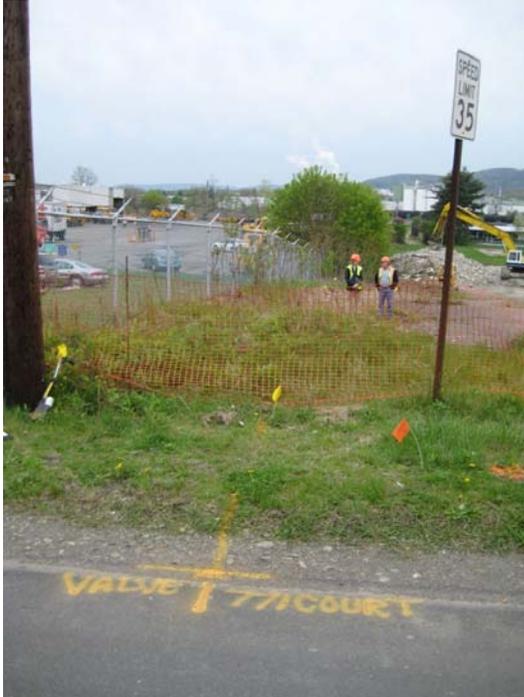
Site 3 Valve Location

Although the gas pipe was not found by the handheld unit, it was later determined by the NYSEG crew that the search was in the wrong area where the gas pipe was expected. Instead, upon digging, a water pipe was found that coincided with the line indicated by the handheld radar survey and within 12” location accuracy.

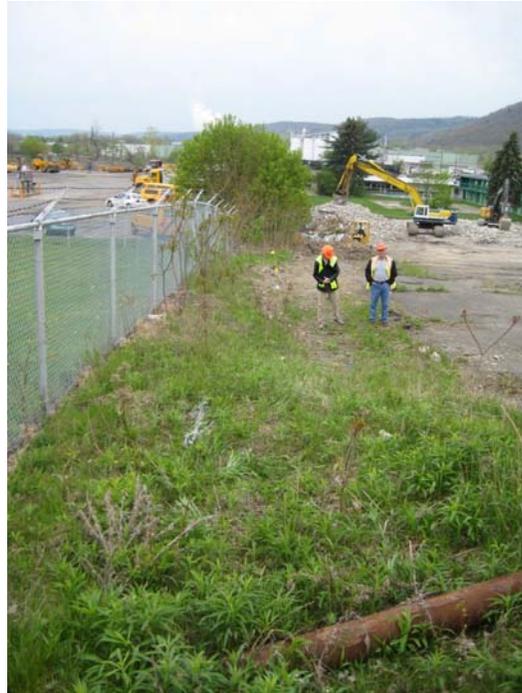
Site 3 Mark-out

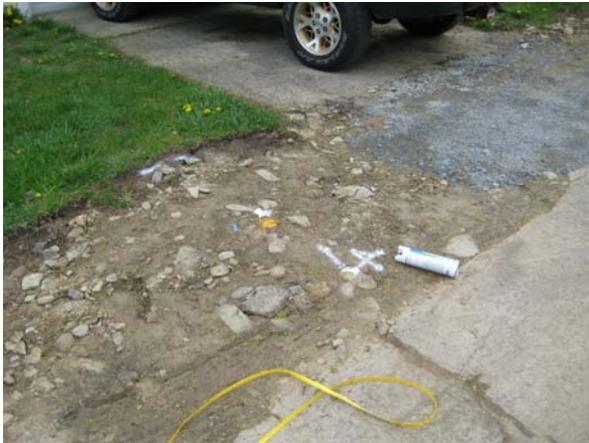
Site 4 First Test Pit Location

Later test pits were dug. The first located the pipe 2'7" from the vegetation and 2'9" deep. The second located the pipe 7'1" from the fence. The trial hole was dug between the two location marks, about six feet along the pipe). Both PipeHawk predictions were found within 6" of what was located.

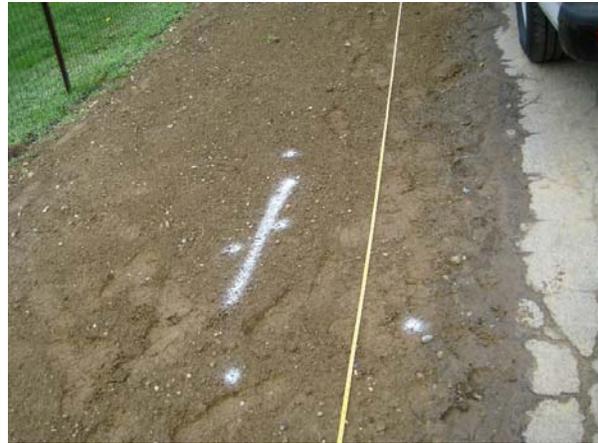
Site 4 Second Test Pit Location

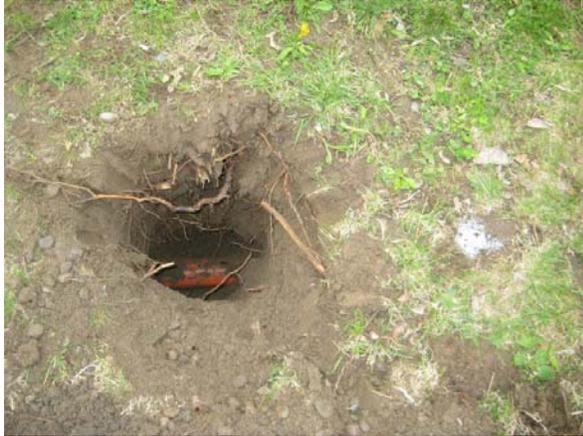
Site 6 Test pit in front of building 3A

Test pits were dug in front of buildings 3A, 3B and 3C. These located the pipe 3'0" from the path for buildings A and B, closing to 2'3" for building 3C. The pipe was 2'0" to 2'7" deep.

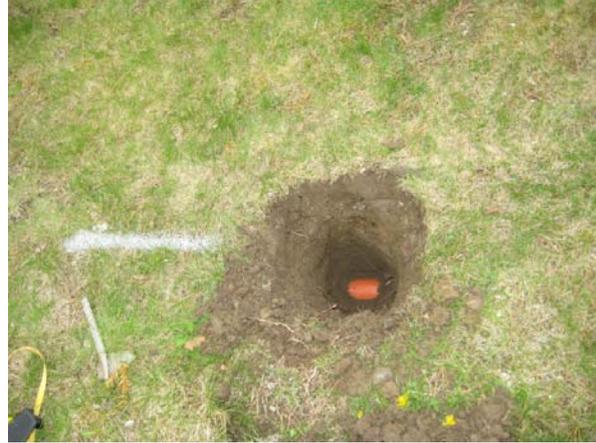
Site 6 Test pit in front of building 3C

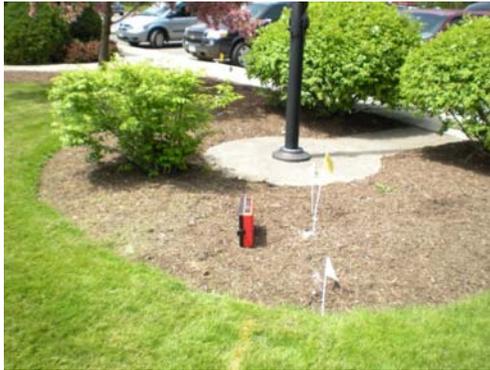
Site 7 Suggested and actual location near flag pole

The predicted location approaching the flag pole was off by 12"-18". Beyond the flag pole, the pipe was located within the trial hole; the location was accurate to within 6". No pipe was found in the flower bed. On the bank near the building side of the parking lot, the pipe was not locatable. In the bank (at the far end of the parking lot), the predicted location was within 6".

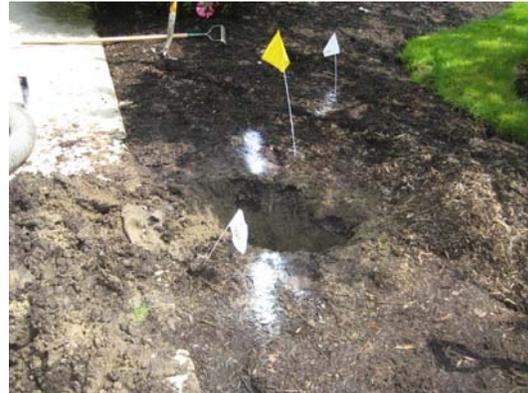
Site 7 Suggested location and locating hole beyond the flag pole. The pipe was within the hole

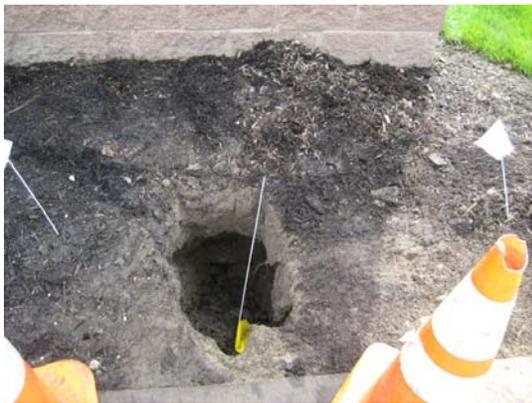
Site 7 Empty trial hole in flower bed

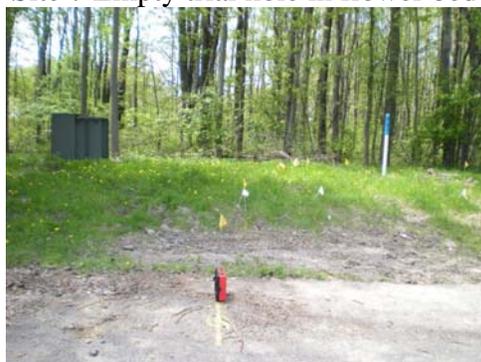
Site 7 Actual location on bank adjacent parking lot

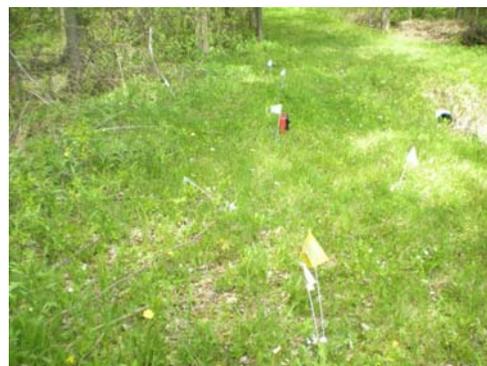
Site 7 Actual and predicted location along bank

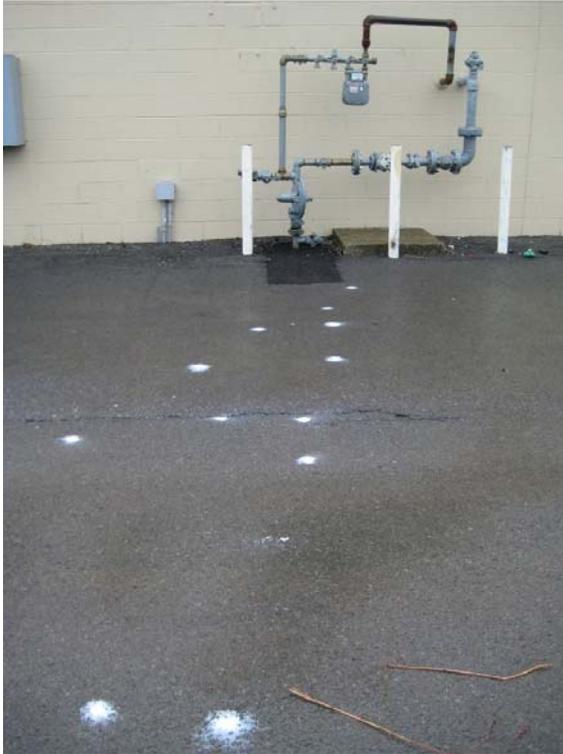
Site 9 Possible traces from meter

The pipe was traced from the meter up the center of the driveway. At the sidewalk, the pipe was located 19'7" from the utility pole.

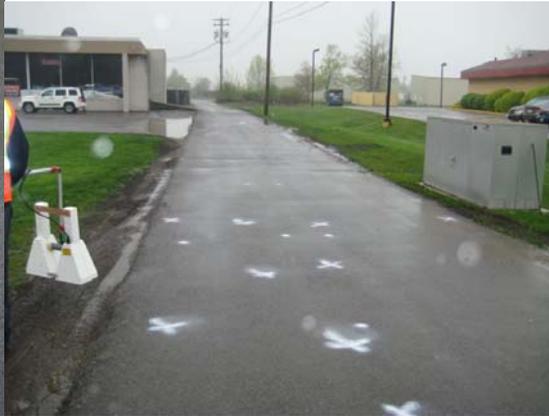
Site 9 Mono-Static Results (dots),
Bi-static Results

For the small area scanned with both antennas, the monostatic appeared to give a more consistent location. The most likely reason is that as the depth of penetration of the bistatic antenna is greater than the monostatic, in certain situations, it may detect other targets that are not otherwise seen by the monostatic version. However, in shallow targets the monostatic antenna produced cleaner and less noisy results than that of the bistatic.

Through digging, the pipe was found at 18'3" from the pole. The difference between predicted and actual location is was approximately 16".

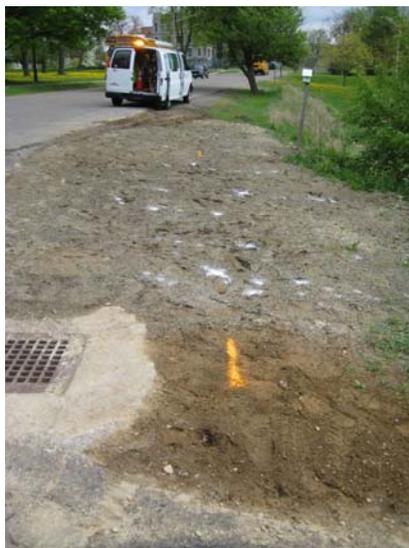
Site 10 Section 1 Actual location of pipe above service; pipe depth at 26" in one area and 36" in a higher area of embankment

The actual location of the pipe in Section 1 was found to be at depth between 26” at the top of the road, and 36” at the bottom of the road in this section.

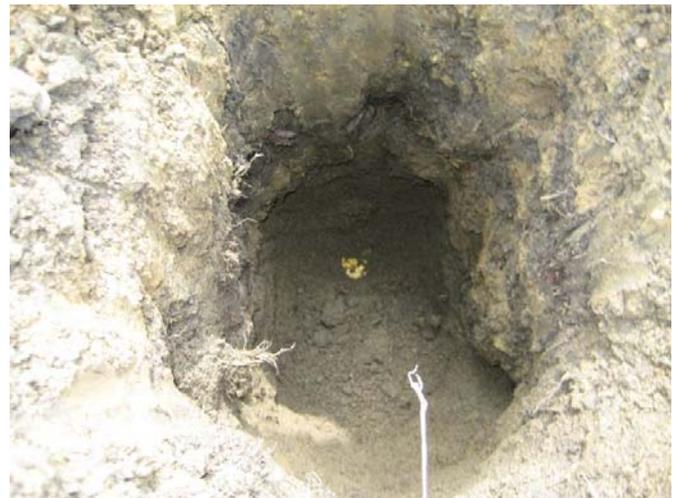
Site 10 Pipe located within trial hole below the service
Pipe depth was 32"
Section 3

The Section 3 trial hole also found the 1.25” diameter, 30” deep service pipe within less than 6” where the handheld unit had indicated.

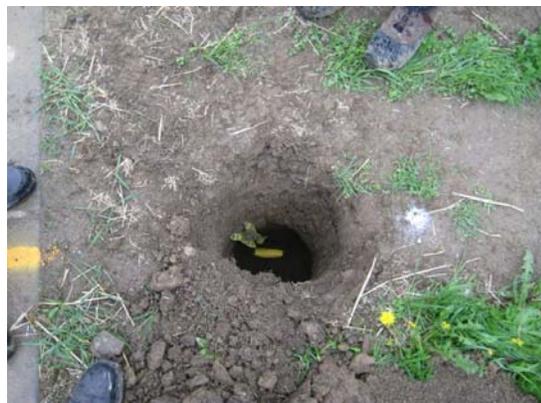
Site 10 Service located within trial hole
Section 2

In Section 2 of the site, the pipe was located within the trial hole that was dug at the location where the scan had indicated. It was found at a depth of 32”. Therefore it can be safely assumed that the handheld unit radar had found the pipe within 6” accuracy.

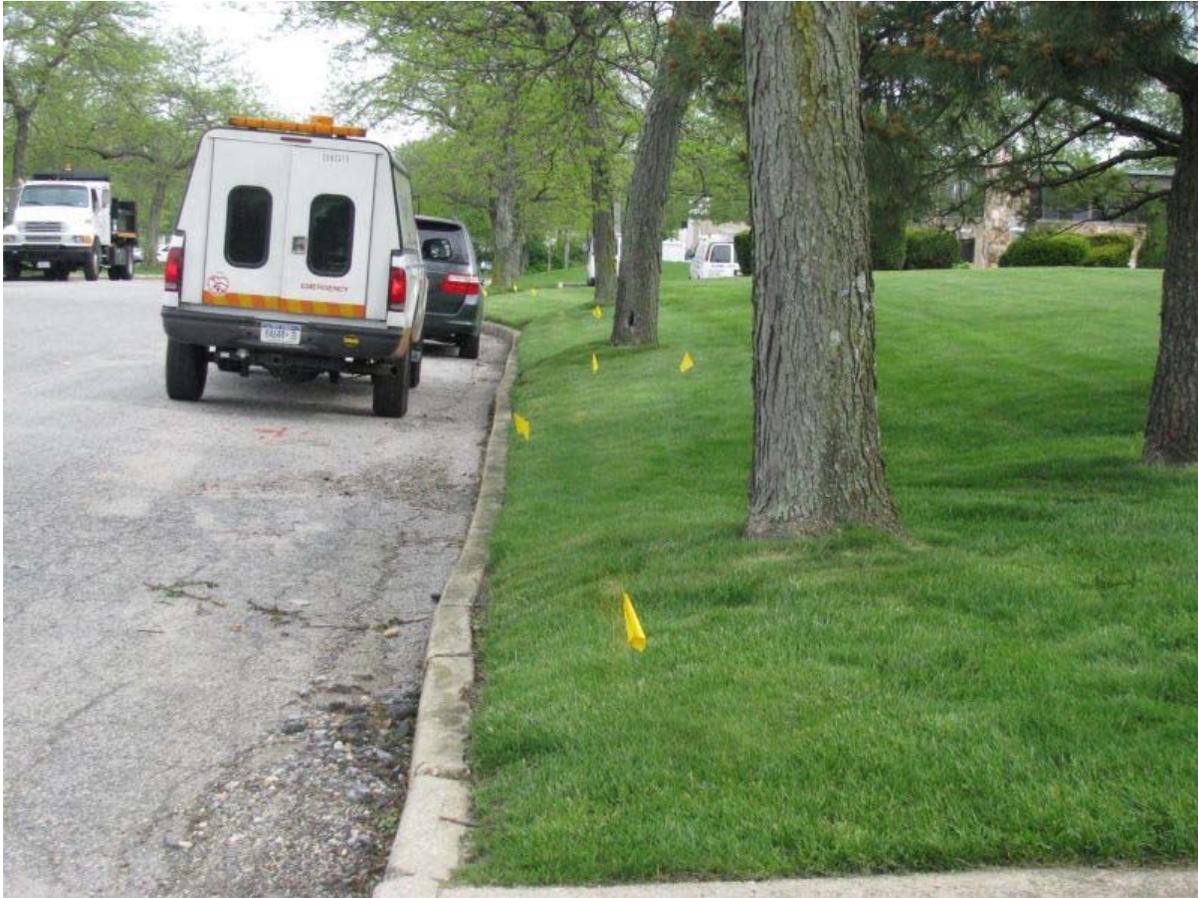
Site 11

The area to be scanned was a grass area in a quiet residential neighborhood. A gas main pipe was suspected to be running parallel to the curb as in the picture below.

The area was excavated to verify the handheld unit findings. A 2" PE gas pipe was found at around 1'4" from the edge with a depth of approximately 30".

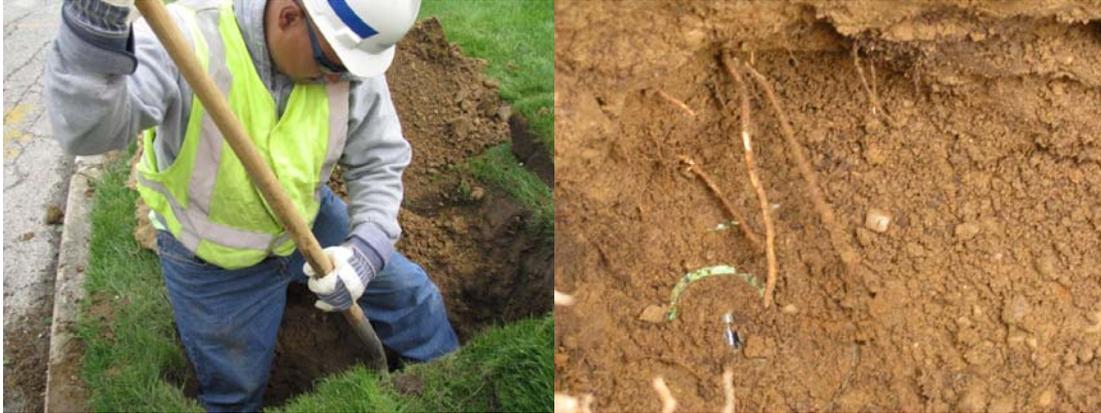
Site 11

It can be concluded that handheld unit was successful in detecting the gas main and within 6" lateral accuracy. For the second line prediction, the handheld unit detected the edges of the trench rather than the pipe itself which can happen because sometimes, GPRs signals from trench edges are stronger than that caused by the target which lays deeper than the trench edge.

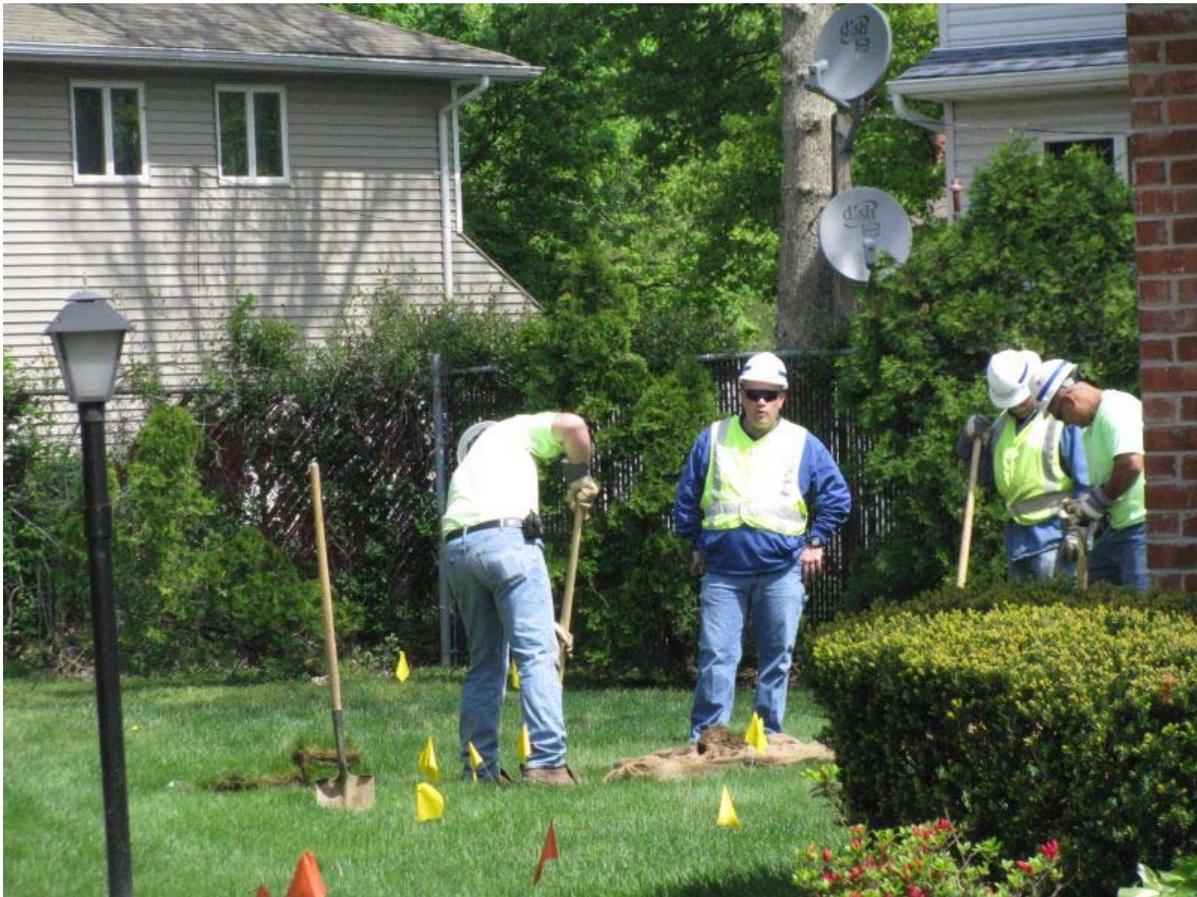
Site 12

Target 1 was not detected initially due to the lack of information about where to start investigation. However, the vertical section was detected within 12"-24" location accuracy with the actual target of the 2" gas main at 4' depth being verified at around 6' from the sidewalk.

Target 2 was not detected.

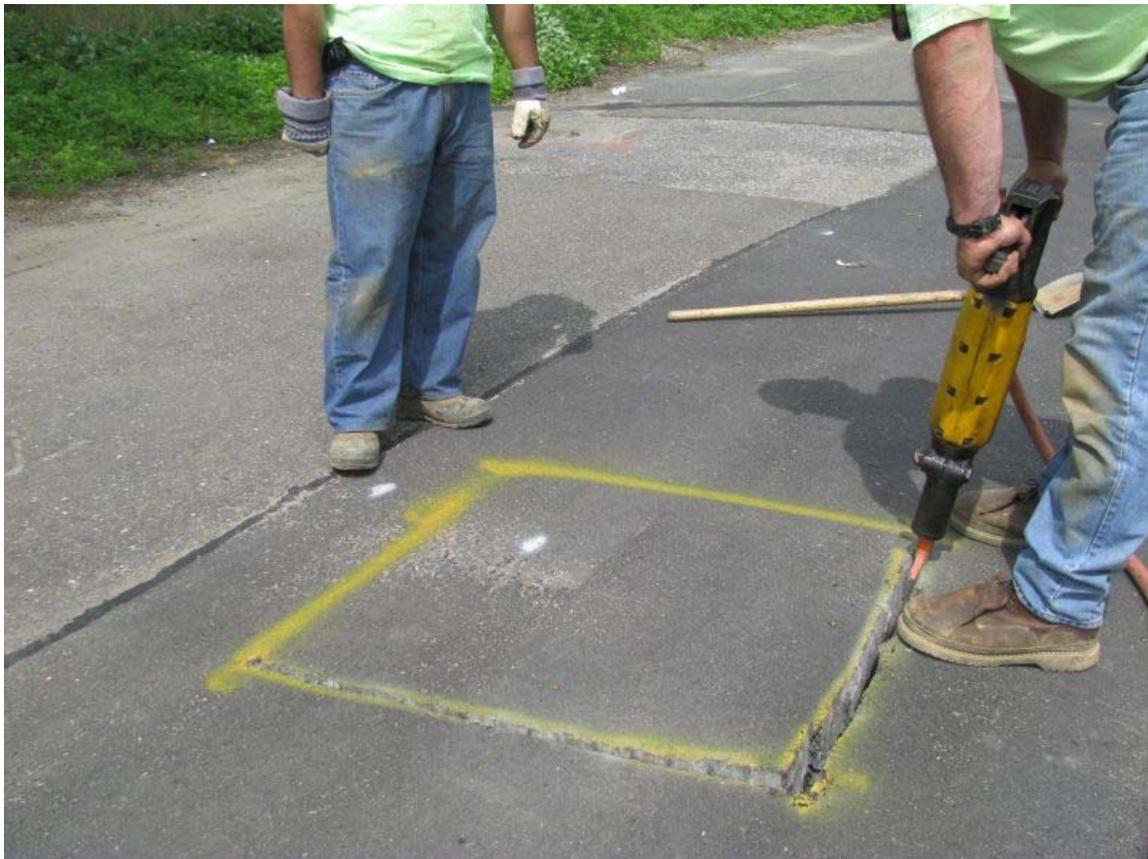
Site 13

<u>Date:</u> May 11 th 2009 – Day 6	<u>Time:</u> 1:30 pm	<u>Town</u> Bay Shore	<u>Site Name</u> 2 nd place
<u>Handheld Version:</u> Monostatic	<u>Number of Pipes:</u> 1	<u>Pipe Material:</u> PE	<u>Pipe Size(s):</u> 4”
<u>Surface Conditions:</u> Tarmac	<u>Soil Type/Condition:</u> Sand	<u>Weather:</u> Sunny/Overcast	<u>Verification Method:</u> Metrotech Dig/expose

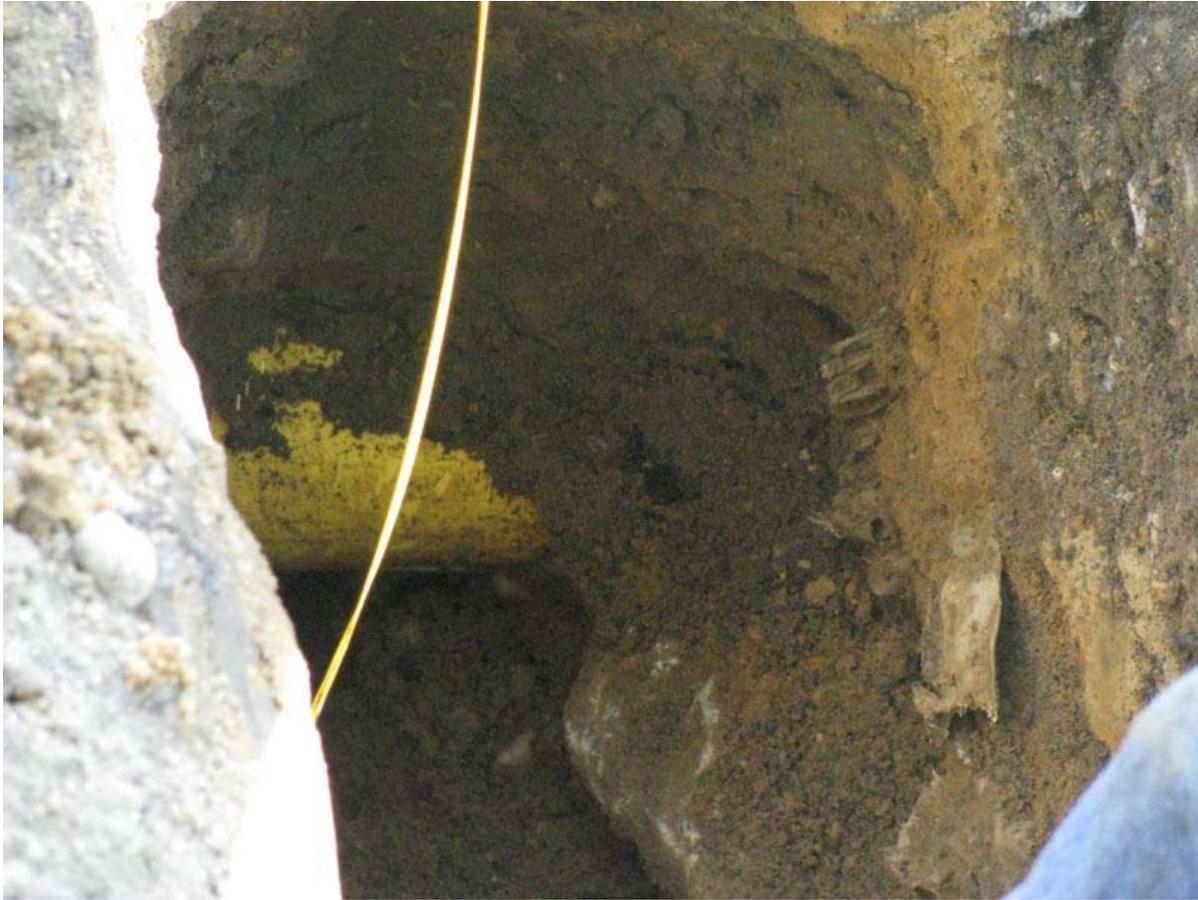
Site 13 4" PE main found at 2'2" depth

Upon digging the suspected area, a 4" PE main gas was found at depth of 2'2" and at approximately 14' from the edge of the road. Therefore, the accuracy of PH prediction against the actual was within 18".

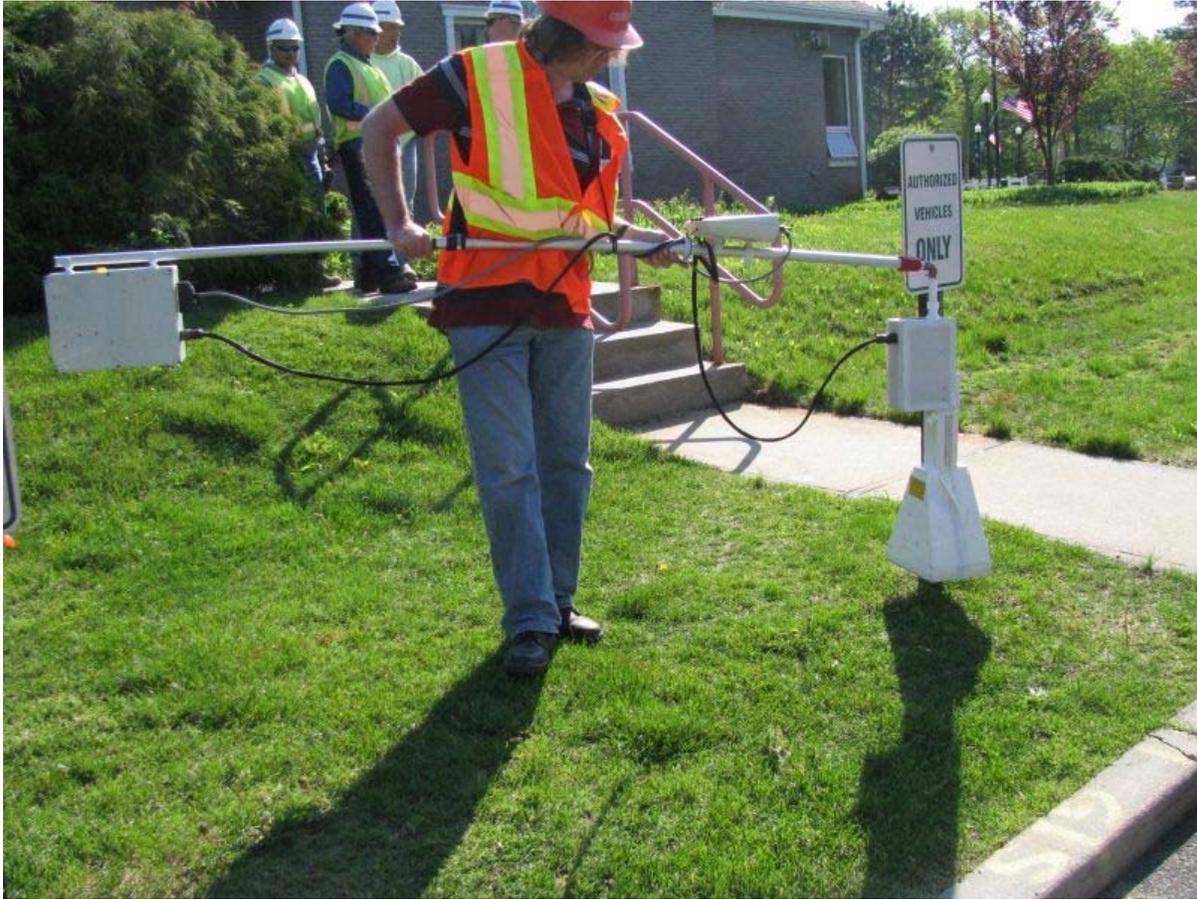
Site 14 Section 2

The indications shown by the handheld unit did not give a reliable pattern to indicate the position or direction of the pipe. The most likely reason is that the handheld unit was detecting the edge of the trench.

The area just outside the dirt area was excavated and it confirmed the existence of 1” main gas pipe that is 1 ft deep. Because of scatter in the handheld prediction pattern, no handheld prediction was considered accurate.

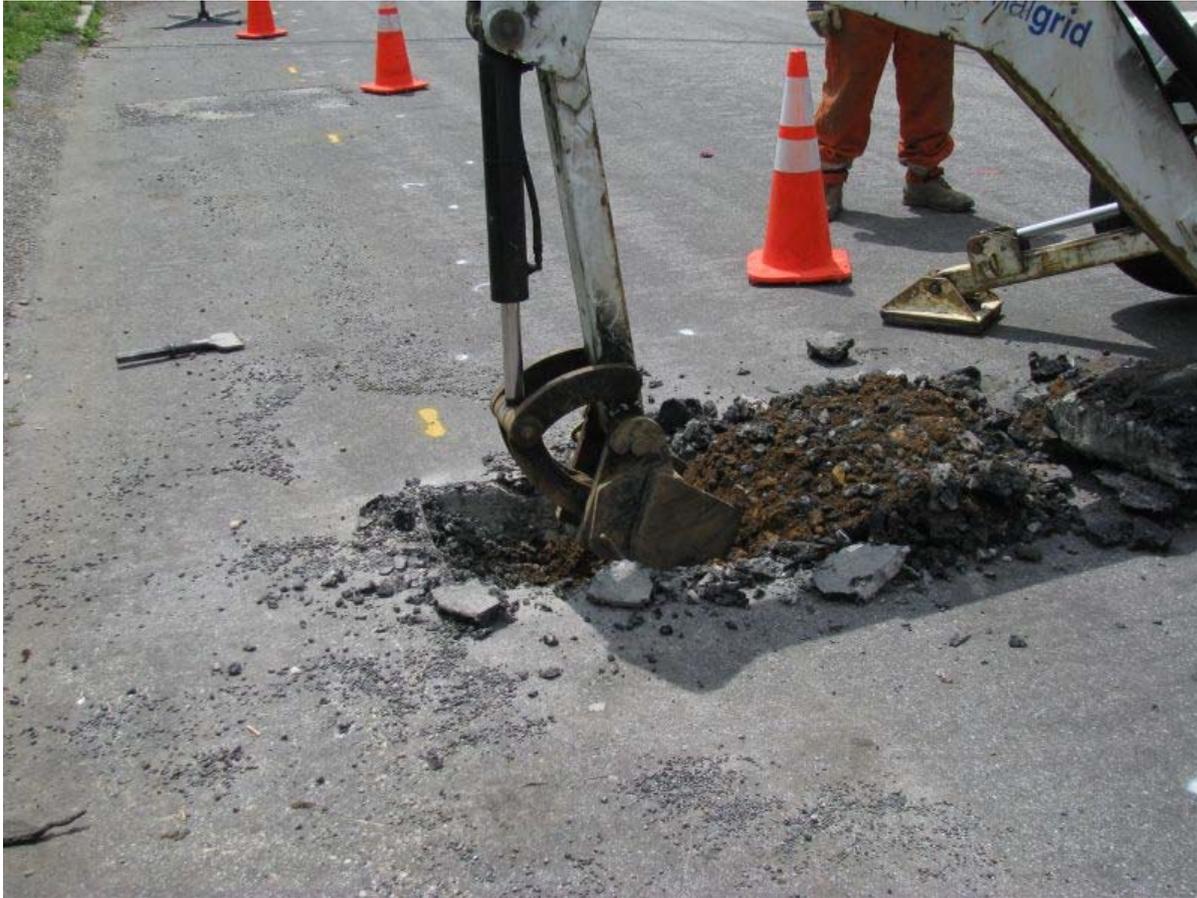
Site 15

The site is in a relatively quiet residential area in Powel Avenue, Islandia. The task was to follow the path of a main gas pipe starting from a valve cover around 3 feet from the edge of the road.

Upon excavating the area, it was found that a steel pipe of 2" is laid at depth of 3 ft. No utility was found to explain the presence of facilities beneath the two lines of indications as indicated by the handheld unit.

The bistatic antenna unit was also deployed but the results did not change.

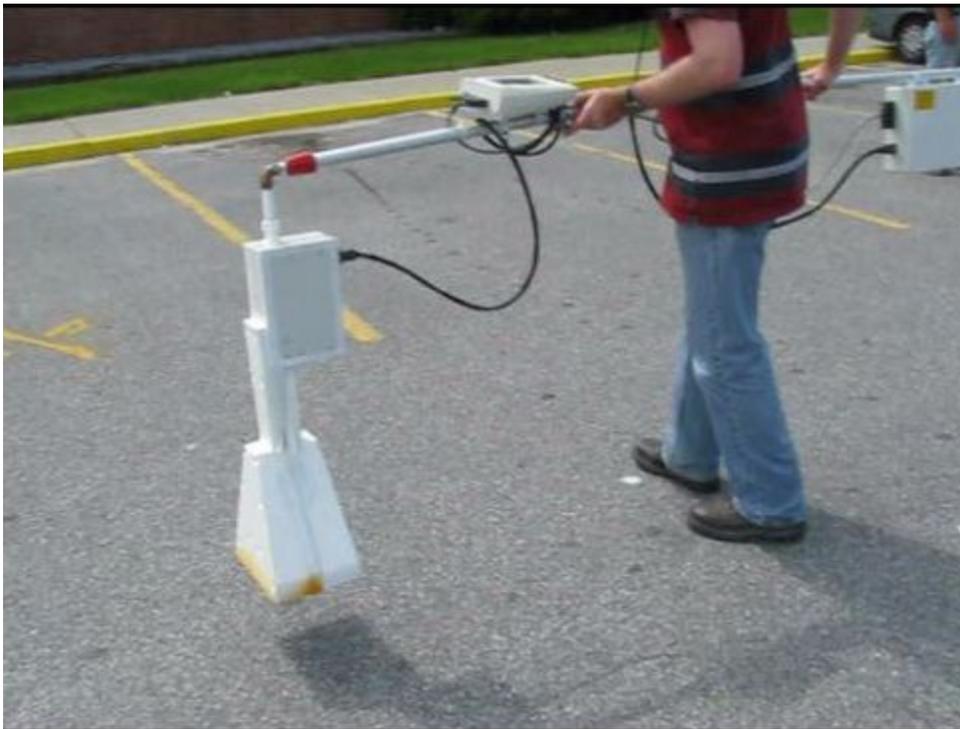
Site 16

Previously marked signs based on the Metrotech equipment were already on the ground and they indicated a line that runs across then changes the path at an angle of almost 45 degrees. (as shown in figure below)

The handheld unit survey started on the far end of the parking lot, and in most cases the indications were at within 6" to 12" from mark or lines as indicated by the Metrotech equipment.

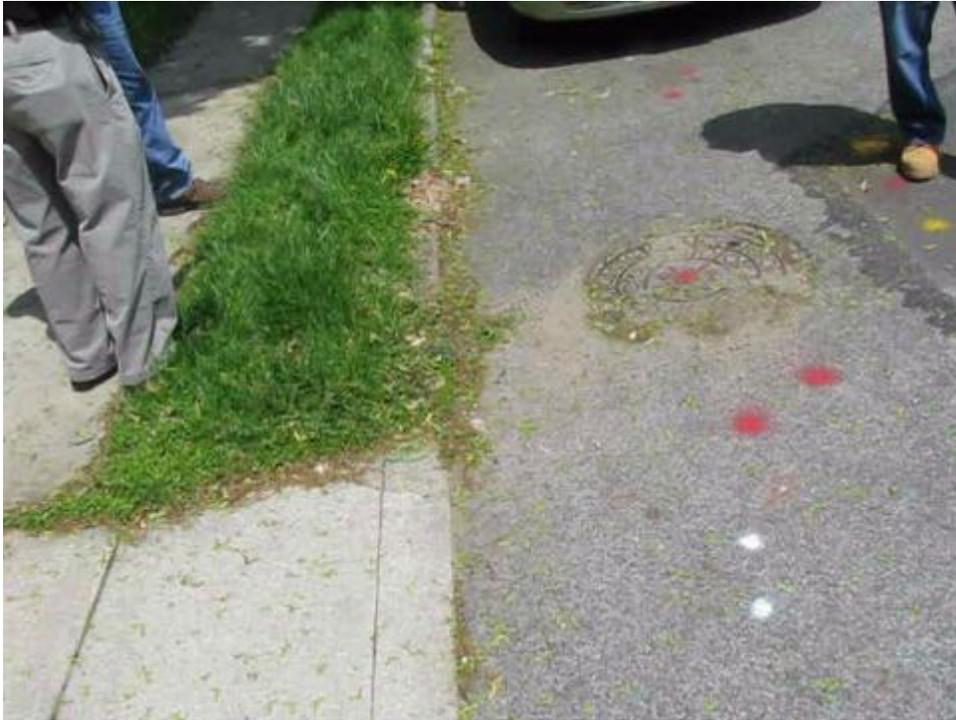
Site 17 Section 2

Upon utilizing the mono-static handheld unit, similar pattern of the two lines that were found in section 1 has been repeated here. And in the same manner as in section 1, the first line was at about 2 ft from the south curb and that is what is thought corresponding to the electric line. The second line was predicted to be at approximately 4-5 ft from the curb and was thought to be the PE gas pipe.

The verification that was available were previous scans as marked on the ground. The marks indicate an electric cable at around 2' from the curb, and a 2" gas pipe at around 4.5' from the curb.

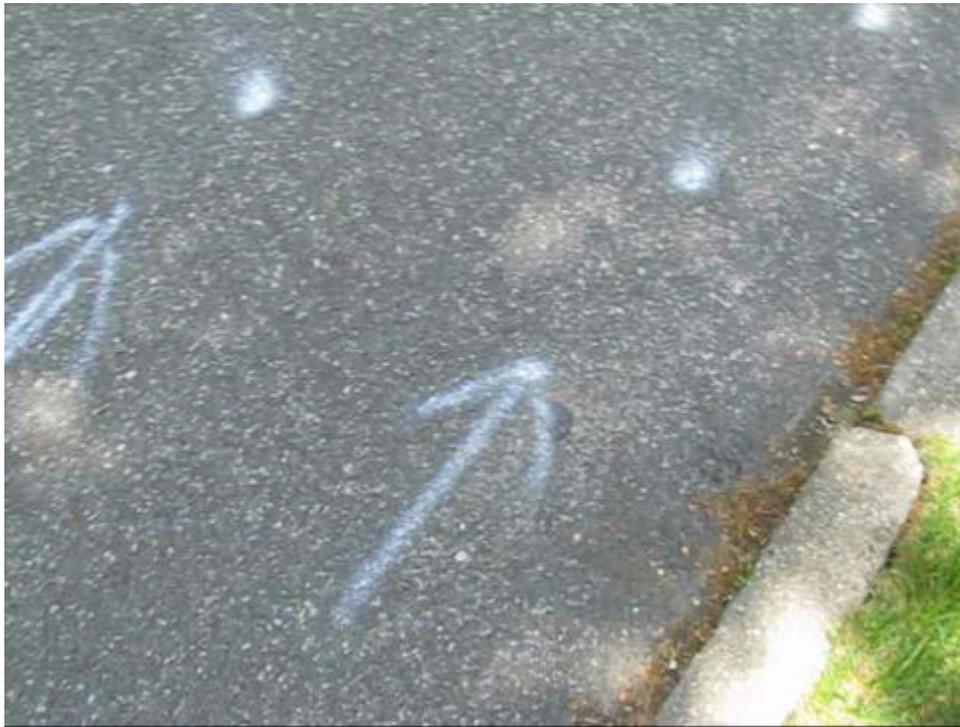
Site 18 Section 1

Three possible utility lines were identified by the handheld unit as possible targets as in the figure below. The potential target lines as indicated by the figure are at 1'6", 3ft and 5 ft north of the curb respectively.

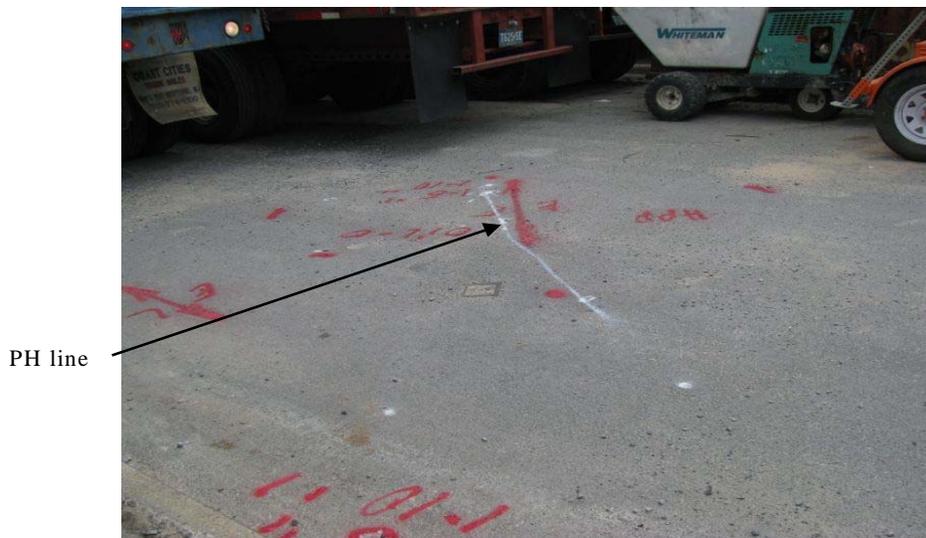
Site 20

The site is near a construction site and a sub-station.

According to an existing map of the area, there should be two steel pipes, of which the 10” carries a cable and cooling oil, and the other is 5” containing cooling oil but no cable (return oil).
