# **Colonial Pipeline Company**

## **Practical Experience on Addressing the Assessment & Management of Dents**

**USDOT PHMSA 2018 R&D Forum  
Baltimore, MD  
September 11, 2018**

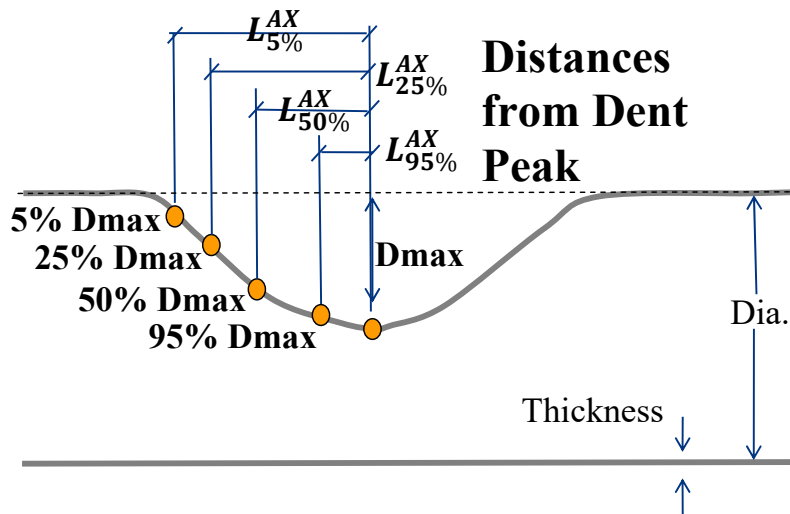
## PRCI Dent Shape Parameter Specification

- PRCI MD 4-9 Technical Note
- Develop shape parameter using characteristic lengths measured across the dent profile
- Use calculated shape parameters, pipe grade, and SCADA data to rank shape severity (L1) and /or fatigue severity (L2)
- L3 – full FEA; complex shapes

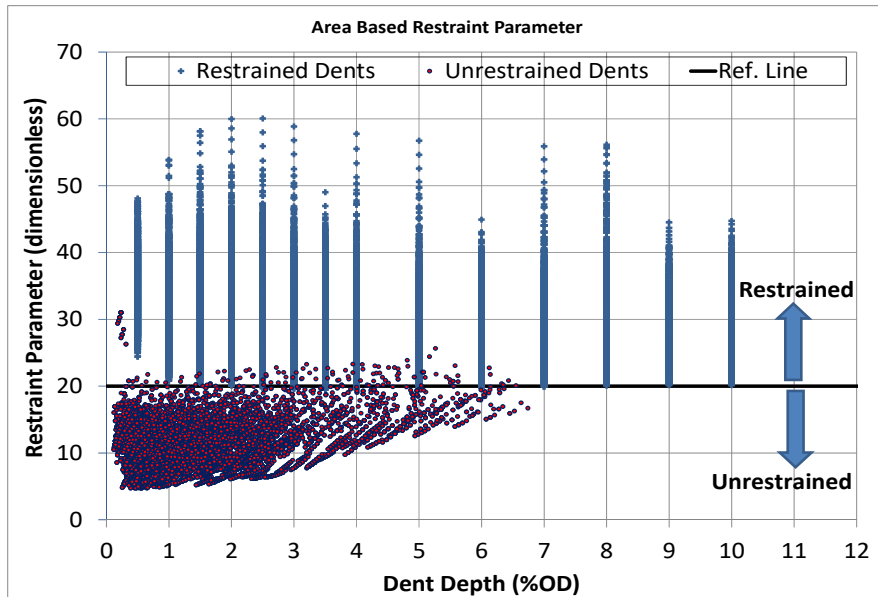
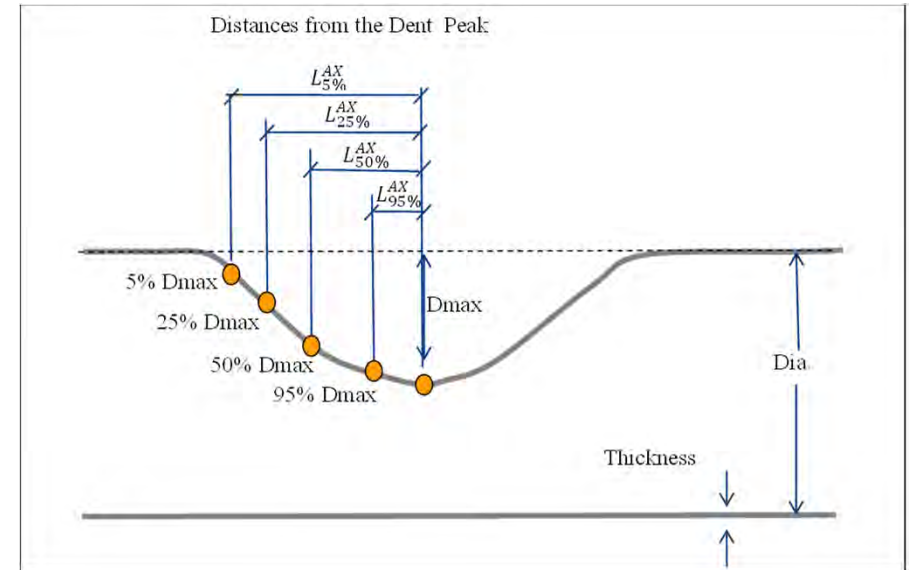
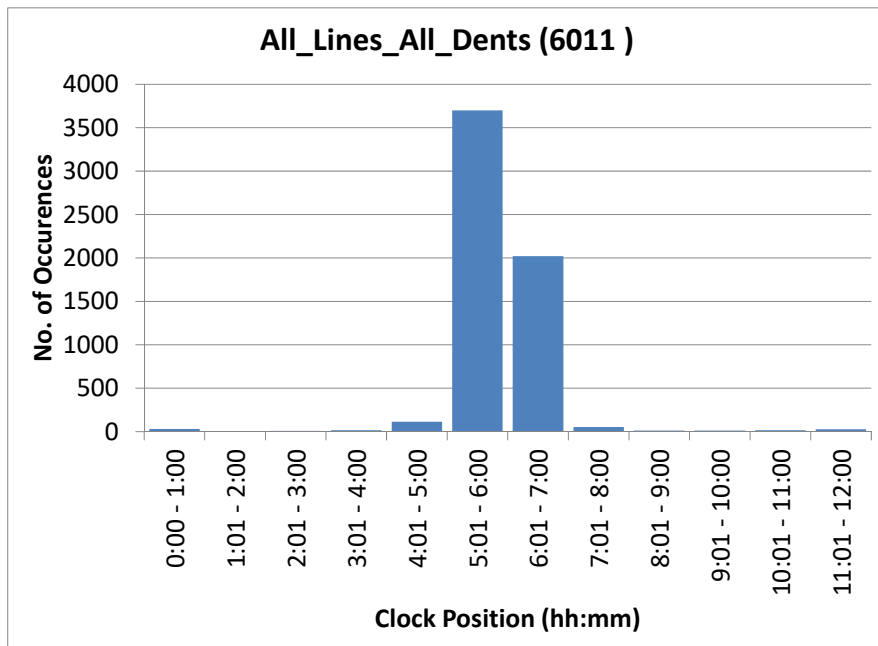
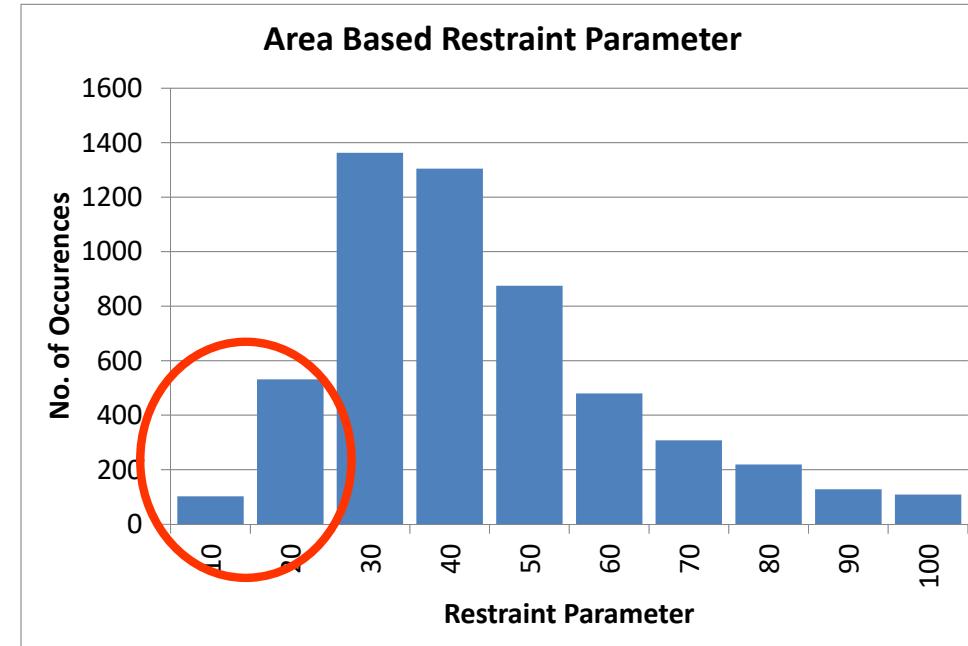
# Analysis of Restraint Condition

- Dent restraint parameter – restrained vs. unrestrained affects fatigue life
  - Restrained – longer life
  - Unrestrained – reduced life
  - Bottom-side dents have higher restraint potential
  - Previously excavated dents: restrained and unrestrained

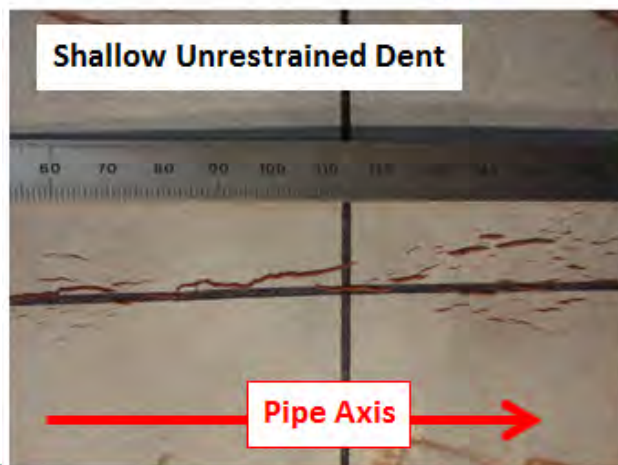
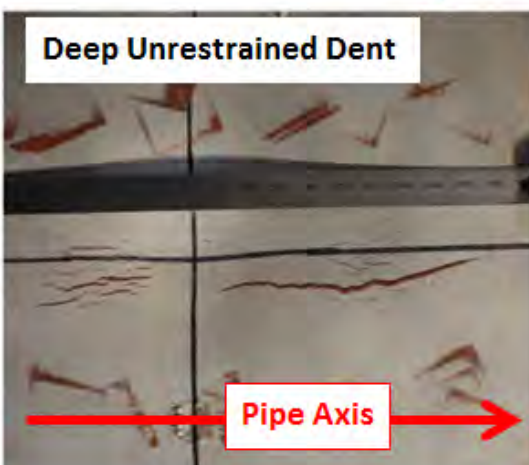
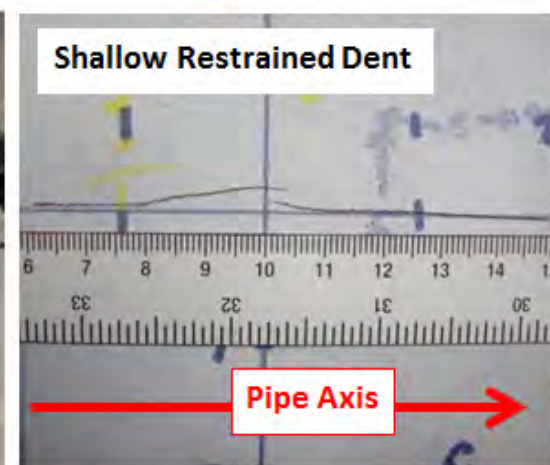
## Dent Fatigue Crack Location, Orientation and Surface

Dent Type	Depth	Shape	Crack Location	Orientation
Restrained	Deep (> 5%)	Blunt or Sharp	Axial Shoulder (one or both) ID Initiation	Circumf.
Restrained	Shallow ( $\leq 2\%$ )	Blunt or Sharp	Center of dent ID Initiation	Axial
UnRestrained	Deep (> 1.5%)	Blunt or Sharp	Axial Shoulder OD Initiation	Axial (Multiple)
UnRestrained	Shallow ( $\leq 1.5\%$ )	Blunt	Center of dent OD Initiation	Axial (Multiple)
		Sharp	Axial Shoulder OD Initiation	Axial (Multiple)

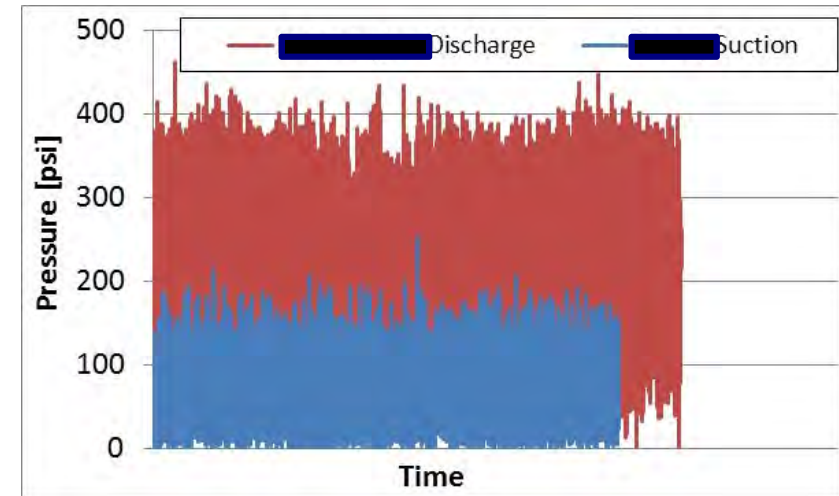
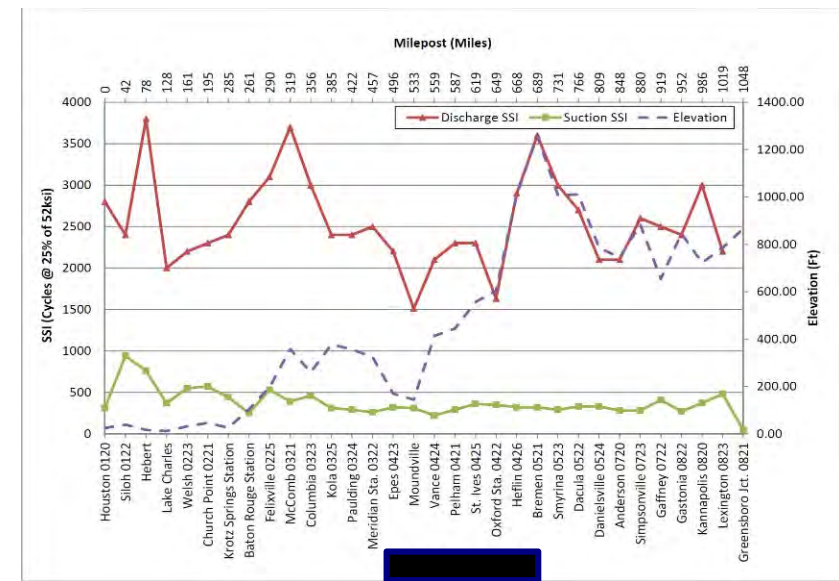
## Pressure Cycle Management

- # of cycles and magnitude of cycling loading influence dent fatigue failure
- Pressure attenuation – discharge vs. suction
- Liquids operations vs natural gas
- Pressure cycling references in regulations
  - *Absent in PHMSA Proposed Final Rule (49CFR § 195)*
  - *Included in PHMSA Advisory for natural gas lines (ADB 2016-0131)*

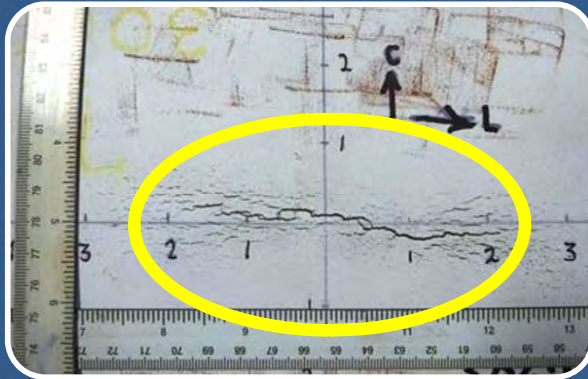
3<sup>rd</sup> Dent (Fatigue Test)

- Fabricated dent  
24" indenter, 1.1% deep
- Smooth dent profile
- 90 psi to 540 psi
- Unrestrained dent
- Center of dent axis
- **455k cycles to failure**

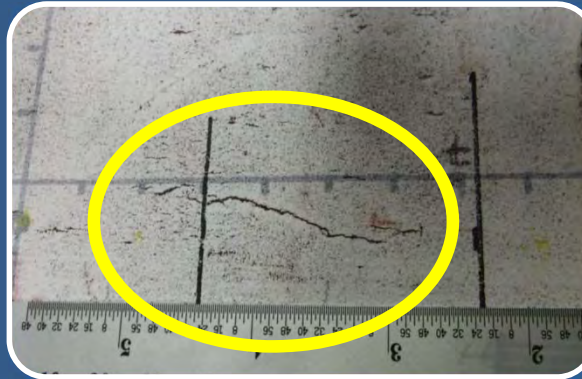
Un-cracked Dent  
(Fatigue Test)

- In-service, bottom-side dent: 1.6% deep
- Smooth dent profile
- 90 psi to 365psi\*
- Previously dug and remediated (2002)
- Restrained & unrestrained
- Near dent peak

• **108k cycles to failure**

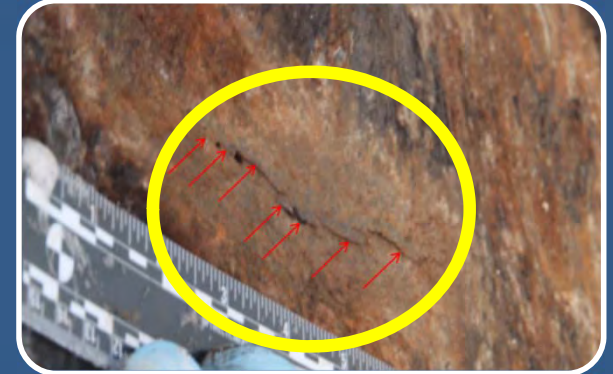
Leak Site  
(failed in-service)

- In-service, bottom-side dent: 1.6% deep
- Complex shape
- 365 psi max
- Previously dug and remediated (1994)
- Restrained & unrestrained
- Near dent peak

• **12k cycles to failure**

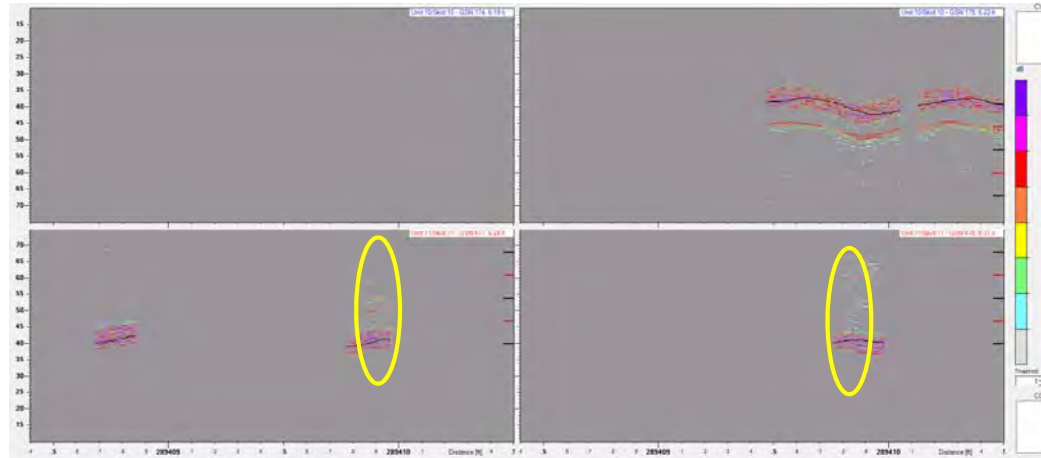
## 2014 UT ILI

- Single reflector only
- Only CCW
- Not seen on skip
- Weak signal

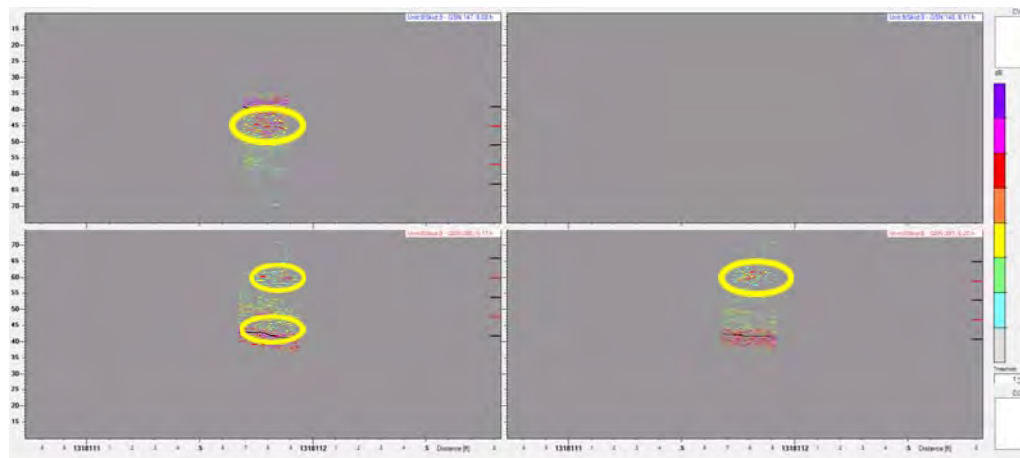
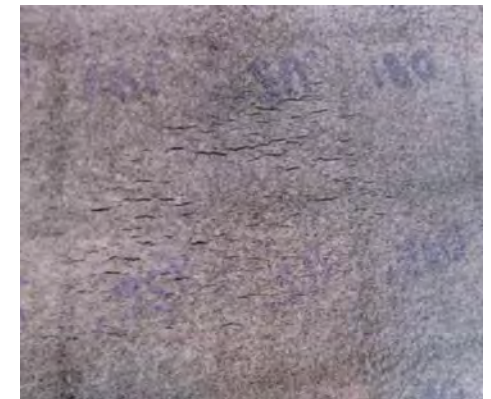
## 2015 UT ILI

- Multiple reflectors present
- CW\CCW
- Seen on ultrasonic skip
- Strong signal
- Called crack by ILI

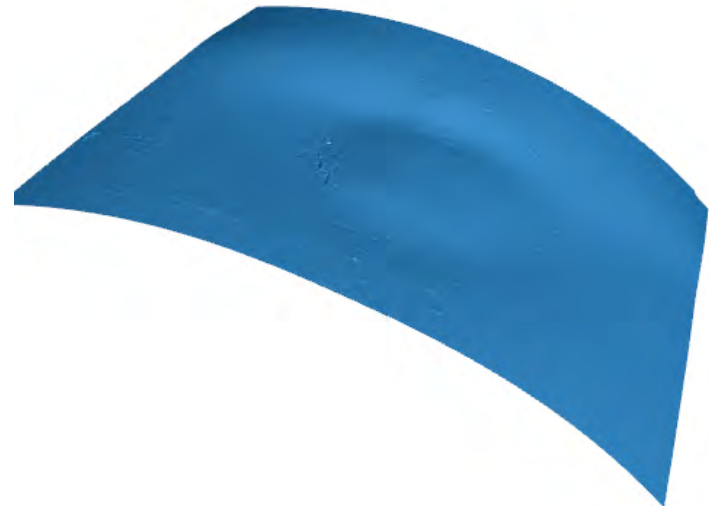
# NDE Methods – Dents and Cracks

- Document deformation profile in grid system
  - Minimum grid points
  - Deepest & most prominent locations
- Magnetic Particle dent and 12" surrounding
- Cracks are sized using shear wave or phased array – **internal cracks**
- If no findings during MP, shear wave or phased array
- 3D scan/profile
  - Compare to ILI – SP and RP
- NDE research
  - Multiple NDE vendors sizing cracks, destructive testing for confirmation
  - PRCI MD 1-13
