# R&D Related to Anomaly Characterization and Assessment at GTI

Chris Ziolkowski  
Gas Technology Institute

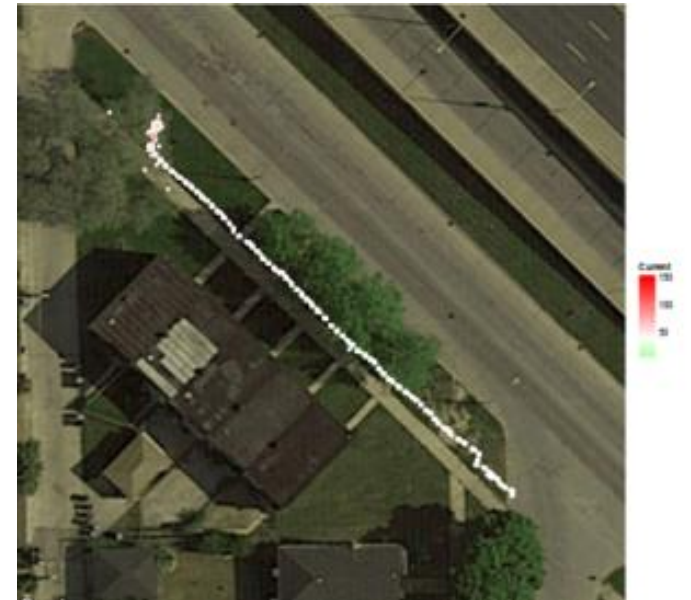
- > Assess the state of metallic pipe/coating system without excavation.
- > Locating, assessment, and mapping are now separate activities.
- > Simplify the work flow by doing all in a single pass.

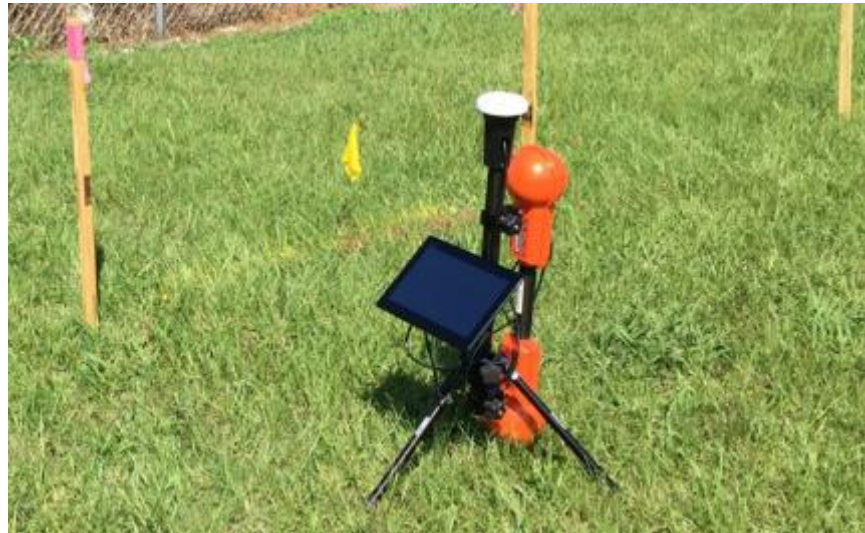
- > The Spar-300 sensor system provides GNSS location and 3-axes of EM field data
- > Captures the EM field in 3 dimensions to triangulate pipe location

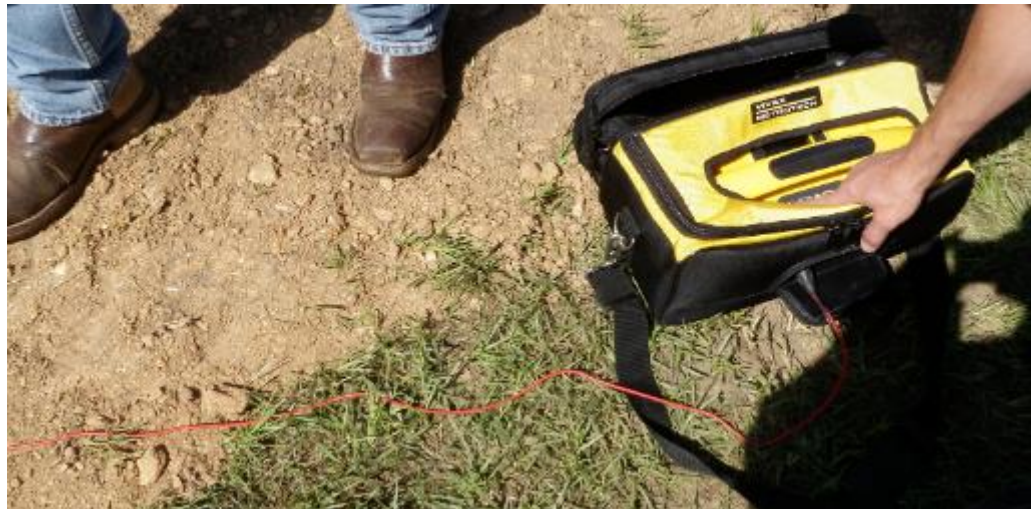
- > Knowing pipe location allows changes in position or depth to be distinguished from real pipe/coating flaws
- > Need to tie into the pipe in order to inject a known signal

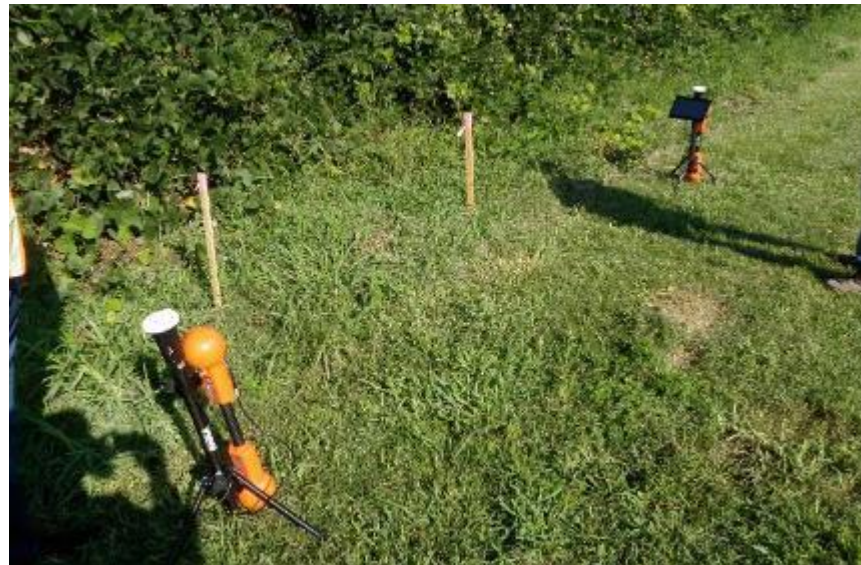
- > Two Spar systems are used in tandem to capture phase shift.
- > Both are moved along the pipe; the distance between them is automatically captured.

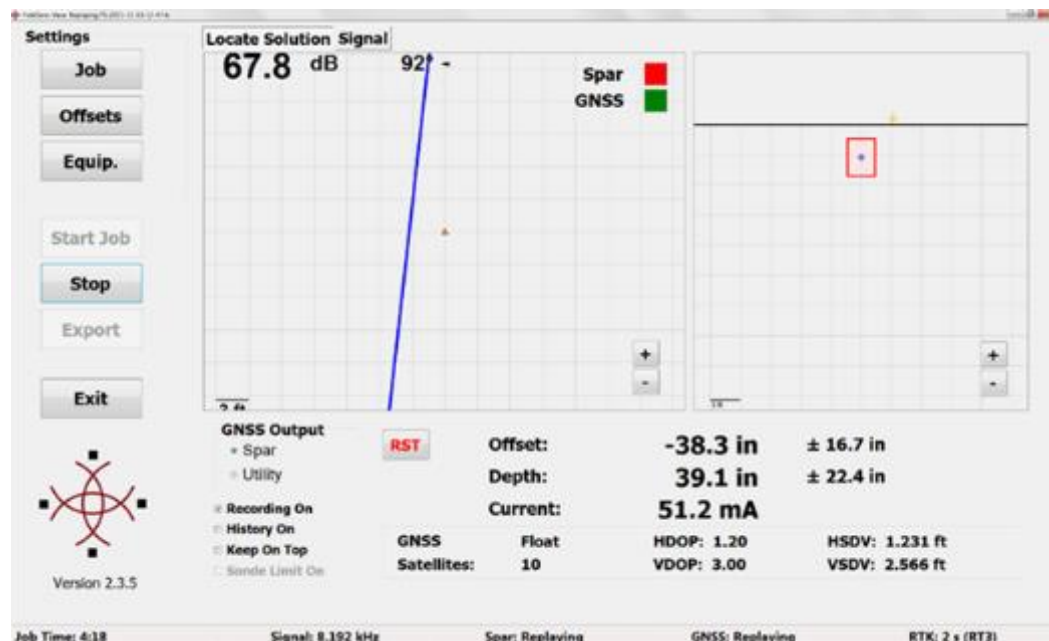
- > Live survey data is viewed on tablet/laptop
- > The operator can see estimated pipe location and other parameters with error bounds

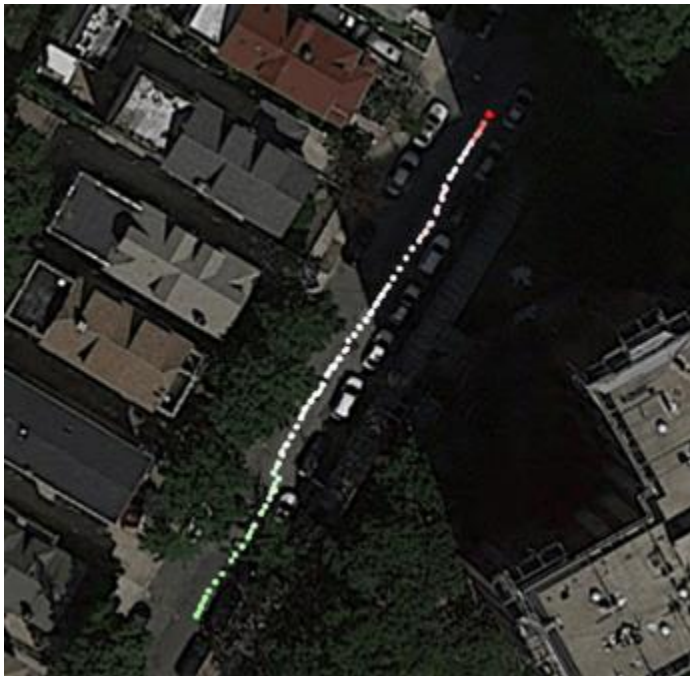
# Example Current Data #1

- > The current data in mA shown both in map and plot

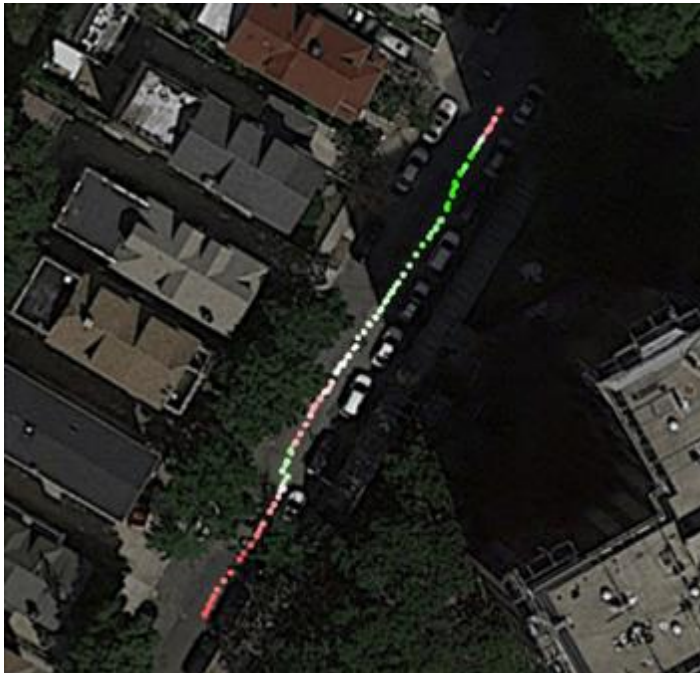
# Example Phase Data #1

- > The phase data shows an interesting feature both in map and plot

- > At this site there was an area of loose coating located at the point indicated by the phase data, and to a lesser extent by the current data.

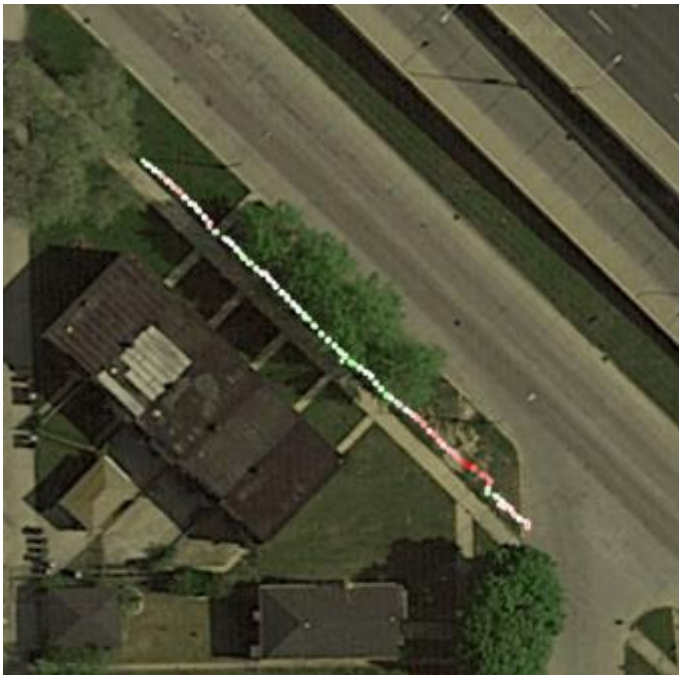
# Example Phase Data #2

- > The phase data shows a feature in the SE area of the map

- > At this site there were culvert sections over a shallow portion of the pipe for protection
- > These changed the “shape” of the system and caused the phase shift

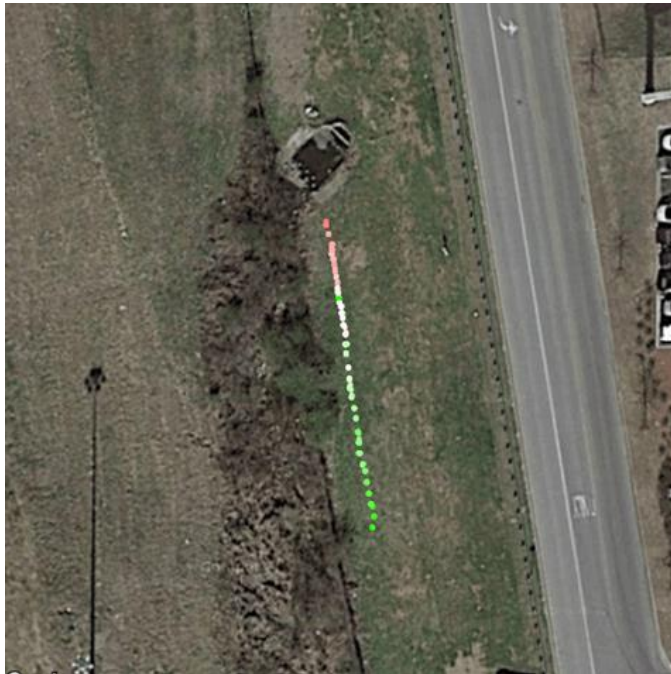
# Example Current Data #3

- > The current data shows a small change in slope partway through the survey

- > Two extremely small coating holidays were found in the designated area and repaired
- > Dig was primarily based on the ACVG indicators

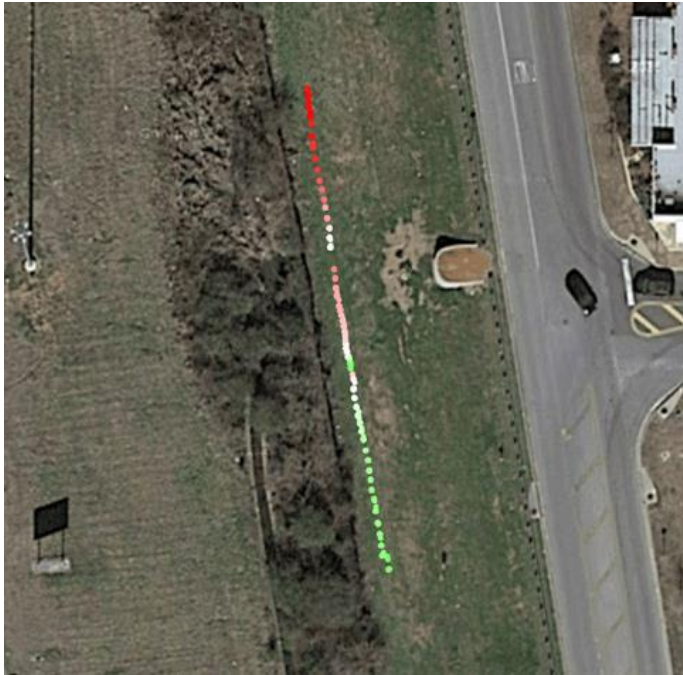
# Example Current Data #4

- > The current data shows several interesting transitions

- > Nothing was found when this site was excavated!
- > Both the ACVG and Spar surveys gave indications.
- > Did both techniques produce a false positive?
- > Is there some underlying structure producing these signals?

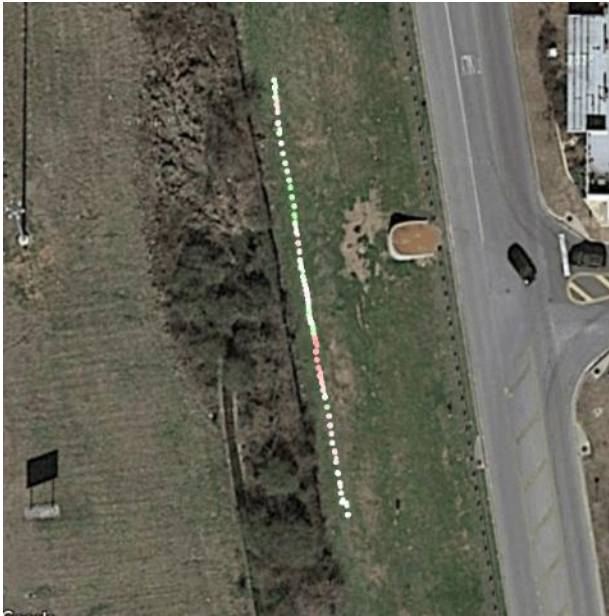
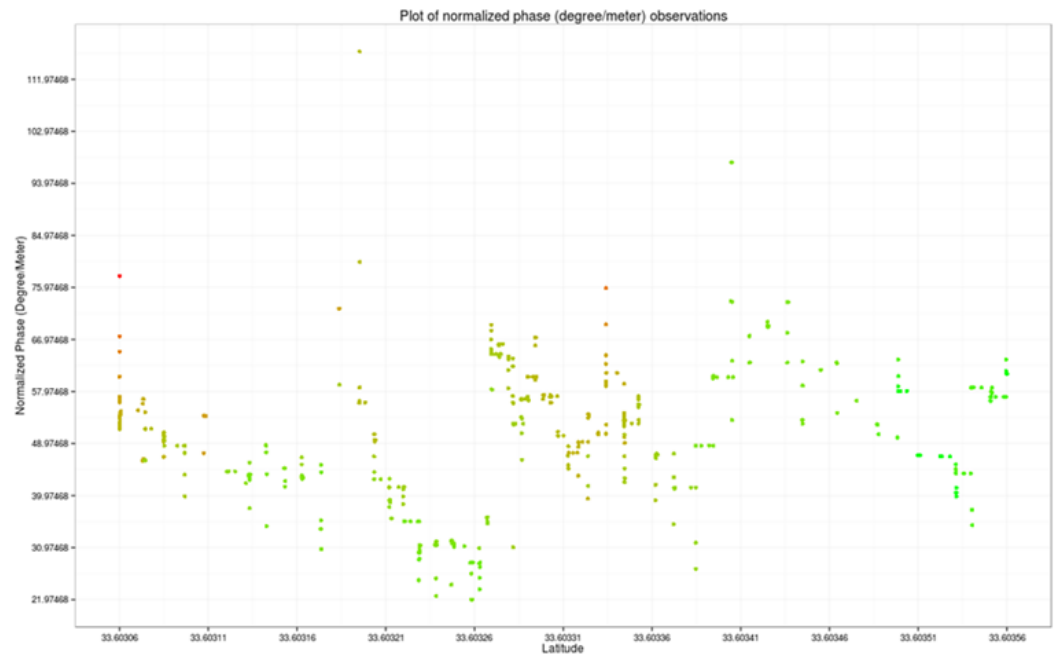
# Example Phase Data #4

- > The phase data also shows transitions that align geographically with those in the current

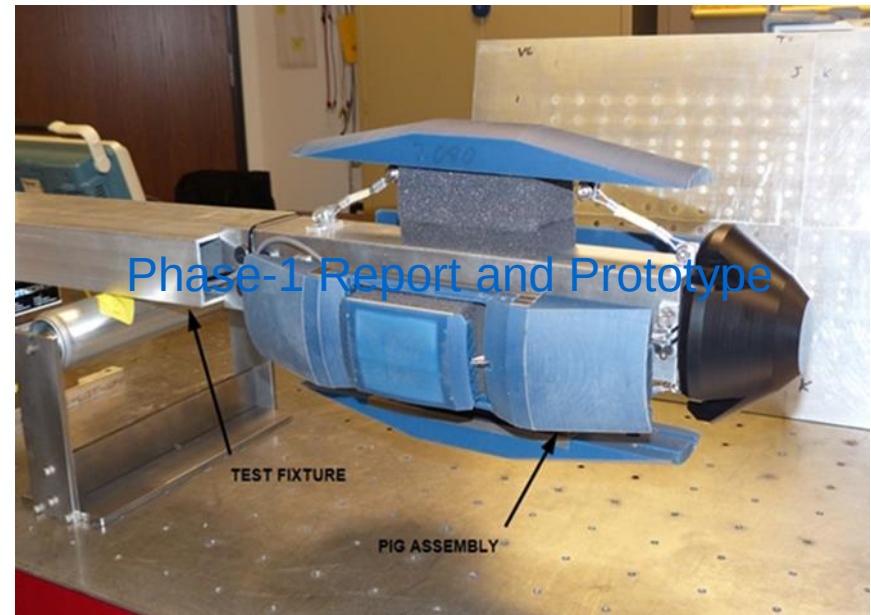
This project builds on Phase-1 of the development of the Electro-Magnetic Acoustic Transducer (EMAT) technology by GTI and Quest Integrated (Qi2).

- The objective of the project is to build and test an EMAT sensor prototype to detect flaws and quantify longitudinal cracks in metallic pipes.
- The sensor will be used to assess small-diameter and unpiggable pipes. The initial target is a prototype for 8-inch pipe diameters.
- Enable natural gas pipeline operators of smaller diameter pipe to identify and size crack defects, which are traditionally difficult to find and assess; and therefore improve system integrity and public safety

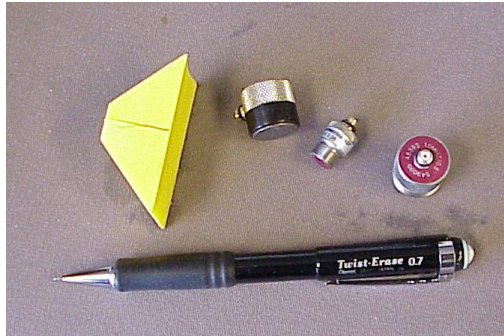
# UT Fusion Inspection Development

- > Built on issues and experience generated by several organizations including McElroy, GTI and others
- > Added pitch/catch sensor to pulse/echo to obtain more information on joint quality
- > Parametric model based on propagation paths rather than neural networks
- > Took advantage of advances in ultrasonic and signal processing

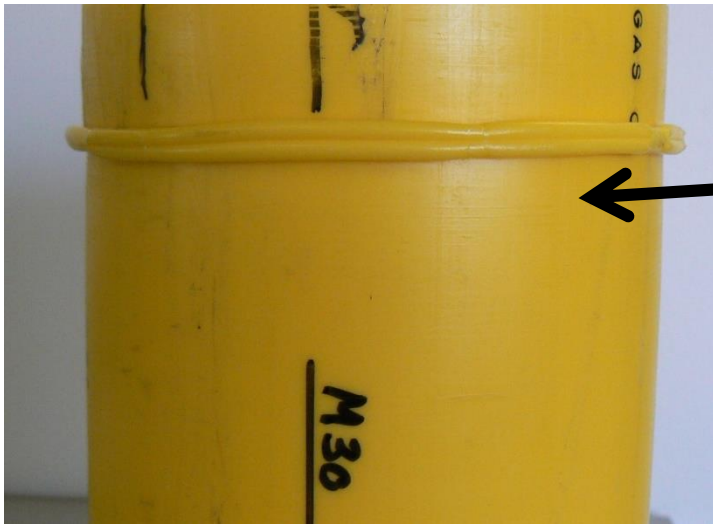
Prepared and heated properly, waited 15 seconds before squeezing

Part of joint failed

Part of joint didn't fail

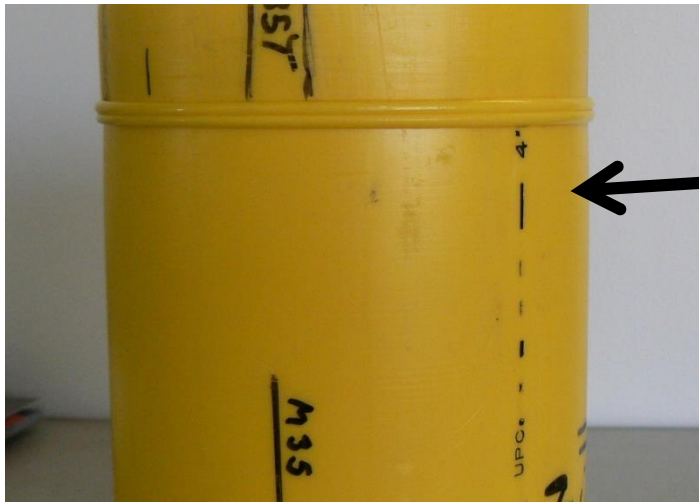
Shortened heating cycle to 45 seconds and didn't press hard enough

Failed at fusion plane

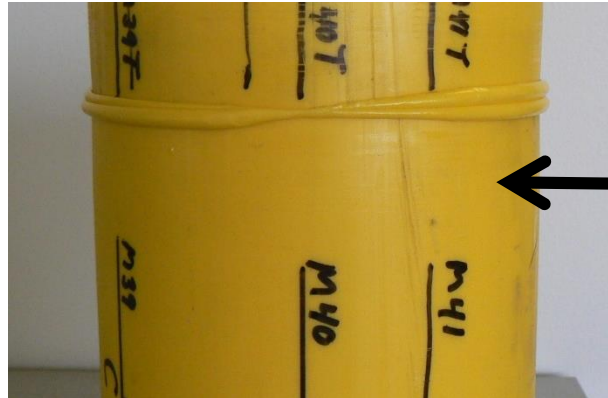
Proper procedure except  
one side not faced

Partial failure at fusion plane
