**Before the  
U.S. Department of Transportation  
Pipeline and Hazardous Materials Safety Administration  
Office of Pipeline Safety**

| Tennessee Gas Pipeline Co. | ) | CPF No. 4-2019-1007 |

**WITHDRAWAL OF REQUEST FOR HEARING**

## ATTACHMENT A

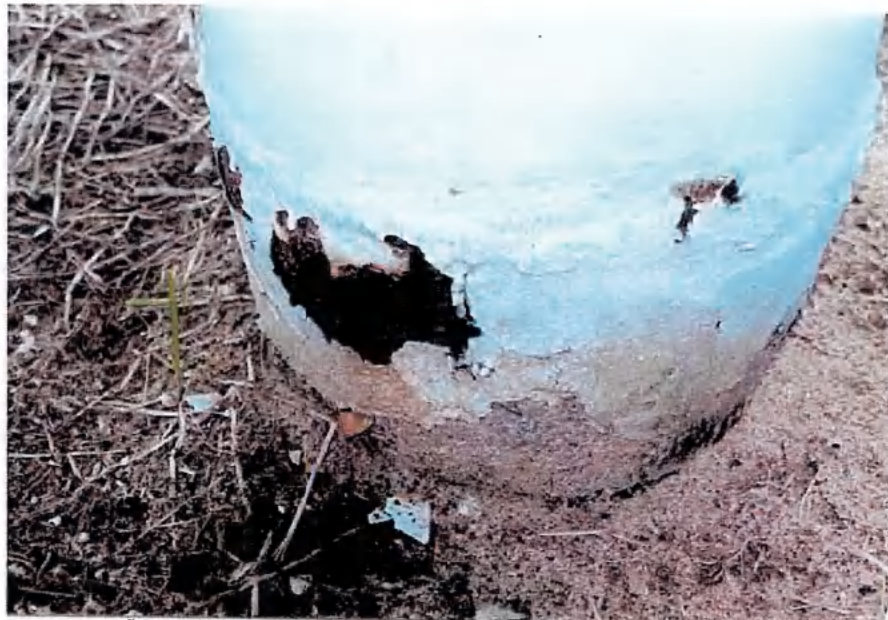
Photograph 1 - Example of piping with **Poor** atmospheric condition

Photograph 1 shows pitting around the air/ground interface of the pipe that measured approximately 20 mils in depth. Although the paint on the rest of the piping at this inspection unit is in **Good** condition, the pitting with wall loss is the criterion that moves this unit into the **Poor** category.

1. Piping within an inspection unit that has greater than 10% light surface oxide over the entire surface area, without regard to the condition of any coating in the inspection unit (for units larger than 10 linear feet of pipe, any continuous segment of approximately 10 linear feet of pipe with greater than 10% uniform surface corrosion) or,
2. the presence of any degree of pitting or scale corrosion where a measurable amount of wall loss has occurred.

An inspection unit graded as **Poor** must be re-coated or remediated in accordance with the timing indicated in [O&M Procedure 918 Inspecting for Atmospheric Corrosion](#). If an inspection unit is graded as **Poor**, grading it as **Fair** or **Good** during future inspections requires either documentation of remediation, or additional documentation (e.g. photos) to justify the upgrade in condition.

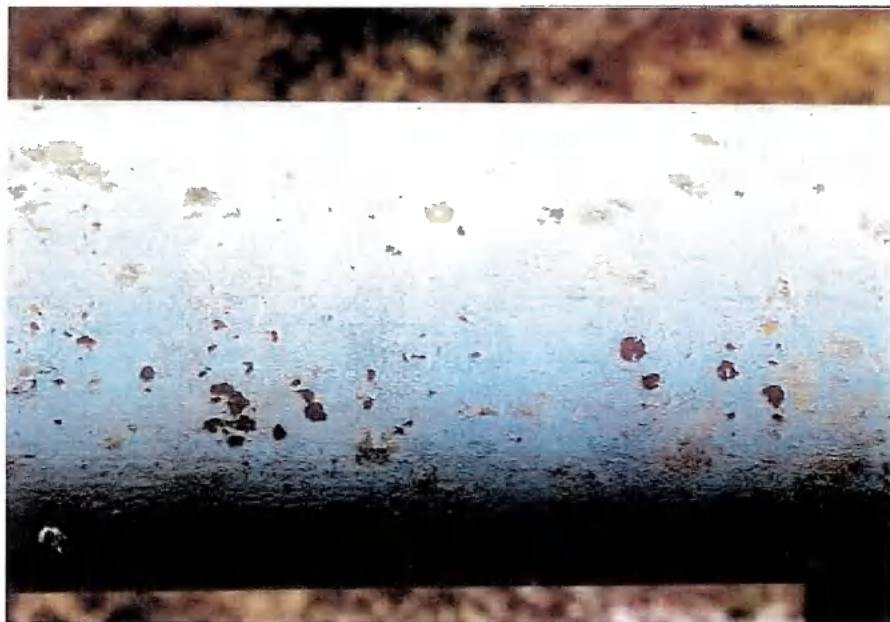
**Photograph 2 - Example of piping within limits of Fair atmospheric condition**

Photograph 2 shows pipe with paint that is flaking and general rusting on pipe is less than 10% of overall surface area. This piping is within the constraints of the above description for **Fair** atmospheric condition.

1. Deterioration of the coating system where coating is cracking, flaking, peeling, or disbonding that does not meet the criteria for **Poor**, or
2. deterioration of the topcoat that exposes the primer more than 10% of the surface area of the inspection unit evaluated (for units larger than 10 linear feet of pipe, any continuous segment of approximately 10 linear feet of pipe with greater than 10% exposed primer).

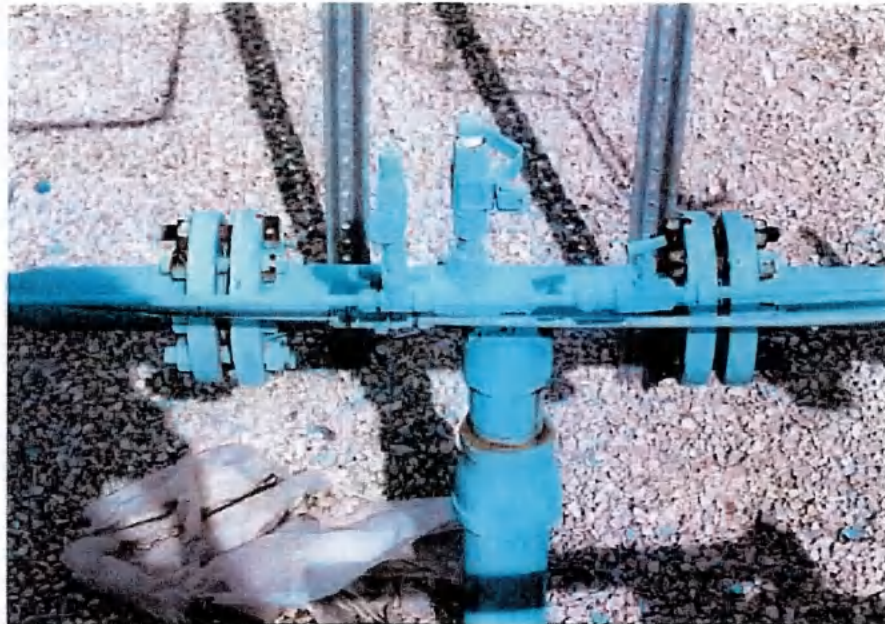
**Photograph 3 – Example of piping within limits of Good atmospheric condition**

Photograph 3 shows minor surface rust on nuts and bolts due to prior maintenance operations. The coating on the rest of this inspection unit is well bonded with only minor chalking. Spot painting these isolated areas can easily mitigate minor rust on these bolts.

1. A coating system that is well bonded and intact, and
2. topcoat degradation that is limited to chalking, and
3. atmospheric corrosion that is limited to minor surface corrosion in flanged areas, nuts, bolts, and areas affected by routine maintenance operations and does not meet the criteria of **Poor** or **Fair**.
