# CAAP Quarterly Report

Date of Report: *Sept. 1, 2015*

Project Title: *Scaling and Self-Sensing in Composite Repairs of Corrosion Defects*

Prepared by: *The University of Tulsa*

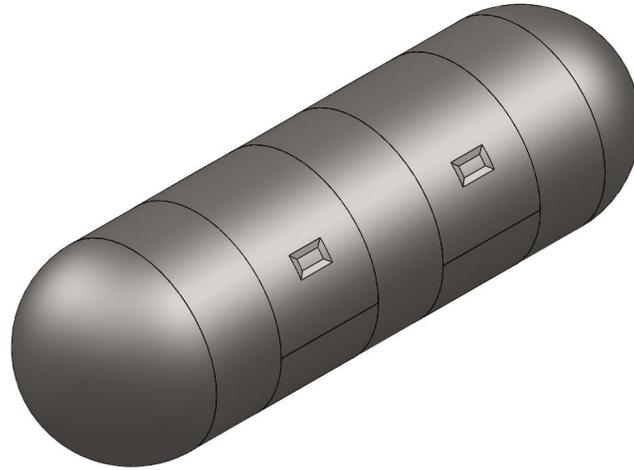
A schematic drawing of the large scale test specimen is shown below in Figure 1 and indicates weld lines and flaw locations. Two vessel heads were purchased last quarter and have arrived. The flaws have been machined and are scheduled to be welded and rolled in the next week.

**Figure 1: Schematic overview of large-scale (42" diameter) pressure vessel.**

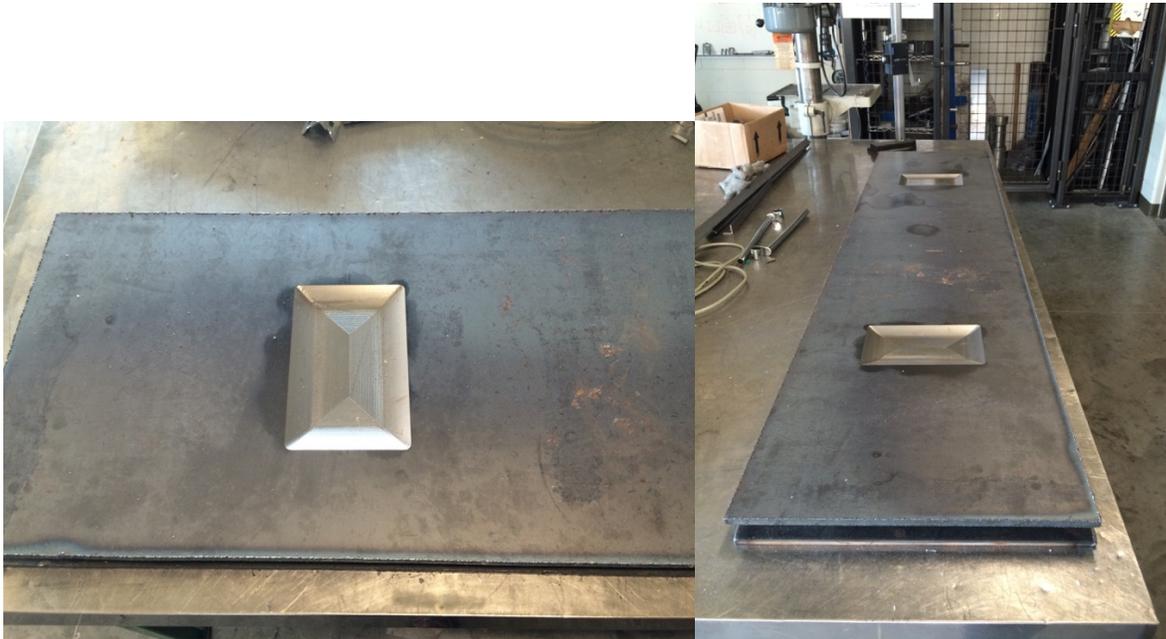
**Figure 2: Images of machined flaws in plate prior to rolling and welding**

Figure 2 shows the machined flaws in the plate prior to rolling and welding for vessel fabrication. The longitudinal welds will be completed using a subarc system and will be x-ray inspected to ensure complete penetration. The tube section of the pipe will be welded and then re-rolled if necessary. We expect this to be completed within the month.
