CAAP Quarterly Report

Project Title: *Advancement in the Area of Intrinsically Locatable Plastic Materials*

Prepared by: *West Virginia University, Constructed Facilities Center (WVU-CFC)*

For quarterly period ending: *June 30, 2016*

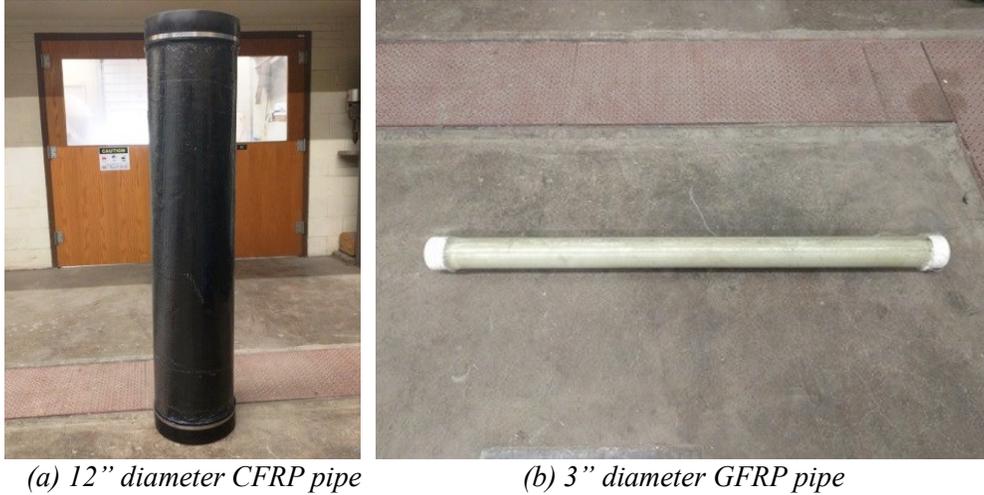
Figure 1: Composite pipes fabricated for use in this research

In addition to the materials procured in the first two quarters, 12” and 6” diameter plastic (PVC) pipes and caps were acquired. Fabrication of 12” diameter Carbon Fiber Reinforced Polymer (CFRP) composite pipes and 3” diameter Glass Fiber Reinforced Polymer (GFRP) composite pipes was also completed in this quarter. Samples of the GFRP and CFRP pipes are shown in Figure 1.

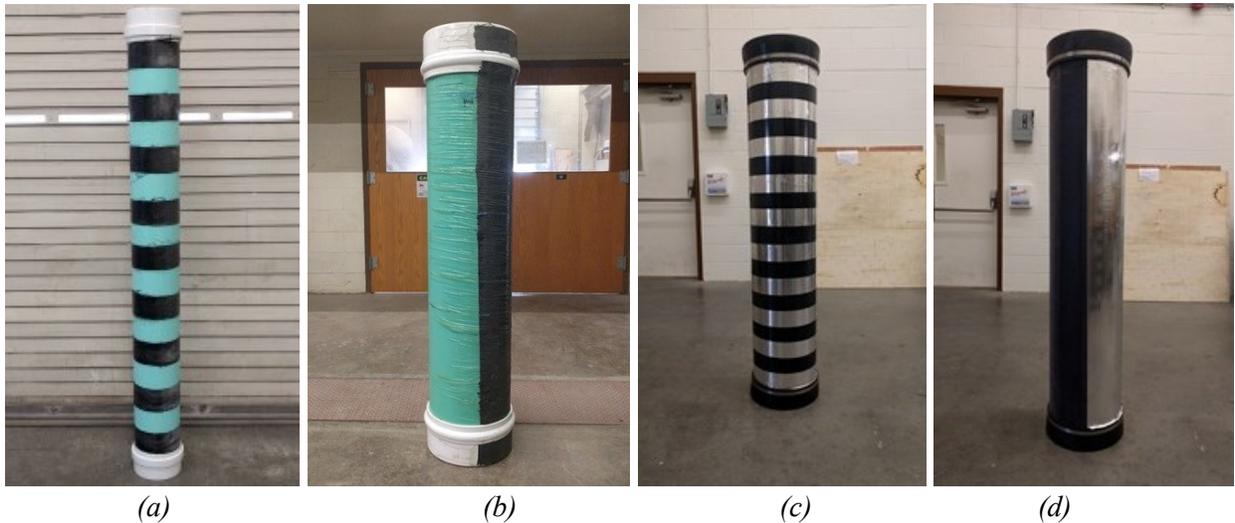
Figure 2: Completed (wrapped) pipes: (a) 6" diameter PVC with carbon fabric rings, (b) 12" diameter PVC with carbon fabric strip, (c) 12" diameter GFRP with metallic rings, and (d) 12" diameter GFRP with metallic strip

Preparatory works (including cutting, surface grinding, and sanding) on additional pipes were completed over the past months. The surfaces of the pipes were sanded to enable adequate bonding with the CFRP fabric during wrapping. CFRP fabric and metallic tapes acquired in the last quarter were used to wrap PVC and GFRP pipes to improve Ground Penetrating Radar (GPR) detectability of these pipes. Some of the PVC and GFRP pipes were not wrapped, and will serve as control specimens during GPR detectability testing of the samples. Some of the wrapped pipes are shown in Figure 2.

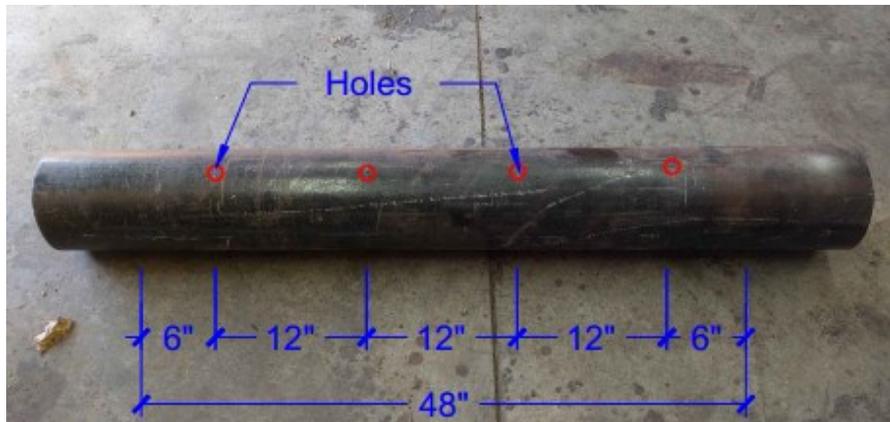
Figure 3: Steel pipe with sixteen 1/8" holes drilled

Additionally, 48"x24"x51" soil box for leak detection (from buried pipe using Fourier Transform Infrared Spectroscopy (FTIR) testing) has been built and filled with soil. Before the wooden box was filled with soil, a steel pipe with sixteen 1/8" diameter holes drilled into the pipe (4 groups of holes along the length of the pipe and 4 holes per group at each quarter point along the circumference of the pipe as shown in Figure 3) was inserted in the box as shown in Figure 4. The steel pipe will enable other pipes (PVC, GFRP, CFRP) filled with the appropriate liquid or gas to be slid in and out of the soil with ease. The 1/8" diameter hole will enable any escaped gas to move through the soil and be detected using FTIR. One undergraduate student majoring in Chemical Engineering has been working on this aspect of the project. The soil filled box will be used in the coming months to investigate the possibility of buried pipe detection using FTIR by collecting and analyzing air samples. The same soil filled box will be used to investigate the detectability of subsurface pipes carrying hot liquids using Infrared Thermography (IRT) in later quarters.

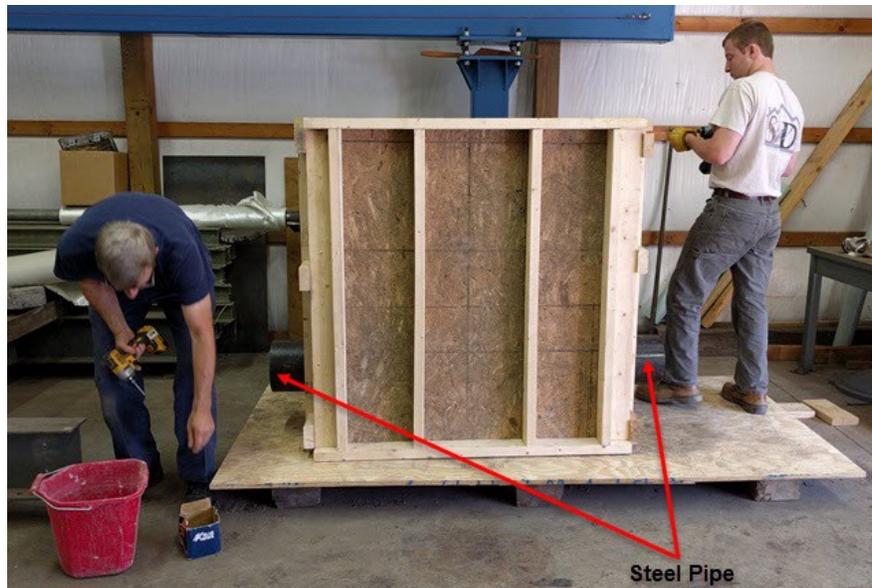
Figure 4: Soil box for leak detection using FTIR

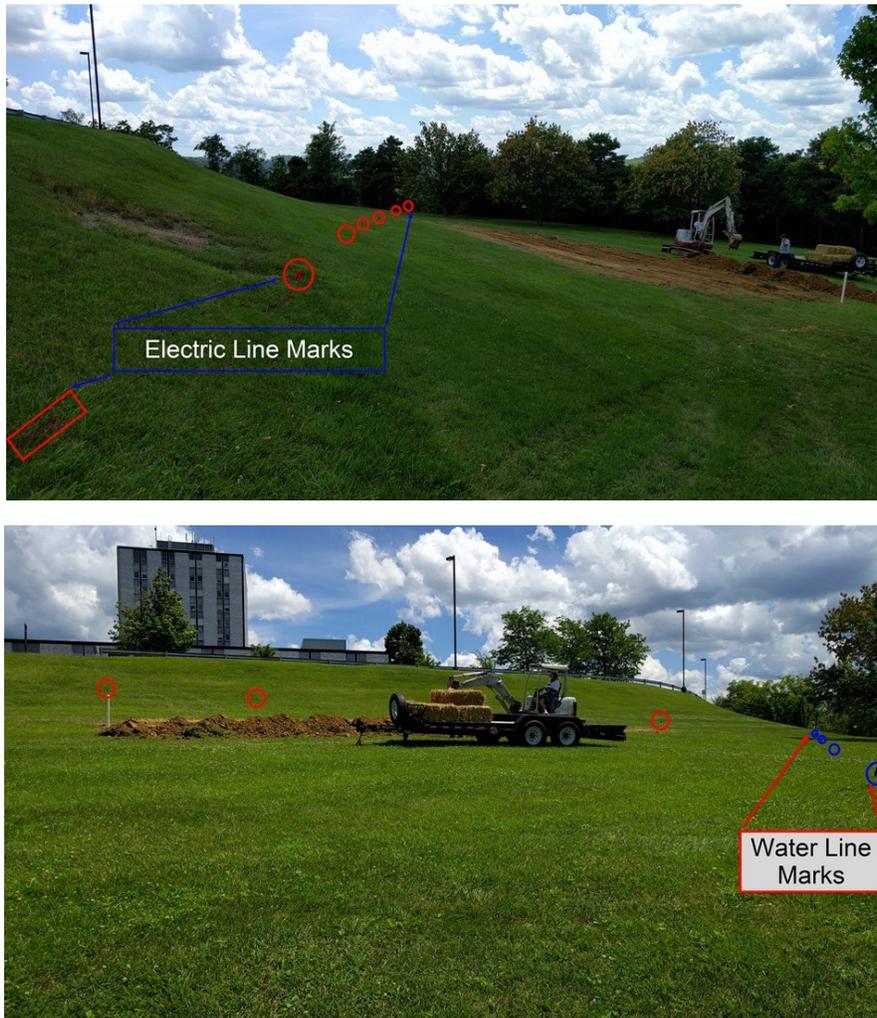
Figure 5: Utility lines marked at the excavation site

Pipe specimens prepared for GPR testing (including PVC and GFRP pipes with carbon fabric rings or strips, PVC and GFRP pipes with metallic rings or strips, unwrapped PVC and GFRP pipes, and CFRP pipes) were buried at the site located on WVU campus. Utility lines close to the allocated site were first marked to prevent excavation damage of the lines at the time of pipe burying. The site and the marked utility lines are shown in Figure 5.

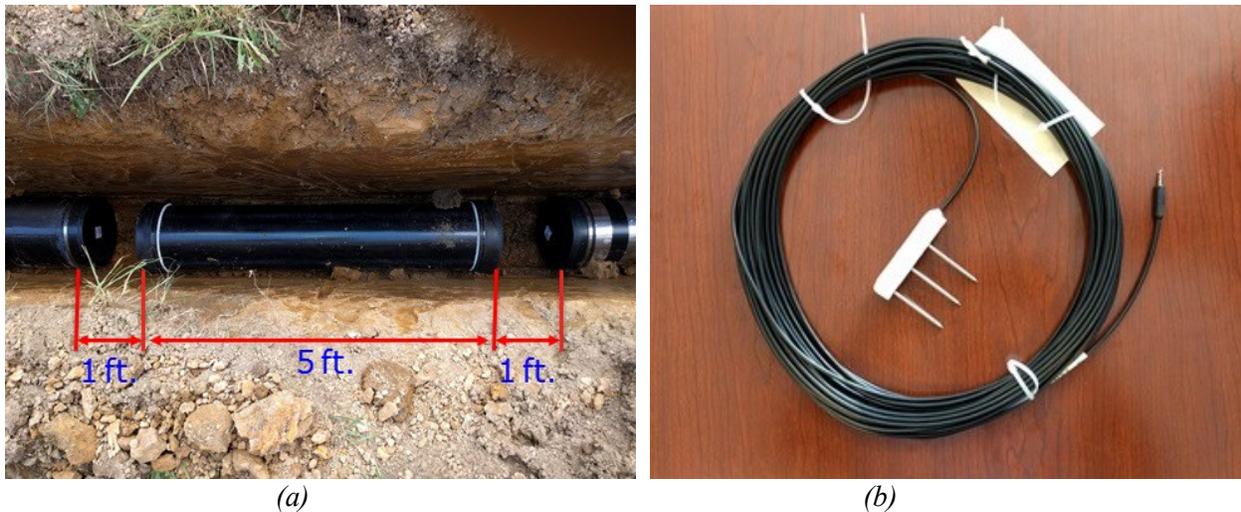
Figure 6: (a) Arrangement of pipes in the trench, (b) soil moisture and resistivity sensor

The pipe samples were buried in 3 separate 65ft. long trenches, spaced at 12 ft. apart. 12" diameter and 5 ft. long PVC, CFRP, and GFRP pipes were buried at a depth of 4 ft. in one of the trenches (total trench depth of 5ft.). The second trench had 3" diameter pipes (each 5ft. in length) buried at a depth of 2ft. (total trench depth of 27"). Two different diameter pipes, 12" and 6" (each 5ft. in length), were buried in the third trench, both diameters buried at a depth of 3ft. to the top of the pipe. Eleven pipes were buried in each trench, with 1ft. spacing between each subsequent pipe as shown in Figure 6(a). Additionally, 5 soil sensors (Figure 6(b)) were buried along the trenches at different depths to measure soil properties throughout the testing period. Two of the sensors were buried at 4ft. depth along the 12" diameter pipes, two were buried at 2ft. depth along the 3" diameter pipes and one will be used to measure soil properties at various locations on the ground surface. These sensors will enable quantitative determination of volumetric water content, electrical conductivity, temperature, and dielectric permittivity of the soil during the testing period.

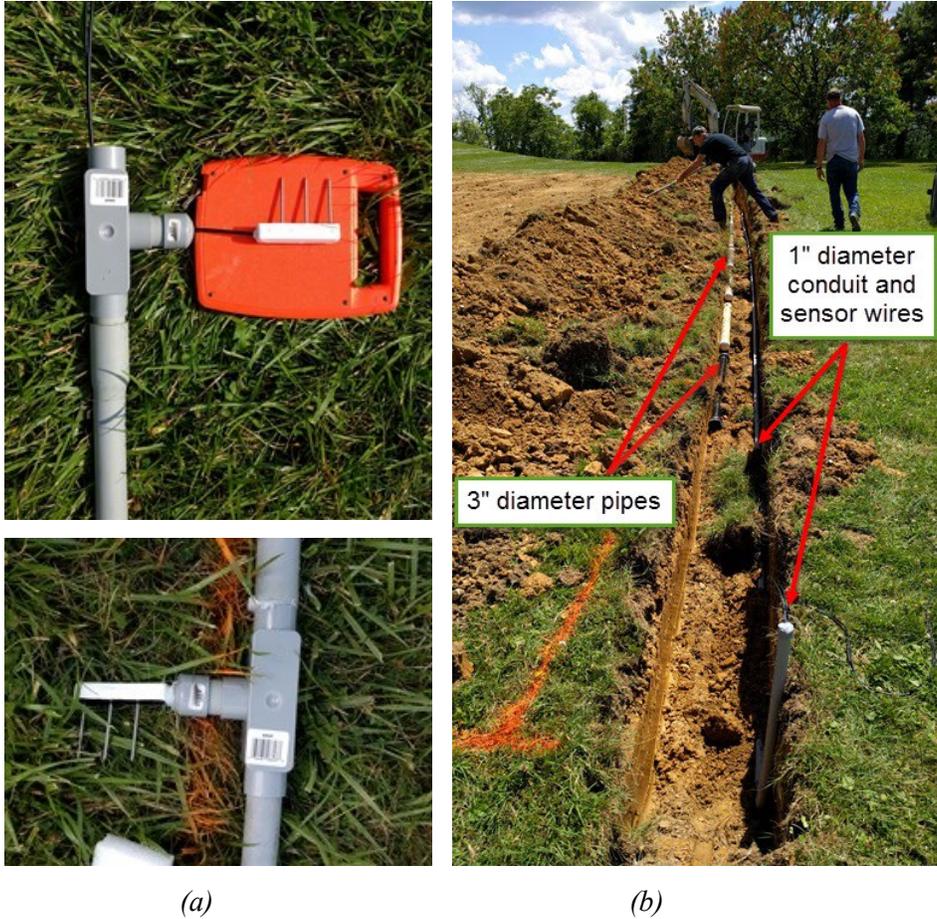
Figure 7: (a) Soil sensors with data wires running through conduits to protect the wires, (b) 3" diameter pipes and sensors in the 27" deep trench

Wire connecting the soil sensors to a datalogger were run through 1" diameter PVC conduits before burying to prevent the wires from getting damaged during compaction of backfill (Figure 7). Figure 8 (a and b) show the 12" and 6" diameter pipes placed at 3ft. depth (to the top of the pipe) in the trench and the pipes being covered with backfill. Figure 8(c) shows some of the 12" diameter pipes placed in the trench at 4ft. depth (to the top of the pipe). Two steel plates were buried at 3" depth (one at each end of the trench) to mark the beginning and end of each trench for GPR testing.

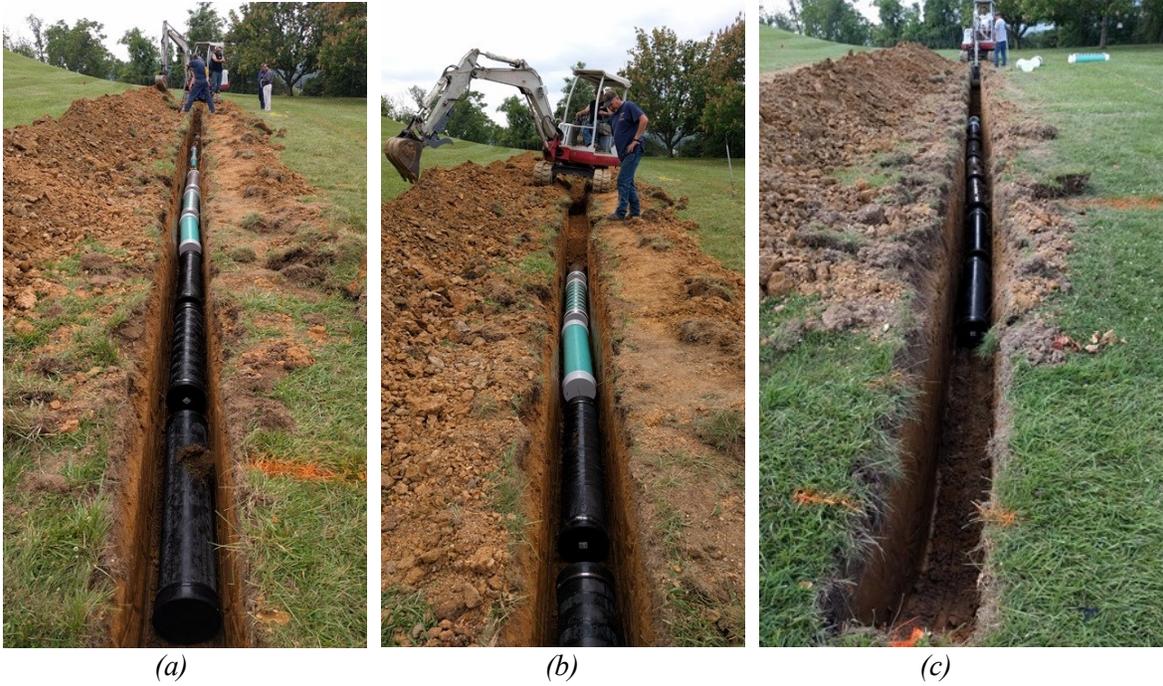
Figure 8: 12" and 6" diameter pipes being buried

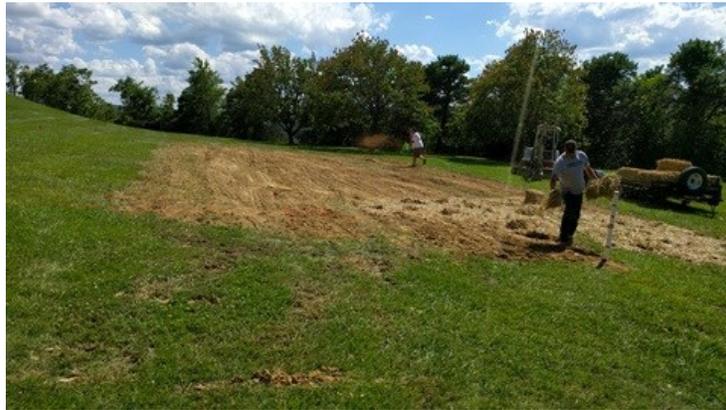
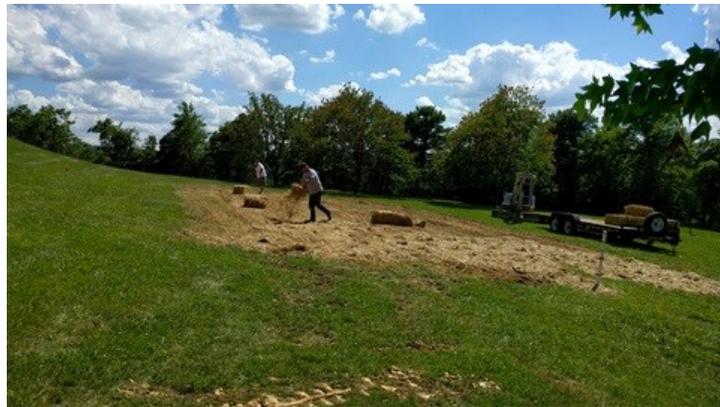
Figure 9: Grass seeding of the ground after burying pipes

Finally, the ground surface was levelled and seeded with grass after backfilling the trenches (Figure 9) to restore the initial field condition. GPR testing will commence after the straw assimilates into the soil and grass starts growing.
