FINAL REPORT
DTPH56-14-H-00002
"Full Scale Testing of Interactive Features for Improved Models"

TEAM TECHNICAL AUTHORS: BMT Fleet Technology

ENGIE, R&I Department

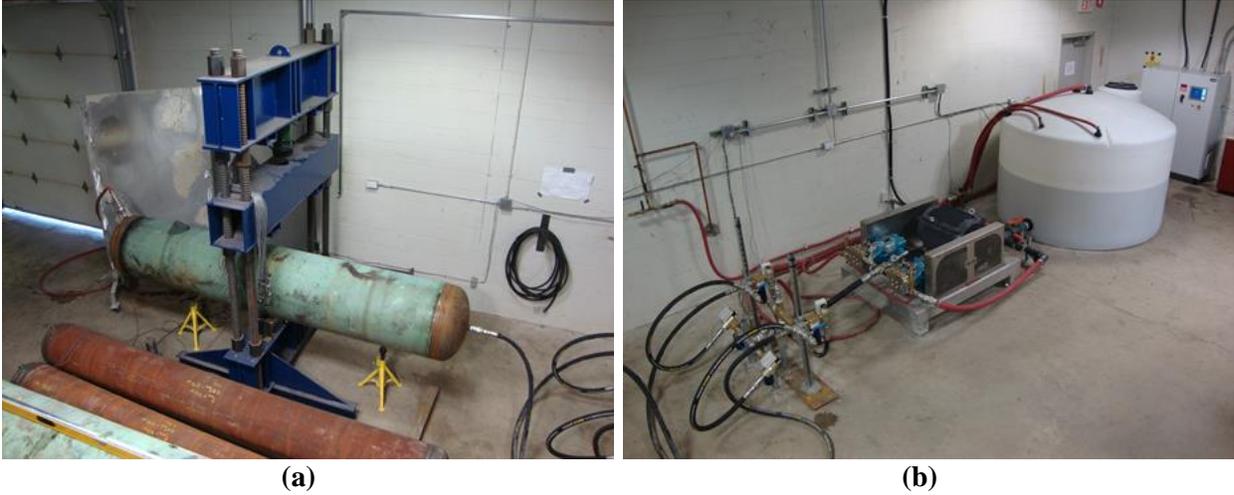
Figure 1: (a) Dent Rig with 24 inch Pipe (b) Pump & Motor Assembly and Water Reservoir

Figure 1a shows the dent test rig used to create dents. Cyclic pressure is generated using the pump, shown in Figure 1b, capable of total water flow of 40 gallons per minute (GPM) at continuous operating pressure of 3500 psi. Figure 2 shows the control system used to control the cyclic pressure test. The test system is capable of running two tests, simultaneously.

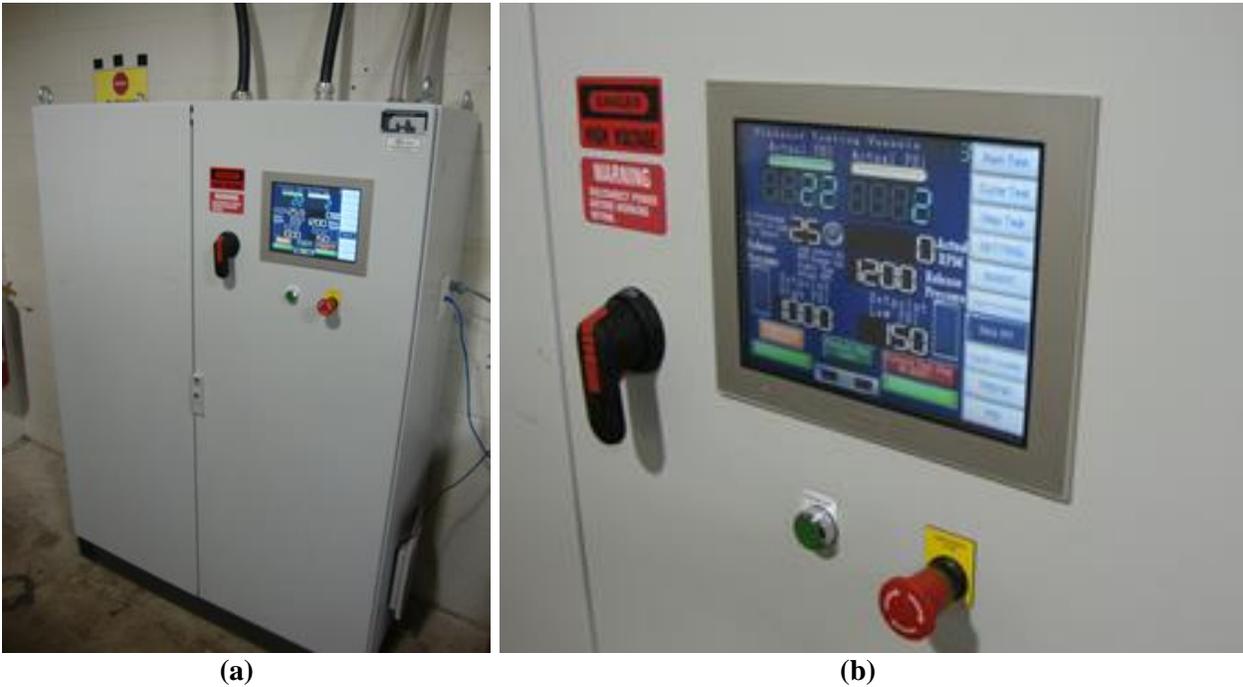
Figure 2: (a) Control System for Cyclic Pressure Fatigue Test (b) Control Panel enlarged view

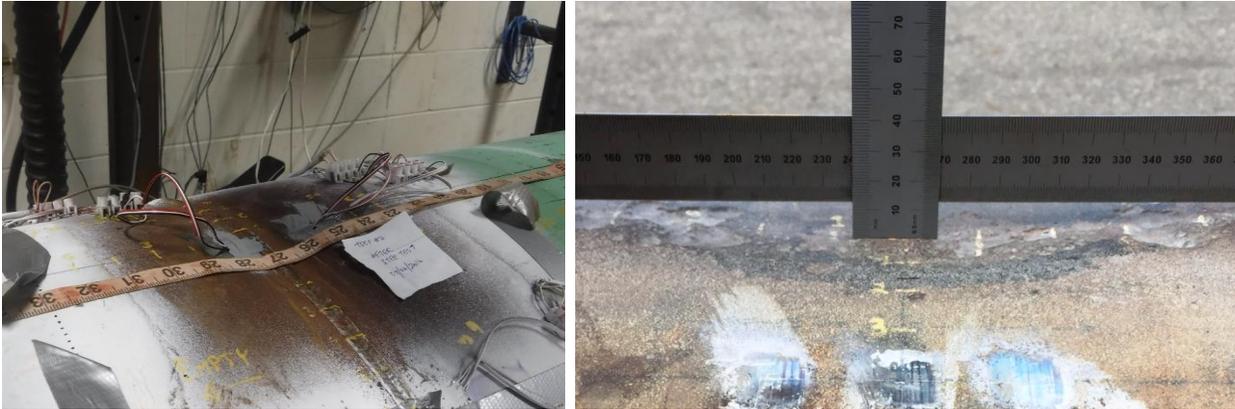
(a) (b)
Figure 6: Dent Interacting with (a) Girth Weld (b) Corrosion

Figure 3 through Figure 5 show the different indenters that were used in the current test program to create dents. Figure 6 shows interacting features, dents interacting with a weld and dent interacting with a corrosion feature, respectively.

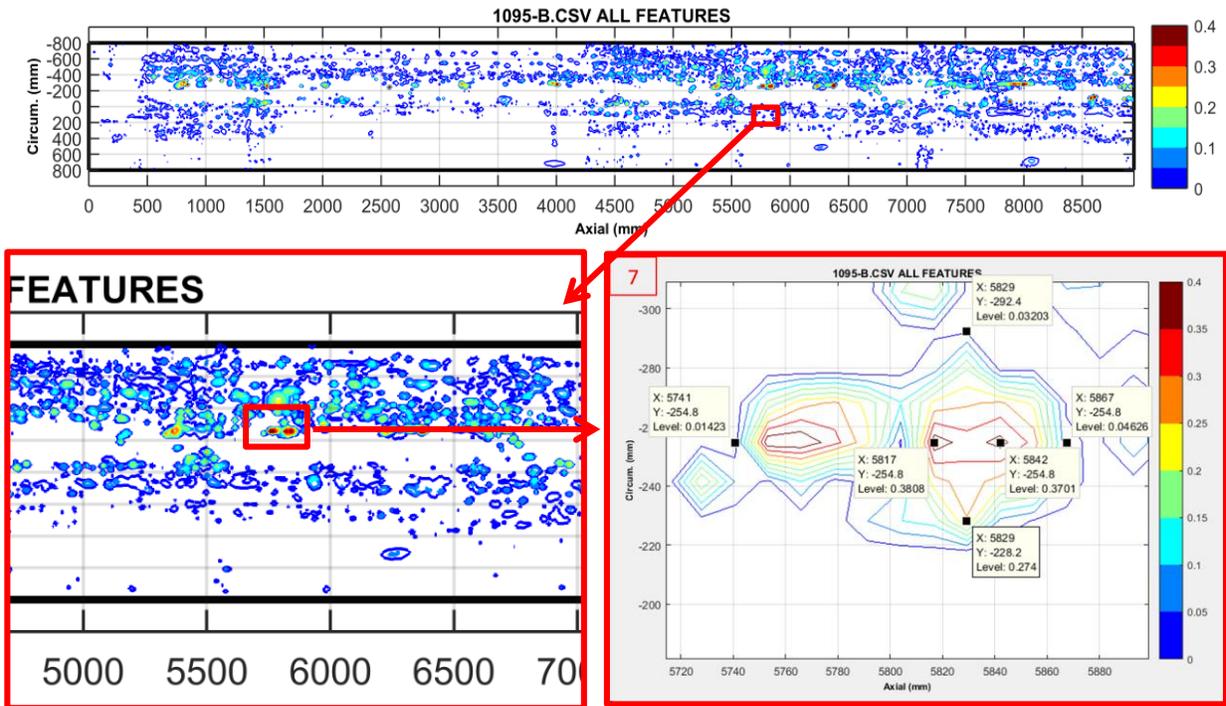
Figure 7: 39% Corrosion Selection Procedure

Figure 7 and Figure 8 show example of a corrosion feature selection process. Table 5 lists the dimensions of the corrosion features that were used for the various dent corrosion interaction full scale fatigue tests. The corrosion depths identified in Table 5 are the depths of the deepest pits identified from the laser scan data and confirmed with ultrasound thickness gauge.

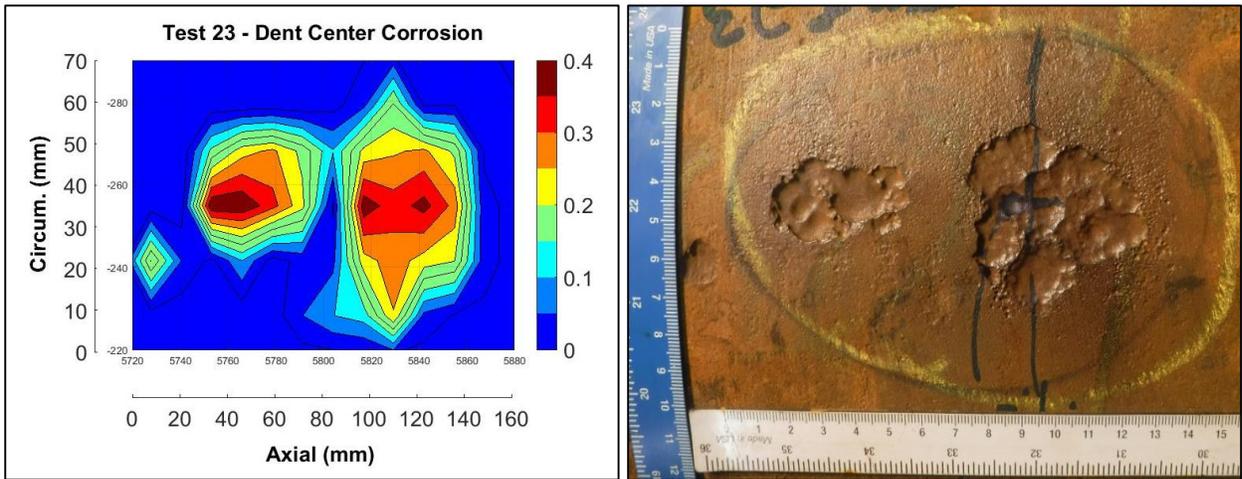
(a) (b)
Figure 8: 39% Corrosion Feature (a) Scan plot (b) Feature

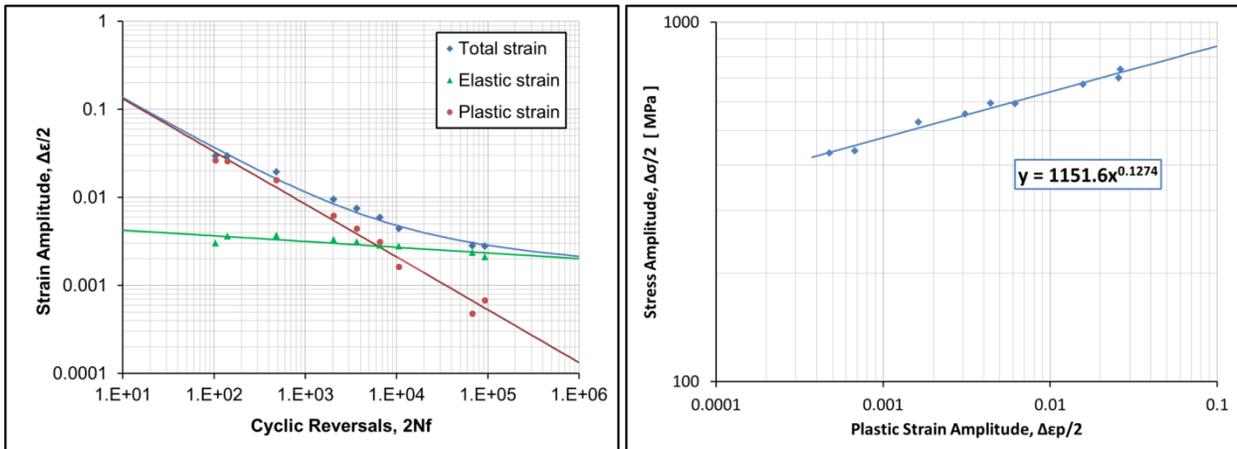
Figure 9: Pipe D Characteristic curves (a) Strain life fatigue curve (b) Cyclic stress-strain curve

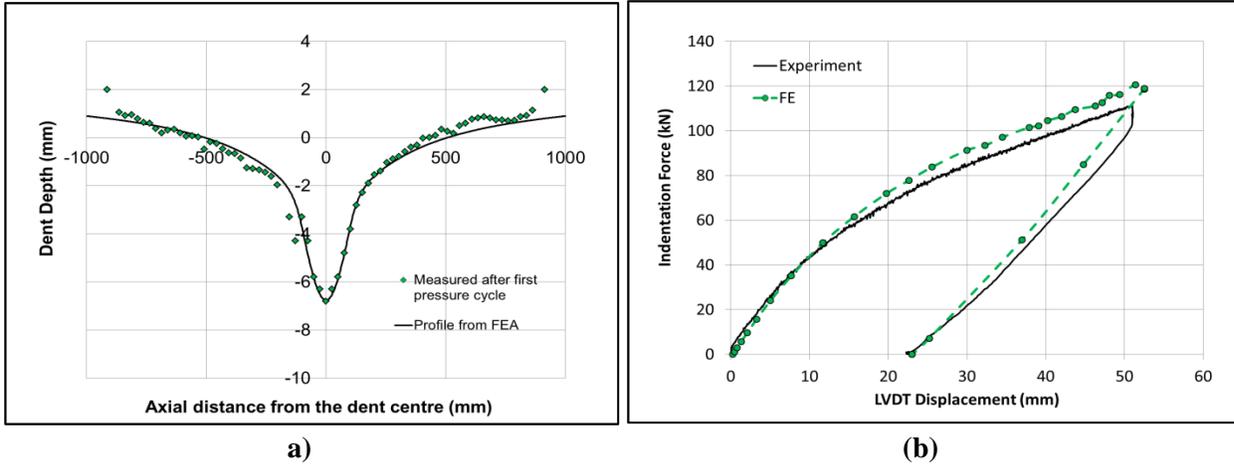
Figure 14: Experiment vs FEA (a) Axial Dent Profile (b) Force vs LVDT Displacement

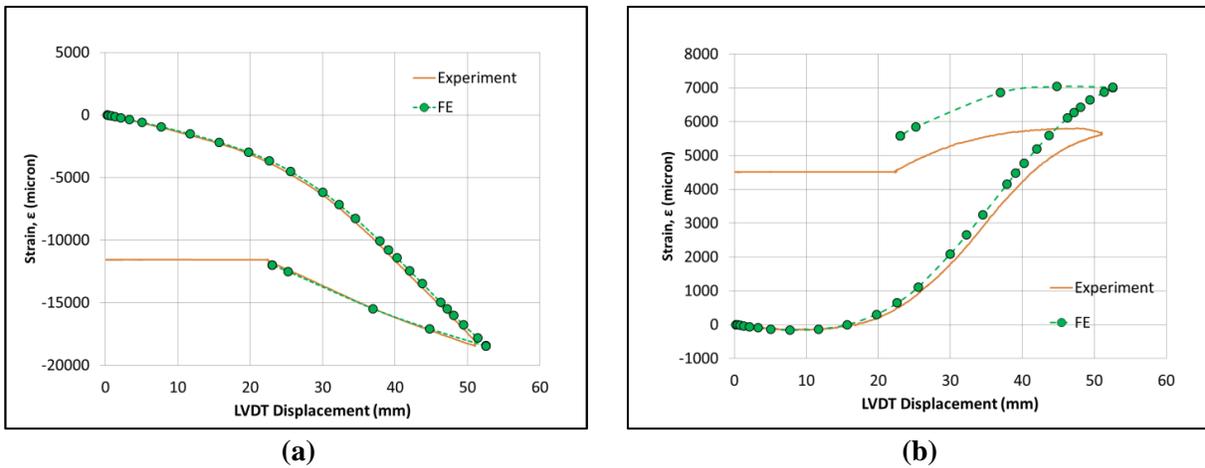
Figure 15: Test 15 Indentation Strains – 120mm Longitudinal Gauge (a) Hoop (b) Axial

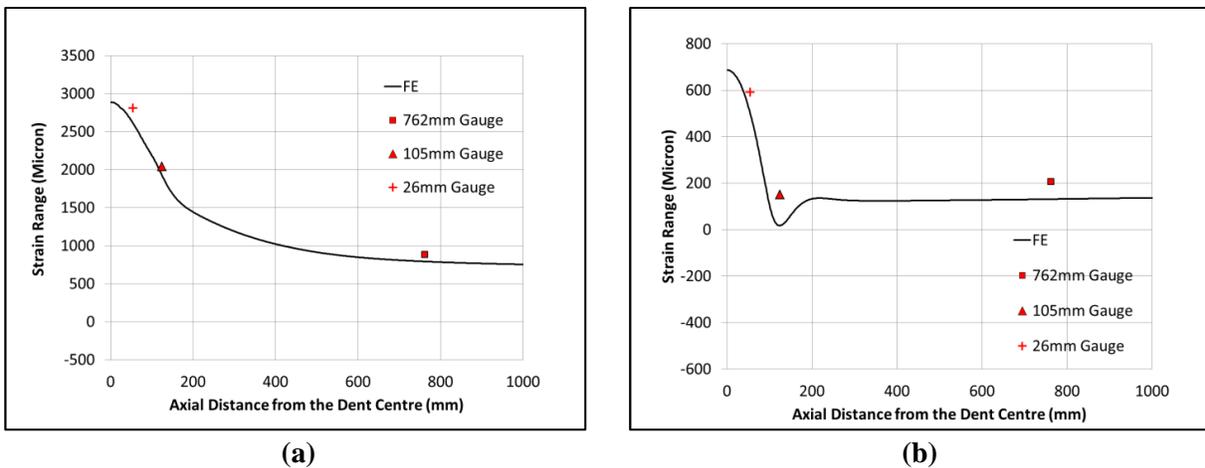
Figure 16: Test 15 Cyclic Strains (a) Hoop (b) Axial OD Strain Ranges on Axial Path from 5% to 55% PSMYS Cycles

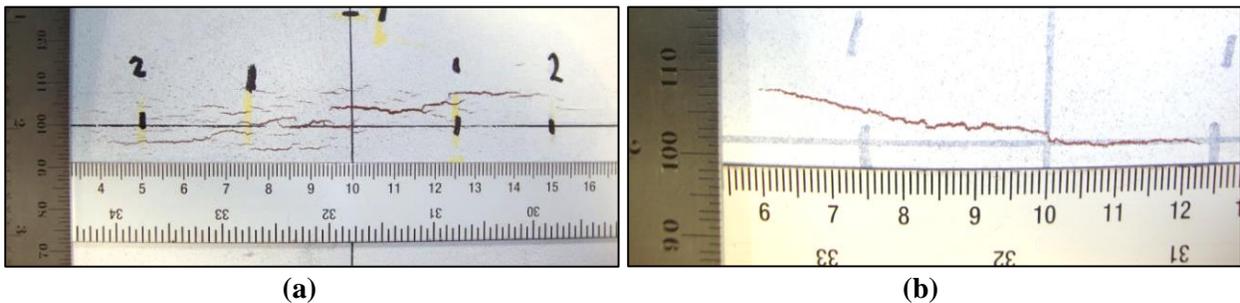
Figure 17: Plain Pipe Unrestrained Dent MPI (a) OD MPI - Axial OD Cracks (b) ID MPI - Axial OD Crack

Figure 17a shows a photograph of the magnetic particle inspection (MPI) carried out on an unrestrained plain dent. Figure 17b shows the MPI carried out on the ID surface for the same test specimen. In unrestrained dents fatigue cracks initiate on the OD surface and are in the axial orientation. In smooth shallow unrestrained dents, created with large indenters, the fatigue cracks initiated close to the dent peak. Deeper and sharper unrestrained dents promoted fatigue crack initiation away from dent peak. Multiple crack indications can be seen on the OD surface and resemble SCC colonies as seen in pipelines. This observation is consistent with previous full scale dent fatigue test results^{3, 4, 5, 6}. However, the multiple cracks are similar to what is typically seen in low cycle fatigue tests. It is conceivable that there can be scenarios present in existing pipelines where unrestrained dents may see similar stress ranges as generated in the present test program and therefore promote multiple low cycle fatigue cracks and may potentially be mis-characterized as SCC colonies.

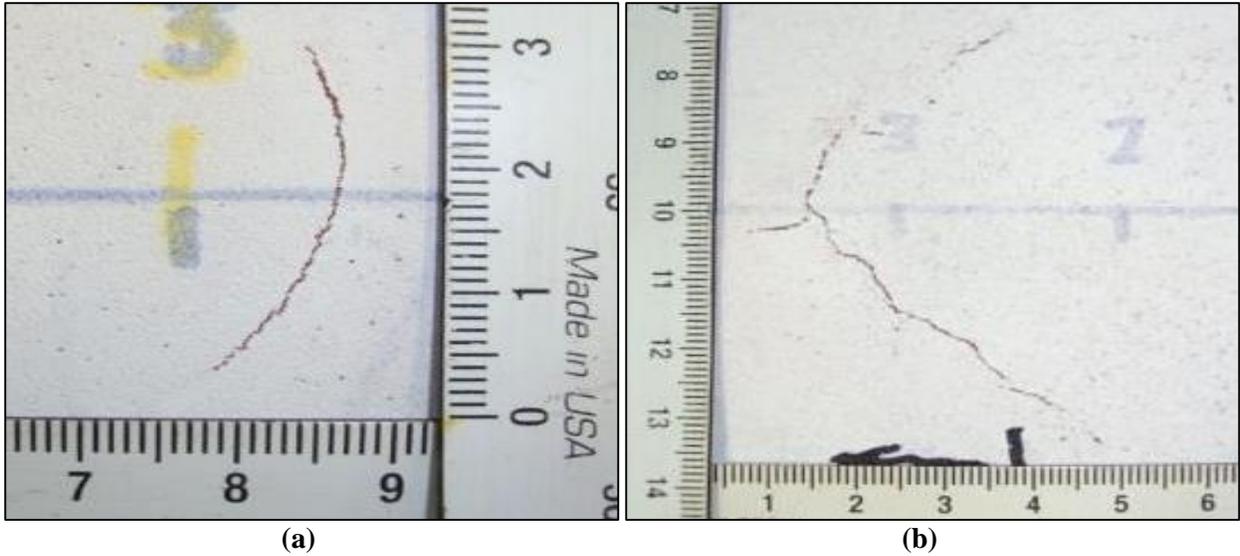
Figure 18: Plain pipe Restrained Dent MPI (a) OD MPI - Circumferential ID Crack (b) ID MPI - Circumferential ID Crack

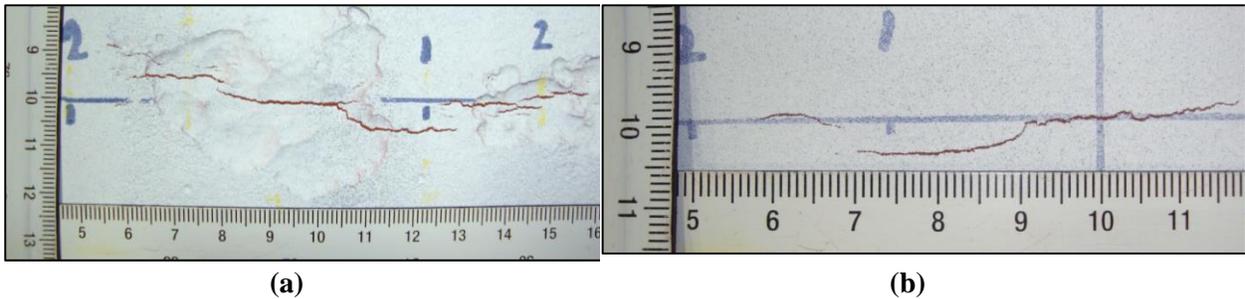
Figure 19: Corroded Pipe (a) OD MPI - Axial OD Cracks (b) ID MPI - Axial OD Cracks

Figure 19a and Figure 19b show MPI photographs of the OD surface and ID surface for an unrestrained dent interacting with a corrosion feature, respectively. For dents interacting with corrosion features, the fatigue cracks initiated in the corrosion feature and were mostly confined within the corrosion feature. In dents interacting with corrosion features, the tendency to have multiple parallel fatigue cracks/crack colonies was lower as compared to the similar plain unrestrained dents.

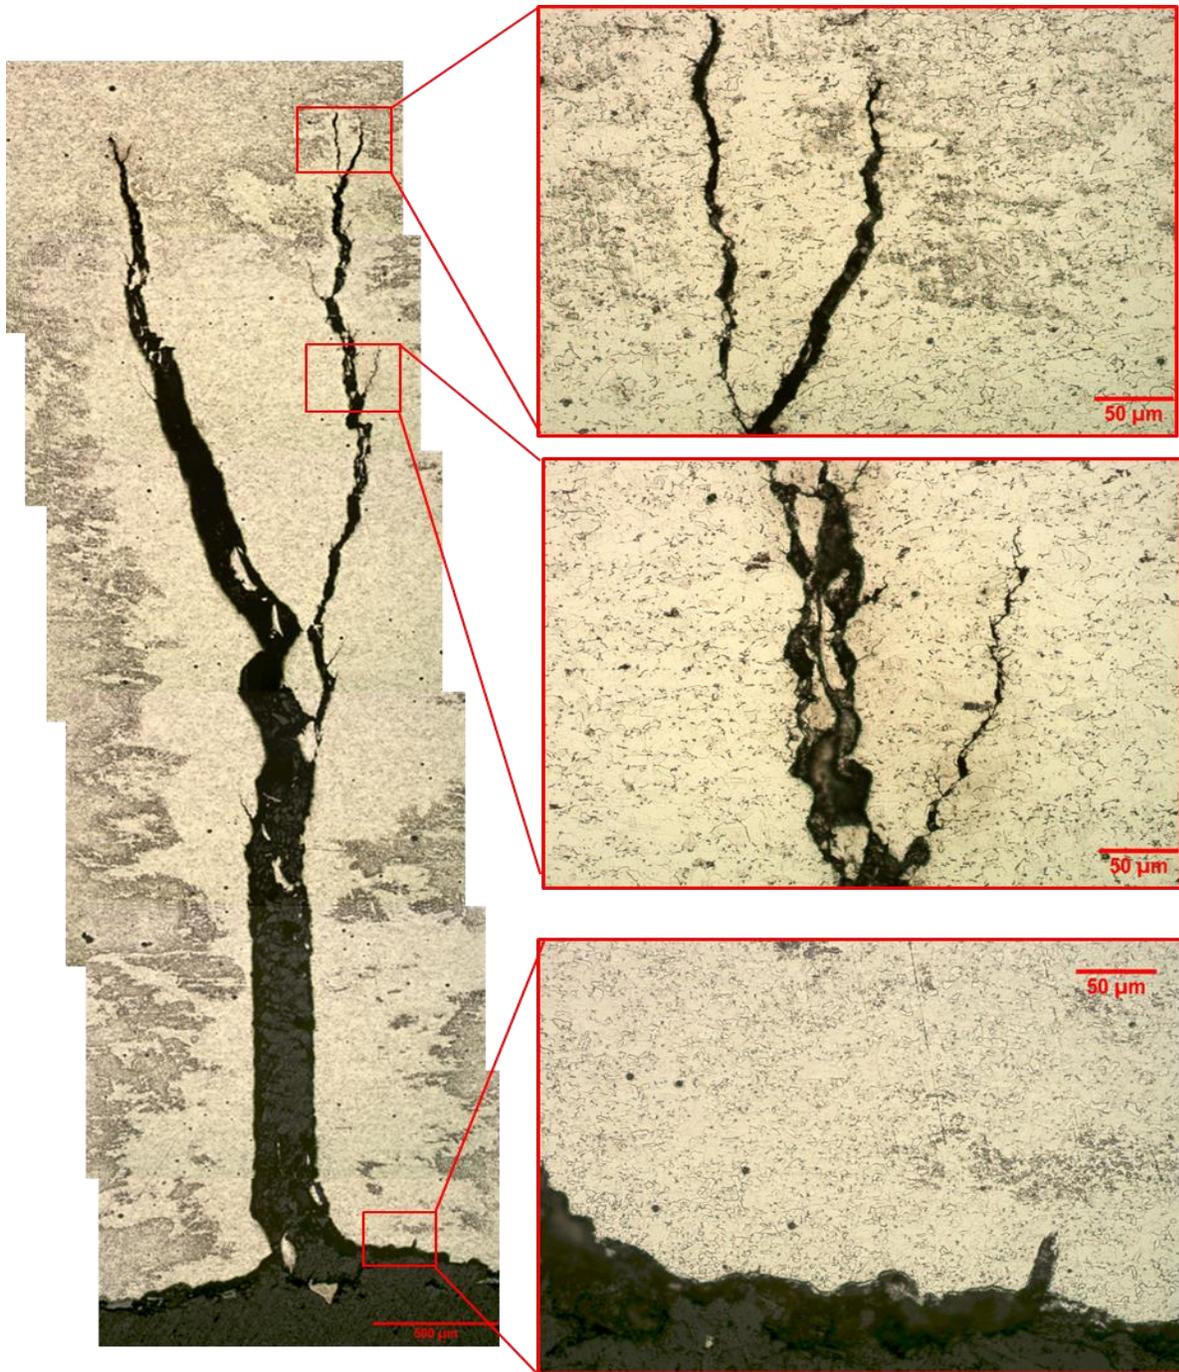
Figure 20: Cross-Section Metallograph of Fatigue Crack in Test Specimen 13

Figure 20 shows a cross-section metallograph of a dent fatigue crack test specimen. There is some crack branching observed when the crack grows through thickness. The through thickness crack branching is possibly a result of a combination of complex stress state in the dent region and due to the microstructure (laminations/inclusions) rather than effect of environment.

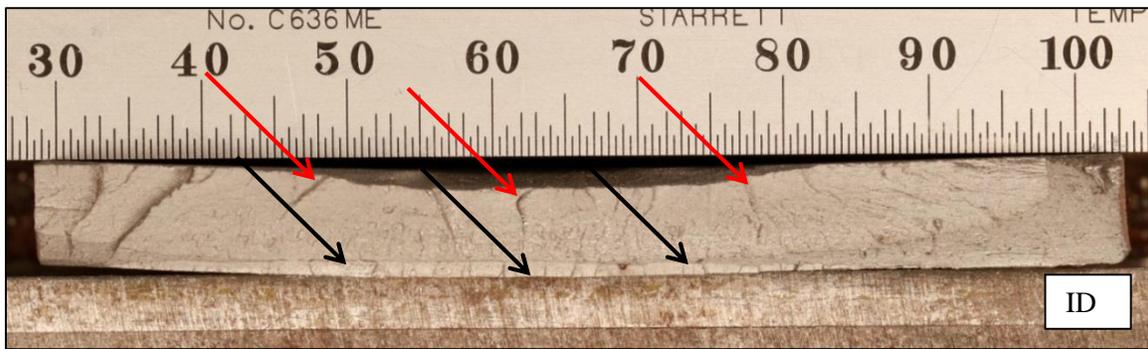
Figure 21: Test # 17 Fracture Photograph

Figure 21 shows a photograph of the fracture surface for an unrestrained dent. The fracture surface looks like a typical fatigue fracture with ratcheting marks, shown as red arrows, on the OD surface where fatigue crack initiated. In some unrestrained dents, there is also indication of fatigue crack initiation on the ID surface as shown by black arrows. The fatigue cracks on the ID surface are less than 1 mm deep and may have initiated at a later stage after the initiation and growth of OD surface cracks.

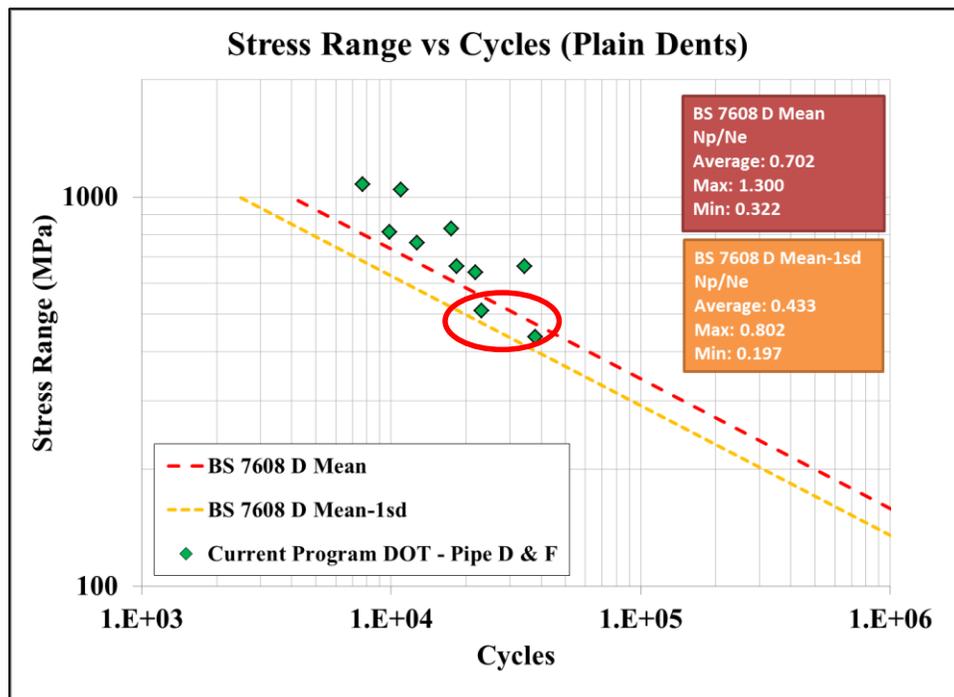
Figure 22: Pipe D & F Plain Dents - Stress Range vs Experimental Life

Figure 22 shows a plot of stress range versus number of cycles (SN curve) for plain dent tests carried out in the current test program. As discussed earlier, FE modeling of the full-scale tests was carried out and the maximum surface stress range for each test specimen model was extracted and plotted against the experimental number of cycles to failure. The FE modelling tool used was developed using the measured material properties and was demonstrated to agree with the measured pipe response. Figure 22 also shows BS 7608 Class D mean curve and BS 7608 Class D mean-1SD curve⁷. BS 7608 Class D mean-1SD curve provides a conservative prediction for all the plain dents tested in the current program. BS 7608 Class D mean curve provides conservative prediction for all the plain dents except two, encircled in red, tested in the current program. The two dents circled in red were created with the transverse long bar and resemble more of a buckle than a dent.

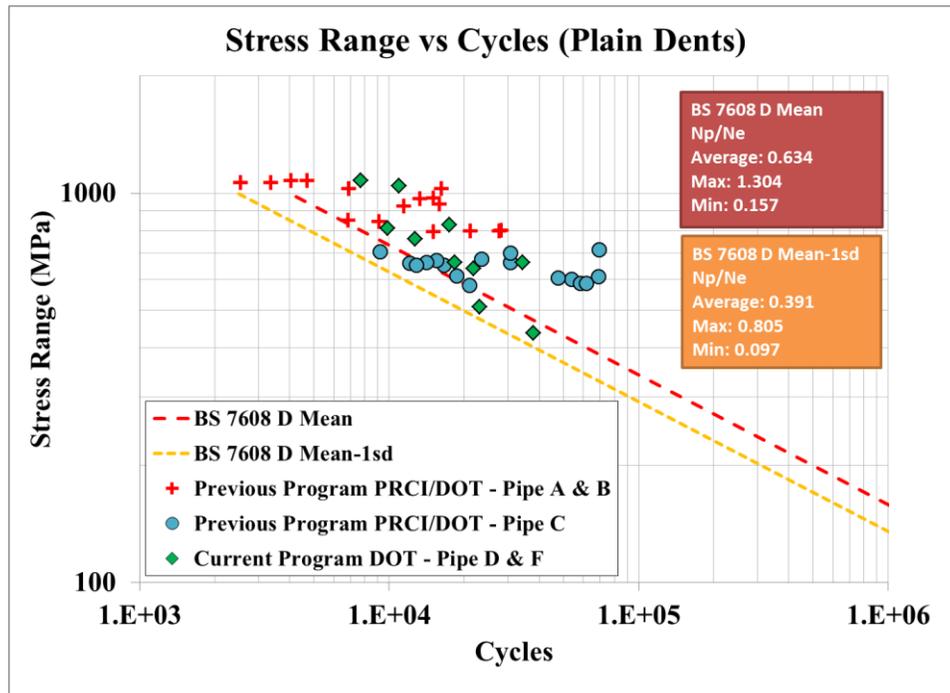
Figure 23: All Plain Dents - Stress range vs Experimental Life

on linepipes of vintage 1950's, 1970's, 1990's and 2005. It includes restrained and unrestrained dents created by 2, 4, 8, 12, and 24 inch semi-elliptical indenters and 10 and 20 inch long Bar indenters. The pipe diameters used were 18, 20, and 24 inch and includes X-52 and X-70 grades. Based on the prediction for the full-scale dent fatigue tests, presented in Figure 23 results in an average predicted fatigue life of 0.40 (~2.5X lower) of the experimentally measured life based on the BS 7608 Class D mean-1sd curve. The predicted fatigue life ranges from a minimum of 0.1 (10X lower) to a maximum of 0.8 (20% lower) of the experimentally measured fatigue life.

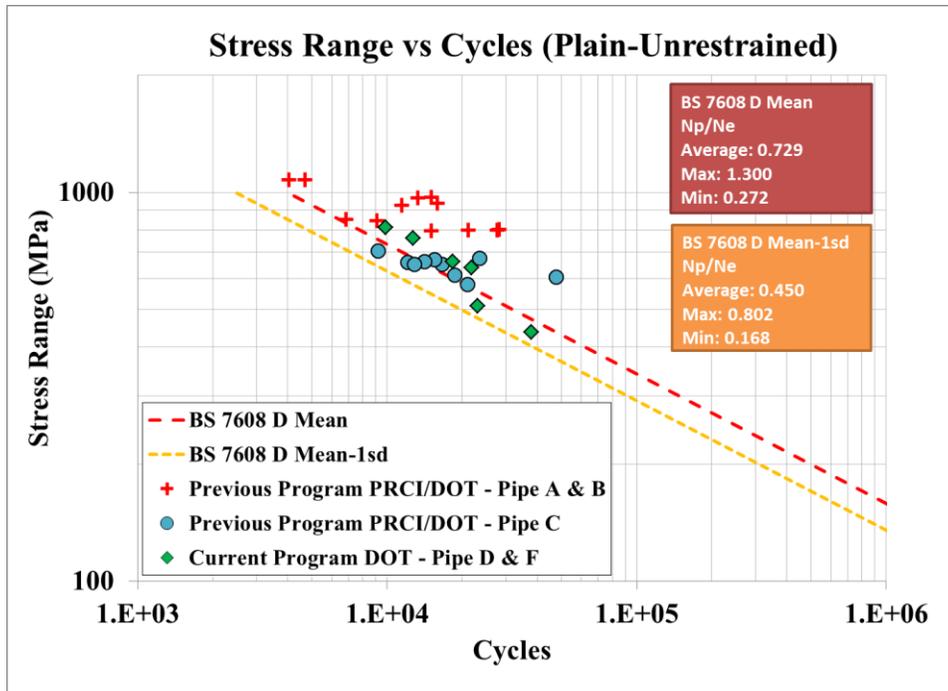
Figure 24: Unrestrained Dents - Stress range vs Experimental Life

BS 7608 Class D mean-1sd curve provides a lower bound (conservative) prediction to all of the plain dent full-scale fatigue tests and BS 7608 Class D mean curve provides conservative prediction for most of the plain dent tests (excluding six) carried out under current and previous full scale test^{3,4,5,6}. Figure 24 and Figure 25 show SN plot of unrestrained and restrained dents separately. BS7608 Class D curves provide a much more conservative prediction of fatigue life for restrained dents as compared to unrestrained dents.

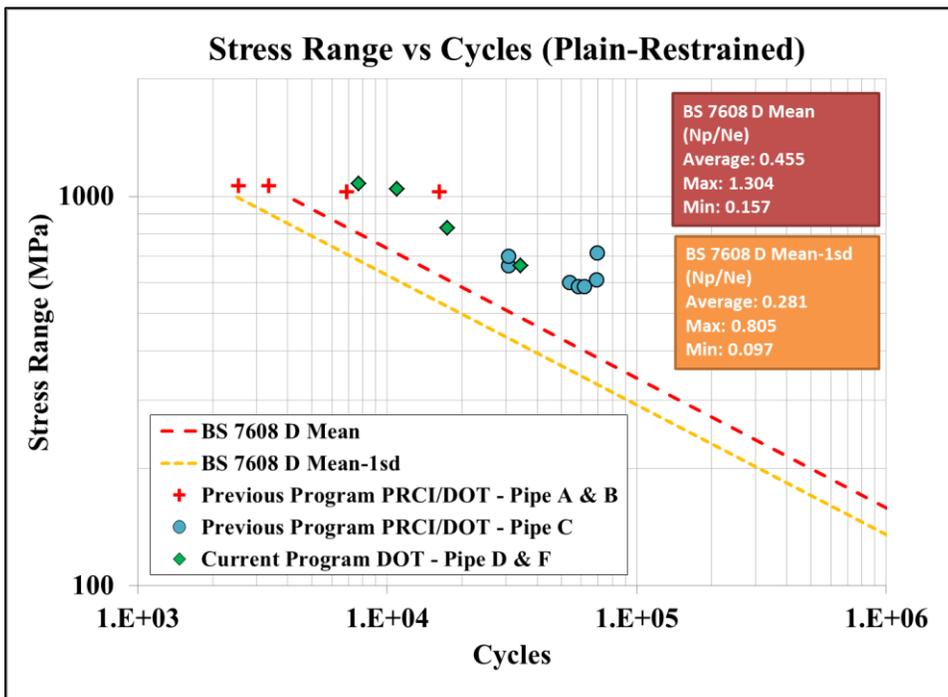
Figure 25: Restrained Dents - Stress range vs Experimental Life

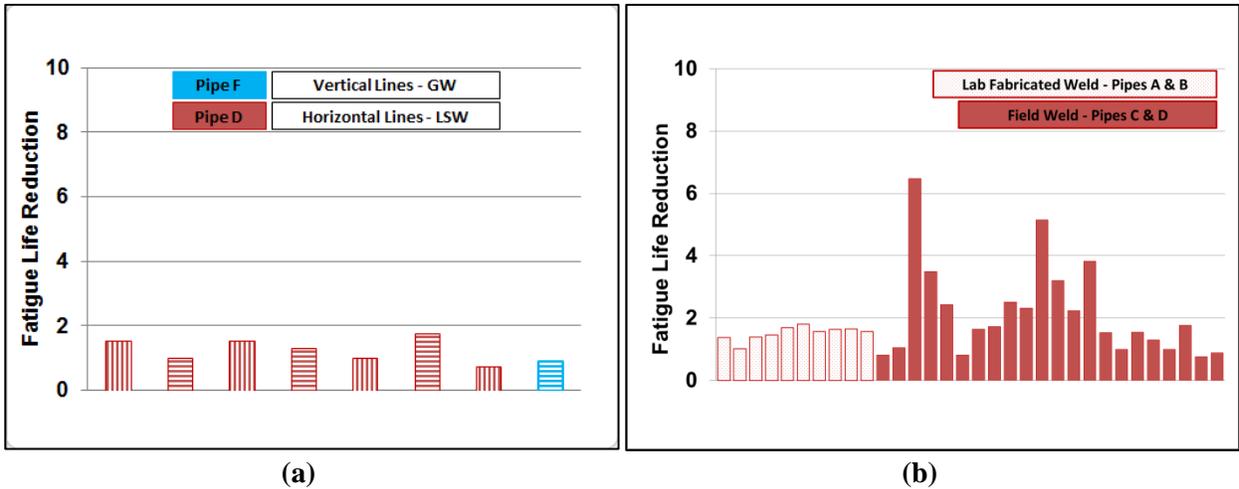
Figure 26: Fatigue Life Reduction due to Long Seam and Girth Welds (a) Current Test Program (b) Previous and Current Test Program

Dent weld interaction tests carried out on dents created with round bars, under the current test program resulted in a maximum reduction of 2 times in fatigue life as compared to the plain dent life, as shown in Figure 26a. The maximum reduction in fatigue life, due to dent weld interaction, of 6 times was observed in the previous test program^{3,4,5,6} as shown in Figure 26b.

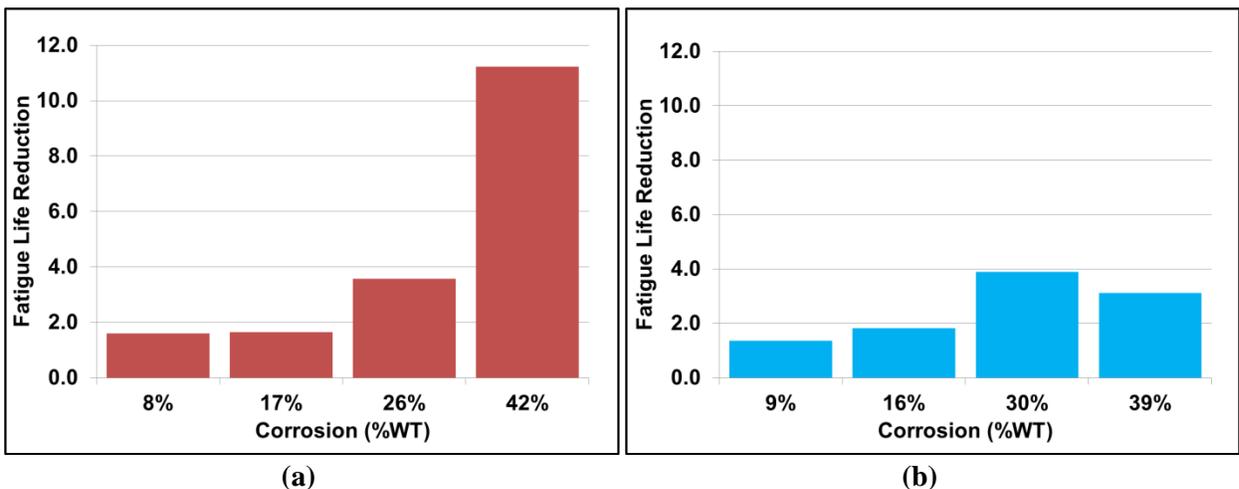
Figure 27: Fatigue Life Reduction due to Corrosion interaction (a) Unrestrained Dent with 24 in Indenter and 10% Travel (b) Unrestrained Dent with 12 in Indenter and 10% Travel

Figure 27a, and Figure 27b show the results for fatigue life reduction due to dent corrosion interaction for unrestrained dents. The fatigue life was reduced by a maximum of 4 times for dent corrosion interaction when the corrosion depth was less than 40%. In one test, where the corrosion depth was 42%, fatigue life reduction of 11 times was observed. The reduction in fatigue life observed in test data will be due to a combination of the effect of reduced wall thickness and surface finish.

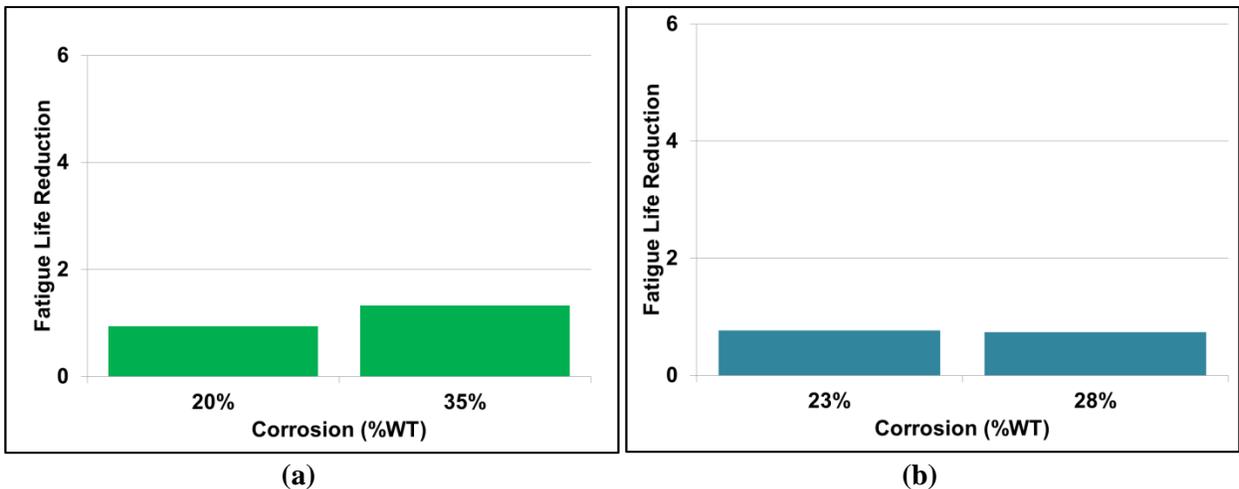
Figure 28: Fatigue Life Reduction Due to Corrosion Interaction with Restrained Dent (a) Restrained Dent with 24 in Indenter with 6% Travel (b) Restrained Dent with 20in Long Bar Indenter with 6% Travel

with the previous full scale test program⁵. Therefore, in the case of restrained dents the effect of surface finish due to the presence of corrosion feature present on the OD surface, is not going to have an impact on the fatigue life.

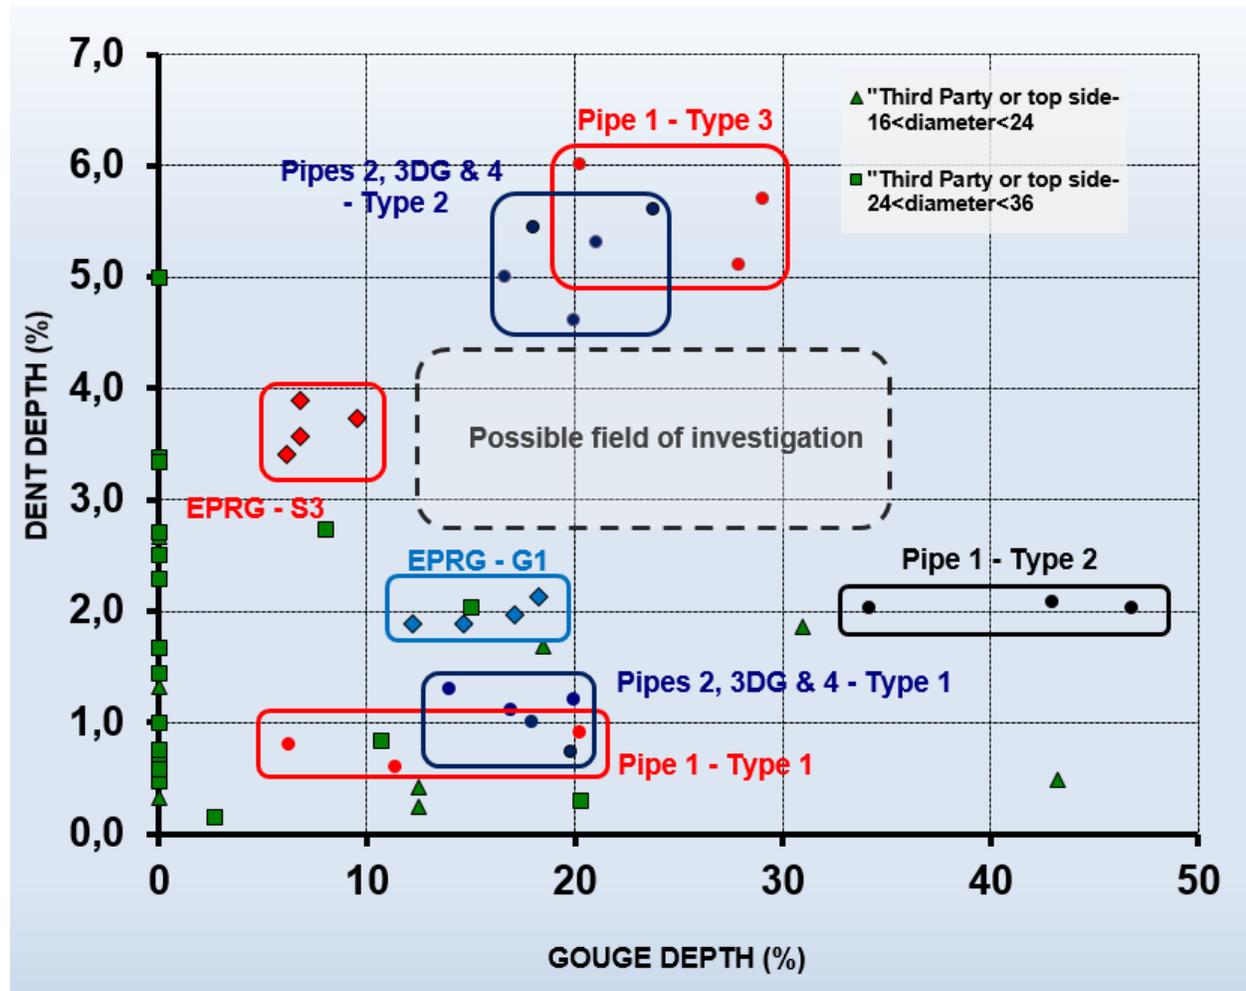
Figure 29: State of the art of Dent and Gouge defect database and possible field of investigation at the beginning of the project t; some results are provided by the European Pipeline Research Group (EPRG)

In this task, additional Dent and Gouge defects were created and tested in order to extend the previous database established by previous PHMSA and PRCI projects^{1,2} so as to fill some knowledge gaps concerning effects of different parameters on defect behavior. The graph in Figure 29 shows the existing database and the possible investigation field at project beginning.

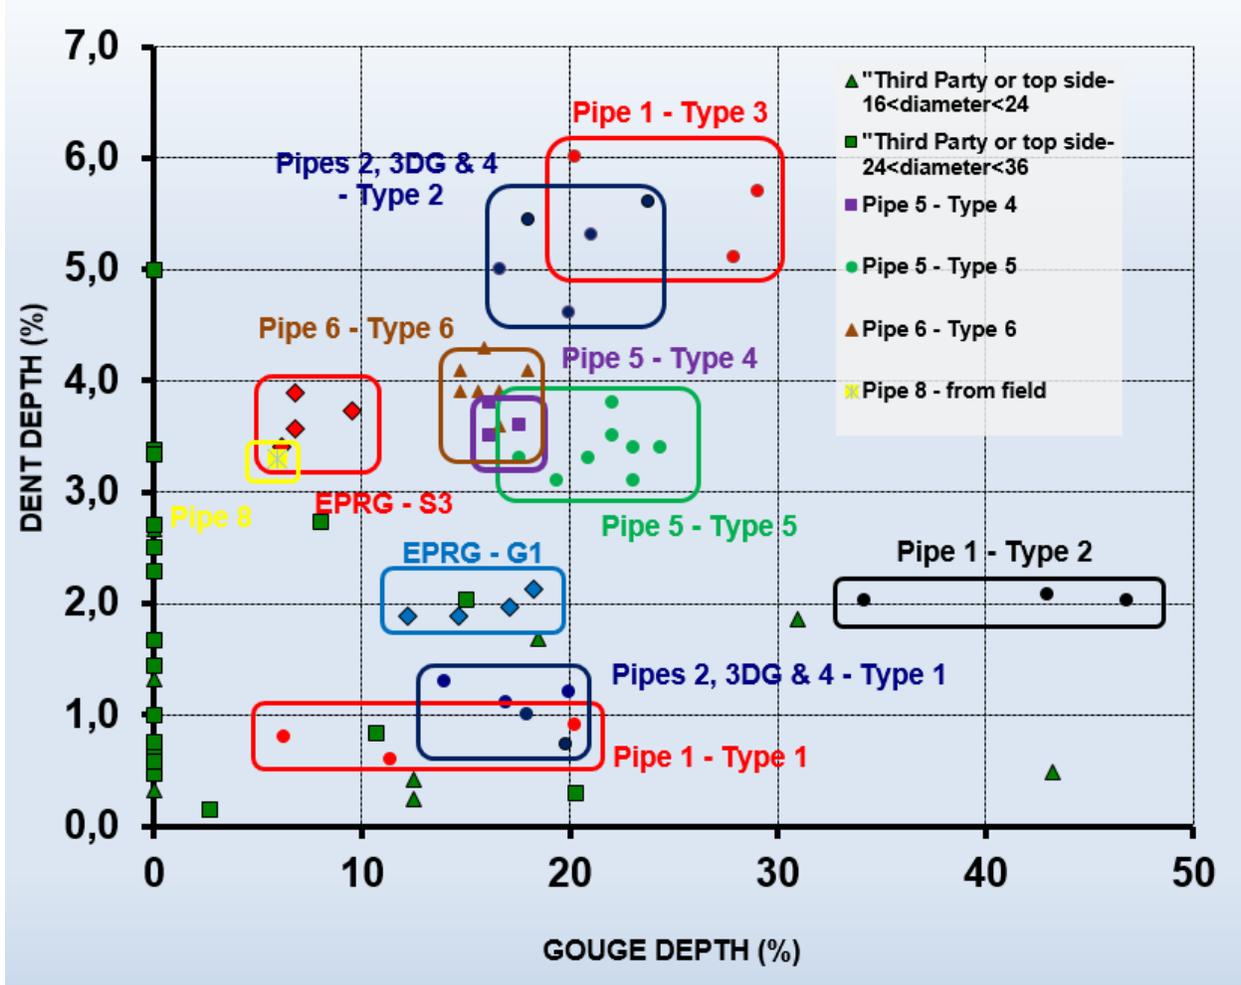
Figure 30: State of the art of Dent and Gouge defect database and defects created during the project. Pipe 7 is not represented because gouge depth measurement had too high uncertainties due to defect configuration

Graph of Figure 30 shows the Dent and Gouge defect database that were completed. Pipe 5 and 6 were bought and two pipes (Pipe 7 and 8) were retrieved from the field to accomplish this task. Three different tools (type 4, 5 and 6) were used for defect creation on Pipe 5 and 6 in order to have different defect dimensions to fill in the gaps of Figure 29.

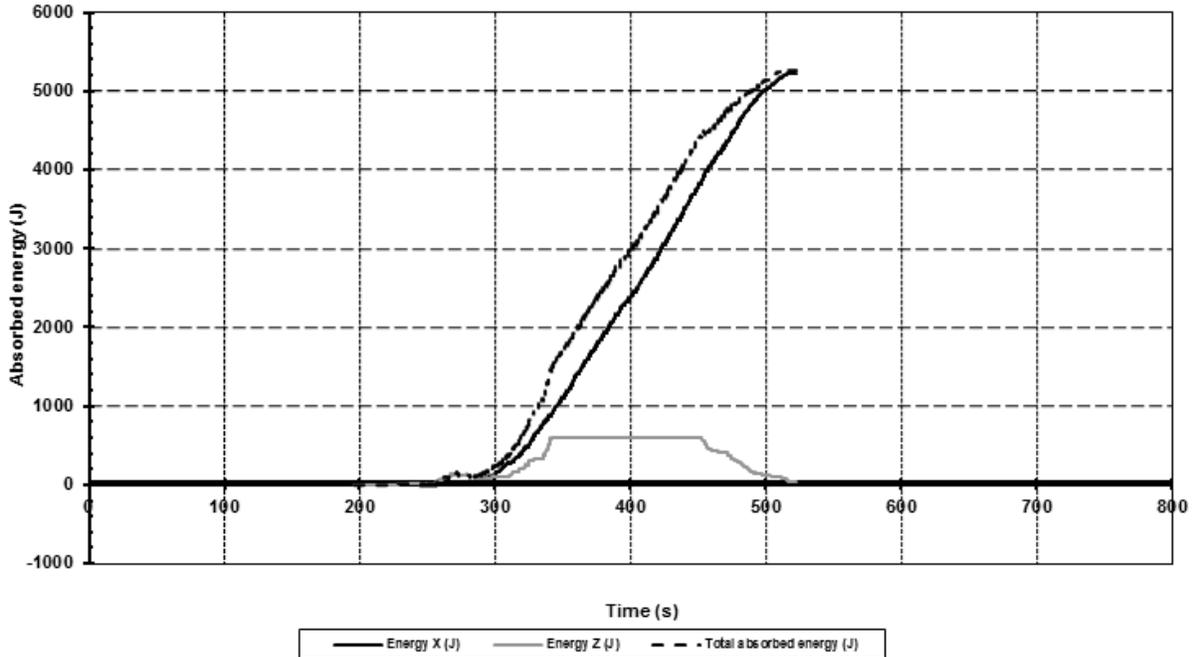
Figure 31: Energy spent to create defect 6.6.1 by slow dynamic aggression (5,267 Joules)

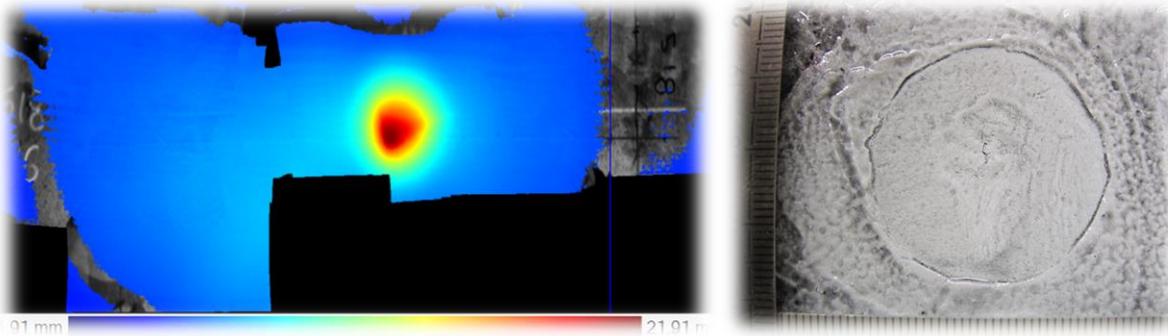
Figure 32: Seikowave measure for defect 7.ext2.2 dimensions (left); MPI on defect 8.ext2.3cp (right);

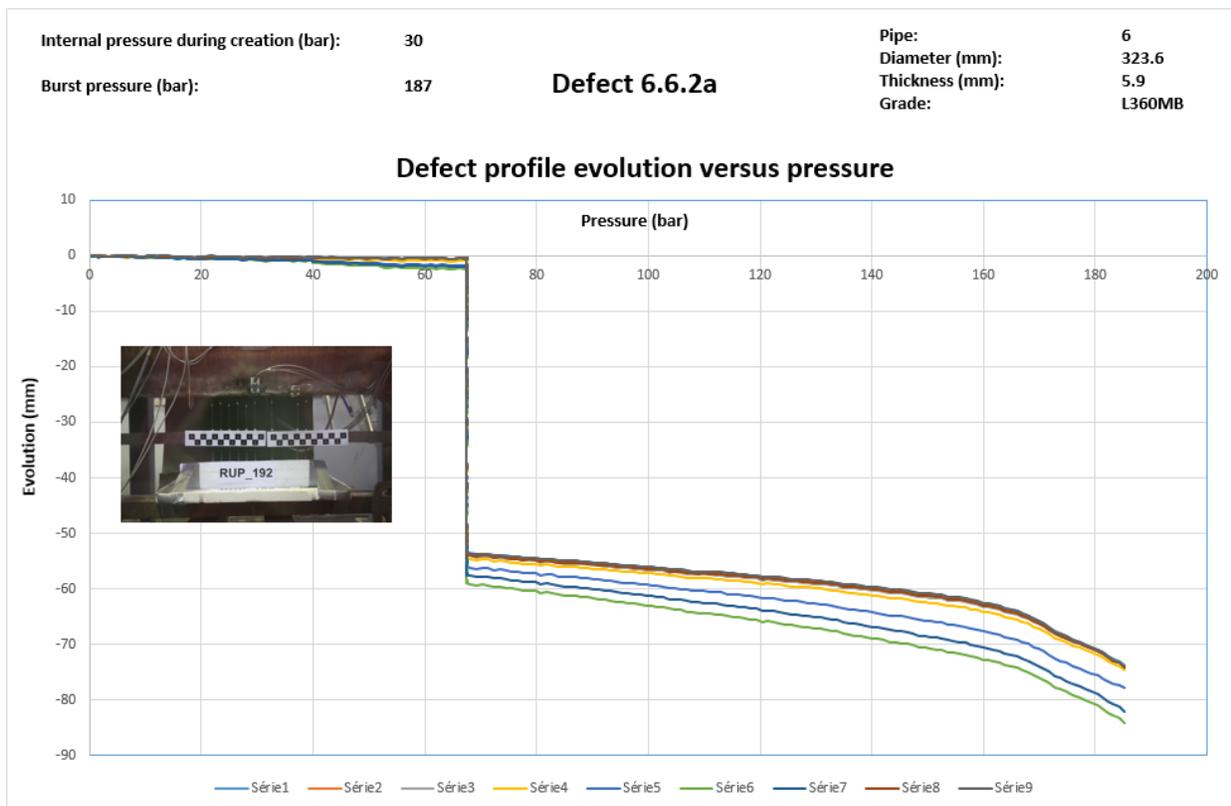
Figure 33: Dent pop-up of Dent and Gouge 6.6.2 followed by significant dent bulging for pressure increase at 67 bar when the four-point bending load was imposed.

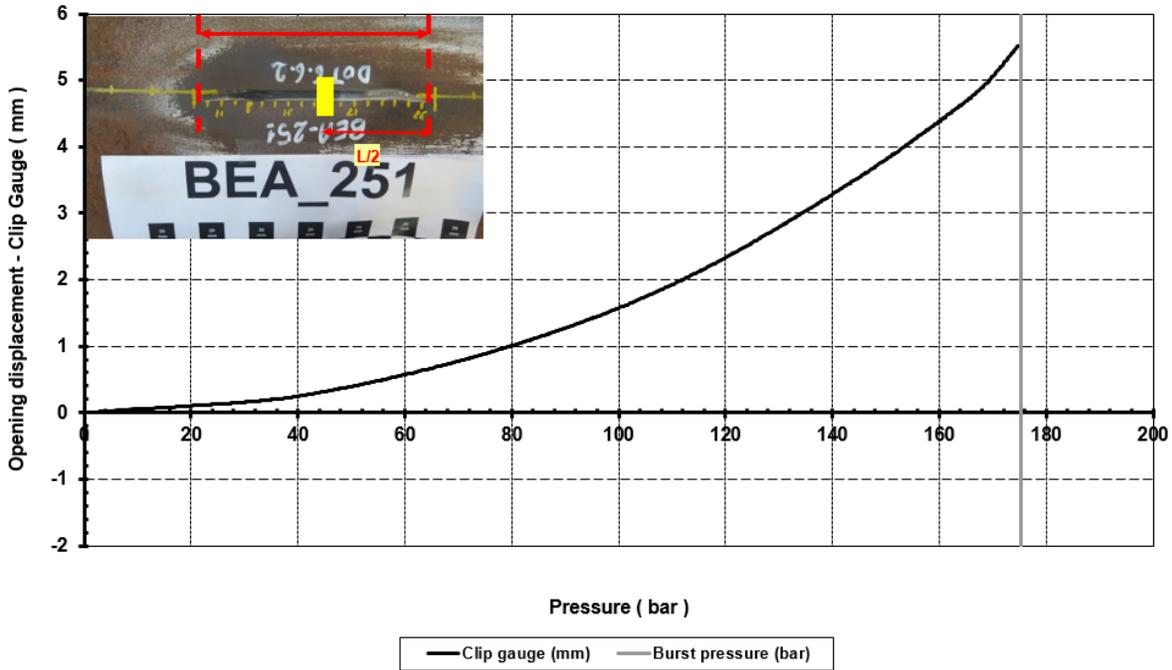
Figure 34: Opening displacement clip gauge for burst test of Dent and Gouge defect 6.6.2

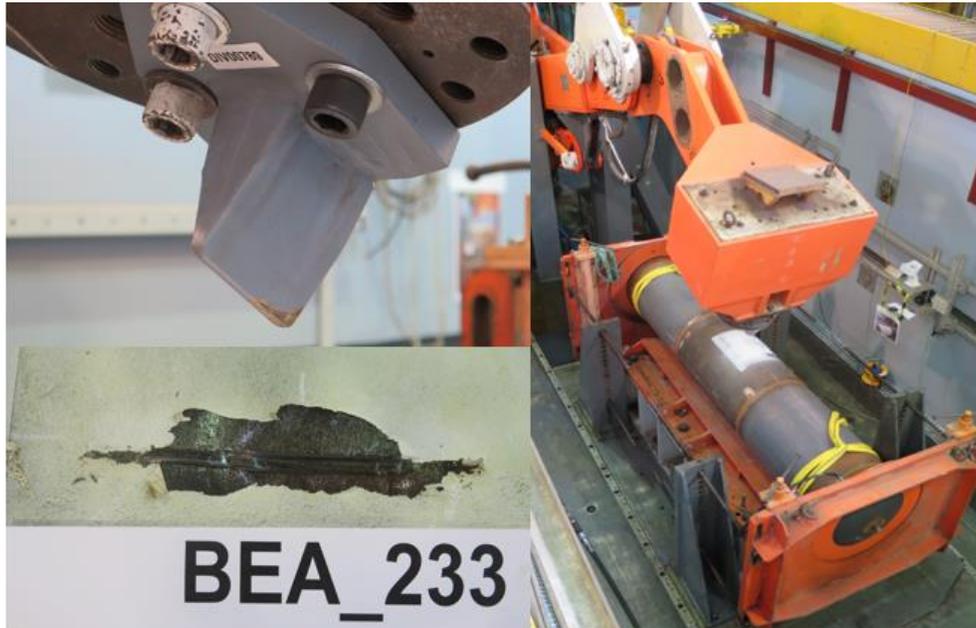
Figure 35: Test set-up for Dent and Gouge defect 5.4.1 (Task 5a)

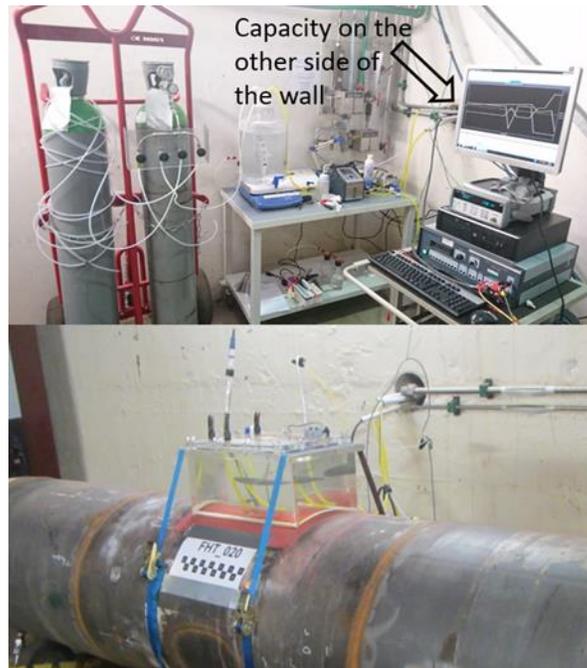
Figure 36: Test set-up for Dent and Gouge defect 5.5.3cp (Task 5a)
