FINAL REPORT
DTPH56-14-H-00002
"Full Scale Testing of Interactive Features for Improved Models"

TEAM TECHNICAL AUTHORS: BMT Fleet Technology

ENGIE, R&I Department

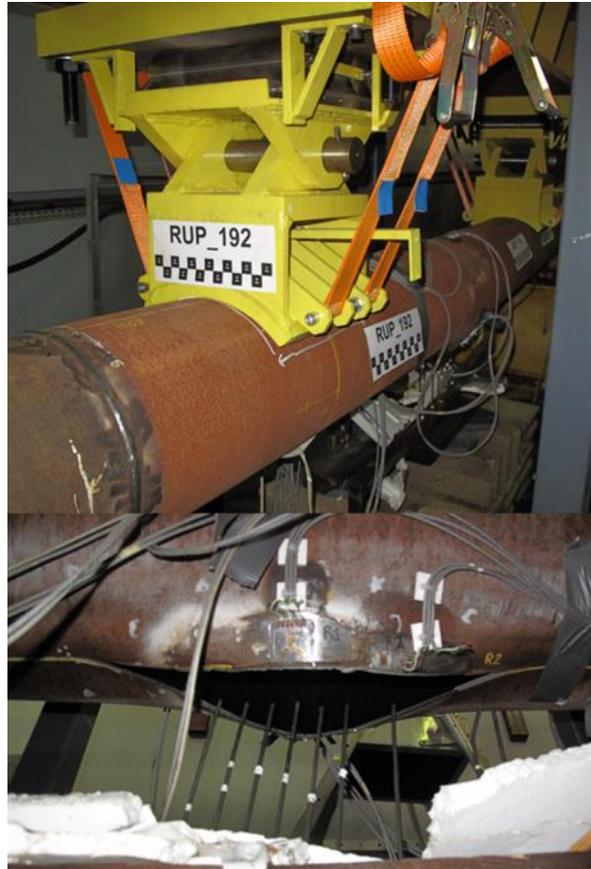
Figure 37: Test set-up for Dent and Gouge defect 6.6.2a burst test with axial load by means of a 4-points-bending loading (Task 5a)

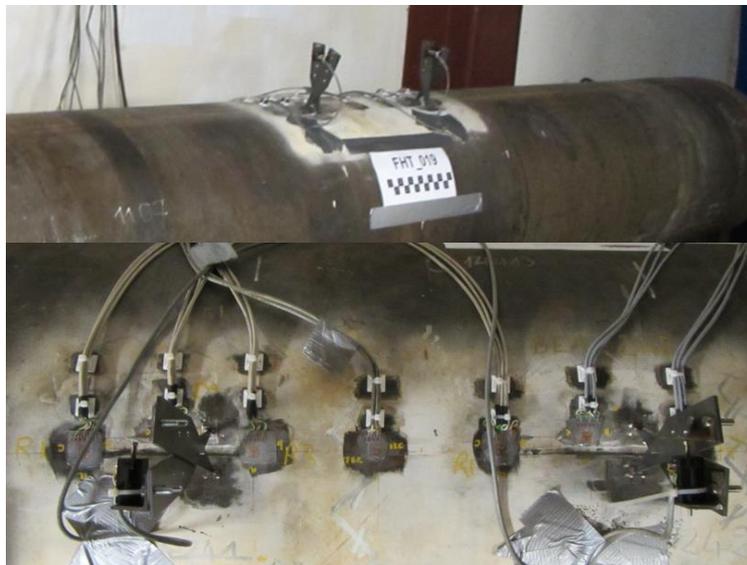
Figure 38: Test set-up for Interacting Dent and Gouge defects 5.5.3i2 and 5.5.3i2' (Task 5b)

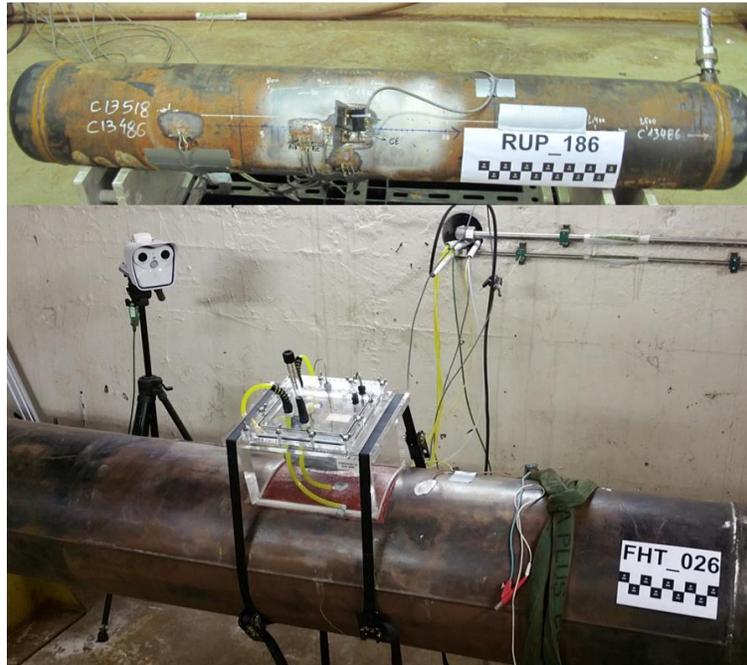
Figure 39: Test set-ups for Dent and Gouge defects 7.ext1.2 (burst test, *top*) and 8.ext2.3cp (fatigue test under over cathodic protection, *bottom*) retrieved from service (Task 5c).

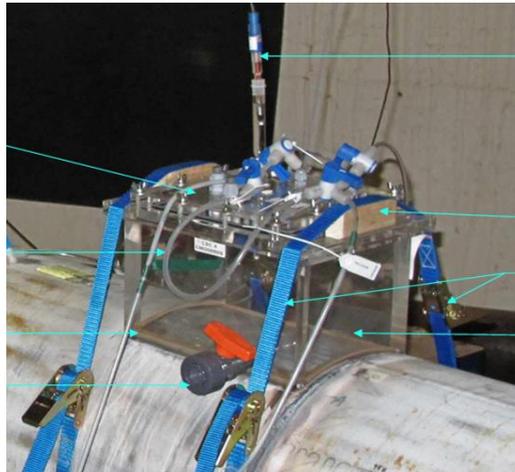
Figure 40: Air-tight electrochemical cell for full scale near neutral SCC crack propagation tests

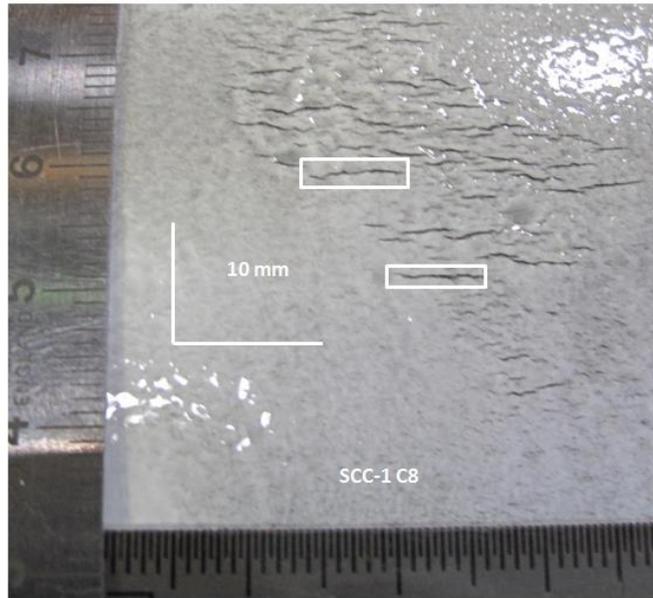
Figure 41: View of the defect C8 after Magnetic Particle Inspection in which the location of the deepest cracks according to sizing with MWM FA214 Jentek Sensor is highlighted.

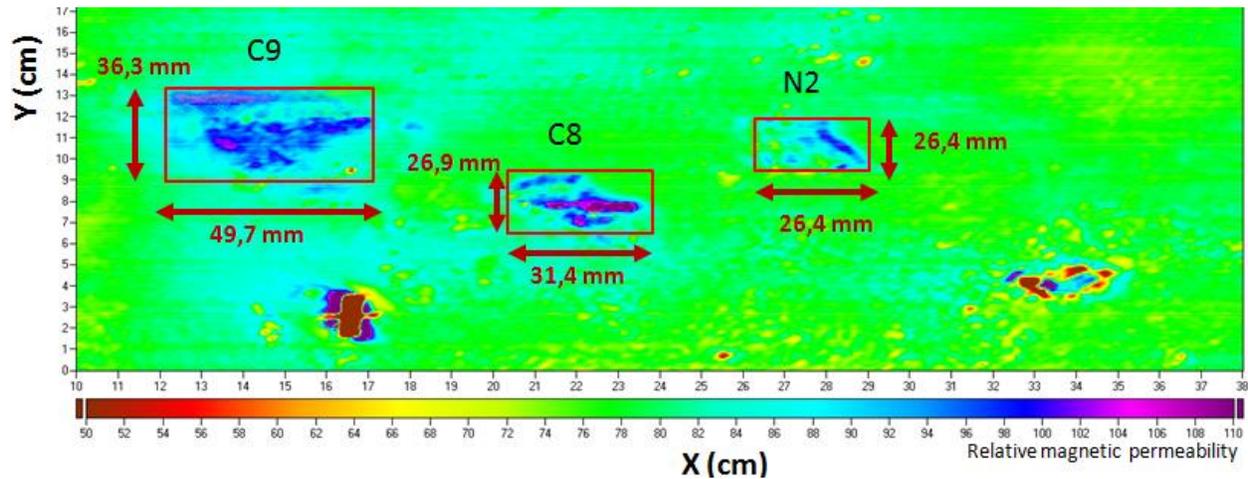
Figure 42: C-SCAN of magnetic relative permeability for colonies C9-C8-N2 colonies, as measured by MWM FA214 Jentek Sensor.

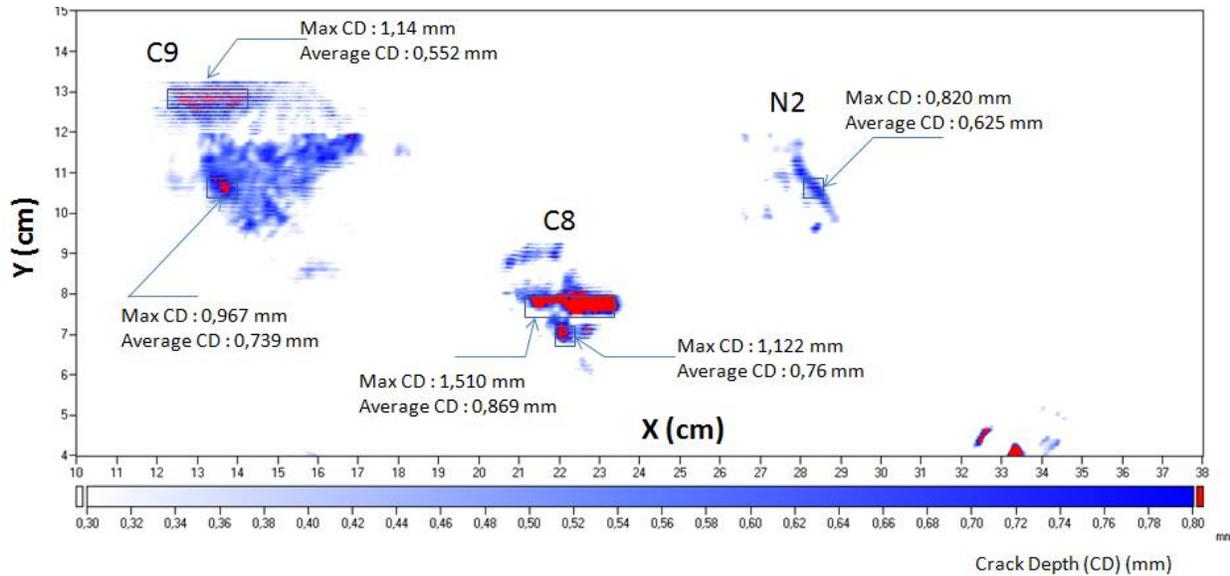
Figure 43: C-SCAN of crack depths in C9-C8-N2 colonies as measured with MWM FA214 Jentek Sensor.

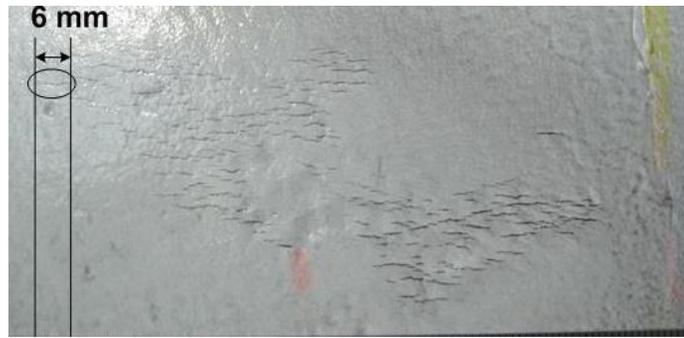
Figure 44: Crack colony R156-im1

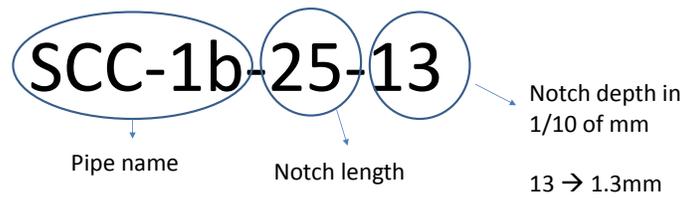
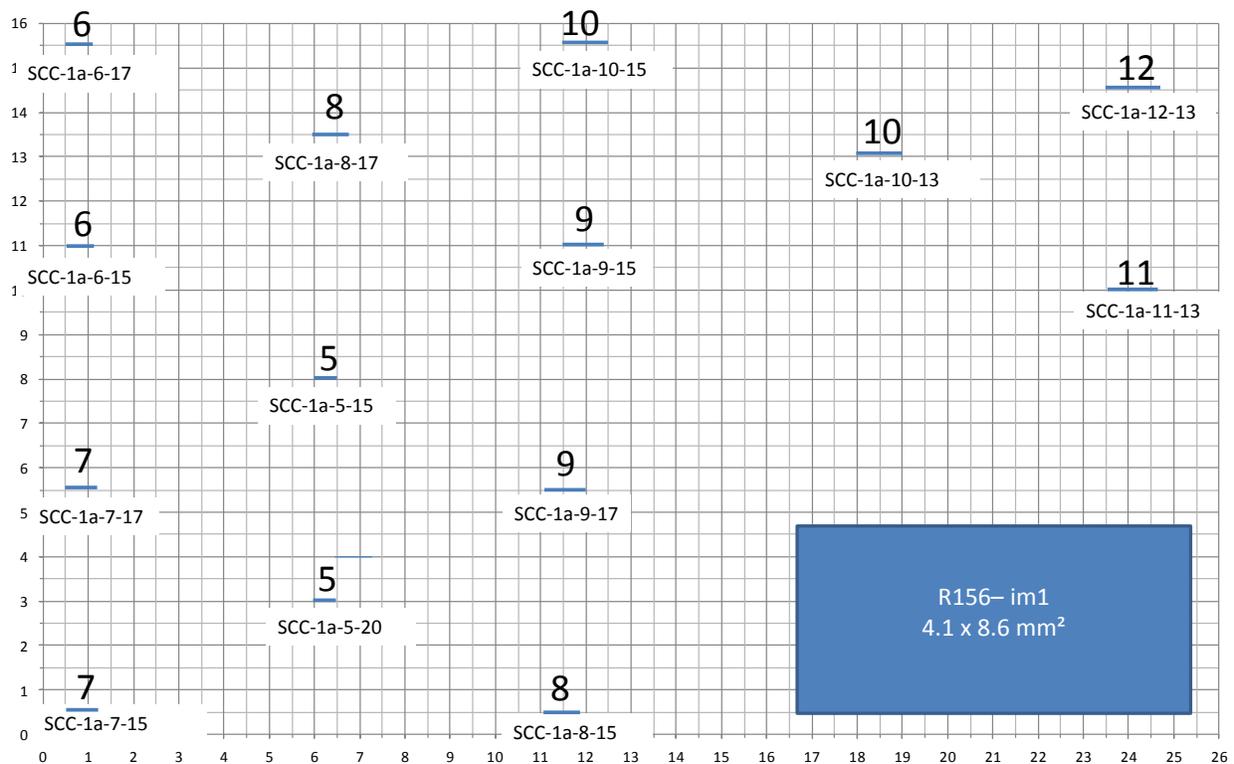
Figure 45: EDM notches + real SCC colony map for pipe SCC1a

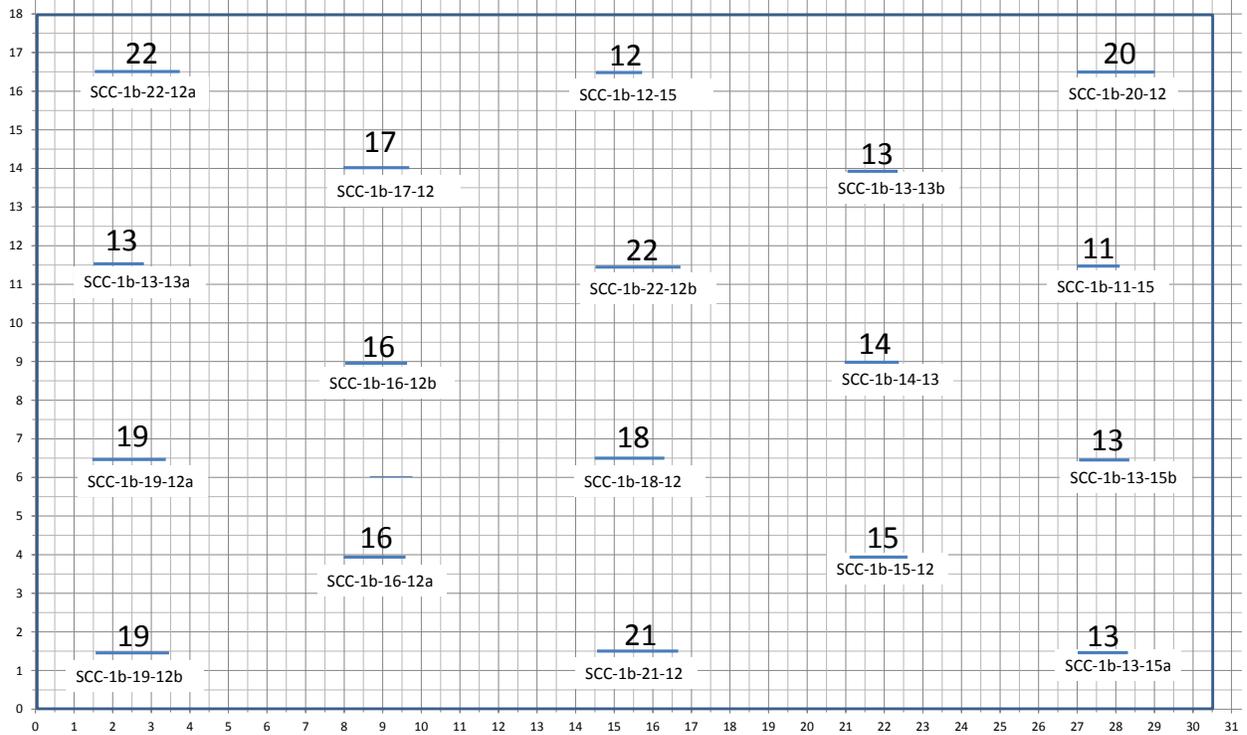
Figure 46: EDM notches map for pipe SCC1b

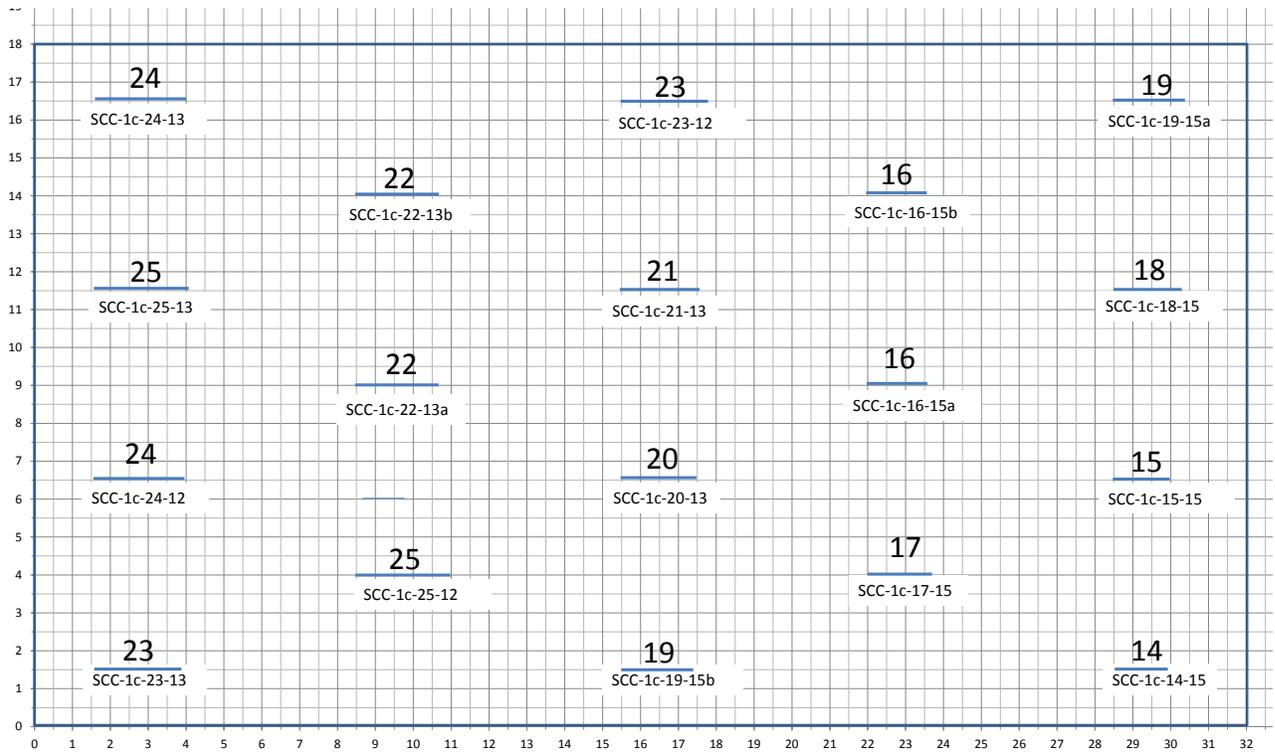
Figure 47: EDM notches map for pipe SCC1c

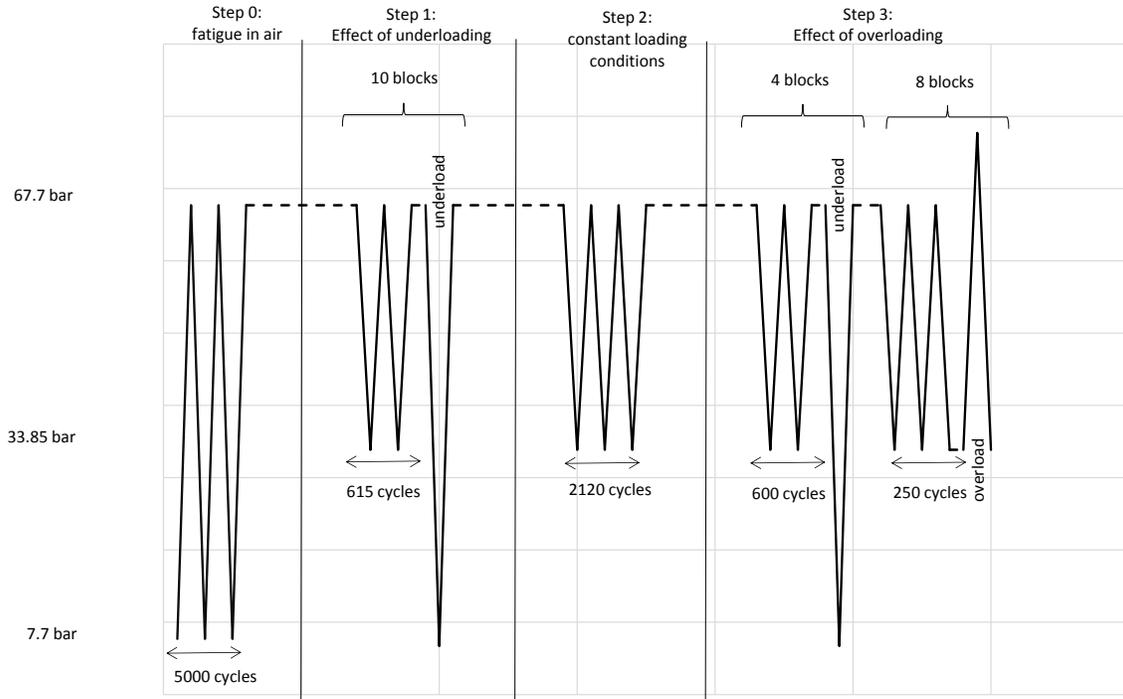
Figure 48: Oil pipe loading profile

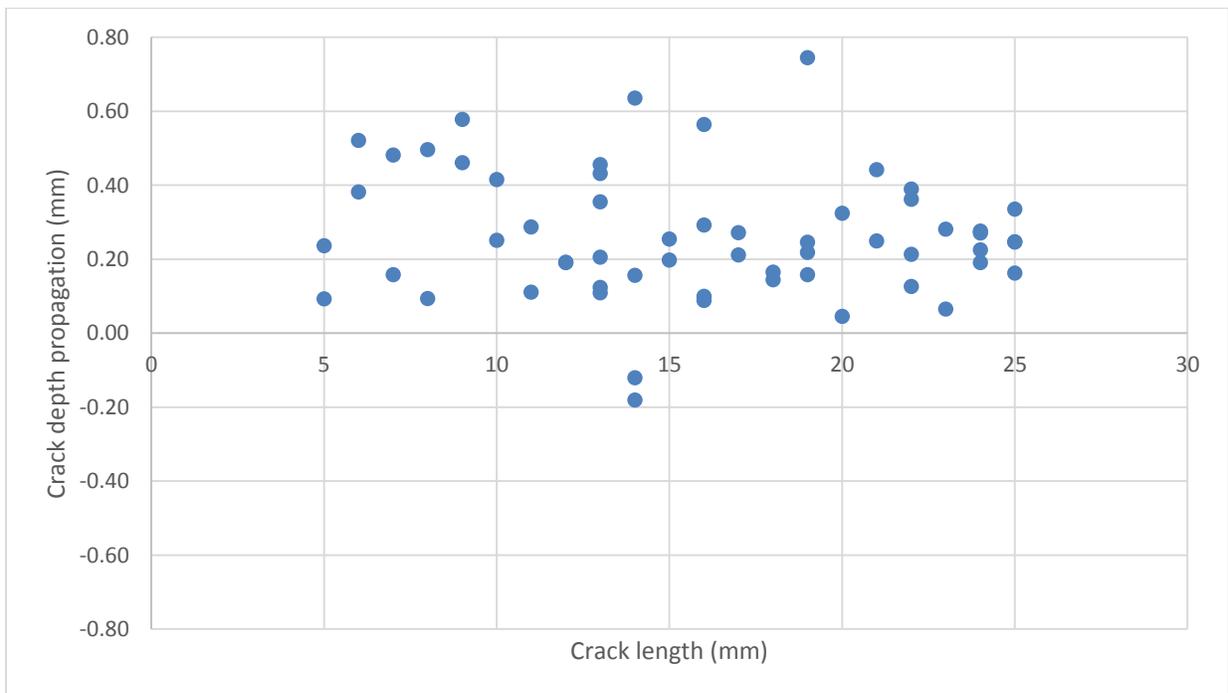
Figure 49: Crack depth propagation during phase 0 (fatigue in air)

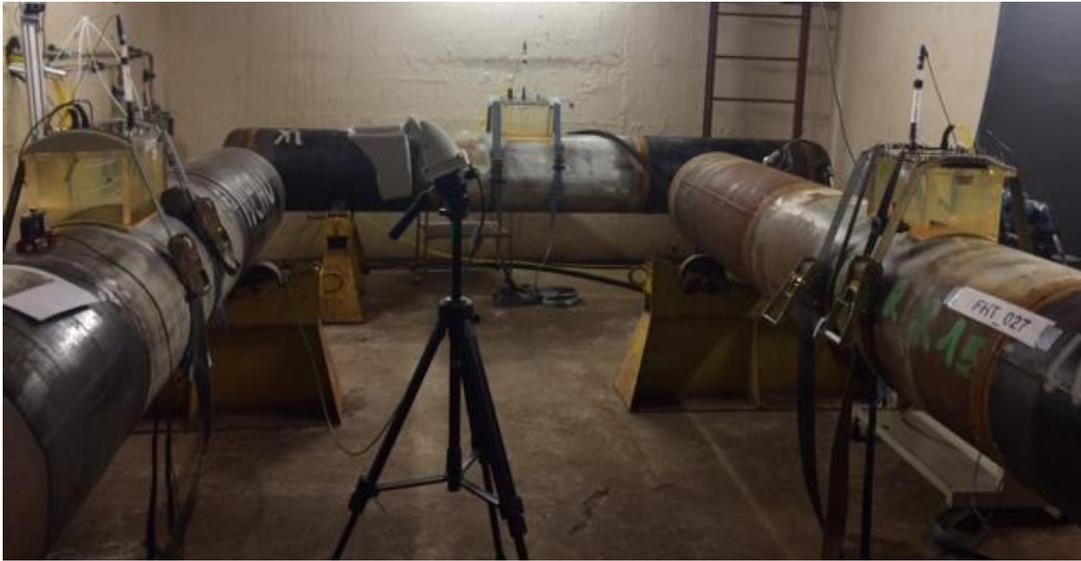
Figure 50: SCC1a, SCC1b and SCC1c pipes with electrochemical cells

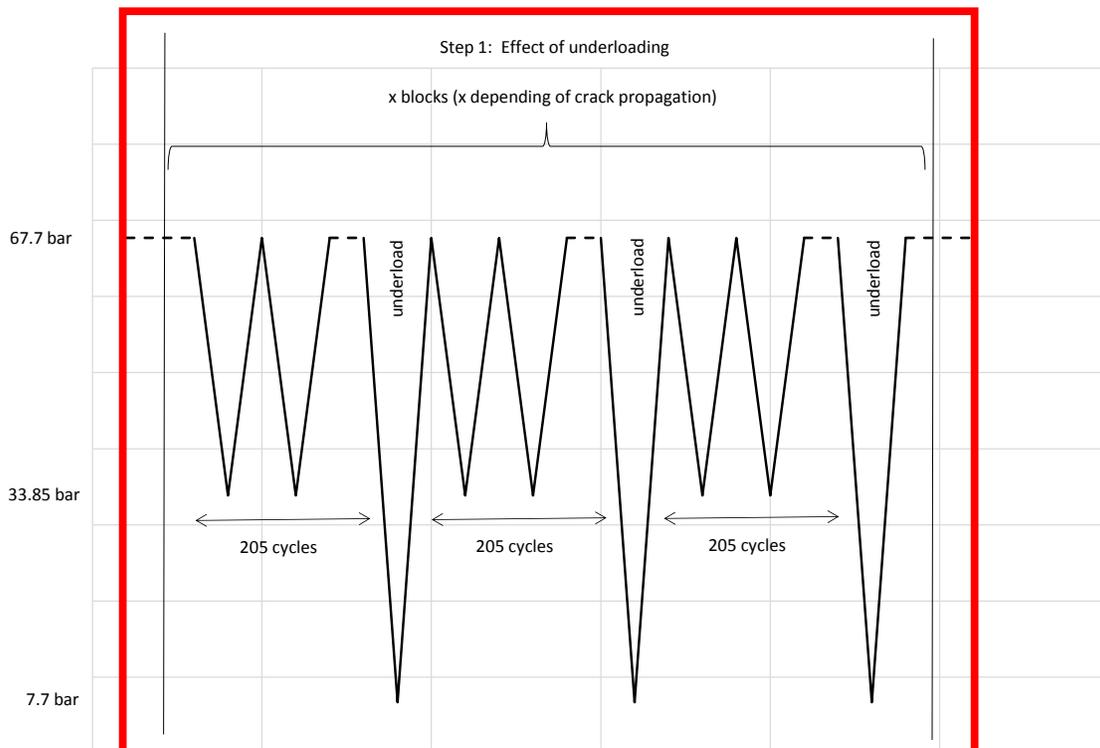
Figure 51: Modified oil test conditions for step 1 - 1 underload each 205 cycles

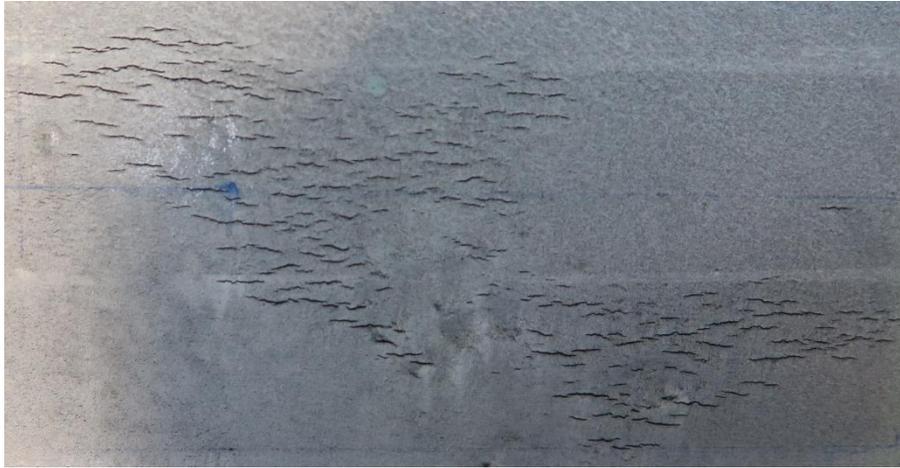
Figure 52 : Magnetic particle inspection of real SCC colony before step 1 of oil condition test

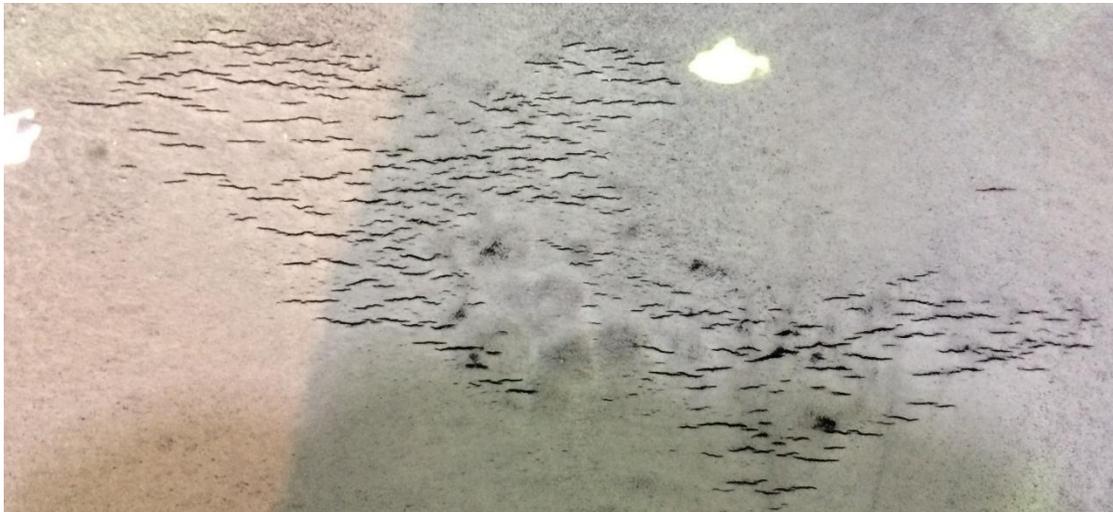
Figure 53 : Magnetic particle control of real SCC colony after 9792 cycles of step 1 of oil condition test

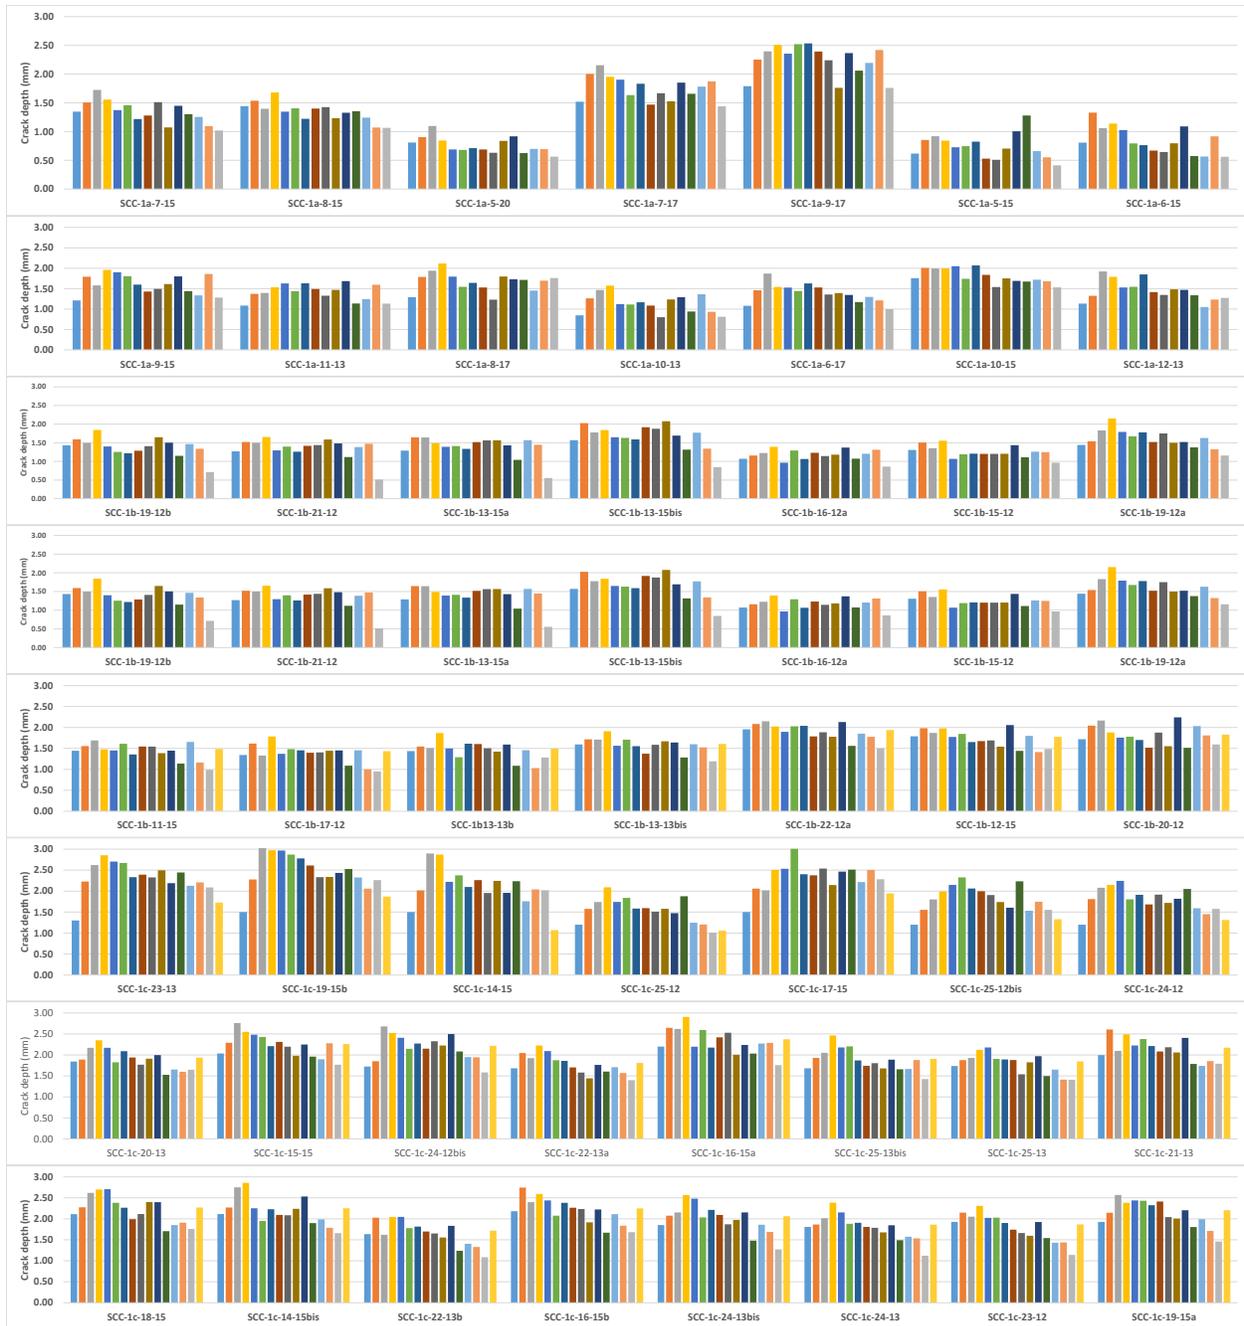
Figure 54: Crack depth measurements during oil conditions test

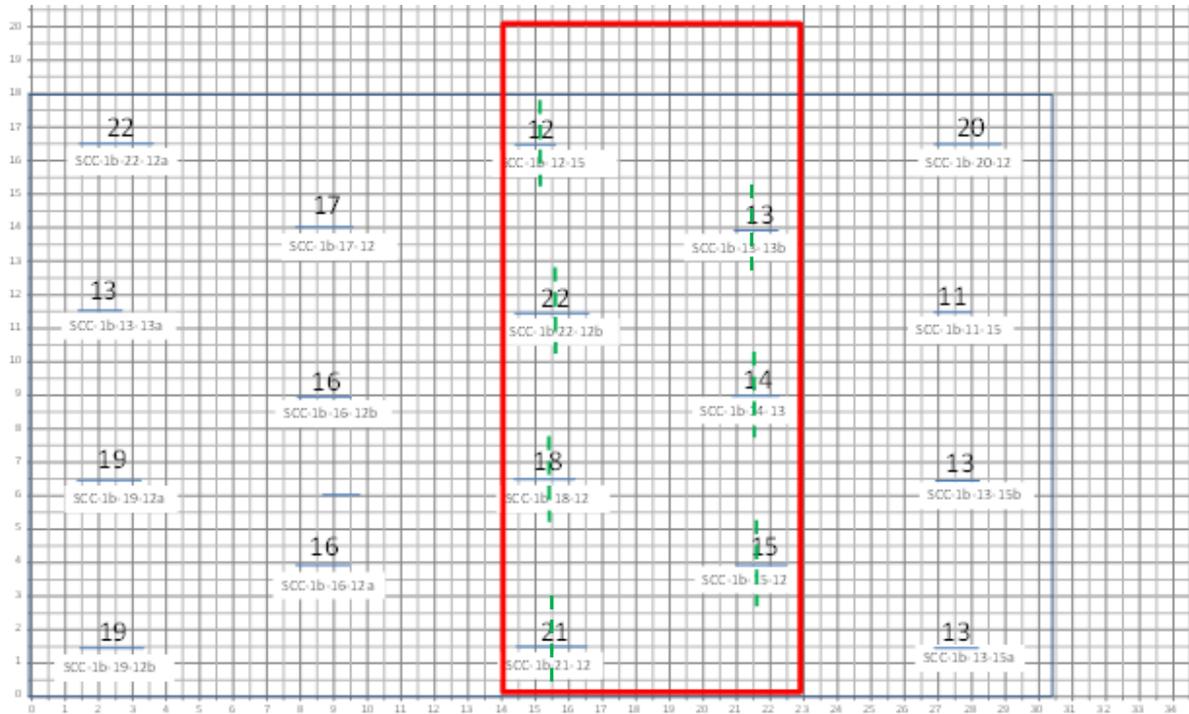
Figure 55: 7 EDM notches chosen for destructive observation.

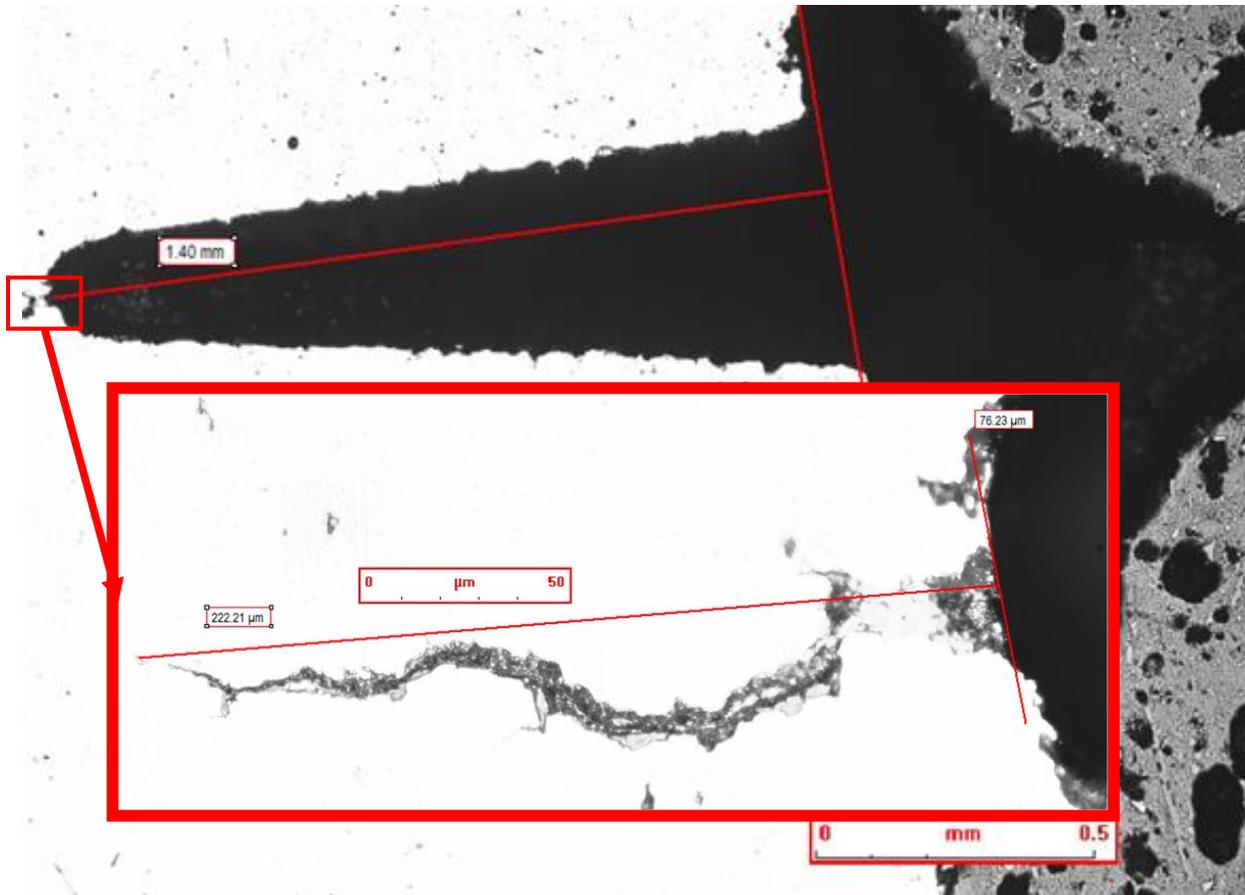
Figure 56: Microscopic observation of SCC1b-12-15 defect after oil conditions test

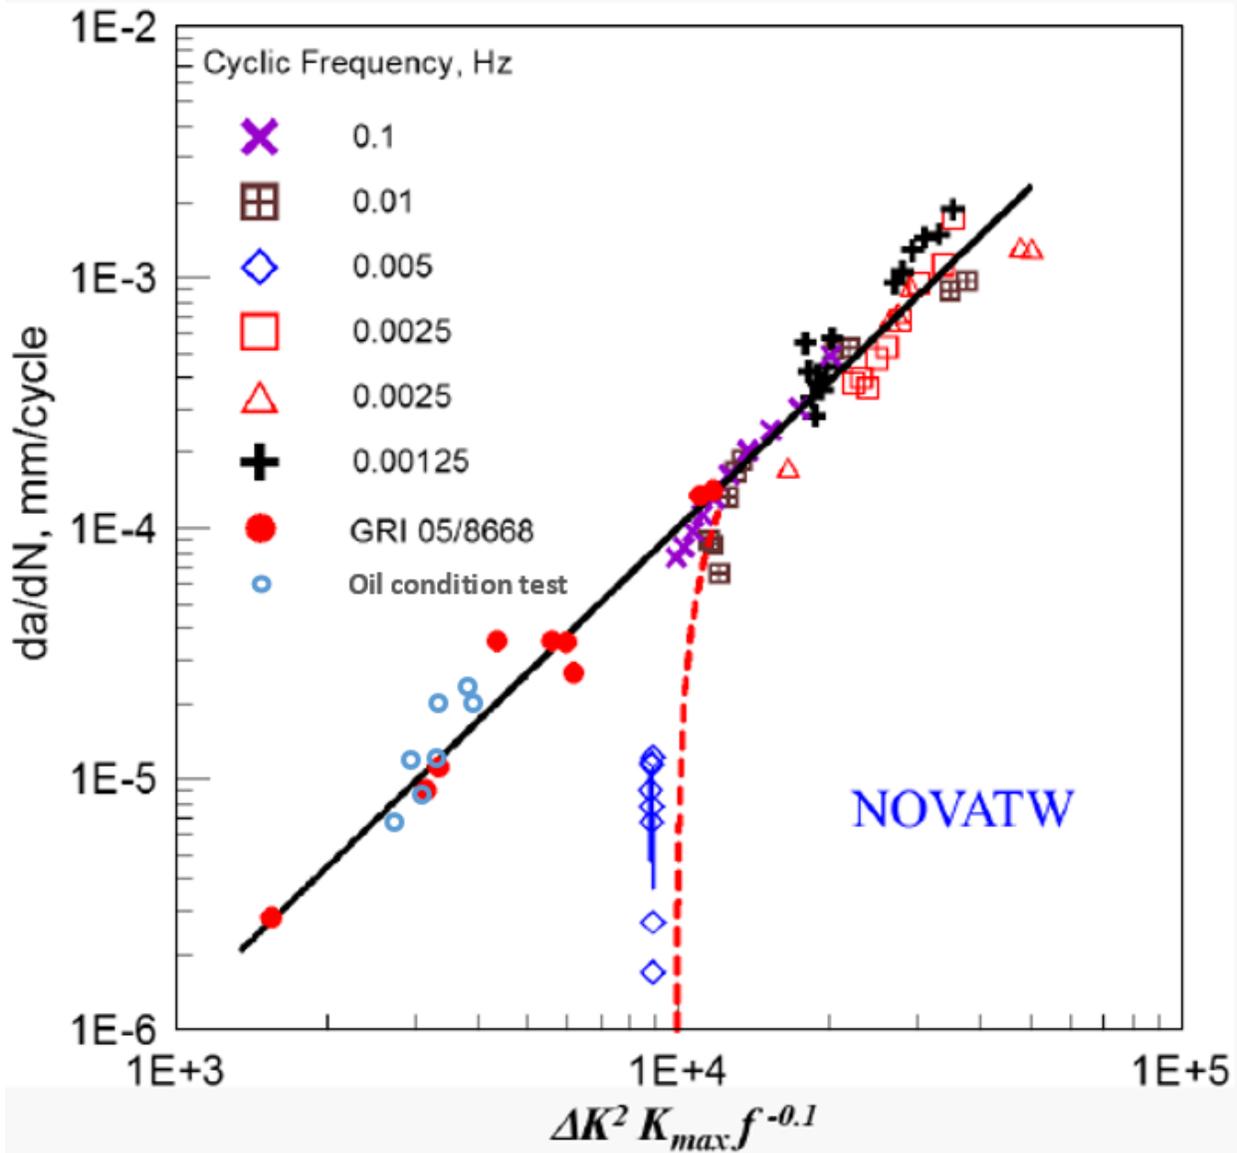
Figure 57: Comparison of oil condition test results and University of Alberta summary of results (paper # IPC2008-64475)

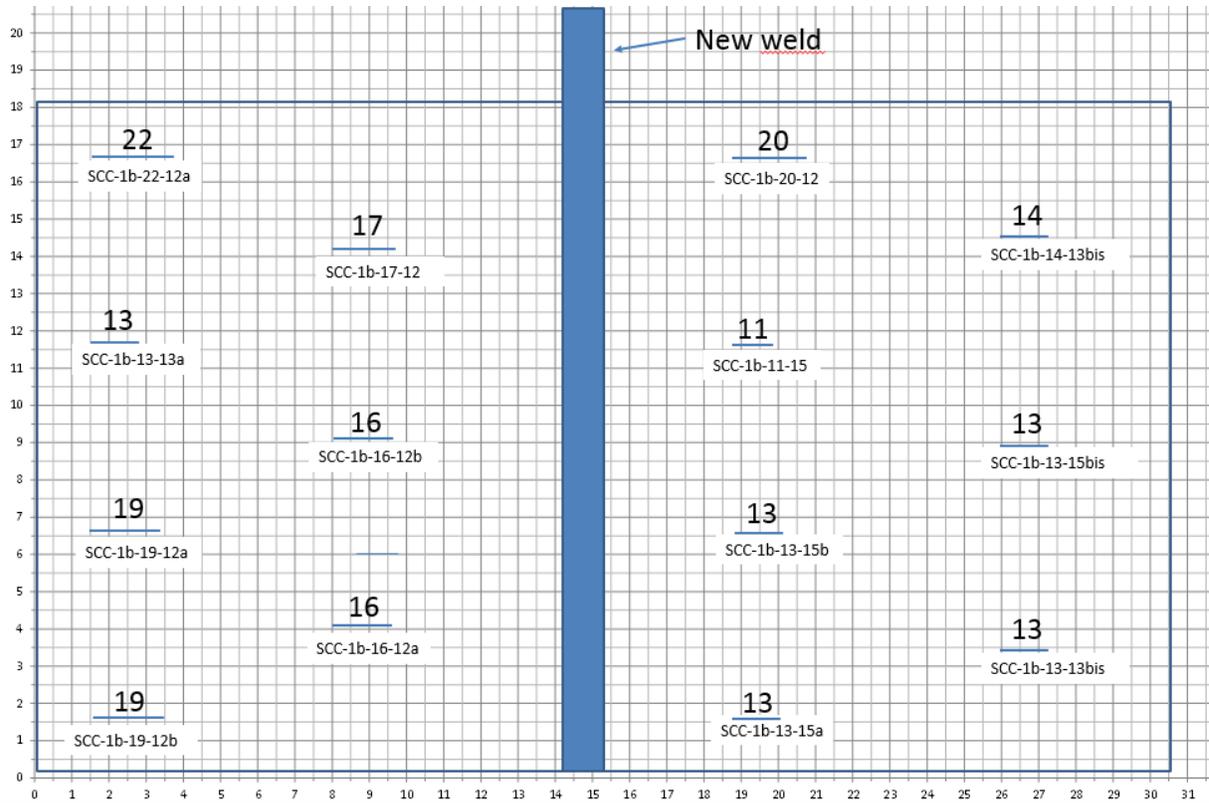
Figure 58: EDM notches map for pipe SCC1b during gas pipeline test condition

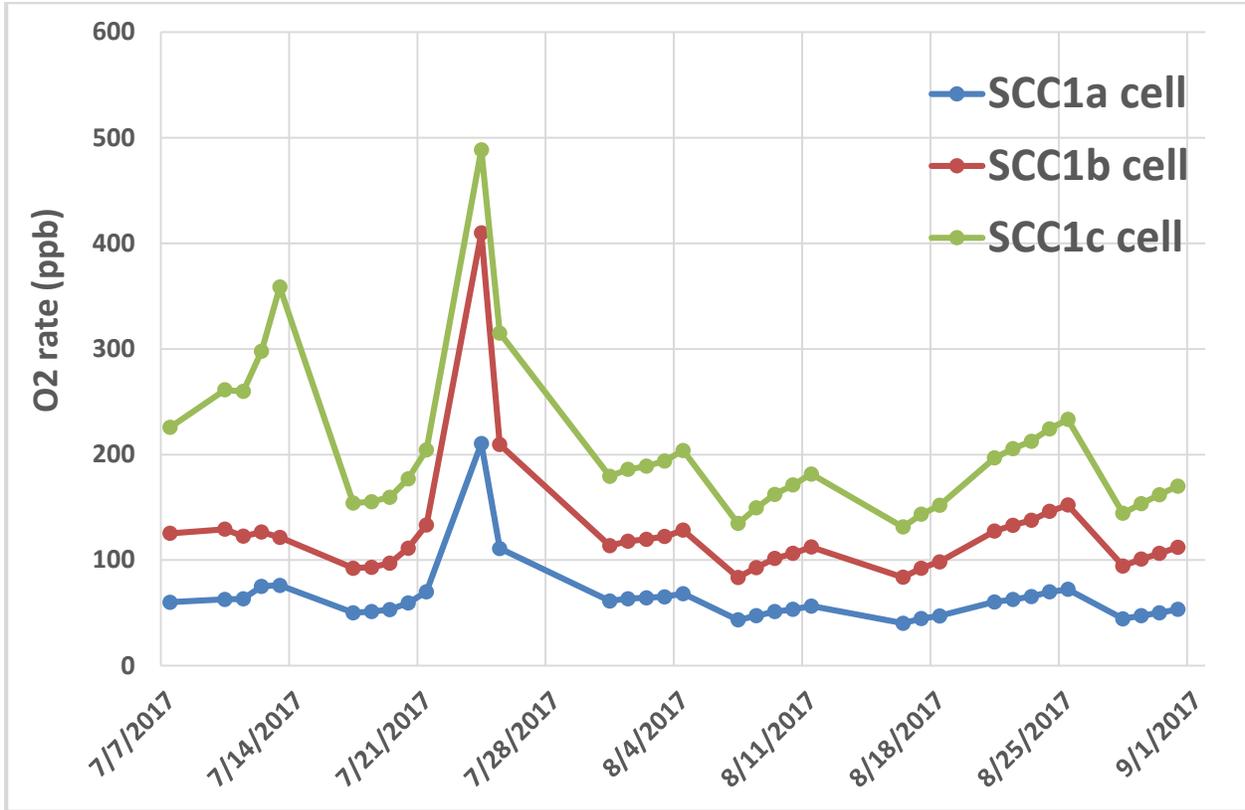
Figure 59: O₂ concentration during the gas pipeline condition test

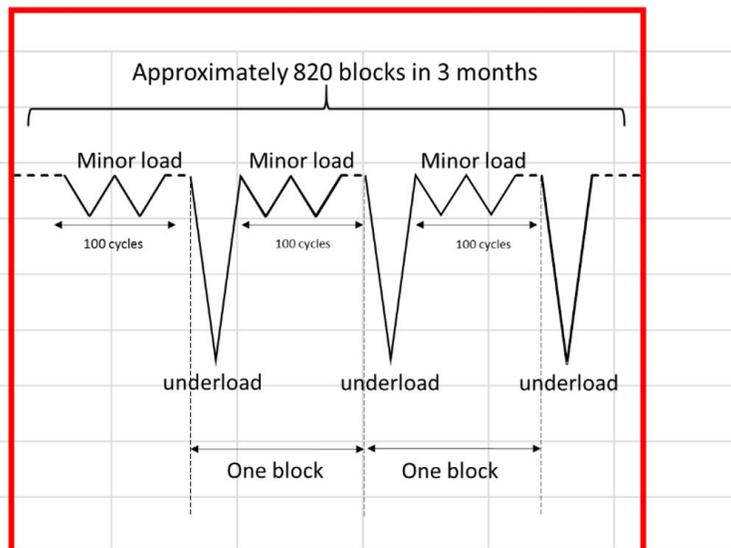
Figure 60: Loading conditions for gas pipeline condition test

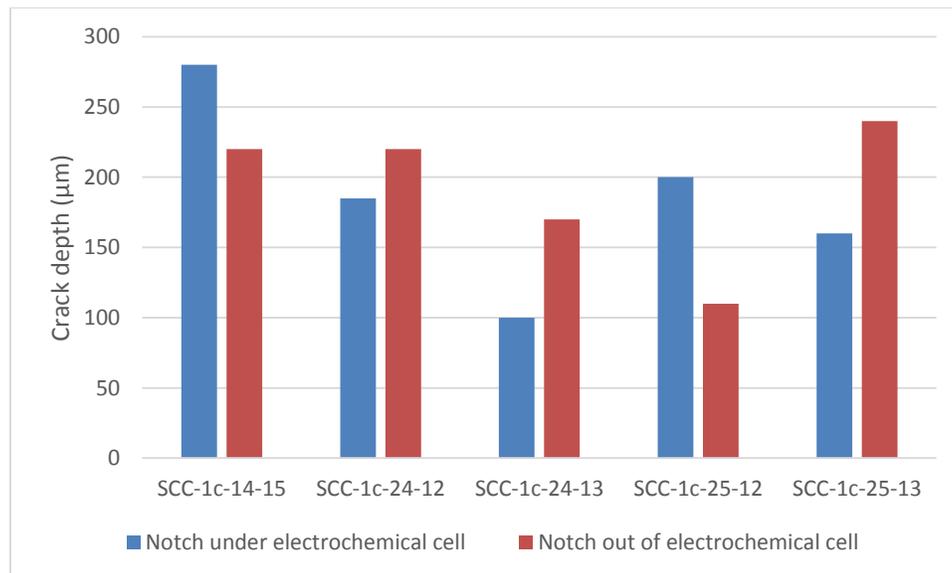
Figure 61: Comparison between crack size at the tip of notches located under or out of the electrochemical cell

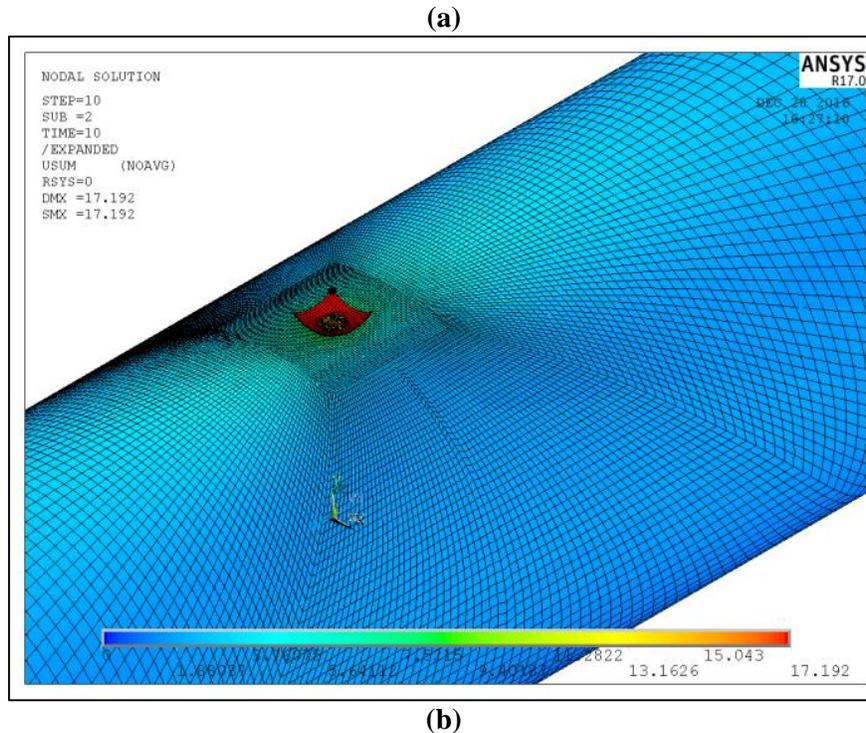
Figure 62: Typical FE Model of the Dent with Axial End Load (a) Side View of the Whole FE Model (b) Close up of the Dent Area

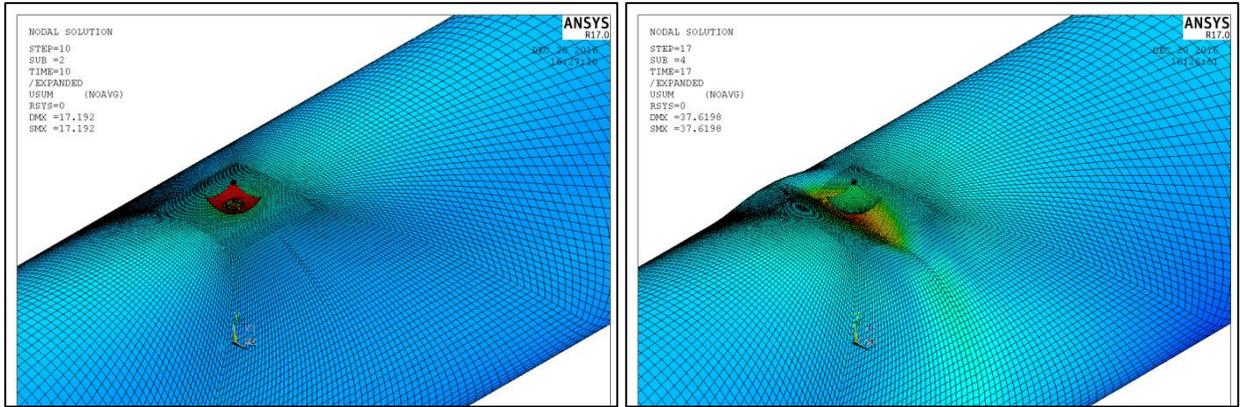
Figure 63: Buckling of a Restrained Dent due to Compression (a) Before Buckling (b) After Buckling

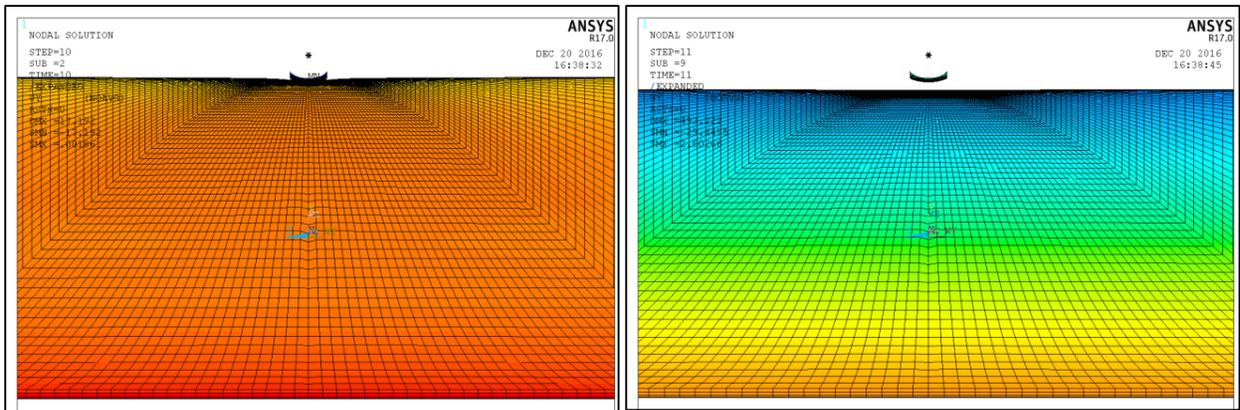
Figure 64: Restrained Dent Under a 1350 kips Tensile Force (a) Before Thinning (b) After Thinning

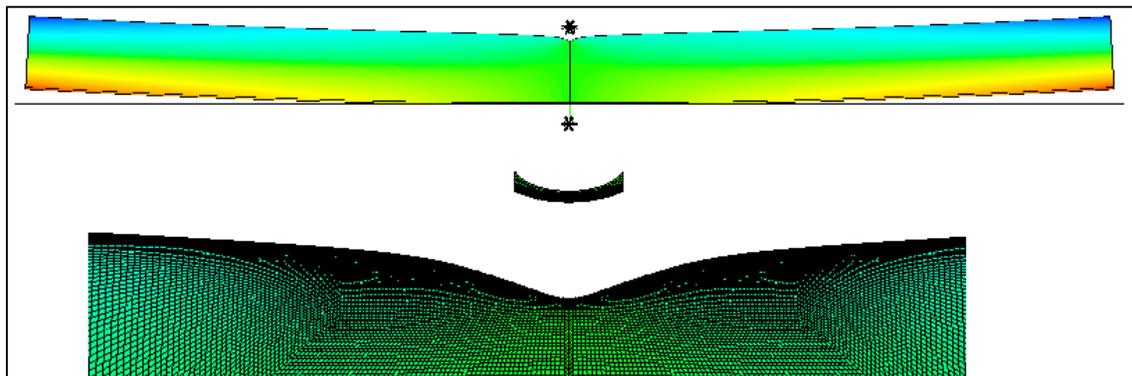
Figure 67: A Typical Restrained Dent under Bending, Beyond the Buckling Point – True Scale

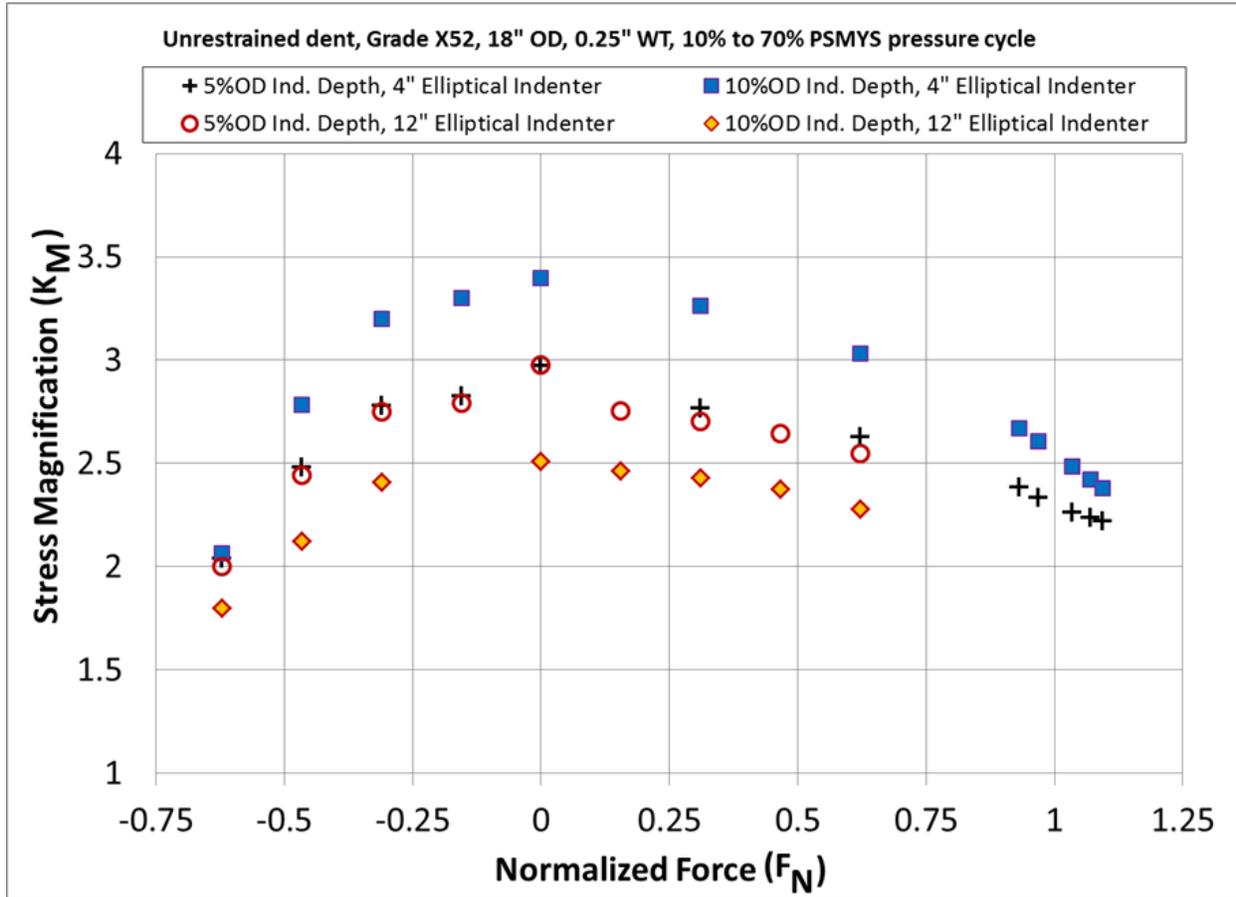
Figure 68: Stress Magnification Factor of Unrestrained Dents with Axial Force
