FINAL REPORT
DTPH56-14-H-00002
"Full Scale Testing of Interactive Features for Improved Models"

TEAM TECHNICAL AUTHORS: BMT Fleet Technology

ENGIE, R&I Department

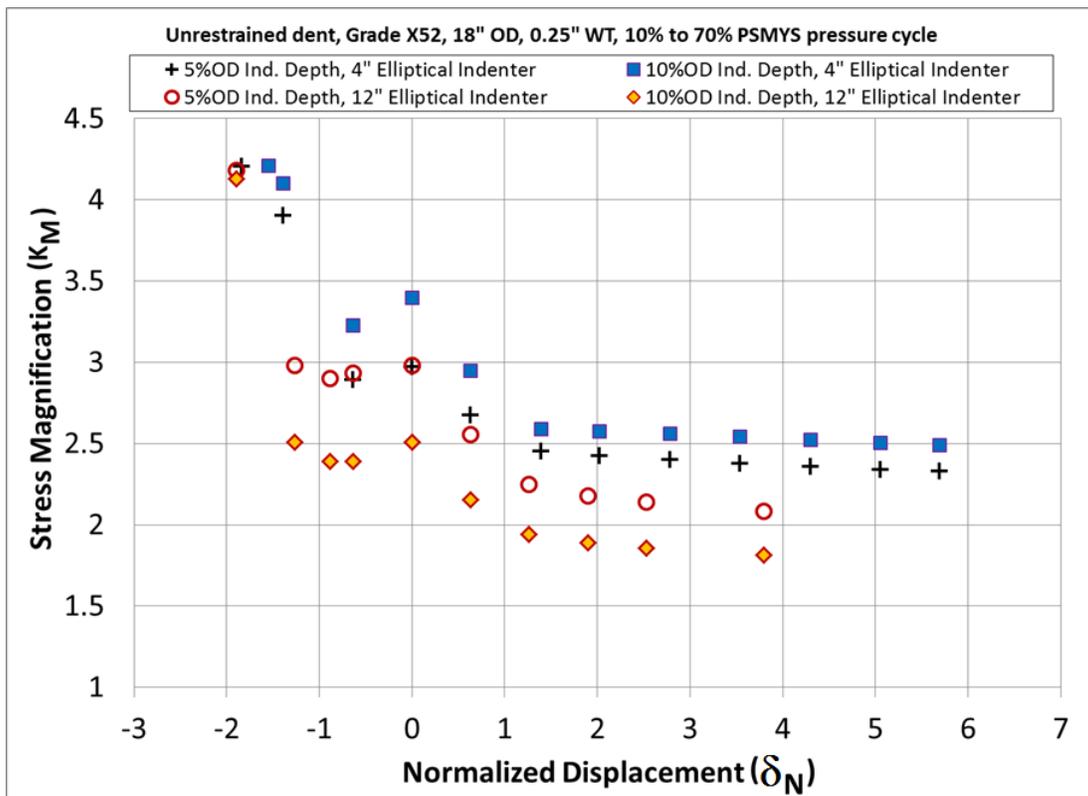
Figure 69: Stress Magnification Factor of Unrestrained Dents with Axial Displacement

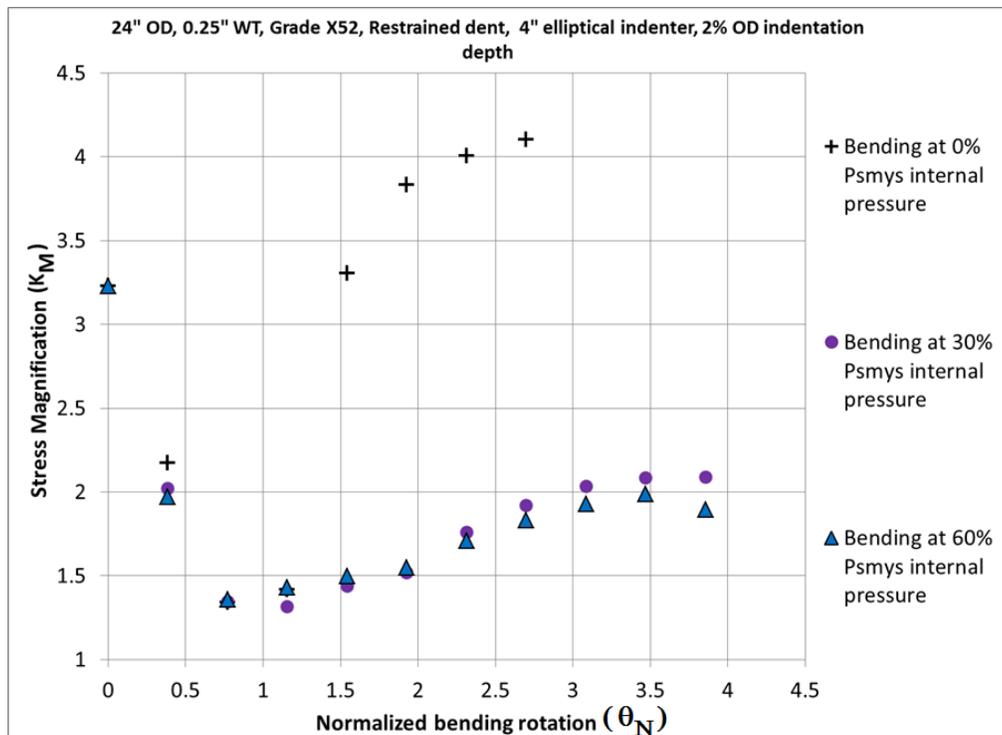
Figure 70: Stress Magnification Factor of Restrained Dents under bending

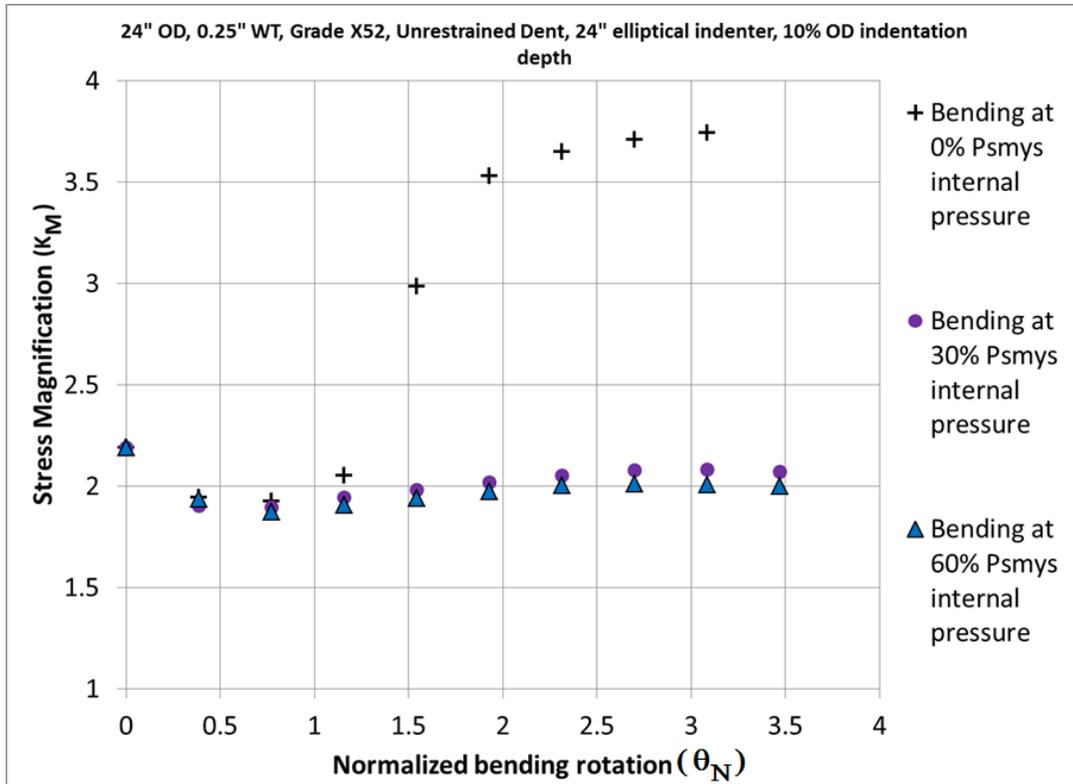
Figure 71: Stress Magnification Factor of Unrestrained Dents under bending

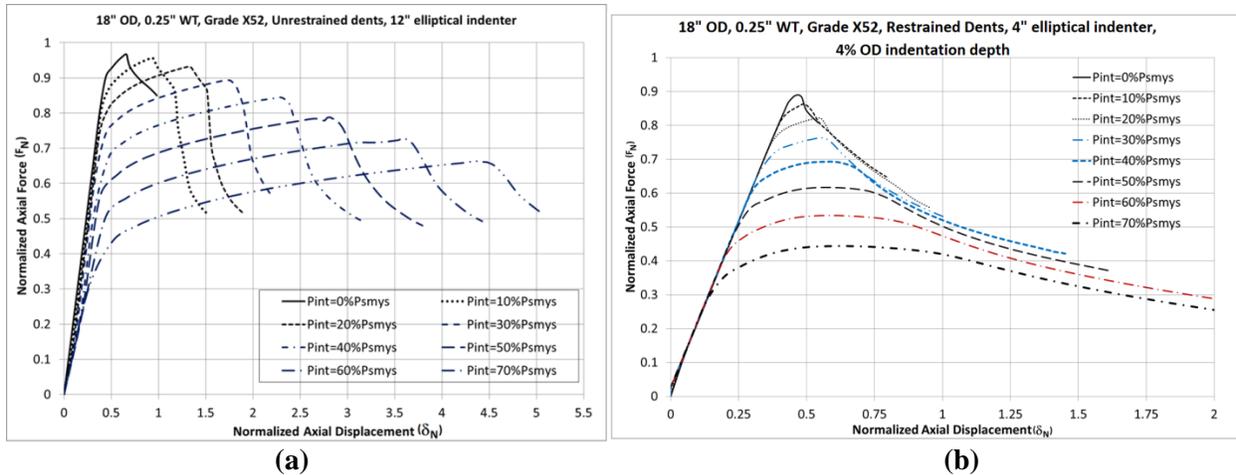
Figure 72: Variation of Axial Force Capacity with Internal Pressure: (a) Unrestrained Dents (b) Restrained Dents

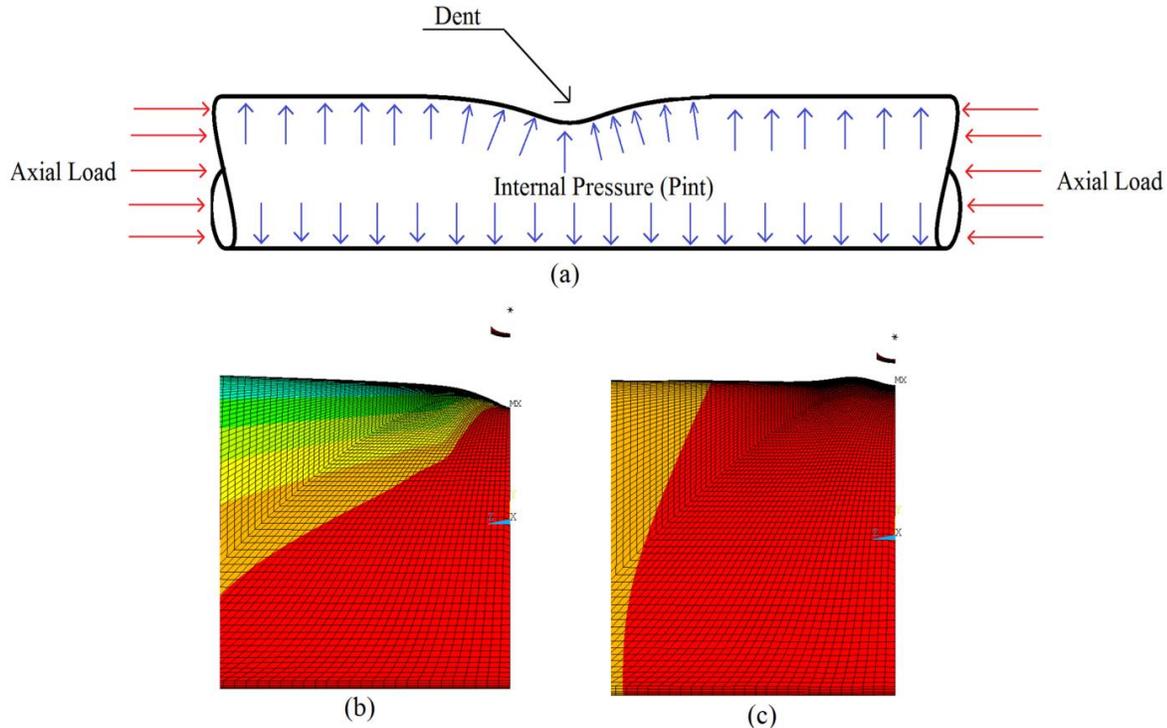
Figure 73: (a) Schematic of a dent under internal pressure and axial load, (b) buckling of dent with zero internal pressure, (c) buckling of dent with 70% PSMYS internal pressure

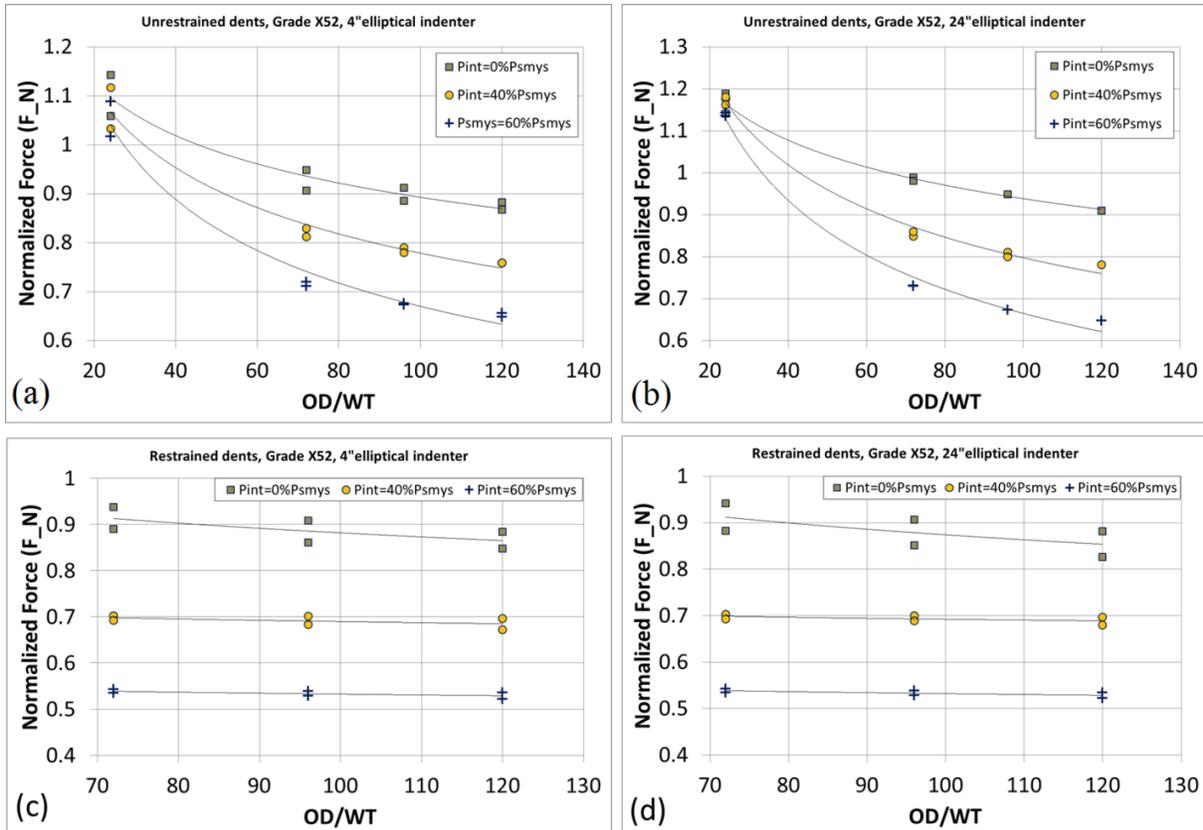
Figure 74: Effect of various parameters on the axial load capacity, (a) and (b) unrestrained dents, (c) and (d) restrained dents

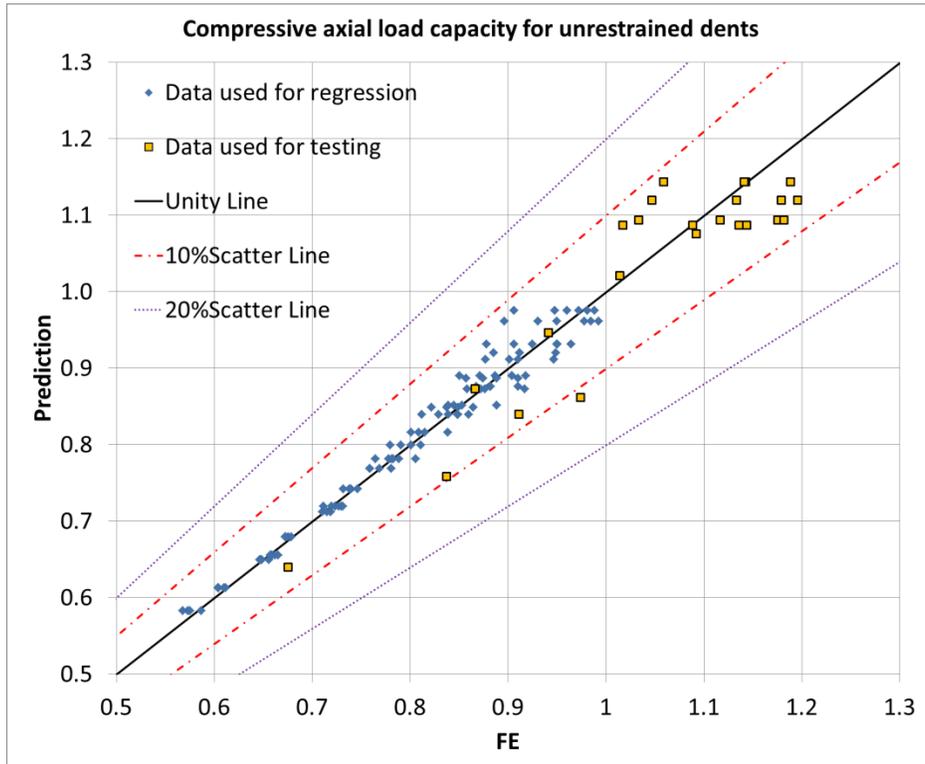
Figure 75: Unity Plot for the Unrestrained Dents Buckling Equation

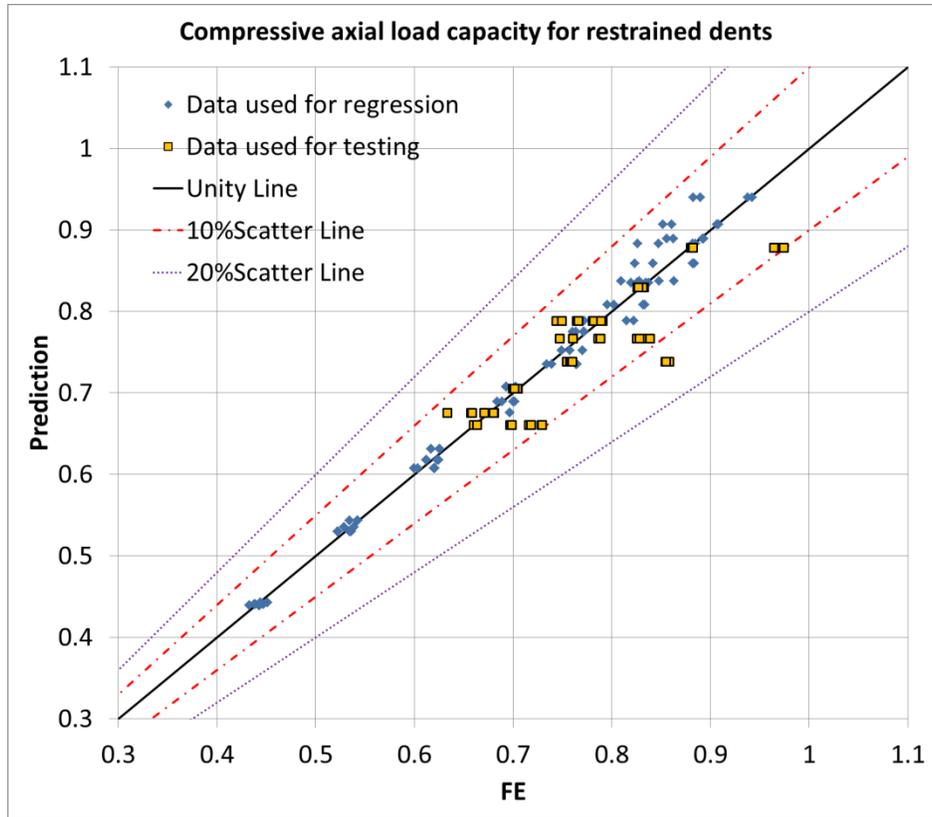
Figure 76: Unity Plot for the Restrained Dents Buckling Equation
