Internal Quarterly Report

Prepared for: USDOT – Pipeline and Hazardous Materials Safety Administration (PHMSA)

Project Title: Improve Pipeline leak Rate Estimation

Prepared by: BMT Canada Ltd / BMT Commercial USA

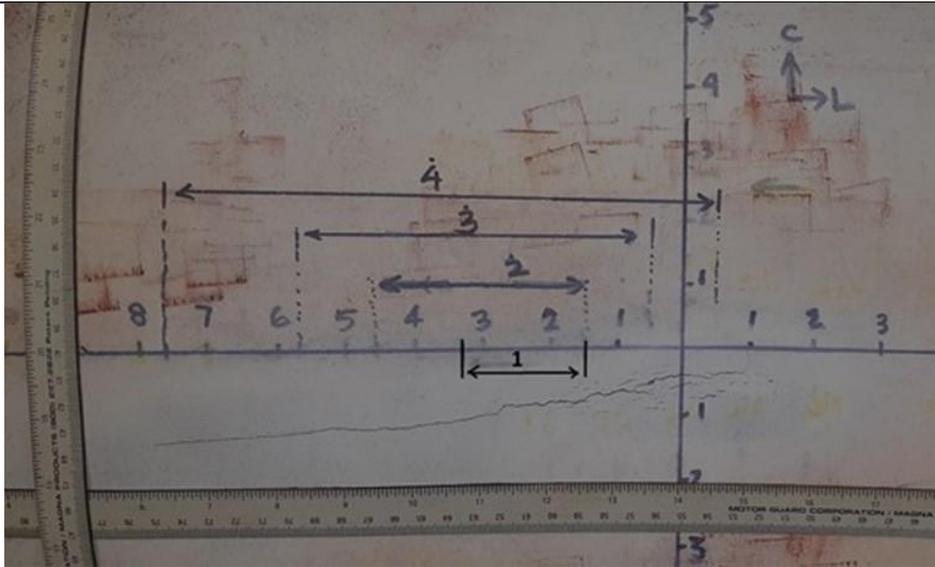
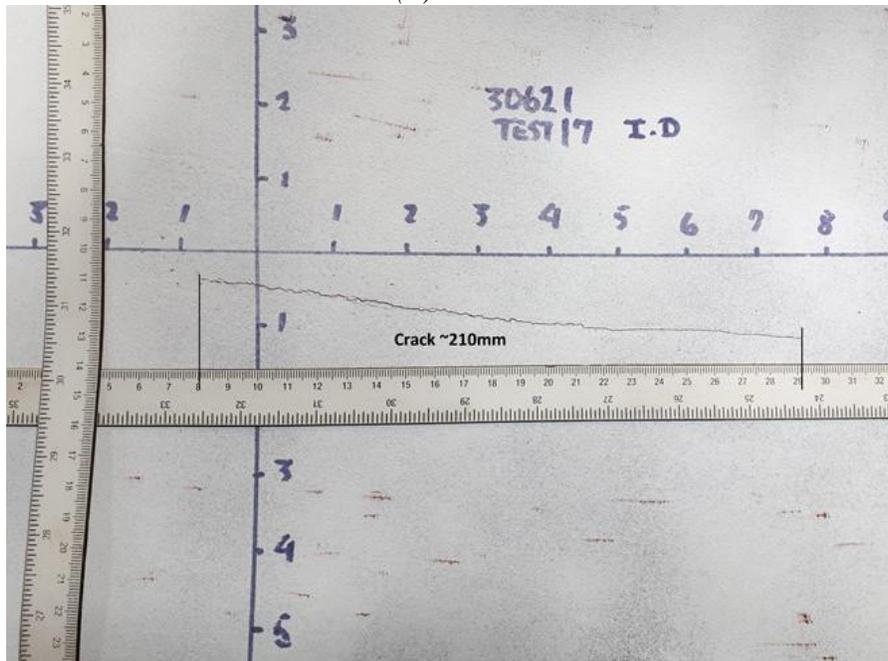
(a) OD MPI

(b) ID MPI

Figure 1 MPI of OD and ID Surface. OD Surface Photograph also shows through Wall Crack Sizes of the 4 Cracks. Dent Center is at the Cross-hair.

Leak rate test was carried out on a dented 40” OD, 0.344” WT, Grade X-60 pipe. The pipe with the dent was removed from service. EndCaps were welded at pipe ends to fabricate a pressure vessel. The test specimen was cycled between 50 psi (5% SMYS) and 565 psi (55% SMYS) till appearance of a through wall fatigue crack close to the dent peak. MPI and UT measurements were carried out to measure crack size at OD and ID. Leak rate test was then carried out at pre-defined pressures. The pressure vessel was held at a fixed pressure for a fixed period of time and water collected in a vessel. The volume of water collected was measured and leak rate calculated. The same process was repeated and a leak rate curve was developed for the crack size. The pressure vessel was then cycled gain to grow the through wall crack size. In this test four leak rates were measured at four different through wall crack sizes. Figure 1a shows the MPI of the OD surface with four different crack sizes marked on it. Figure 1b shows the MPI of the final ID crack. Figure 2 shows the leak rate curves for the four different crack sizes.

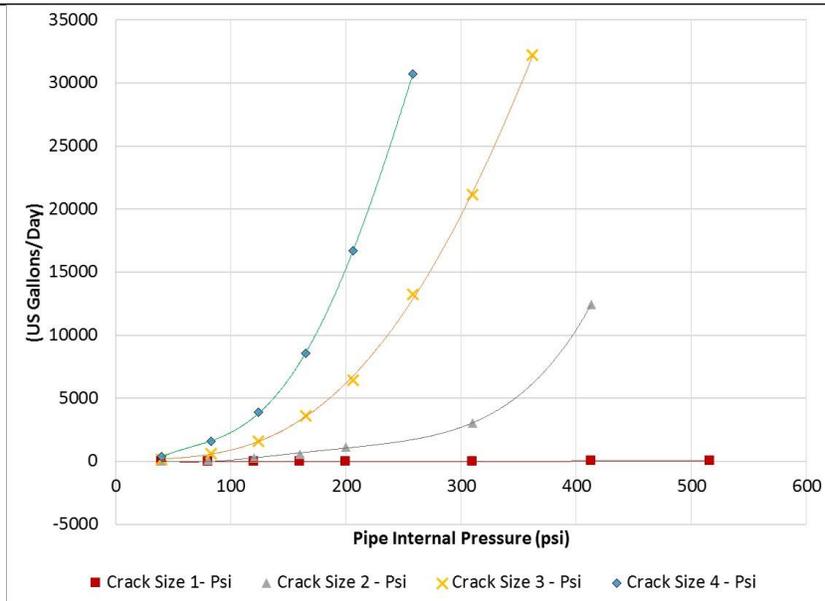
Figure 2: Leak Rate Curves for Four Different Fatigue Crack Sizes at Different Pressures.

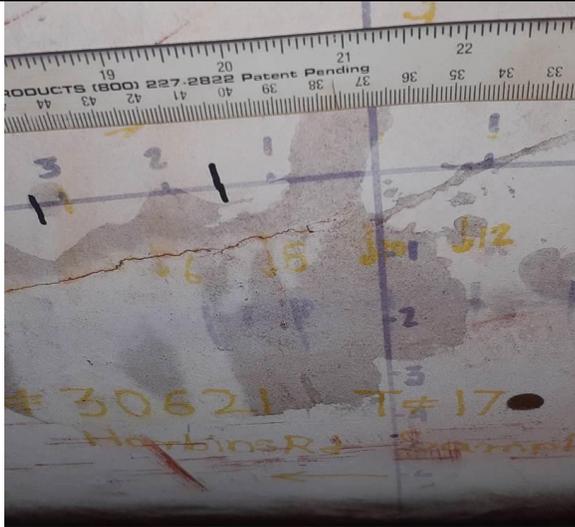
Leak Test Photograph @ 206 psi - Crack Size 1

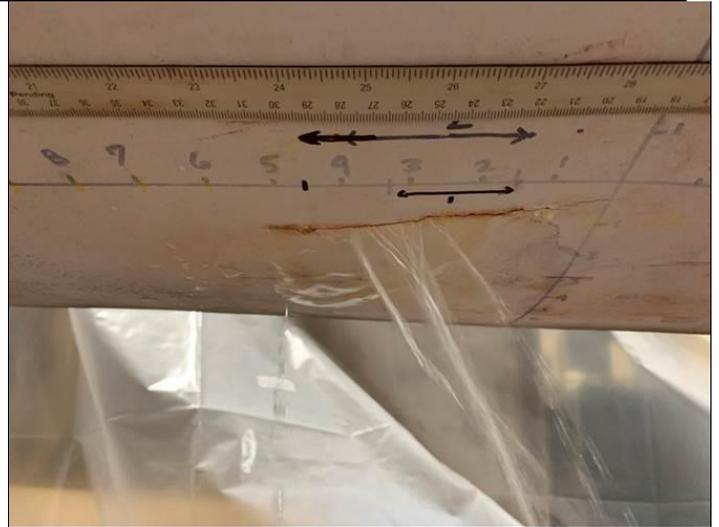
Leak Test Photograph @ 206 psi - Crack Size 2

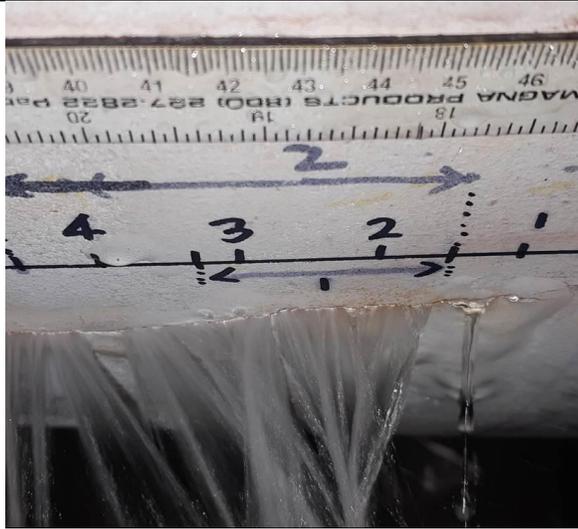
Leak Test Photograph @ 206 psi - Crack Size 3

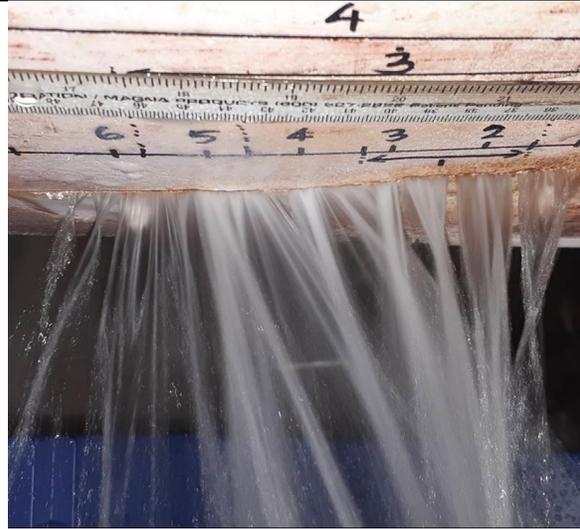
Leak Test Photograph @ 206 psi - Crack Size 4
