# CAAP Quarterly Report

Date of Report: July 19, 2020

Project Title: A Fast and Low-cost Method to Automate Detecting, Locating, and Mapping Internal Gas Pipeline Corrosion using Pig-mounted Thermal and Stereo Cameras

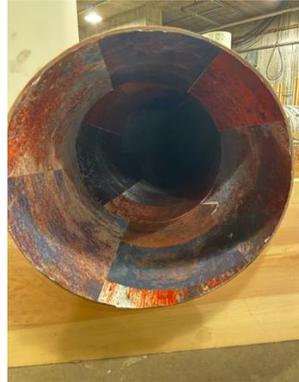
Figure 1. An example of a pipe section with artificial corrosions patterns

1. A corrosion image database was created, which contained more than 400 difference corrosion texture images collected from online. The corrosion images were used for assisting with pipeline 3D modeling, as well as corrosion detection. Figure 1 shows how these corrosion images were used to create the internal pipe corrosion scene.

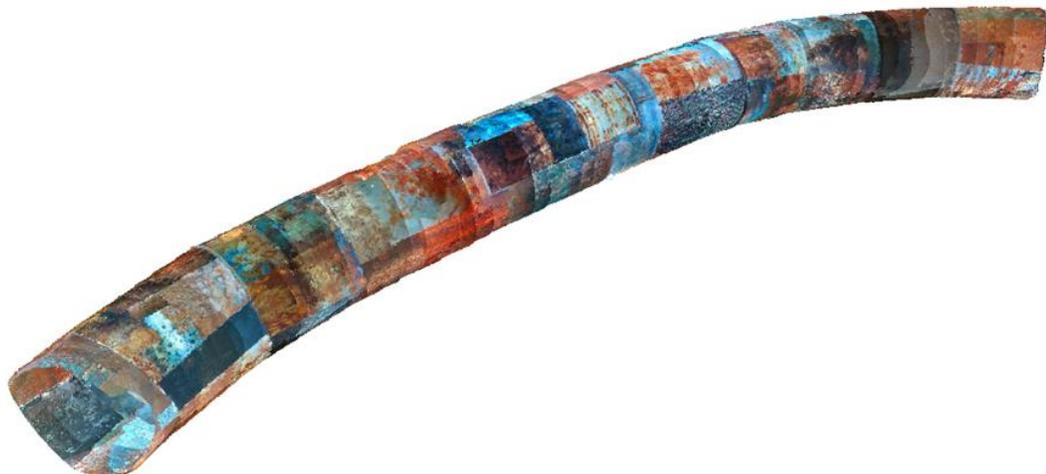
(a) Raw images captured by the inline robot

(b) Reconstructed 3D pipeline with corrosion patterns

Figure 2. An illustration of the image-based 3D pipeline reconstruction.

The team explored using corrosion texture features to improve the outcomes of the optical flow based 3D reconstruction. Figure 2a shows the raw RGB images acquired by the robot's cameras. Figure 2b shows the reconstructed 3D pipeline. A journal article is in preparation to report the progress.
