Electric Resistance Welded Pipe (ERW)

Randy Vaughn, RAILROAD COMMISSION OF TEXAS

ERW AS A RISK OR THREAT CONSIDERATION

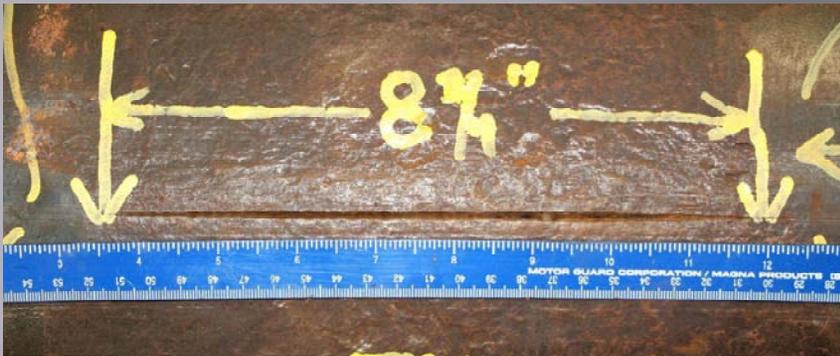
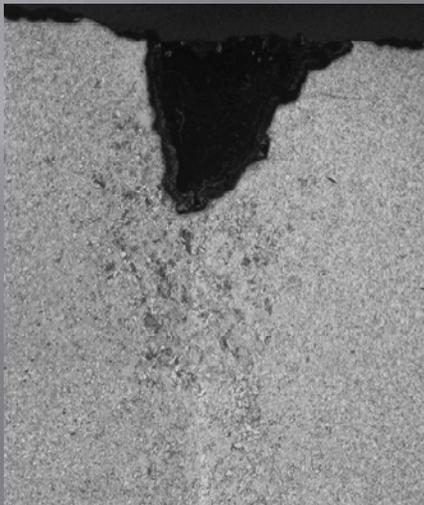
Grooving corrosion at an ERW longitudinal seam

The variation in microstructure between the base metal and the heat affected zone (HAZ) may create minor localized galvanic differences, with the seam structure being more anodic.

The microstructure and chemistry of the steel was typical of the vintage and grade and the chemistry met the API 5L specifications in place at the time of manufacture.

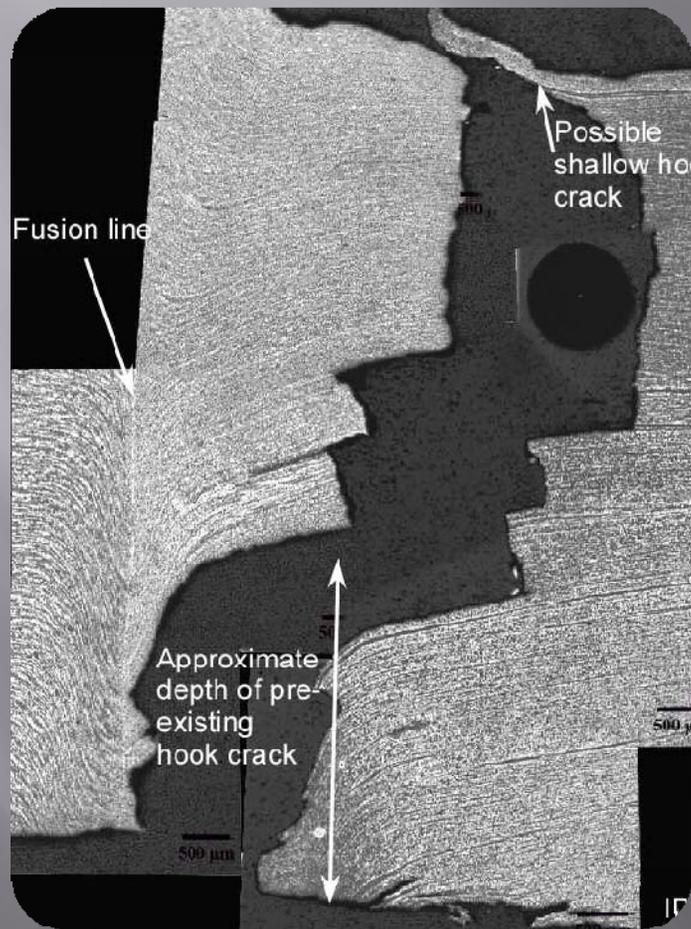
Hook Crack Failure

The analysis for this failure indicated that the rupture initiated at an ID connected pre-existing hook crack. This and all hook cracks are slightly offset from the bond line of the ERW seam.

No evidence of in-service growth by fatigue was found, although the quality of the image is poor as a result of corrosion of the fracture surfaces that occurred after the ruptures.

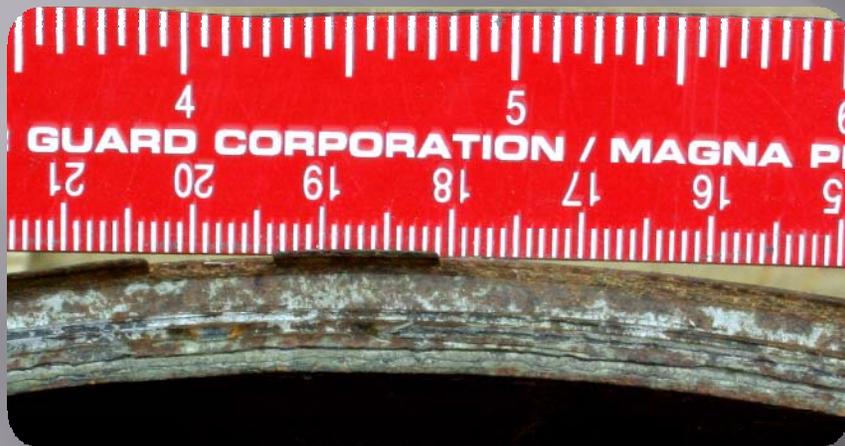
Hook Crack Failure

There was no evidence of external corrosion of the pipe section, which indicates that the coating was intact prior to the rupture and was removed by the rupture or by subsequent handling.

The pre-existing hook crack that was surface breaking on the ID surface was evident on the fracture surface. The hook crack was approximately forty-four inches in length, with a maximum depth of 40% of the wall thickness.

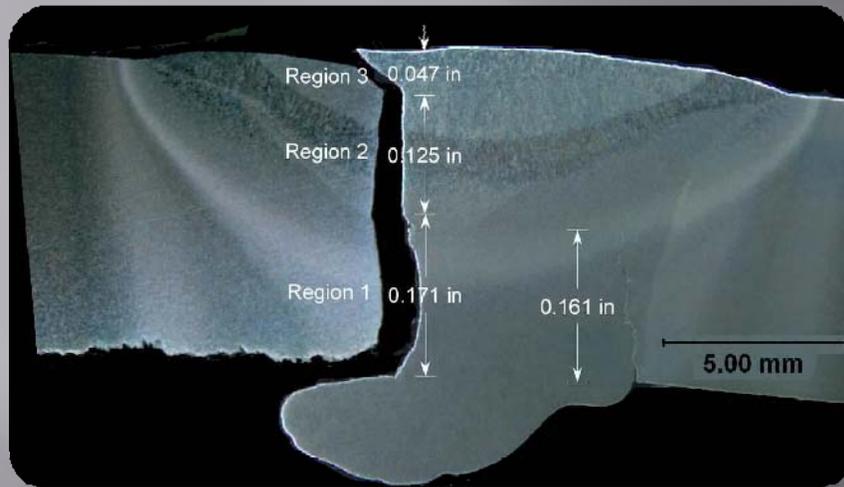
Lack Of Fusion

The sample analysis indicated that the rupture initiated at an ID surface breaking lack-of-fusion (LOF) defect that was located at the root of the SSAW seam. The LOF defect was one of three regions observed on the fracture surface at the failure origin.

The three regions were: a smooth and relatively featureless region near the ID surface that was;

- **Region 1** - LOF defect ,
- **Region 2** - a mid-wall region that contained fatigue striations, and
- **Region 3** - an overload region produced by the final failure.

Region 3 was ductile in nature at the deepest portion of the flaw and located adjacent to the OD surface.
