Final Report Nr. 09202

**Pipeline Company
12" Pipeline from A – B**

October 2002

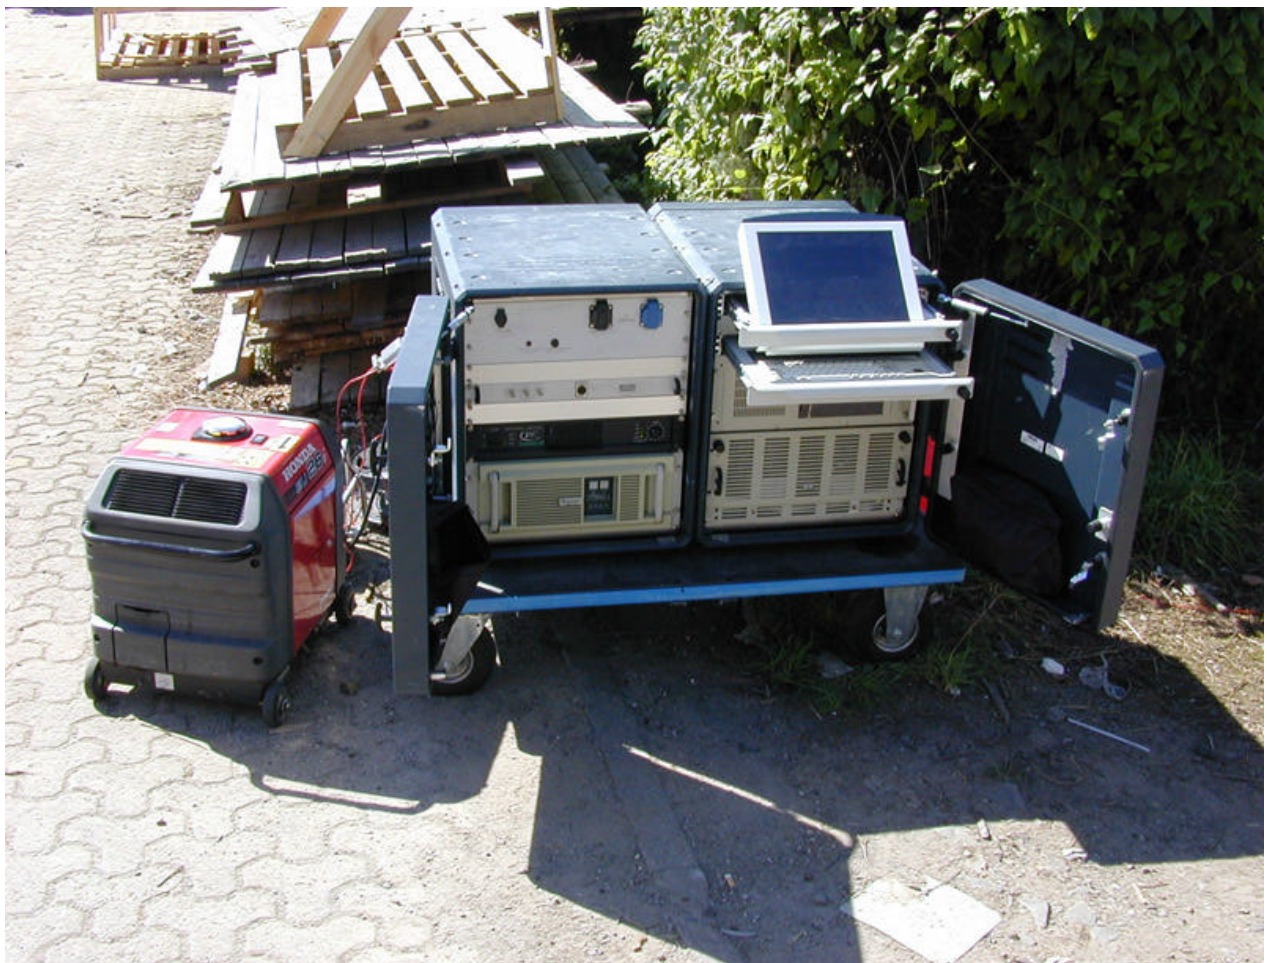
The NoPig Pipeline Inspection System analyses the magnetic field of a pipeline from above ground. To induce the magnetic field, an inspection current is introduced between two contact points on the pipeline. The inspection current is produced in the current source module shown below.

The inspection current is the superposition of components at two frequencies, 9 Hz and 630 Hz. The component at 9 Hz fills up the whole cross section of the pipe and the other one at 630 Hz flows only on the outer surface of the pipe.

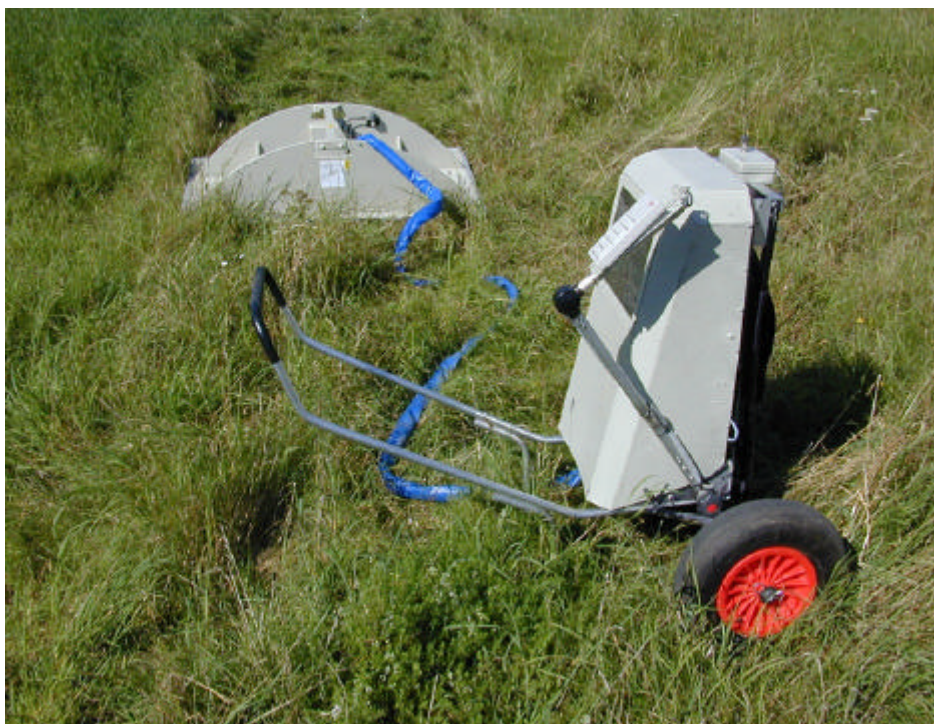
In the sensor array 6 magnetic sensors are installed in one line. The sensor array consists of four lines with a total of 24 magnetic sensors. Every sensor measures the horizontal component of the magnetic field. The acquisition and storage of collected data will be done in the back pack unit (trolley), which is connected to the sensor array. The following figure shows sensor array (rear) and back pack (front).

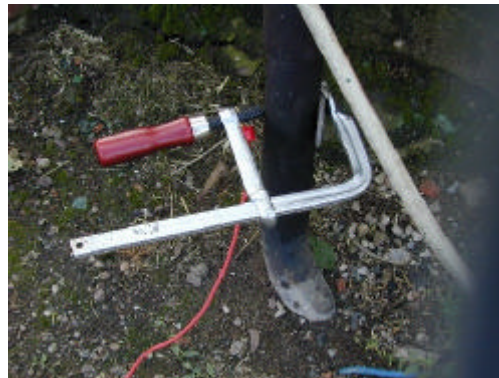
Wire connected by clamp:

The pipeline will be connected with the current wires. This will either be done on above ground areas of pipe, cathodic protection attachments or holes will have to be dug.

The 2 connections necessary for the system to function must be no longer than 500 metres apart. After connection and calibration, the NoPig sensor array will be placed on the ground above the pipeline to be inspected. The pipeline locator of the system gives the precise location of the pipe under ground as well as the depth and is stored along with the

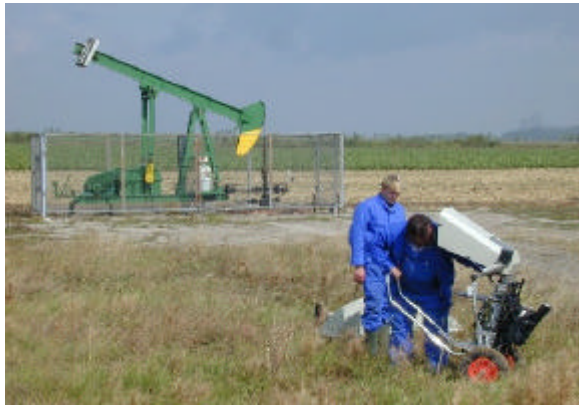
GPS data. At each inspection step, the array is placed directly on the ground. After the data acquisition is done, the array is then moved forward one step.

This step is generally 1 meter. In this manner, the distance between the connection points is inspected.
