## **FINAL REPORT**

### **Real-Time Multiple Utility Detection During Pipe Installation Using Horizontal Directional Drilling (HDD) System**

**DOT Project # 493**

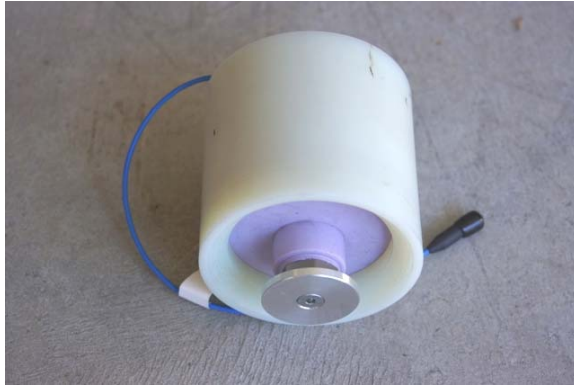
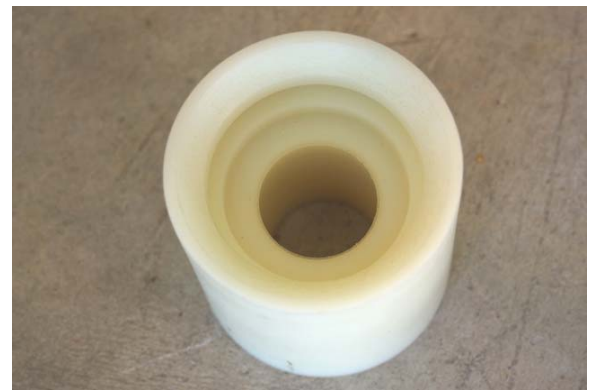
**Figure 9 Sensor module design, first article, for the sensor array: (a - b) partially assembled sensor module and (c - d) exposed sensor module with silicone molding and housing.**

Several transducer array and a system carriage were designed, reviewed, and evaluated. Figure 6 shows the outline of the finalized sensor array and system carriage design for the upgraded acoustic system. The carriage design is similar to the previous golf-cart configuration. Figure 7 shows a couple of designs for the sensor module that replaced the old design. The design goal is to simplify the housing and packaging of the sensing transducer and to provide effective coupling suspension to the ground surface. Figure 8a shows the design for the sensor module that replaced the old design. Silicone mold fills the sensor housing for acoustic isolation and damping purposes. Figure 8b shows a detailed layout of the array structure. The overall size of the detection system allows that it is easy for functional deployment, equipment transportation, and system storage. A first article of the sensor module was built and evaluated, refer to Figure 9.

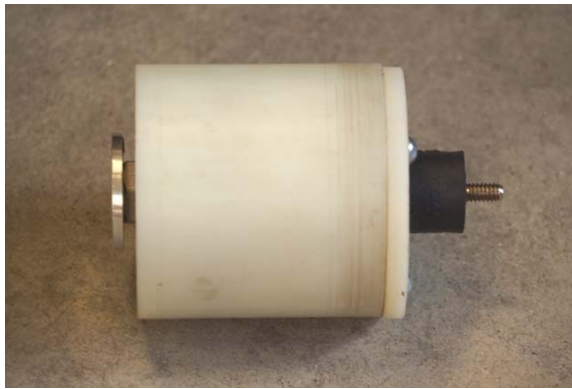
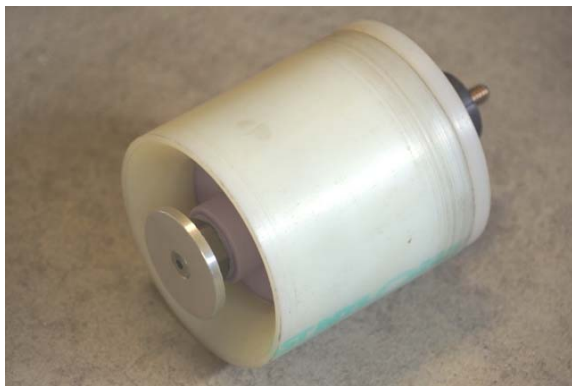
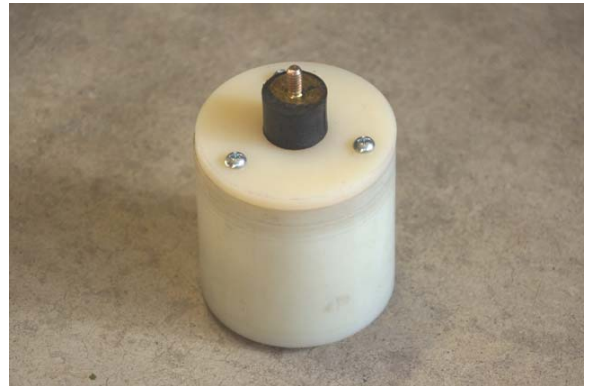
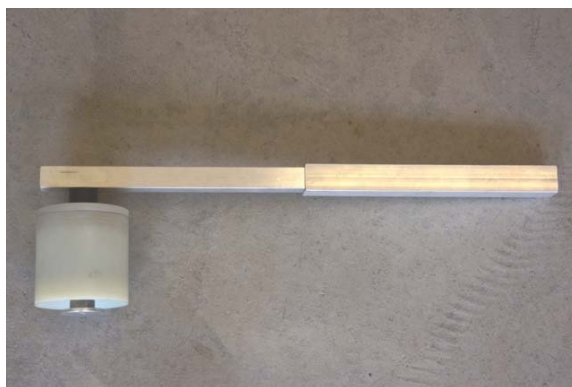
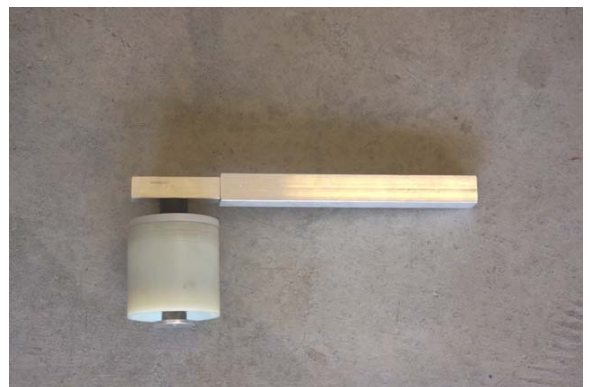
**Figure 10 Final configuration of sensor module assembly: (a - d) completed module with vibration damping mount, silicone modeling, nylon housing, and transducer, and (e - f) sensor module with array arm extended and retracted.**

Figure 10 shows the completed, fully assembled sensor module design. The silicone molding and vibration damping mount provide necessary acoustic isolation and suspension subsystem during the array deployment and system operation. The array structure uses the telescoping tubing for easy assembly, storage, and transportation, see Figure 10e-f. Figure 11 shows a partially assembled system carriage with wheels and a single sensor array arm attached.

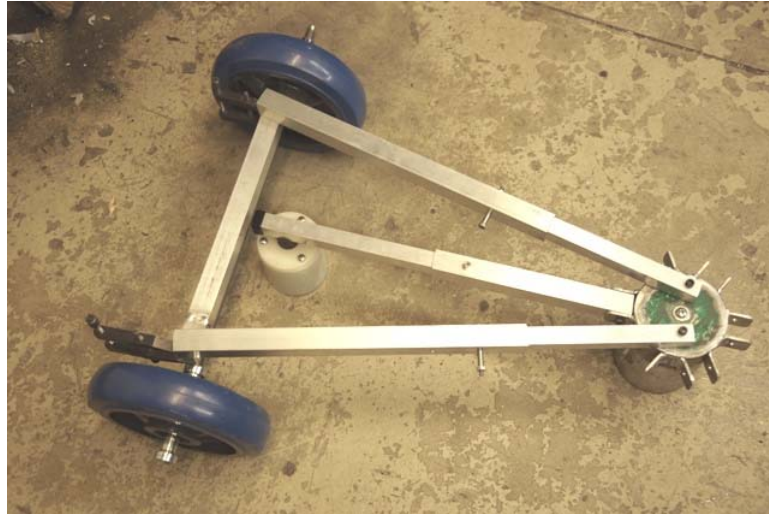
**Figure 11 Partially fabricated system carriage with wheels and array assembly.**

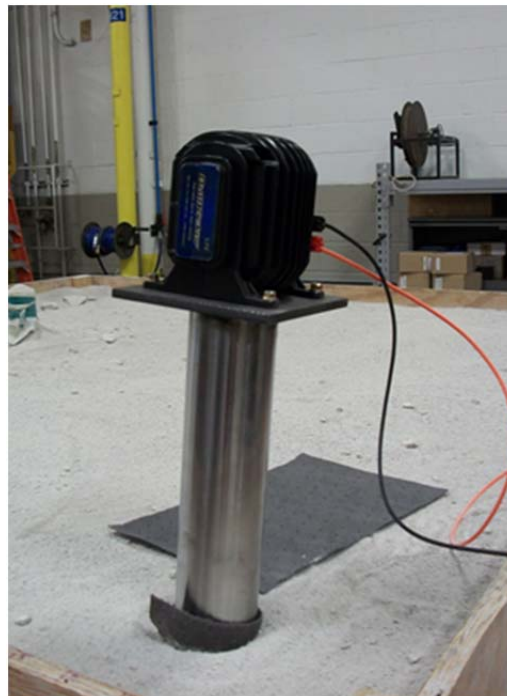
**Figure 15** Photograph of the surface seismic actuator transducer. Fixtures have been made that allow axial or transverse motion to be applied to the ground.

The first of these is a small seismic actuator purchased commercially. This transducer uses a magnetically suspended piston to impact the ground surface or a structure, operates in the 5 to 200 Hz range, and is manufactured by Guithammer. This device can accept an audio wave file, and transmit low-frequency vibrations into the ground. Both a chirp waveform and random duty cycle square waves have been successfully applied to the source. The disadvantage of this source is that it is small and does not provide high amplitude vibrations into the ground. This is exclusively a surface source. Figure 15 illustrates the surface actuator being tested in a laboratory setting.

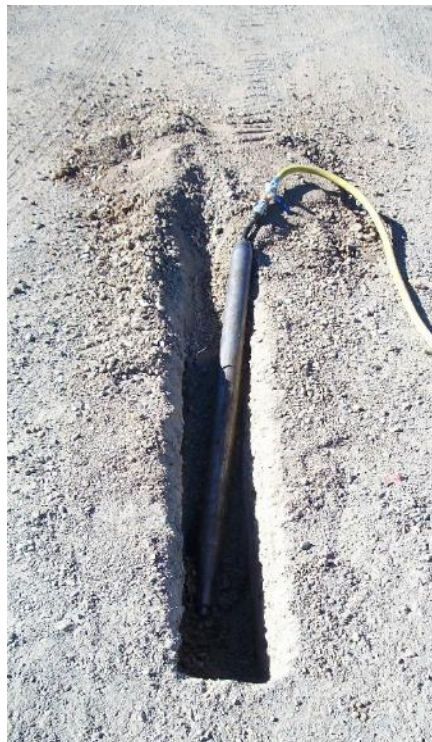
**Figure 16 Photograph of a utility installation pneumatic 'mole'.**

A mole is a device commonly used in the construction industry to lay pipe underground without trenching. During the mole operation, a pneumatically driven piston impacts the nose of the mole (internally), forcing the entire apparatus forward. The machine forces its way through the soil with each impact. As used in tests performed on this project, each impact produces a seismic displacement pulse that can be detected by the sensor array. One advantage of the mole is that it produces a large amplitude repeatable pulse. Disadvantages include a restricted frequency range and general limited use in utility installations. Figure 16 shows a representative picture of a mole prior to placement in the ground.

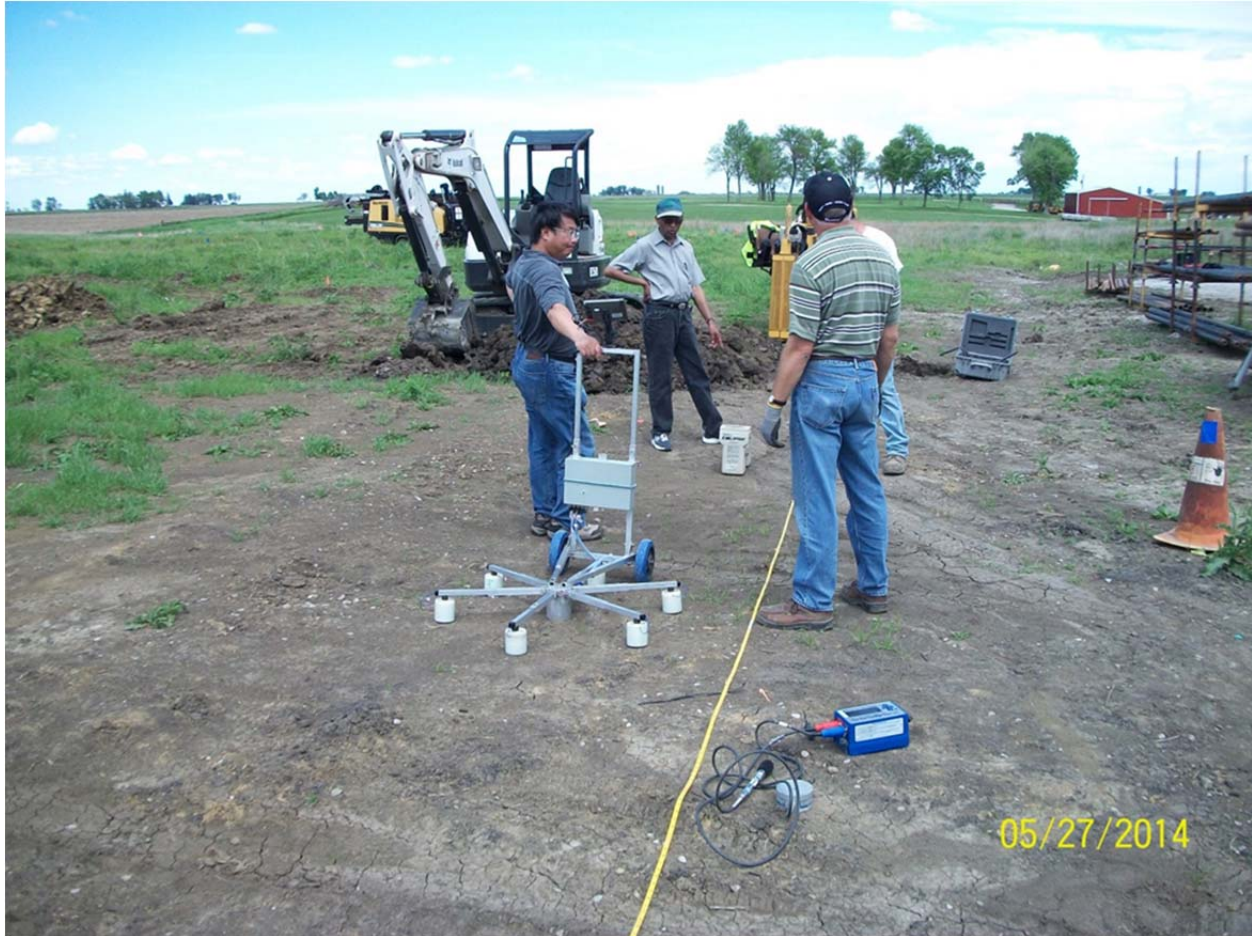
**Figure 18 Acoustic system testing in the local area.**

The acoustic system was tested with several noise generators to detect buried pipes in the local area in the last week of May 2014 and results were analyzed. Figure 18 shows the acoustic system being tested in the local area.

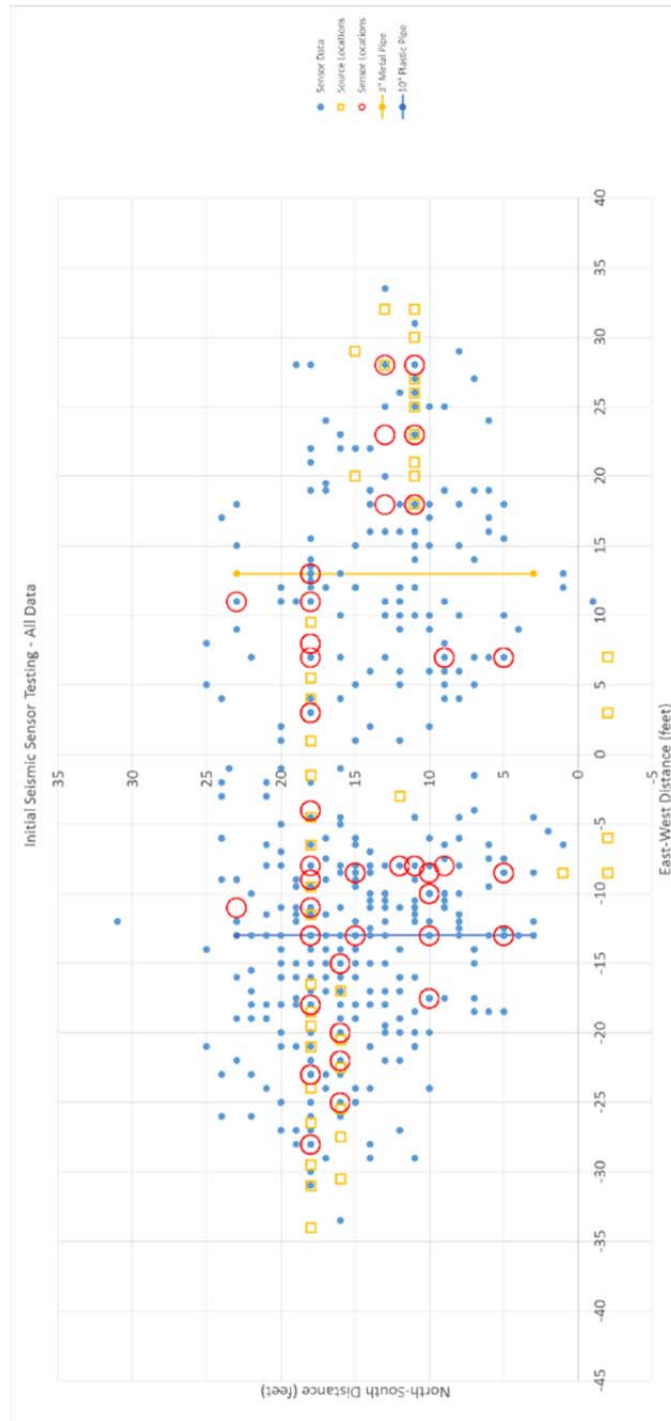
**Figure 19 Plan view of all computed pipe/obstacle locations from the initial test campaign. Also shown are the source, sensor array, and target pipe locations. The origin of the plot lies at the midpoint of the concrete blocks used as sources. Included in this plot are all the solutions that lay under the center point of the array.**

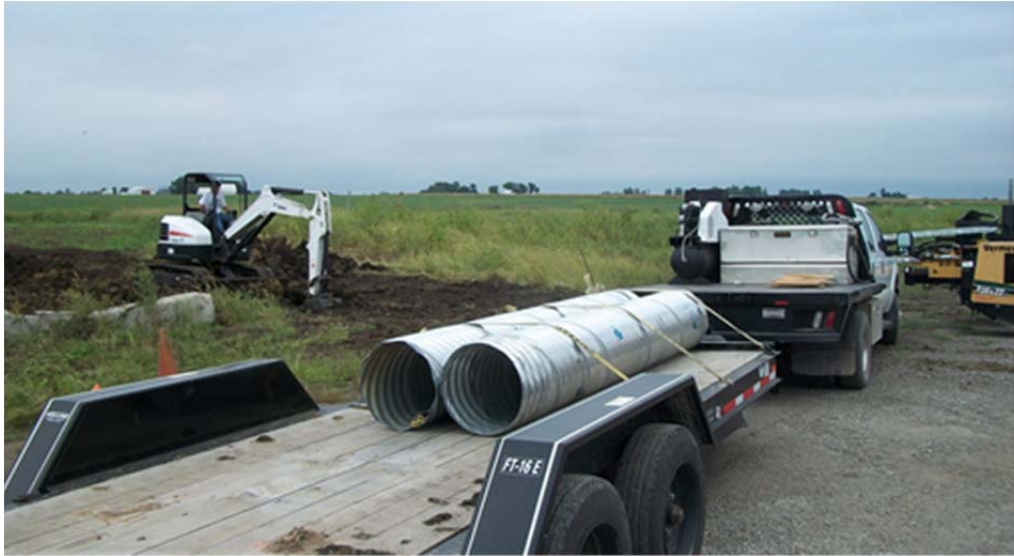
**Figure 24 Photograph of 18" culverts to be used as test targets prior to their burial.**

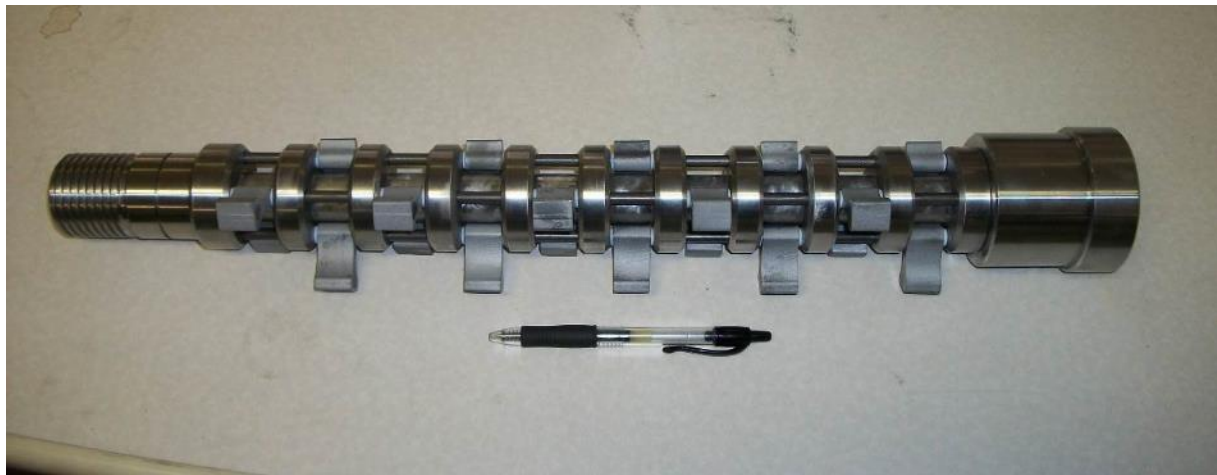
**Figure 46 Photograph of the dry fit hammer assembly.**

The assembled hammer section is shown in Figure 46.

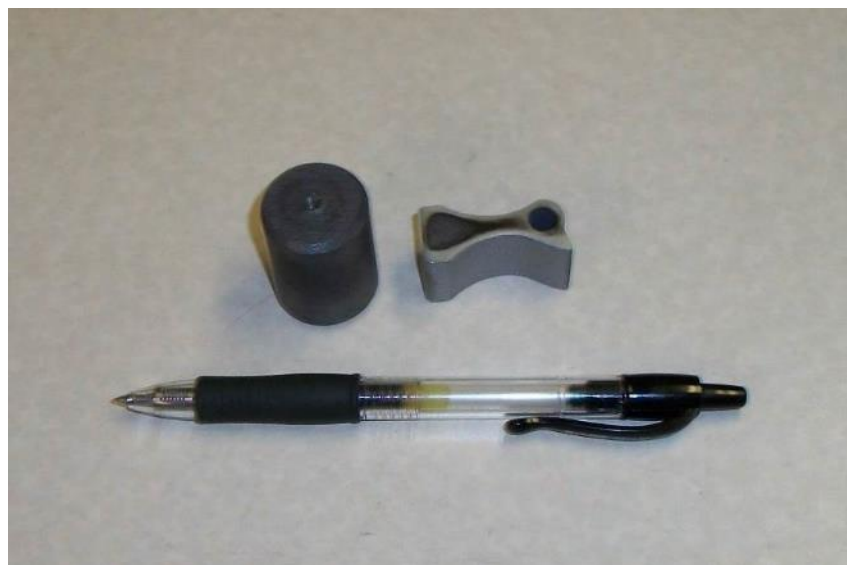
**Figure 48** Close-up of the anvil (left) and hammer (right) to be used in the enhanced acoustic source. A ball point pen is included for scale.

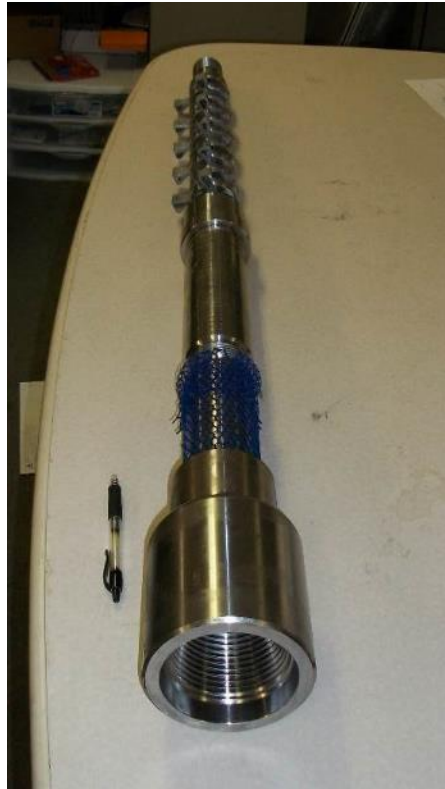
**Figure 49** Photograph of the coupling/drive assembly for the acoustic source. The inner drive rod of the dual rod system will be used to rotate the near fitting, resulting in the hammer rotation and impacts.

A smaller inner drive rod is used to rotate the hammer assembly. Figure 49 shows part of this coupling assembly that will be torqued to the inner drive rod of the horizontal directional drill.

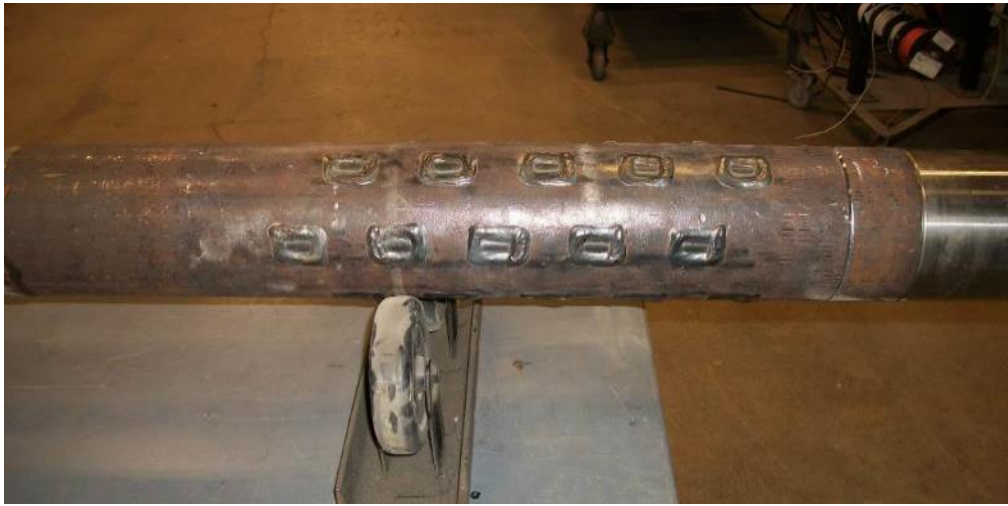
**Figure 50** Photograph of the hammer section of the acoustic source after the hardened anvils have been welded in place. Diameter of this section is 5.5 inches.

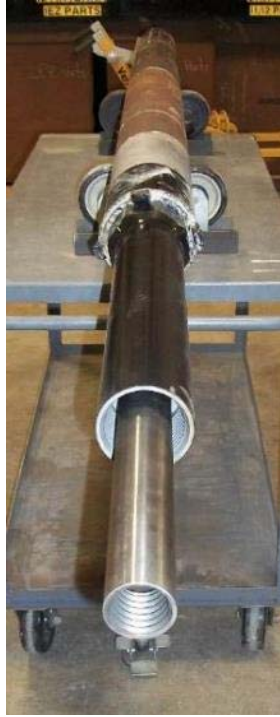
**Figure 51** Photograph of the source showing the uphole rod-in-rod design. The inner rod turns the hammer assembly.

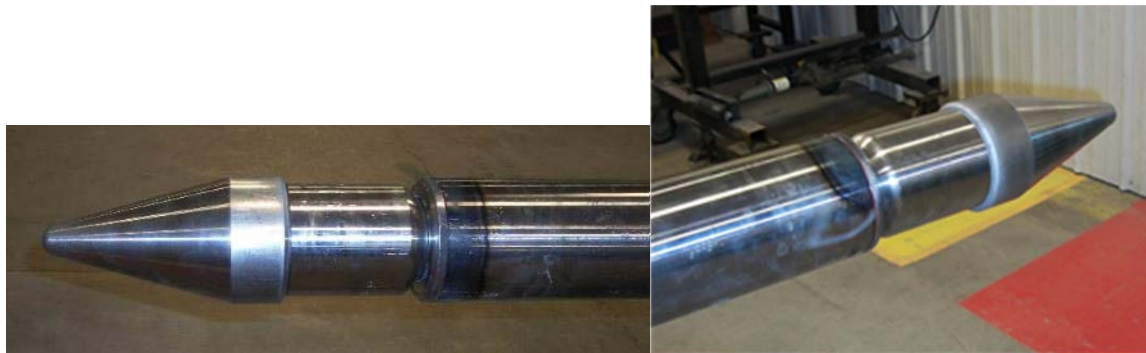
**Figure 52** Photographs of the nose of the acoustic source. This nose piece rotates independently of the larger diameter outer rod seen to the rear of the nose.

For this head, the normal tri-cone bit used in rock drilling applications is replaced by a simple bullet head. Two views of this assembly are shown in Figure 52. While not optimal for steering, this head proved adequate for testing.

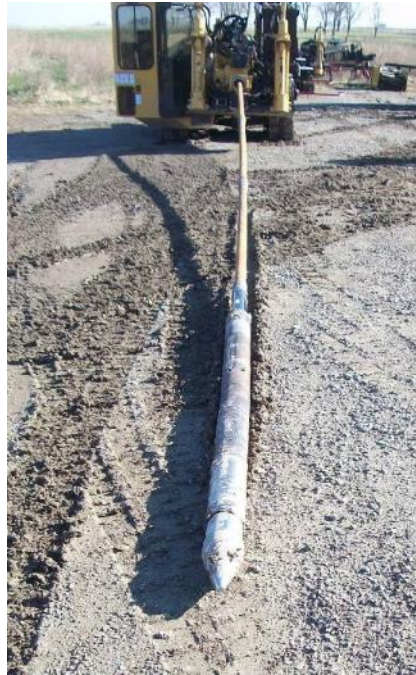
**Figure 53 Photograph of the source during initial testing. During this test the hammers were rotated up to a maximum of 270 rpm with no failures or jams.**

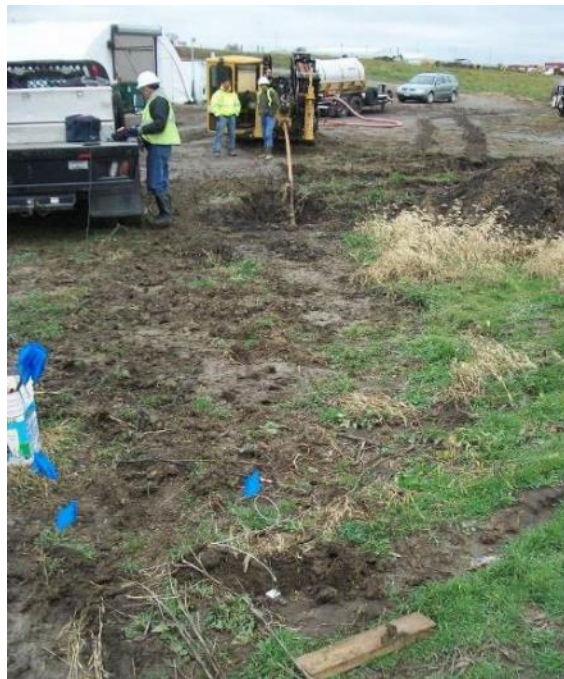
**Figure 54 Data collection setup. Accelerometers mounted on aluminum cubes were placed at varying distances from the source as its hammer assembly was rotated at 120 and 240 rpm.**

Figure 54 shows the rig deployment along with the sensor location for 0 foot offset distance. The vibration measurements were made with an Olson Instruments Impact Echo Test System. For these tests, a 100 microsecond sampling rate was used along with a record length of 2048 points. This resulted in a total time series record of 0.2047 seconds, and a Nyquist frequency of 5000 Hz.

Accelerometers were mounted on the top surface of an aluminum cube fitted with a 3-inch long conical spike. The spike was fully pressed into the ground surface to provide coupling. The sensor mounting was moved to different distances from the head to collect distance versus amplitude data. There was considerable wind present during the tests and so sandbags were placed on top and to the sides of the sensors to dampen wind noise.

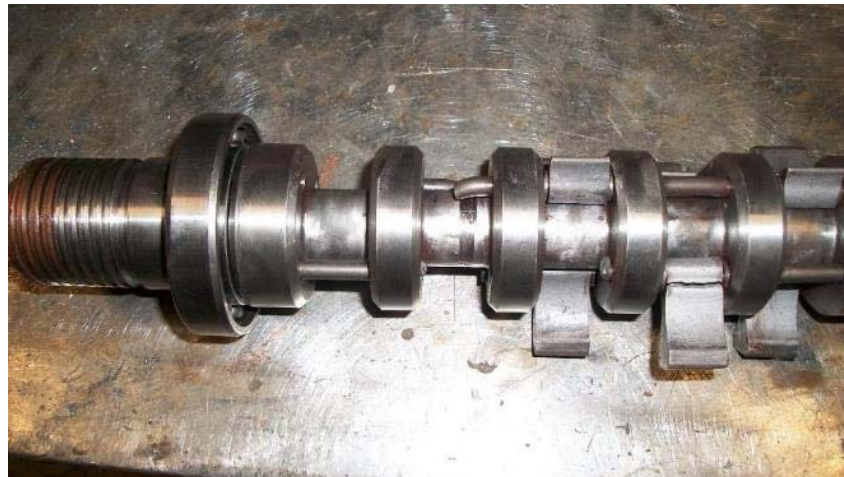
**Figure 60** Photograph of the damaged hammer assembly recovered after initial source testing. Both failed rods and hammers can be seen. Failures were most likely due to counter-rotation of the hammers against the anvils, as explained in the text.

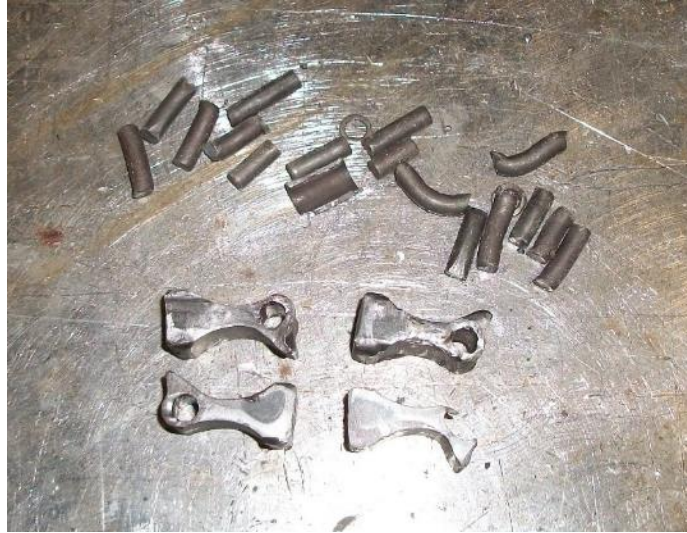
**Figure 61 View of the pieces of the hammers and rods recovered from the source after initial testing.**

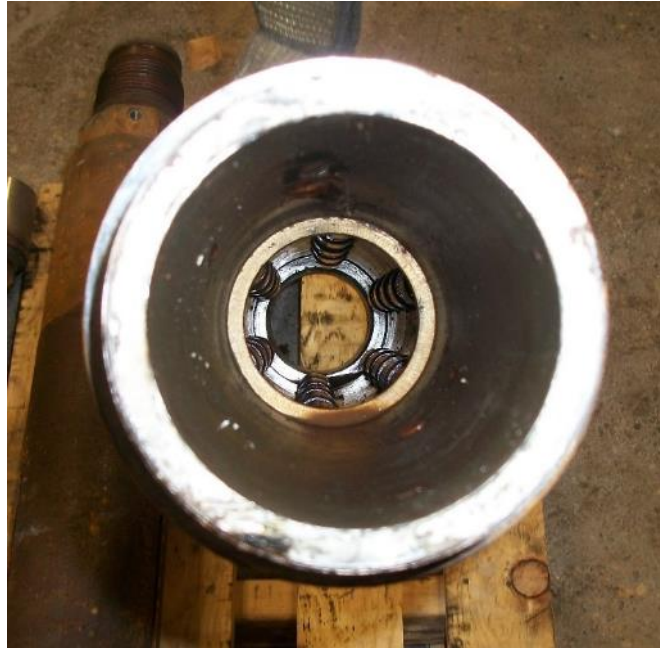
**Figure 62** View down the interior of the outer head casing showing anvils. This photo was taken after operating procedures were corrected and trials conducted. There is essentially no wear on the anvils resulting from testing.

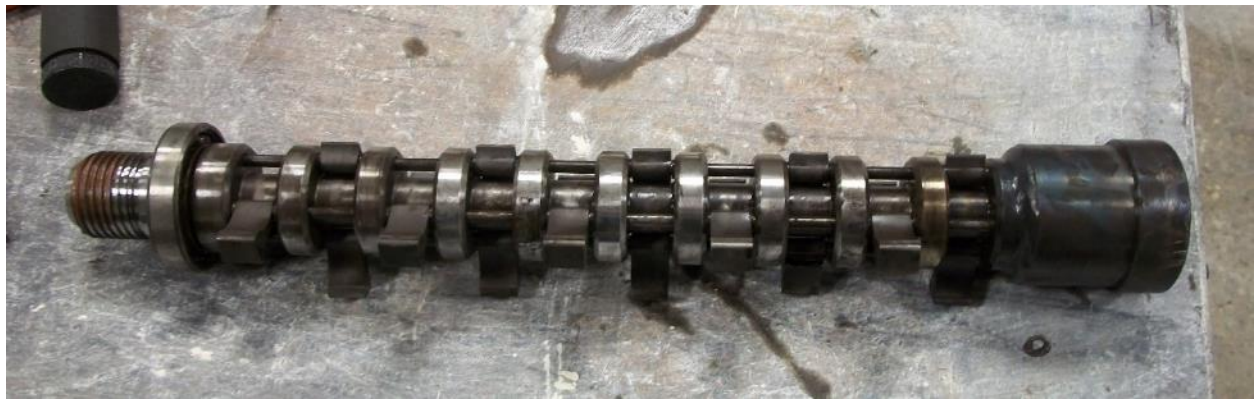
**Figure 63** View of the hammer assembly recovered after the completion of trials. Other than damage to one hammer, no wear or damage could be found on the source.

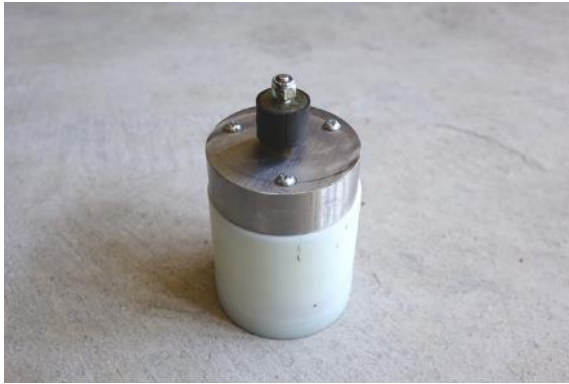
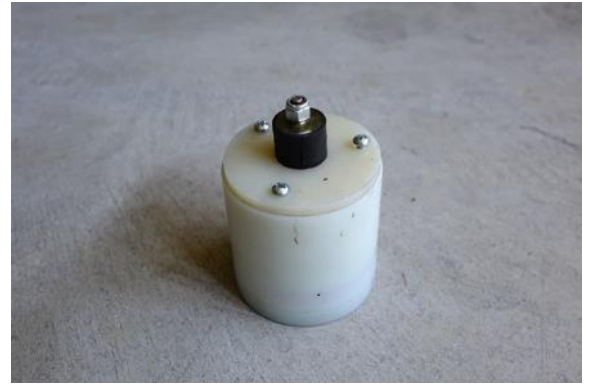
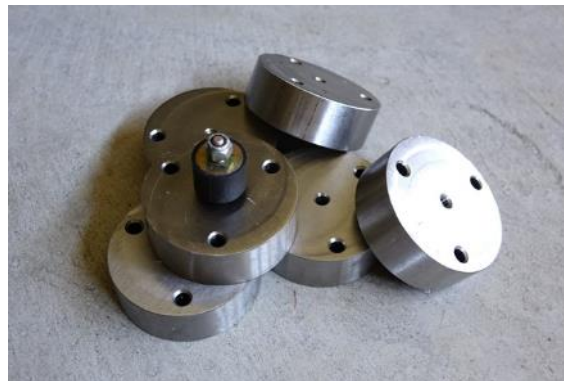
**Figure 64 Ground coupling enhancement of sensor module: (a) new external, metallic capping weight mounted on the existing sensor module vs. (b) the original plastic cap on the sensor module, and (c) metallic add-on disks/caps used to improve coupling mechanism of the existing sensor module – made of stainless steel material with about two (2) pounds of coupling weight.**

Figure 64 shows the comparison between the current sensor module design and the new metallic cap configuration. The thickness of the weighting disk/cap is about one (1) inch which complies with the articulation limit specified in the existing sensor design specification and requirements.

Several pieces of metallic disks/caps were made and fitted to the existing sensor modules, see Figure 64c. These external weighting mechanisms were made of stainless steel with volume density of approximate 500 lb/ft<sup>3</sup>. Each disk/cap weights about 2 pounds. When fully mounted to the existing sensor module, the sensing transducer will be loaded with approximately 3 pounds force when coupling to the ground. Based on the previous OTD/GTI project result, this weighting configuration is well within the optimal range of the sensor mounting arrangement.

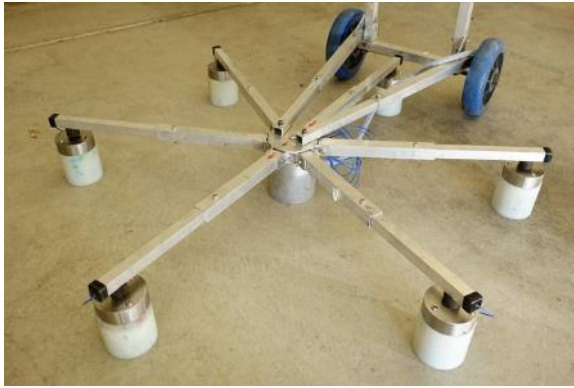
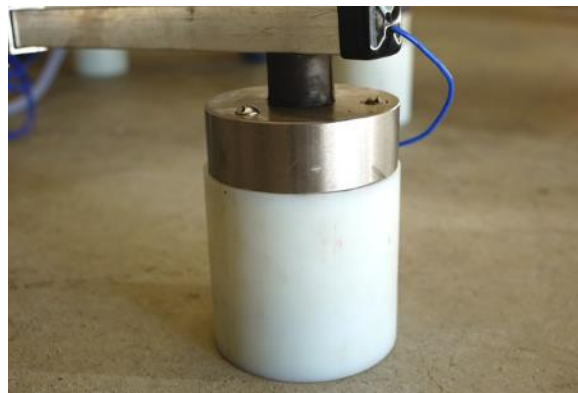
**Figure 65 The finalized array structure with newly optimized coupling mechanisms mounted: (a) improved array structure tested on the concrete surface, and (b - c) close-up views of the new metallic-capped sensor module.**

Figure 65 shows the improved array structure with optimized coupling mechanism mounted to the sensor modules. The overall weight of the array has been increased about 12 additional pounds. This additional coupling weight provides a much more stable array deployment, especially in rough, uneven terrain.

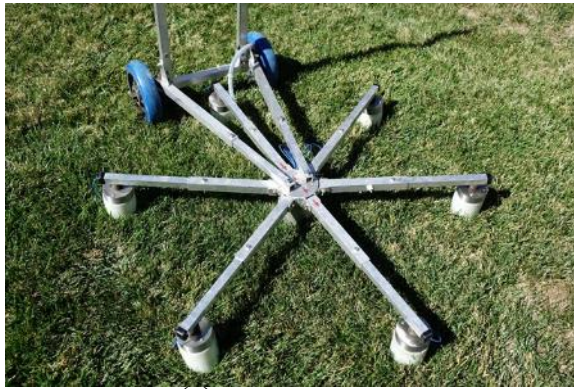
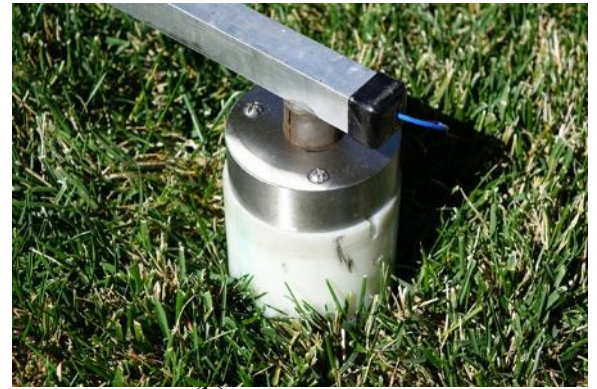
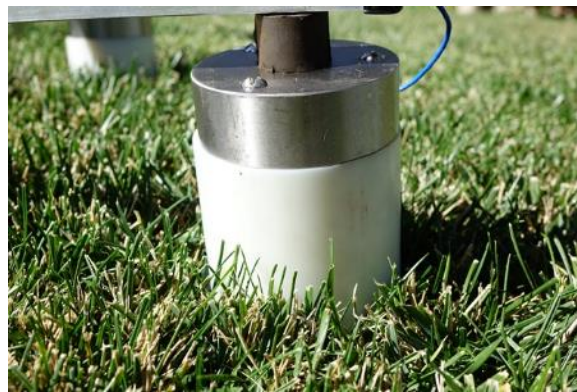
**Figure 66 Local area test of finalized array structure with newly optimized coupling mechanisms:**  
**(a) improved array structure tested on the grassy field, and (b - c) close-up views of the new**  
**metallic-capped sensor module when coupling to the ground.**

Figure 66 shows the same improved array structure deployed and tested on the grassy field. The additional weight helped the sensor module more tightly couple to the ground. The array mobility, however, suffers some due to the overall weight increase.

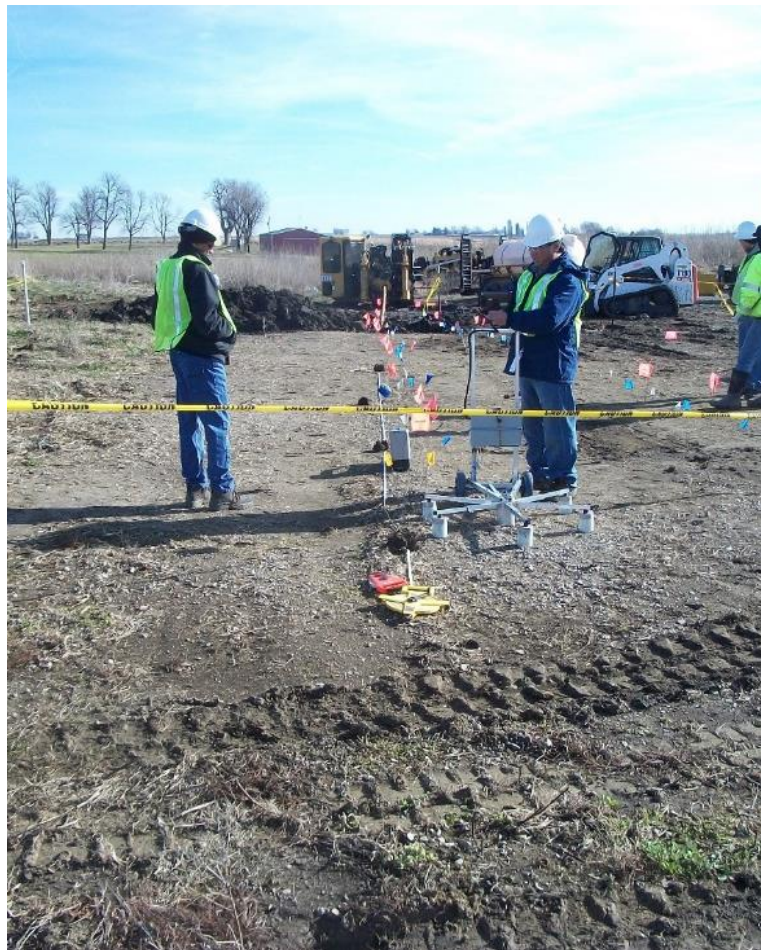
**Figure 74** Photograph of the setup during December 2015 testing. Flags indicate the location of locator sonde positions, sensor, and source locations along the bore.
