# Results of Onshore and Offshore Composite Repair Studies

Workshop Presentation

Prepared for: BSEE / PHMSA

Date: 17 January 2018

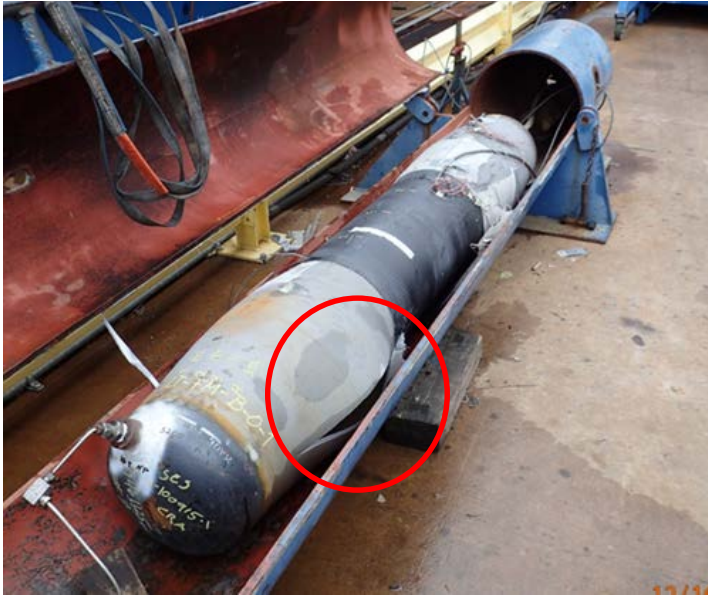
# Reinforced Samples – Corrosion: Burst Summary

- A narrow range of failure pressures was observed and was a reflection of the failures being driven by the tensile properties of the base pipe (i.e. almost all failures located outside of the repair)
- Maximum range between failure pressures was for a given repair system was 63 psi. The minimum range was 9 psi.

- Installation pressure had no noticeable effect on the burst pressure of the composite repaired samples
  - All repairs exceeded unreinforced burst pressure
- All repairs averaged approximately the same burst pressure regardless of installation pressure and were predominantly governed by the tensile properties of the nominal base pipe
  - Only one manufacturer had failures located within the repair – all other failures occurred in base pipe outside of the repair
  - 67 psi – max pressure range between repairs
  - 9 psi – min pressure range between repairs

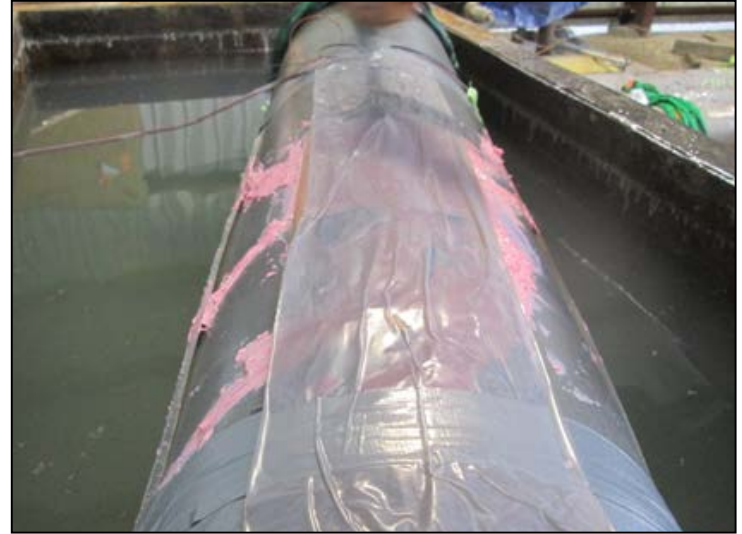
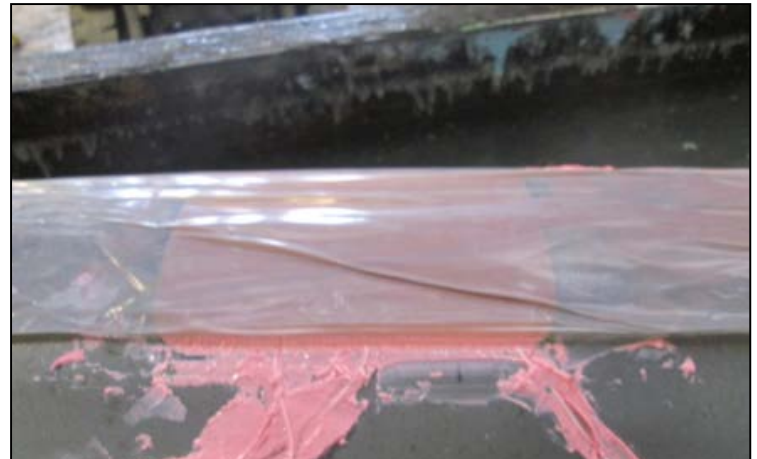
- Intentional delamination samples represented a poor installation and evaluated its effect on composite performance
- High-temperature PTFE tape was installed axially around the pipe every 90° starting at the corrosion defect.
- Delaminations covered approx. 60% of the steel pipe surface.

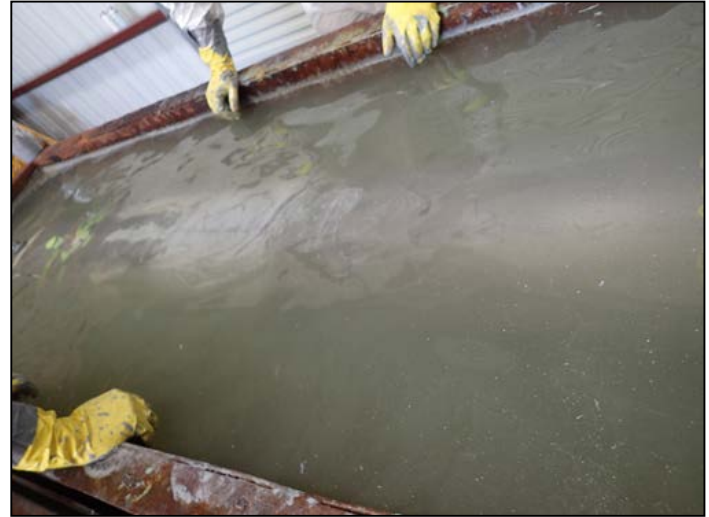
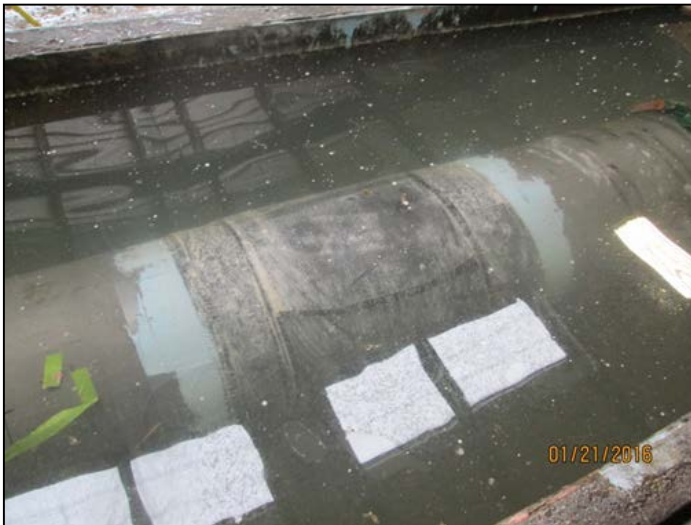
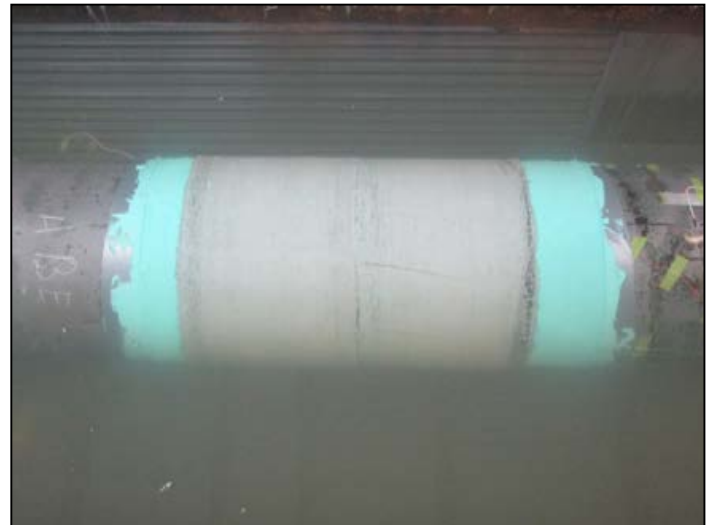
- Installations and curing completed while submerged in simulated seawater

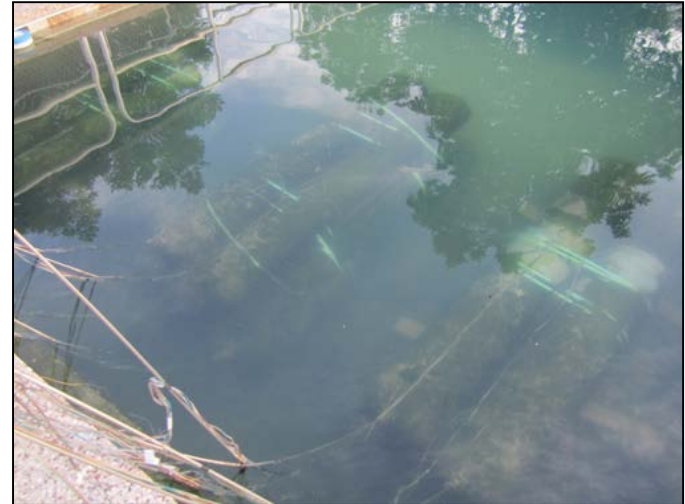
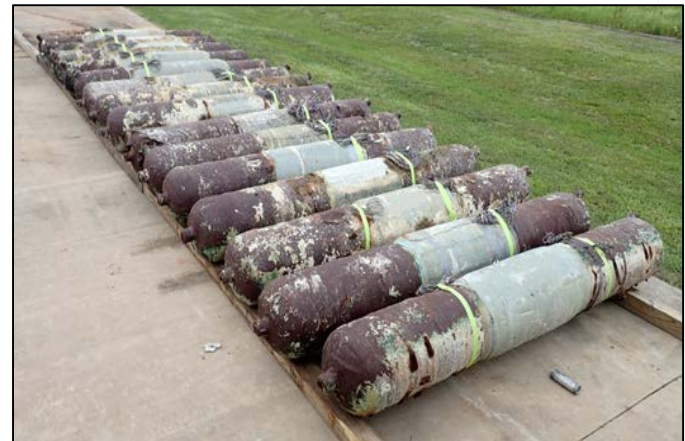
# Project Overview – Exposure Testing (1/3)

- Samples were submerged in simulated seawater for 10k hours (10k hours  $\approx$  1.15 years)
- Intended to simulate an extended in-service subsea environment
- Pressure maintained at 72% SMYS (+/- 15% SMYS)
- Samples also subjected to 90 day UV exposure test once removed from seawater

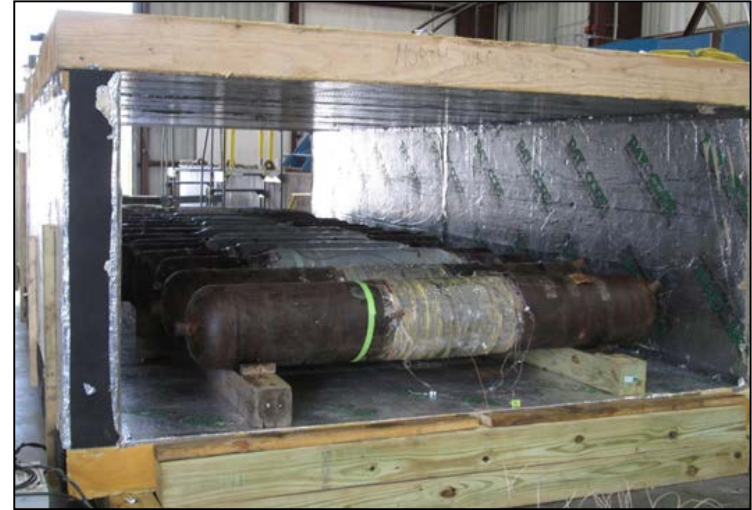
# Project Overview – Exposure Testing (2/3)

- In addition to UV exposure test, samples completed 12 thermal cycles
- High temperature: 110 - 130 °F
- Low temperature: 30 - 10 °F

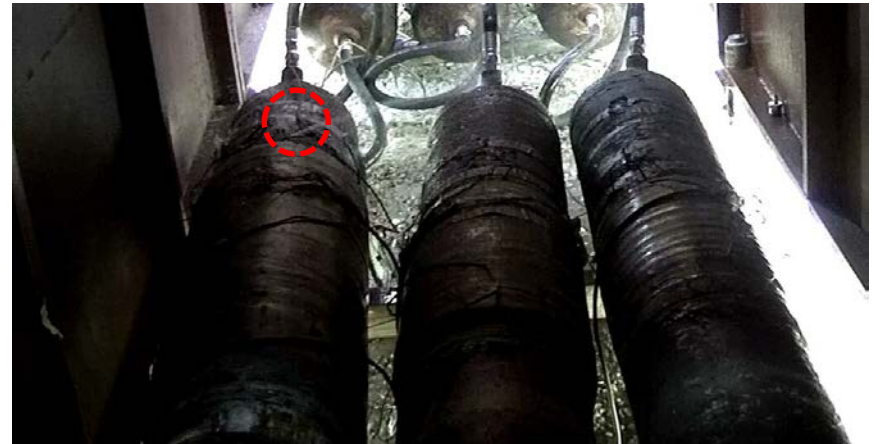
- All samples survived the 10,000 hour pressure hold
- No apparent damage to the repairs was caused by thermal and pressure cycling
- Five samples failed during pre-cycling
  - Photograph of leak (bottom)

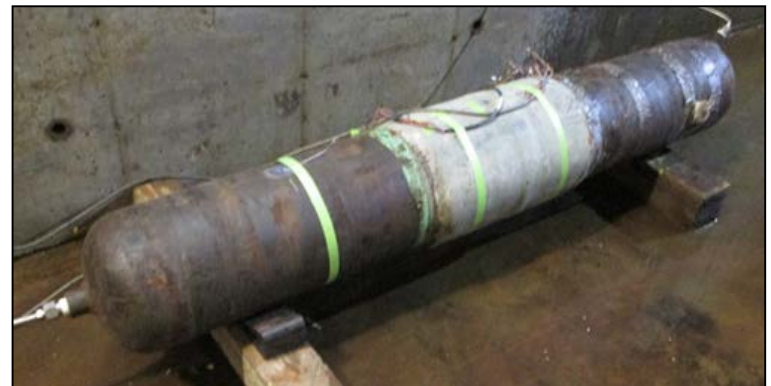
# Full-scale Testing – Burst

- Two reinforced samples designated for burst survived exposure testing
- Two minute hold periods were completed at 890 psi (36% SMYS), 1,780 psi (72% SMYS), and 2,470 psi (100% SMYS)

- First of two samples completed all two minute hold periods
- Max pressure: 4,037 psi (163% SMYS)
- Strain gages indicate significant deformation in the base pipe and corrosion region during the test (2H and Base Hoop).
- Failure was located in the base pipe outside of the reinforced wall loss.

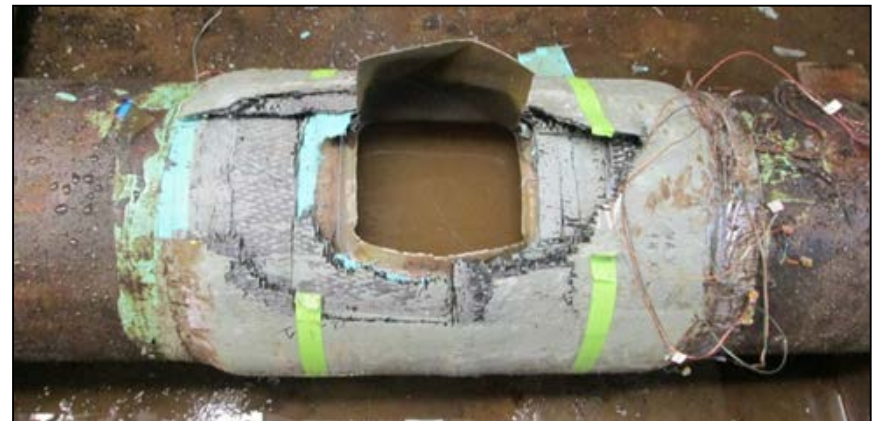
- Second sample also completed all two minute hold periods
- Max pressure: 3,615 psi (146% SMYS)
- Strain gage in the base pipe indicates significant deformation outside of the repair (Base Hoop).
- Failure was located underneath the repair in the machined wall loss region.

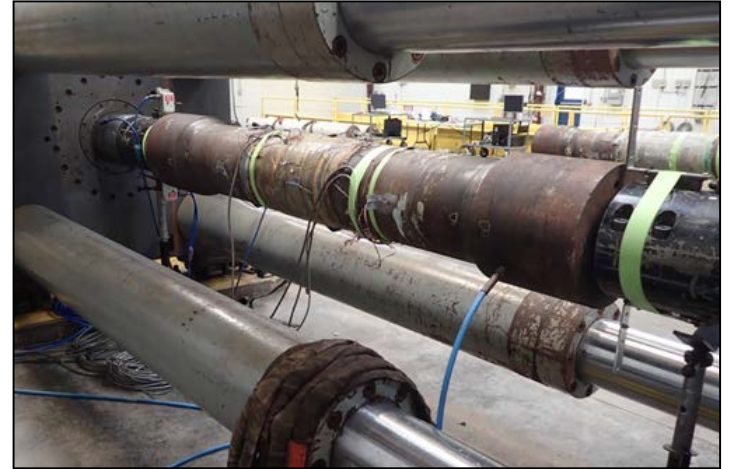
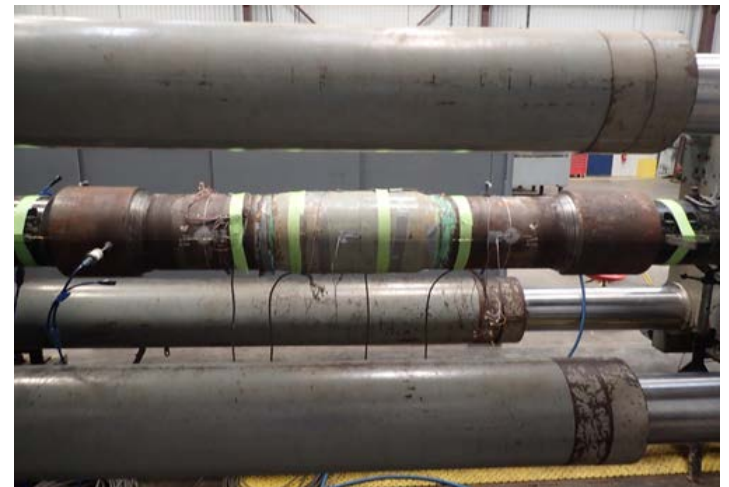
# Full-scale Testing – Tension

- Two reinforced samples designated for tension testing survived exposure testing.
- Additionally, one delamination sample designated for tension testing survived exposure testing.
- Procedure for tension testing was as follows:
  - Pressure sample to 1,780 psi (72% SMYS)
  - 15 minute hold period at applied tension of 200 kips (65% with PEL)
  - 15 minute hold period at applied tension of 470 kips (110% SMYS with PEL)
  - 15 minute hold period at applied tension of 620 kips (135% SMYS with PEL)
  - Increase tension to failure

- Tension sample from Manufacturer B reached a maximum applied tensile load of 604.7 kips.
- Failure occurred when the sample was no longer able to maintain the internal pressure, and a leak path developed from the corrosion defect to the edge of the repair.
- Plot shows that the initial two hold periods were completed, but sample failed prior to third hold period.

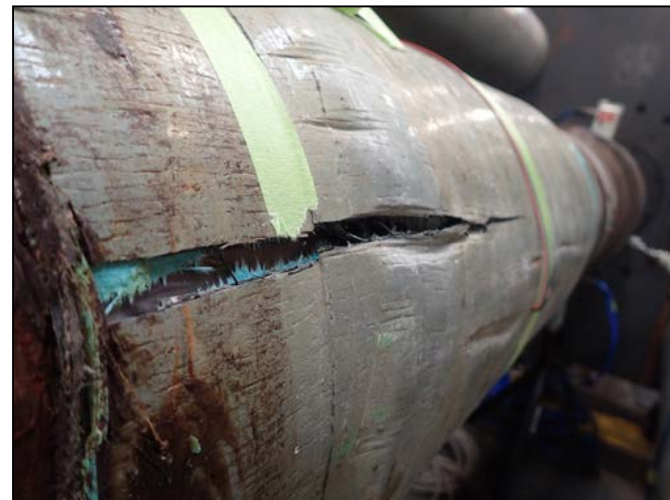
- Delamination sample from Manufacturer C reached a maximum applied tensile load of 635 kips.
  - The drop in load was to repair a leak in a pressure line and does not represent a failure of the sample
- Test results indicate the delaminations had very little impact on the tension test.
- Post-test photograph shows failure location

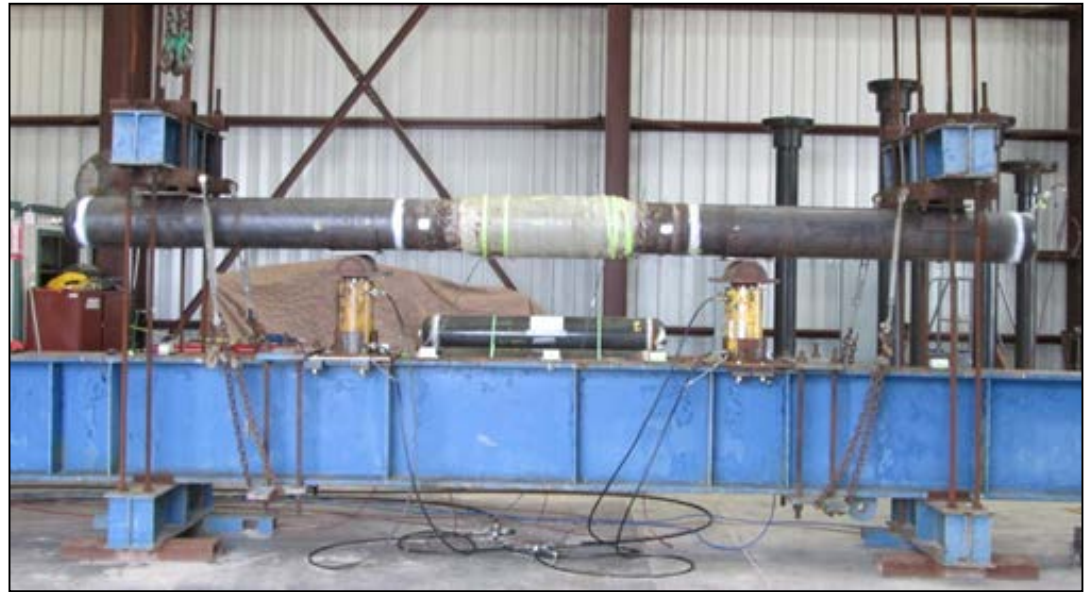
# Full-scale Testing – Bending

- All reinforced samples designated for bending survived exposure testing.
  - One bend sample from each manufacturer
- Procedure for tension testing was as follows:
  - With wall loss positioned at 0° (tension):
    - Pressurize sample to 1,780 psi (72% SMYS)
    - Increase bending to 125 ft-kips (hold for 15 mins)
    - Reduce internal pressure and bending to 0 psi and 0 ft-kips
    - Rotate sample 180°
  - With wall loss positioned at 180° (compression)
    - Pressurize sample to 1,780 psi (72% SMYS)
    - Increase bending to 125 ft-kips (hold for 15 mins)
    - Increase bending to failure

- Manufacturer A's bending sample successfully completed bend testing with wall loss in tension.
- After the sample was rotated to place the corrosion defect in compression, the sample failed at a bending moment of 264.6 ft·kips.
- Failure occurred in the reinforced wall loss which ruptured through the composite repair (photograph).

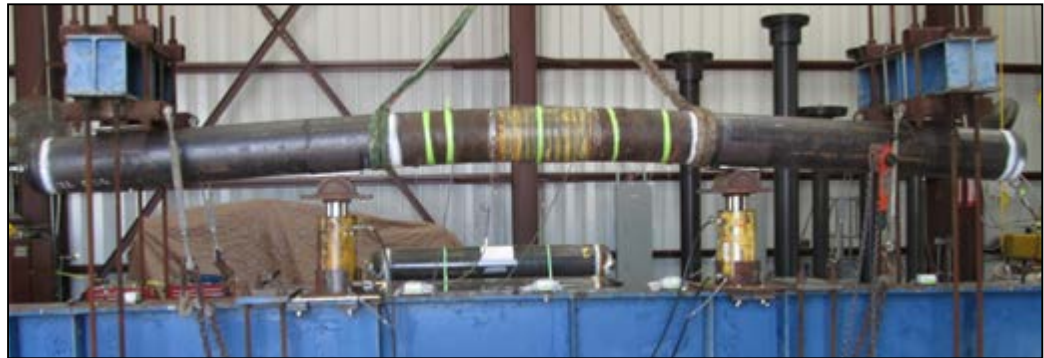
- Manufacturer B's bending sample successfully completed bend testing with wall loss in tension.
- The sample failed at a bending moment of 262.4 kip·ft with the wall loss in compression.
- Failure occurred in the wall loss region and leaked from the edge of the repair.
- The sample experienced permanent deformation and exhibited a visible curvature following the bend test (photograph).

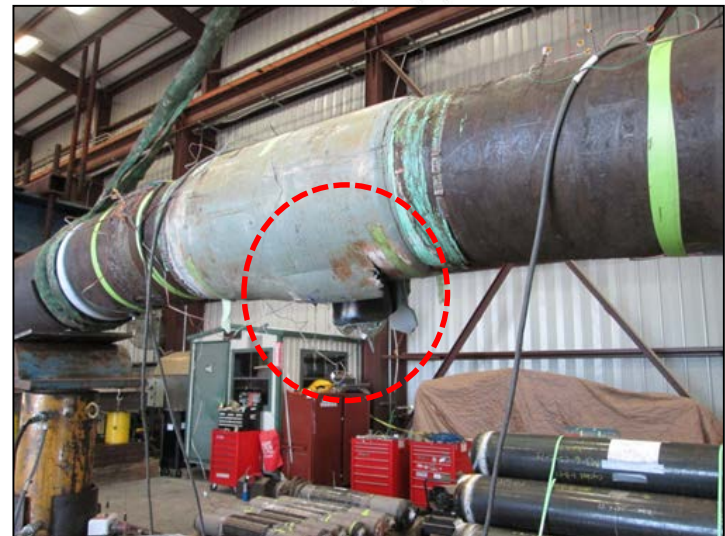
- Manufacturer C's bending sample successfully completed bend testing with wall loss in tension.
- The sample failed at a bending moment of 278.4 kip·ft with the wall loss in compression.
- The sample began to deform near the end of the test and it became difficult to maintain the internal pressure
- Failure occurred in the wall loss region underneath the composite repair (photograph). Permanent deformation was evident in the sample following testing
