Date of Report: <December 20, 2018>

Project Title: <Mitigating Pipeline Corrosion Using A Smart Thermal Spraying Coating System>

Prepared by: <North Dakota State University>

(b) Draft Final Report

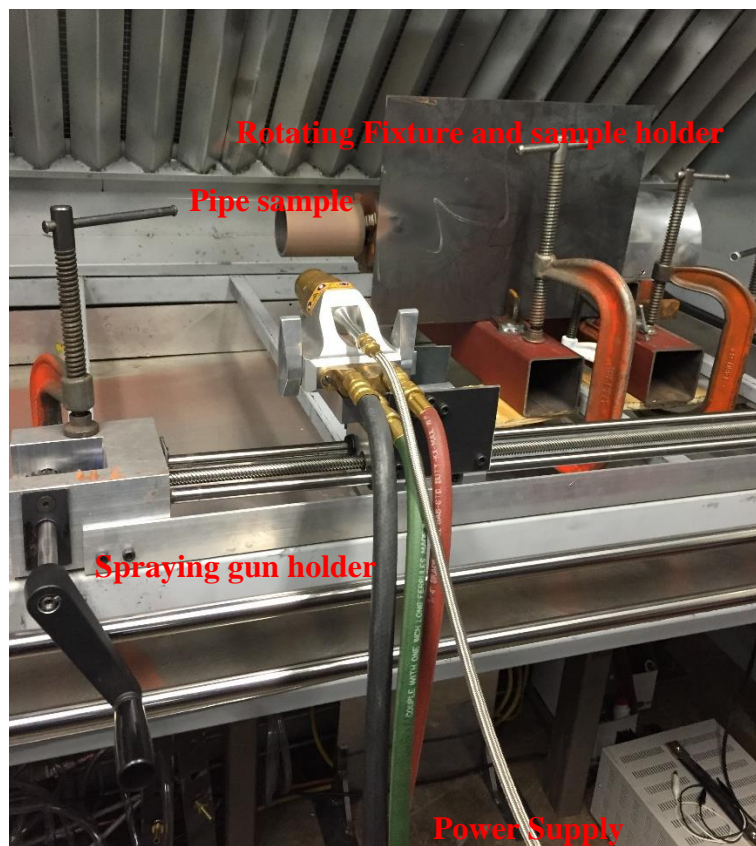
To develop a more convenient spraying process for round objects such as pipes, two undergraduate students, Alan Perrault and Caio Molina Ferreira, from Mechanical Engineering department, NDSU, designed a rotating fixture to hold pipe samples in front of spraying nozzle for coating deposition. Figure 5 shows the spraying set-up for spraying process. It includes several parts: an adjustable pipe fixing holder, a rotational axle connected to a speed-control instrument, and a manually movable spraying gun holder. Pipes with inner diameter from 1 inches to 12 inches can be placed on the holder for spraying. The pipe can rotate at various speeds which is adjustable from low to high speed during the spraying process to meet the requirement for different spraying thickness. The spraying gun holder is designed to move horizontally at constant speed to provide a uniform deposition on the surface of the pipe samples.

Figure 5. Automatic rotational fixture for pipe samples.

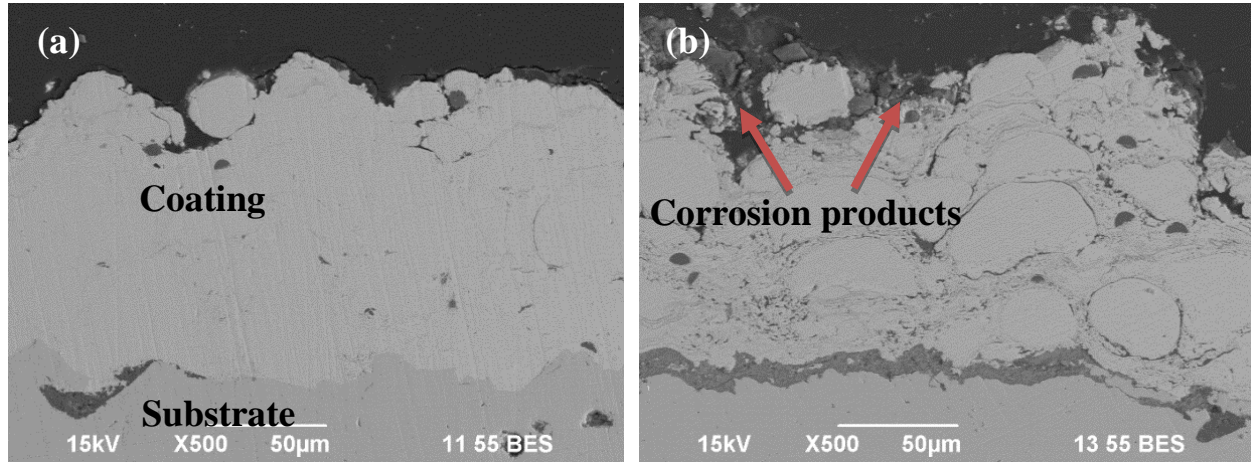
For HVOF deposited Al-Bronze coatings which had been studied in previous project (Project No. DTPH56-13-H-CAAP05), the SEM micrographs taken from the cross-section of the coatings before and after corrosion were shown in Figures 12 (a, b) and for the wire arc sprayed Al-Zn coating, the SEM images were shown in Figures 13 (a, b). It could be concluded that corrosion products significantly were formed on the surface of the HVOF deposited Al-bronze and the wire arc sprayed Al-Zn coatings after corrosion. The dark gray areas presented very close to the surface of the coating were observed after corrosion which did not exist in the SEM micrograph of the HVOF deposited Al-bronze and the wire arc sprayed Al-Zn coatings before corrosion. These areas could be associated to the corrosion products formed after exposing to the NaCl solution.

Figure 12. SEM micrographs of the HVOF deposited Al-bronze coating (a) before and (b) after corrosion.

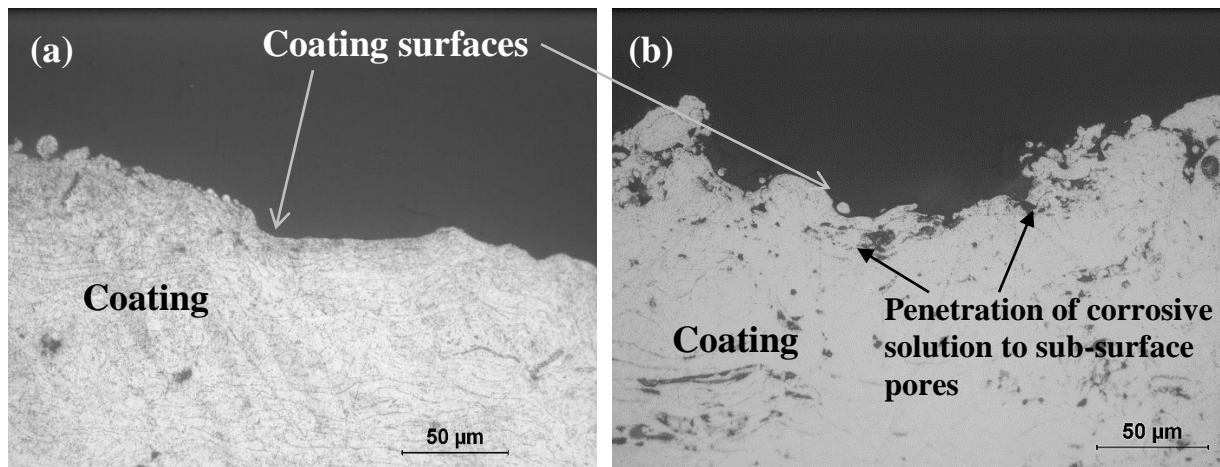
Figure 13. SEM micrographs of the Wire arc deposited Al-Zn coating (a) before and (a) after corrosion

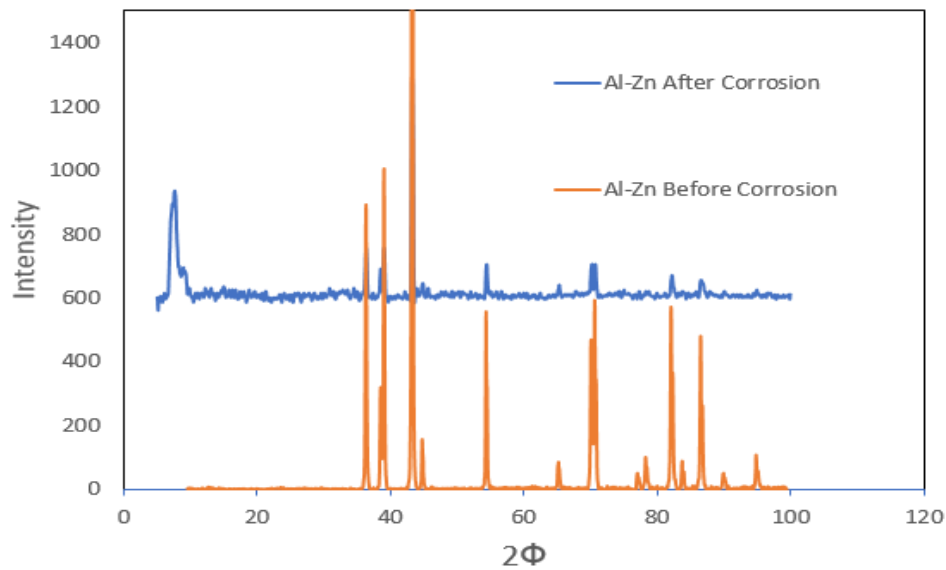
oxides were also identified in the earlier report considering the Tafel curve obtained after corrosion of the Al-Zn coating in 3.5% NaCl solution.

Figure 17. X-Ray pattern of wire arc sprayed Al-Zn coatings before and after corrosion.

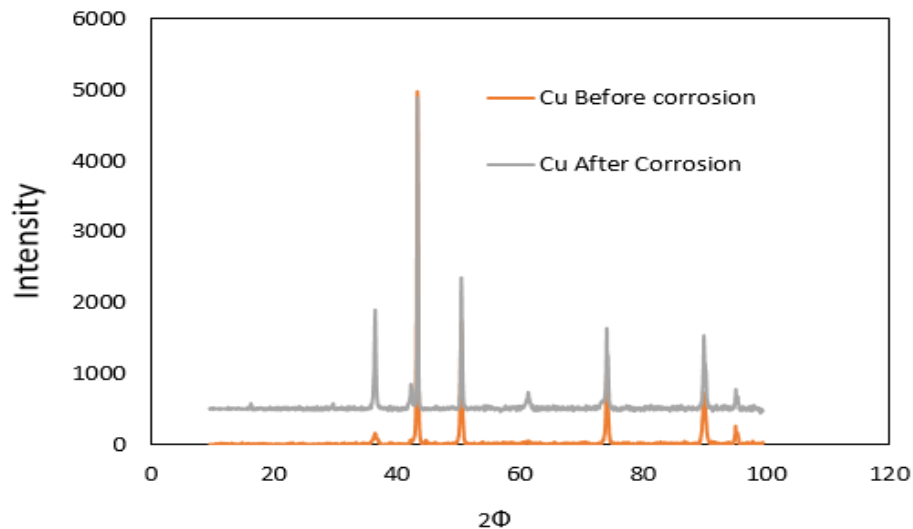
XRD-pattern of the HVOF sprayed copper coatings which was also deposited earlier in this project exhibited some dissimilarity when comparing before and after corrosion conditions in this coating. The XRD pattern shown in Figure 18 demonstrated that copper oxide was the main composition appeared after corrosion whilst it was not detected in the coating structure before the corrosion experiments.

Figure 18. X-Ray pattern of HVOF sprayed Copper coatings before and after corrosion.

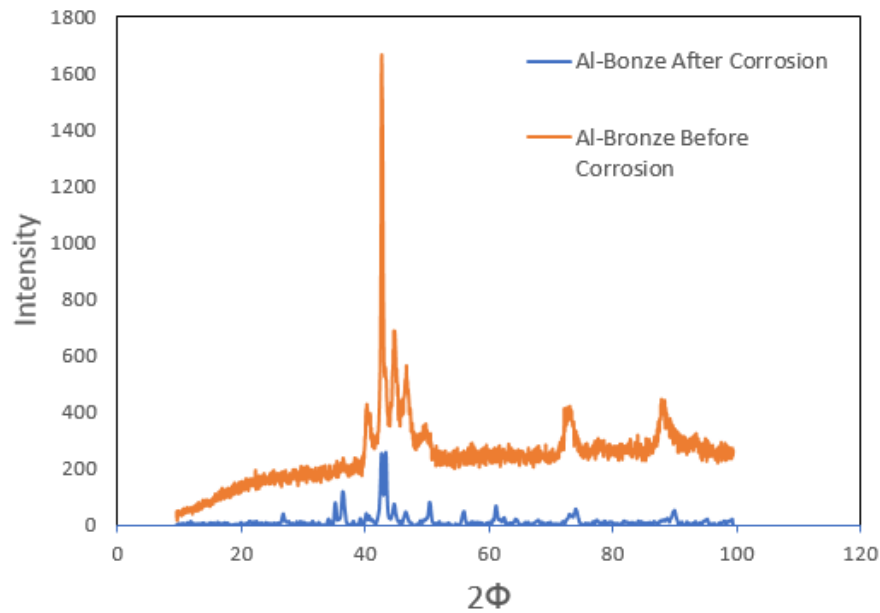
HVOF deposited Al-bronze was mainly contained AlCu_3 and Ni_3ZnCo_7 before corrosion as it is shown in Figure 19. After exposed to the corrosive environment, there were more materials such as AlCu_3 , Cu_2O , and $\text{FeO}(\text{OH})$ were identified in the Al-bronze coating.

Figure 19. X-Ray pattern of HVOF sprayed Al-bronze coatings before and after corrosion.

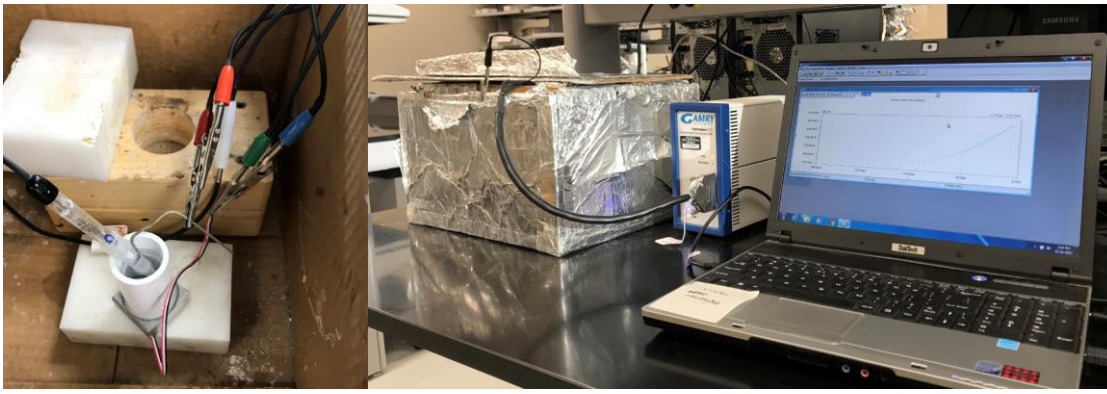
Figure 33. Accelerated electrochemical corrosion test setup.

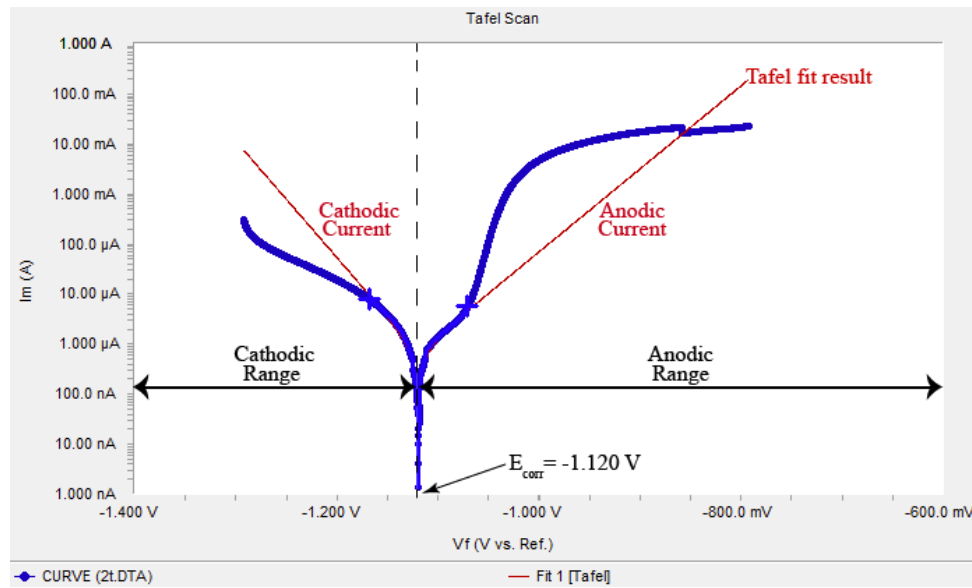
Figure 34 shows a general Tafel test result with detailed markers. Tafel curve was drawn by applying an incremental potential (x-axis) over counter electrode and working electrode, and measuring the current (y-axis, in logarithmic scale) in this system. The lowest point of the curve indicated that anodic reaction and cathodic reaction reach an equilibrium. The corresponding potential at that lowest point was open circuit potential or corrosion potential. The curve left to corrosion potential part was cathodic range, and in right side of the graph anodic range could be found. Tafel fit was conducted on the linear part of both cathodic and anodic range. Thus, two straight lines representing cathodic and anodic current should be carried out. The corresponding current to the intersection of these two straight lines is corrosion current. The slope of anodic range (called Tafel parameter A), together with corrosion potential and corrosion current, serve as three major indicators for corrosion resistance in Tafel test.

Figure 34. A general type of Tafel curve showing anodic and cathodic range.

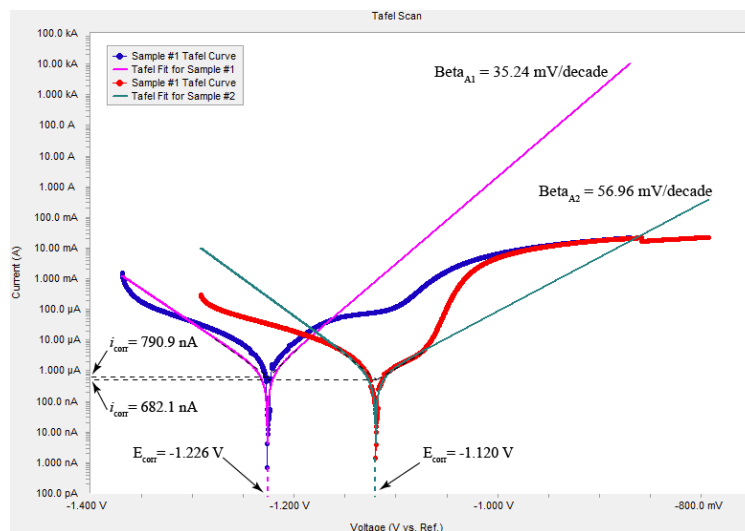
To investigate the influence of coating thickness of the corrosion performance of the coating, laboratory electrochemical tests were performed and detailed as in the following sections. Figure 39 showed Tafel test results of Sample #1 and #2.

Figure 39. Tafel curve of Sample #1 and Sample #2.

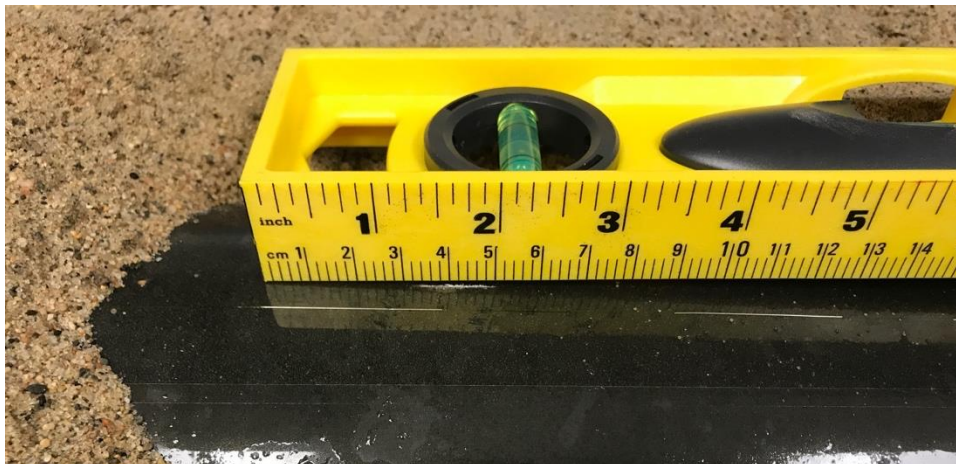
Figure 88. Distance measurement between crack and Sensor 2/Sensor 3.

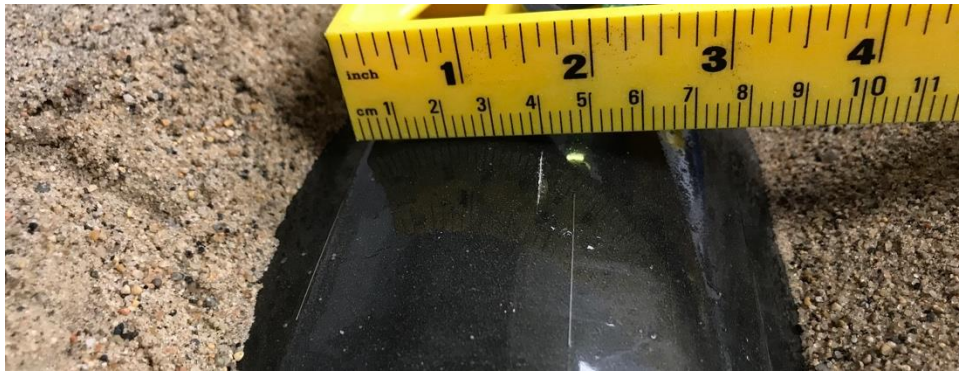
Figure 89. Distance measurement between crack and Sensor 1/Sensor 3.

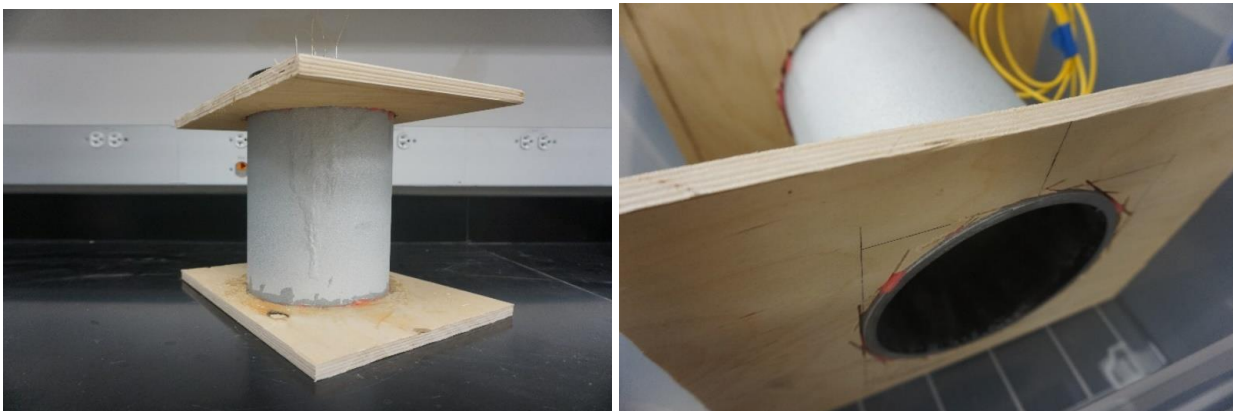
Figure 95. Coated pipe samples with wood board for isolating moisture soil from internal corrosion
