**Development of an AMR Eddy Current-Based Crack
Detection Sensor for Live Inspection of Unpiggable
Transmission Natural Gas Pipelines**

PHMSA Contract Number: **DTPH56-15-T-00013**

NYSEARCH/Northeast Gas Association

April 2019

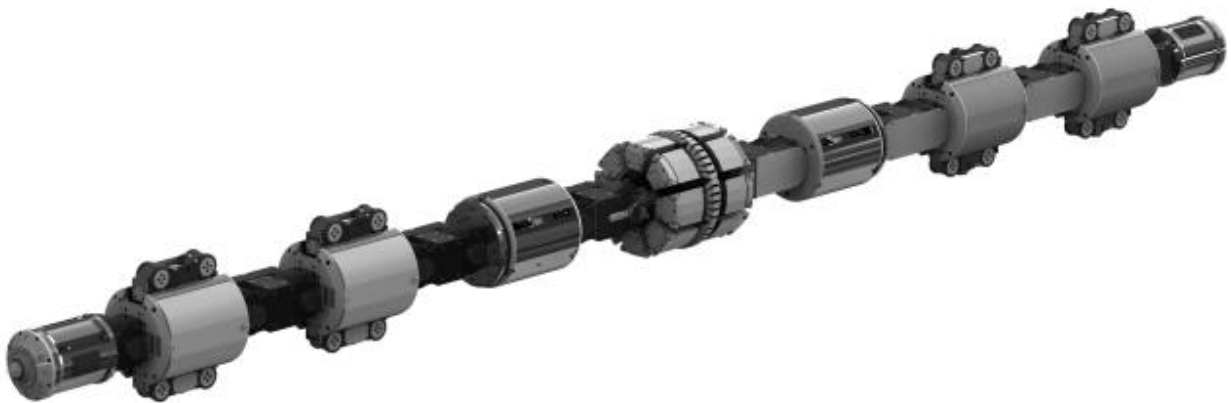
FIGURE 1: EXPLORER 8

The Explorer robots are untethered, remotely controlled, self-powered robots for the visual and inline inspection of natural gas pipelines under live pipeline conditions. The Explorer 8, Explorer 10/14, Explorer 16/18, Explorer 20/26 and Explorer 30/36 offer visual and high resolution magnetic flux leakage (MFL) sensing in addition to mechanical damage detection using an optical, laser-based, sensor.

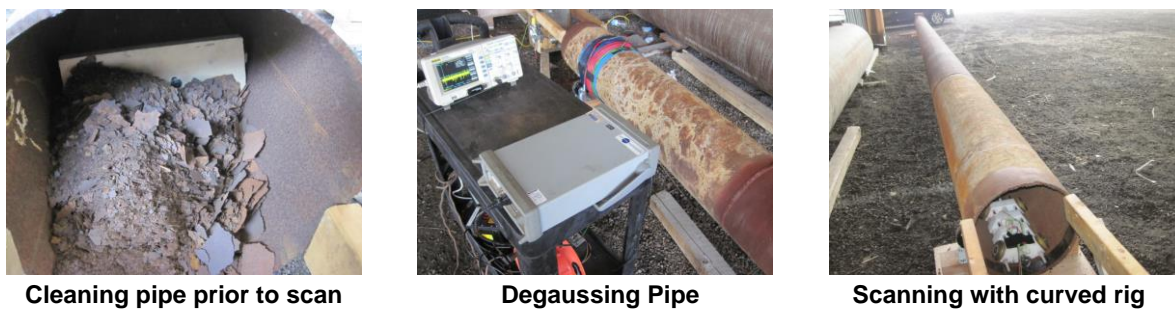
FIGURE 20: BATTELLE PIPE TESTING PHOTOS

Both pipes were scanned using the curved scanning rig (three AMR EC sensor modules). The rig was moved back and forth using a motor / pulley system attached to each end of the pipe (*Figure*). Initial scans (*Figure 12*) show higher background noise than pipe sourced for simulated defects (previous section). The pipe was degaussed using the same technique but that did not have the same effect as in previous cases. The background noise was not reduced to the same extent as previous uses. Of the 20 defects in the seam weld, three were identified using the AMR EC sensor (*Figure 13*).

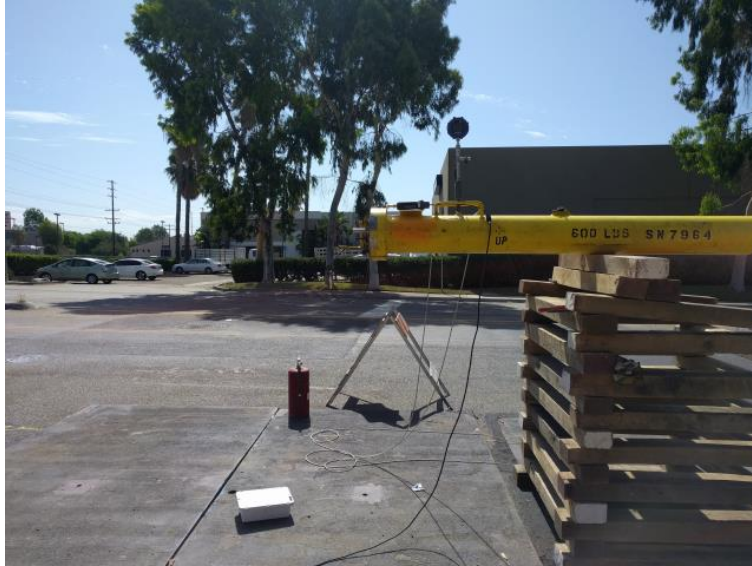
FIGURE 321 EXPLORER 8IN LAUNCH TUBE

The robot was loaded into a launch chamber (*Figure 321*) and driven into the pipe. The sensor (seen in *Figure 35*) was deployed to the pipe wall and the eddy current exciter coils turned on. All sensors recorded the response of the AMR sensors on the pipe wall for the duration of the test. A total of 369 [ft] of pipeline was scanned with the system.

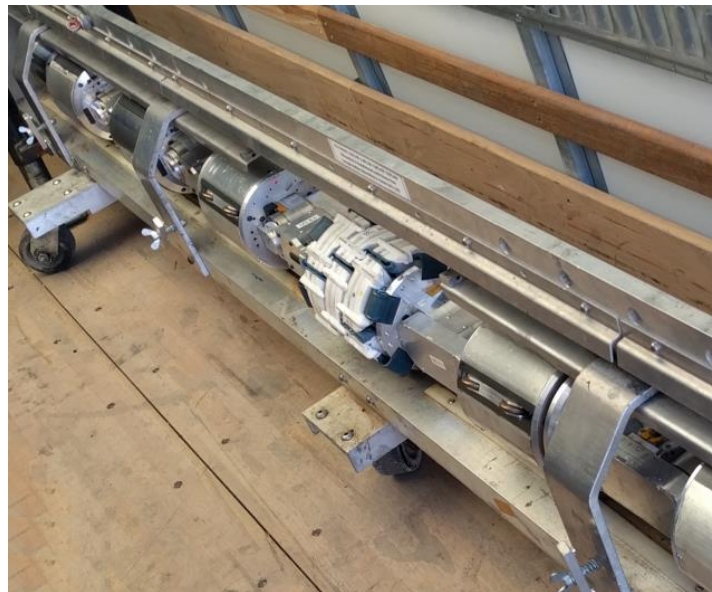
FIGURE 35: AMR EC SENSOR ABOARD 8IN EXPLORER

The result of the pipeline test was a fully tested sensor system. All mechanical, electronic, and firmware systems functioned as expected. No technical issues of any kind emerged during the entire operation. All AMR sensors, coils, and sensor modules performed as in prior testing during system design and implementation. The only issue that emerged was that some plastic parts on the sensor module were damaged during entry/exit from the pipeline, without however affecting overall system performance.

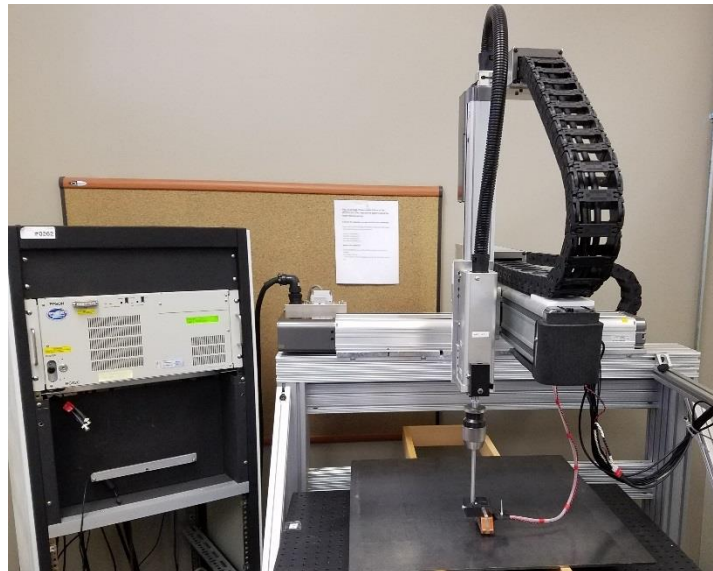
FIGURE 5. EPSON 3-STAGE SCANNING ROBOT WITH FLAT PLATE MREC.

Invodane sent their plate for testing to us in order to verify their results. This plate is 24" by 24" by .25" thick. It has two large notches measuring 1.5" long by 1/16" wide with 50% through depth.
