## **Evaluation of Casing Integrity for Underground Storage Wells**

### **US-3J**

C-FER Technologies (1999) Inc.

**Final Report**

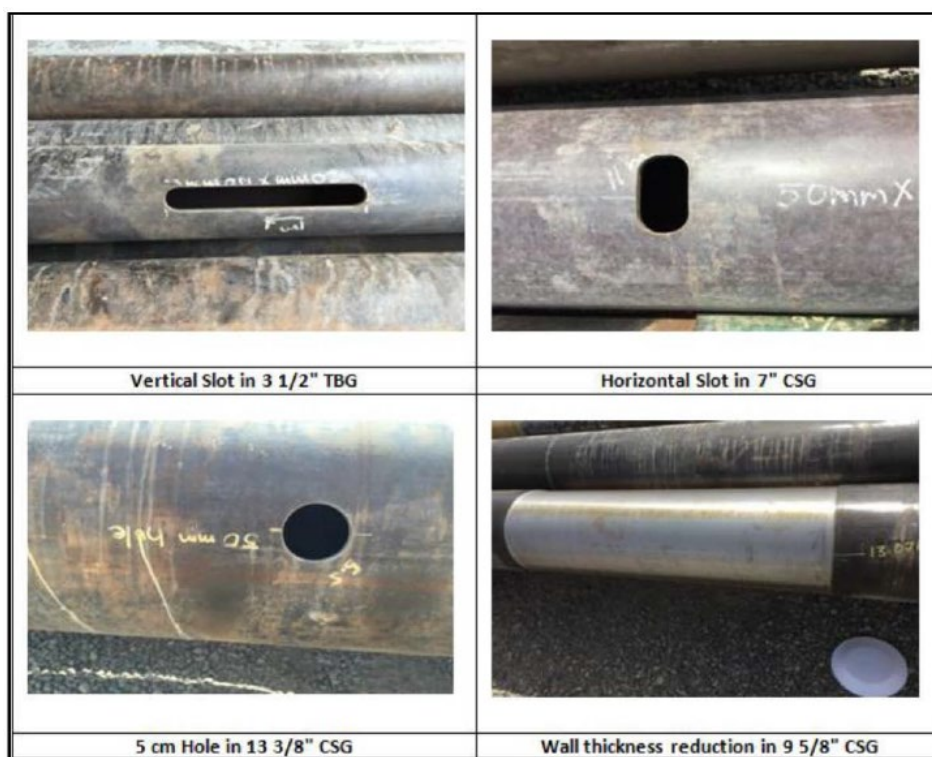
Figure 6 – Examples of Machined Features in PDO Test Program [15]

In 2016, the Petroleum Development of Oman (PDO) conducted a comprehensive yard test to evaluate the capability of EM corrosion logging technology [15]. Multiple service providers anonymously participated in this test program. The vendors claimed their tools were able to quantitatively estimate the WT for each casing string (“layer”) for up to three layers of concentric casing strings. The logging tool test setup included four sets of multiple layers (two or three layers) of concentric casing samples. The casing samples were setup horizontally and the logging tools were pulled through the inner casing during the logging test. Multiple machined features with varying size, geometry and orientation were made on the casing samples, as shown in Figure 6.

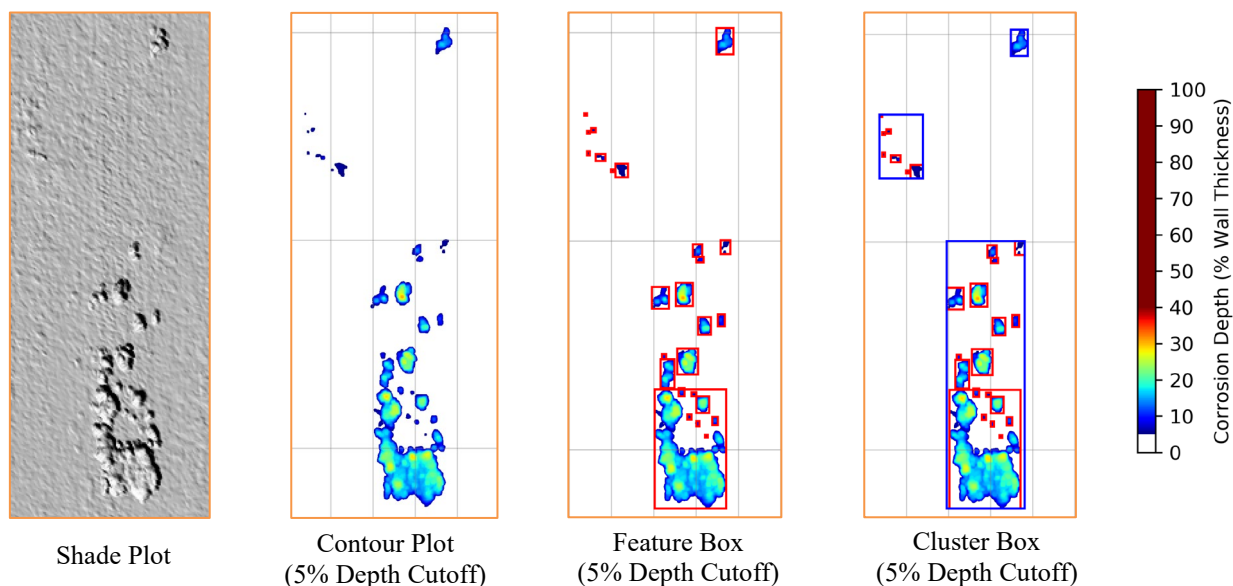
Figure 16 – Metal Loss Contour Plot Example of Natural Corrosion Features

Figure 16 shows an example of the natural corrosion features analyzed from the LS data. A 5% WT depth cutoff was applied to filter out minor imperfections in the pipe surface profile. Further details about these features can be found in the PRCI project report [2].

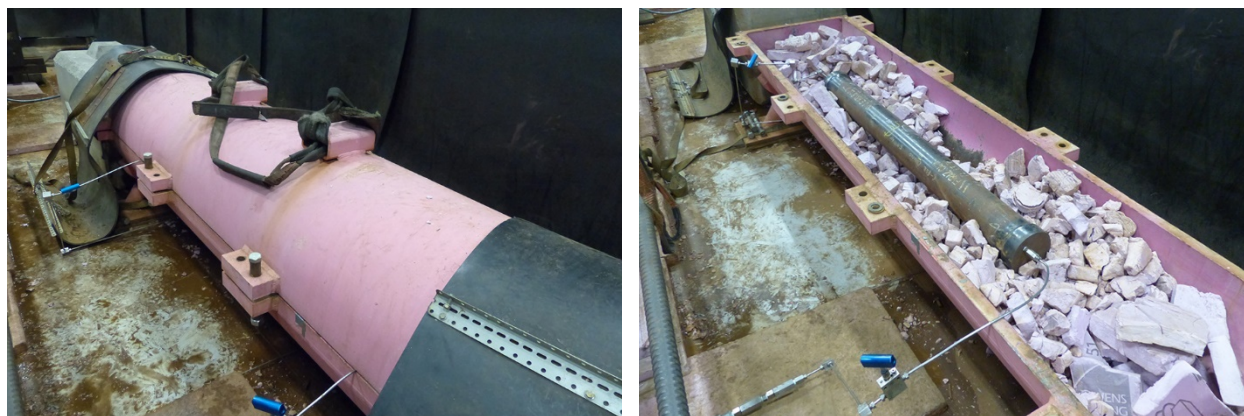
Figure 33 – Burst Test Chamber

acquisition system (DAS) to record the water pressure during the test. The specimen pressure was manually increased at a nominal rate of 200 psi/minute. In most tests, the specimen leak or rupture was clearly identified by a sudden pressure drop. In one case (i.e. 4.5in-JT3-D5), a small leak developed, resulting in a small pressure drop (i.e. the pump was still able to maintain the specimen pressure). The test continued until a large pressure drop occurred. In the post-test diagnosis, the initial failure at the small leak was identified by a clear differential between the pump pre-charge pressure and the specimen pressure. Nonetheless, the small leak occurred at the peak pressure measured over the entire test. Figure 34 shows examples of failed burst test specimens: one showing a rupture and the other a leak failure mode. Table 5 to Table 7 summarize the burst test results. Details of each of the burst tests and photographs of the failed specimens are provided in Appendix E.

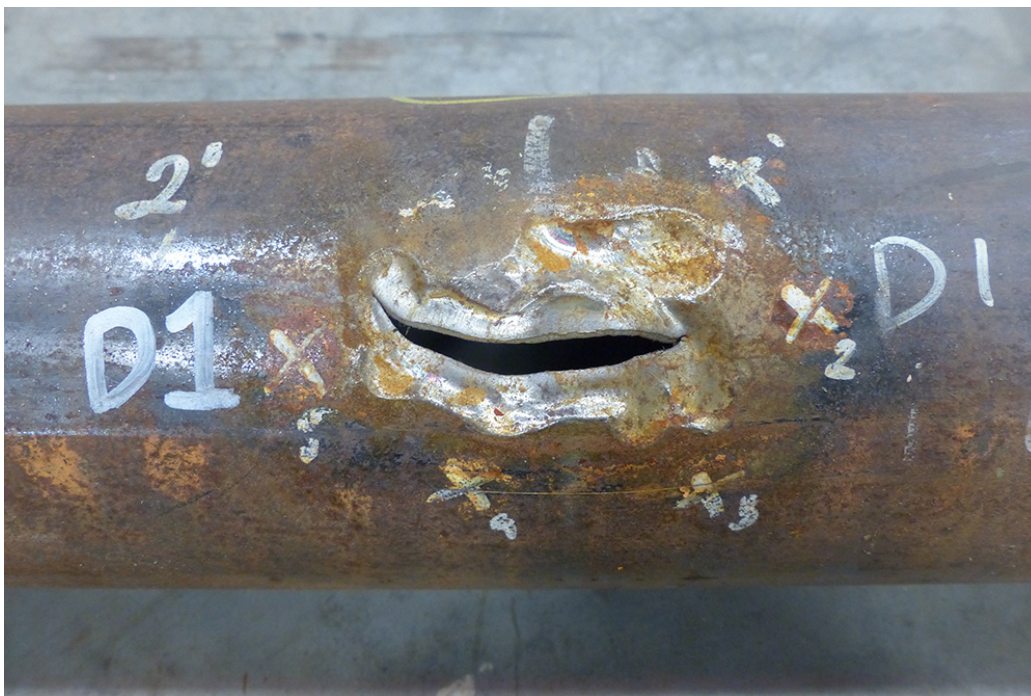
a). Rupture (4.5in-JT#3-D1)
