# Development of New Multifunctional Composite Coatings for Preventing and Mitigating Internal Pipeline Corrosion

**Xingyu Wang, Dr. Zhibin Lin, P.E.**

Dept. Civil and Environmental Engineering  
North Dakota State University

May 24, 2021

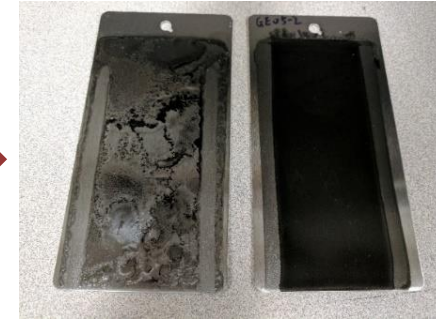
**Fig. 9** GNP-epoxy composite with and without proper dispersion procedure

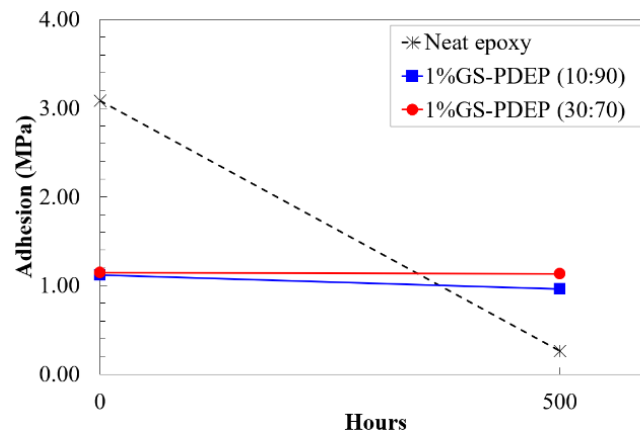
**Fig. 24** Pull-off strength of the 1%GS-PDEP coatings after exposure

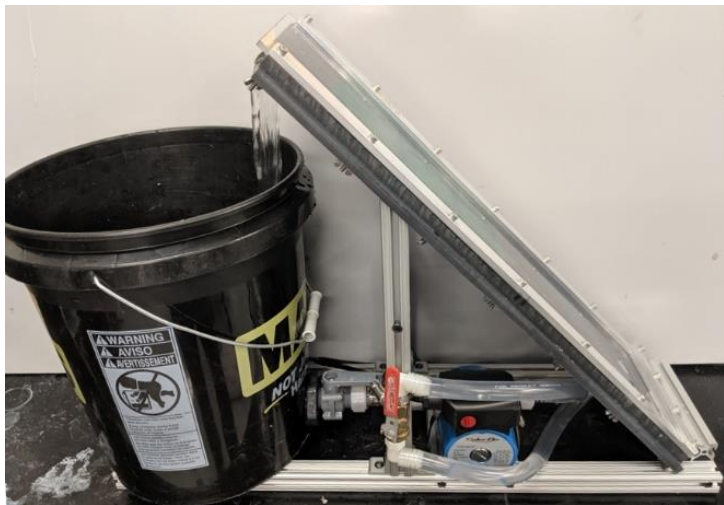
**Fig. 29** Simulated long-term test of the developed coatings under flow condition
