# **Validation of Remote Sensing and Leak Detection Technologies Under Realistic and Differing Conditions**

## **FINAL REPORT**

GTI PROJECT NUMBERS 22660 & 22690

U.S. Department of Transportation  
Pipeline and Hazardous Materials Safety Administration  
Office of Pipeline Safety

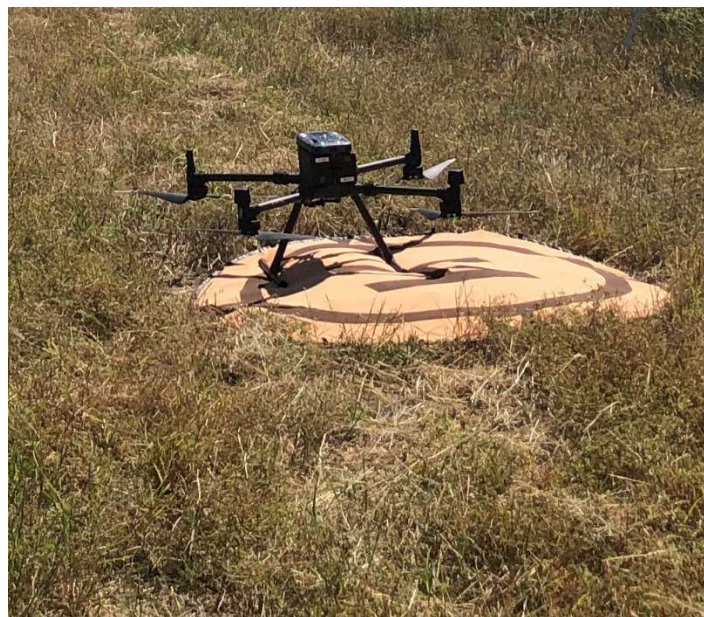
***Figure 1. DJI Matrice 300 RTK (drone-only) during testing***

The M300 (Figure 1), further, was selected on account of its safety and reliability. Its ability to inspect both open corridors and difficult to reach pipe sections was also a key factor that led to it being chosen for this project. The M300 has a heavy payload capacity as well as 55 minutes of max endurance without a payload and 40-45 minutes with the payload included. An extended range of operation in excess of 15 kilometers (km) coupled with coordinated flight control that allows for multiple operators cemented this UAV as adequately fail-safe. Lastly, the M300 possesses advanced obstacle avoidance technology that allows for a remarkably high level of safety when traversing unknown hard-to-access areas.

The M300 had backups for 12 different vital flight components. While a scenario involving hardware failure was unlikely, backups were prepared to come online to ensure safety. Some of

the redundant systems are barometers, the inertial measurement units, intelligent batteries, and even the RTK positioning system has dual antennas that can serve to back up the compasses, if needed. The drone also has six pairs of vision sensors to sense changes in position and altitude which can be replaced by infrared time-of-flight sensors if any sensor encounters difficulties. The M300 can perform an emergency landing with just three propellers in the event of a motor malfunction. The drone is equipped with DJI AirSense to further protect any operator by providing real time information about aircraft within 20km of the drone position. Lastly, there is an FPV camera attached to the drone that delivers a live feed at a 145-degree field of view that ensures operators can still have sight if the main payload camera fails.

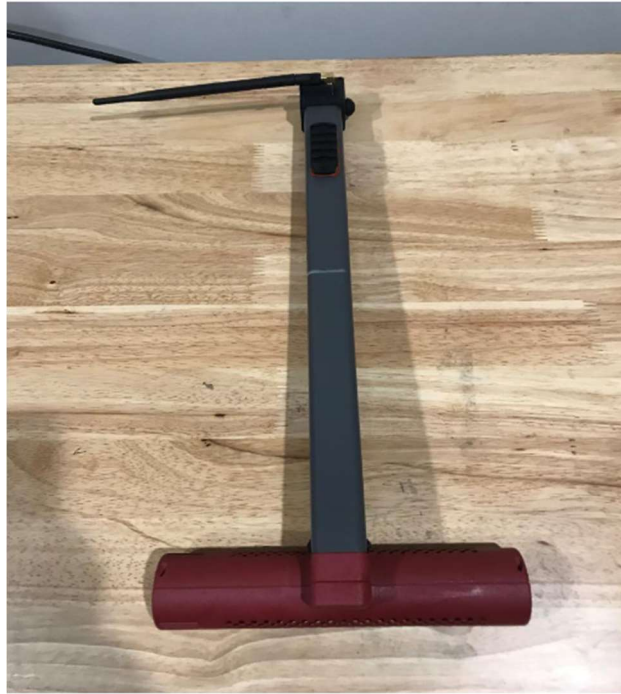
***Figure 2. SeekIR™ Methane Sensor***

The leak detection/methane sensor that was paired with M300 was the SeekOps SeekIR™ methane sensor, shown in Figure 2. SeekIR™ is a drone-agnostic system originally developed at the NASA/Caltech Jet Propulsion Laboratory. The methane sensor technology fits into a 6-inch-long tube and directly samples the air to detect a methane leak. The sensor is known as a “point sensor,” therefore it and the drone must be flown directly through a plume of leaking methane. This detection method is in contrast to a “path integrated” system detection that only requires the beam of the sensor to pass through plume of leaking methane (rather than the whole system).

The open cavity on the SeekIR™ methane sensor can instantaneously respond to the presence of methane due to high sensitivity and selectivity. The mid-wave 3.2  $\mu\text{m}$  infrared (IR) tunable diode laser absorption spectroscopy (TDLAS) technology allows for a sensitivity as low as 50 parts per billion (ppb) generating a consistent 150 ppb minimum detection level. This level of detection allows the sensor to track flow rates above 1 standard cubic feet per hour (scfh) at a distance of 10 meters from an aboveground leak as shown in Ravikumar et al. 2019<sup>7</sup>. The sensor has a weight of 0.5 kg and an internal battery with 6+ hours of run time allowing it to be compatible with and independent of most UAVs. The sensor also contains an internal data logger that provided 900 mHz real time data to develop telemetry of methane levels which was conducted during the period of this project.

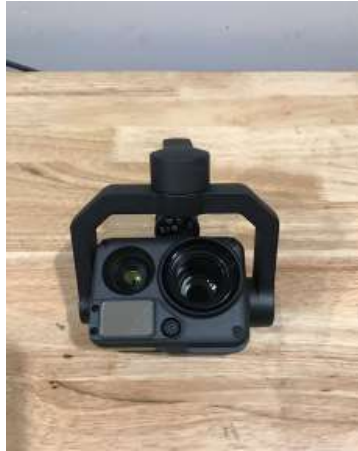
**Figure 3. Zenmuse H20T Camera**

**Table 2** provides specifications for each of the three camera types housed in the H20T: zoom, wide angle, and thermal. It should be noted that thermal camera has a spectral range of 8-14 $\mu$ m,

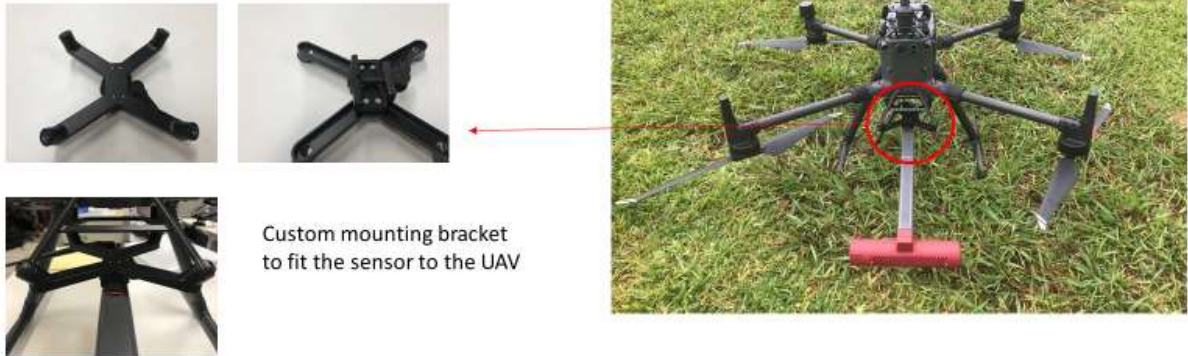
- Top mounted camera
- Bottom mounted methane sensor

***Figure 4. Camera and Methane Sensor Drone Mounting Configuration***

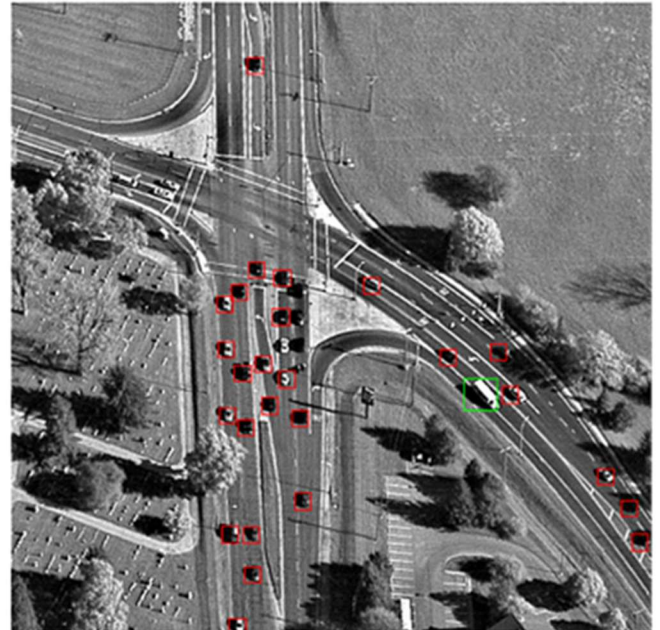
*Figure 5. Example detections from University of Dayton software when mounted to a downward facing aircraft mounted camera (photo source University of Dayton Vision Lab).*

The Vision Lab at the University of Dayton (UD) developed an automated, deep learning-based computer vision algorithm to detect and identify pipeline encroachment threats from aerial images as shown in Figure 5. The automated threat detection designed by UD was combined with the SeekOps image collection drone platform. The UD system was initially developed in partnership with organizations such as Pipeline Research Council International (PRCI) since the early 2010s to develop and fully test the software using images collected by manned aircrafts. Testing at the time of selection had shown that the software had achieved a level of maturity and robustness for analysis of image data collected on drone flights to validate integrity threat identification for basic equipment (vehicles). Future iterations of the software could extend capabilities to cover more configurations of encroachment threat, ground disturbances, and geotechnical threats (outside the scope of this project).

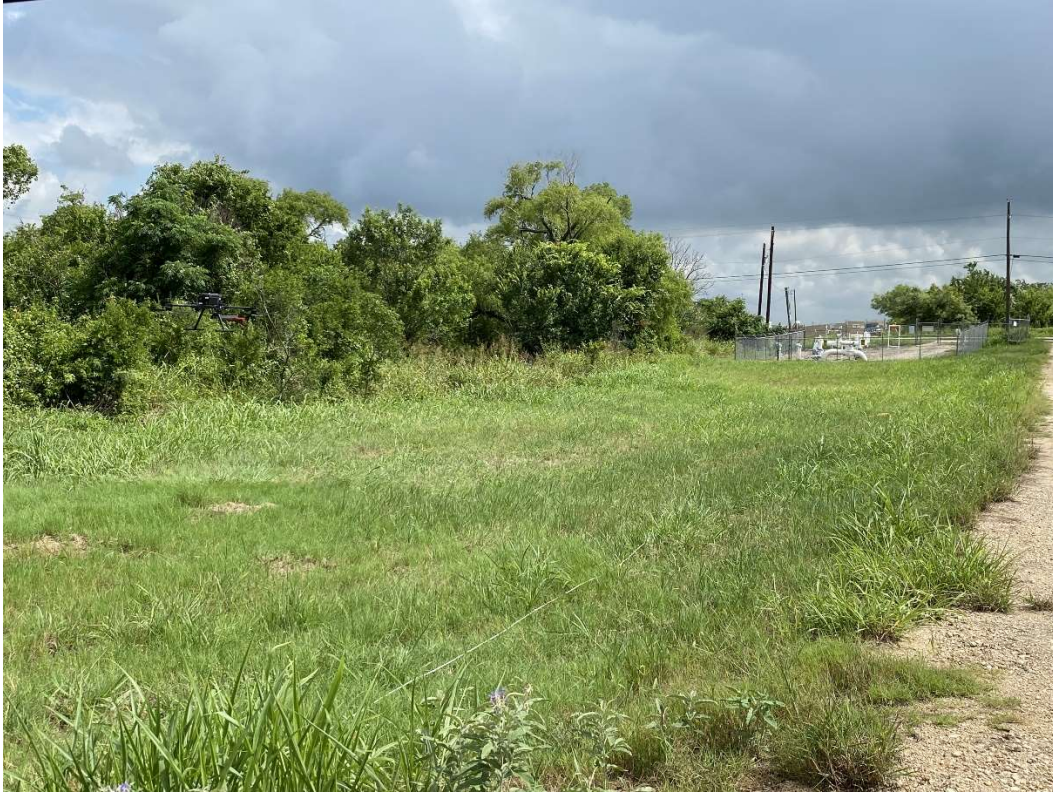
***Figure 8. Utility owned natural gas transmission pipeline ROW site***

Testing was done at two simulated real-world sites: 1) a natural gas utility owned transmission pipeline site (Figure 8), and 2) at a ranch near other gas processing/production equipment (Figure 9) offering a unique real-world experience involving background interference. Members of the TAP stressed that real-world test sites like these were important because they could incorporate a much wider array of terrains, environmental parameters, and potential interferences when compared to a large-scale laboratory setting.

The lack of relationship between detection location and wind direction highlights an important caveat to leak detection and localization with any drone system. The localization is only as good as the data that is fed to the algorithm. For example, as shown in Figure 8 and Figure 14 above,

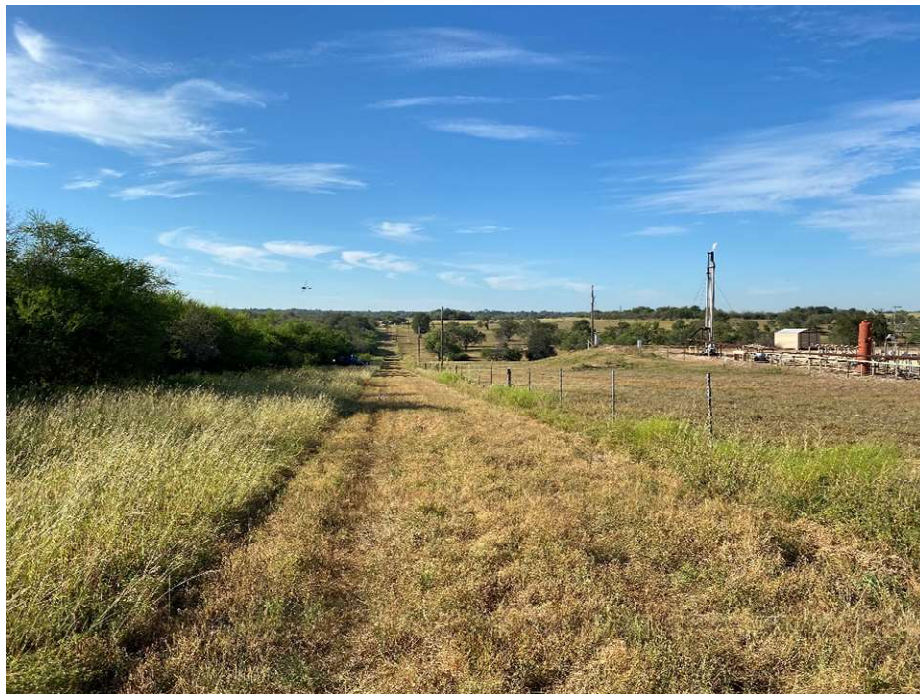
***Figure 9. Private ranch testing site***

In September 2021, the teams visited a second simulated real-world test site on a private ranch. The private ranch field site allowed for the collection of data on a transmission ROW that was near other gas processing/production equipment as shown earlier in Figure 9 and in Figure 24 below. The terrain was also hilly. Emphasis of the test centered on surveying over hilly terrain and over a water source (Figure 24). As shown in Figure 24, concentrations in the background air were as high as 20 ppm or more as measured with the drone and a handheld combustible gas indicator (CGI). This allowed for testing and detection evaluation of the methane sensor in a high background concentration environment.

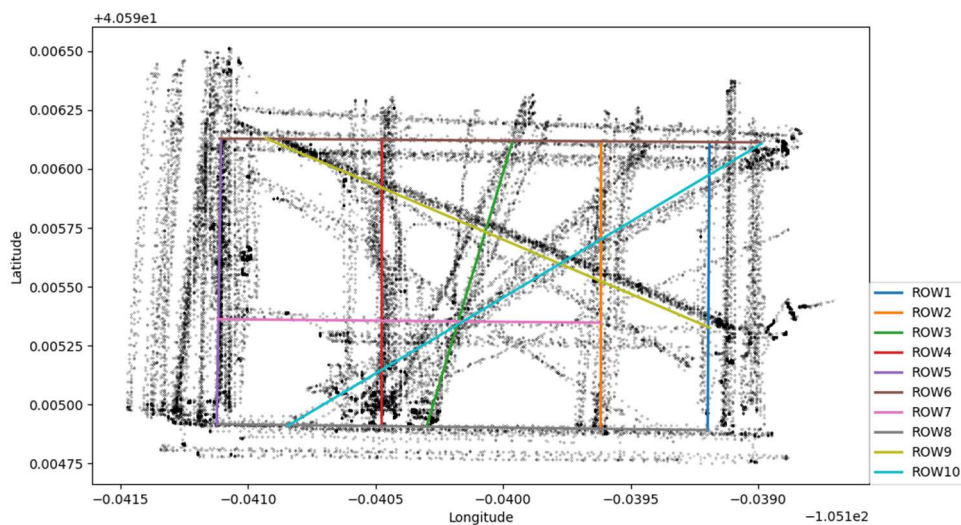
**Figure 10. All location records from the drone for the 10 ROWs at METEC**

A run was considered to have a detection if there was at least one detection above the SeekOps predetermined concentration threshold for a leak in the run. An average of 6.8 runs were performed with each scenario (one combination of leak rate and drone altitude). There were 45 runs performed with “blanks” (no controlled release) and 471 runs with controlled releases. During experimental planning, GTI aimed to get enough passes on blank leaks to determine the false positive performance (chance of creating false alarms). The black dots shown in Figure 10 represent the location records of the drone during all days of testing at METEC.

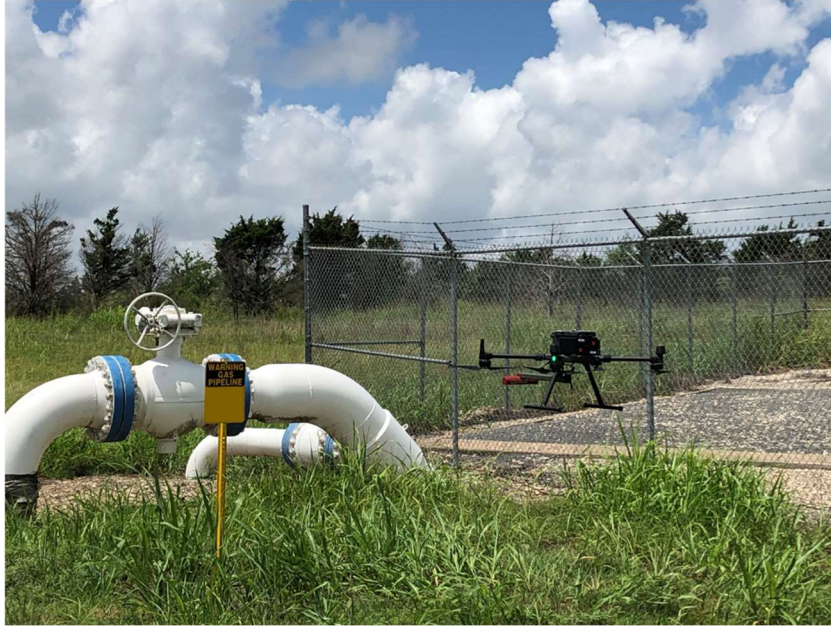
***Figure 14. Aboveground equipment at the utility owned transmission ROW site.***

In June 2021, the teams participated in controlled simulated real-world leak testing at a natural gas utility owned transmission pipeline site. Testing occurred near operating gas transmission equipment (Figure 14) that the team determined to be emitting a detectable amount of methane depending on wind direction and distance from the equipment. Natural gas “sniffers” were used to survey the area to confirm that no other methane sources existed in the test area.

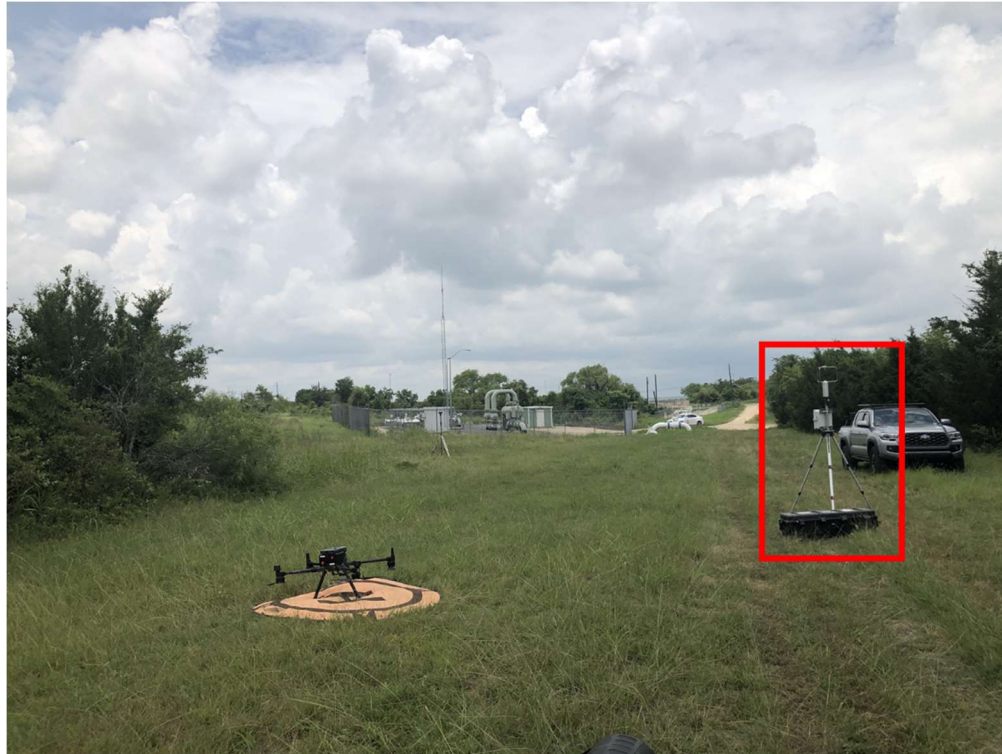
***Figure 23. Utility owned transmission test site with wind monitoring equipment highlighted in the red box.***

the area around the ROW was lined with trees that were taller than the altitude of the drone flight paths. This could have caused the local micrometeorology to be variable across short distances, especially near the canopy edge. Further, the wind speed and direction are not measured directly on the drone, but at a fixed anemometer adjacent to the testing area as shown in Figure 23. These factors are likely the cause of the lack of relationship between detection and wind direction.

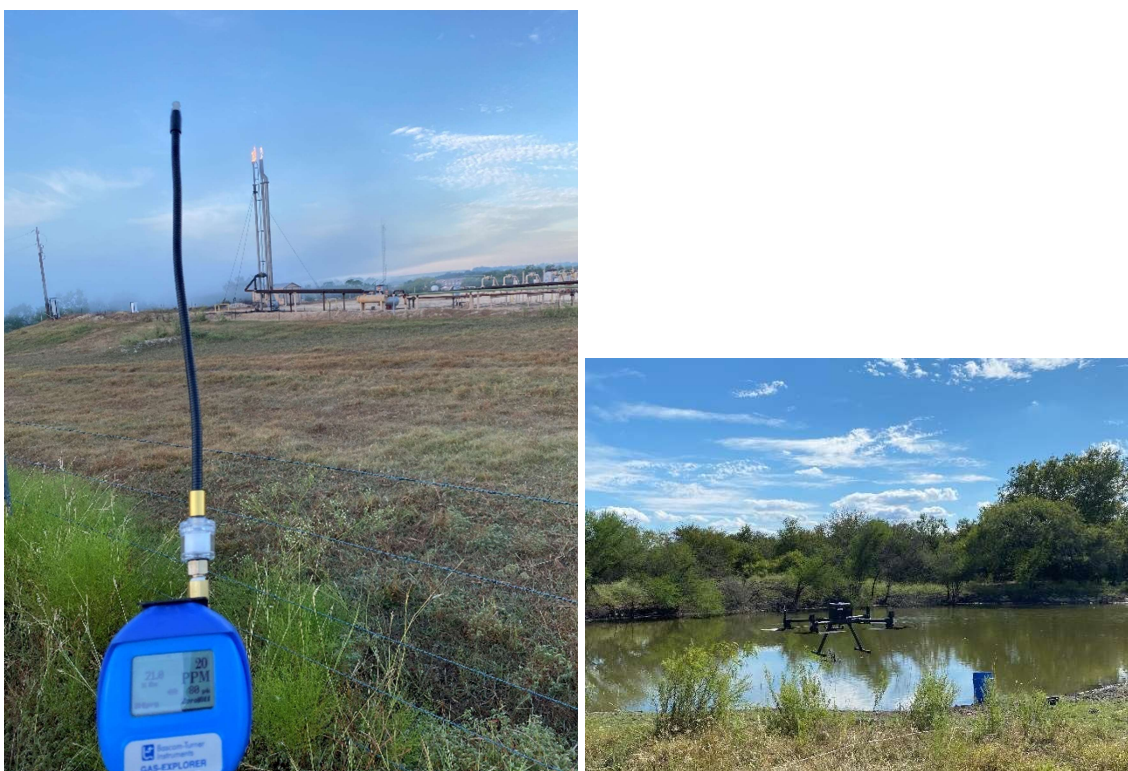
***Figure 24. Private ranch testing near oil and gas production equipment and on the edge of a pond.***

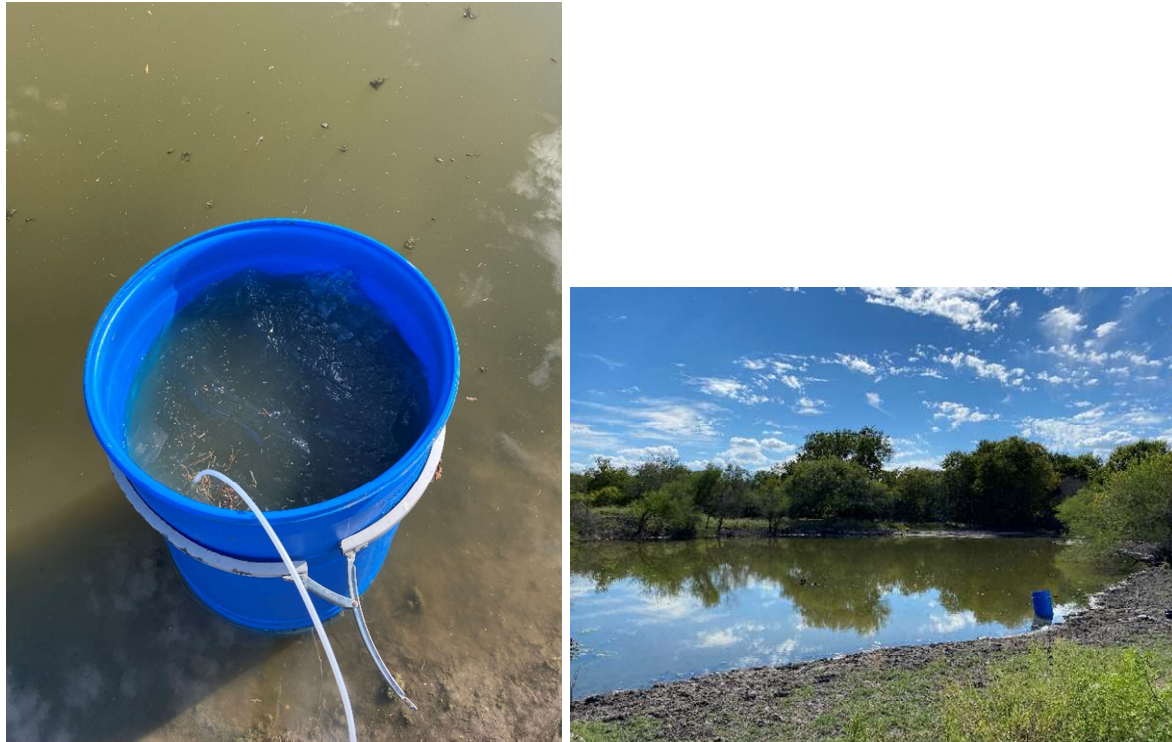
***Figure 25. Underwater emission release point at the private ranch***

For surveying over a water source, a container was filled with water from a pond and tubing was placed in the container and weighed down to keep it under the water surface as shown in Figure 25. Due to landowner restrictions the release point could not be in the pond itself which greatly limited the depth of the release. The drone flew a box pattern around the water source to evaluate detection capabilities. The box pattern tests were performed as in the previous field test at altitudes of 2,3, and 5 meters with 6 passes or repetitions.

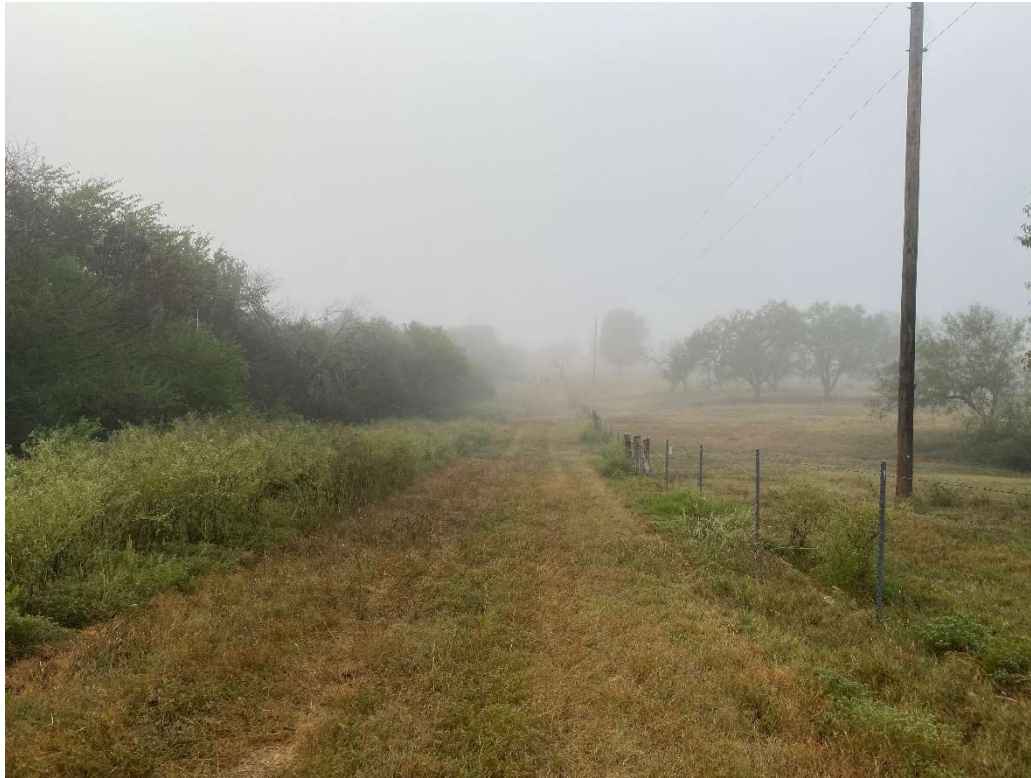
**Figure 26. Dense fog and high moisture on one day during the private ranch testing.**

One interesting observation was that dense fog and high moisture (as shown in Figure 26) caused high concentrations of methane to be measured in the air (above 50ppm). The ambient air concentrations were above the maximum detection limits of the highly sensitive SeekOps SeekIR™ sensor. The concentrations measured in air with a CGI reached 60 to 80 ppm and they lasted for approximately 2 hours before they dropped below 40 ppm (as measured with the CGI). It is highly likely that a stable boundary layer/capping inversion occurred overnight trapping methane being emitted in the surrounding area, impacting the measurements. This could indicate that in an area of high oil and gas activity that measurements must occur after mid-morning when the nocturnal boundary layer has been replaced due to surface heating and turbulent mixing<sup>13</sup>.

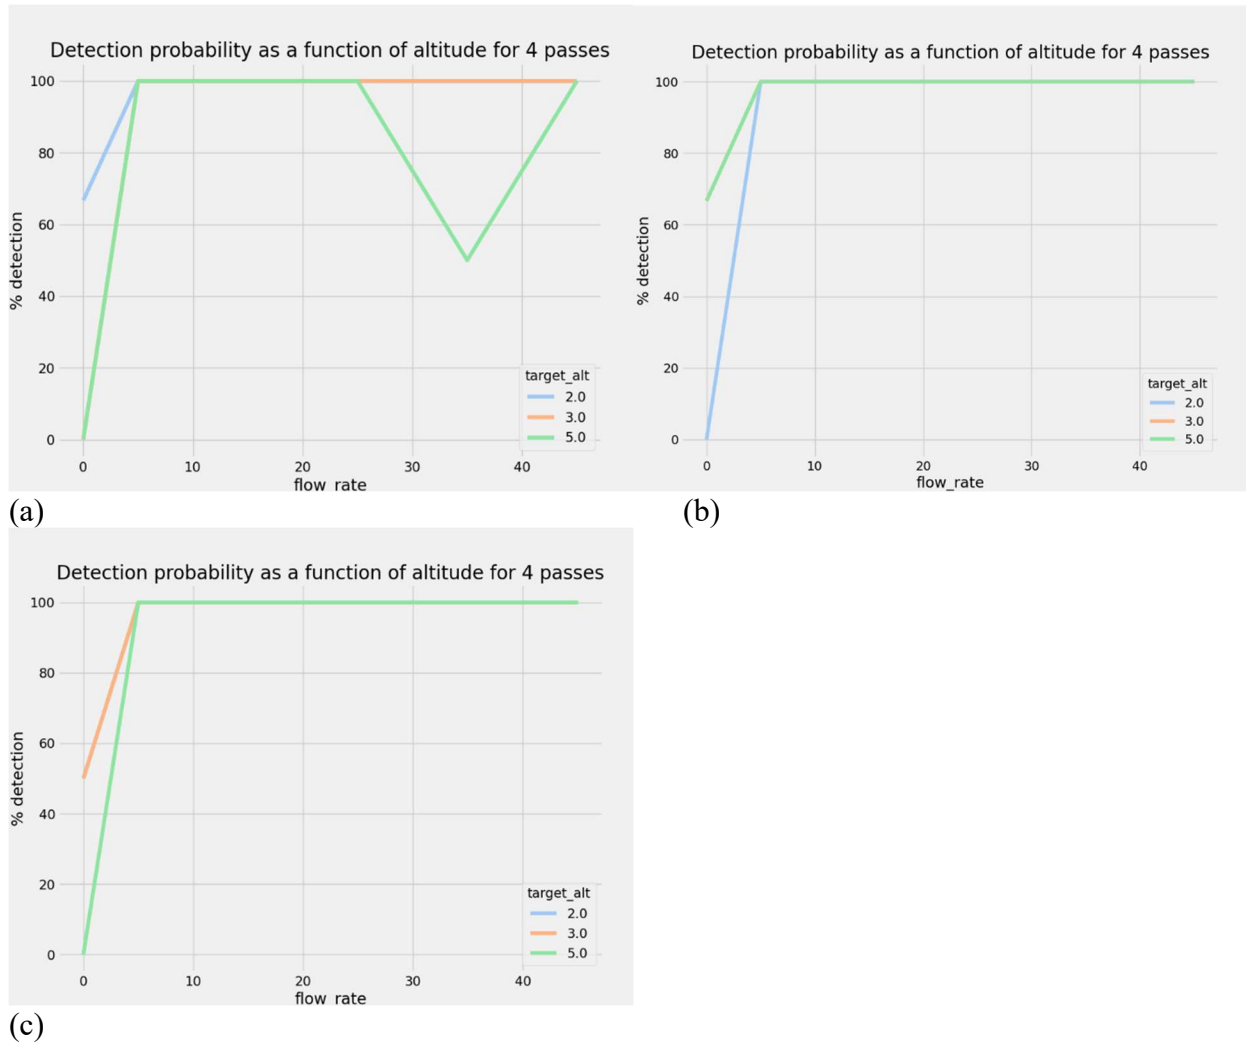
**Figure 32. Detection Probability as a function of drone altitude for grouping 4 passes for (a) line tests, (b) box tests and (c) box tests with water feature.**

Figure 32 showed the detection probability as a function of altitude when grouping 4 passes in each testing type. Comparing the detection probability against different altitudes, it was found that there is no obvious benefit of flying at a lower altitude for the line tests. The leak detection performance was evaluated at different drone altitudes. Similar to the findings in the transmission site testing, there is not enough evidence of an optimum flying altitude.

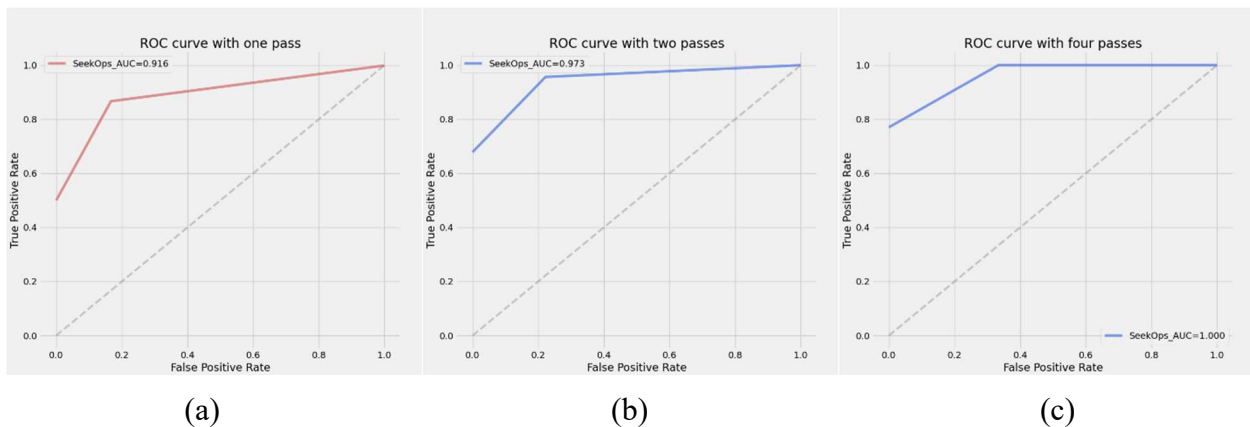
**Figure 35.** The ROC analysis for the box tests with water feature at the private ranch for (a) single passes, (b) grouping 2 passes and (c) grouping 4 passes for the private ranch testing

ROC analysis was also performed for the three testing types at the private ranch and summarized with an AUC statistic. The results are plotted in Figure 33, Figure 34 and Figure 35 for the line tests, and box tests with water feature, respectively. The results were quite promising for the SeekOps drone system for the overall testing at the private ranch. As shown in Figure 17, the lowest/worst score was 0.858 for the single pass AUC for the line test, which already indicated good performance before combining runs. When runs were combined, the AUC score improved, even reaching 1, for the testing conducted under water. This indicated that the water had little impact on the performance of the SeekOps.

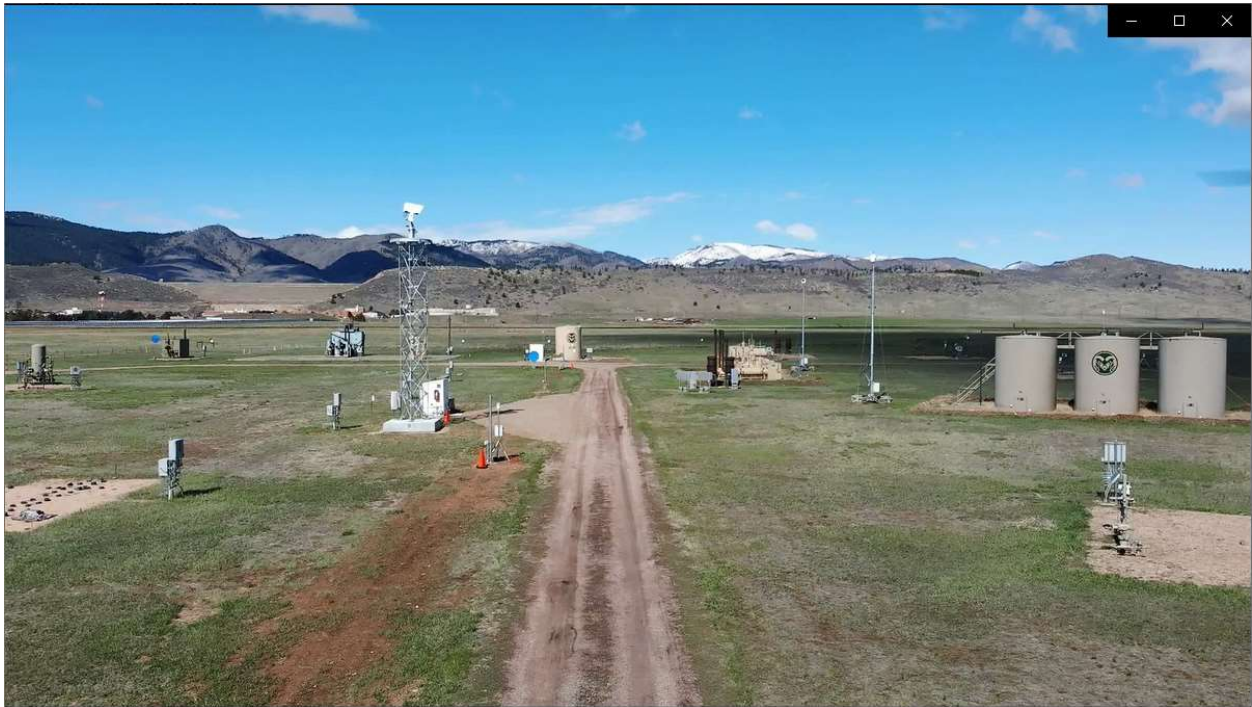
***Figure 36. The METEC testing facility on a blank run with no integrity threats staged***

The UD Vision Lab software was under development, therefore, the libraries of various types of equipment had not been completed for both downward and forward-looking videos at the time of the evaluation. Despite this limitation, the initial evaluation of the software was successful in demonstrating the capabilities, limitations, and usefulness of the software for integrity threat monitoring. Since the system was still under development a high-level qualitative evaluation was performed for video data collected during testing at the METEC facility as shown in Figure 36 through Figure 41.

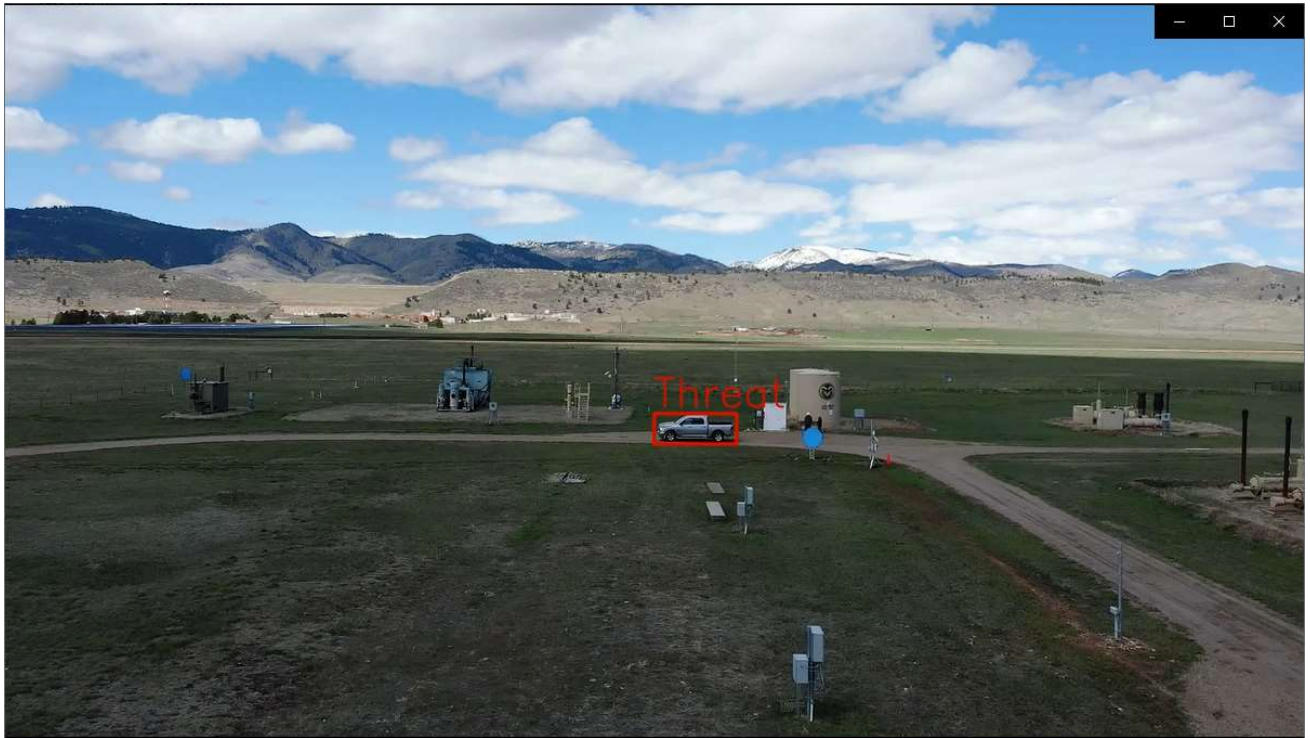
*Figure 37. METEC facility with a single pickup truck staged along the ROW.*

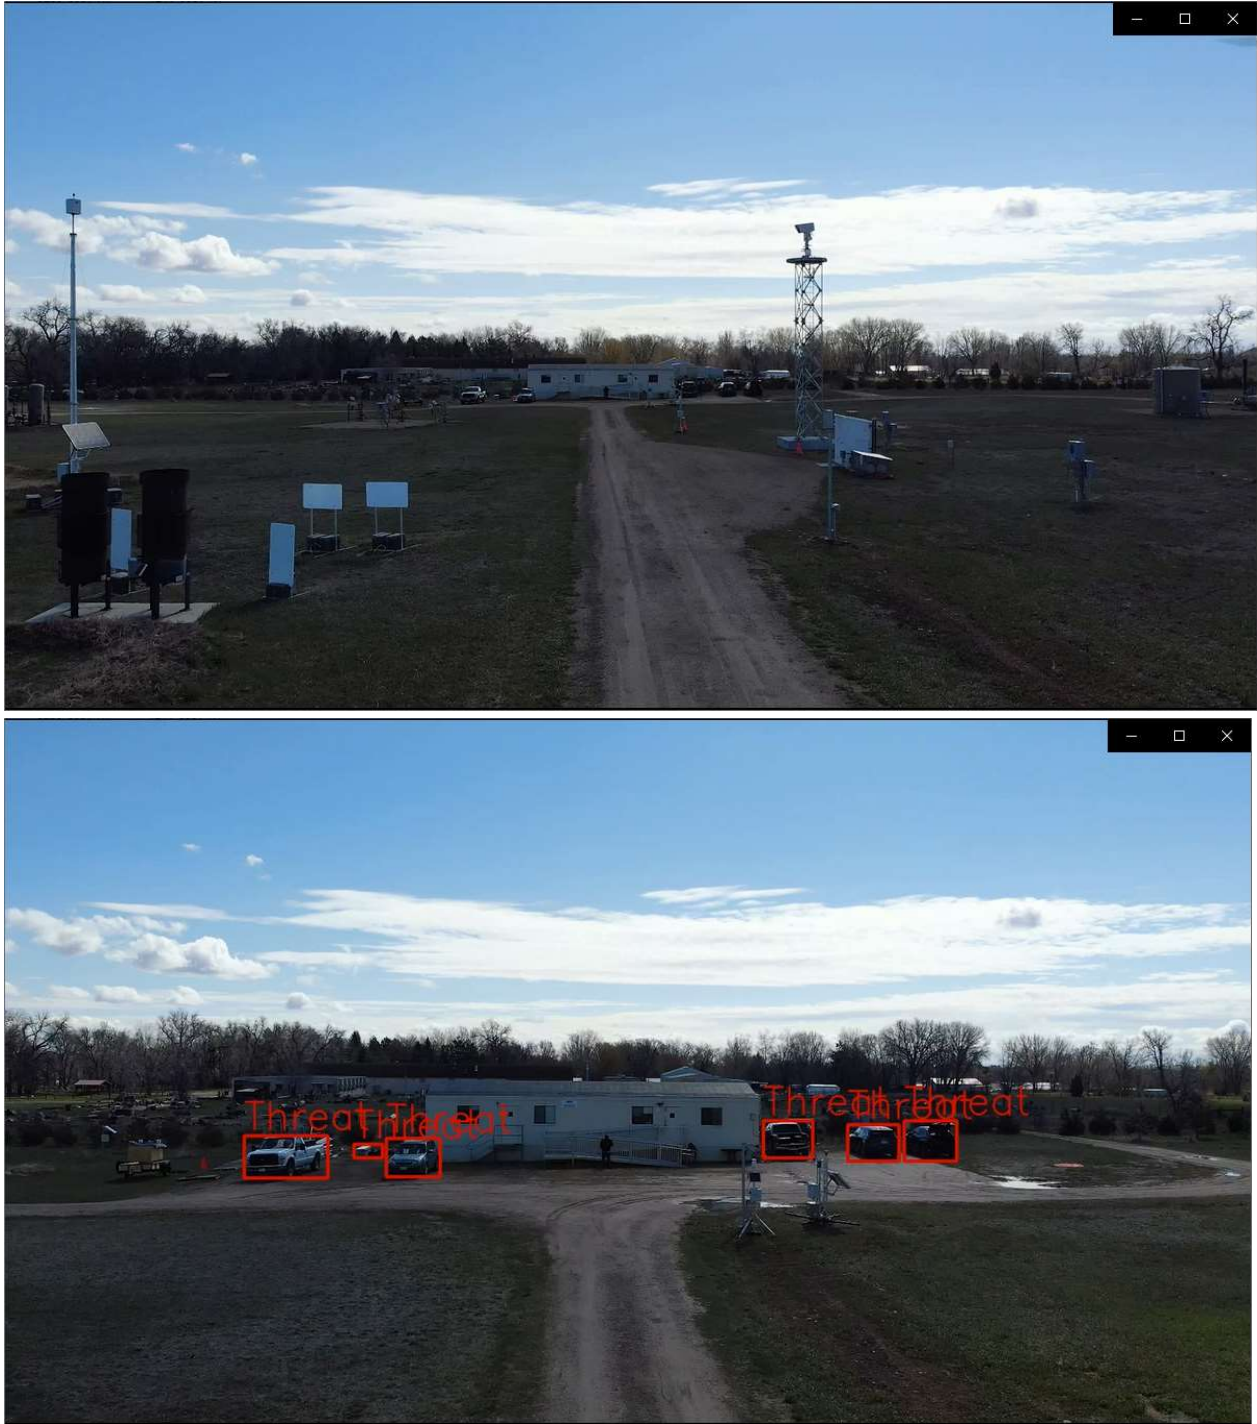
***Figure 38. UD software identification of potential threats (passenger vehicle) near the office building as the drone approaches.***

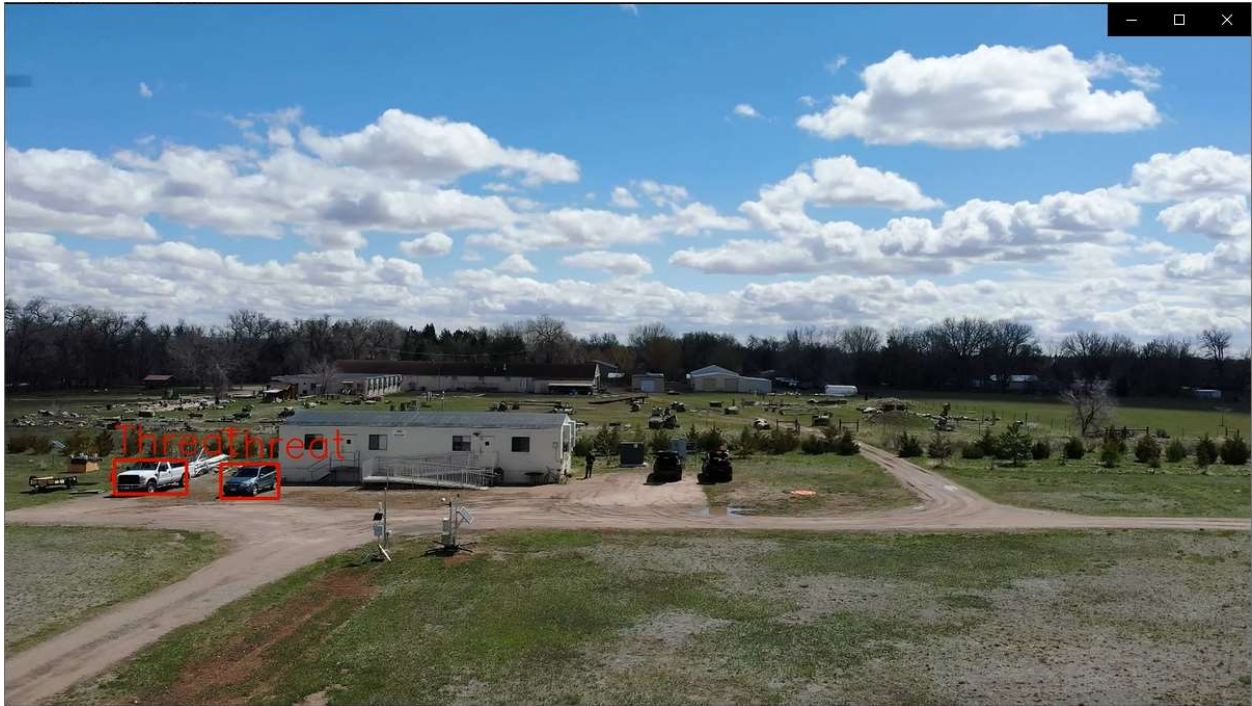
*Figure 39. Demonstration that orientation impacted the ability of the UD software to identify threats.*

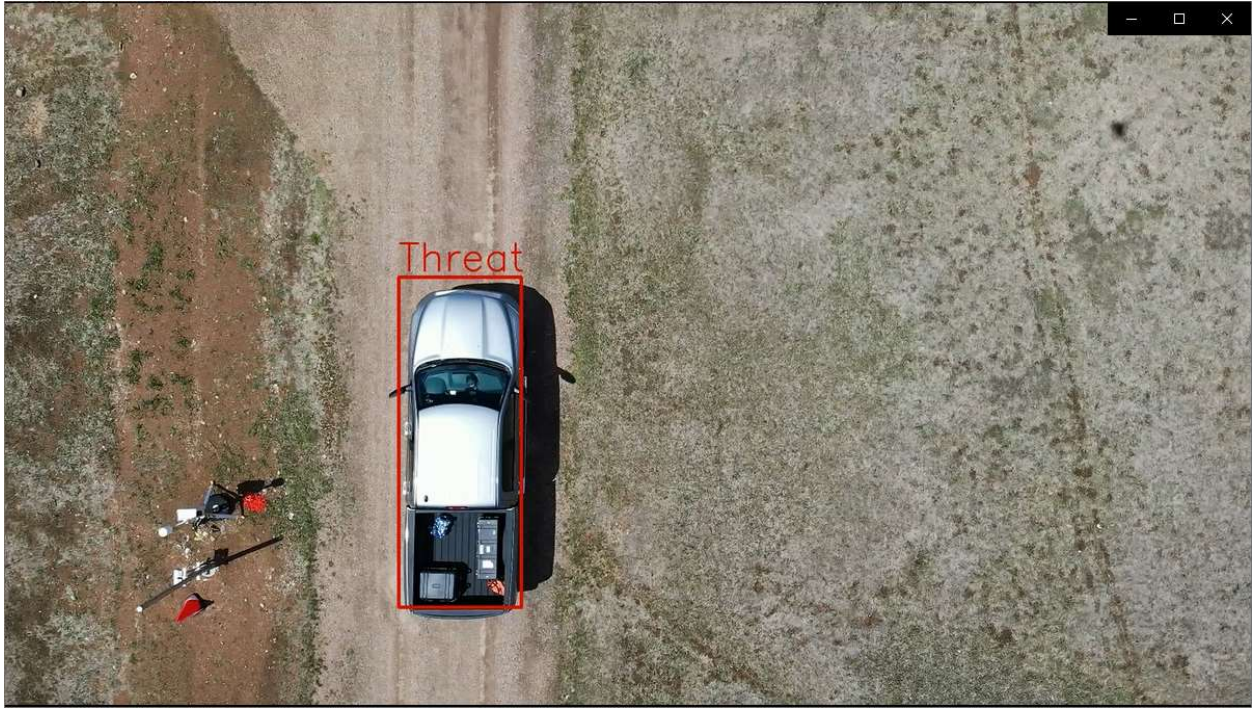
***Figure 41. Another example of the UD software identifying a threat. In this case the threat was moving along the road.***
