CAAP Annual Report

Prepared for: *U.S. DOT Pipeline and Hazardous Materials Safety Administration*

Annual Period: *From (10, 01, 2022) to (09, 30, 2023)*

Project Title: *Easy Deployed Distributed Acoustic Sensing System for Remotely Assessing Potential and Existing Risks to Pipeline Integrity*

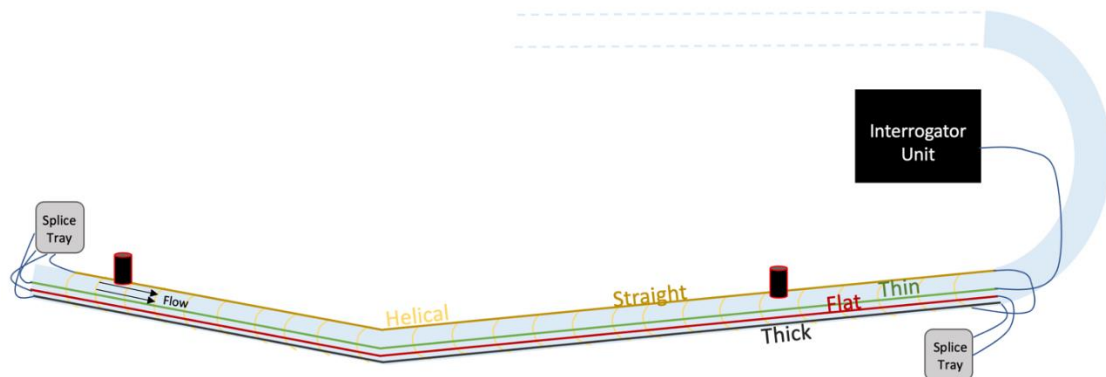
Figure 2. Schematic of Task#1 and #2 layout, depicting the interrogator unit spliced to a sequence of cables – thin, flat, thick, straight, and helical. Two pressure sensors, shown as black cylinders in the schematic, are positioned both uphill and downhill along the experimental section of the flow loop.

An external single-mode jacket cable was helically wrapped around the exterior of the clear PVC pipes. For every 10 ft of pipe, 100 ft of cable was employed, resulting in a spacing of 3 cm between each cable wrap. Tension and duct tape were utilized to secure the cable in place. Three internal cables of varying thicknesses (thin, thick, and flat) were deployed within the PVC pipes, where they were positioned freely. These internal cables exit the pipe through custom-designed seals located at opposing ends of the clear PVC section. Figure 2 shows the schematic of the multiphase flow test section, depicting the connection of the fiber optic cables.

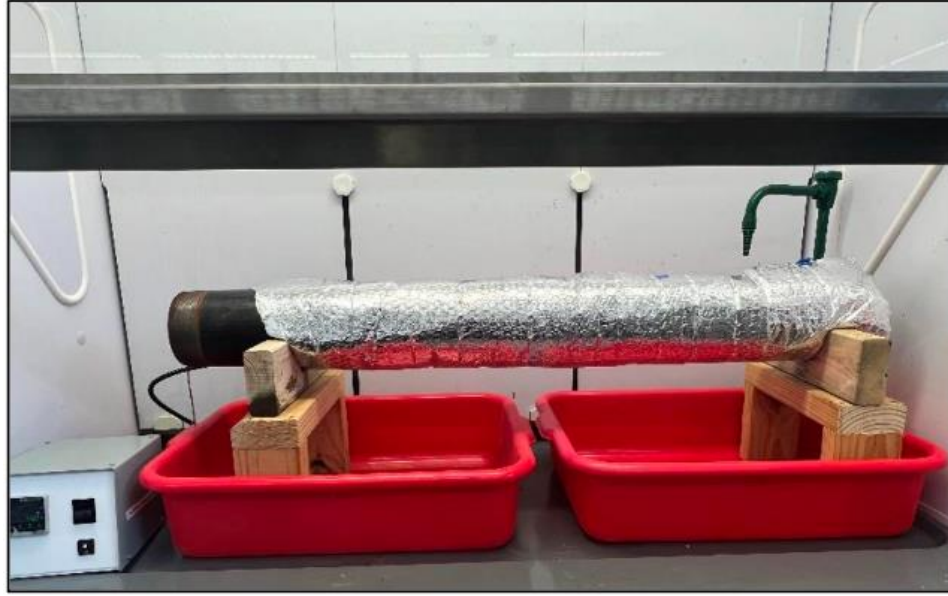
Figure 7. Photograph of the 1-m steel pipe during an ongoing lab corrosion preparation

For Task#3, the same procedures and methods outlined in the 1st year annual report were employed to induce corrosion in the 1-m test sections. This includes: 1) 400 ml of hydrochloric acid (12M) is introduced into the 1-m pipe section to initiate corrosion at the 6 O'clock position. The acid is replaced every 24 hours. 2) A general corroded depth is generated, and mechanical grinding is applied to create surface scratches, increasing the pipe wall's roughness. 3) For the purpose of accelerating the corrosion rate, a heating system is utilized to increase the temperature of the acid within the pipe. An optimal temperature of 65°C was identified and maintained during the corrosion lab experiments. This temperature enhancement played a crucial role in attaining the targeted corrosion rate. Figure 7 shows the 1-m test section during an ongoing experiment creating the corroded internal surface. We successfully corroded two 1-m pipes, with one simulating a scenario of moderate wall corrosion, featuring a depth of 3 mm, and the other representing a severe corrosion case with a depth of approximately 5.8 mm and a small penetration (see Section 3.6).

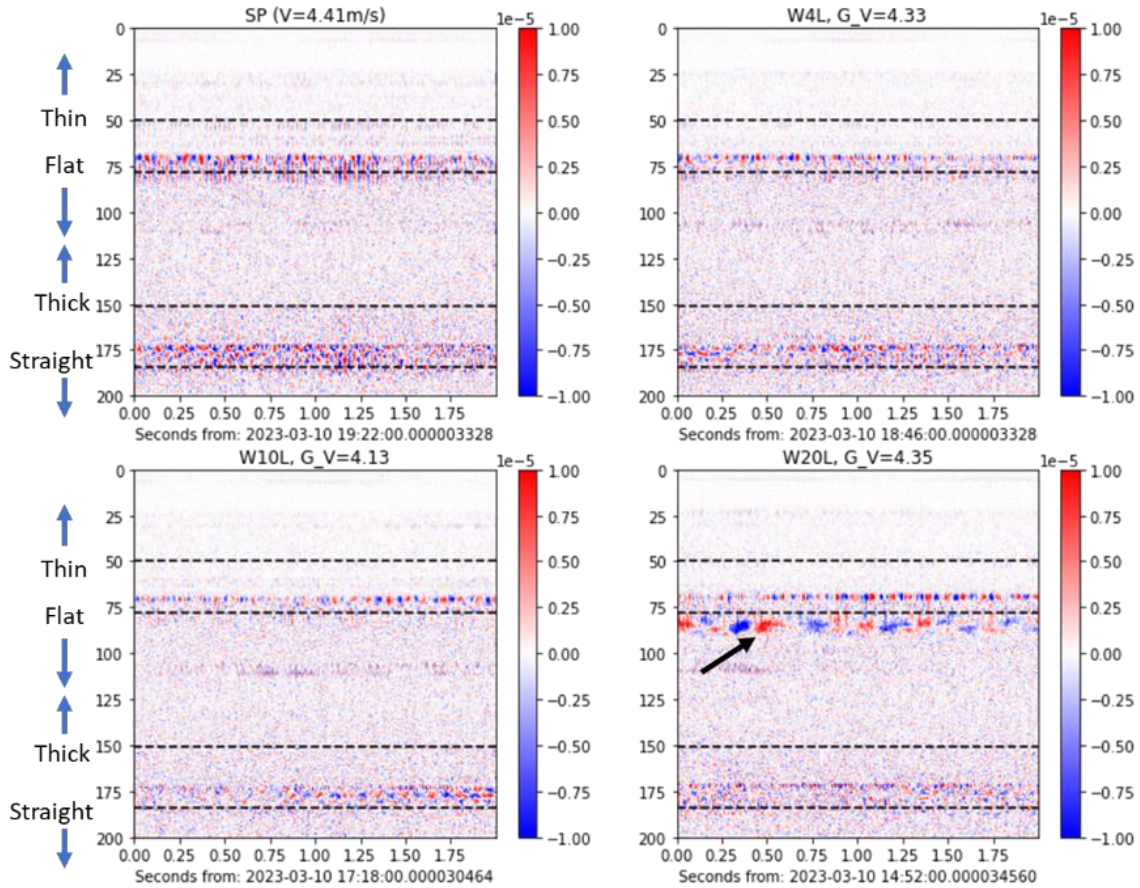
Figure 8. Waterfall plots for DAS raw data all observed at around 4 m/s gas velocity with different volumes of water accumulated at the V-section. The vertical axis is distance along the fiber in meter, and horizontal axis is time. Top row: no water accumulation (left), 4L water accumulation (right). Bottom row: 10L water accumulation (left), 20L water accumulation (right). The location of V-section is indicated by black dashed lines. From top to bottom, the dashed lines mark the V-section location for thin, flat, thick, and straight cables. Blue arrows indicate flow direction in each fiber section. Black arrow highlights the vibration of flat cable associated with the wavy liquid surface.

The results obtained from experiments involving water volumes of 4L, 10L, and 20L at velocities of 2 m/s, 4 m/s, and 6 m/s, as recorded by DAS data, reveal promising capabilities in the detection of liquid accumulation within pipeline low points. Figure 8 shows the processed DAS data recorded with around 4 m/s gas velocity with the three different water volumes. A clear low-frequency vibration can be observed by the flat cable near the V section, which is associated with wavy liquid surface and water-cable interaction.

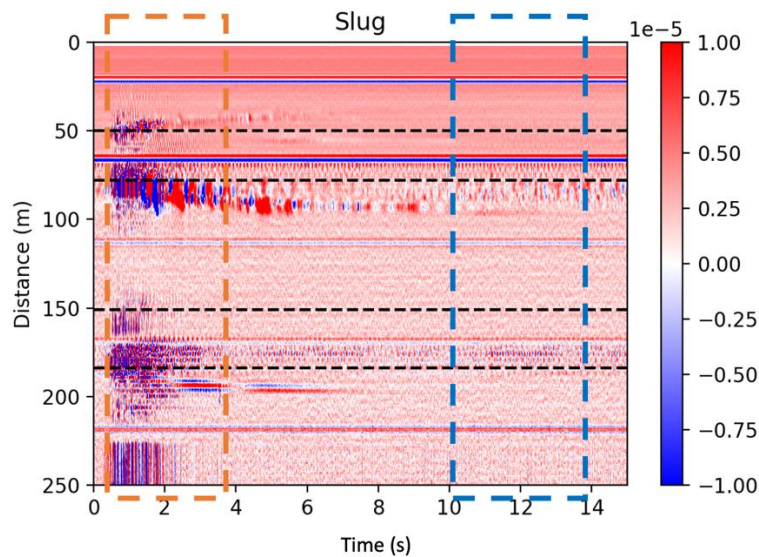
Figure 10. Raw DAS data at 6 m/s air flow velocity showing the slugging behavior captured on the thin, flat, thick, and straight cables, with the V location indicated by the black dashed line. The orange box encompasses the time when a slug is occurring, and the blue box encompasses the time when there is no slug.

The experimental investigation of multiphase flow, where the water flow rate was consistently maintained at 0.6 GPM (superficial velocity at around 0.005m/s) while air flow rates were systematically adjusted to achieve velocities ranging from 18 m/s to 2 m/s, has yielded significant insights into the capability of DAS to capture dynamic intermittent slug structures. The DAS system demonstrated its capacity to effectively capture slug events. Figure 10 provides a visual representation of the raw DAS cable responses during slug and non-slug conditions, highlighting the system's sensitivity to slug detection. For improved visualization and analysis, standard-deviated processed data was employed, as exemplified in Figure 11. Processed DAS data exhibited a robust correlation with pressure sensor readings, with elevated values consistently corresponding to the presence of slugs at different time points (Figure 12).

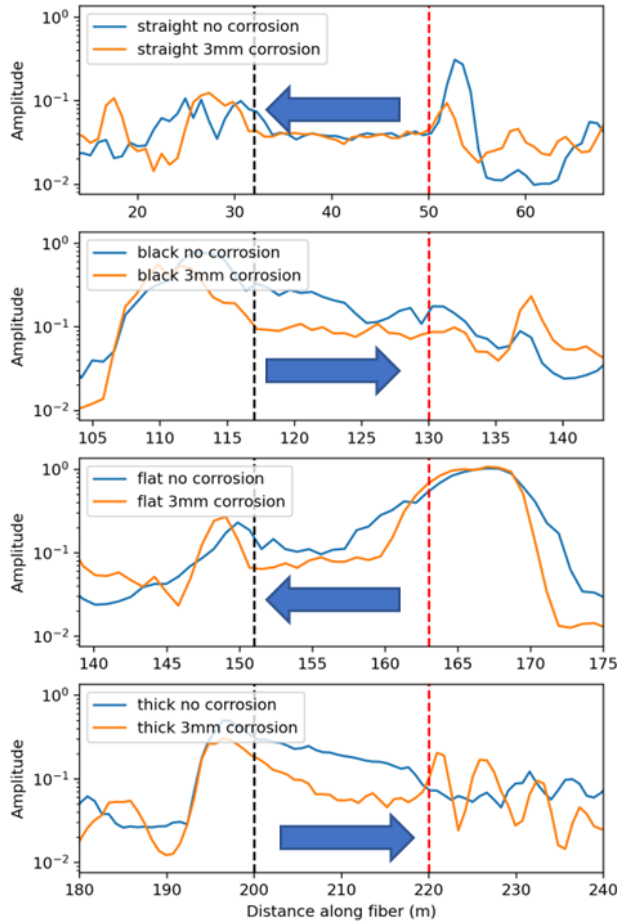
Figure 16. Vibration amplitude comparison at different fiber sections (straight, black, flat, and thick) between the corroded pipe and the baseline. These measurements were taken with a gas flow velocity of 6 m/s, and the data were filtered between 100 Hz and 1000 Hz. The arrow shows the flow direction compared to the fiber distance. Black and red dash lines mark the beginning and end of each section.

For a more quantitative comparison, we calculated the average vibration amplitude over an eight-minute period within the frequency range of 100 Hz to 1000 Hz. This amplitude, plotted against fiber distance, is depicted in Figure 16. The measurements were taken at a velocity of 6 m/s, and similar results were obtained at other velocities.

Our results demonstrate that, even after a complete reinstallation of the flow loop to replace a 1-m section in the middle, the DAS measurements within each section are remarkably consistent. This consistency testifies to the repeatability of our experimental setup.

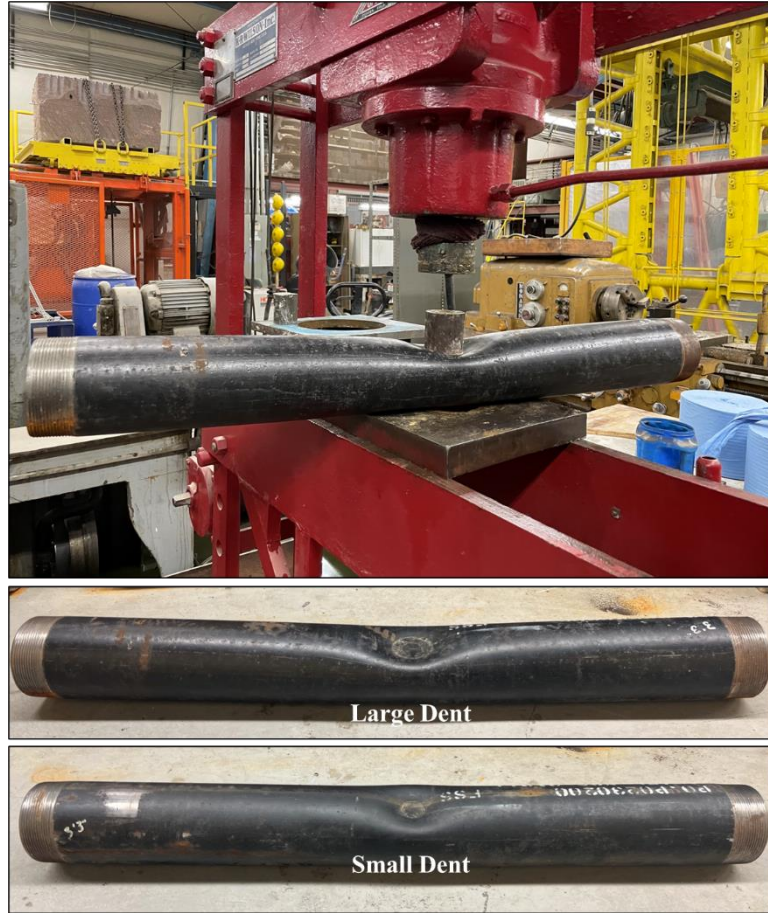
Figure 18. Photograph of the facility that created the dents and the 1-m test sections with two dent sizes.

During the past year, we worked with EMI (the Excavation Engineering and Earth Mechanics Institute) at the Colorado School of Mines on the fabrication of dents in the 1-m test section. We have successfully prepared two deformed pipes with different dent sizes. The pipe that exhibits a substantial deformation represents a significant structural compromise, while the other that showcases a smaller dent simulates a less severe scenario, as depicted in Figure 18. Our intention is to test these two differently deformed pipes in the flow loop during the upcoming reporting period.

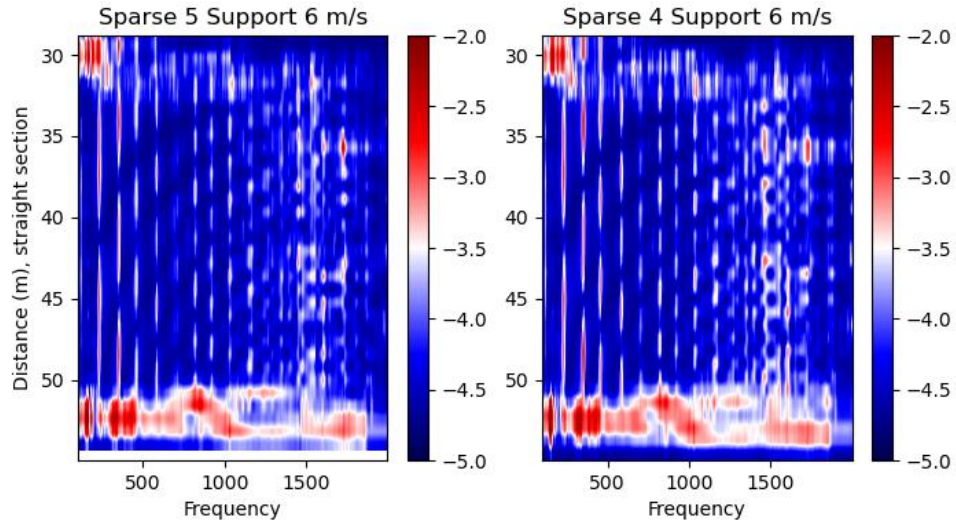
Figure 19. Frequency Spectrum of the straight fiber section with gas flow rate at 6 m/s. Vertical axis is the distance along the fiber/pipe, horizontal axis is frequency. Warmer color indicates higher amplitude at a certain frequency/location. The color is in log scale.

To extract these resonant frequencies, we carried out spectrum analysis using the Fourier transform. The collected DAS data were divided into 10-second sections, with a Fourier transform performed on each channel. We then averaged the spectra over eight-minute intervals during each experiment. The resulting amplitude spectrum for the sparsely supported condition, when plotted against the fiber distance, can be seen in Figure 19.

As shown in Figure 19, the steel pipe vibrates at discrete resonant frequencies with an interval of approximately 120 Hz as the gas flows. These are illustrated by the vertical line-like patterns in the colormap plots. Each resonant frequency, characterized by alternating sections of higher and lower amplitude along the pipe, can be effectively explained by the theory of standing waves. For a standalone pipeline, the frequency and amplitude of each resonant mode, especially the higher frequency ones, are closely associated with the boundary condition of the pipe. In this experiment, we altered the boundary condition by removing one of the weight-bearing supports of the steel pipe, which in turn changed the resonant vibration patterns. A comparison of the left and right subplots in Figure 19 reveals that the vibration pattern is fairly consistent between the two cases. However, a detailed analysis shows that the frequency and amplitude of several resonant modes have changed after reducing the number of supports from five to four. As shown in Figure 20, the resonant mode at around 700 Hz exhibits two adjacent frequency peaks. After the removal of the support, these two frequency peaks merged into one. We also observed a slight frequency shift in several vibration modes. For instance, the peak at 583 Hz shifted to 585 Hz following the removal of the support. Similar results can be seen in the densely supported experiments.

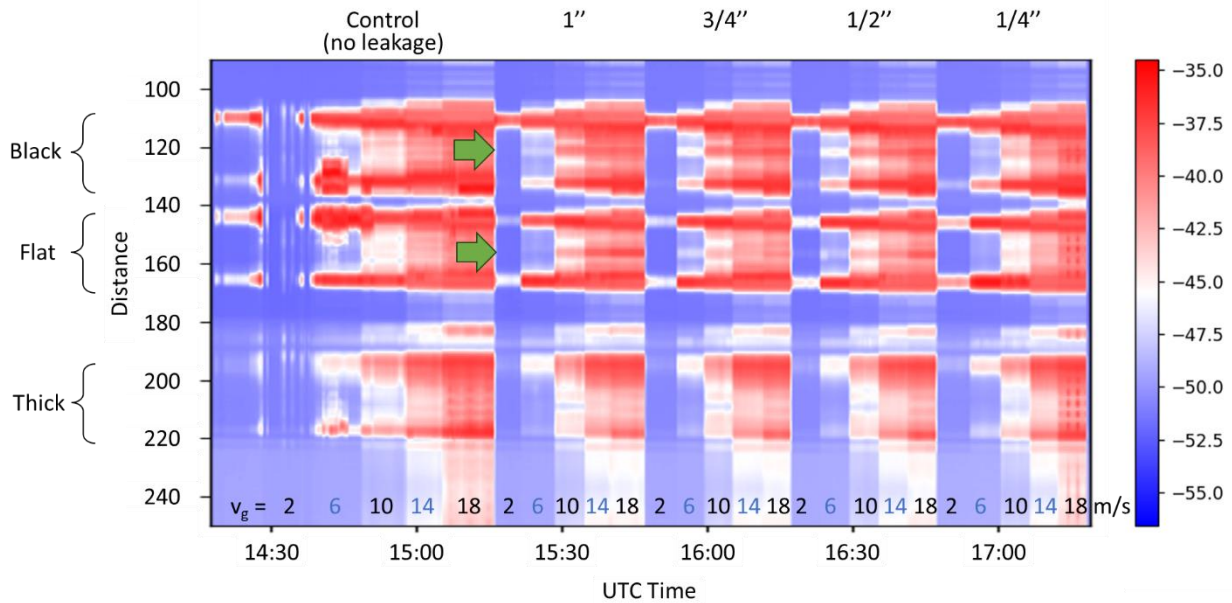
Figure 21: Magnitude of standard deviation values along the fiber during the experiment on August 17th, 2023. For each hole size, the flow rate changes from 2, 6, 10, 14 and 18 m/s. The gas velocities are indicated at the bottom of the image.

The figure displays the vibration intensity for three distinct types of cables during the experiment conducted on the same day. The study commenced with a control experiment featuring no leakage, followed by the sequential introduction of 1", 3/4", 1/2", and 1/4" leakage

Notably, more intense vibrations are visible near the pipe's center, where the leakage was introduced, for both black and flat cables. The vibration anomaly appears to diminish with decreasing hole size and is entirely absent in the control tests.
