# Develop and Deploy a Multi-Sensor Platform for Right of Way Defense

Agreement #693JK31910007POTA

Debriefing Webinar - December 2023

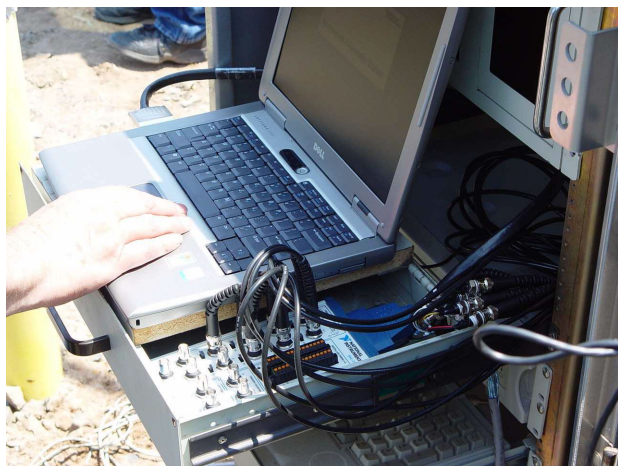
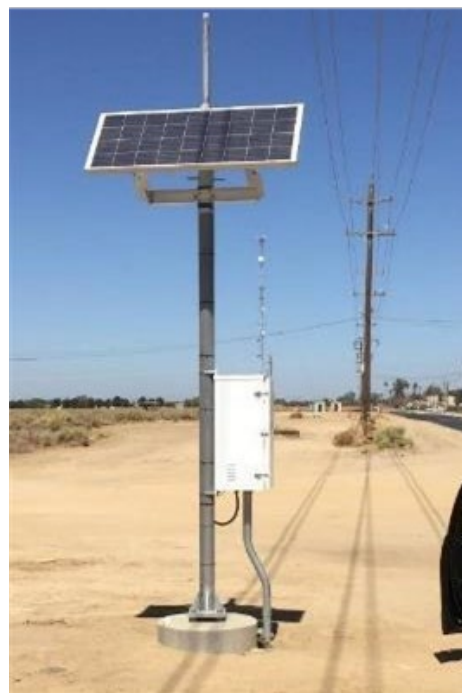
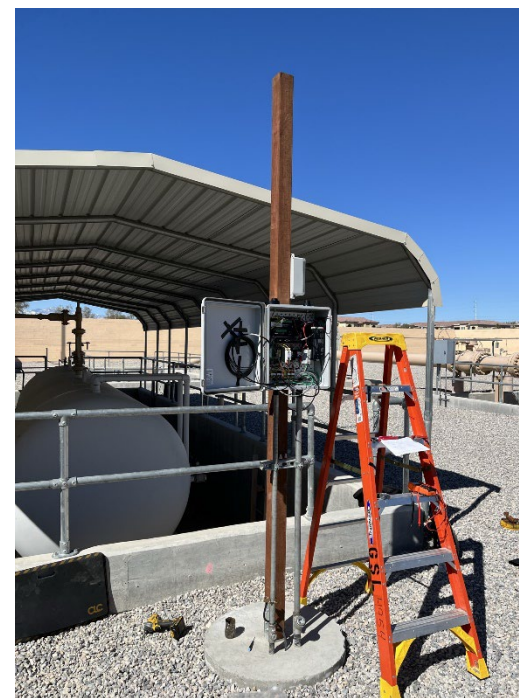
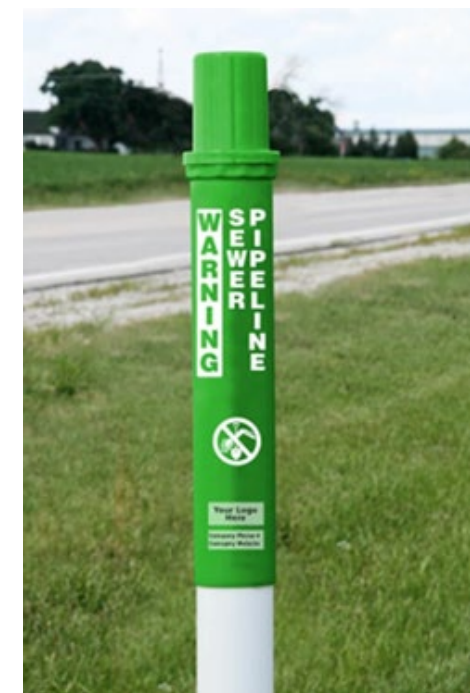
- The technical progress has been driven by improvements in:
  - Sensing
  - Low-power electronics
  - Miniaturization
  - Wireless communication

- Develop and Demonstrate a Remote Multi-Sensor Platform for ROW Defense
  - 2021 through 2023
- Pipeline ROW Monitoring and Notification System
  - 2015 through 2019; Co-funded by California Energy Commission, PHMSA, and OTD
- Detection of Unauthorized Equipment in the Pipeline ROW
  - 2003 through 2005; GTI early assessment of fiber optics; OTD funding
- Real-Time Acoustic Monitoring of Contact to Pipelines – Phase 4
  - 2003 through 2006; Battelle point acoustic sensors; GRI funding

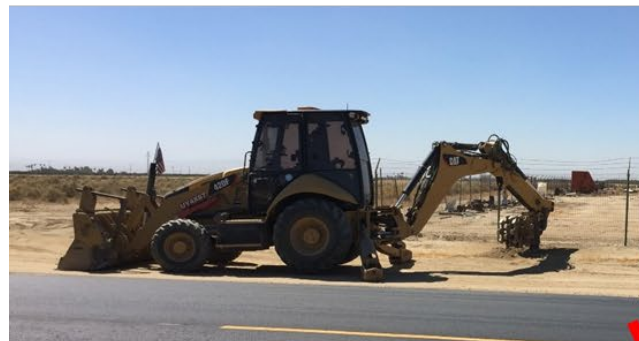
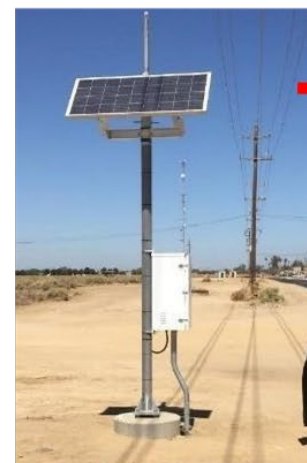
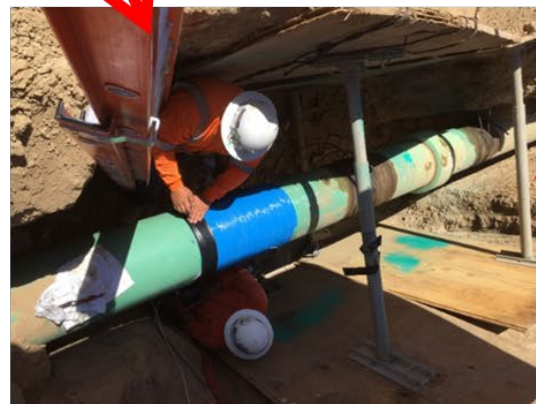
A sensor-based system that monitors for ROW activity

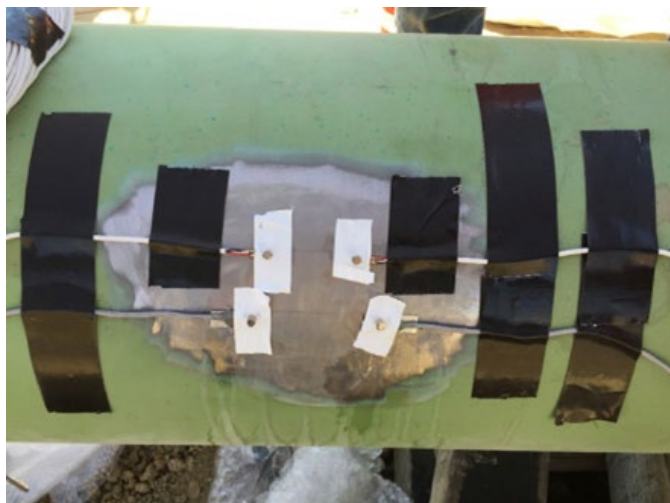
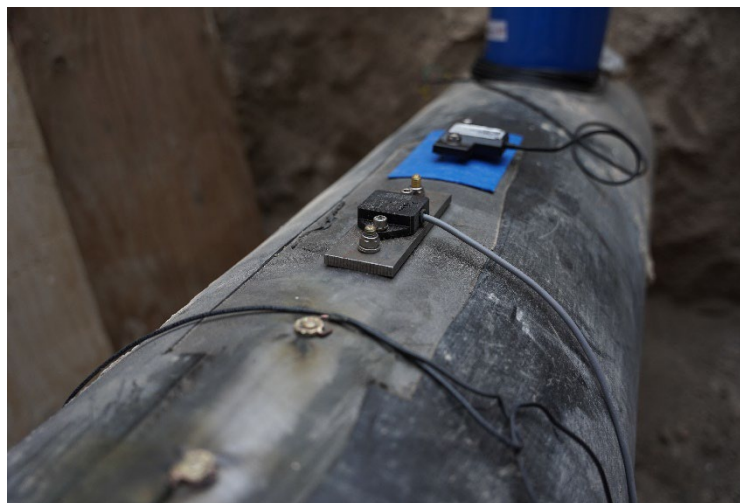
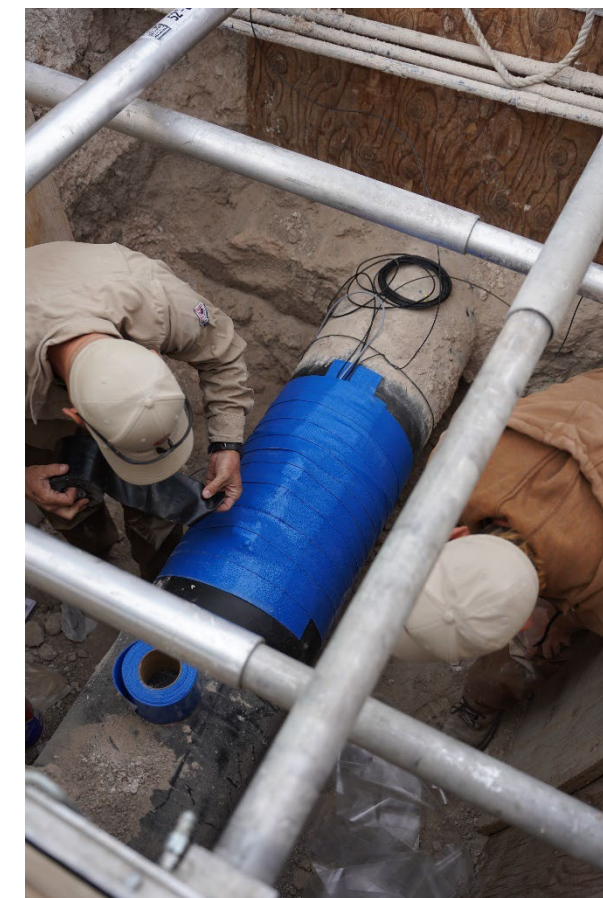
- An improved method for pipe sensor attachment, pin brazing, was successfully tested.
- Operators generally allow pin-brazing on live pipelines.
- The original adhesive bonding method was impractical under most field conditions.

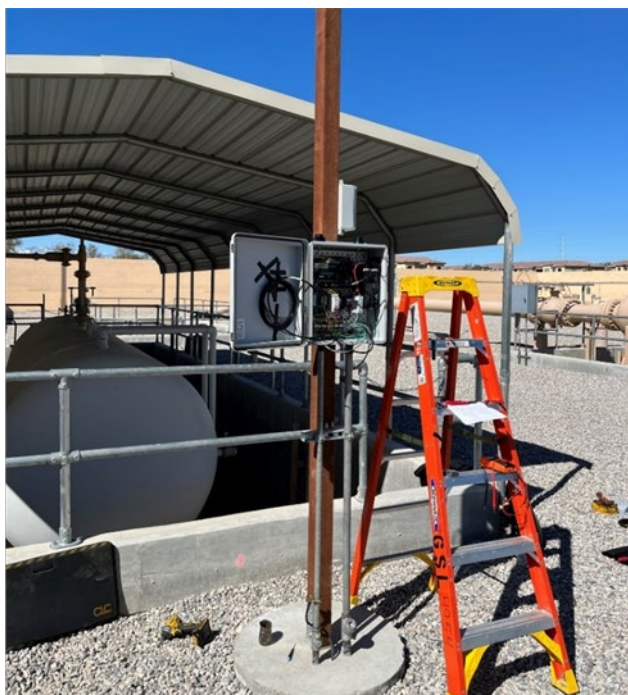
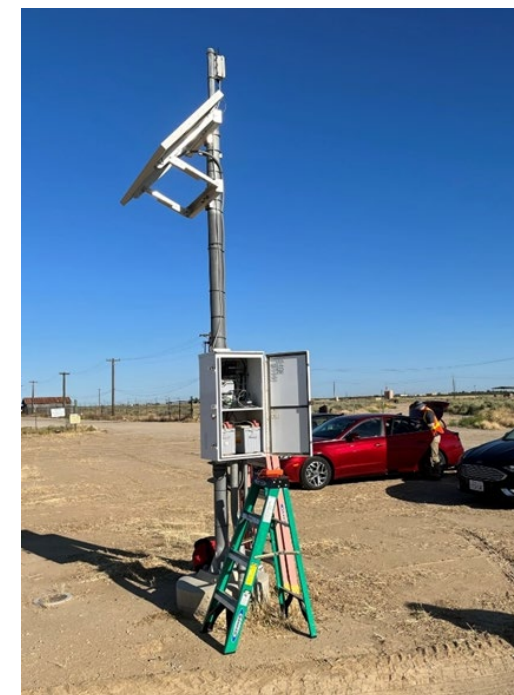
- For the original system, the vibration sensors and supporting instrumentation were provided by a third party that was separately contracted by CEC.
- This part of the instrumentation did not perform well during the earlier field test.
- This sub-system was redesigned for the current project and is operating reliably.

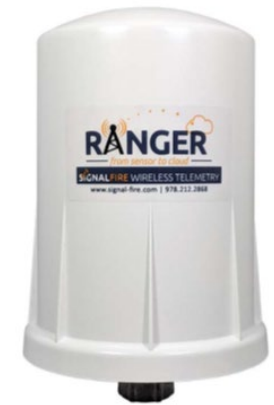
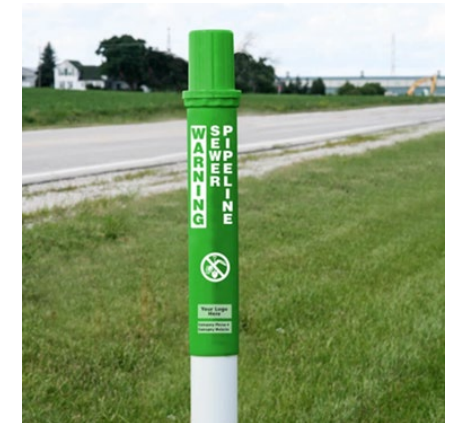
- The original RPMA radio system is not well supported.
  - For the near-term tests, cellular modems are being used.
  - LoRaWAN could be used on appropriate sites.
- Getting permits to install the equipment in the ROW is difficult.
  - Several promising sites were lost to permitting issues, driving schedule delays.
  - The newest test site is “inside the fence” and did not require permitting.
  - The older, upgraded site was already permitted and built.
- Future equipment must be made smaller and less expensive.
  - Fewer sensors per location may facilitate this.
