**NIST Interagency Report
NIST IR 8535**

Mechanical Metallurgy on Columbia Gas X100 Experimental Pipe

This study evaluates the material properties of an X100 pipeline steel extracted from an experimental transmission pipeline section placed into service in the 1960s. The purpose is to compare these properties with current X100 steel standards. Comprehensive chemical characterization, microstructure analysis, and a series of mechanical tests—including tensile, Charpy impact, and indentation tests—were conducted to assess the long-term stability and reliability of these early high-strength steels. The analysis involved seven different welded sections of the pipeline to account for potential variations within the material and welding procedures.

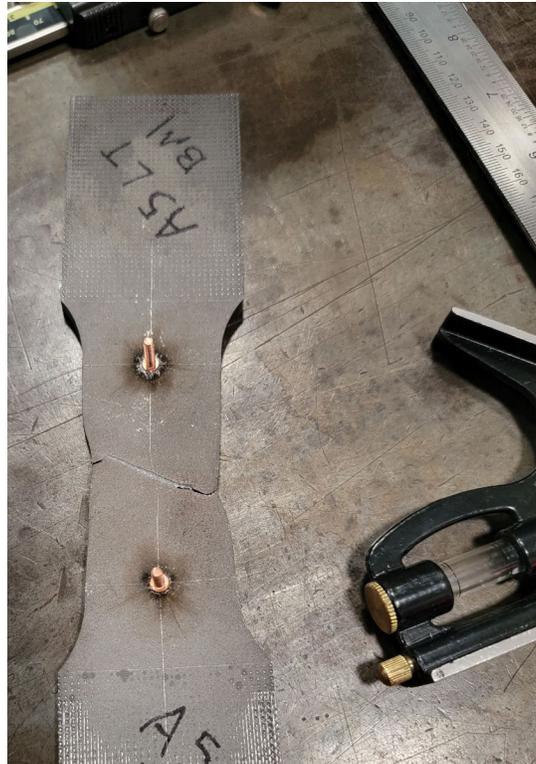
Figure 9 - Post-test photo of a tensile specimen.

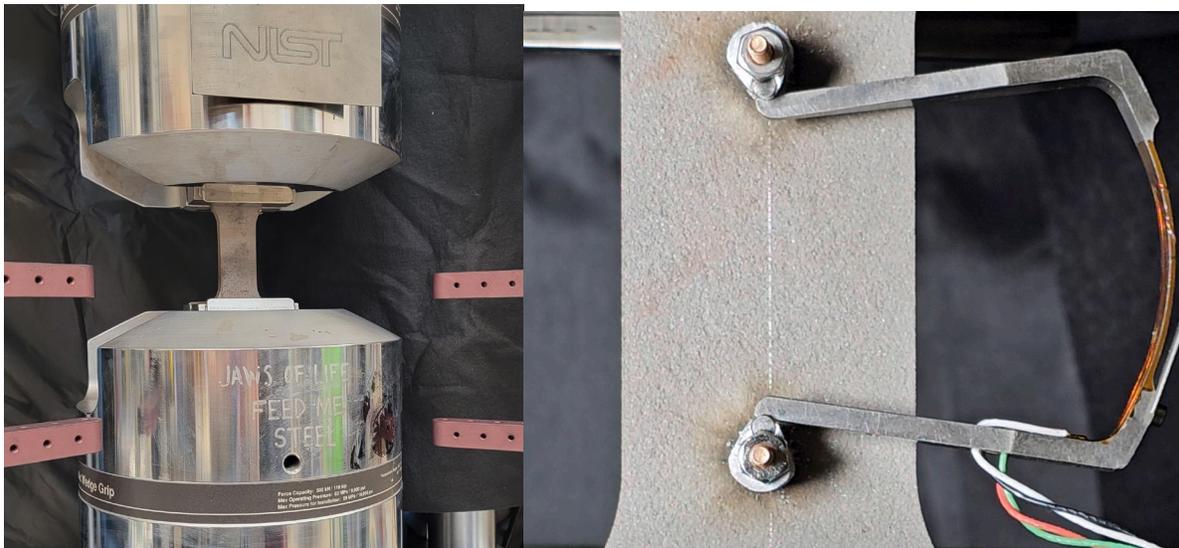
Figure 10 - Full wall thickness tensile specimens were tested in a servo-hydraulic universal test frame and were gripped in hydraulic grips (left). A close-up view of the gage section of the specimen on the ID side shows how the extensometer is attached to the specimen prior to testing (right).

Each specimen was measured and scribed for the installation of a threaded stud. The threaded studs were welded to the ID surface of the specimens with a capacitive discharge stud welder. A cam-like fixture with a hardened steel pin was installed on each stud to interface with the extensometer. A post-test photo of a specimen is shown in Figure 9, illustrating the alignment scribe lines and showing the welded studs. A specimen loaded into the hydraulic grips is shown in Figure 10 , along with a photo of the extensometer installed on the specimen.
