FINAL PROJECT SUMMARY REPORT
PROJECT IDENTIFICATION INFORMATION

**High Resolution Electromagnetic Imaging
and Decision Support for Pipeline Life Management**

Department of Transportation
Phase I SBIR Contract Number DTRT57-07-C-10005

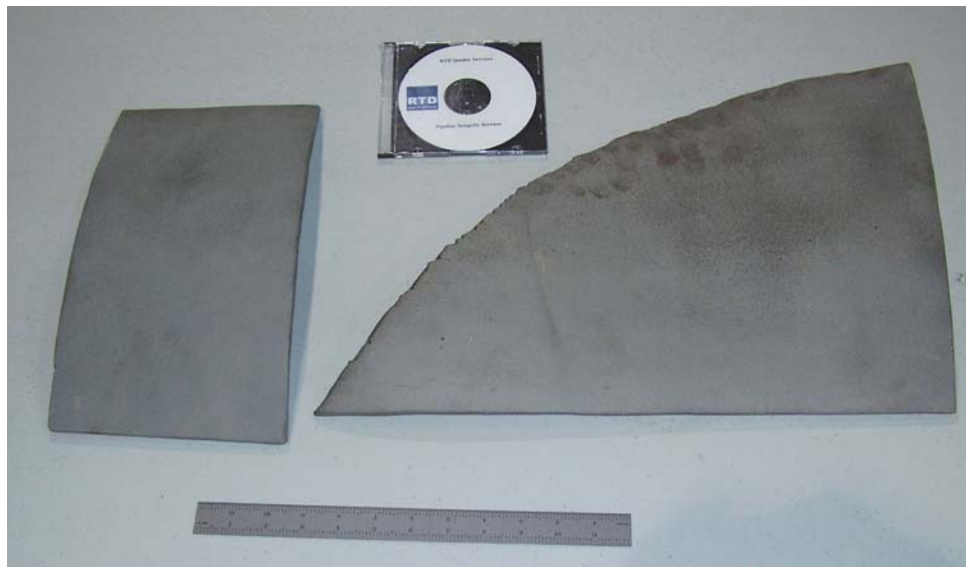
1. Plate, RTD #10407, is generally triangular in shape with a slight double curvature, and is approximately 18 x 13 in. (see Figure 1)
2. Plate, RTD #10413, is 7 x 12 in. with a single gradual curvature (see Figure 1).

These two plates are 0.33 in. thick steel, and contain numerous SCC clusters.

Figure 1. Photograph of two pipeline sections with SCC received from RTD Quality Services, Inc.

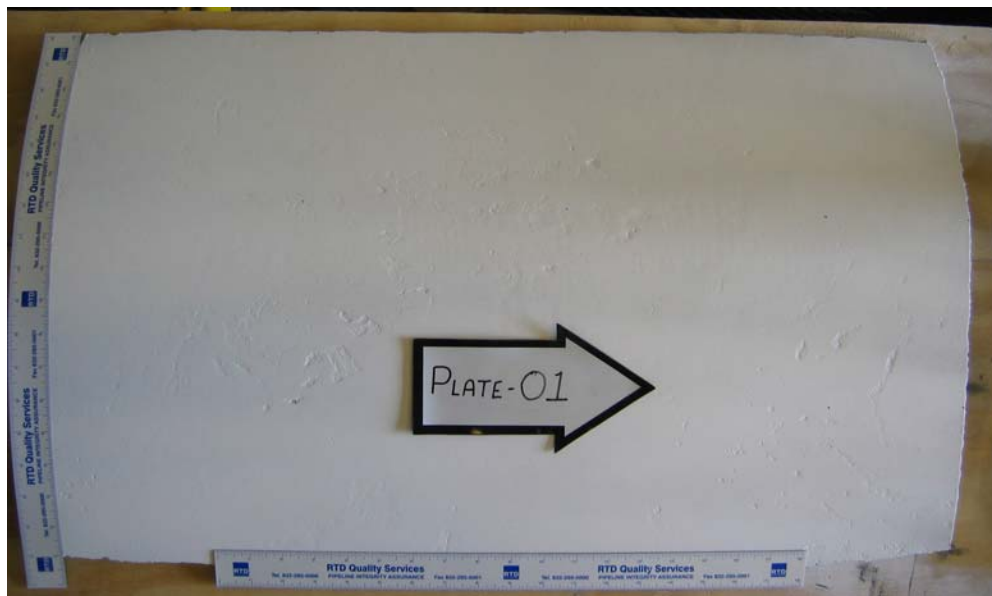
Figure 2. Photograph of "Plate-01" from the transition study.

Samples from the ongoing, transition effort were also made available for this program. This study provided eight plates cut from various transmission pipelines, ranging in size from 8 x 18 in. to 20 x 30 in. Three of these plates are shown in Figure 2, Figure 3, and Figure 4.

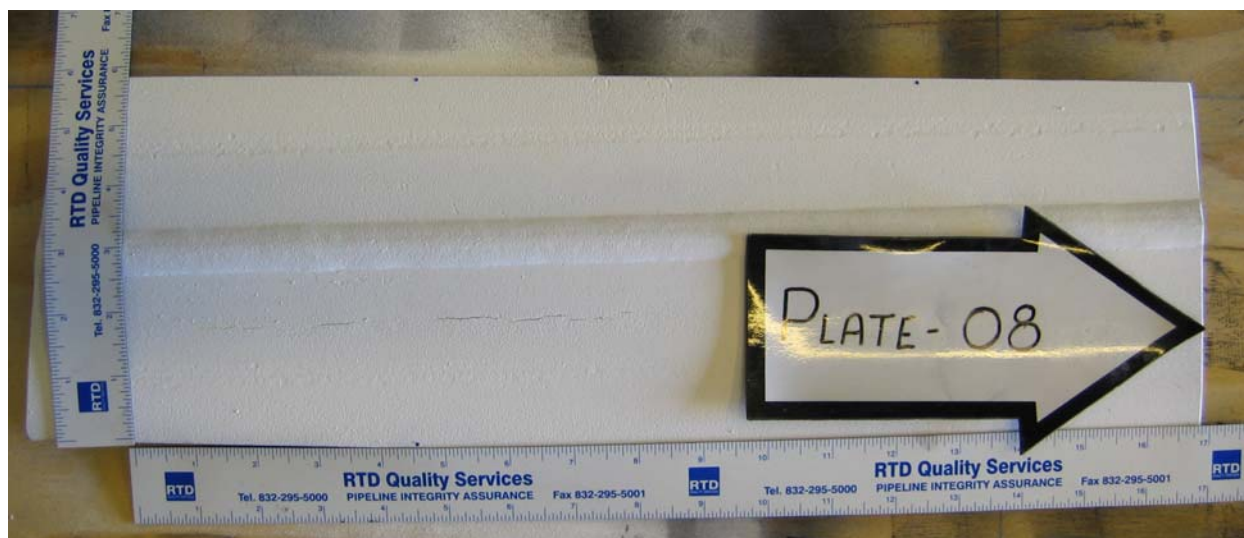
Figure 4. Photograph of “Plate-08” from the transition study.

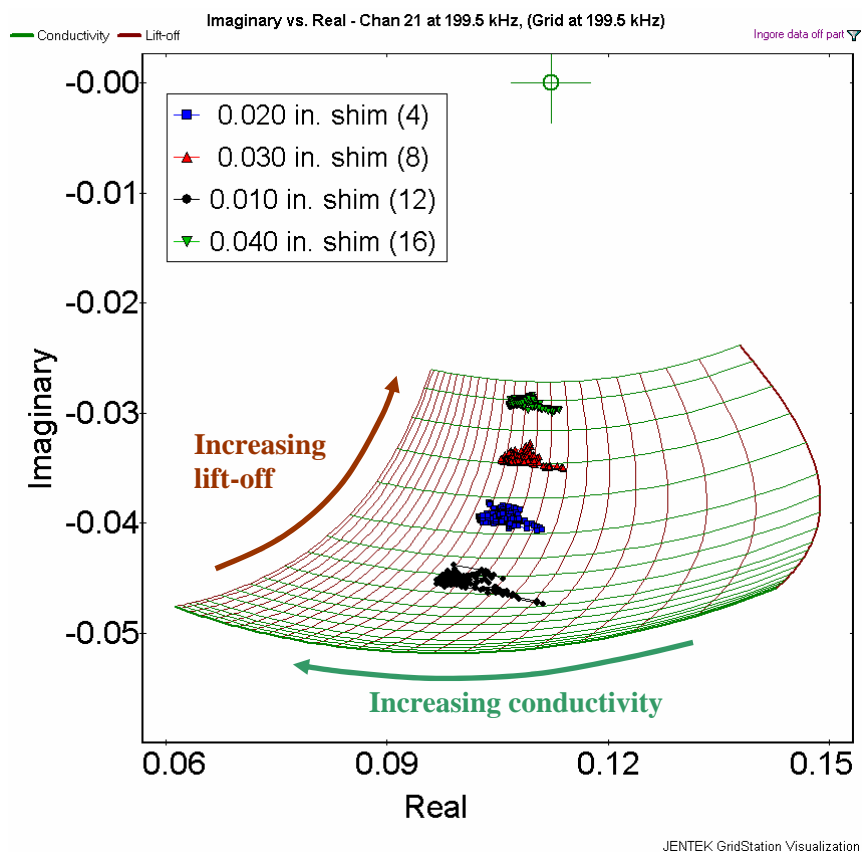
Figure 6. (Top) Illustration showing how information about the sensor and the material under test are used to construct a precomputed database, or Measurement Grid, which is used to convert the sensor response into property values such as conductivity (σ) and lift-off (h). (Bottom) A σ - h Measurement Grid used in scans of the steel specimens with SCC. Plotted are data from one of the FA24's thirty six sensing channels (channel 21) in scans performed with four different coating (shim) thicknesses. The data show how the GridStation independently measures the lift-off values while determining the material's conductivity without significant influence from varying lift-off.

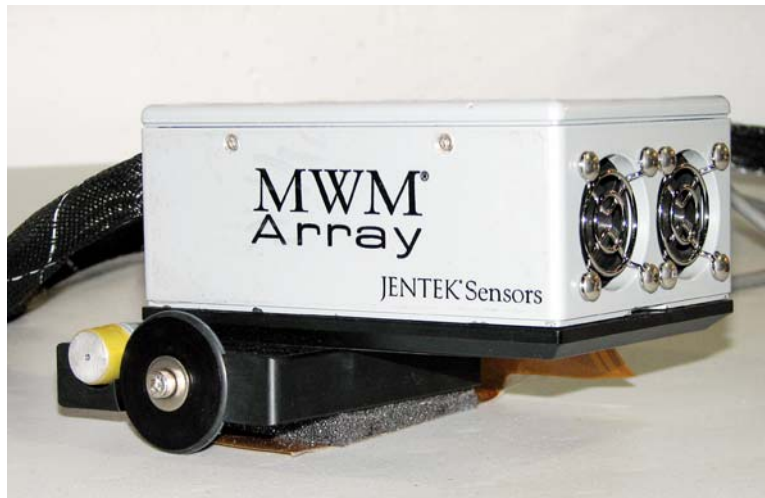
Figure 7. (Top) Photograph of the setup used to perform manual scans of the triangular plate. Shown are JENTEK's 39-Channel impedance instrument, host laptop computer, and the triangular RTD plate with a lined Mylar sheet laying on it to assist in registering the position of the multiple scans. (Bottom) Photograph of the probe electronics/scanning cart assembly showing the position encoder and foam-backed sensor, which conforms to the curvatures of the plate.

The setup used to perform the scans is shown in Figure 7. The manual scanning cart used to perform the measurements was equipped with an encoder to obtain positional information with the measurements. The sensor was backed with foam so that it would conform to the curvatures of the plate, and registration between the multiple scans was achieved by laying on top of the plate a 0.010 in. thick Mylar sheet that had lines drawn on it to mark the location of each scan. Conductivity images of the full sample plate were achieved by combining the data from multiple adjacent scans automatically using JENTEK's GridStation software.

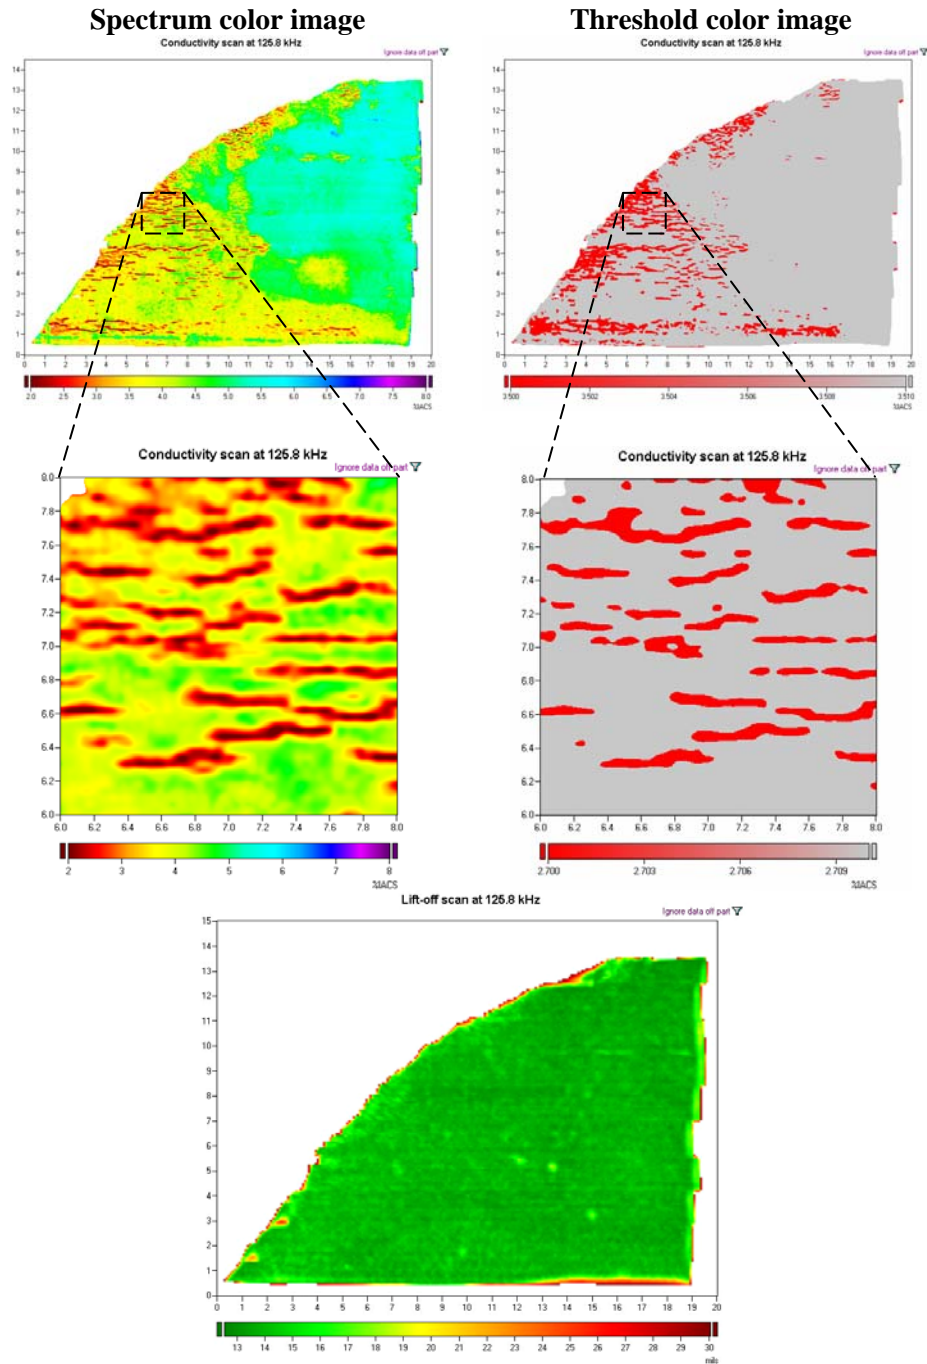
Figure 8. Conductivity and lift-off images of plate # 10407, which contains numerous stress corrosion cracks. The left pairing of images show the conductivity data in a spectrum color scheme, where variations in effective conductivity across the surface are presented in a continuous color scale. The right pairing of images show the same data using a threshold color scheme, in which red indicates where the effective conductivity is below a certain value. The bottom image shows the lift-off data, in which green indicates that the lift-off values are within a suitable range. X- and Y-axis units are inches.

Results of the high resolution FA28 scans of the triangular part are shown in Figure 8. Data are presented as effective conductivity maps of the material, and cracks appear as regions of low conductivity. The images reveal large regions where SCC has occurred, and discrete cracks can readily be identified. The measurement data are presented here in two color schemes. In the spectrum color scheme, conductivity values are presented in a continuous color scale, and in the grey-red threshold color scheme, the red regions are locations on the plate where the effective conductivity is lower than a specified value. The two color schemes can be used by the operator to obtain more information from the images than available in the two-color images.

Also shown in Figure 8 is a corresponding lift-off image, showing the distance between the sensor and the sample during these scans. The recording of lift-off provides not only surface topology information, as described later, but also ensures that the lift-off range is within an acceptable range to achieve the desired crack detection sensitivity and sizing accuracy. The green image confirms that these measurements were within the acceptable lift-off range. Note that as each scan is performed, an image of the scan appears instantly in JENTEK's GridStation software environment, providing immediate feedback to the operator. Furthermore the software can easily archive this digital data for historical records and convert crack detections into logs of crack lengths and locations, as described below.

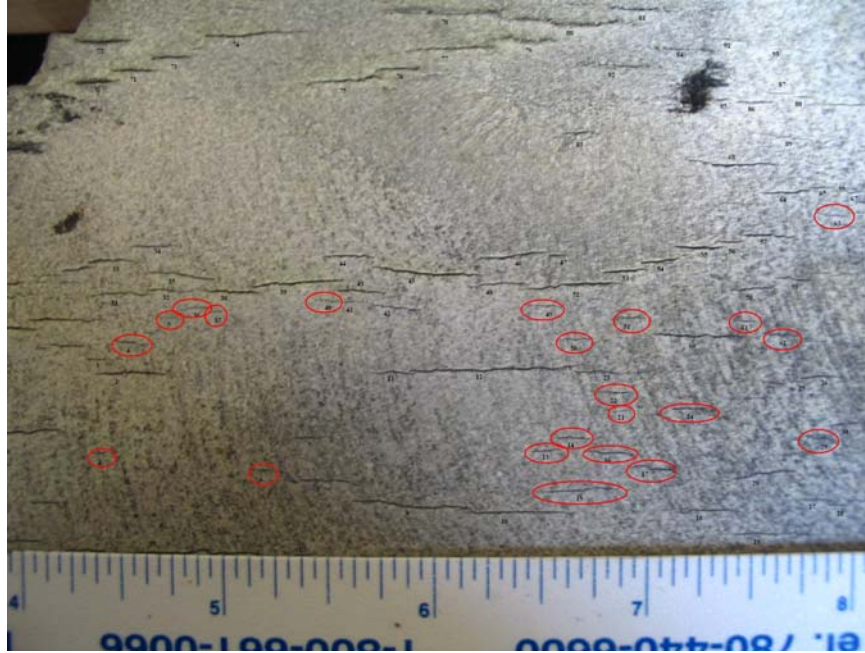
Figure 10. RTD's MPI results from the same area shown in Figure 9.

Figure 9 shows a larger view of the same conductivity scan image. A photograph of MPI results from the same area, provided by RTD, is shown in Figure 10. Shown in Figure 11 is the same area imaged using a thresholded color scheme where the threshold is set at a conductivity value of 2.7 %IACS. This threshold image does not show some of the smaller (circled) cracks shown in the MPI photograph of Figure 10. However, the smaller cracks are all visible in the spectrum image of Figure 9.

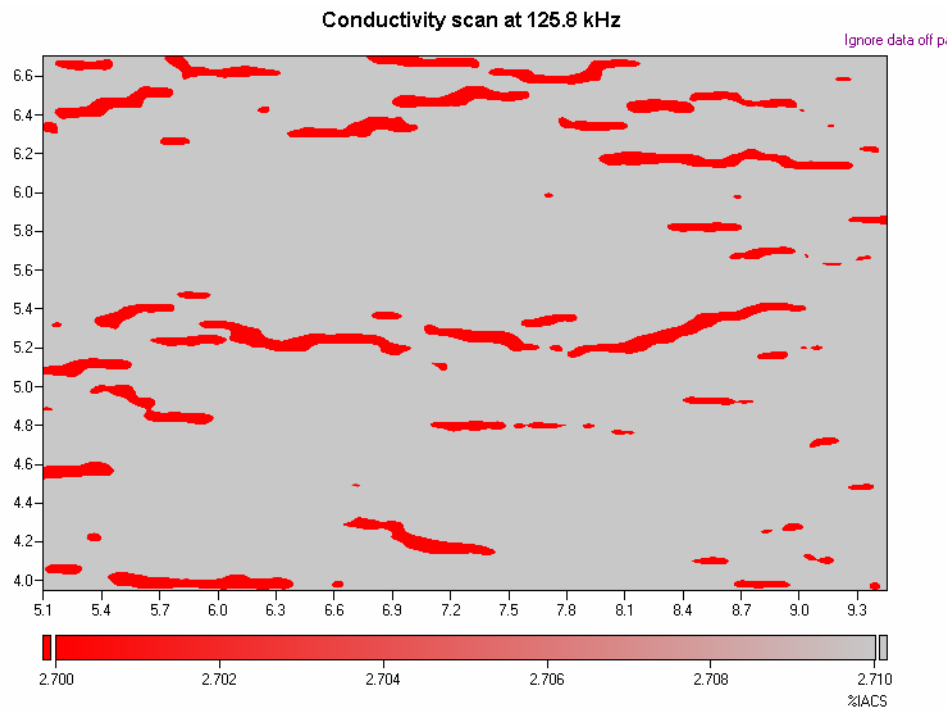
Figure 11. Thresholded FA28 scan image from the same area shown in Figure 9 and Figure 10, with the conductivity threshold set at 2.7 %IACS. The cracks in Figure 10 that are circled in red do not appear in this image, but do appear in the spectrum color image of Figure 9.

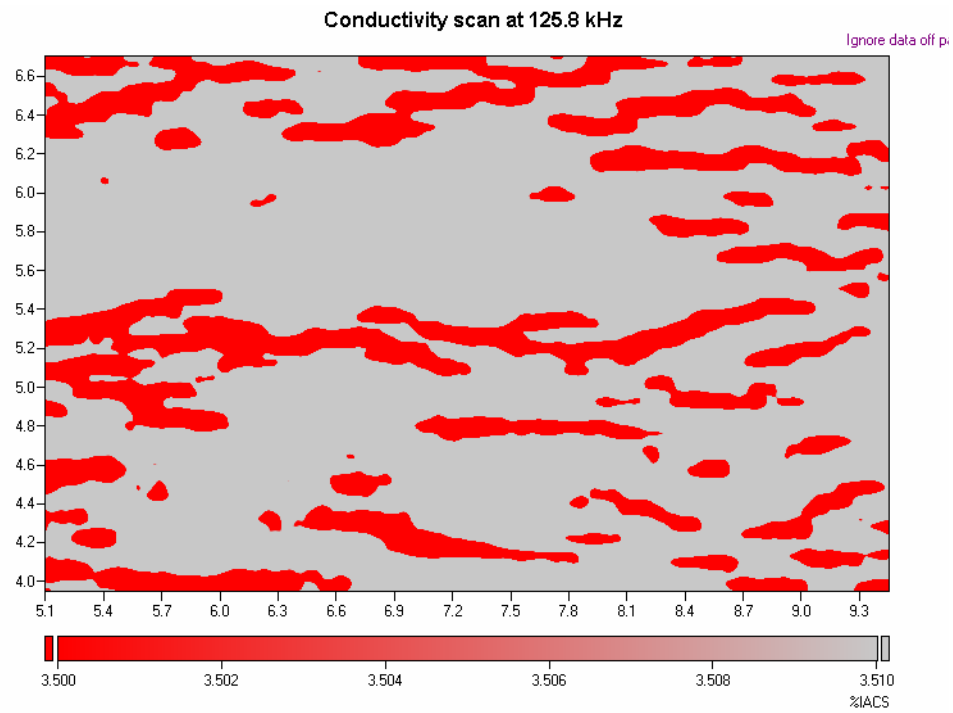
Figure 12. The same expanded view with the threshold set at 3.5 %IACS.

When the threshold is increased to 3.5 %IACS, the smaller cracks become visible as shown in Figure 12. It is important to note that the threshold value appropriate for SCC characterization in pipelines is currently being determined under the ongoing transition program by obtaining feedback from both RTD and the pipeline operators on their current MPI practice.

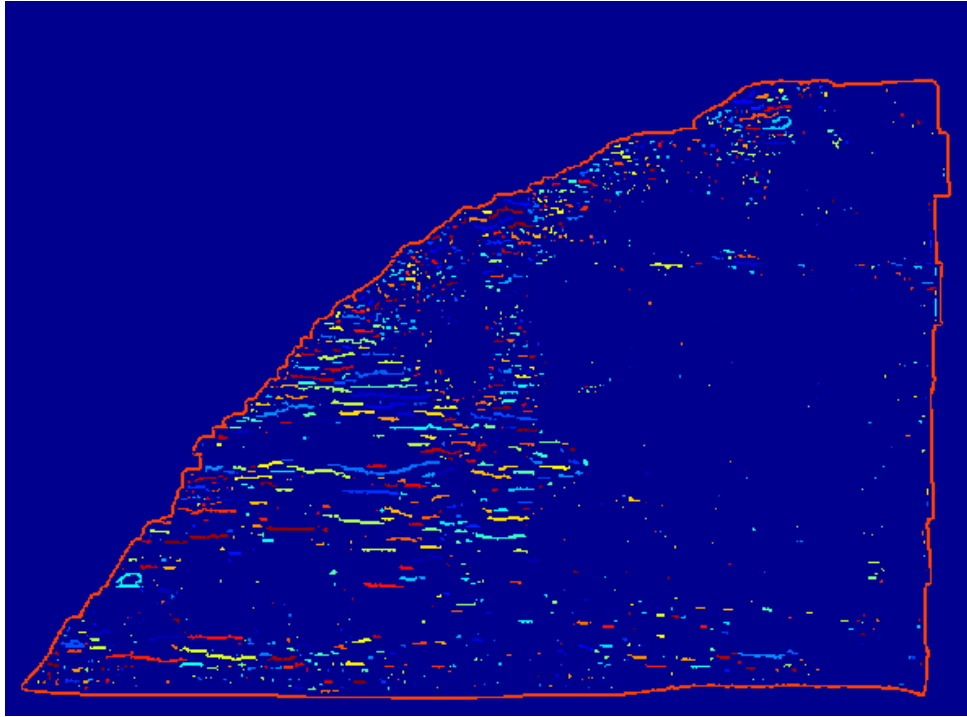
Figure 25. Connectivity algorithm using the threshold that was applied to the data shown in Figure 22. Each color corresponds to a crack that meets the algorithm's definition of a discrete crack.
