**VALIDATION AND ENHANCEMENT OF LONG RANGE GUIDED
WAVE ULTRASONIC TESTING**

**A KEY TECHNOLOGY FOR DIRECT ASSESSMENT OF BURIED
PIPELINES**

Public Version of Final Report

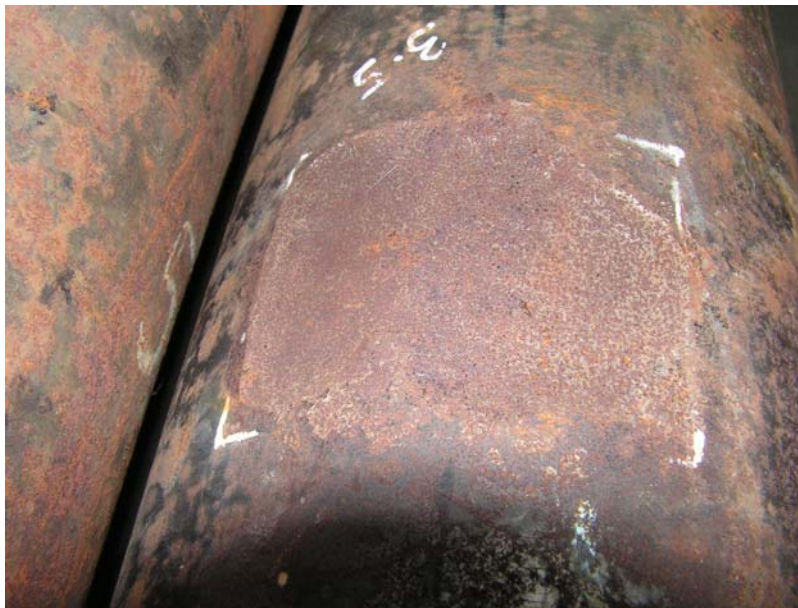
Figure C Corroded area on a 6" schedule 40 pipe used for procedure validation work

The aim of this work was to demonstrate the performance achieved by using the optimized procedures on controlled specimens. These were 6" schedule 40 (0.28" wall) un-coated pipes containing deliberately introduced corroded areas which had been physically measured previously. A total of (26) defects were available. This allowed the performance of the procedure to be assessed. The corroded areas were considered to be representative of real defects. An example is shown in Figure C.

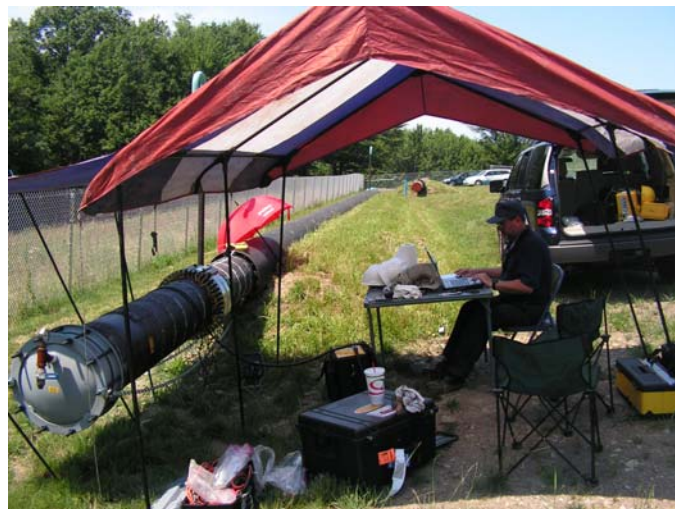
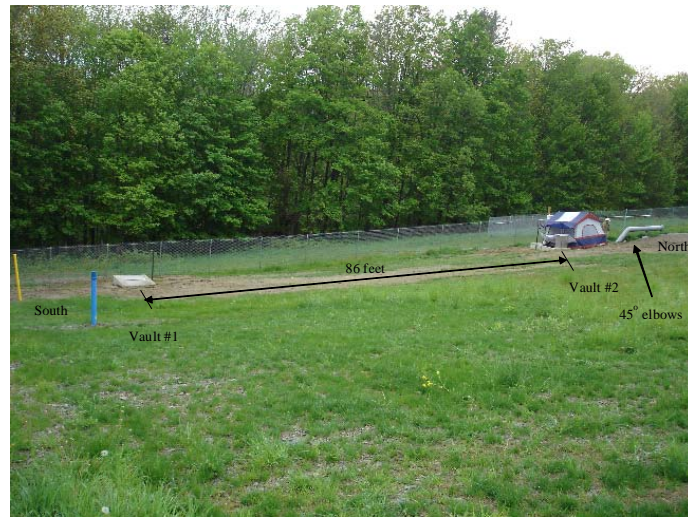
Overall layout of the 12" pipe

Teletest on 12" coated, cased, and buried pipe (Vault #1)

Figure D shows overall views of the Johnson City site. In each section, the length of the cased section was approximately 80 feet.

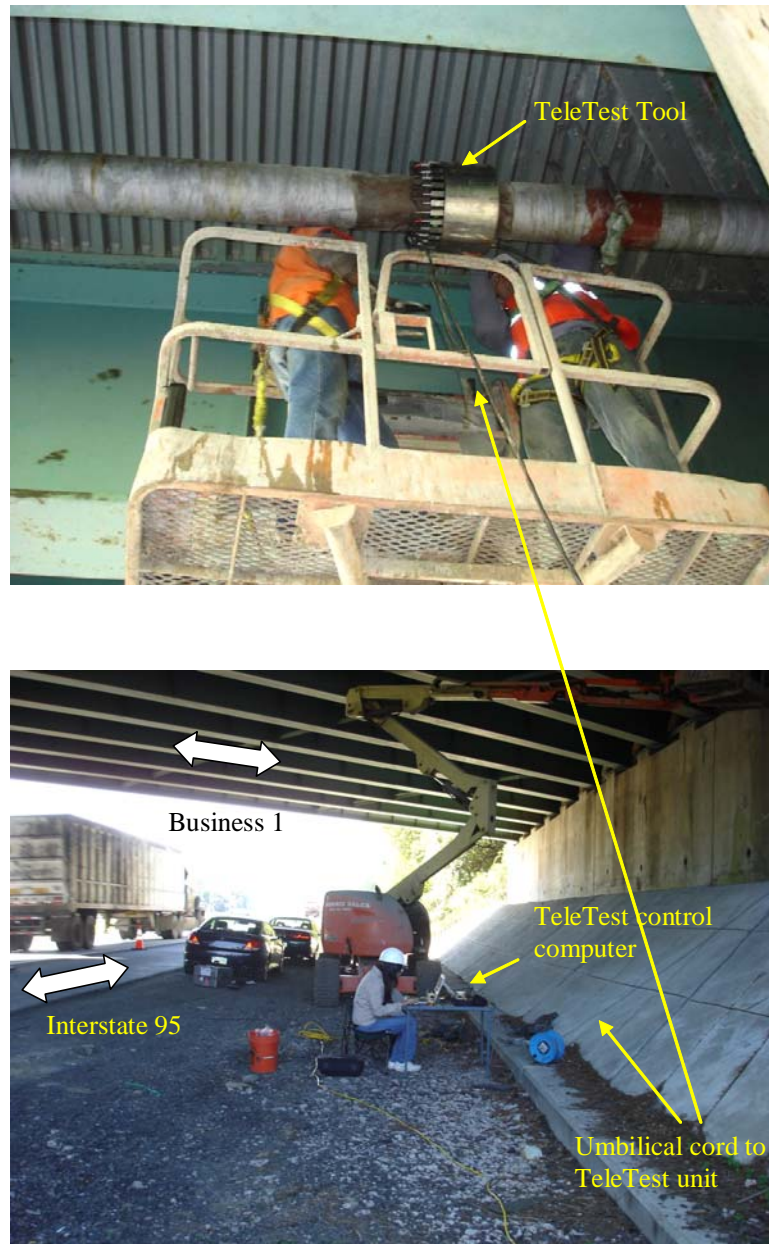
Figure G Test on 8" pipe on bridge over I95, for PECO Energy

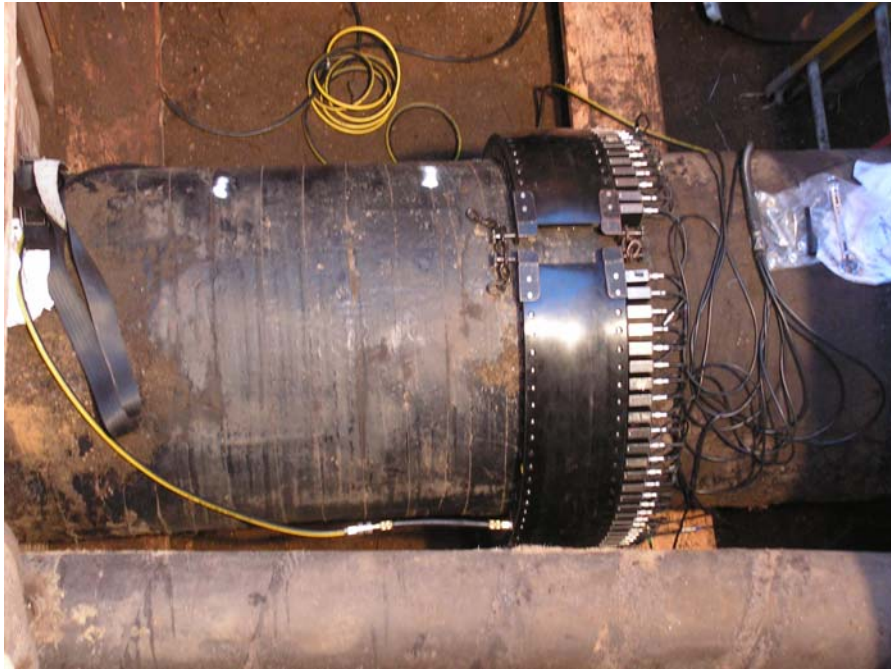
Figure I 30" tape coated gas line at Garden City NY. The 8" electrical cable conduit in the foreground was also examined

The test on the 8" electrical cable conduit at Keyspan Energy, Garden City NY identified a defect just inside the casing. This casing was cut back and a defect revealed at the location specified. The test on the 30" high pressure gas pipe proved that the predicted defect area was correct axially to within 1" and the angular orientation (circumferential prediction) was off by 180°.

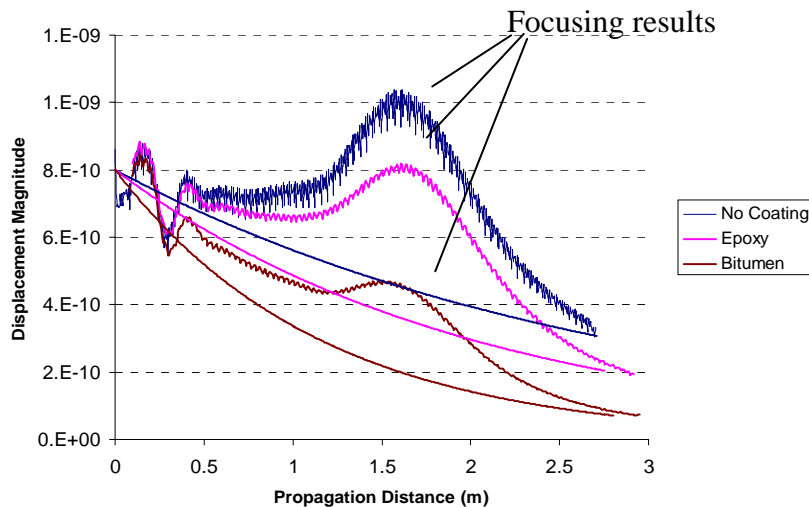
Figure K Angular profile for the 100 kHz L(0, 2) wave with axisymmetric and phased array loading, for no coating, 3 mm epoxy and 3 mm bitumen. Note that focusing increase the magnitude significantly at the focal point.

There is considerable laboratory evidence that focusing the ultrasound can offset some of the attenuating effects of the coatings. Figure K shows the effect of focusing the ultrasound on the decrease in signal amplitude with distance and how a local focus can increase the amplitude.

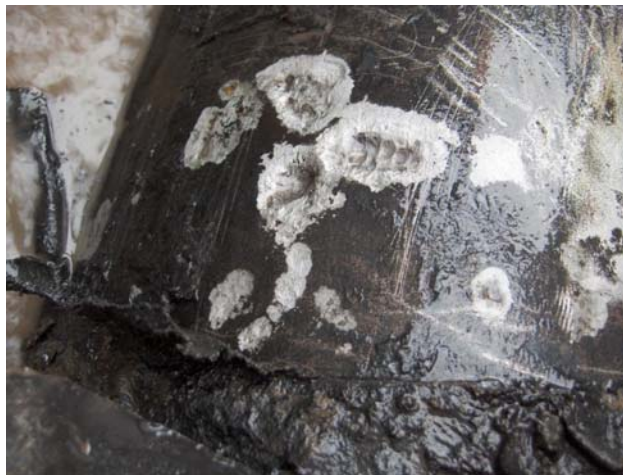
Figure O Defect detected by Teletest examination at Enbridge, Ottawa

Initial prove-up by excavation of the 12" line tested at Enbridge Gas, Ottawa did not reveal any indications at the reported location. However, a discrepancy was found in the positioning of the datum points for distance measurement. Once this was corrected, the reported defect was found (Figure O).
