# Pending PRCI Project

## Pipeline NDT from Inside and Out, with MWM-Array Technology

10 February 2010

**JENTEK Sensors, Inc.**  
110-1 Clematis Avenue  
Waltham, MA 02453-7013; USA  
Phone: 781-642-9666  
Email: jentek@shore.net

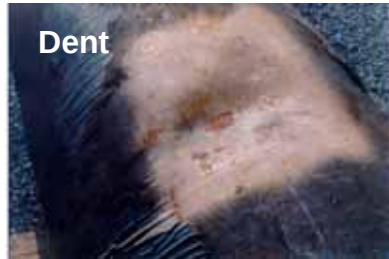
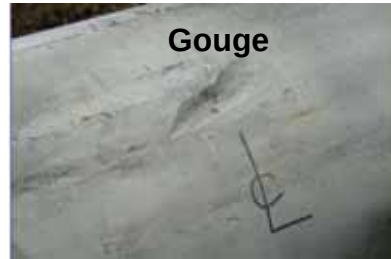
## Mechanical Damage Conditions

JENTEK Dented Steel Plate

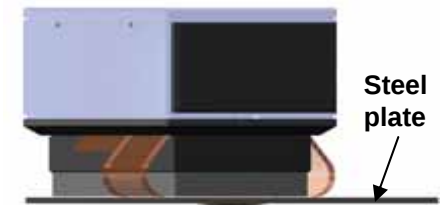
Illustration, Side View  
MWM-Array Probe and  
MWM-Array Sensor

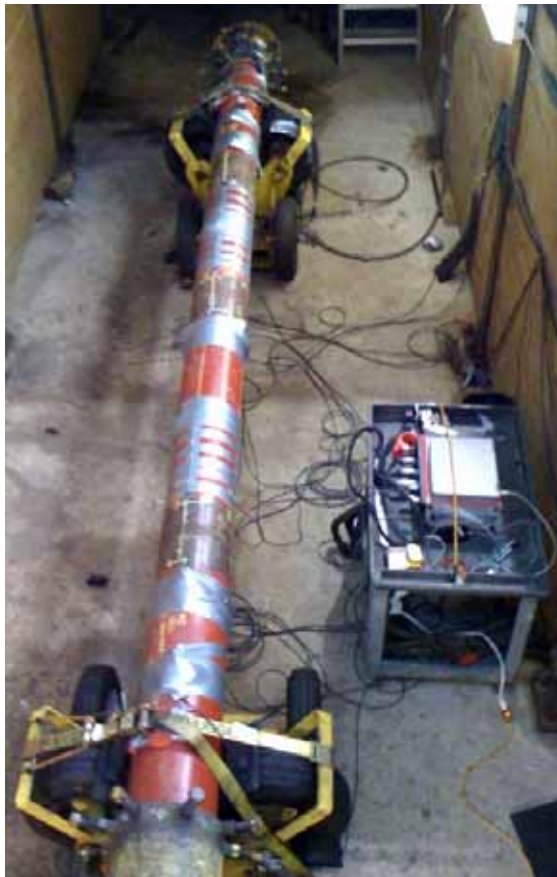
EDM notch C2  
on Weld 11 of  
String 3

# Weld Fatigue Imaging (MWM-Array FA24) (PRCI/Chevron Funded Task)
