Prepared for: U.S. DOT/PHMSA

**LONG-TERM MONITORING OF CASED PIPELINES USING  
LONGRANGE  
GUIDED-WAVE TECHNIQUE**

**Final Report**

**NYSEARCH/Northeast Gas Association**

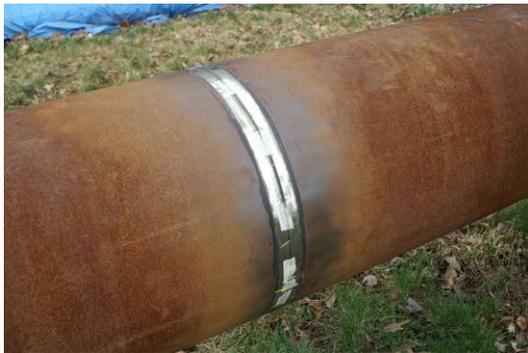
Figure 1. Alloy strips bonded to pipe with epoxy

The MsS is composed of a thin strip of magnetostrictive material bonded around the pipe circumference with epoxy adhesive (Figure 1). The strip material used is a heat treated iron-cobalt alloy approximately 0.006 inch thick and 1 inch wide. Once the adhesive has cured the strip is manually magnetized (Figure 2) and a coil is wound around it (Figure 3). After electrical connections are installed, the assembly may be coated with a wax or similar coating prior to burial (Figure 4).

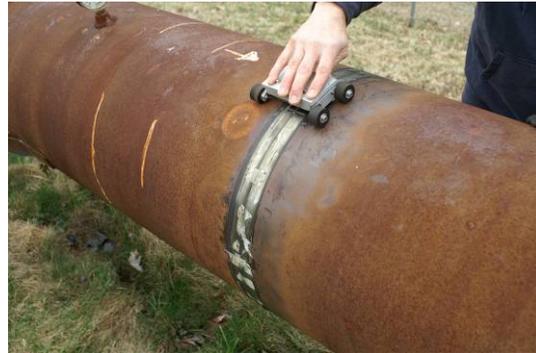
Figure 2. Manual magnetization of the alloy strips

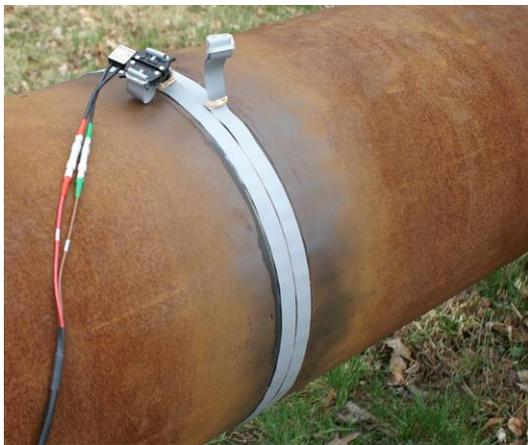
Figure 3. Coil installed around strips

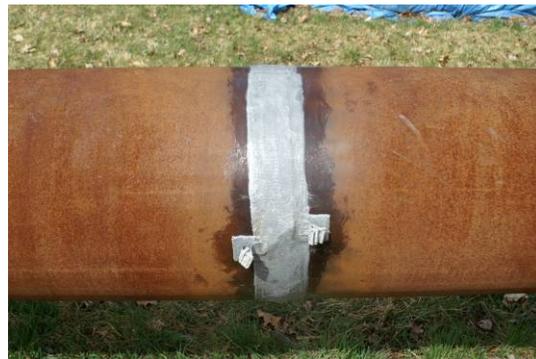
Figure 4. Wax coating applied over MsS assembly

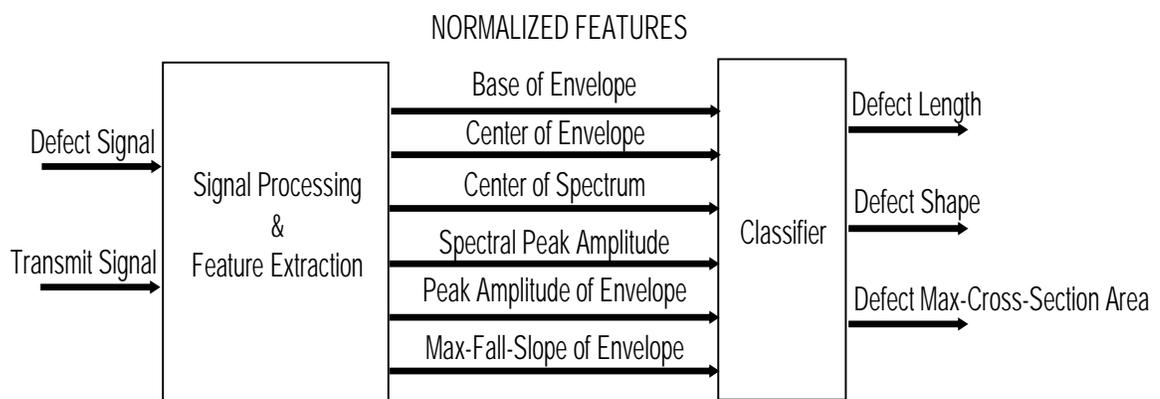
Using the six feature parameters, classification algorithms (i.e., classifiers) were developed to estimate defect length, shape, and CSA. Figure 1 illustrates the flow diagram of the defect classification algorithm. The defect signals containing noise were de-noised by a wavelet-based filter. Then from the defect signal, the six feature parameters were extracted and normalized (to the corresponding features extracted from the transmit signal to minimize the effect of probe variations). The normalized values of the six feature parameters are then input to the classifier, which outputs the classification of defect length, shape, and max-cross-section area. The classification of max-cross-section area requires the determination of the defect length and shape.

**Figure 1. Flow diagram of the defect classification algorithm**

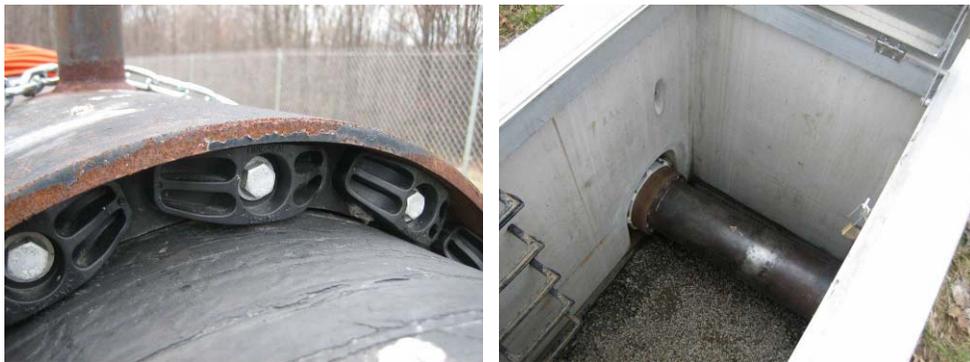
Figure 1. Link seal at the edge of casing (left) and vaulted access to the buried test pipe (right)

All test pipes are seam-welded and have a 0.375 inch in wall thickness. All test pipes contain machined defects circumferentially and axially along the pipe. The 16 inch pipe also contains simulated natural corrosion defects having smooth contours. Casing spacers are placed along the pipe and the edge of the casing is sealed with a link seals shown in Figure 1. The underground test pipe is accessible for guided-wave testing from the two vaulted excavations shown in the Figure 1.

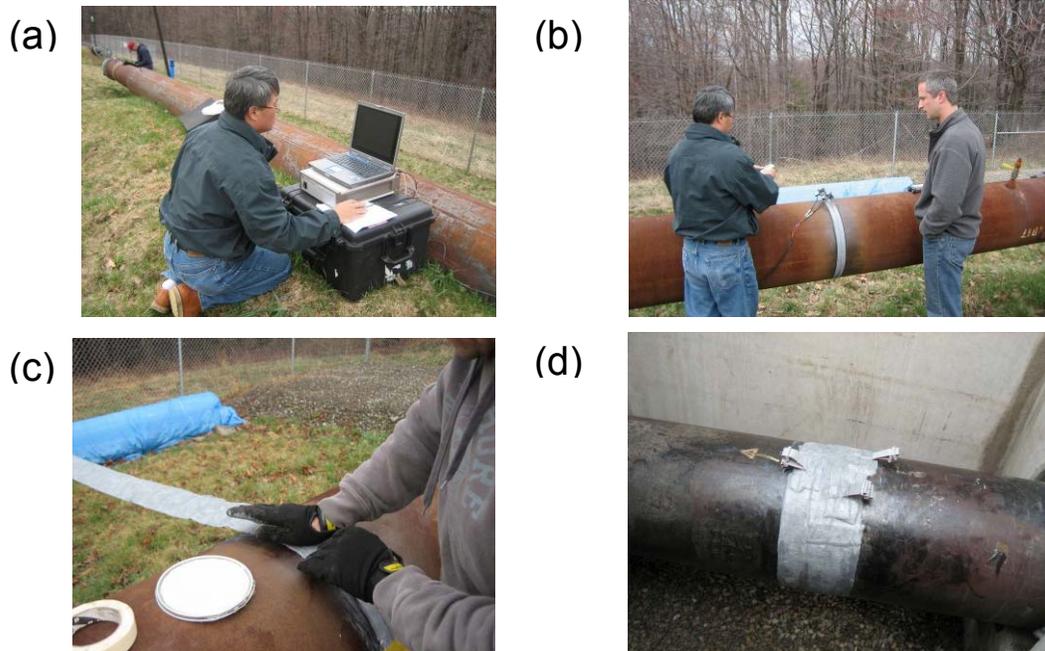
MsS installation and baseline testing of the three cased test pipes was conducted during the week of April 23<sup>rd</sup>, 2007. MsS coils were semi permanently installed for long-term condition monitoring (SHM). Photos taken during the testing are shown in Figure 2.

**Figure 2. MsS testing at the NYSEARCH/NGA test bed facility: (a) MsS system during data acquisition from the 20-inch-OD bare steel pipeline, (b) MsS ribbon coils placed over the magnetostrictive strips for testing, (c) wax tape applied over the MsS ribbon coils for protection from environment for long-term monitoring, and (d) MsS ribbon coils installed with protective wax tape on the 12-inch-OD CTE steel pipeline.**

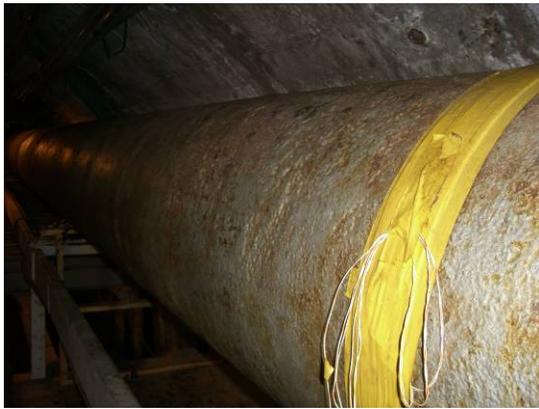
MsS installed on 26" gas pipeline in the Astoria Tunnel

Testing was conducted with ConEd during the week of May 28<sup>th</sup>, 2007 at the Astoria Tunnel in Queens, NY. The tunnel is beneath the East River and spans a distance of approximately 1 mile. The gas pipeline is a 26 inch steel pipe coated with wax tape wrap. The MsS probes were installed at two short sections where the wax tape wrap was removed. Generalized corrosion around the pipe circumference was evident at the two areas where the probes were installed. The surface of the pipe had extensive pitting. The length of the test section between the probes was approximately 74 feet.

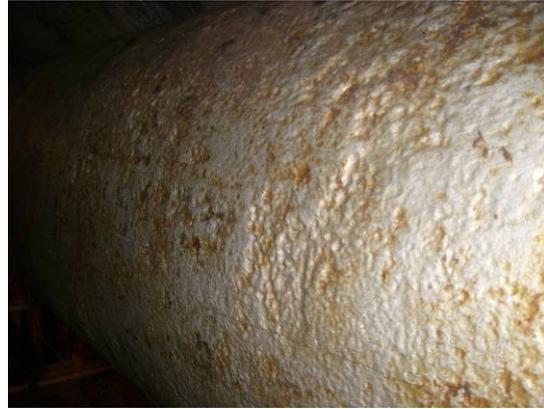
General corrosion located on much of the pipe

Baseline data were acquired using the installed sensors. The combination of the wax tape coating and general corrosion developed a high attenuation (about 0.5 dB/ft at 16 kHz and 1.0 dB/ft at 32 kHz). The achievable test range at 16 kHz was approximately 40 to 45 ft. The baseline data suggested four defect indications estimated at 10 to 15% CSA. ConEd staff removed the wax tape coating at the four defect indication locations and visually inspected the locations. Generalized corrosion around the circumference was found to be similar to the condition at the sensor installation locations. ConEd reported the severity of wall loss to be benign; however, % CSA was not determined.

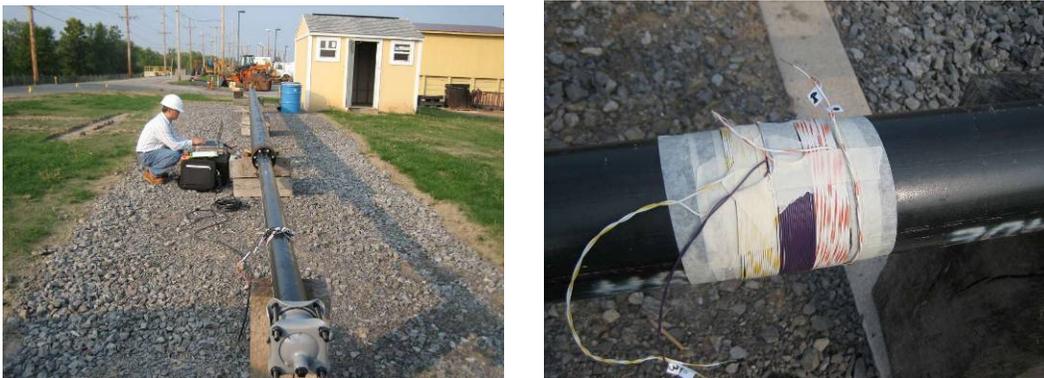
The MsS probes were installed on both sides of the casing and baseline data were measured on September 20, 2007. Figure 1 shows photos of the testing and the installed probes at one end (the probes were wrapped with a protective tape).

Figure 1. MsS testing on the 1st RG&E cased pipe mockup with installed probes

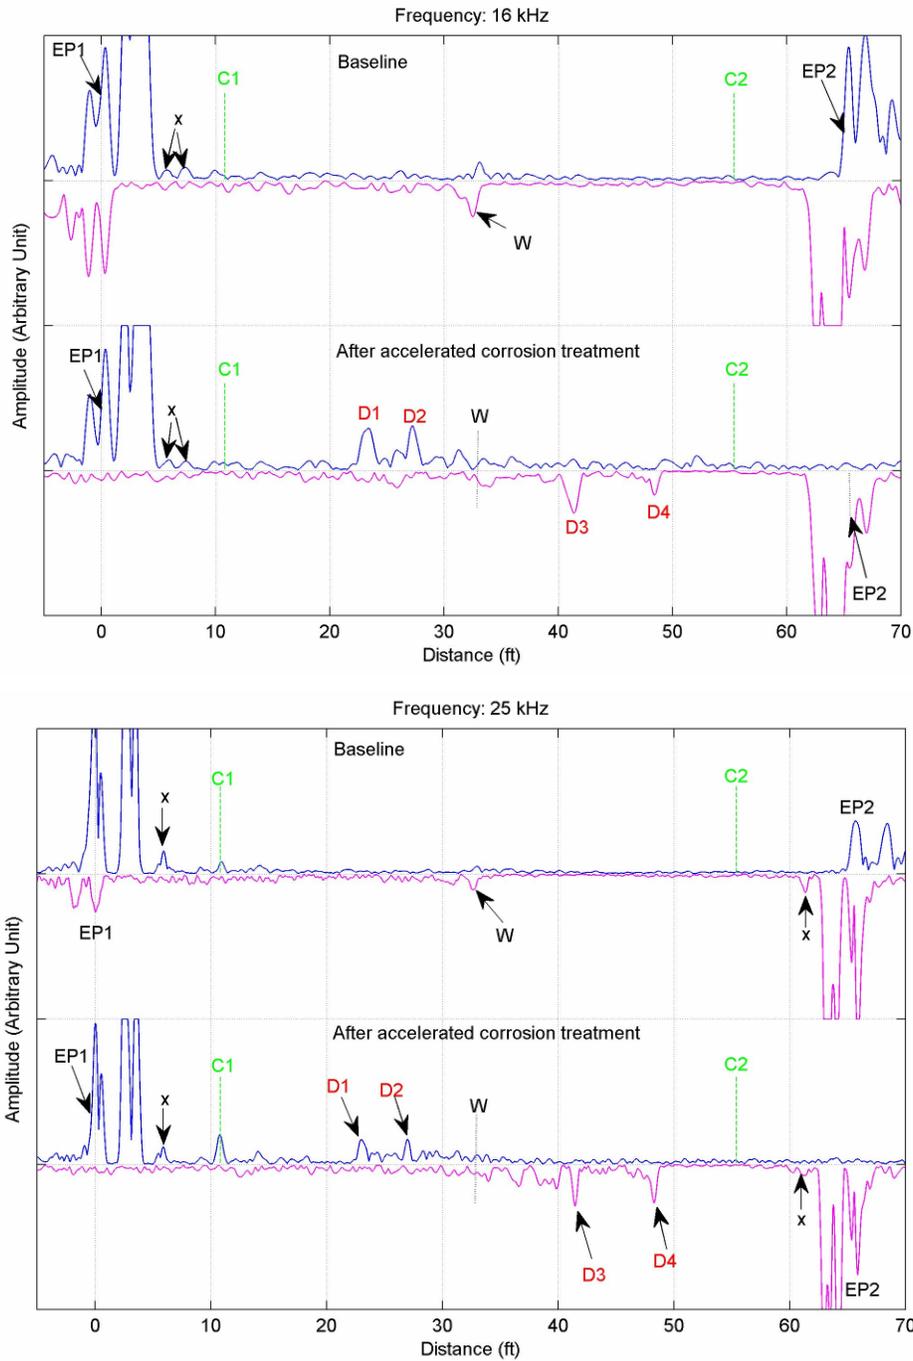
After recording baseline measurements, the annular space was filled with salt a water solution and reverse cathodic protection current was applied to the test pipe. Accelerated corrosion defects developed at four known locations along the pipe. These known defects were prepared to occur in specific areas by RG&E and kept confidential from SwRI. After several weeks of accelerated corrosion treatments, SHM measurements were conducted on November 6, 2007. The graphs in Figure 1 show the data acquired at 16 and 25 kHz.

Figure 1. Data at 16-kHz and 25-kHz from the 1<sup>st</sup> RG&E mockup: top half = baseline data, bottom half = data taken after the accelerated corrosion. Blue lines correspond to data taken from the east end of the pipe (EP1). Pink lines correspond to data taken from the west end of the pipe (EP2). C1 and C2 are the casing ends. W is the weld. D1 to D4 are the corrosion defects.

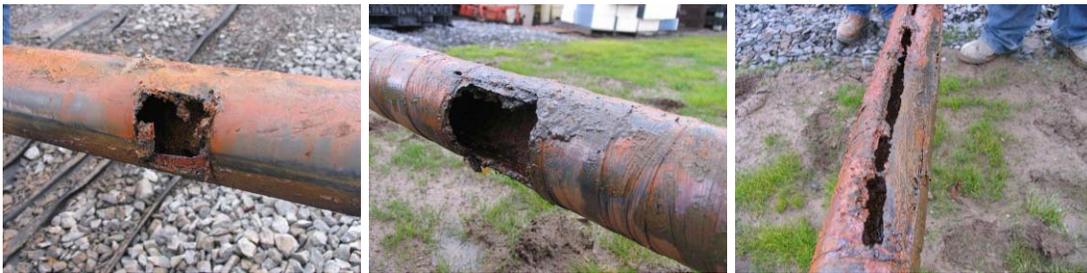
Figure 2. 1<sup>st</sup> RG&E Test Pipe Defects: Large defects (left two) and 2.8% CSA defect at the weld location (right)

While SwRI analyzed the MsS signals in their Texas headquarters, RG&E removed the casing and measured the actual defects for comparison with the SHM results. The four defects were large through-holes about 3 to 6 inches in axial length. The actual % CSA ranged from 21 to 42% of the total cross-section of the pipe. The large defects are shown in Figure 2 including a photo of the 2.8% CSA defect induced at the weld location. The latter defect was not clearly detectable from the SHM data because of the poor S/N ratio.

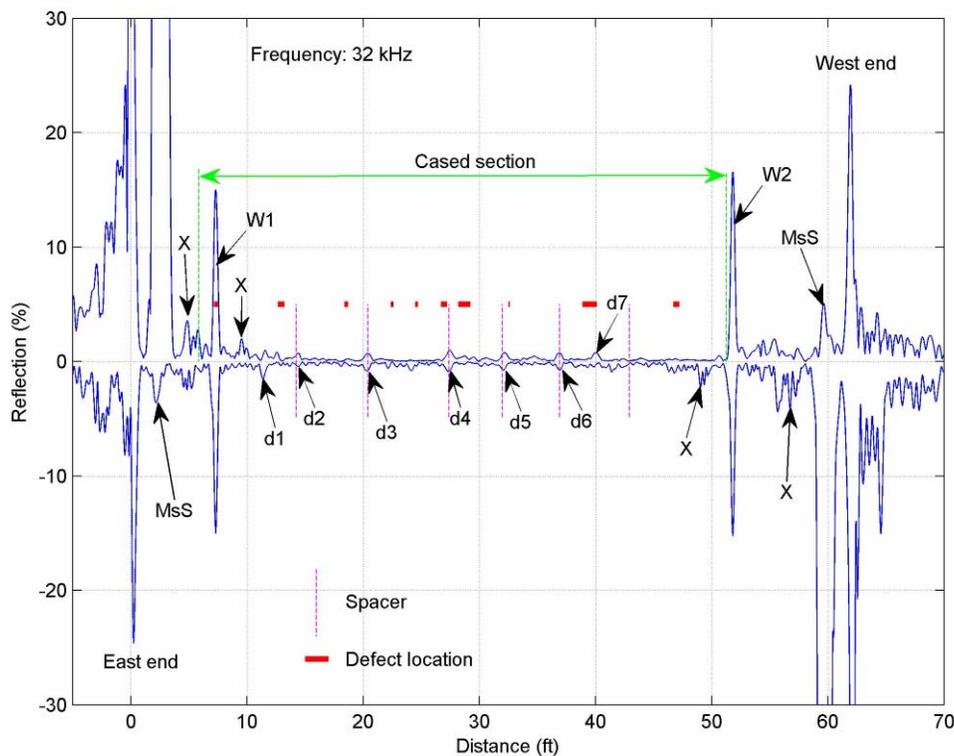
Figures 3 and 4 show the baseline data acquired at 32 and 16 kHz. The wave attenuation was low (approximately 0.09 dB/ft at 32 kHz and 0.07 dB/ft at 16 kHz). The data had low background noise (equivalent to approximately 0.4% reflection). The attenuation and background noise level were low due to the FBE coating. There were seven (7) defect indications found with the 32-kHz data, (d1 through d7) their distances from the east end of the pipe were respectively 11.3, 14.4, 20.4, 27.4, 32.2, 37, and 40 ft. The defect indications represented approximately 0.8% CSA. Signals labeled as X in the figures are those caused by imperfections in direction control or multiple reflections. For comparison, the actual defect locations are indicated as bold red dots in the figures.

Figure 3. 32 kHz baseline data from the 2<sup>nd</sup> RG&E test pipe

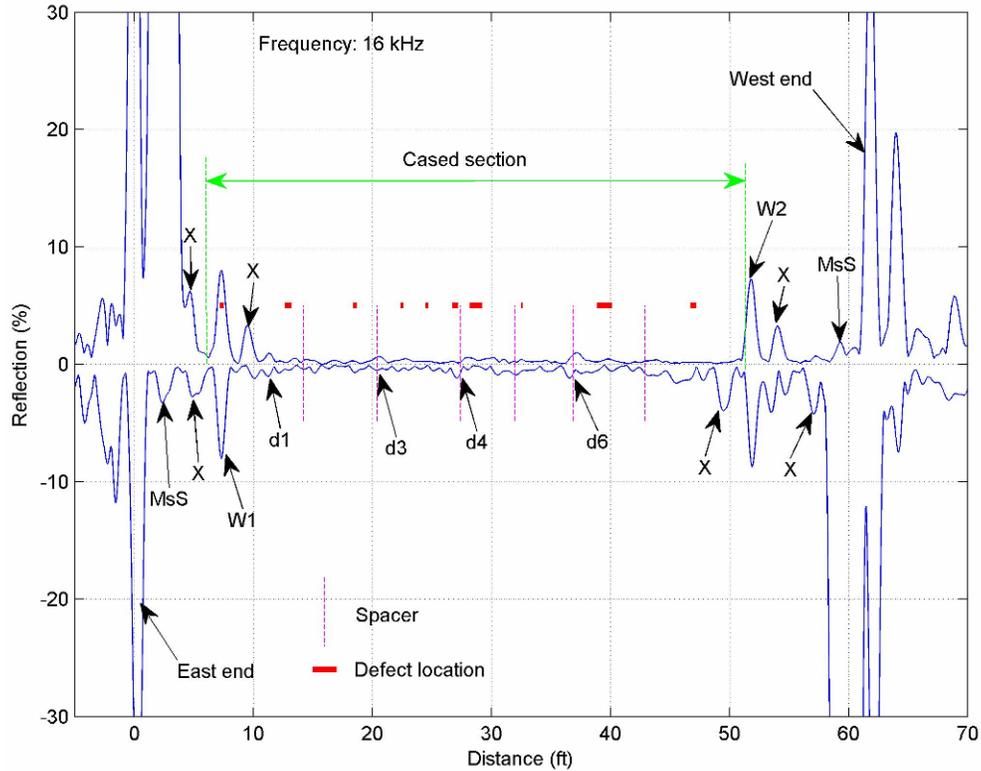
Figure 4. 16 kHz baseline data from the 2<sup>nd</sup> RG&E test pipe

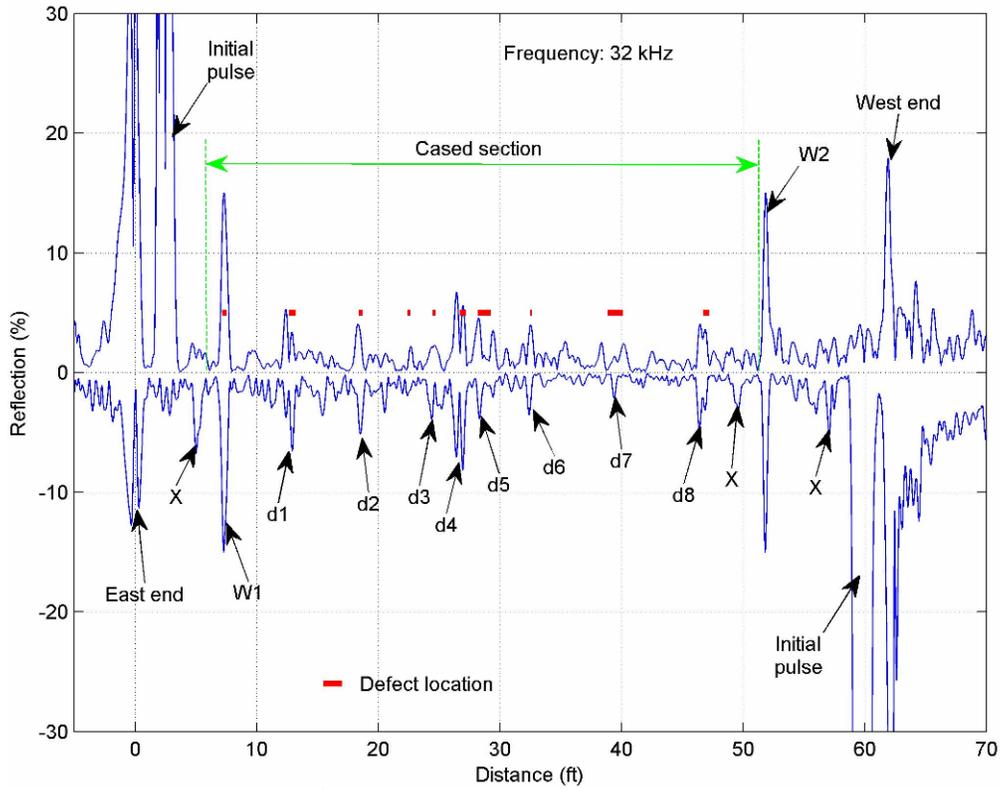
Figures 5 and 6 show the 1<sup>st</sup> SHM data acquired from the mockup at 32 and 16 kHz, respectively. The wave attenuation was higher than before resulting from the general corrosion induced on the carrier pipe. Using the two weld signals as reference, it was determined that the attenuation increased from the baseline values to about 0.24 dB/ft at 32 kHz and to about 0.19 dB/ft at 16 kHz. 8 defect signals were detected. The majority of the 32-kHz defect signals were double-peaked, indicating that the defect length was long enough to separate the signals reflected from the front and the rear of the defect. For comparison, the actual defect locations are indicated as bold red dots in the figures.

Figure 5. 1<sup>st</sup> SHM data at 32 kHz from the 2<sup>nd</sup> RG&E test pipe

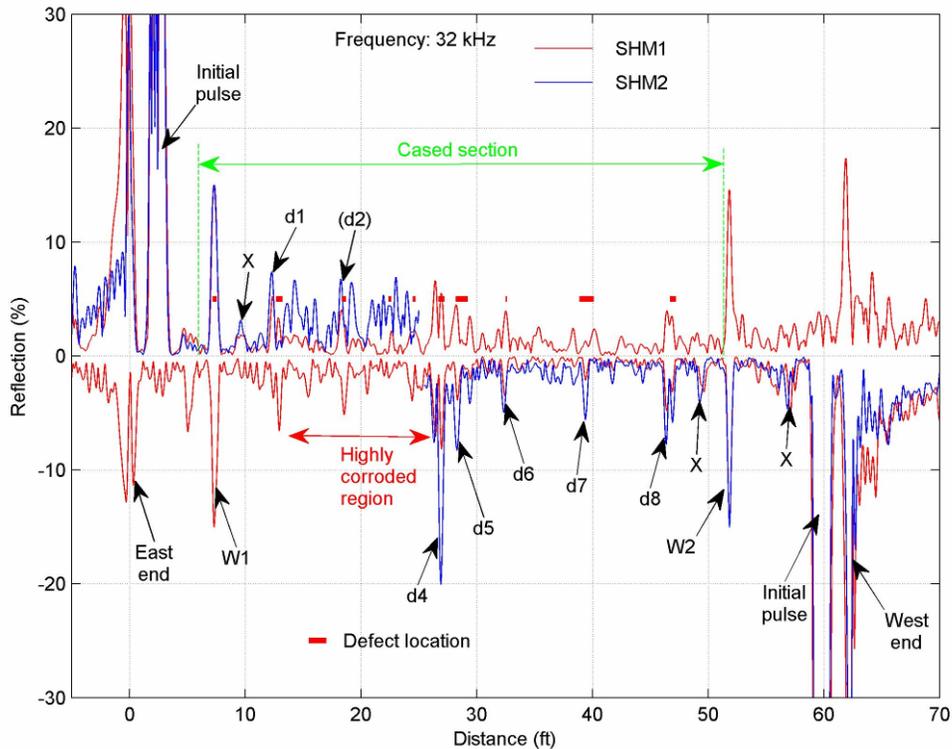
Figure 8. Comparison between the 1<sup>st</sup> and 2<sup>nd</sup> SHM data at 32 kHz

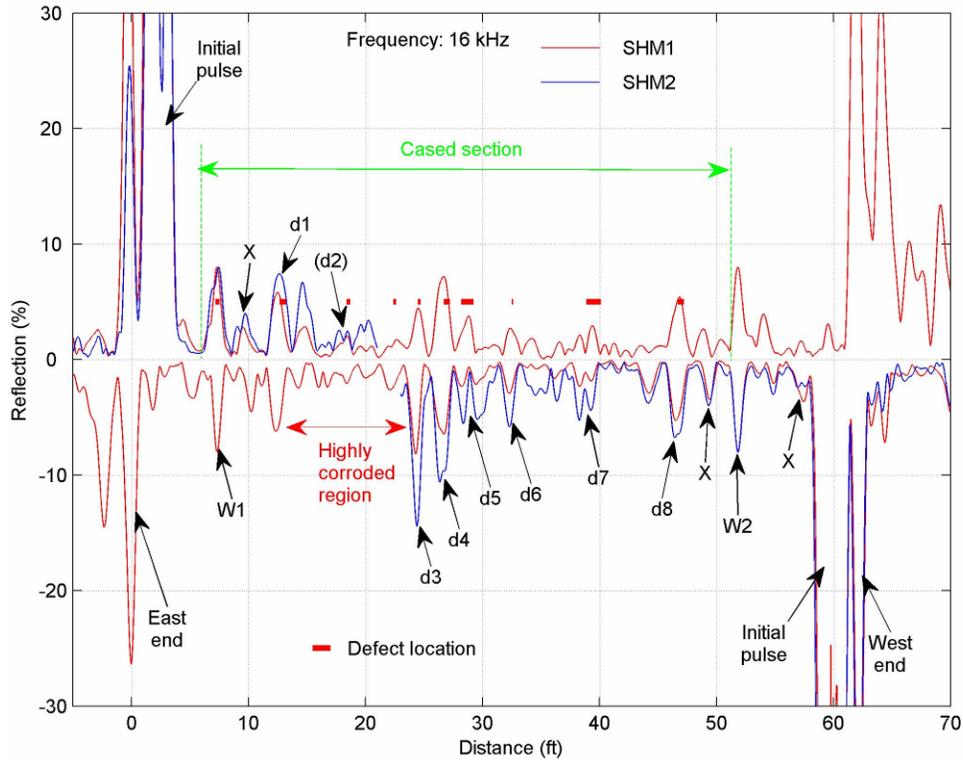
Figure 9. Comparison between the 1<sup>st</sup> and 2<sup>nd</sup> SHM data at 16 kHz

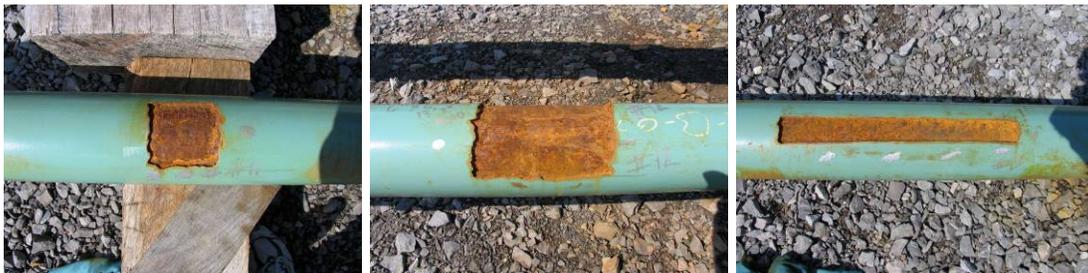
**Figure 12. Typical defect induced in the 2nd RG&E mockup: RG&E Defect ID 11**

Actual locations and sizes of defects in the mockup are listed in Table 11. Except for the full-circumferential defect in the east-side weld (W1) area (RG&E defect ID No.1), all other defects were square or rectangular in shape. An example of a defect that was taken after the 2<sup>nd</sup> SHM test is shown in Figure 12.

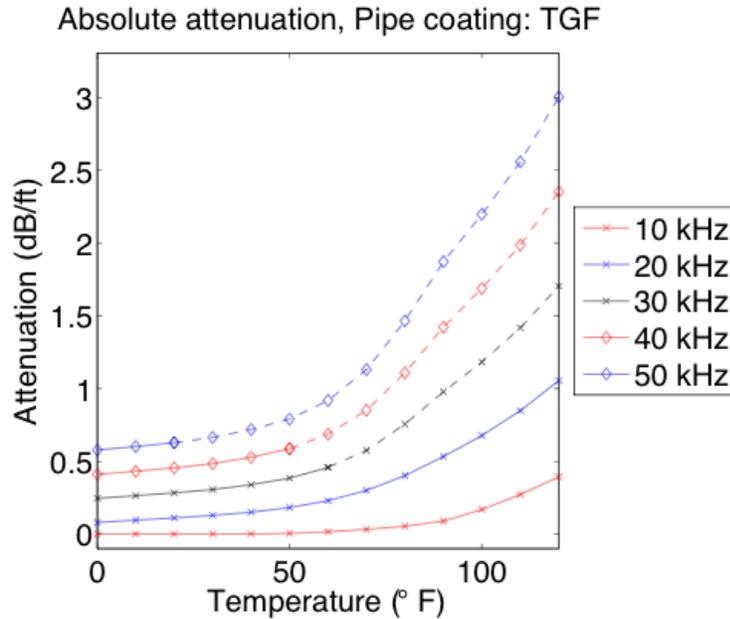
coated pipe. Thus, the consideration of temperature is even more so important for guided-wave inspection of Coal Tar (TGF-3) coated pipelines.

Figure 2. Experimental results from the TGF-3 coal tar coated pipe illustrating the temperature dependence of attenuation at discrete frequencies. Dashed lines represent extrapolated approximations.

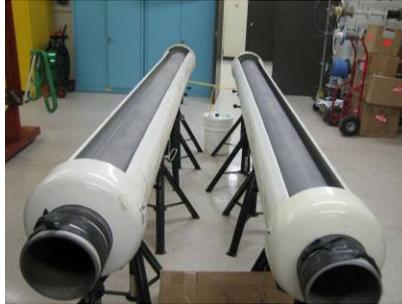
Figure 3. Experimental setup for investigation of corrosion effects on guided-wave attenuation.

Two 10 foot lengths of 6 inch bare carbon steel (CS) pipe each having a 0.28 inch wall thickness were acquired for the investigation. Each pipe was placed in a 10.5-inch OD PVP pipe with a 4 inch section of one end exposed for MsS as shown in Figure 3.

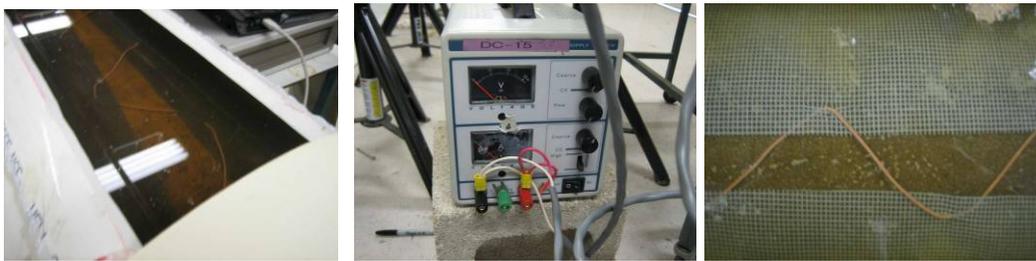
Figure 4. PVC pipe filled with salt water solution (left), power supply used to impress the electric current (middle), and fiberglass mesh wrapped around pipe sample (right)

General corrosion was implemented using salt water solution with impressed electric current to accelerate corrosion as shown in Figure 4. Baseline MsS measurements (made on November 17, 2008), confirmed that the water surrounding the pipe sample has no effects on the wave attenuation. While subjecting the pipe samples to impressed electric current, MsS data were acquired periodically (from 10- to 140-kHz at 10-kHz intervals). Final periodic measurements were made on February 9, 2009.

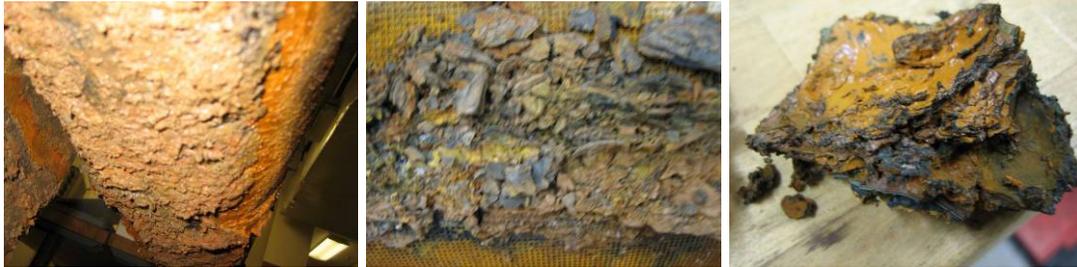
Figure 5. Corrosion products on the pipe surface

Over a span of 82 days, a total of 15 periodic MsS measurements were conducted. To determine the corrosion wall loss level during the corrosion treatment, ultrasonic wall thickness measurements were performed periodically together with MsS measurements. Because of large error in ultrasonic thickness measurements (approx.  $\pm 0.003$  inches), the wall loss induced in the pipe samples could not be determined reliably. Instead, the corrosion was estimated from the impressed current level at first, then the overall estimated corrosion at the end of treatment was calibrated using the actual wall thickness measured. Figure 5 shows the pipe surface and a section of corrosion product. Except for

the top ¼ of the pipe circumference, the pipe surface was covered with a thick layer of corrosion product loosely attached to the pipe.

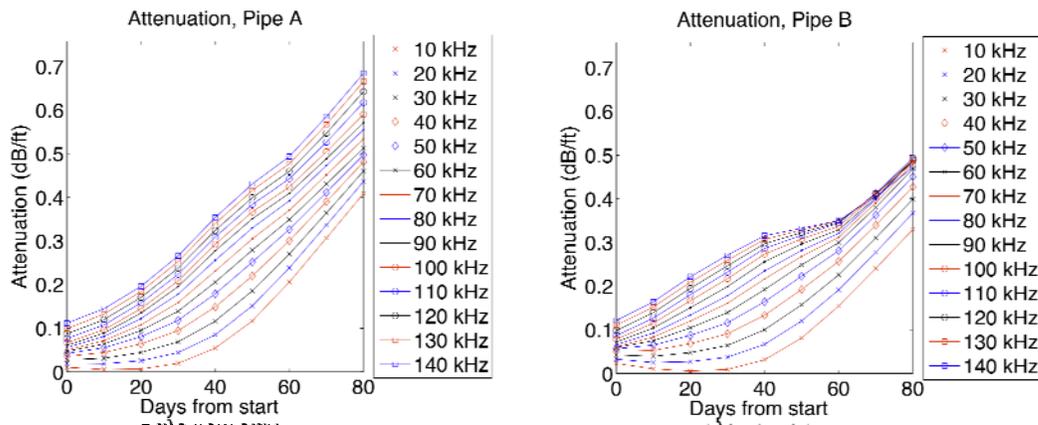
Figure 8. Attenuation as a function of days of corrosion treatment at various frequencies

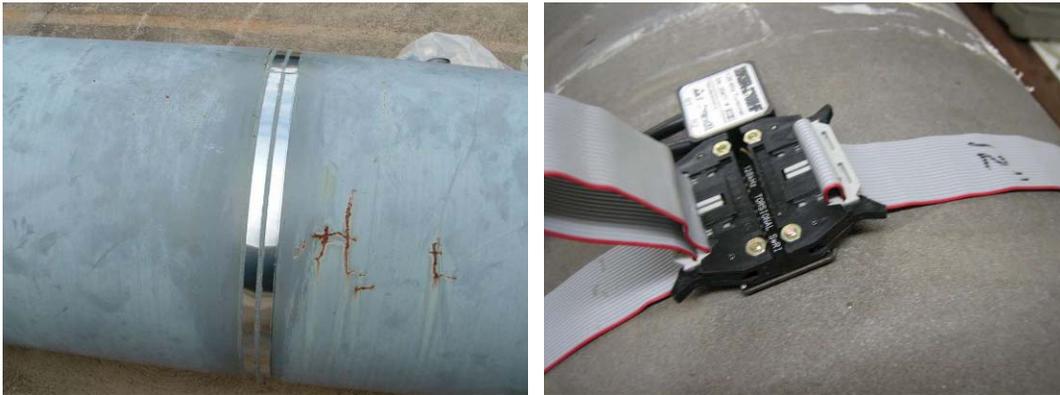
Figure 2. Photo of thin strips bonded around a pipe (left) and the MsS coil placed over the strip (right)

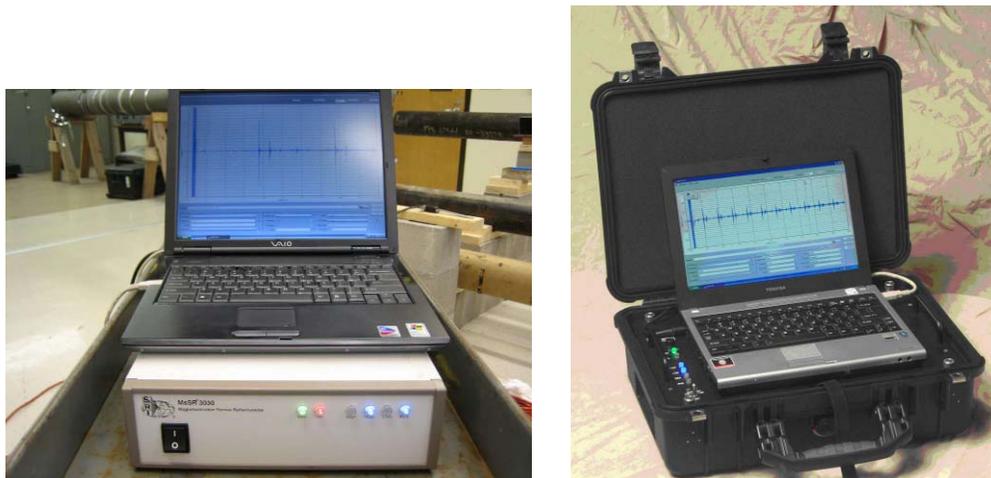
Figure 4. MsS Instrument Model MsSR 3030 (left) and MsSR 3030R (right)

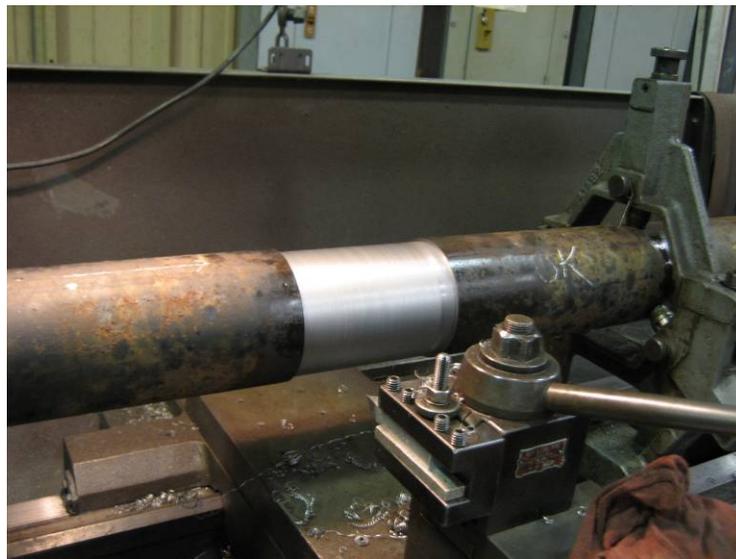
Figure 6. Photo of 4.5-inch-OD, 0.337-inch-wall pipe sample with 6-inch-long machined-in 360-degree notch

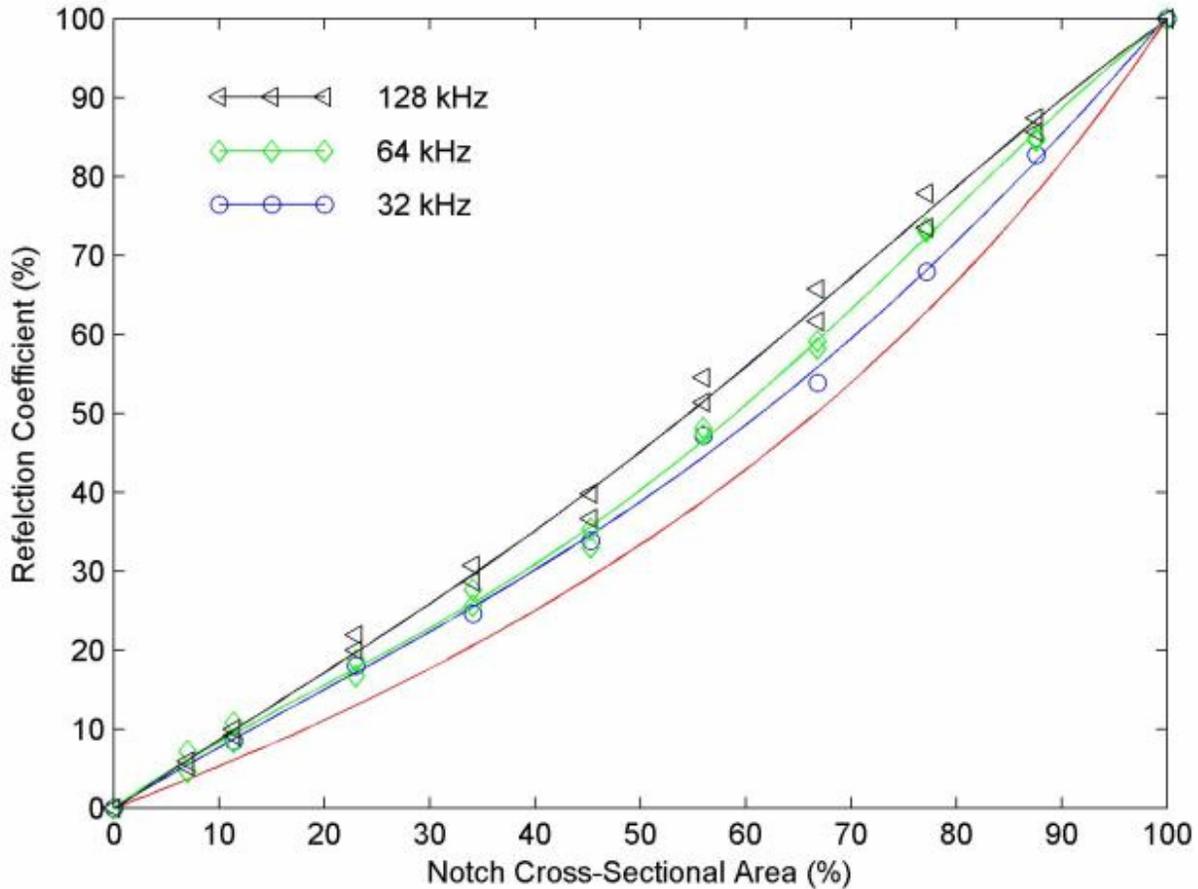
Figure 8. Reflection coefficients from the front end of a 360-degree notch as a function of the notch cross-sectional area relative to the total pipe-wall cross-section

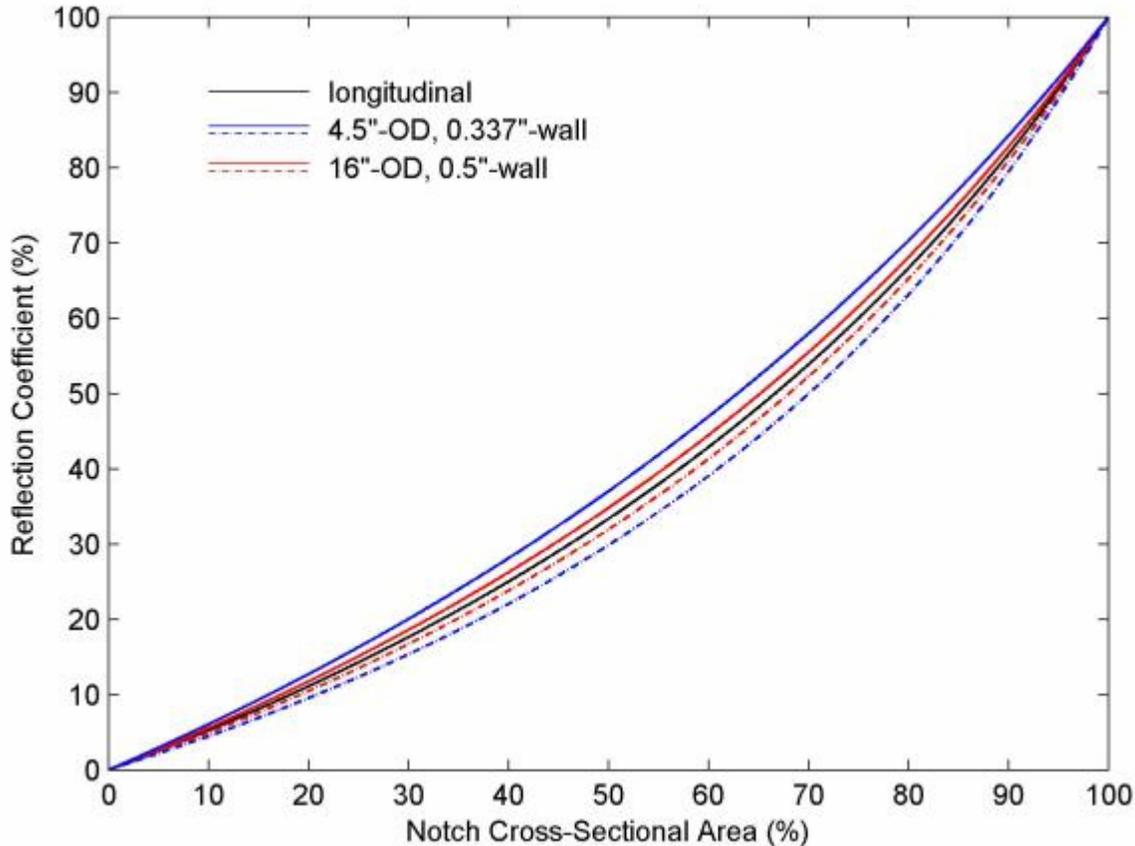
Figure 9. Theoretical reflection coefficient from the front end of 360-degree notch. Black line is for longitudinal wave mode. Blue and red lines are for torsional wave modes; continuous lines for the OD side notch and dotted lines for the ID side notch.

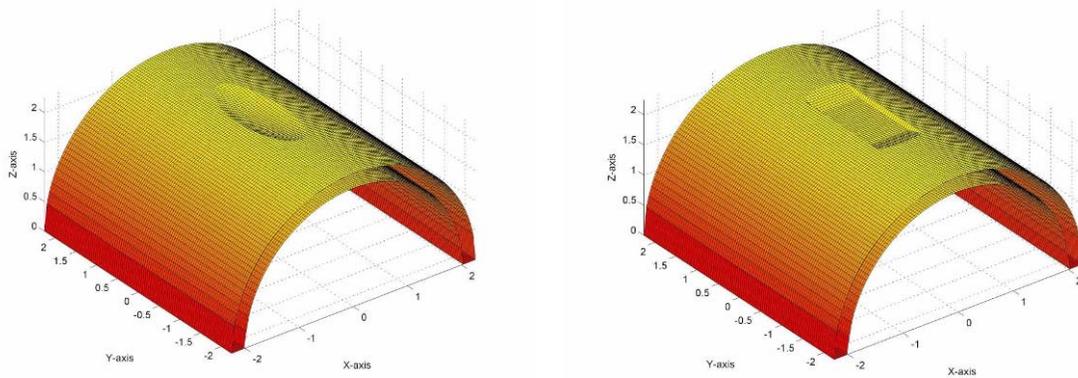
Figure 10. Example of OD defect configurations that can be input in the simulation software

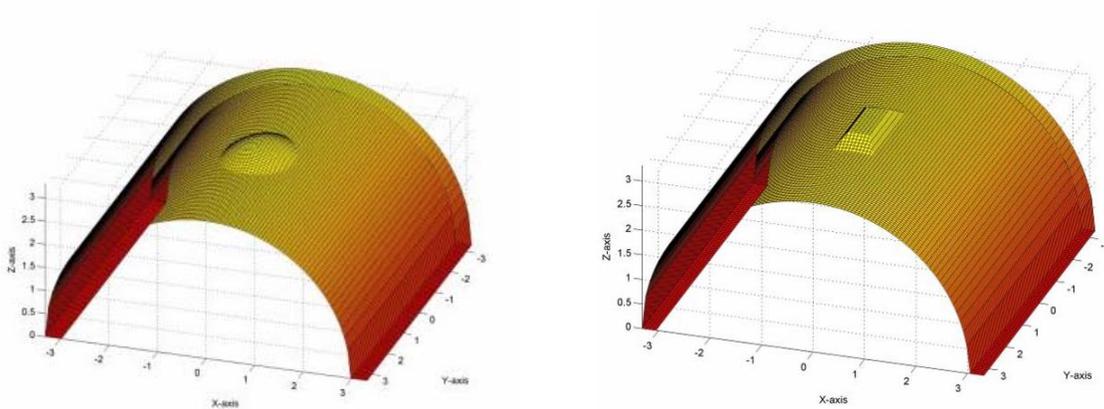
Figure 11. Example of ID defect configurations that can be input in the simulation software

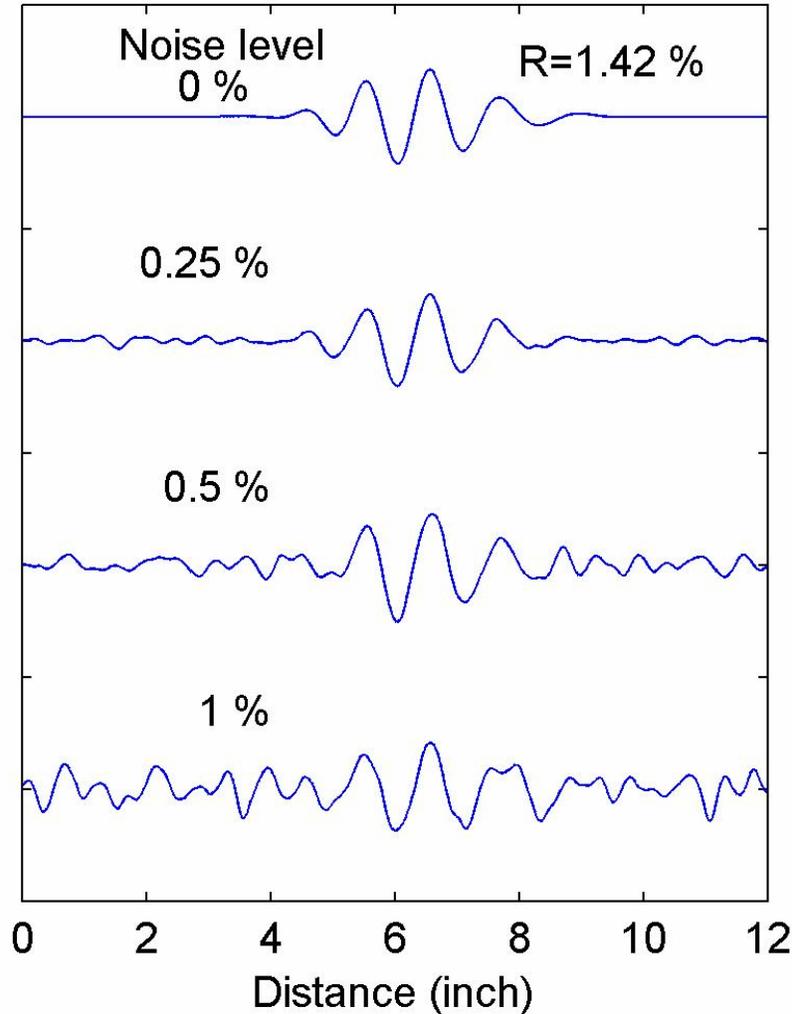
Figure 13. Examples of defect signals mixed with varying degrees of noise level. The noise level is in the unit of % reflection. The simulated defect signal's reflection coefficient is 1.42%.

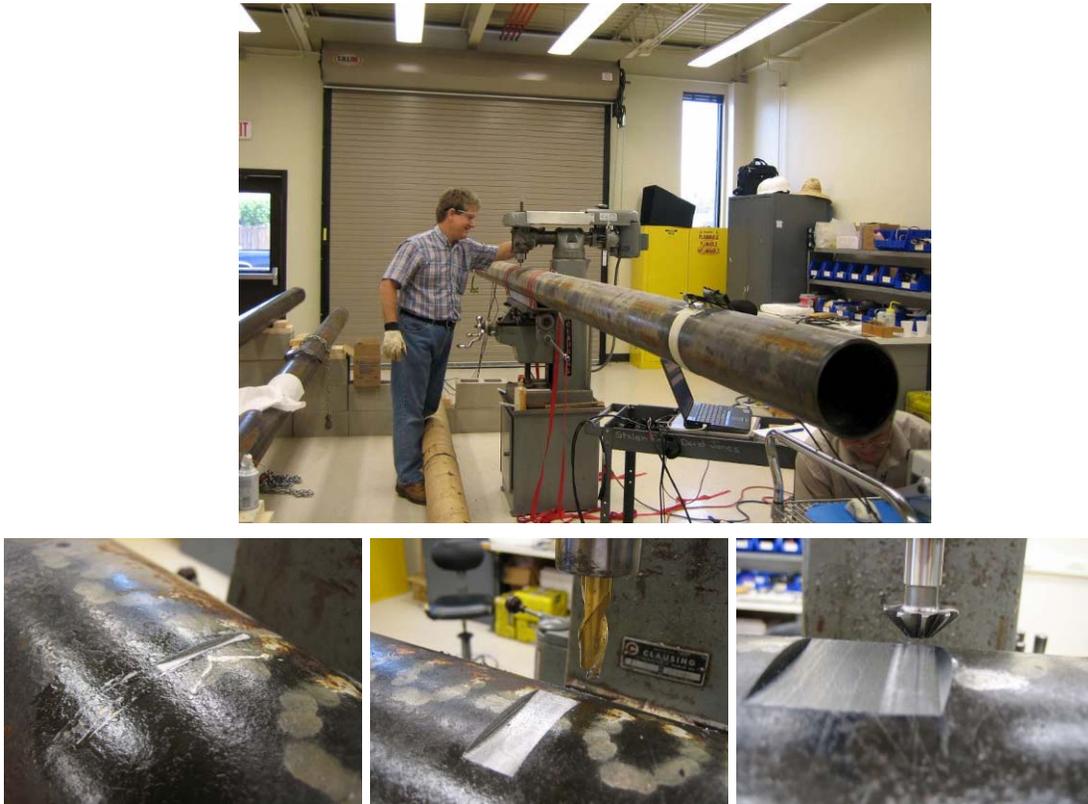
Figure 14. Photos of experimental setup and examples of notch defects of varying axial length and slope

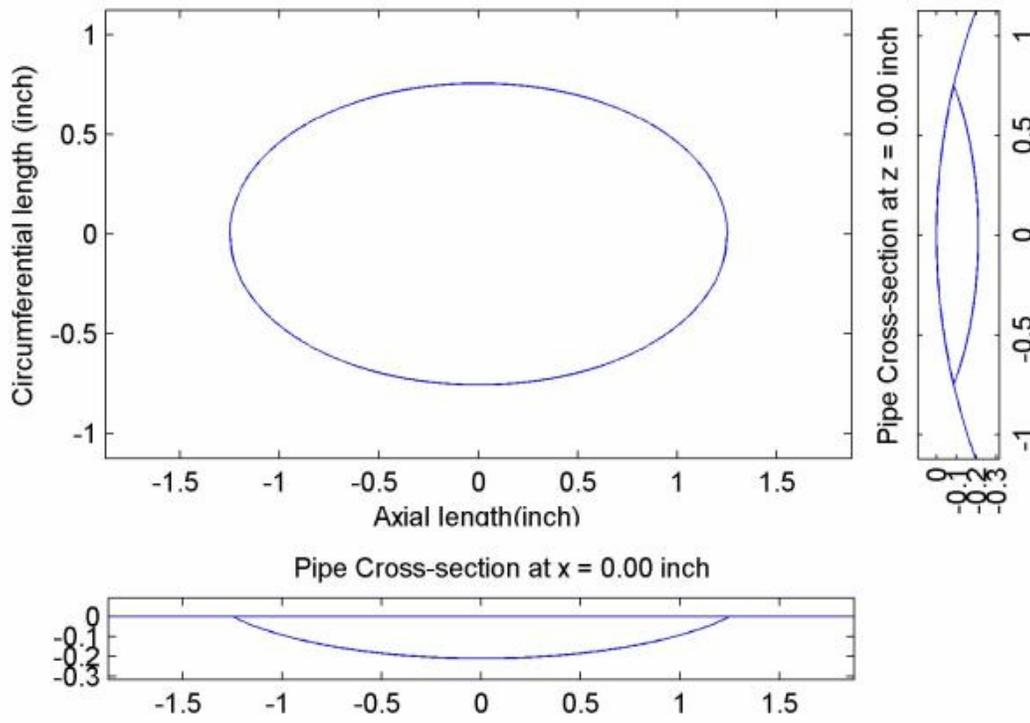
Figure 15. Configuration of ellipsoidal-shaped defect (for 2.5"L/1.5"W)

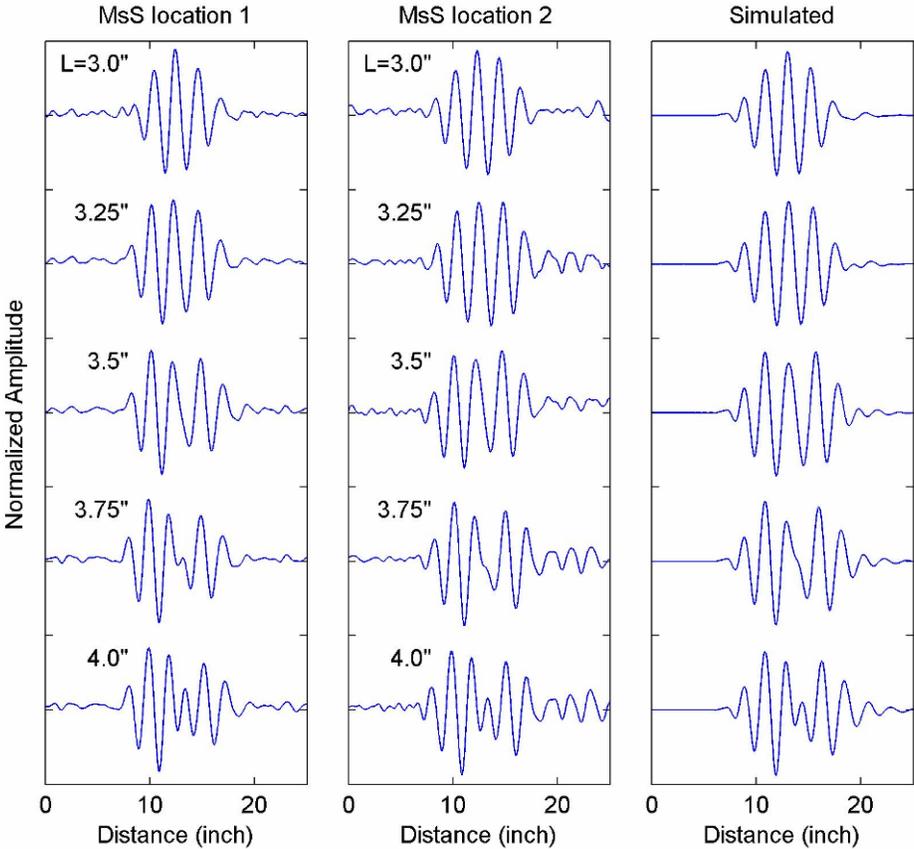
Figure 17. Experimental (left and center) and simulated (right) waveforms for 32-kHz T-wave and 50%-deep circumferential notches with axial length from 3 to 4 inches with 3.2% CSA

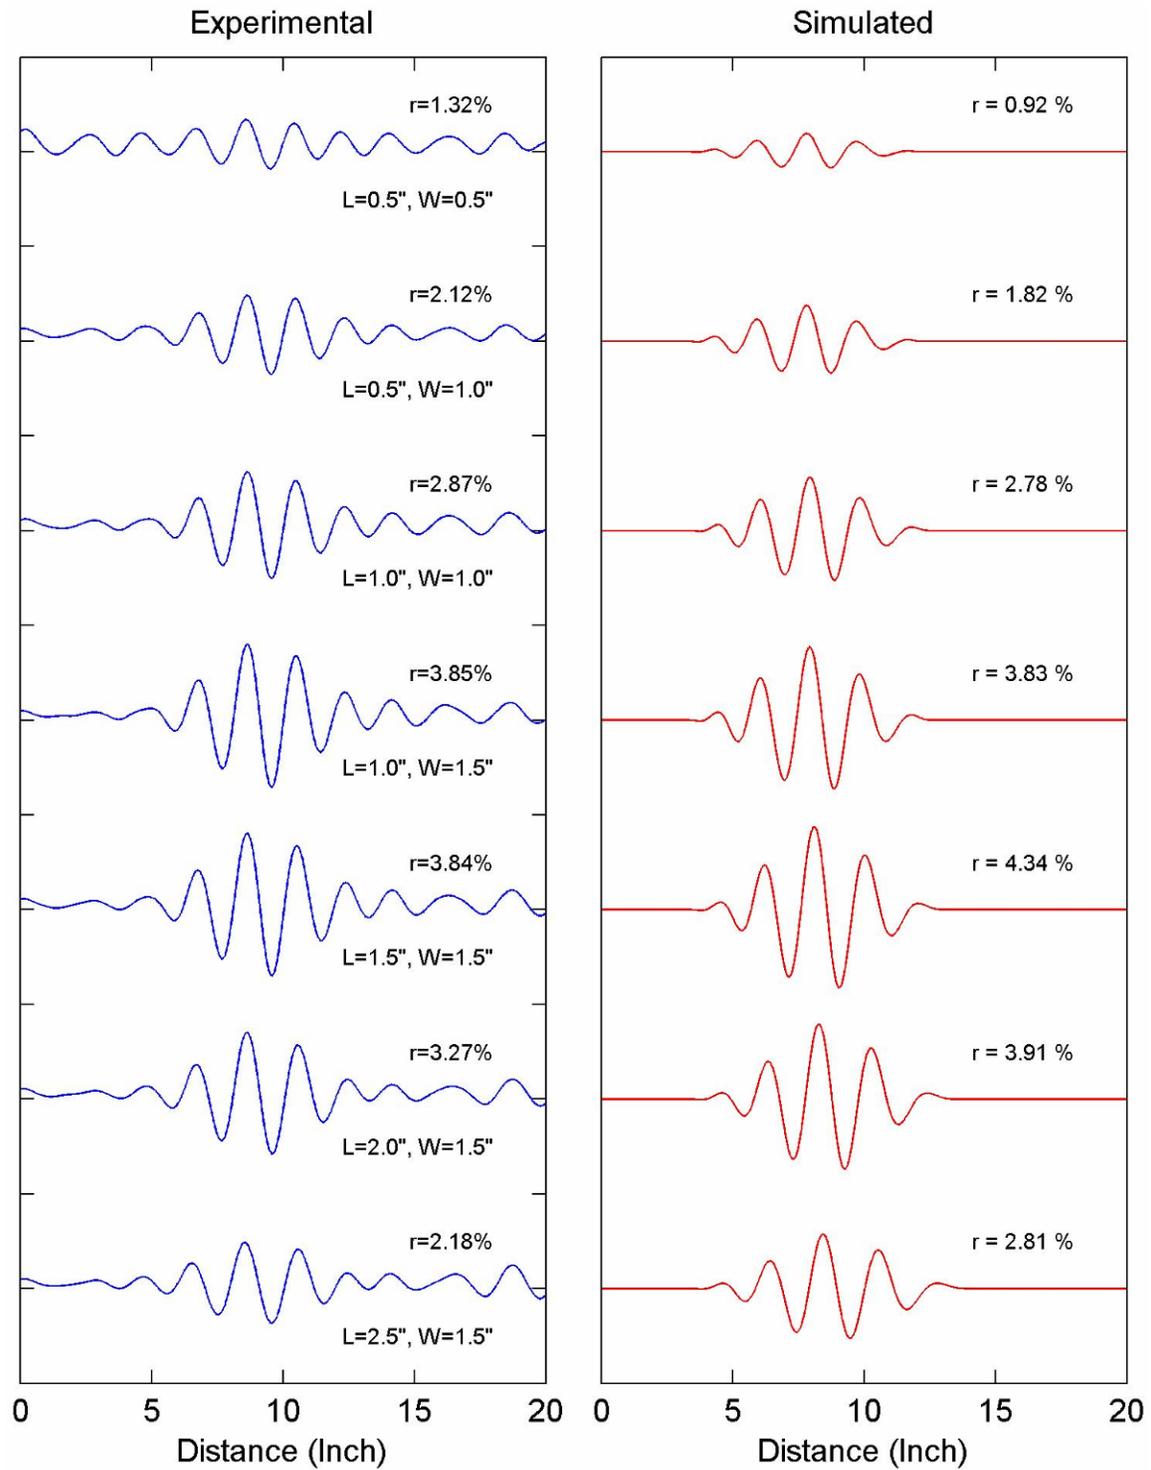
Figure 21. Experimental and simulated signals from ellipsoidal defects at 32 kHz; CSA of defects was 1.32% for W=0.5", 2.60% for W=1.0", and 3.81% for W=1.5"
