Prepared for: U.S. DOT/PHMSA

**LONG-TERM MONITORING OF CASED PIPELINES USING  
LONGRANGE  
GUIDED-WAVE TECHNIQUE**

**Final Report**

**NYSEARCH/Northeast Gas Association**

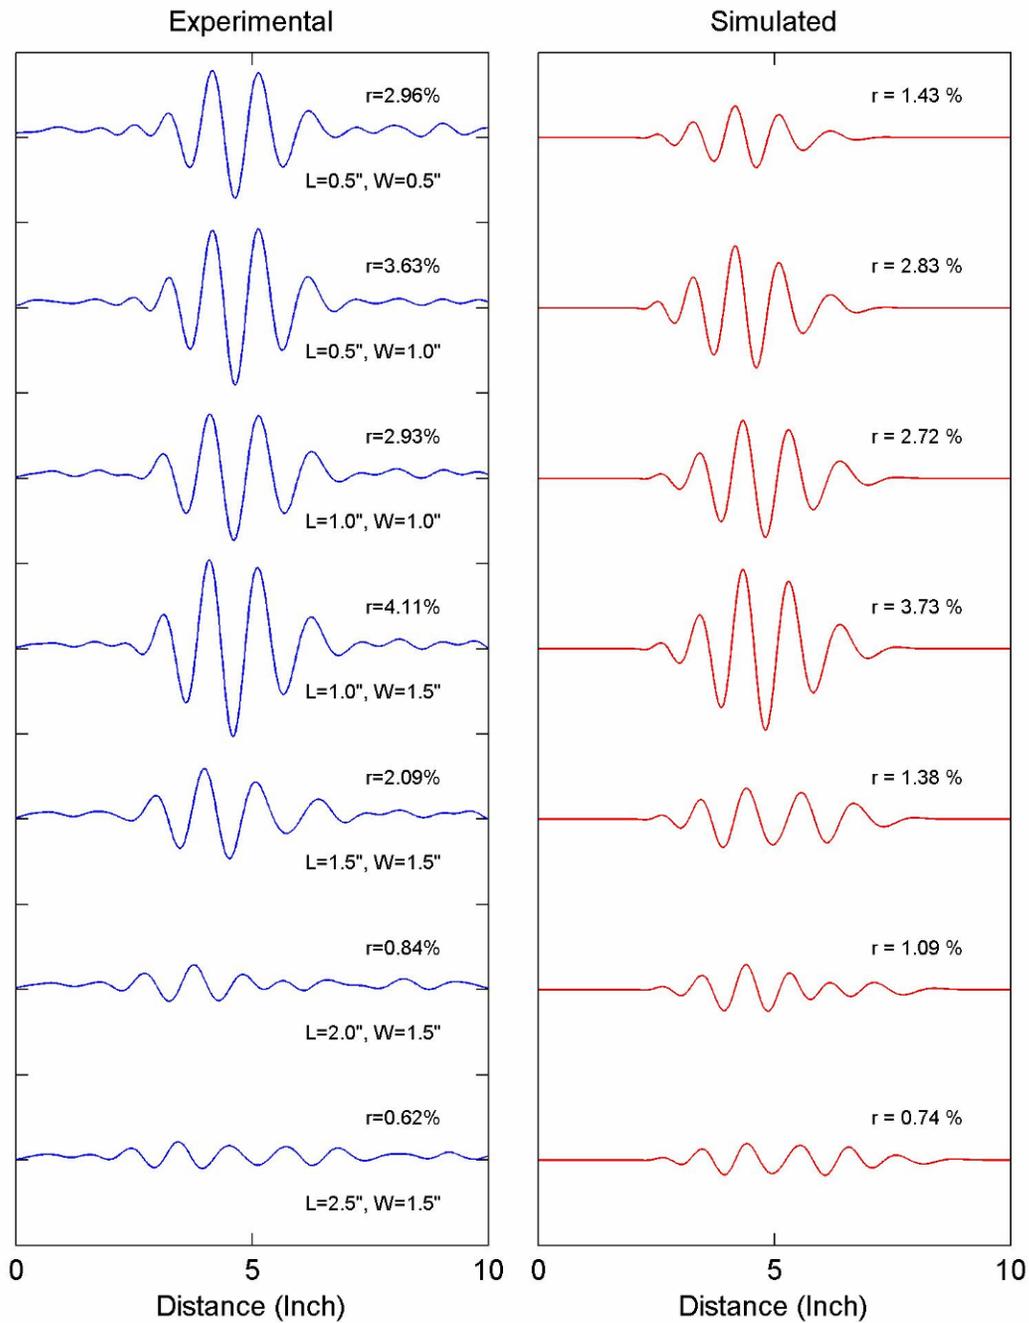
Figure 22. Experimental and simulated signals from ellipsoidal defects at 64 kHz; CSA of defects was 1.32% for W=0.5", 2.60% for W=1.0", and 3.81% for W=1.5"

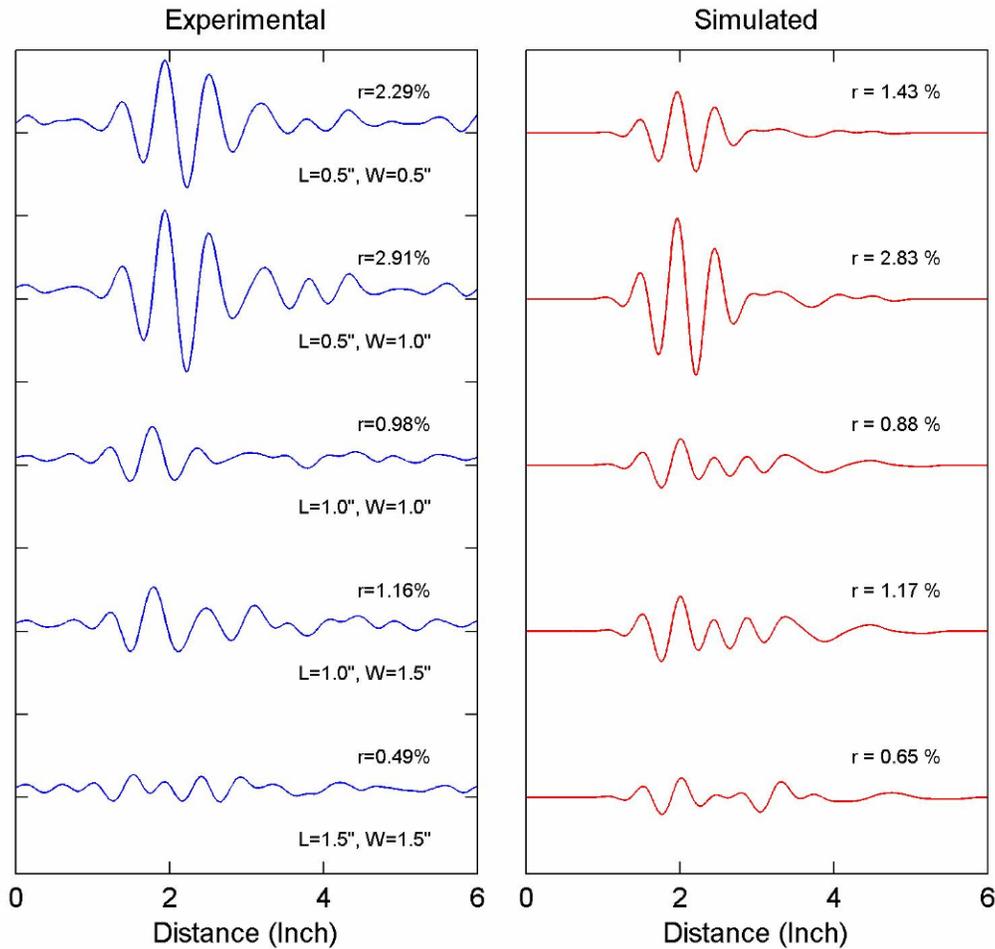
Figure 23. Experimental and simulated signals from ellipsoidal defects at 128 kHz; CSA of defects was 1.32% for  $W=0.5''$ , 2.60% for  $W=1.0''$ , and 3.81% for  $W=1.5''$

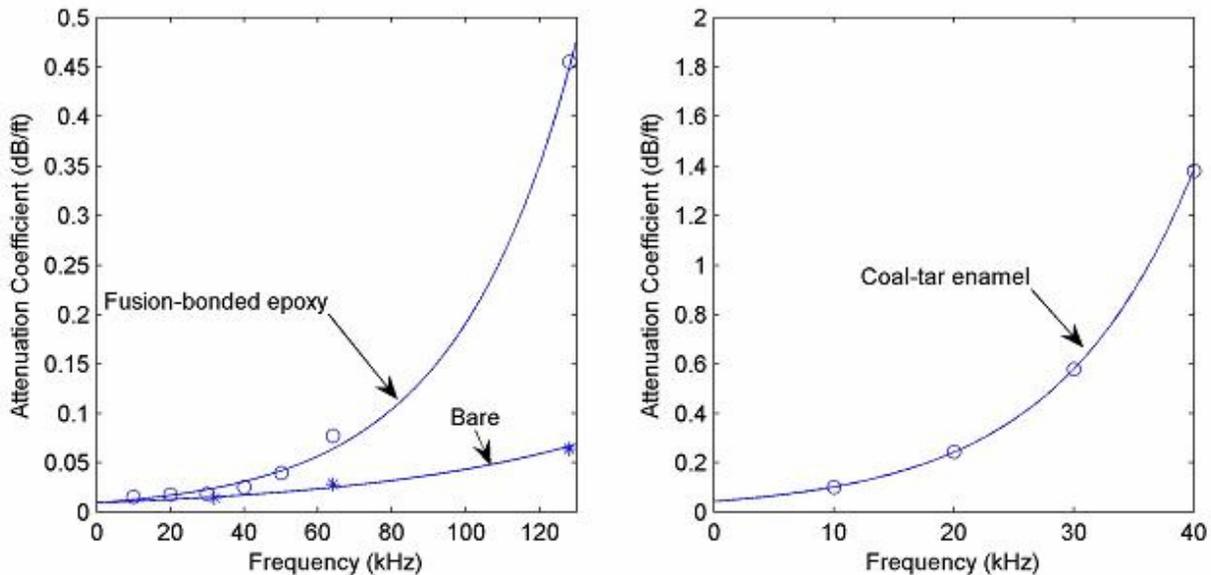
Figure 24. Attenuation coefficients of T-wave

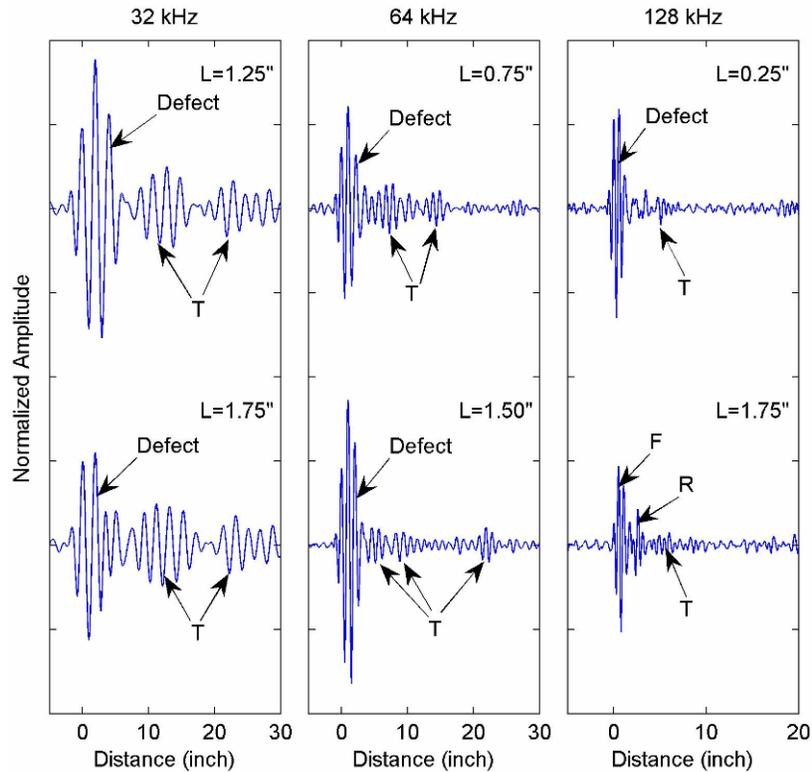
Figure 26. Examples of trailing (T) signals. The data are from the signals measured with the 80%-wall-deep notches. L refers to the axial length of the notch.

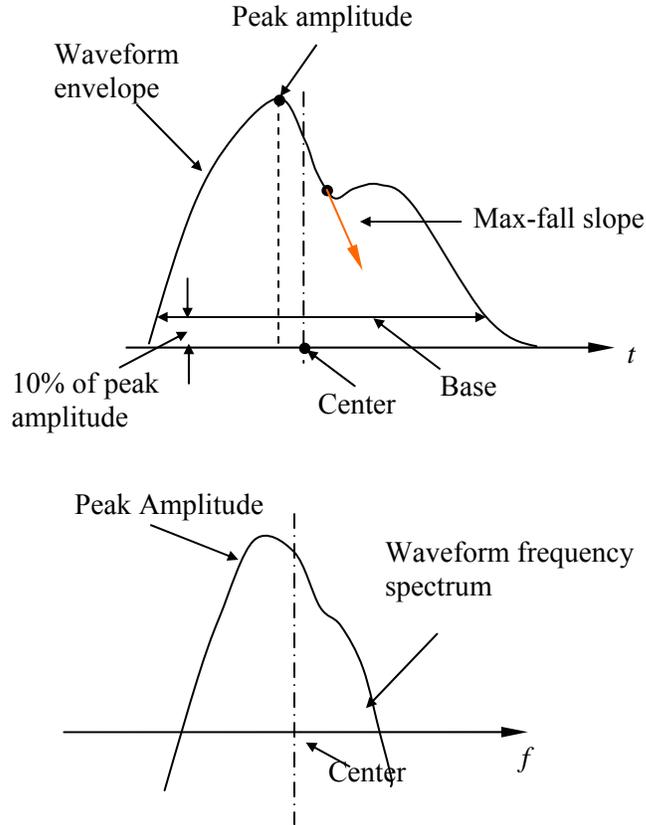
Figure 27. Illustration of feature parameters used for defect characterization algorithms

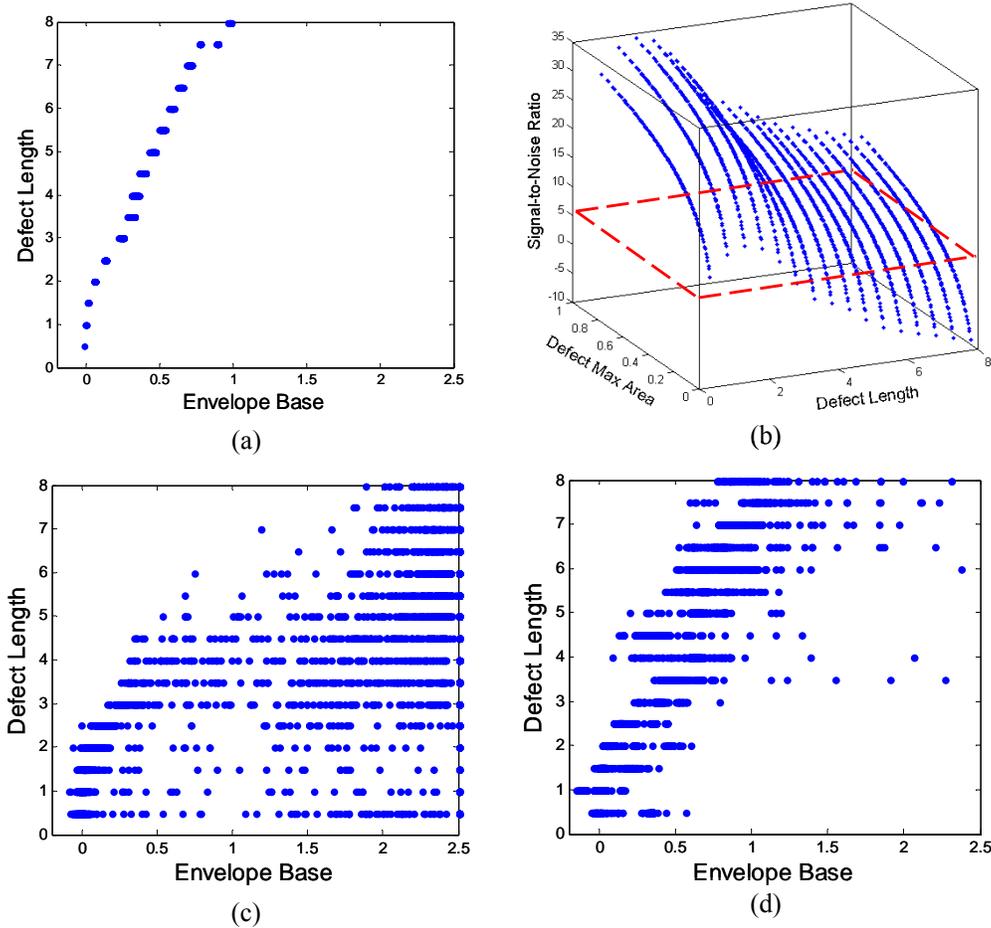
Figure 28. Correlation between the base of envelope and defect length for ellipsoidal defects: (a) without noise, (b) distribution of SNR of defect signals versus defect length and CSA, (c) with noise added to the defect signal, and (d) after the denoising algorithm was applied to improve SNR

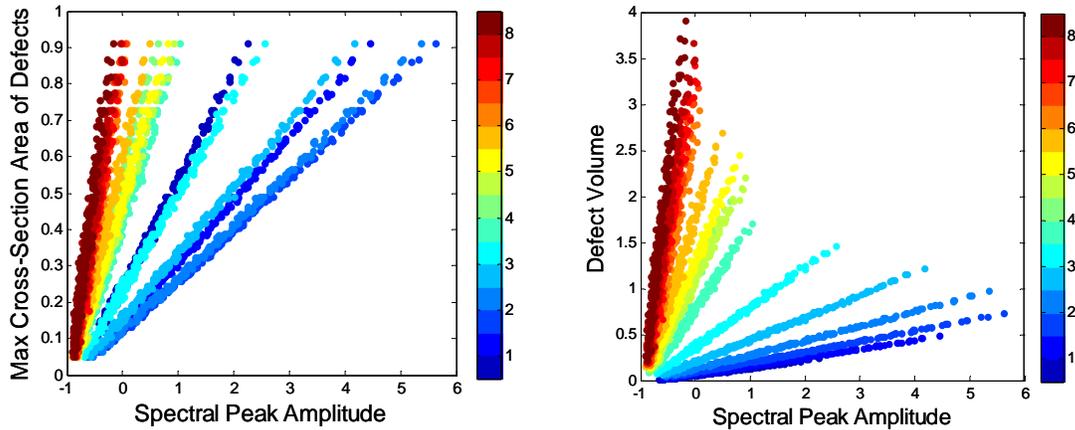
Figure 29. Correlation between the spectral peak amplitude of defect signal with noise and the maximum circumferential cross-sectional area of defect (left) and the defect volume (right) for the ellipsoidal defects. The color bar indicates the defect length from 0.5 inch (dark blue) to 8 inches (dark red).

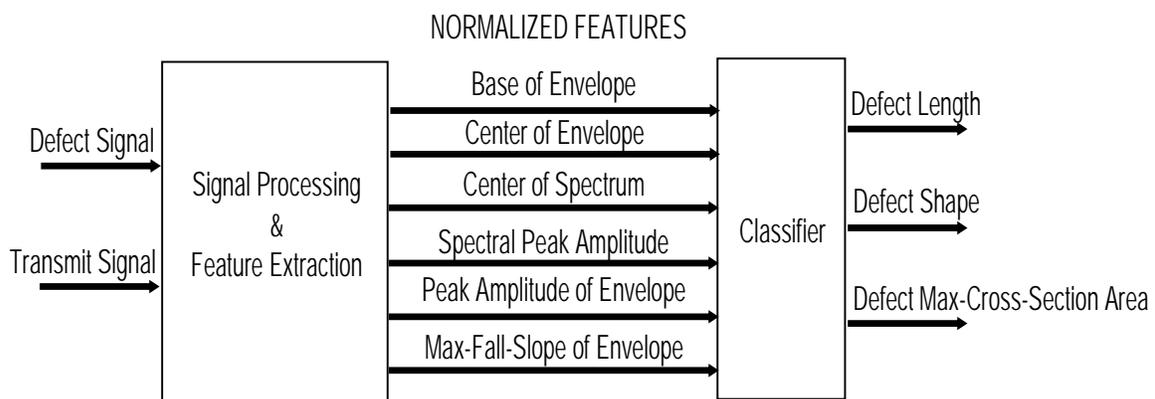
Figure 31. Flow diagram of the defect classification algorithm

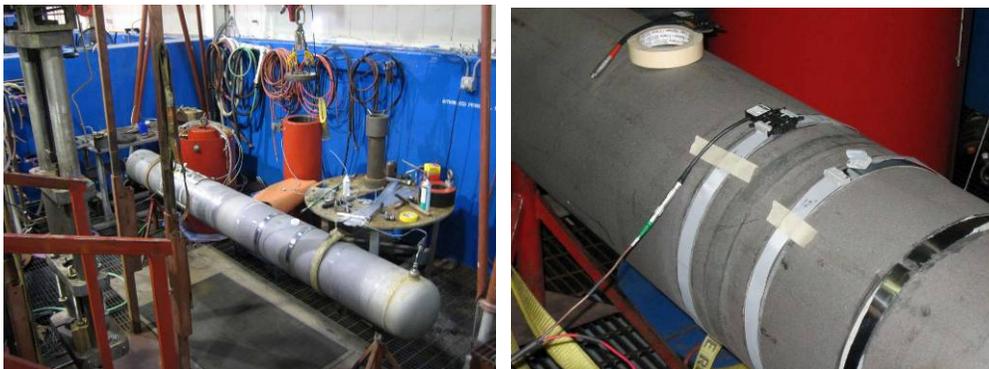
Figure 32. Photo of the 12-inch-OD pressure test sample (left) and the strips and MsS coils installed on the test sample (right)

Various materials were evaluated for their suitability on the 12-inch-OD pressure test sample used in the previous project [6]. Photos of the test sample and the MsS setup are shown in Figure 32.

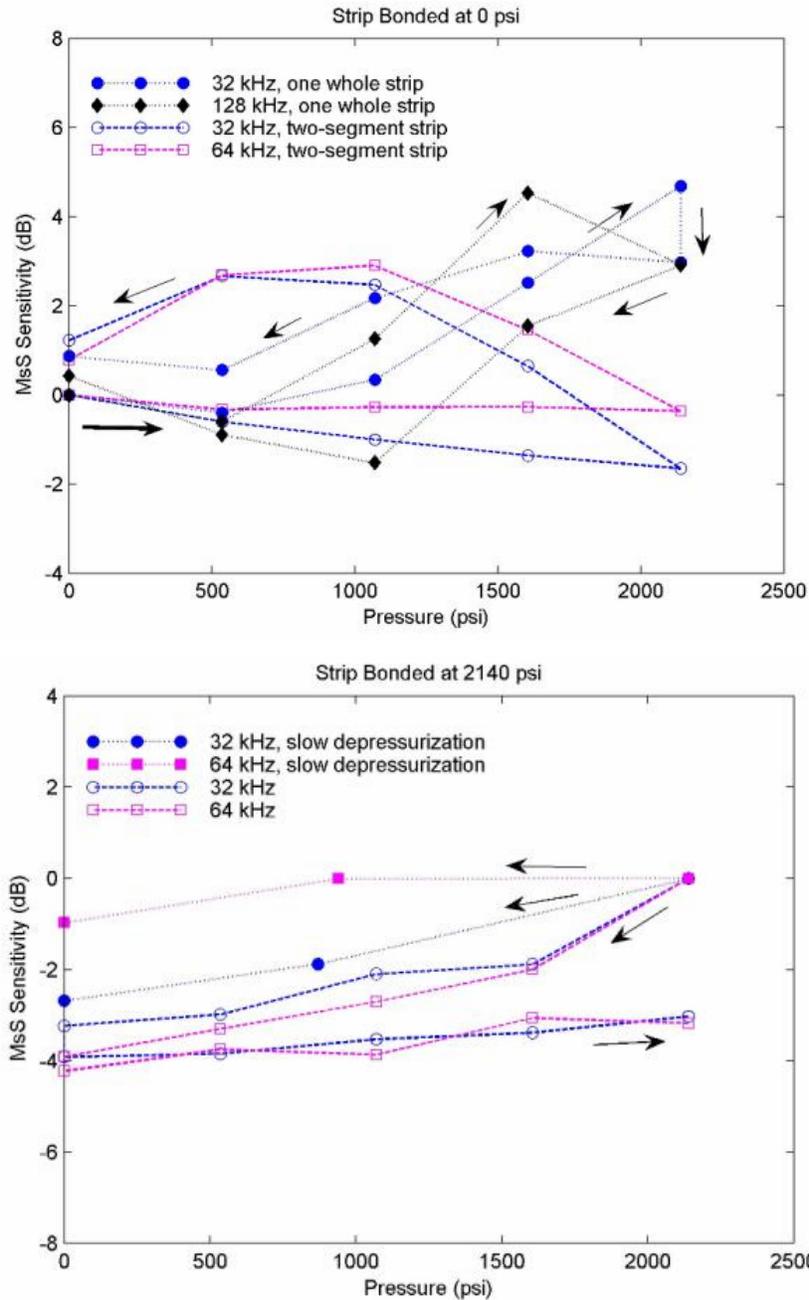
Figure 33. MsS sensitivity variations with line pressure change for strips bonded using Hysol U-10FL at 0 psi (top) and 2140 psi (bottom) line pressure. The hoop stress caused by 2140 psi was 36 ksi.

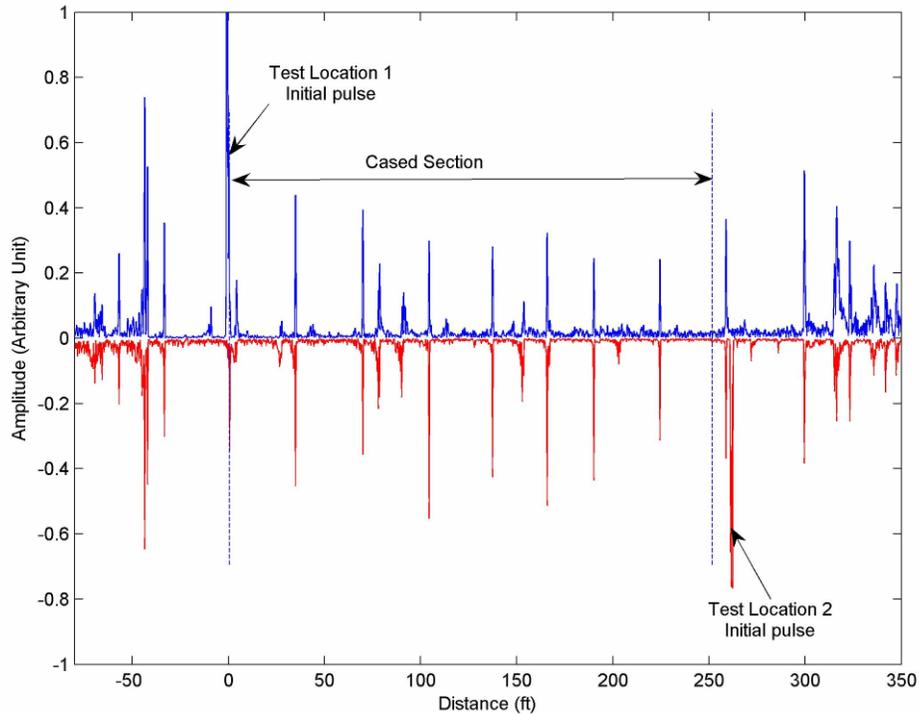
Figure 34. Example of correlated data from both ends of a cased section of gas transmission line (data from the previous DOT project) [5].

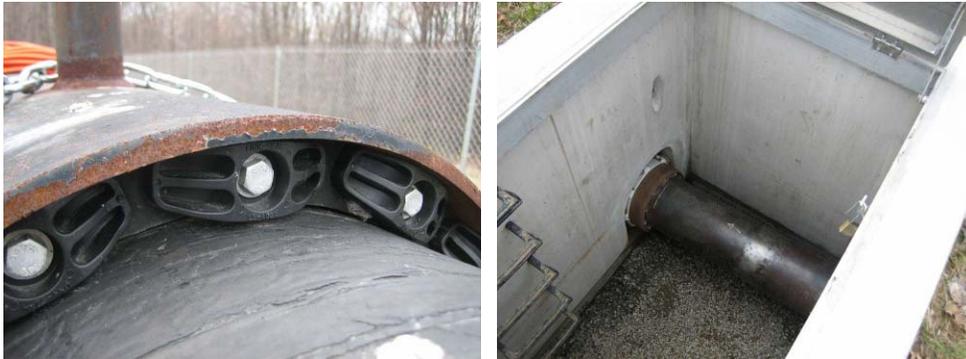
Figure 36. Photos of link joint seal at the edge of casing (left) and vaulted excavation for access to the underground test pipe (right)

All test pipes were seam-welded and were 0.375-inch in wall thickness. All test pipes contained machined defects at various points around the circumference and axially along the pipe. In the cased section, casing spacers were placed along the pipe at various locations and the edge of the casing was sealed with a link joint shown in the Figure 36 photos. The underground test pipe was accessible for guided-wave testing from the two vaulted excavations shown in the Figure 36 photos.

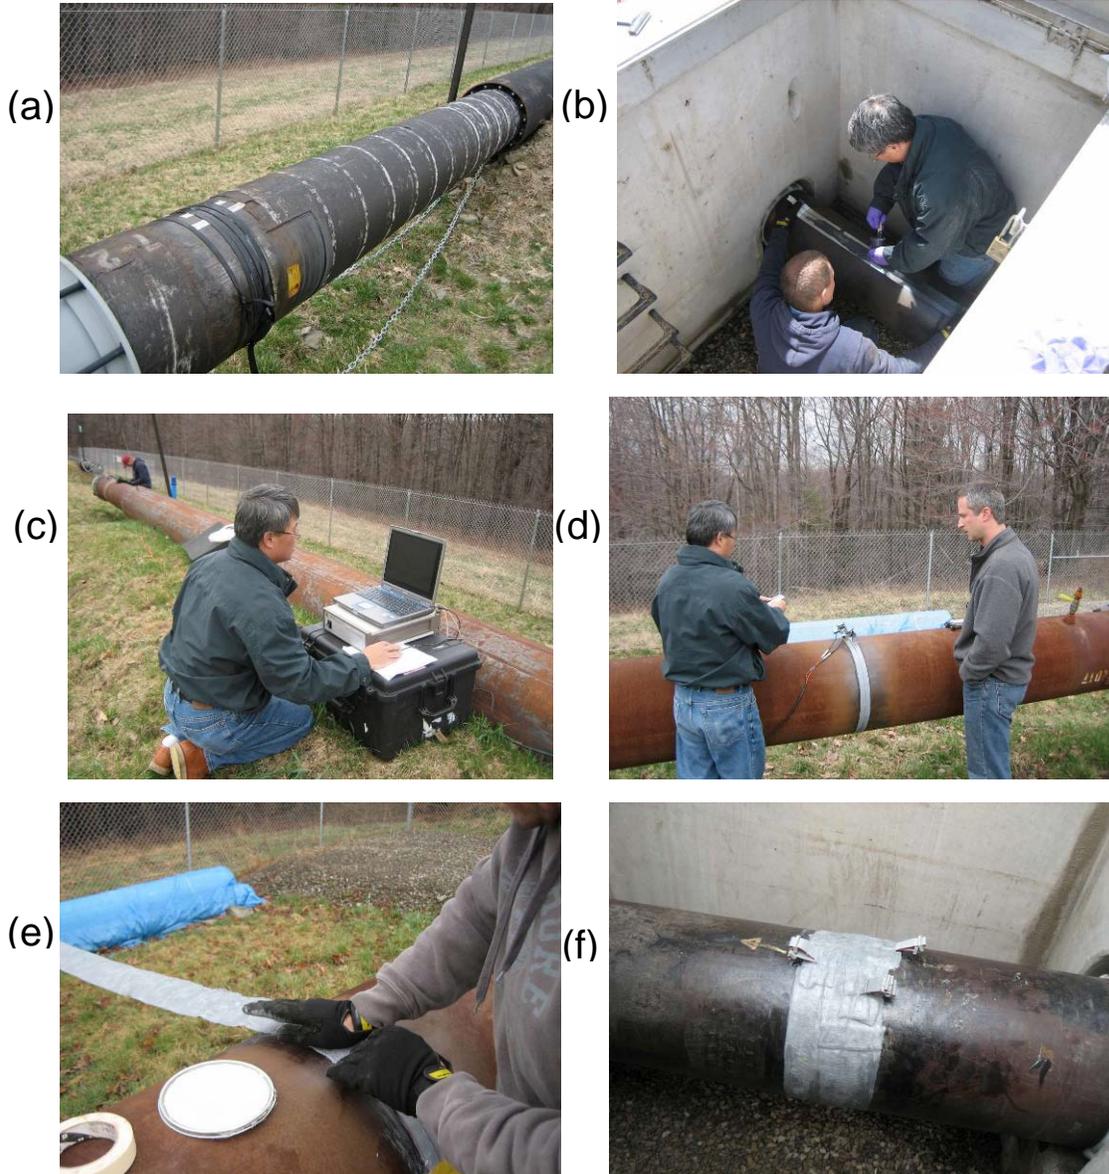
Figure 37. Photos of MsS testing at the NYSEARCH/NGA test bed facility: (a) rubber strap wrapped over the magnetostrictive strips bonded around the 16-inch-OD TGF-3-coated pipeline, (b) applying epoxy on the magnetostrictive strips for bonding to the 12-inch-OD CTE steel pipeline, (c) MsS system during data acquisition from the 20-inch-OD bare steel pipeline, (d) MsS ribbon coils placed over the magnetostrictive strips for testing, (e) wax tape applied over the MsS ribbon coils for protection from environment for long-term monitoring, and (f) MsS ribbon coils installed with protective wax tape on the 12-inch-OD CTE steel pipeline; the exposed ends of the ribbon coils were later wrapped with plastic tape for protection.

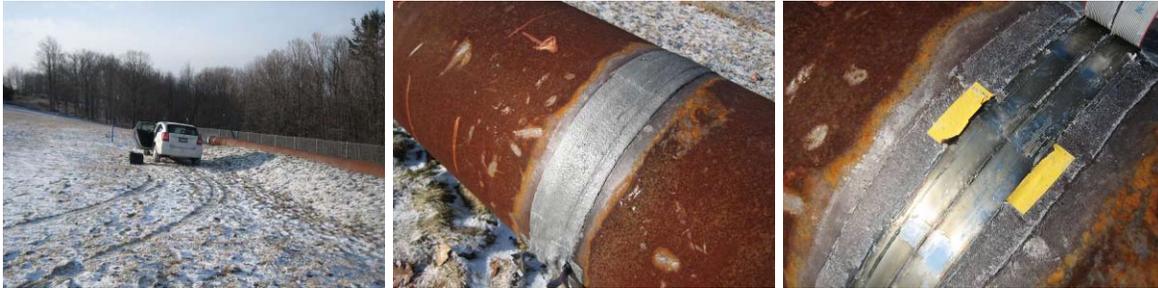
Figure 38. Photos from the 2<sup>nd</sup> SHM testing: scenery of the test bed (left), installed sensors on 20-inch bare pipe (middle), and the iron-cobalt strips exposed after the wax tape and MsS ribbon coils were removed (right)

Two monitoring tests were conducted – 1<sup>st</sup> on November 6, 2007 and 2<sup>nd</sup> on February 20, 2008. The temperature during the 1<sup>st</sup> SHM measurements was in the low 40s in F. During the 2<sup>nd</sup> SHM measurements, the temperature ranged from about 15 to 25° in F. After the 2<sup>nd</sup> SHM measurements, the installed sensors on the test pipes were removed. Photos taken during the 2<sup>nd</sup> SHM testing are shown in Figure 38.

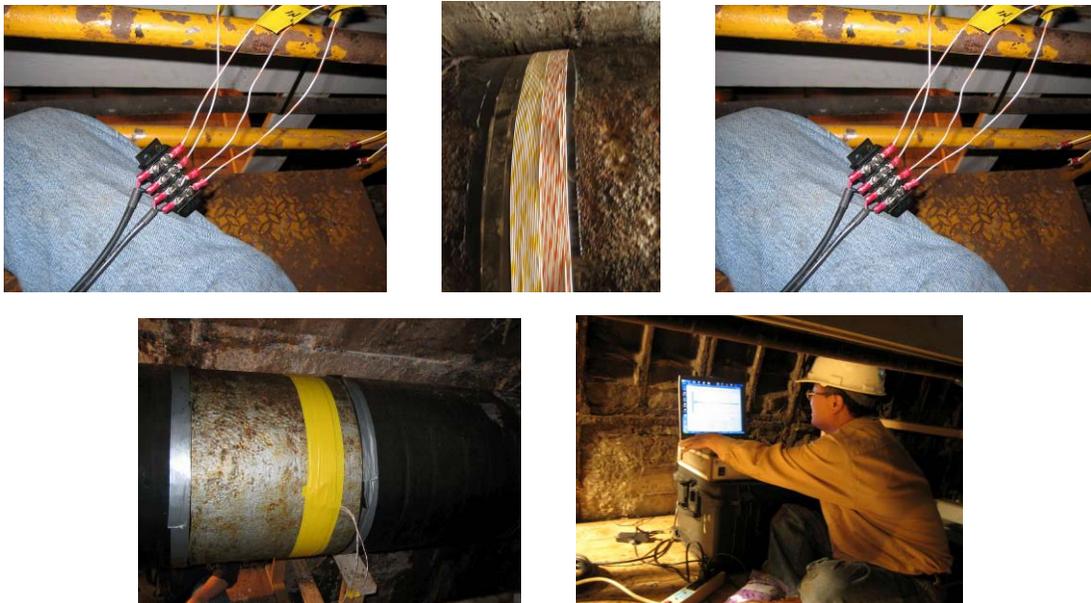
Figure 39. Photos of MsS testing on 26-inch OD gas pipeline: (a) a spool of #22 gauge insulated wire, (b) wires wound over the iron cobalt strips, (c) electrical connections to MsS instrument, (d) protective tape wound over the coils, and (e) acquisition of baseline data

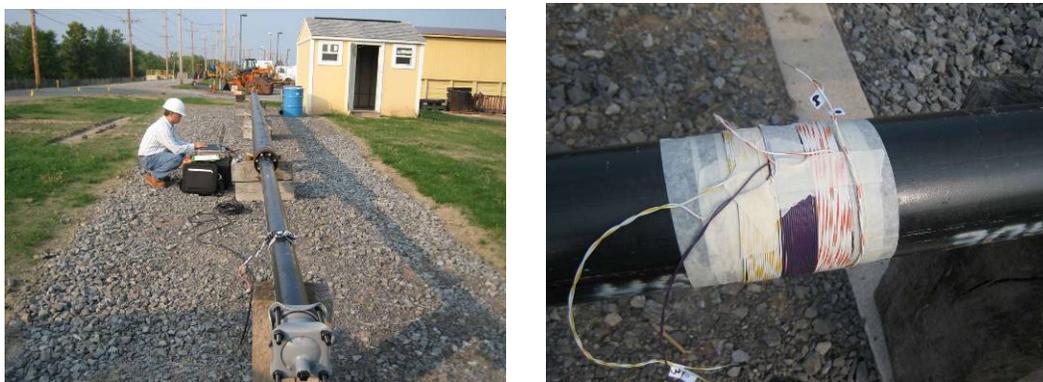
Figure 40. Photos of MsS testing on the 1st cased-pipeline mockup and installed probes

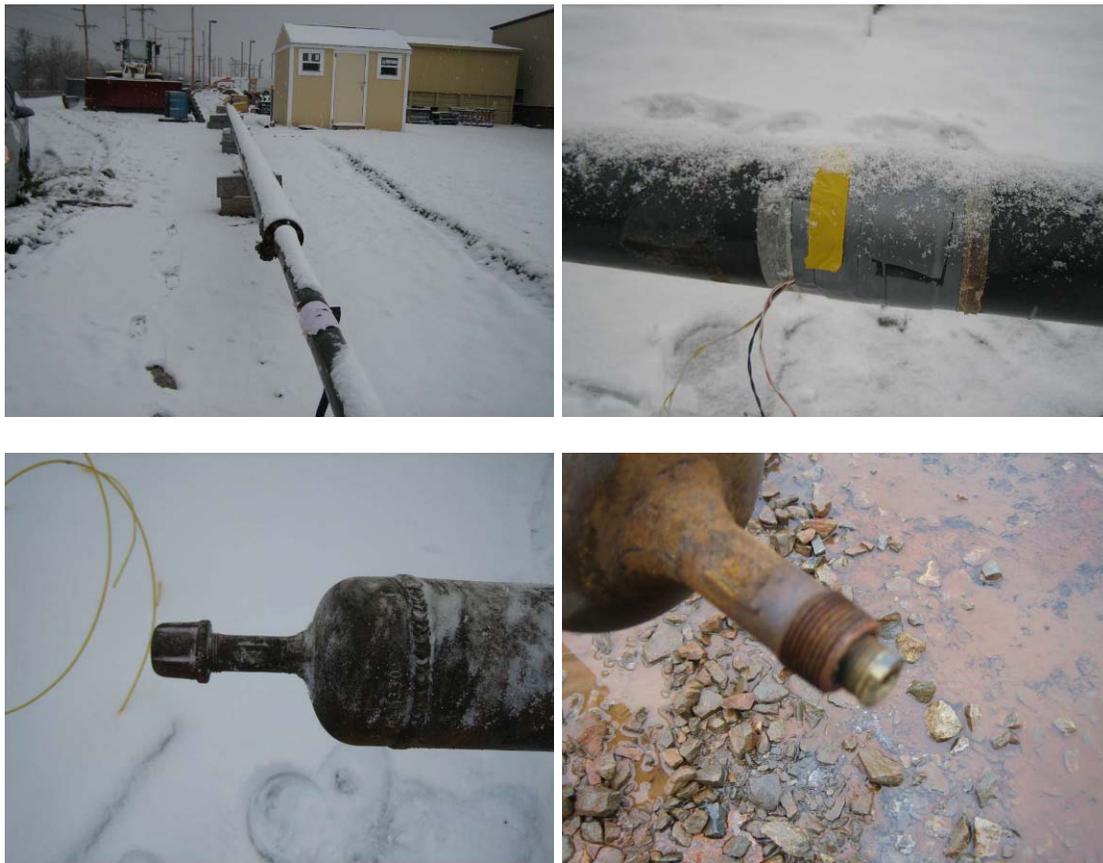
Figure 41 shows photos taken during the testing on the 2<sup>nd</sup> mockup.

Figure 41. Photos taken during the testing on the 2<sup>nd</sup> mockup: test pipe (top left), MsS probes (top right), and ends of test pipe (bottom)

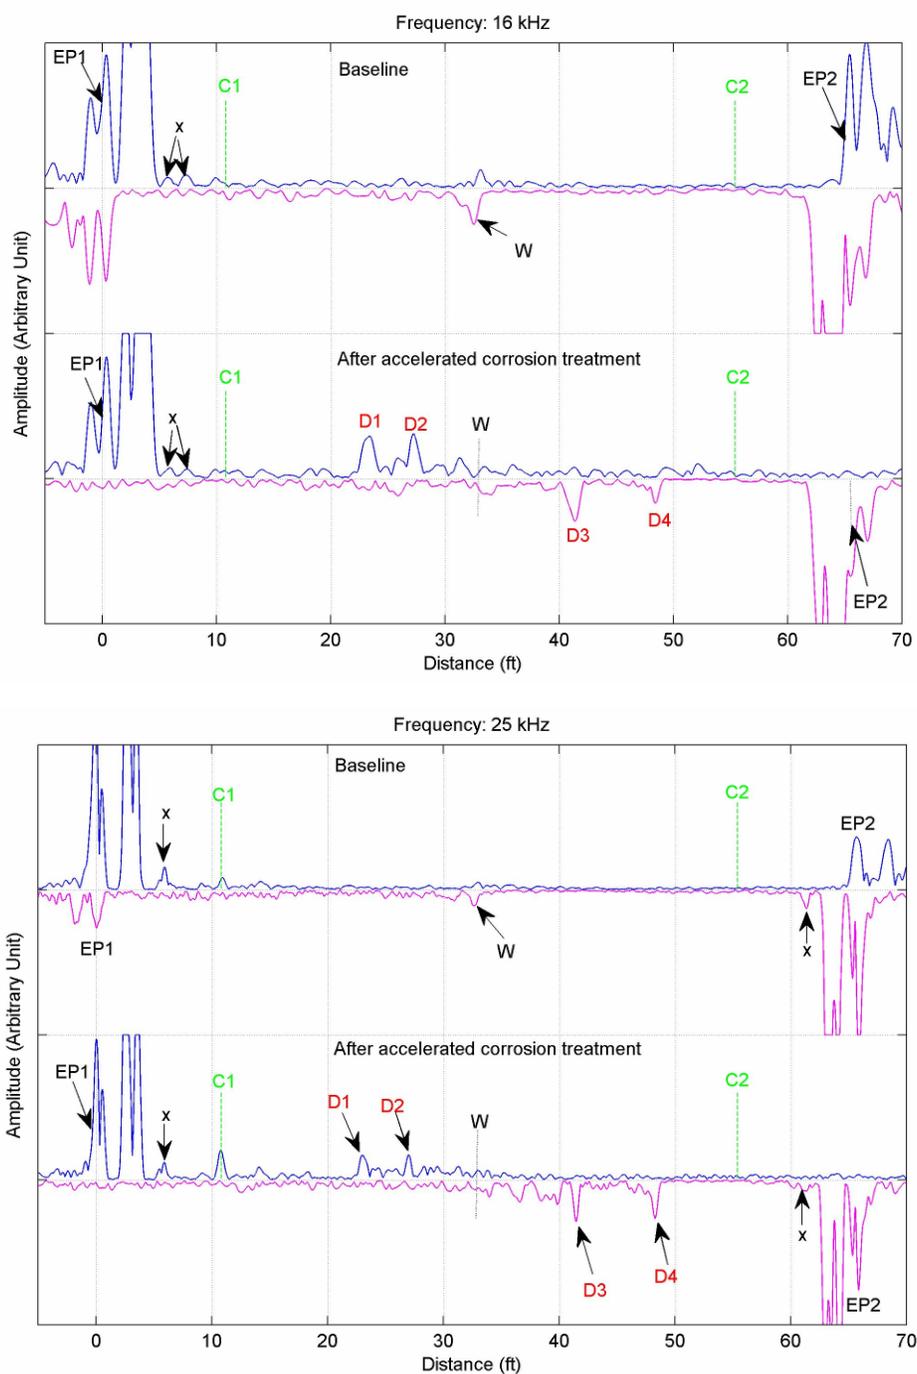
Figure 42. 16-kHz (a) and 25-kHz (b) data from the 1<sup>st</sup> RG&E cased-line mockup: top – baseline data, bottom – data taken after the accelerated corrosion treatment. Blue line is for the data taken from the east end of the pipe (EP1). Pink line is for the data taken from the west end of the pipe (EP2). C1 and C2 are the casing ends.

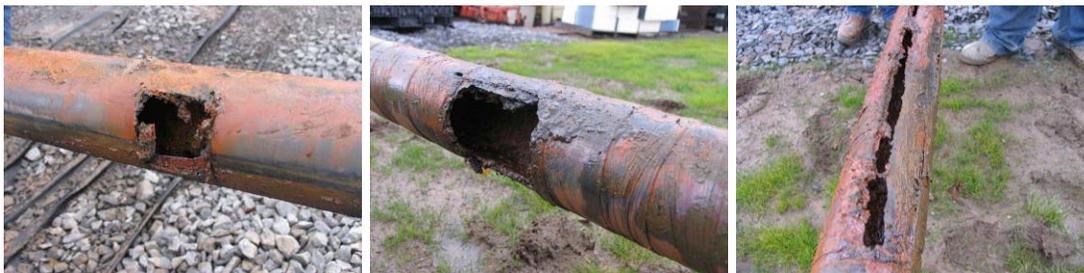
Figure 43. Photos of defects induced in the 1<sup>st</sup> RG&E test pipe: large defects (left two) and 2.8% CSA defect around the weld location (right)

After the SHM measurements, RG&E staff members pulled the test pipe out of the casing and observed the defects induced in the test pipe. The four defects were large rectangular-shaped through-holes with circumferential CSA ranging from 21 to 42% of the total pipe-wall cross-section and about 3 to 6 inches in axial length. Photos of these large defects are shown in Figure 43 along with a photo of 2.8% CSA defect induced around the weld location; the latter defect was not clearly detectable from the SHM data because of the poor S/N ratio.

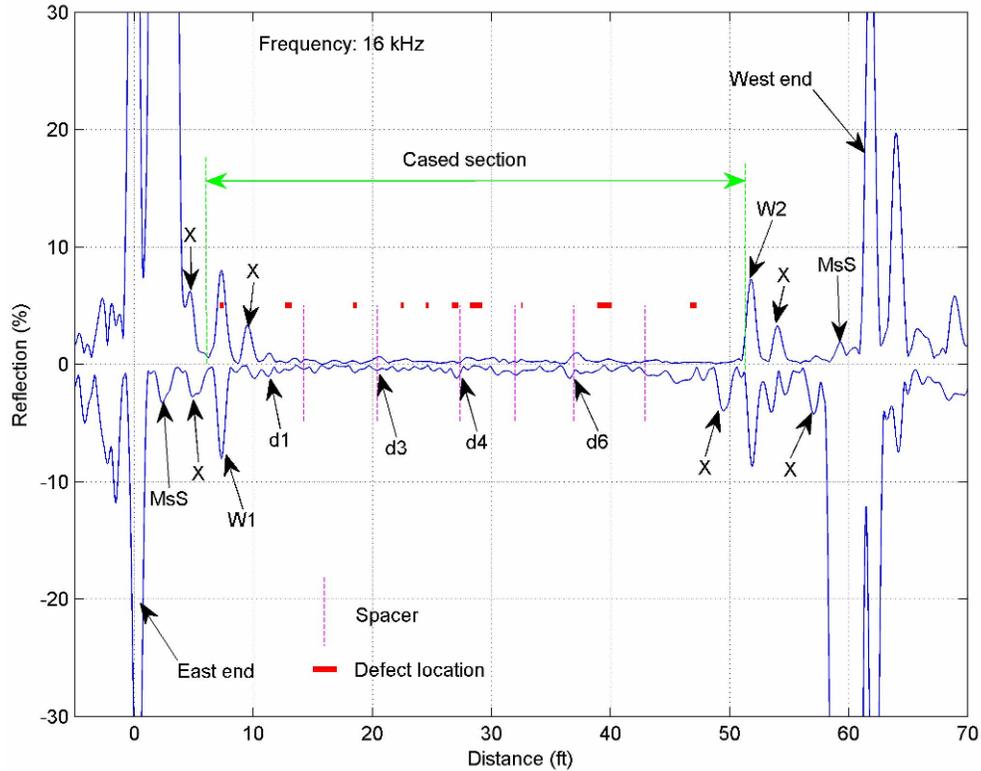
Figure 45. 16 kHz baseline data from the 2<sup>nd</sup> RG&E test pipe

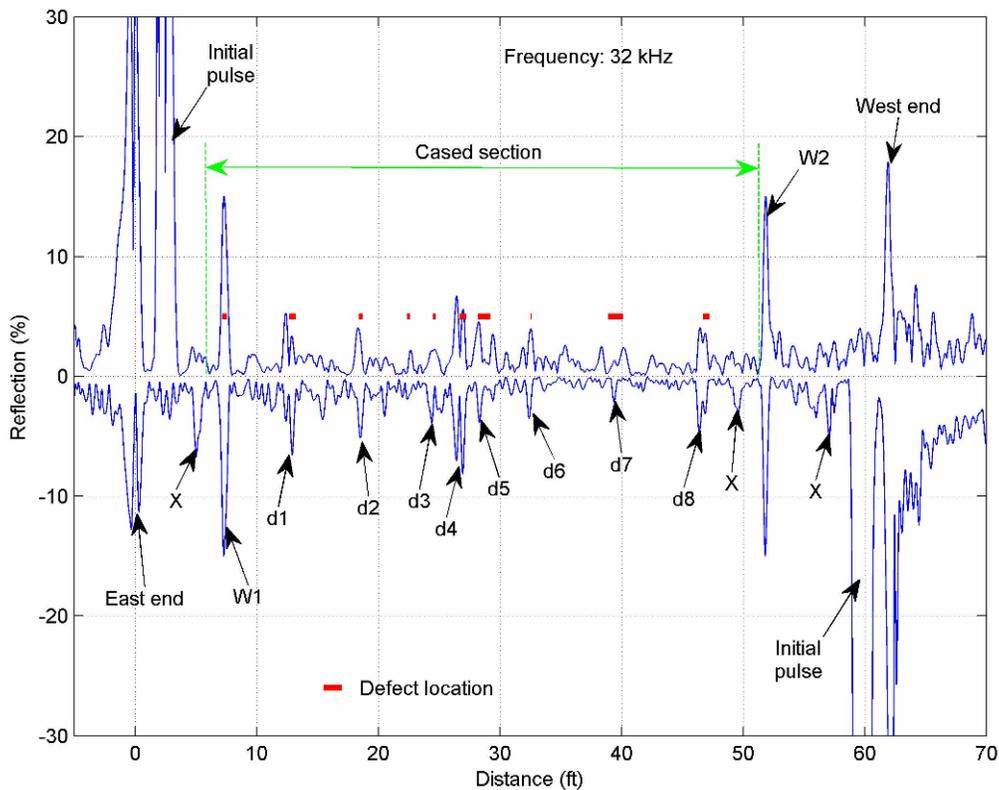
Figure 46. 1<sup>st</sup> SHM data at 32 kHz from the 2<sup>nd</sup> RG&E test pipe

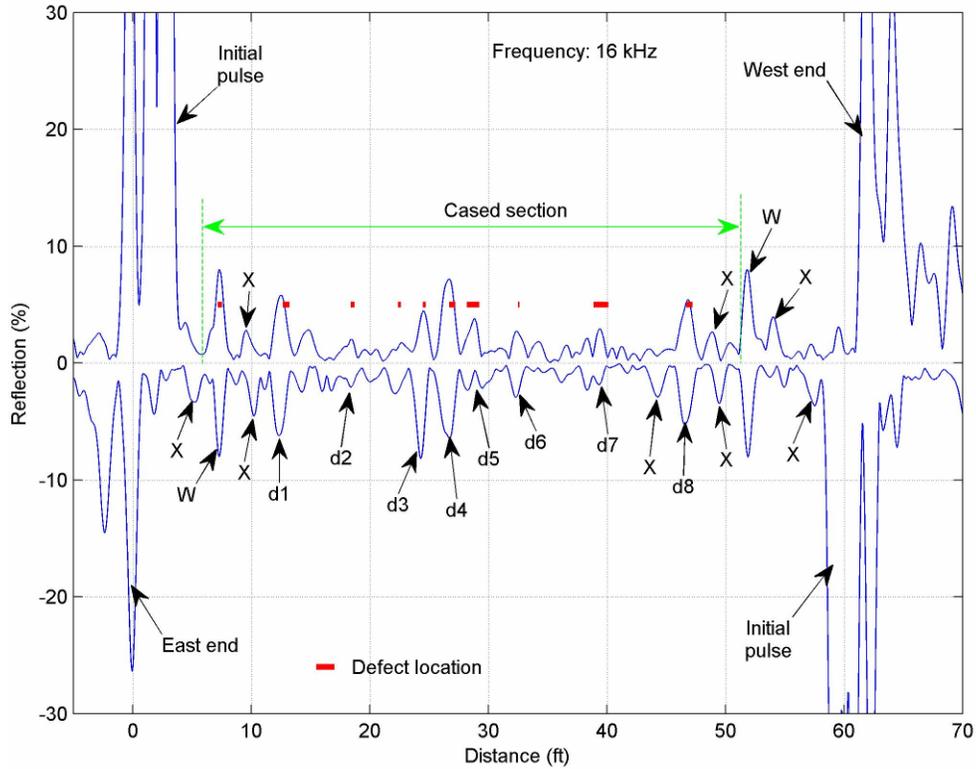
Figure 47. 1<sup>st</sup> SHM data at 16 kHz from the 2<sup>nd</sup> RG&E test pipe

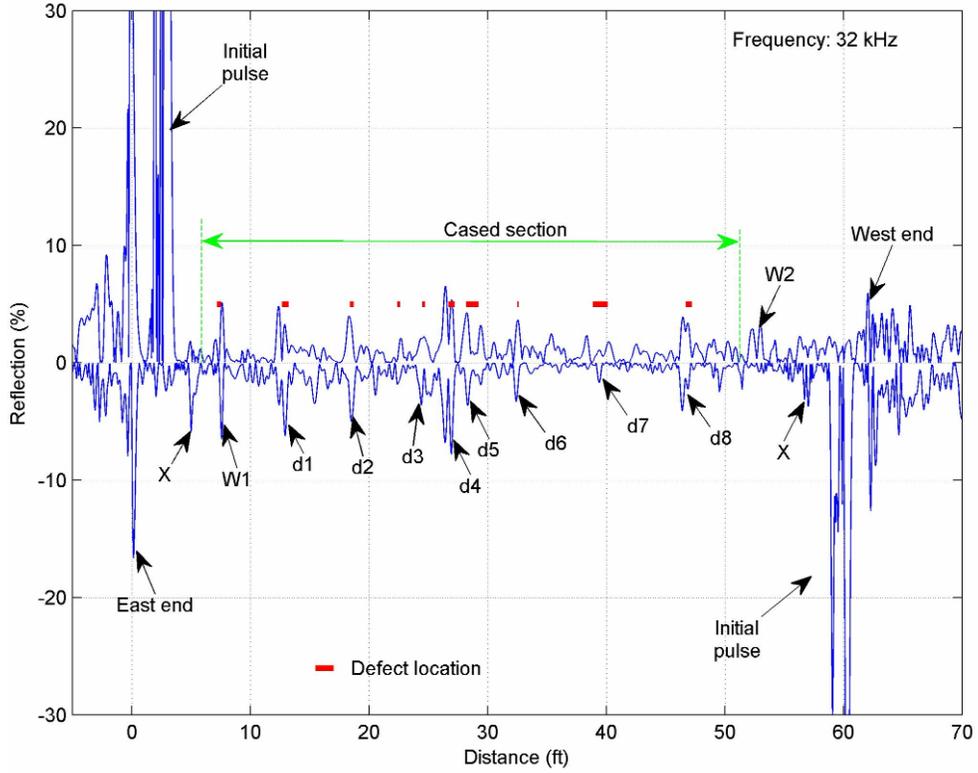
Figure 48. Difference between the baseline and the 1<sup>st</sup> SHM data at 32 kHz

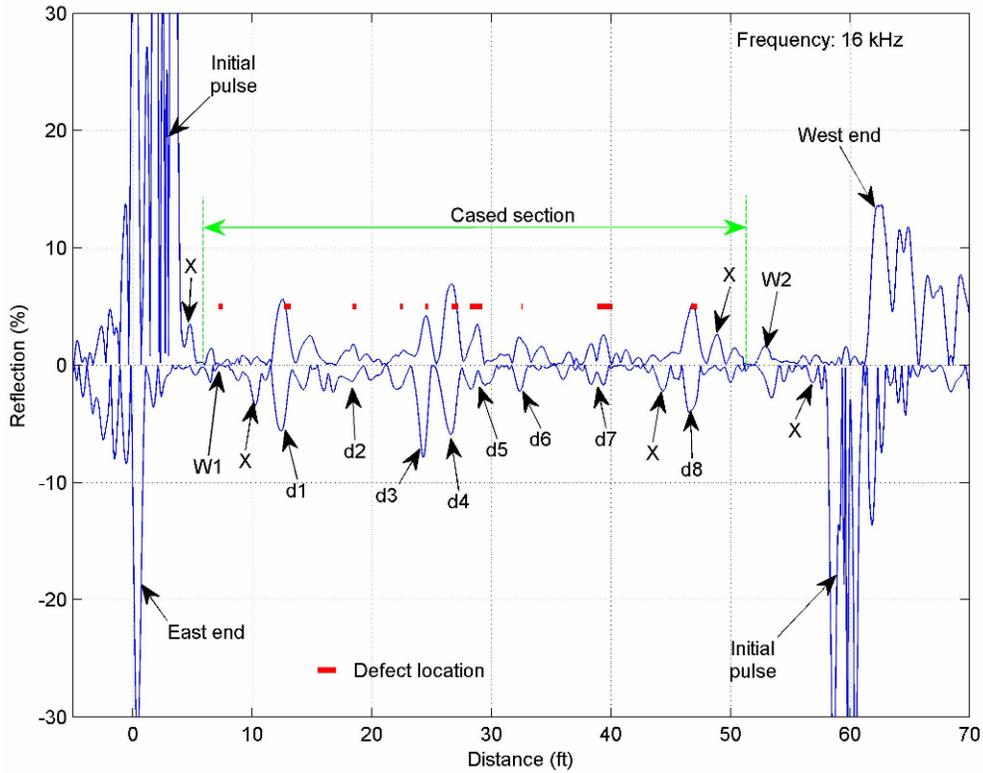
Figure 49. Difference between the baseline and the 1<sup>st</sup> SHM data at 16 kHz

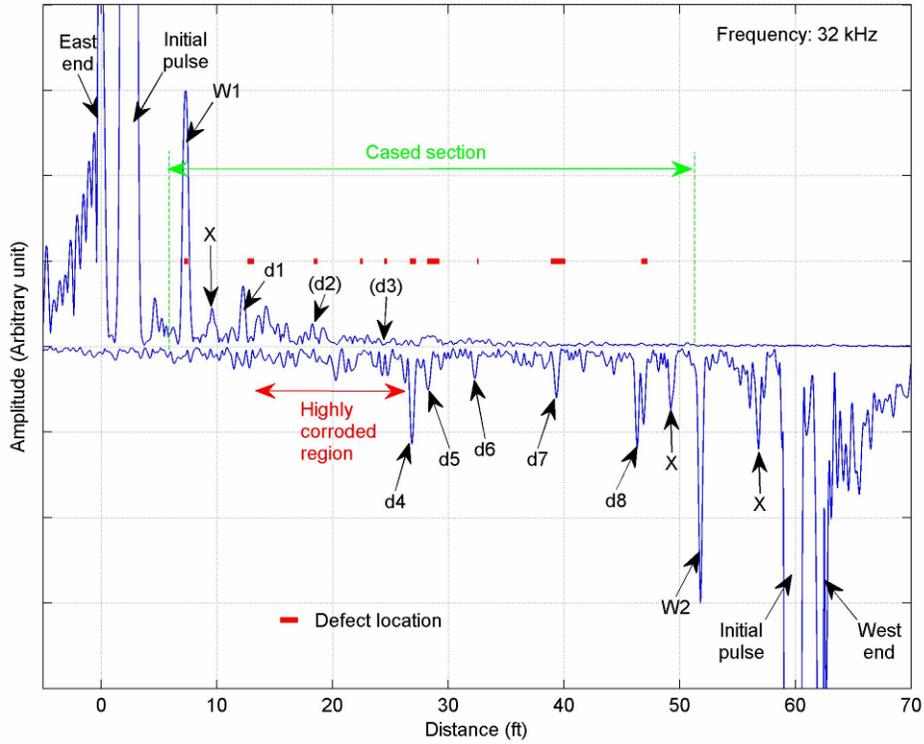
Figure 50. 2<sup>nd</sup> SHM data at 32 kHz from the 2<sup>nd</sup> RG&E test pipe

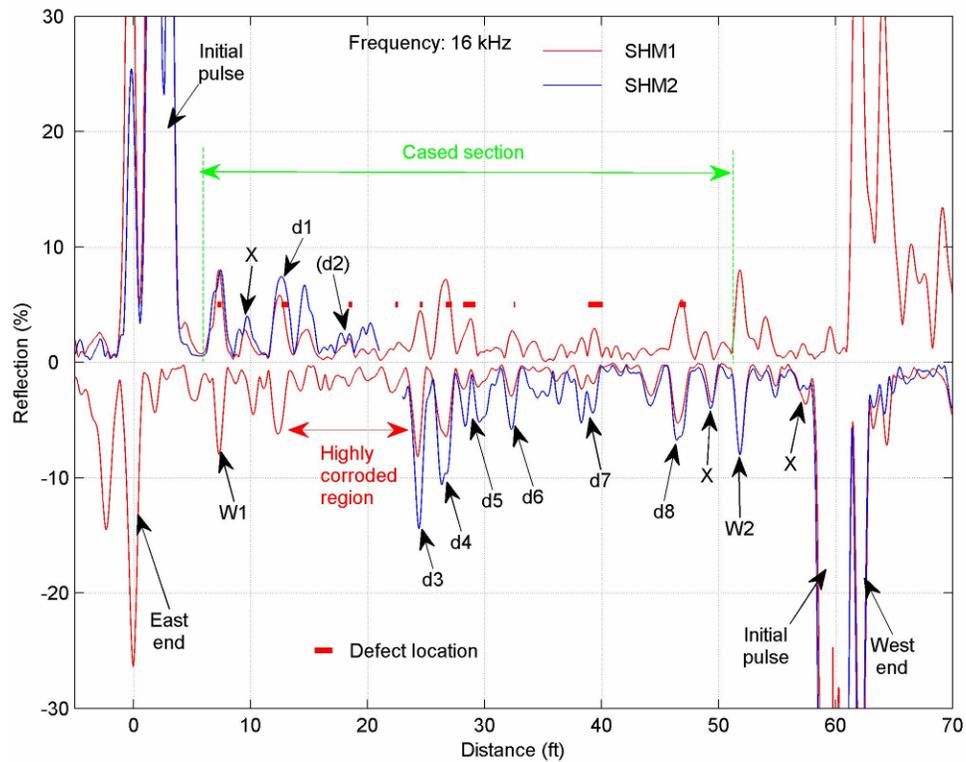
Figure 53. Comparison between the 1<sup>st</sup> and 2<sup>nd</sup> SHM data at 16 kHz

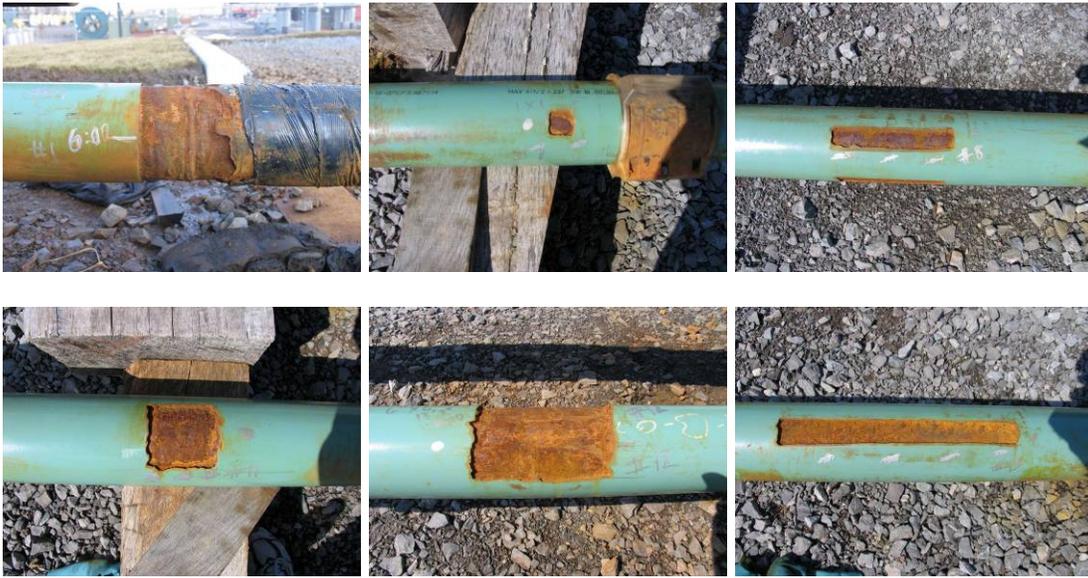
Figure 54. Photos of defects induced in the 2nd RG&E Test Pipe: RG&E defect ID Nos. 1, 7, 8 (top row from left to right) and 11, 12, 15 (bottom row from left to right)

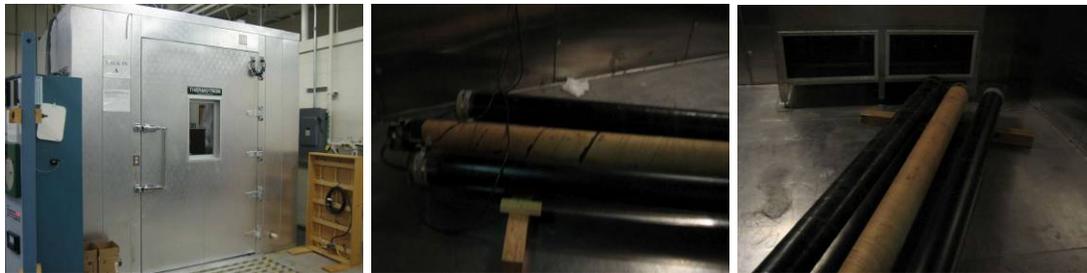
Figure 55. Environmental chamber (left) and three coated pipe samples (middle and right)

For each coating type, a 10-ft-long, 6-5/8-inch OD and 0.28-inch wall pipe sample was acquired. On each sample, MsS probes were installed near one end. All three samples were then placed in a large environmental chamber as shown in Figure 55 photos.

The temperature was cycled over a range from 0 to 120° F and MsS data (that showed several end reflected signals for attenuation measurements) was acquired at every 10° F increment at six different frequencies (10 to 60 kHz at every 10 kHz interval).

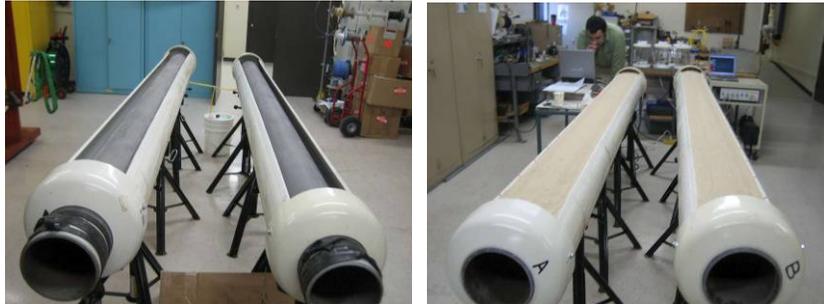
Figure 56. Photos of experimental setup for investigation of corrosion effects on guided-wave attenuation; samples placed in PVC pipes (left) and with the PVC pipe filled with sand (right)

For the investigation of general corrosion effects on the wave attenuation, two 10.3-ft-long, 6-5/8-inch OD and 0.28-inch wall, bare carbon steel (CS) pipe samples were acquired. Each sample was placed in a 10.5-inch OD PVP pipe with approximately 4-inch section of one end exposed for MsS as shown in Figure 56 (left photo). To encourage uniform corrosion, the pipe sample was sandblasted before placing it in the PVC pipe.

The initial plan for inducing general corrosion on the pipe OD surface involved embedding the pipe samples in sand by filling the PVC pipe with fine sand and then keeping the sand saturated with simulated seawater. Baseline MsS measurements on the pipe samples embedded in sand (right photo in Figure 56) showed that the surrounding sand causes a large increase in wave attenuation (from approximately 0.02 dB/ft at 10-kHz to 0.05 dB/ft at 140-kHz in air to 0.24 to 0.27 dB/ft with dry sand, and then to 0.80 to 0.83 dB/ft with saturated sand). Because accurate measurements of additional attenuation caused by general corrosion (which is expected to be small in the early stages of corrosion) in the presence of the large attenuation caused by the saturated sand are very difficult, the initial plan was abandoned.

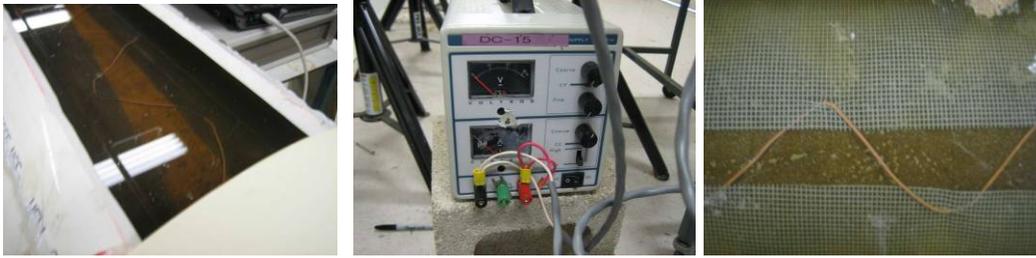
Figure 57. Photos of present experimental setup; PVC pipe filled with simulated seawater (left), power supply used to impress the electric current (middle), and fiberglass mesh wrapped around pipe sample (right)

Subsequently, a revised plan was developed that involved inducing general corrosion in simulated seawater solution with impressed electric current to accelerate corrosion. To implement the above, the sand was removed and three stainless steel tubes (1.25-inch OD) were attached to the inside surface of the PVC pipe, spaced at 120° apart around the pipe along the entire length of the PVC pipe. The PVC pipe was then filled with simulated seawater and anodic potentials were applied between the pipe sample and the stainless steel rods surrounding the sample. To help the resulting corrosion oxides remain attached to the pipe sample surface and the sample was wrapped with a fiberglass mesh. Figure 57 shows photos of the final experimental setup used for the investigation.

Baseline MsS measurements (made on November 17, 2008), confirmed that the water surrounding the pipe sample has no effects on the wave attenuation. While subjecting the pipe samples to impressed electric current, MsS data were acquired periodically (from 10- to 140-kHz at every 10-kHz interval). Final periodic measurements were made on February 9, 2009. Further details on the measurements are given in section 8.3.2.
