Prepared for: U.S. DOT/PHMSA

**LONG-TERM MONITORING OF CASED PIPELINES USING  
LONGRANGE  
GUIDED-WAVE TECHNIQUE**

**Final Report**

**NYSEARCH/Northeast Gas Association**

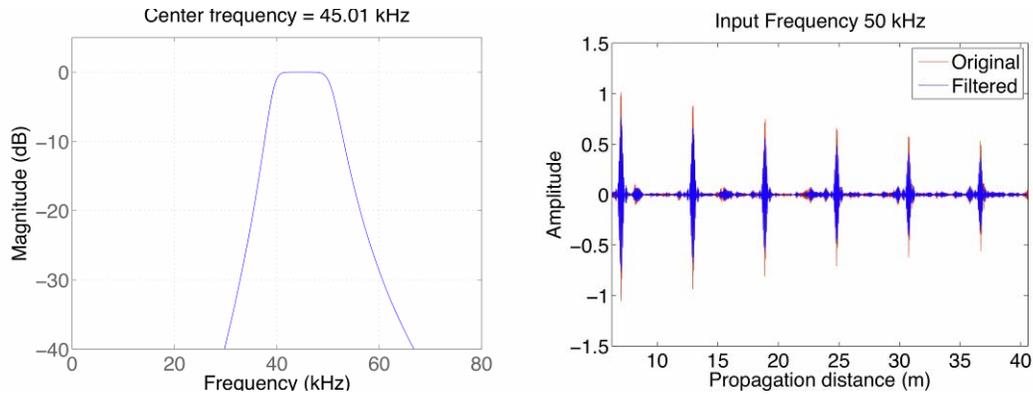
Figure 59. Example of the filter (left) and plots of original and filtered data (right) per procedure steps 2 and 3

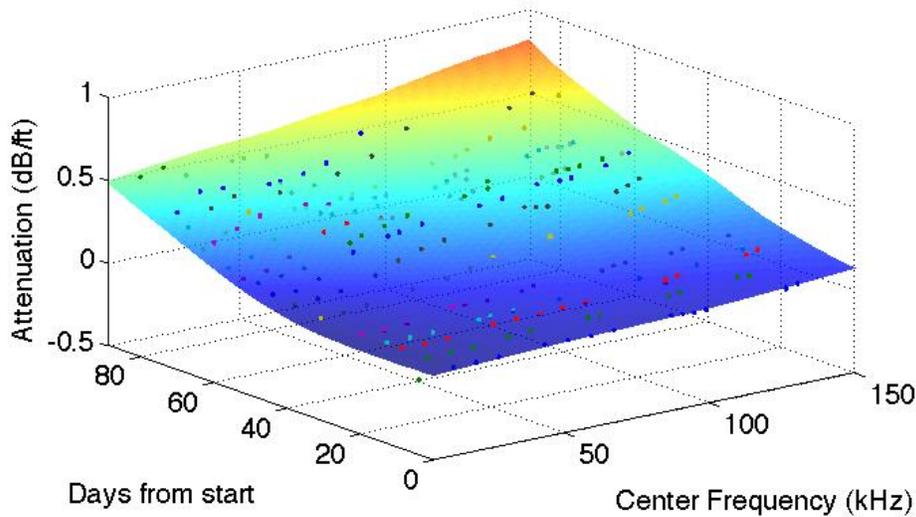
Figure 61. Example of a 3-D data plot and smoothly varying surface.

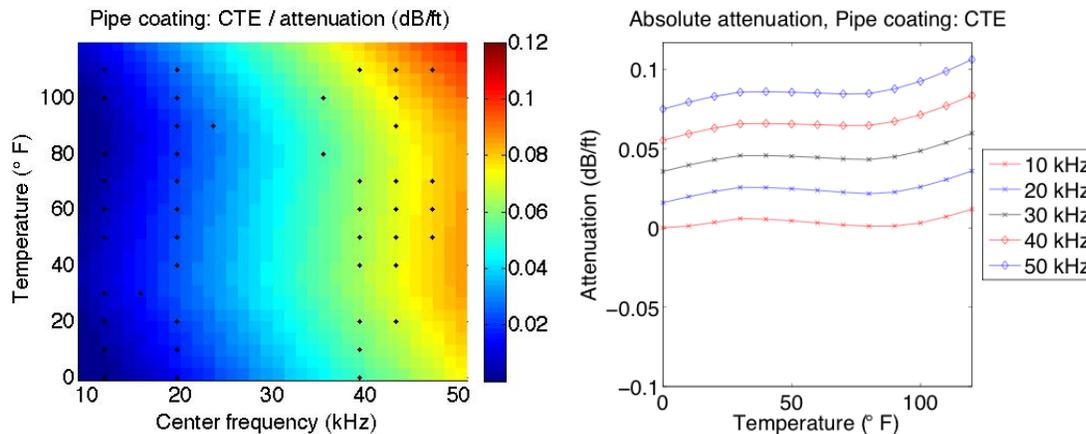
Figure 62. Experimental results from the coal tar epoxy (CTE) coated pipe sample. Left: attenuation surface as a function of frequency and temperature (data measured at the center frequencies shown as the black dots). Right: temperature dependence of attenuation at discrete frequencies.

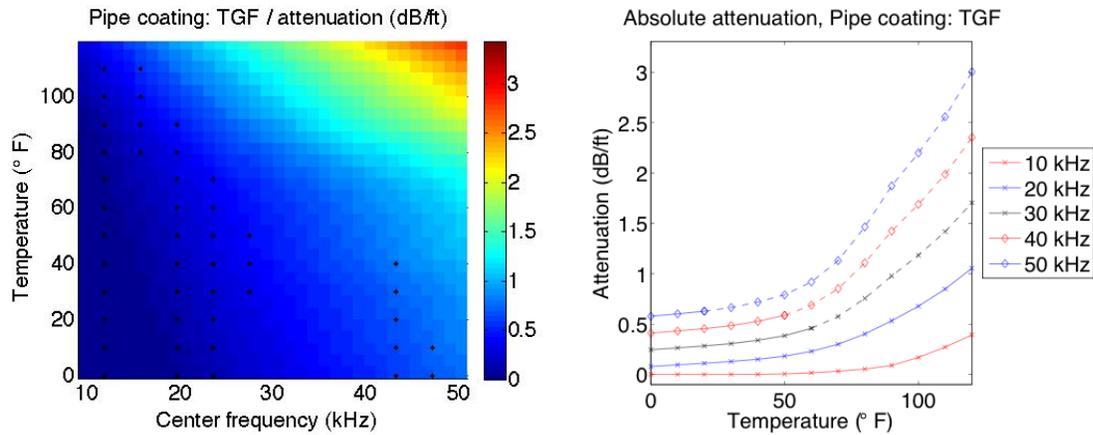
Figure 64. Experimental results from the coal tar (TGF-3) coated pipe sample. Left: attenuation surface as a function of frequency and temperature (data measured at the center frequencies shown as the black dots). Right: temperature dependence of attenuation at discrete frequencies, where dashed lines represent the extrapolated approximations.

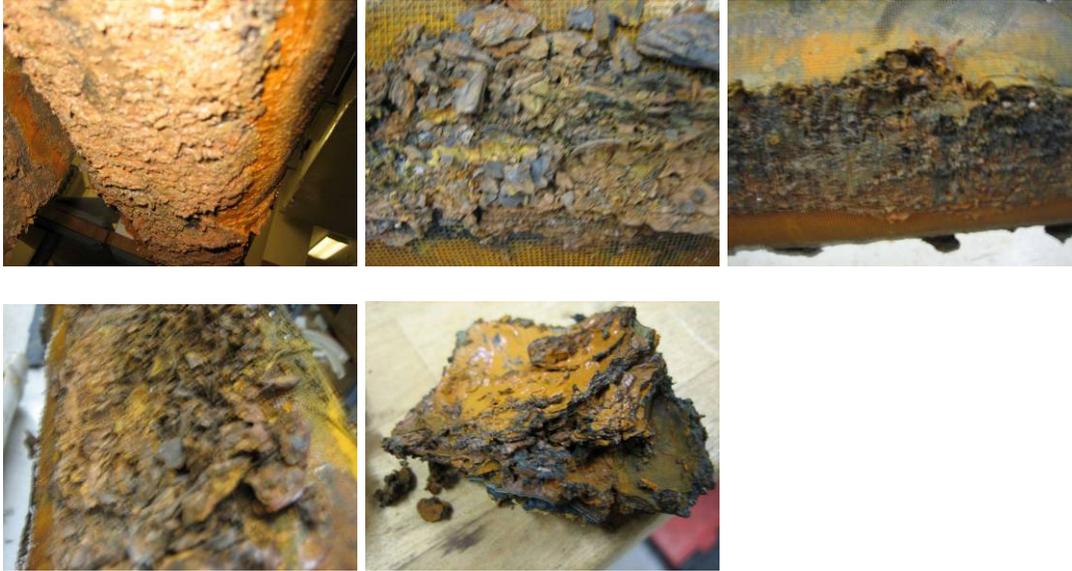
Figure 65. Photos of pipe surface on the bottom side (upper left), on sides (upper middle and right) and a piece of corrosion product (lower right)

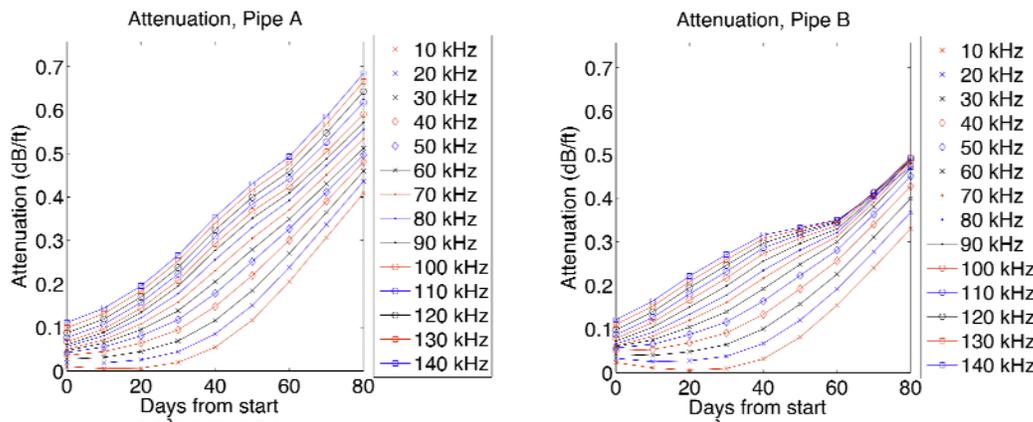
Figure 69. Attenuation as a function of days of corrosion treatment at various frequencies

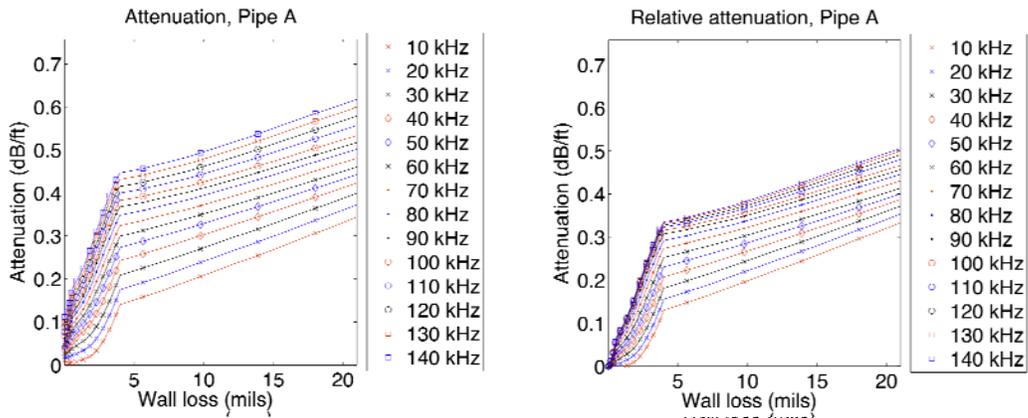
Figure 70. Attenuation as a function of wall loss level (left) and attenuation caused by corrosion (right)

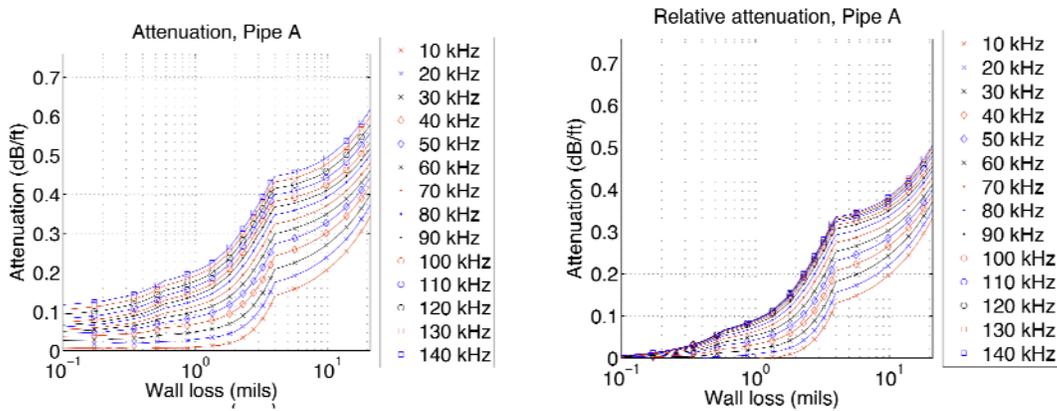
Figure 71. Attenuation as a function of wall loss level (left) and attenuation caused by corrosion (right)

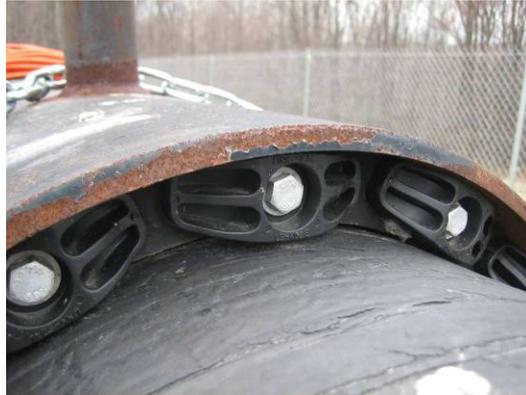
- The seal at the casing end shown in the photo or any spacers placed on the pipe did not produce detectable signals.

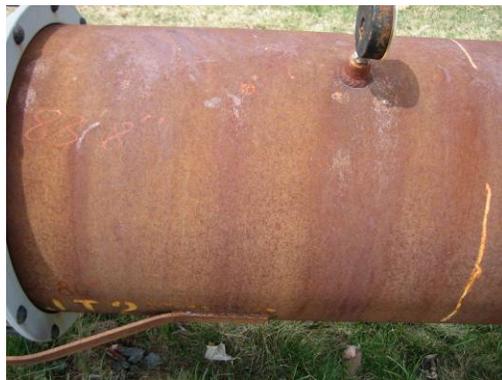
- The branch piping for pressure gauge and the weld attachments (indicated as BP in the test results) are shown in the photo below.

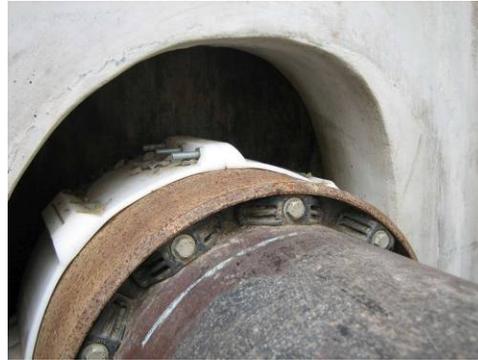
- The distance in the test results was referenced to the casing end of the 12-inch pipe (shown in the photo) in the north side vault.

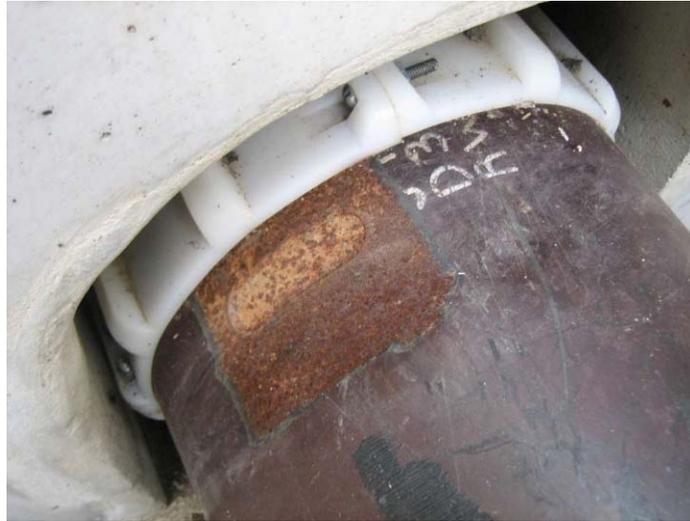
A photo of Spacer 9 in the South Excavation Vault

- (3) The 2<sup>nd</sup> SHM data from the south end vault showed a large signal from SP9. It appeared that the cold temperature on that day increased the tightness of the spacer (shown in the following picture), leading to a large wave reflection.

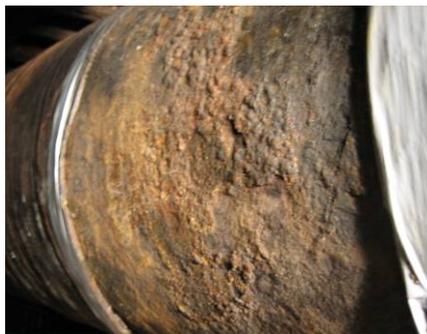
Figure 1. photo of pipe surface at the 1<sup>st</sup> test location

- (1) Both test locations had general corrosion and the pipe surface was rough as shown in Figure 1.

- (2) Due to the wax tape wrap and the general surface corrosion (corrosion oxide layers are good attenuators), the wave attenuation was high: average-wise about 0.5-dB/ft at 16-kHz and 1.0-dB/ft at 32-kHz.
