FINAL REPORT

EXTERNAL CORROSION DIRECT ASSESSMENT FOR UNIQUE THREATS TO UNDERGROUND PIPELINES

CONTRACT NO. DTPH56-06-T-0012

**PREPARED BY
CC TECHNOLOGIES, INC., A DNV COMPANY
MARK YUNOVICH, MS, MBA, NACE CORROSION SPECIALIST
STEVEN WATERS, BS**

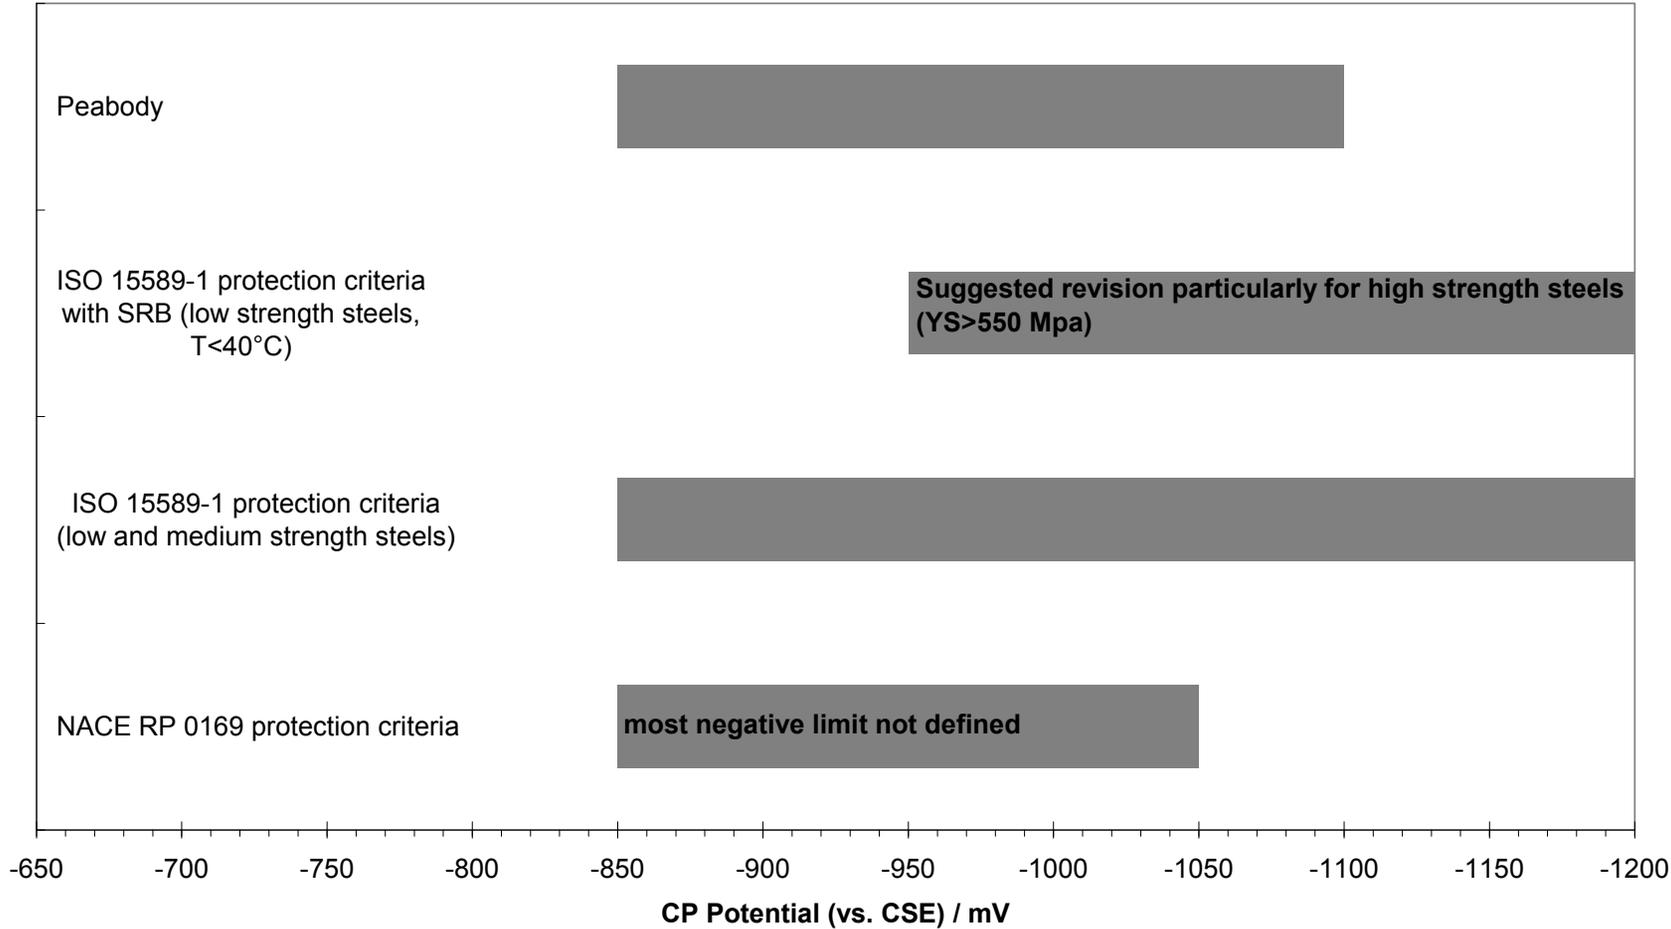
Figure 1. Summary of cathodic potential limits established by different standards and key literature.

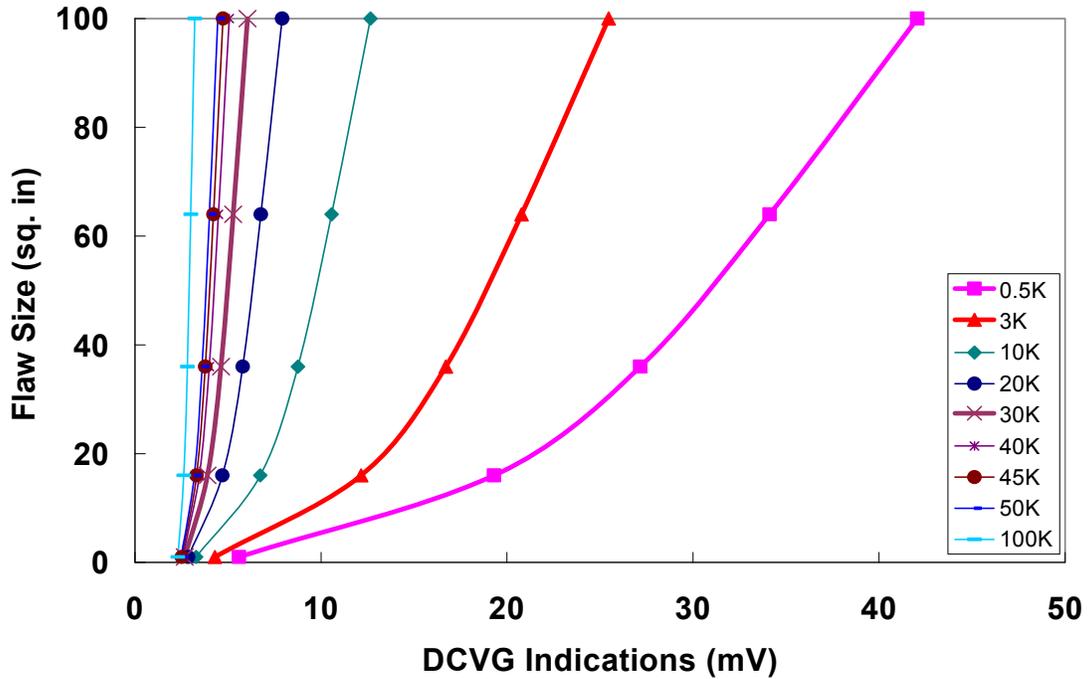
Figure 5. Predicted flaw size vs. DCVG signal strength (CP3D model). Cases for several soil resistivities are shown.

The graph in Figure 5 shows the correlation between the flaw (holiday) size and the DCVG signal strength.

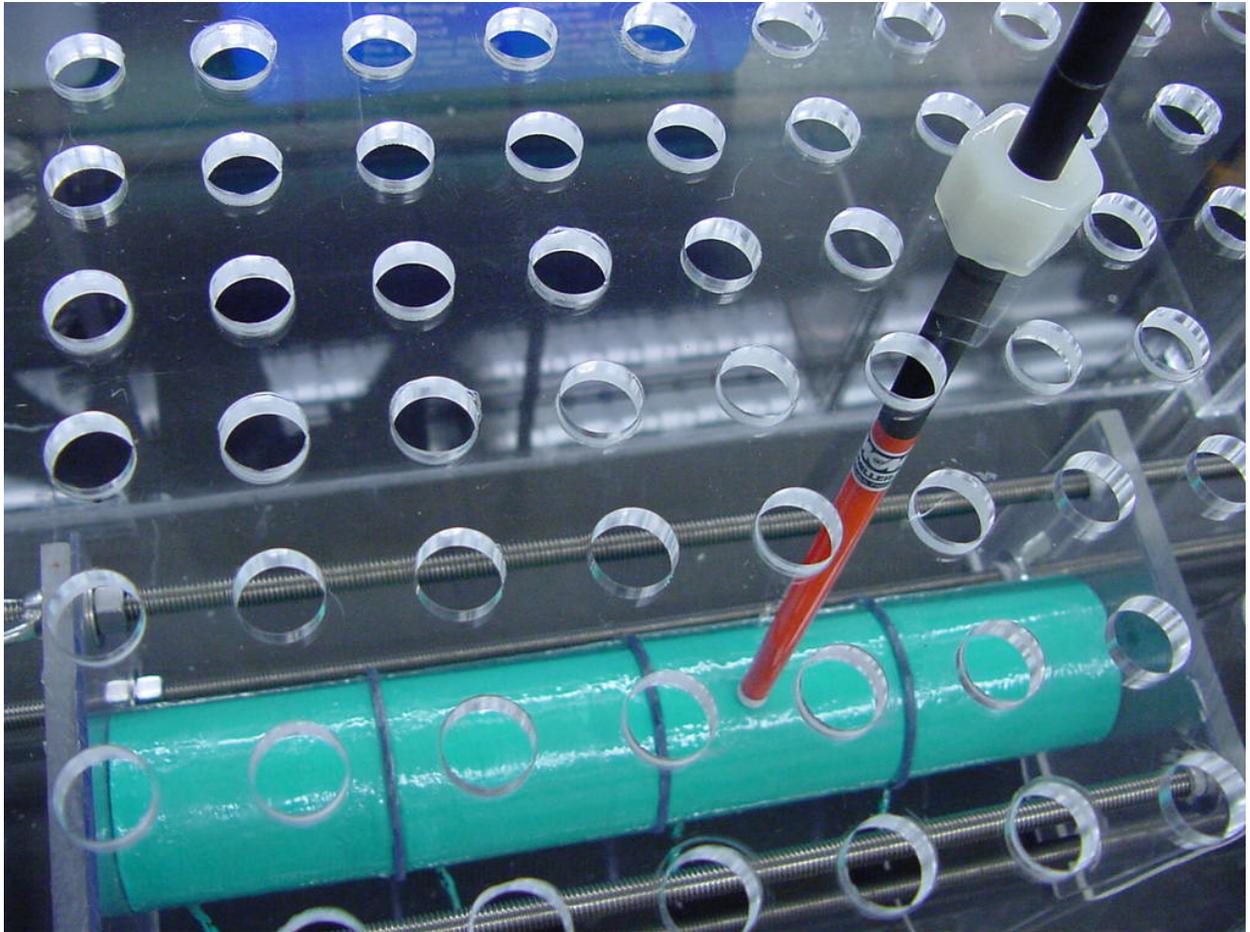
Figure 9. The pipe assembly inside the cell; the reference electrode is fed through the hole in the lid.

The photographs of the pipe segments, the actual cell with the pipeline assembly are shown in Figure 9 and Figure 10. The cell was covered with a lid with a network of approximately 280 equally spaced holes, such that a reference electrode position can be consistent. In addition to the pencil-shaped copper/copper sulfate reference electrodes, the potentials of the defects could be measured with the help of platinized niobium wires placed in close proximity to the defect surface. The platinized wire maintains a relatively stable potential and thus can be used a pseudo-reference electrode. The potential of the wire can be then measured against the standard CSE and convert the potential values measured with regard to Pt to the CSE scale.

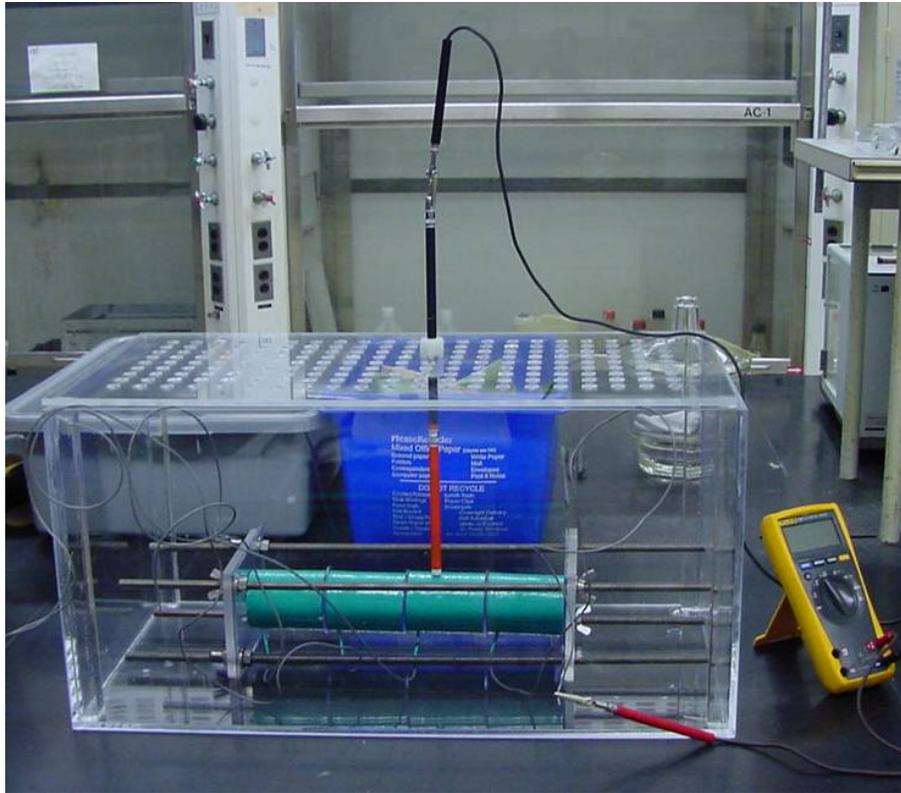
Figure 10. General view of the experimental cell and the pipe assembly.

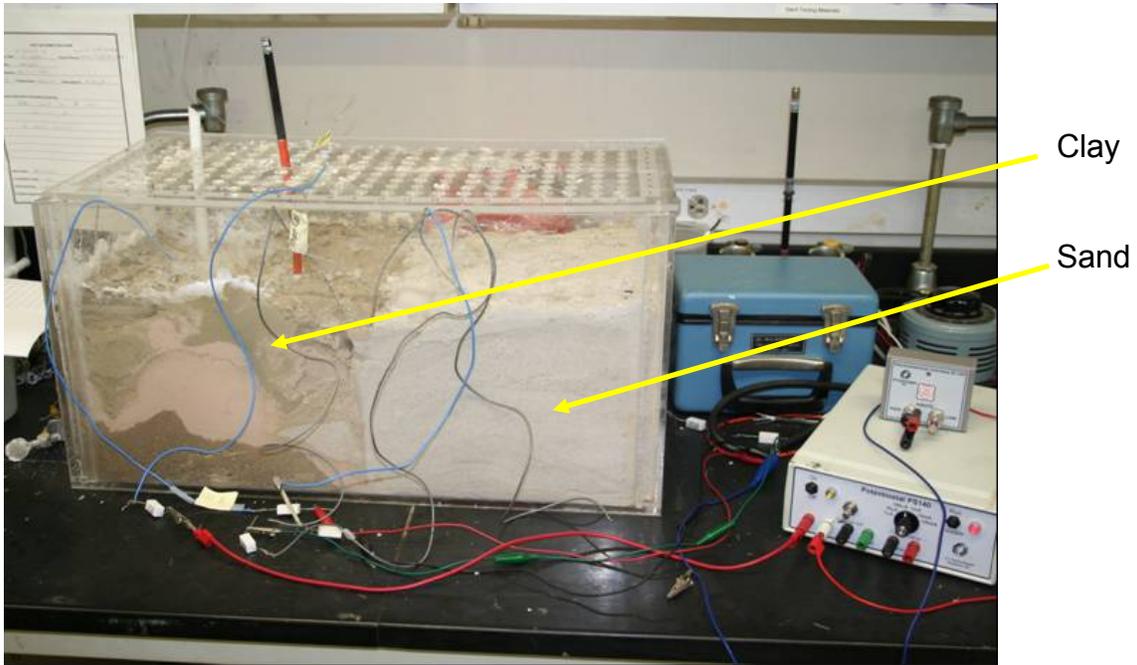
Figure 11. Small cell filled with clay and sand.

The resistivity of sand was considerably higher than that of clay (approximately 74,000 ohm-cm for sand and 90 ohm-cm for clay). The CP anode was located closer to Defect 1, in the sand portion of the cell.

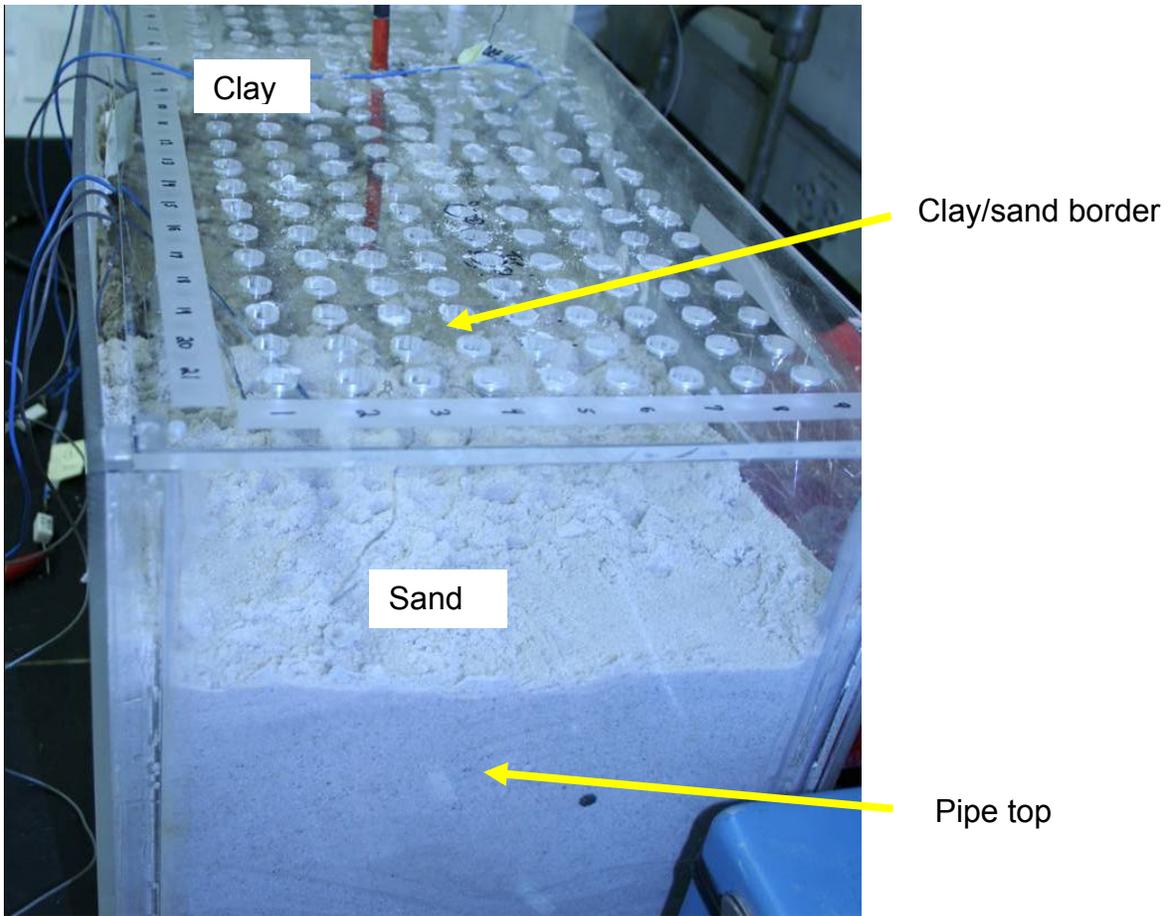
Figure 12. Small-cell experimental setup.

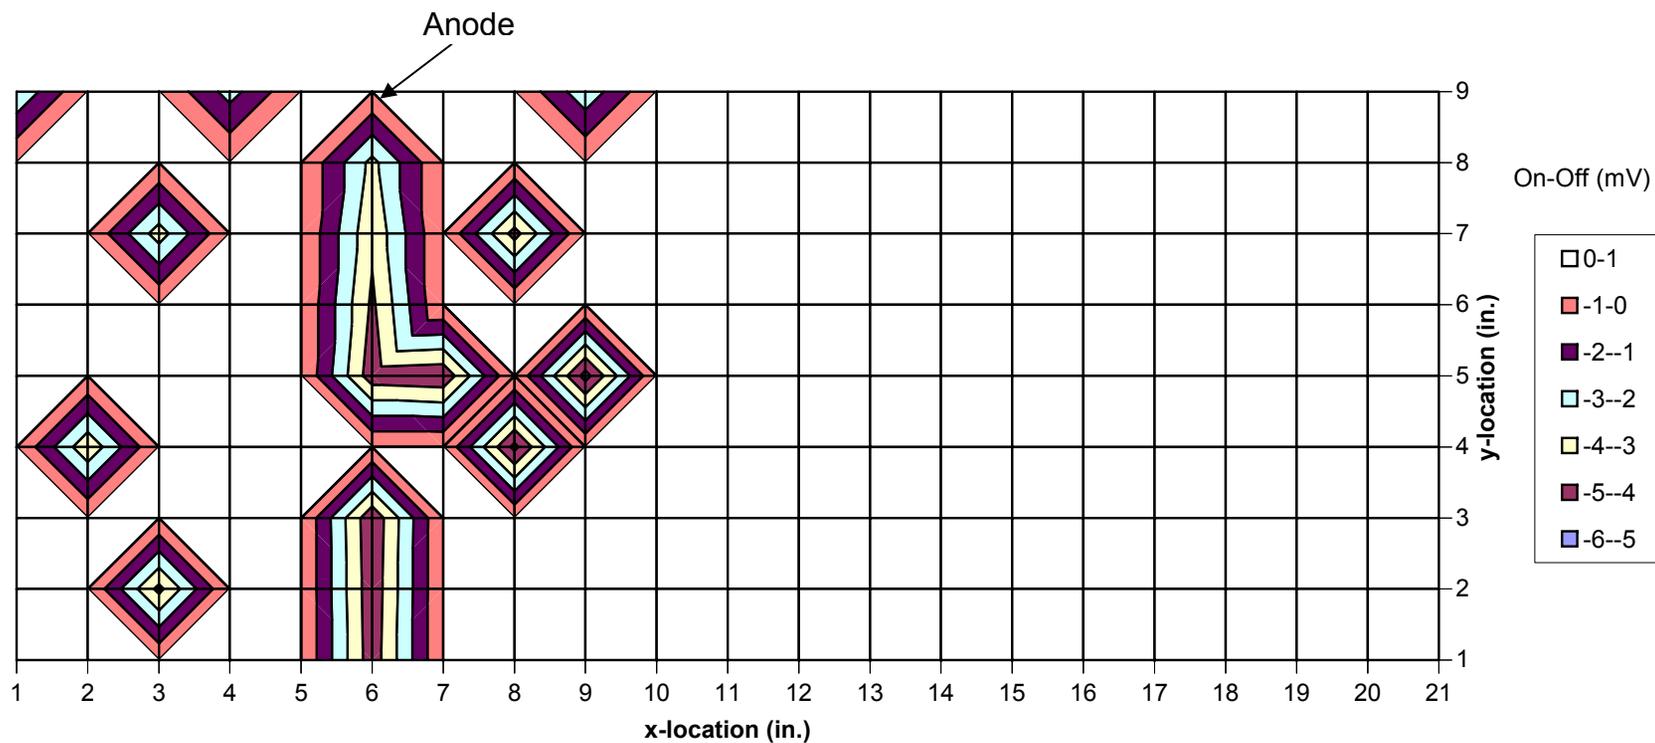
Figure 13. Contour plot of DCVG measurements near anode, $i = 0.931$ mA DC with anode positioned at $x=6, y=9$.

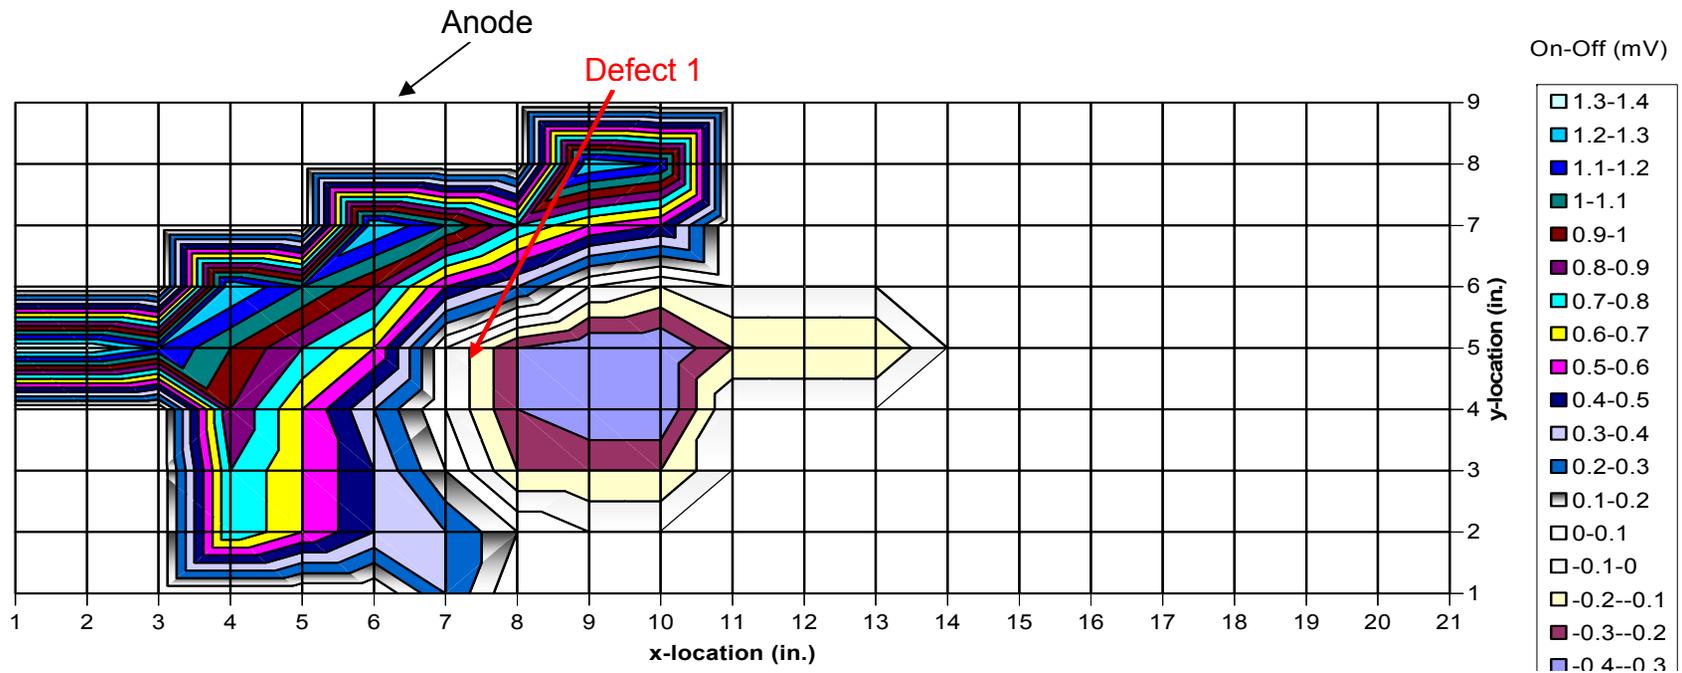
Figure 14. Contour plot of DCVG measurements near Defect 1 (Case 1).

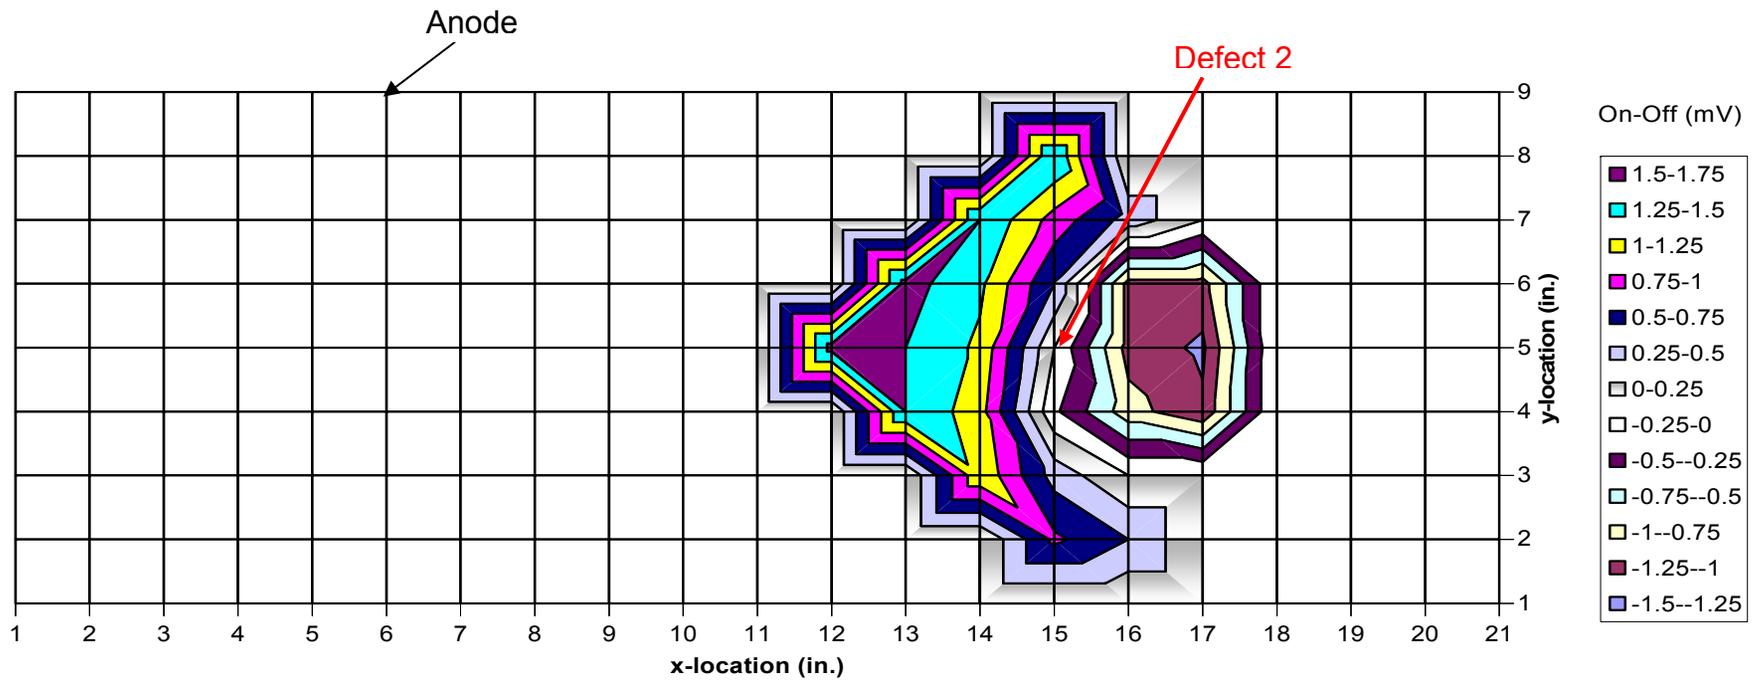
Figure 15. Contour plot of DCVG measurements near Defect 2 (Case 1).

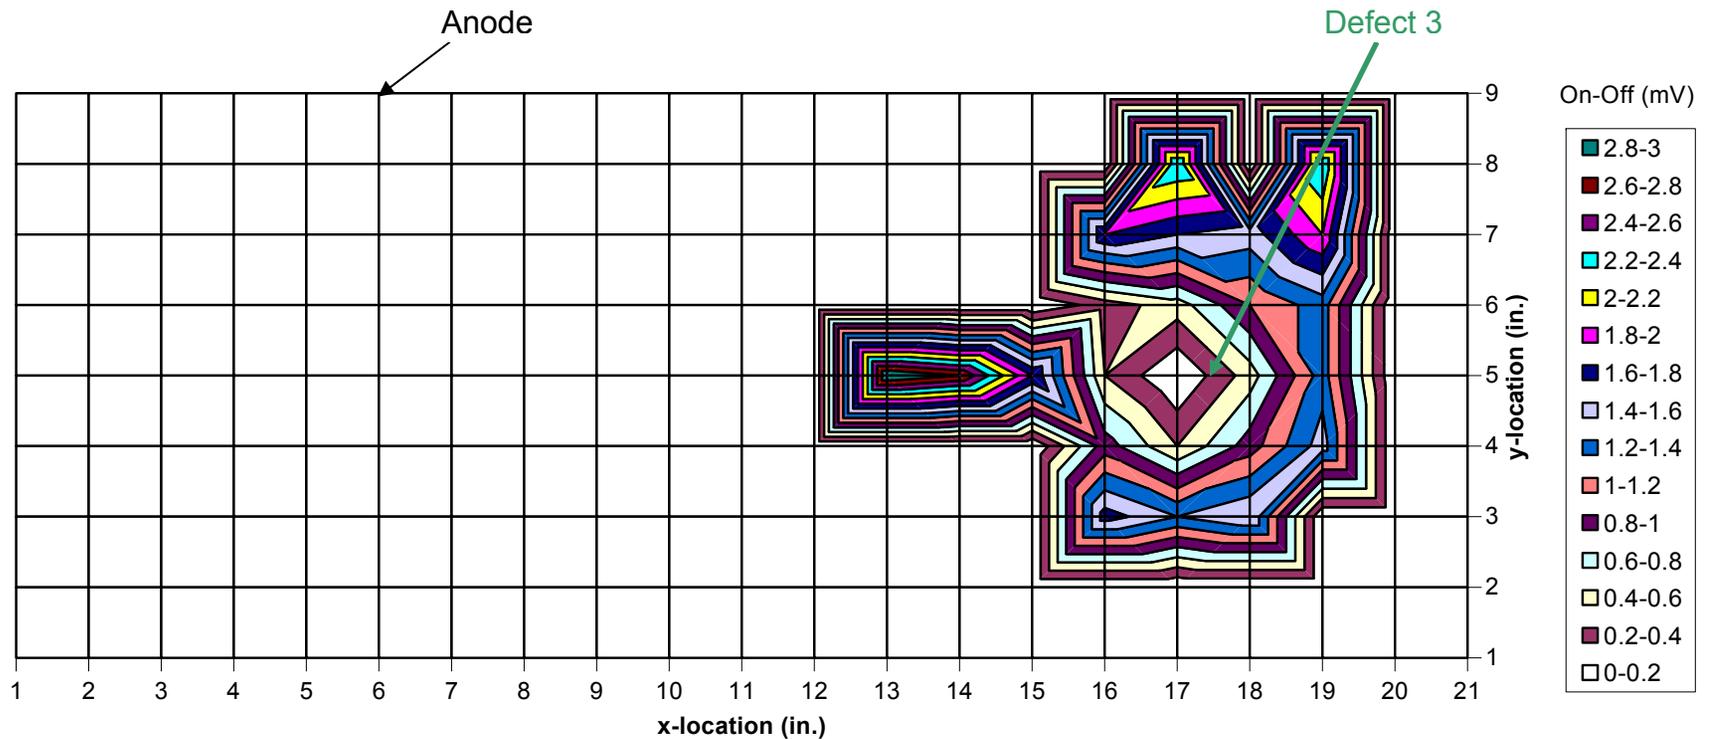
Figure 16. Contour plot of DCVG measurements near Defect 3 (Case 1).

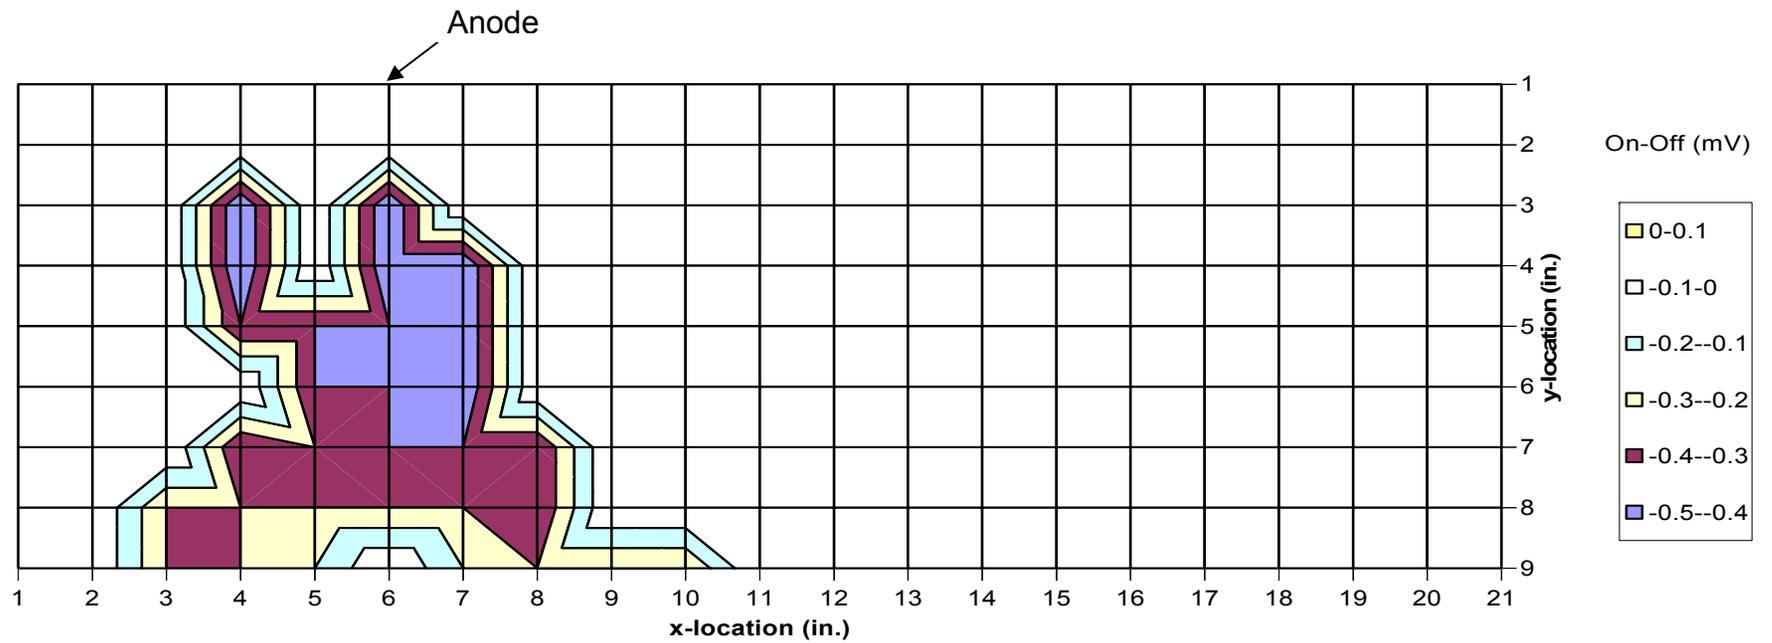
Figure 17. Contour plot of DCVG measurements near anode, $i = 0.118$ mA DC with anode positioned at $x=6, y=9$.

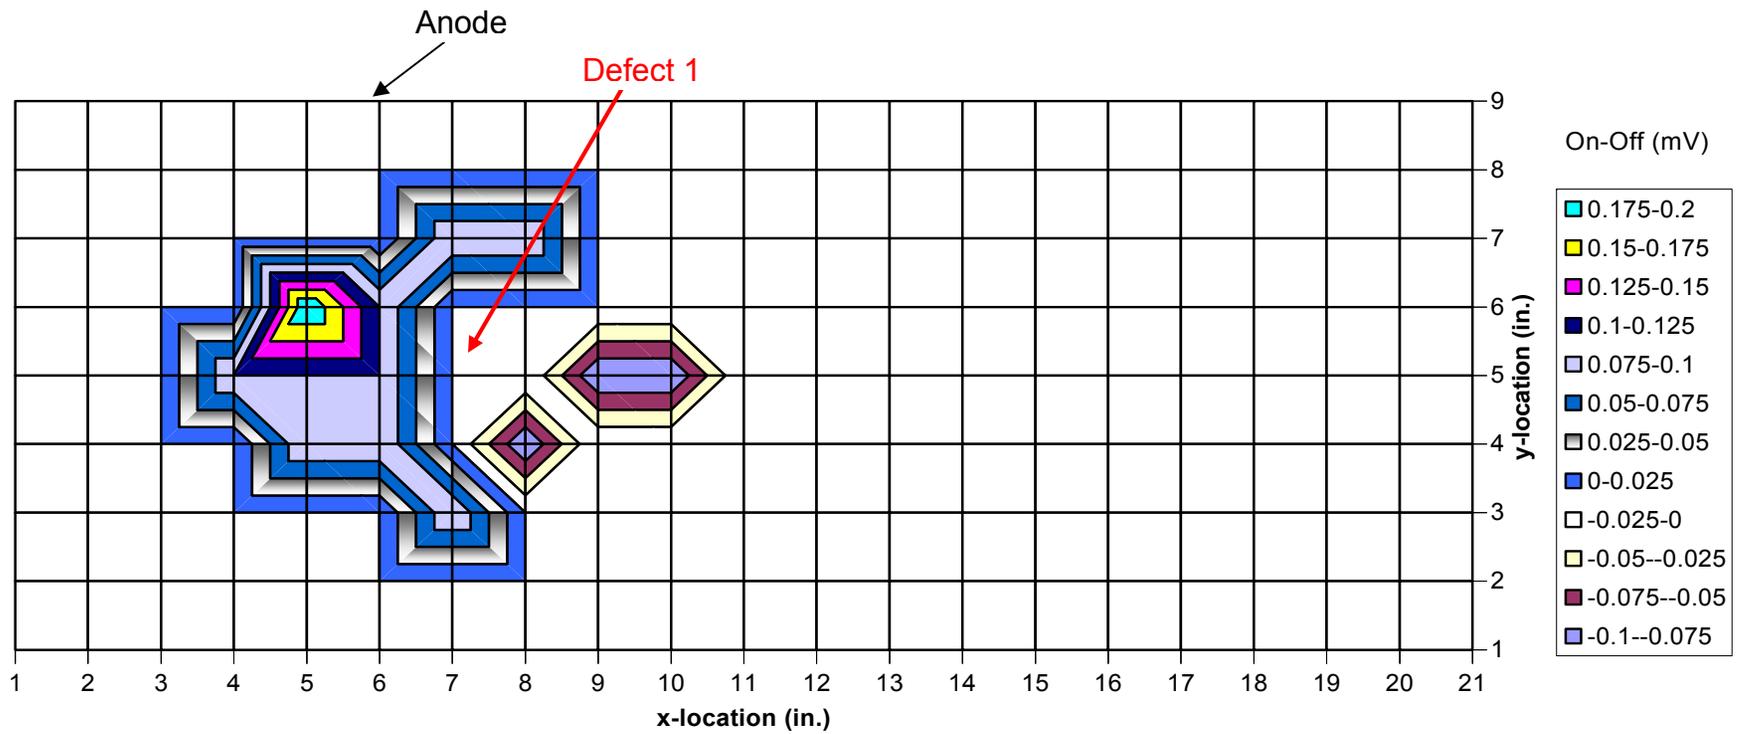
Figure 18. Contour plot of DCVG measurements near Defect 1 (Case 2).

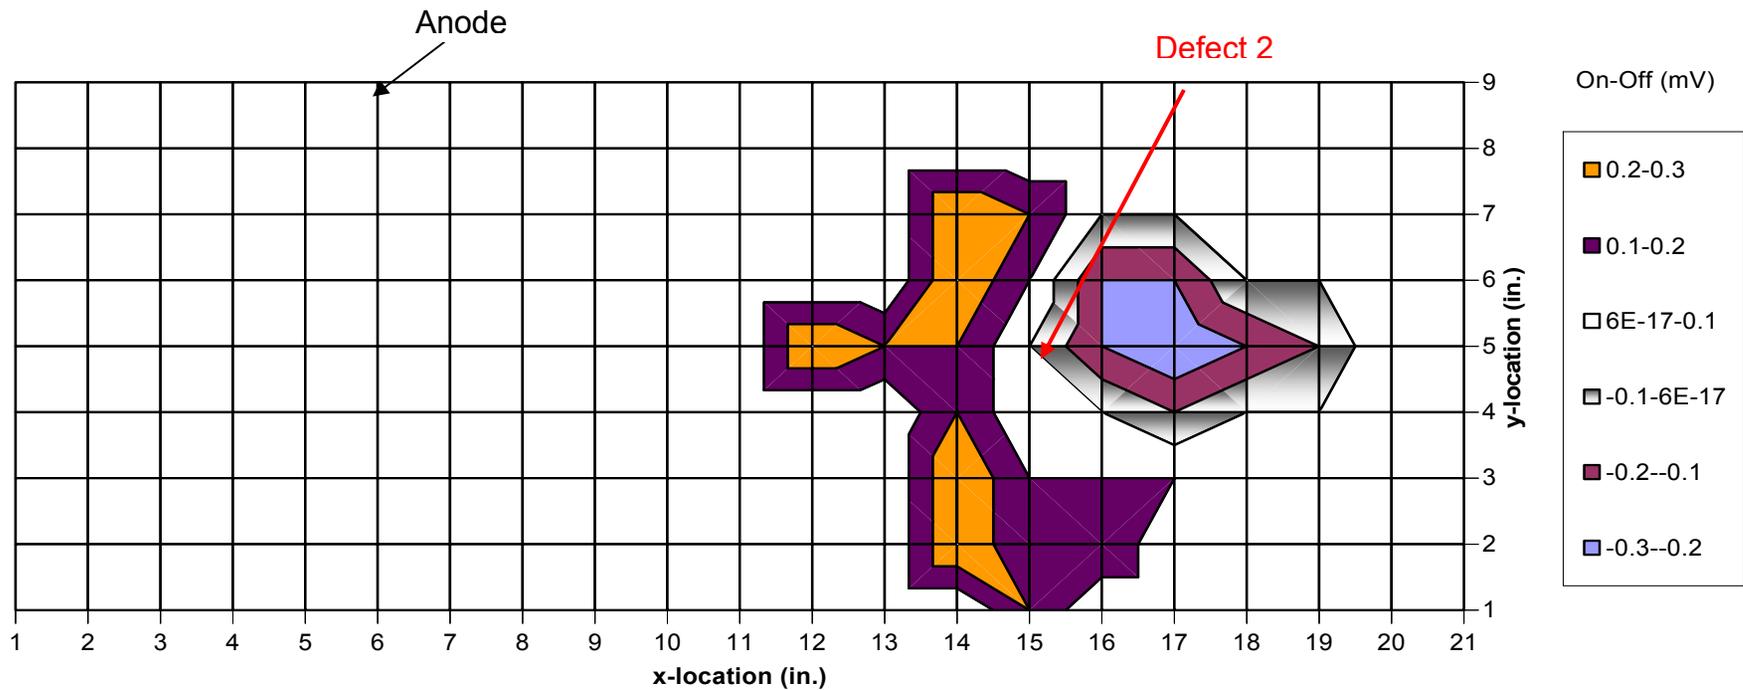
Figure 19. Contour plot of DCVG measurements near Defect 2 (Case 2).

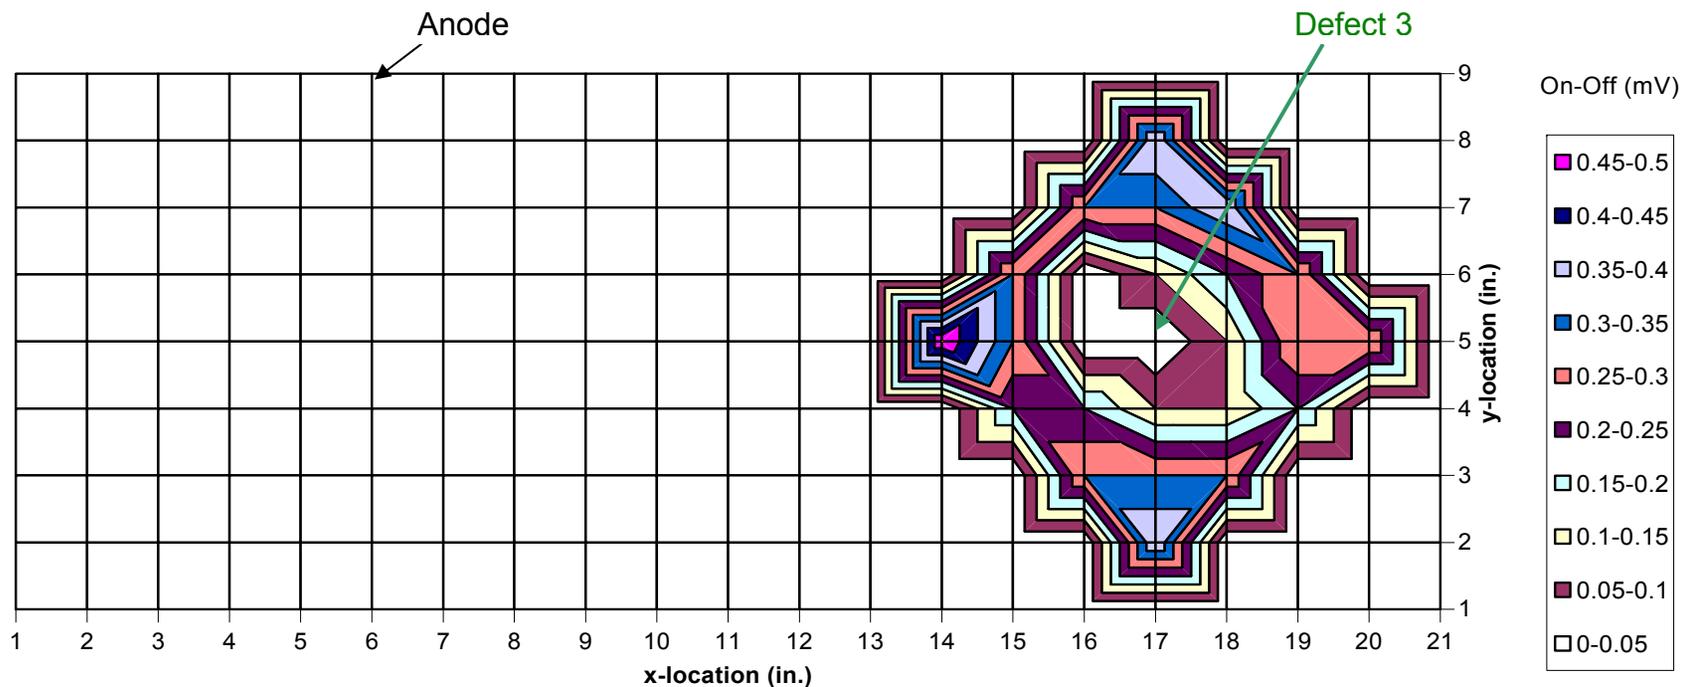
Figure 20. Contour plot of DCVG measurements near Defect 3 (Case 2).

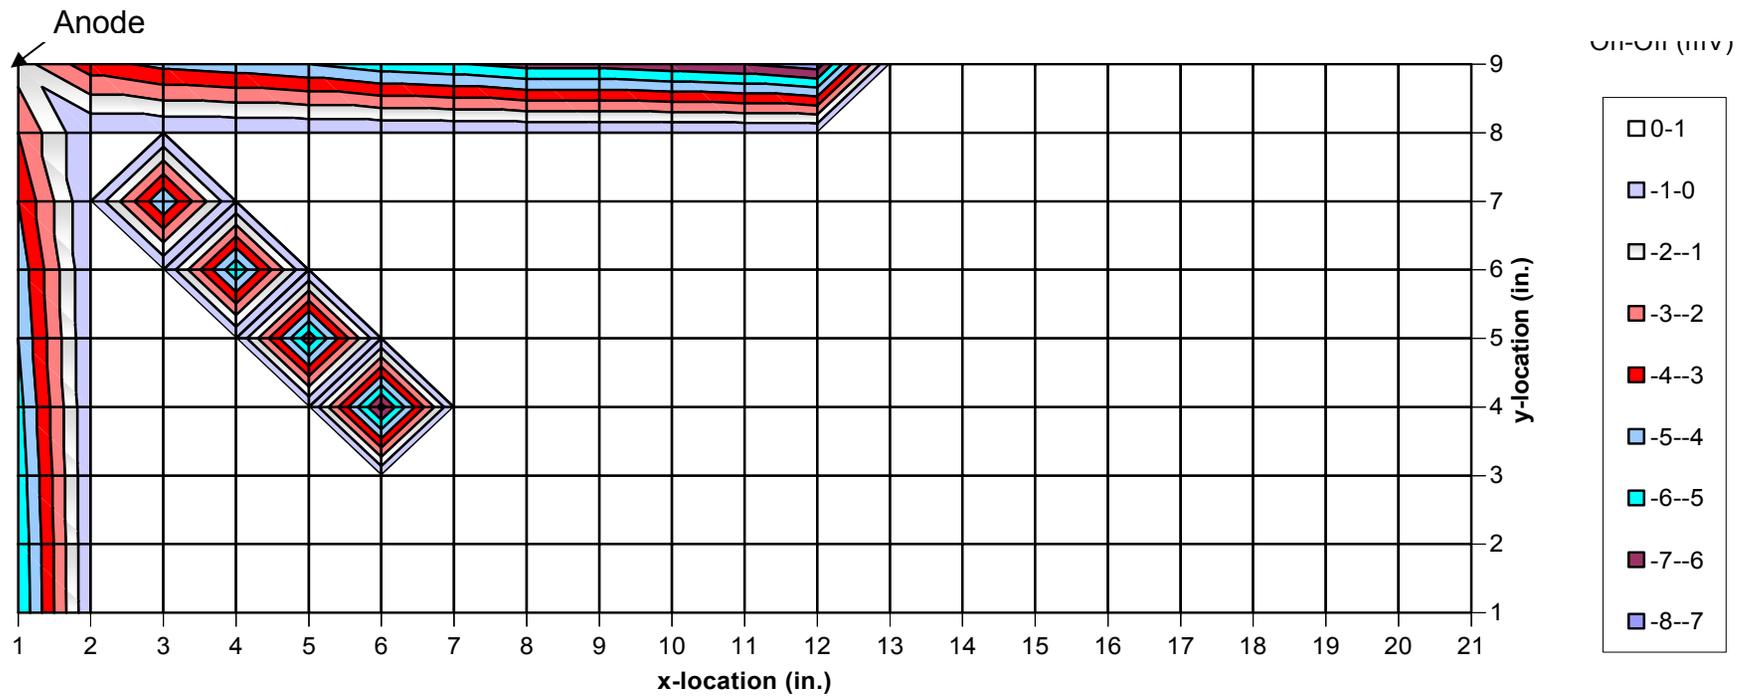
Figure 21. Contour plot of measurements near anode, $i = 1.217$ mA DC with anode positioned near $x=1, y=9$.

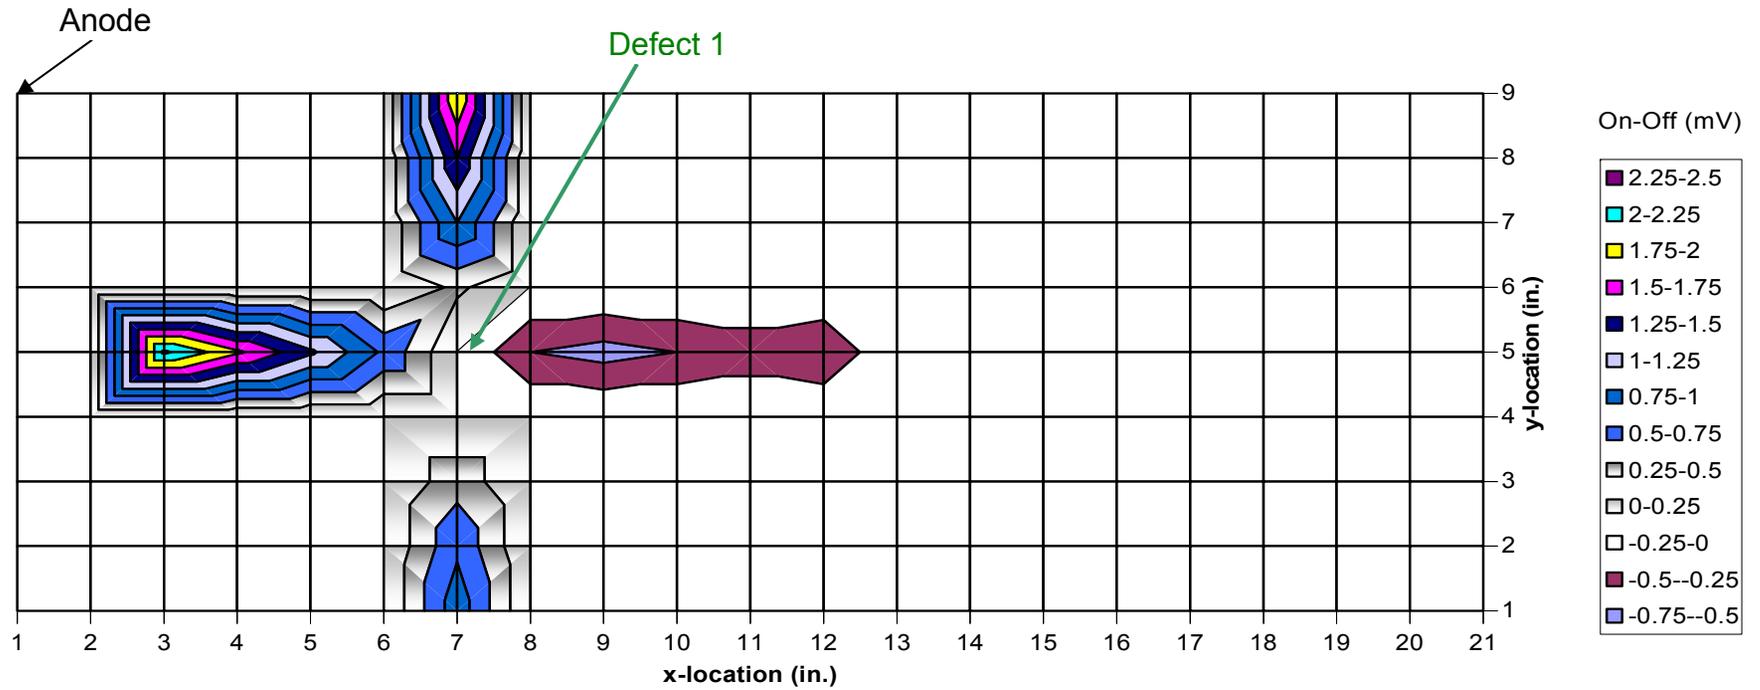
Figure 22. Contour plot of measurements near Defect 1 (Case 3).

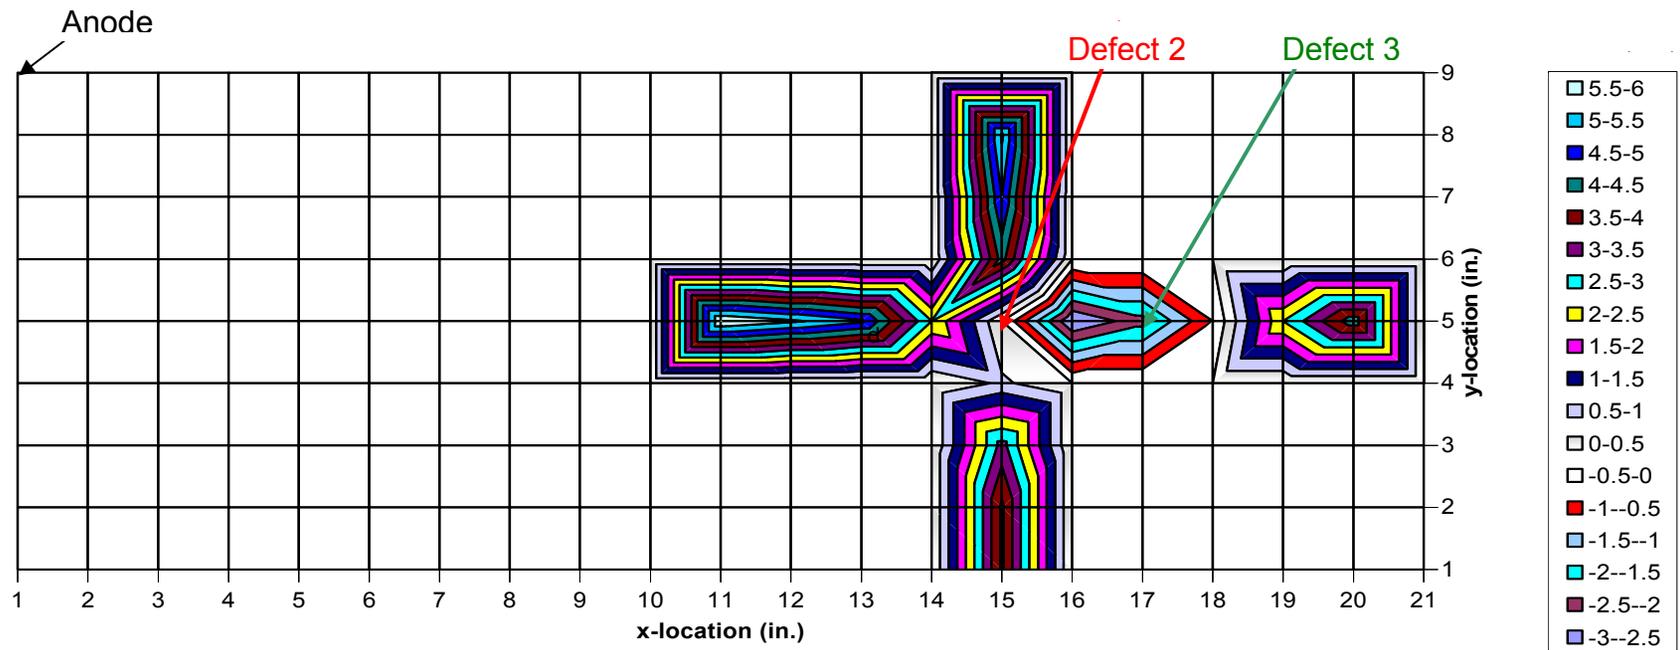
Figure 23. Contour plot of measurements near anode Defect 2 (Case 3).

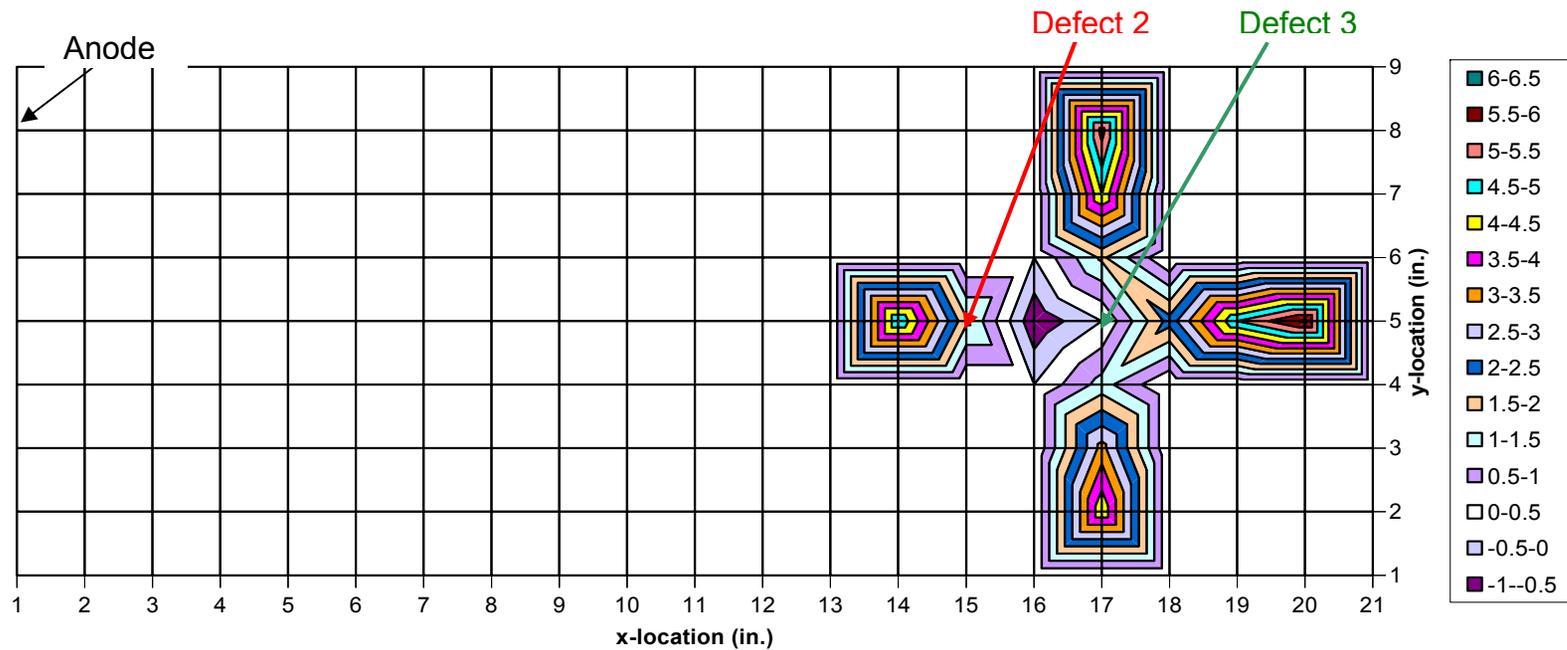
Figure 24. Contour plot of measurements near Defect 3 (Case 3).

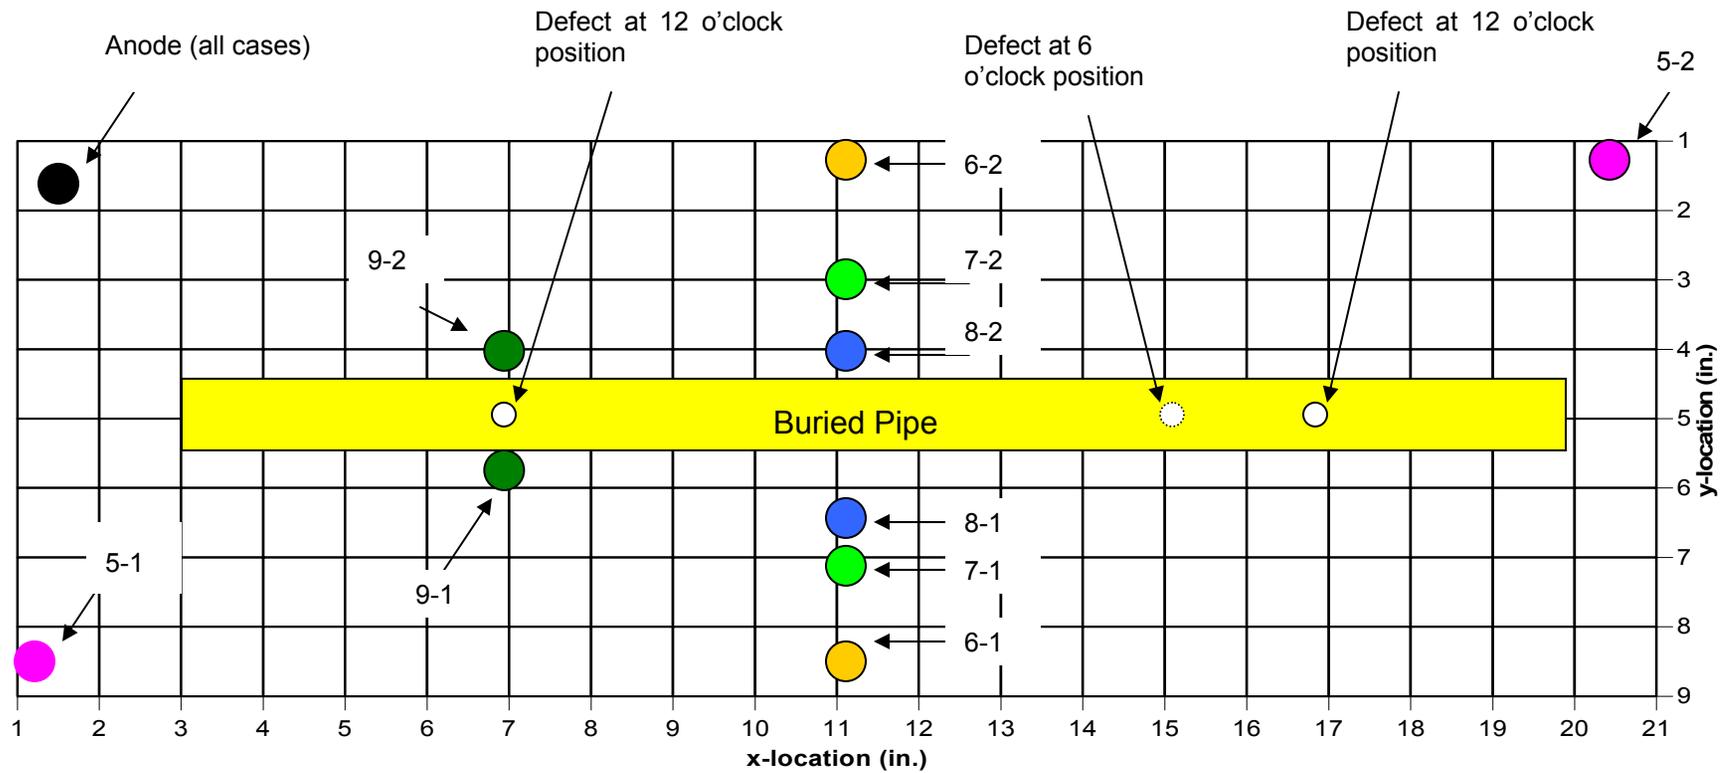
Figure 25. Layout of buried pipe in 'sandbox' – colored anodes show where interference anodes were positioned for the various cases
