FINAL REPORT

EXTERNAL CORROSION DIRECT ASSESSMENT FOR UNIQUE THREATS TO UNDERGROUND PIPELINES

CONTRACT NO. DTPH56-06-T-0012

**PREPARED BY
CC TECHNOLOGIES, INC., A DNV COMPANY
MARK YUNOVICH, MS, MBA, NACE CORROSION SPECIALIST
STEVEN WATERS, BS**

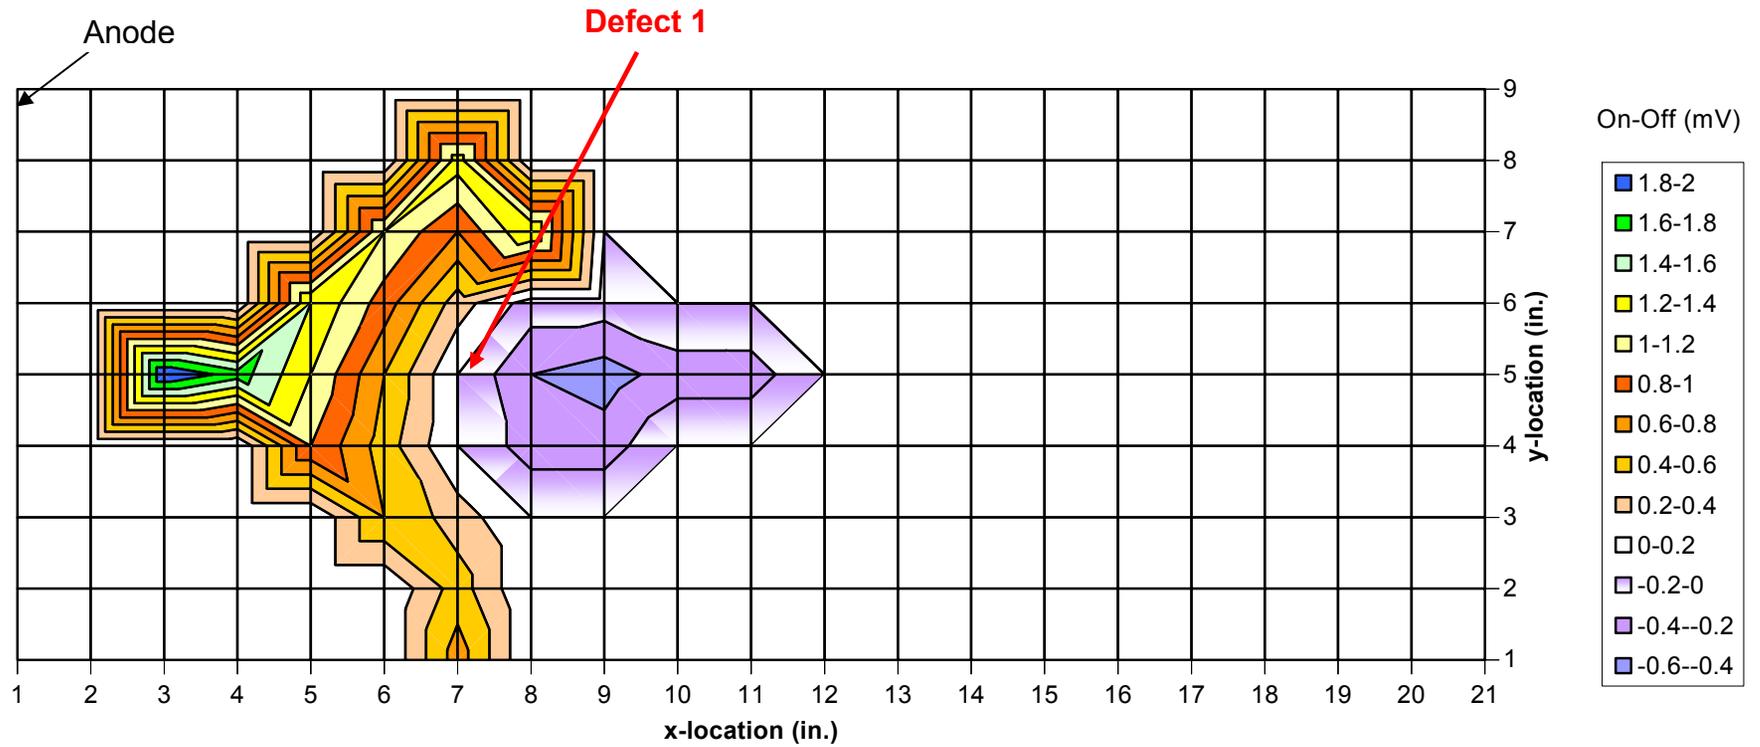
Figure 26. Contour plot of measurements (Case 4 – repeat of baseline conditions).

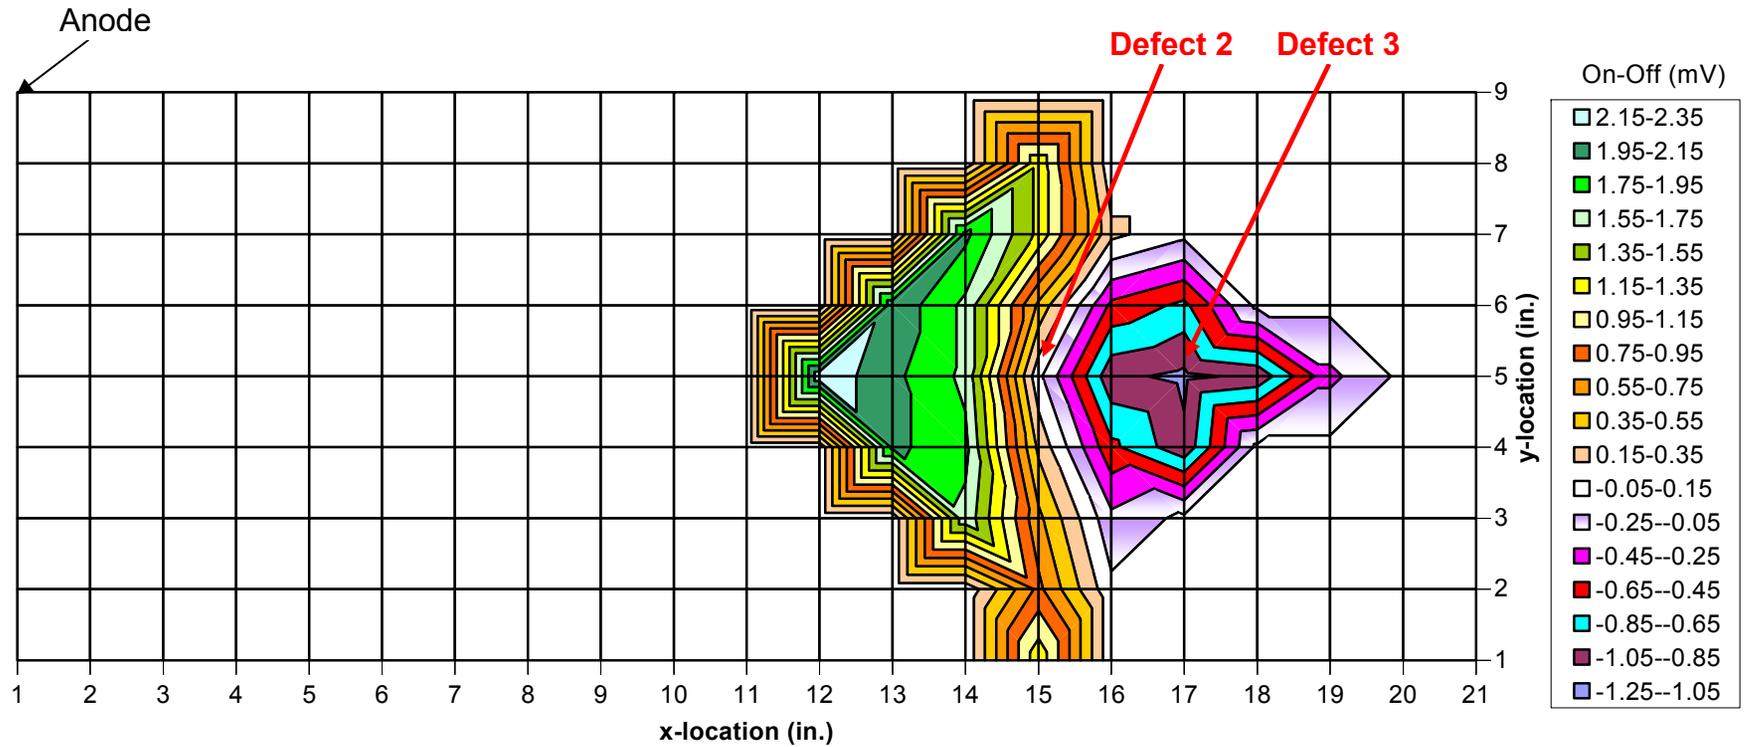
Figure 27. Contour plot of measurements (Case 4 – repeat of baseline conditions).

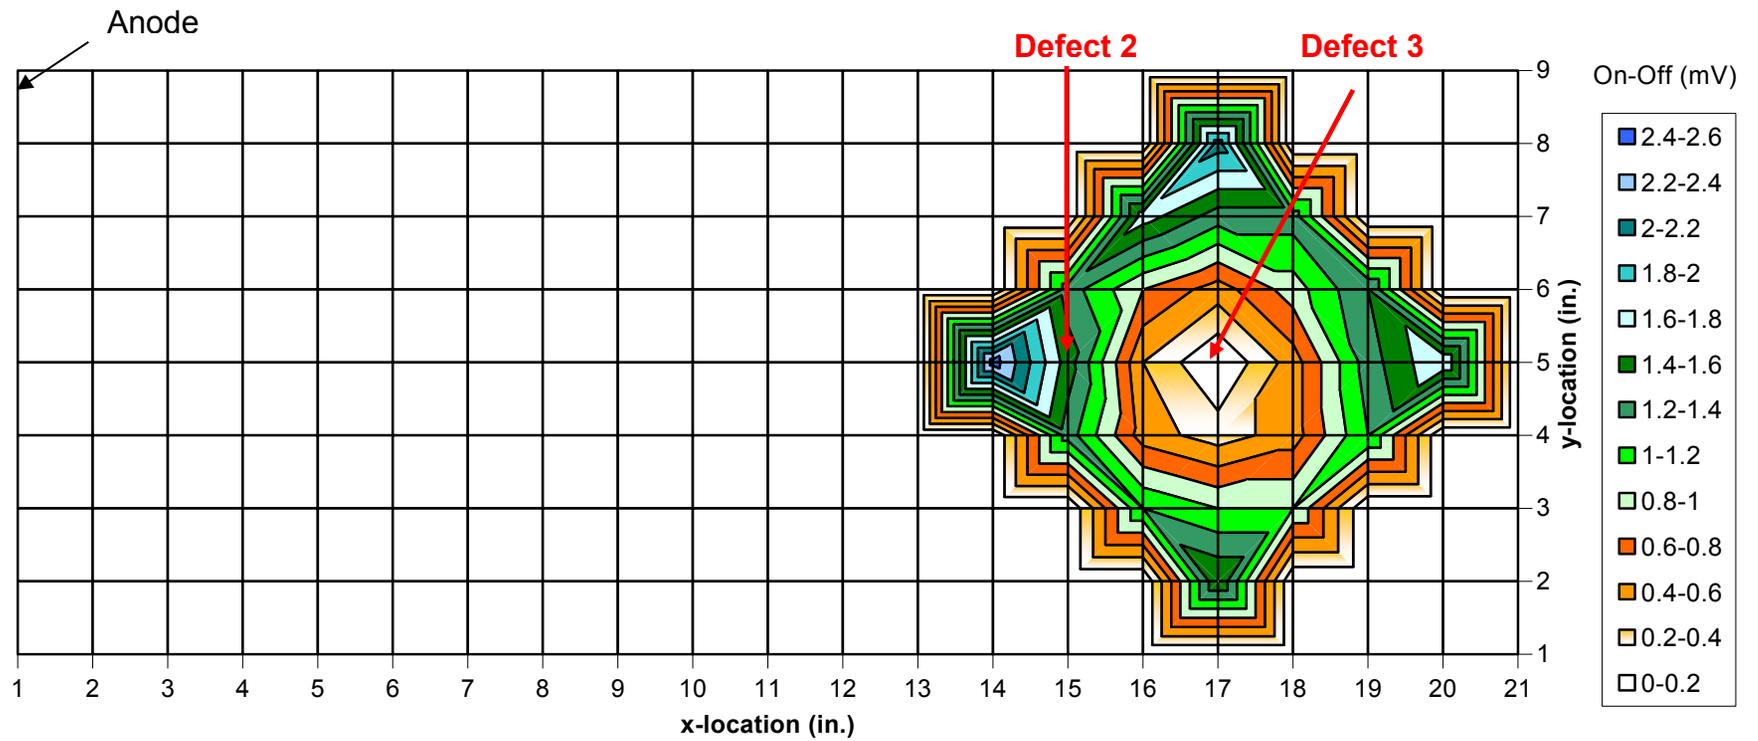
Figure 28. Contour plot of measurements (Case 4 – repeat of baseline conditions).

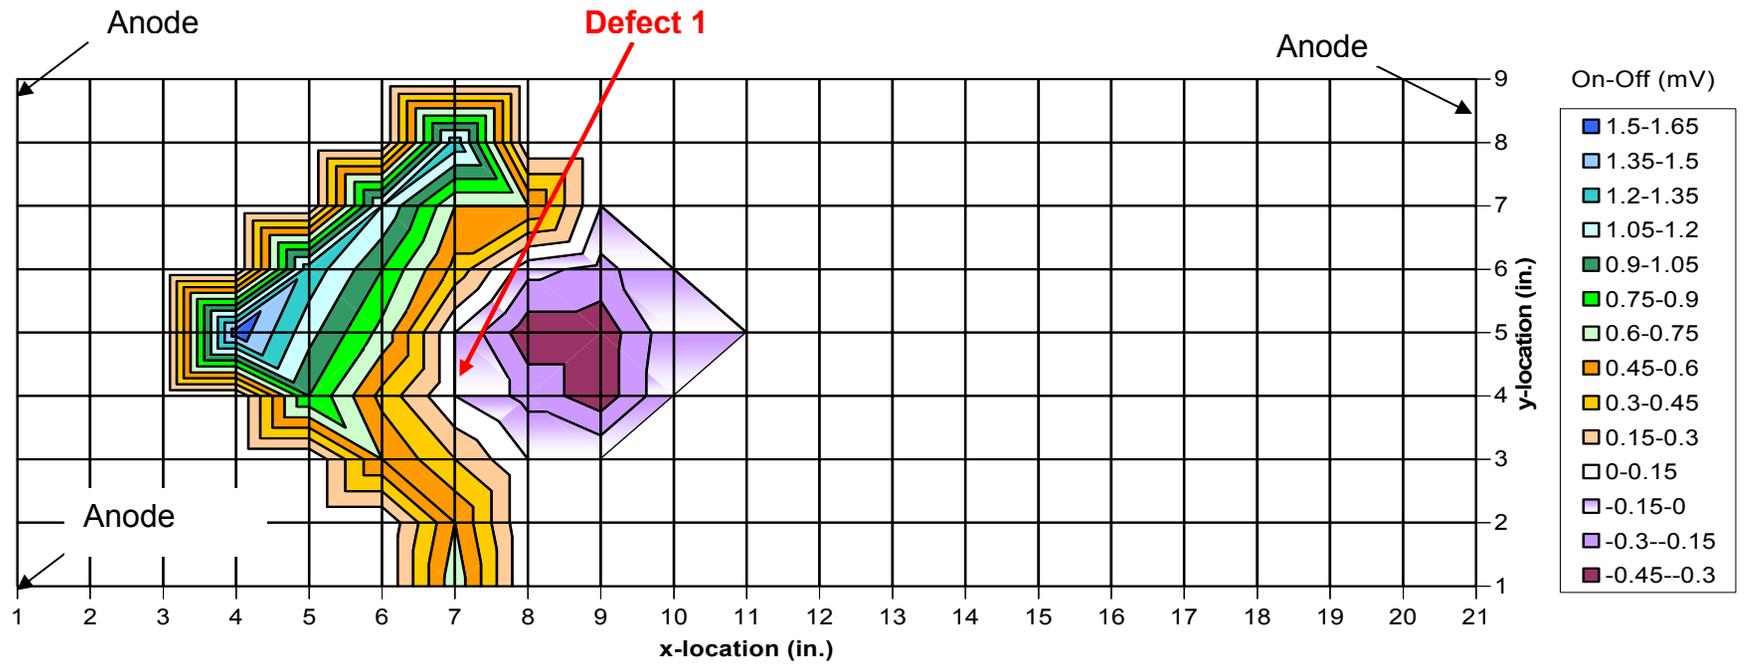
Figure 29. Contour plot of measurements (Case 5).

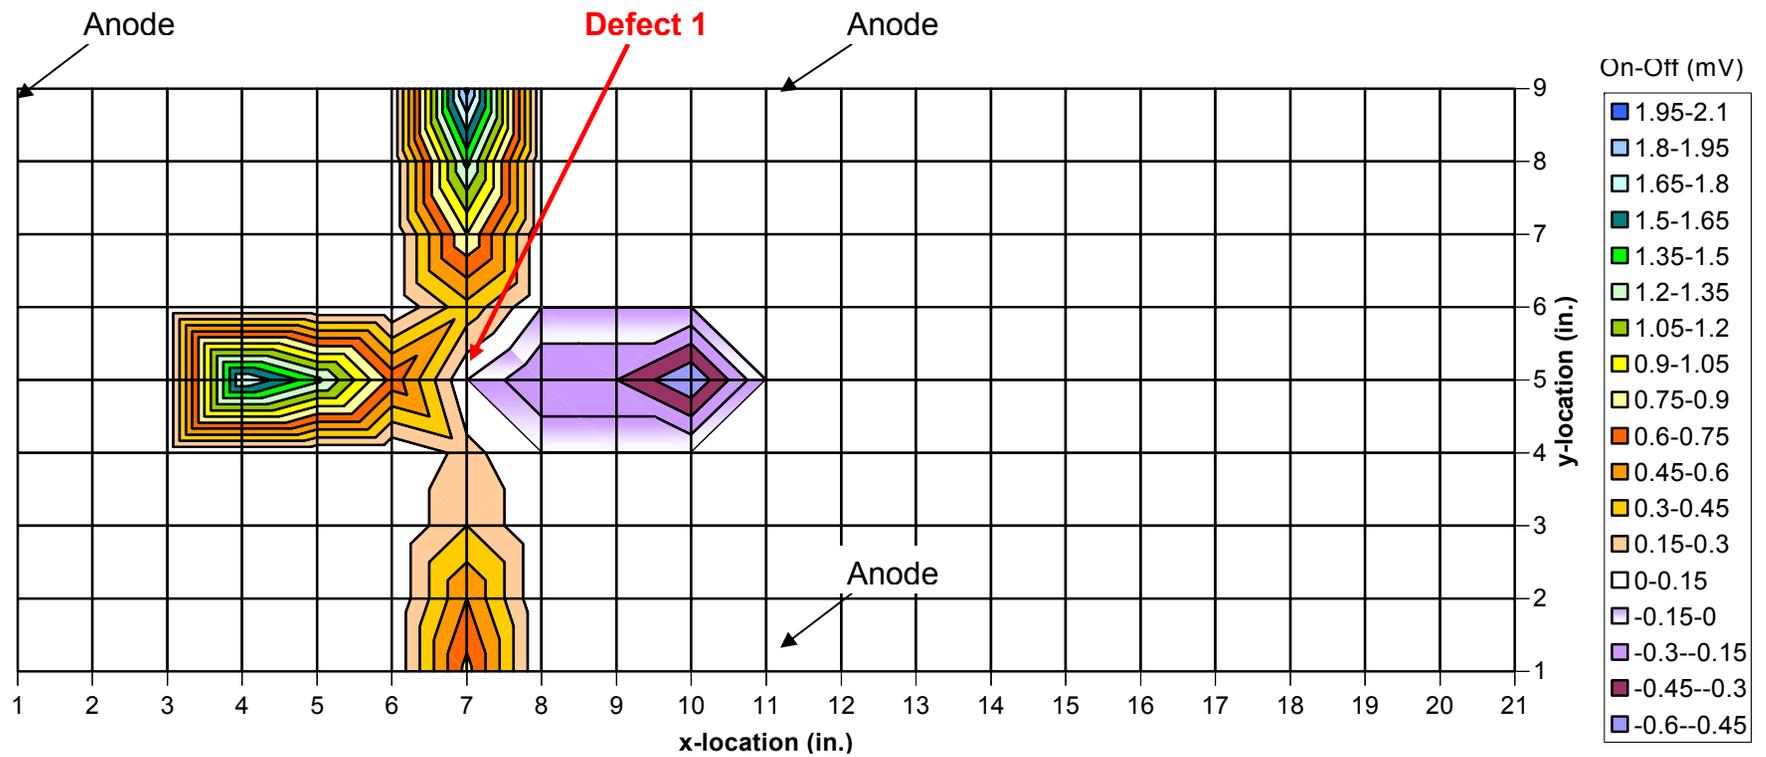
Figure 30. Contour plot of measurements (Case 6).

Figure 30, Figure 31, and Figure 32 show the results obtained for the above condition. Similarly to Case 5 above, introducing stray current in this manner appeared to have virtually no effect on the ability to detect defects on the pipe. Considering that the interference was not strong enough (and/or near enough to the pipe) to affect the DCVG measurements, the interference anodes were moved nearer the pipe in Case 7

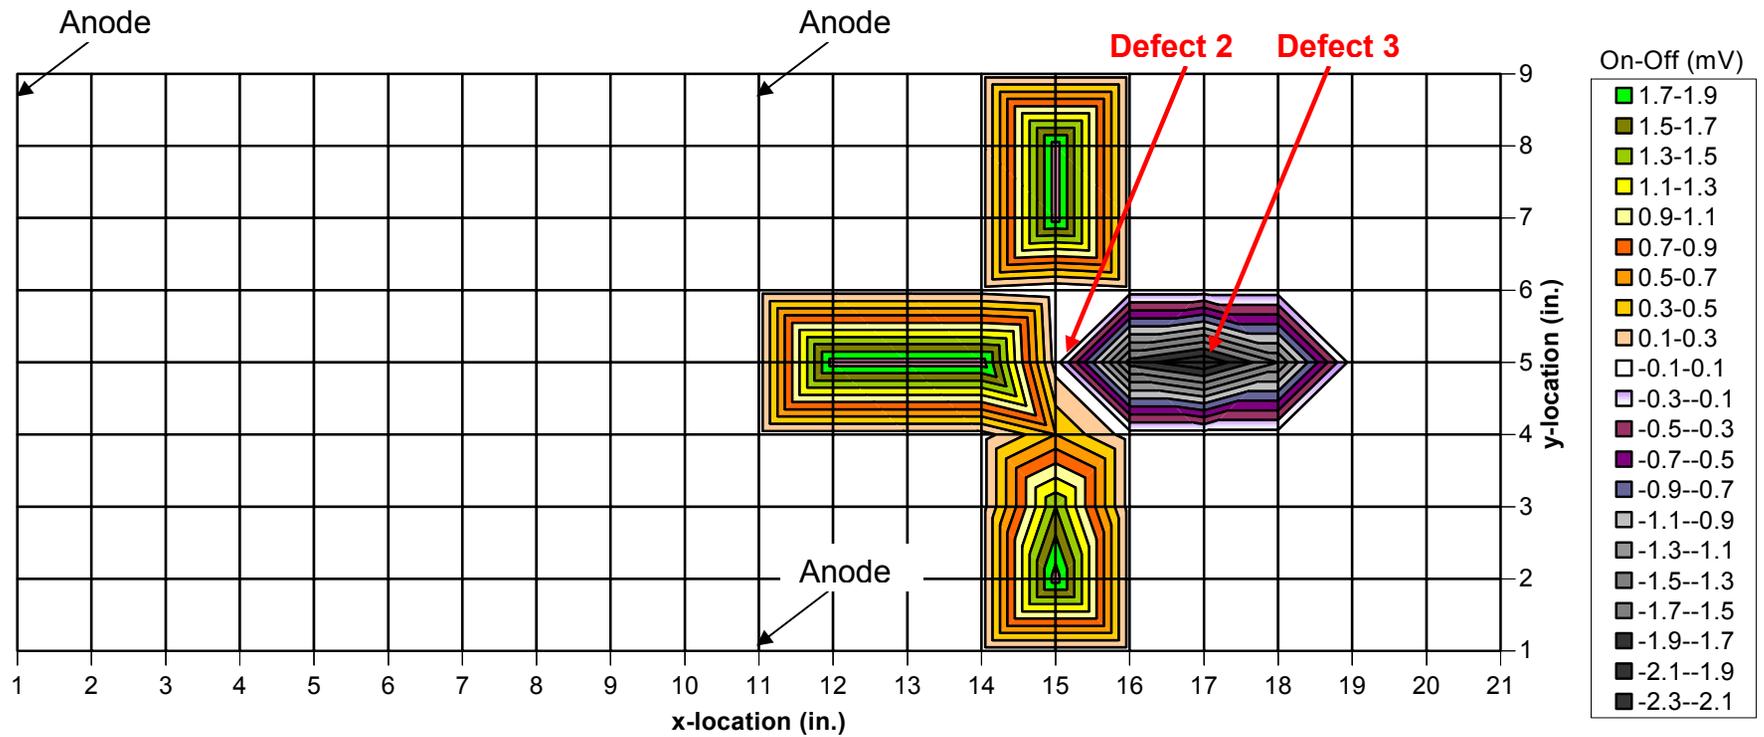
Figure 31. Contour plot of measurements (Case 6).

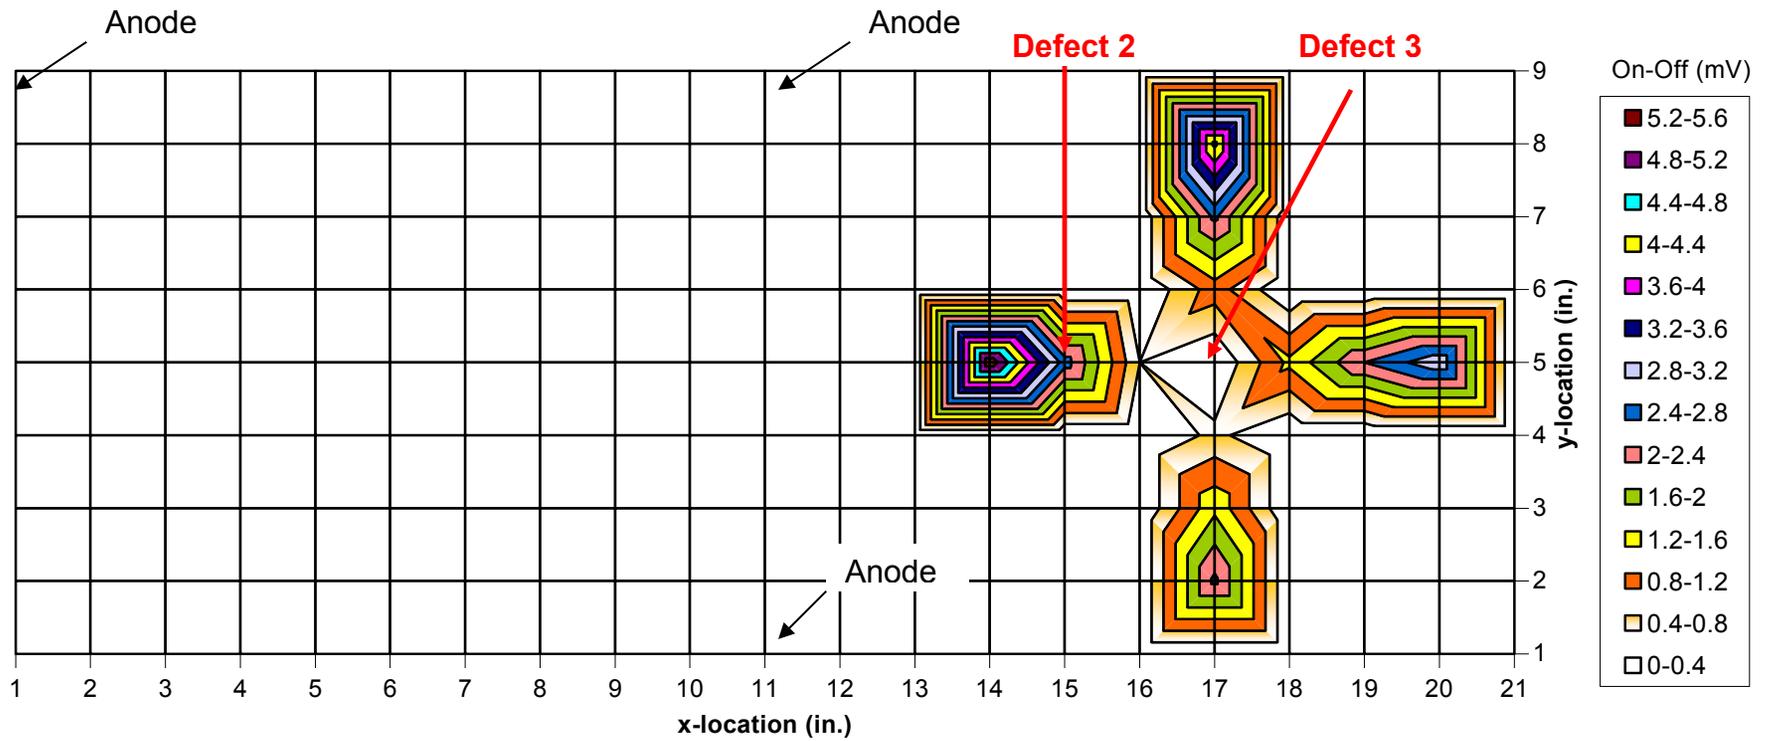
Figure 32. Contour plot of measurements (Case 6).

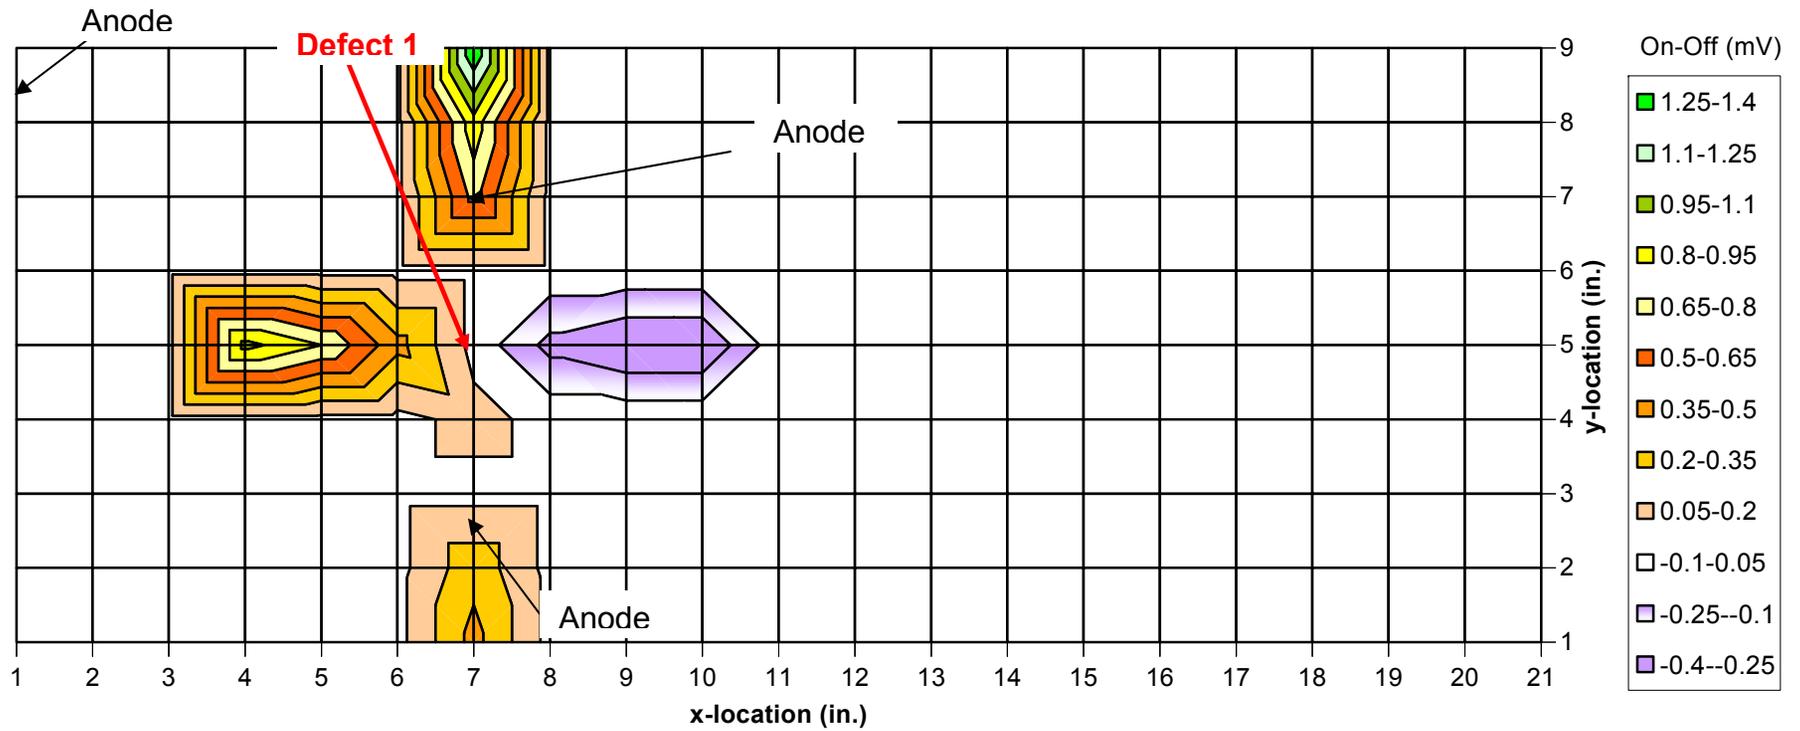
Figure 37. Contour plot of measurements (Case 9).

As a final test, the interference anodes were positioned in line with one of the defects (defect 1) and as near the pipe as possible. Measurements again indicate that the interference current has no effect on the DCVG profile, as evidenced by Figure 37.

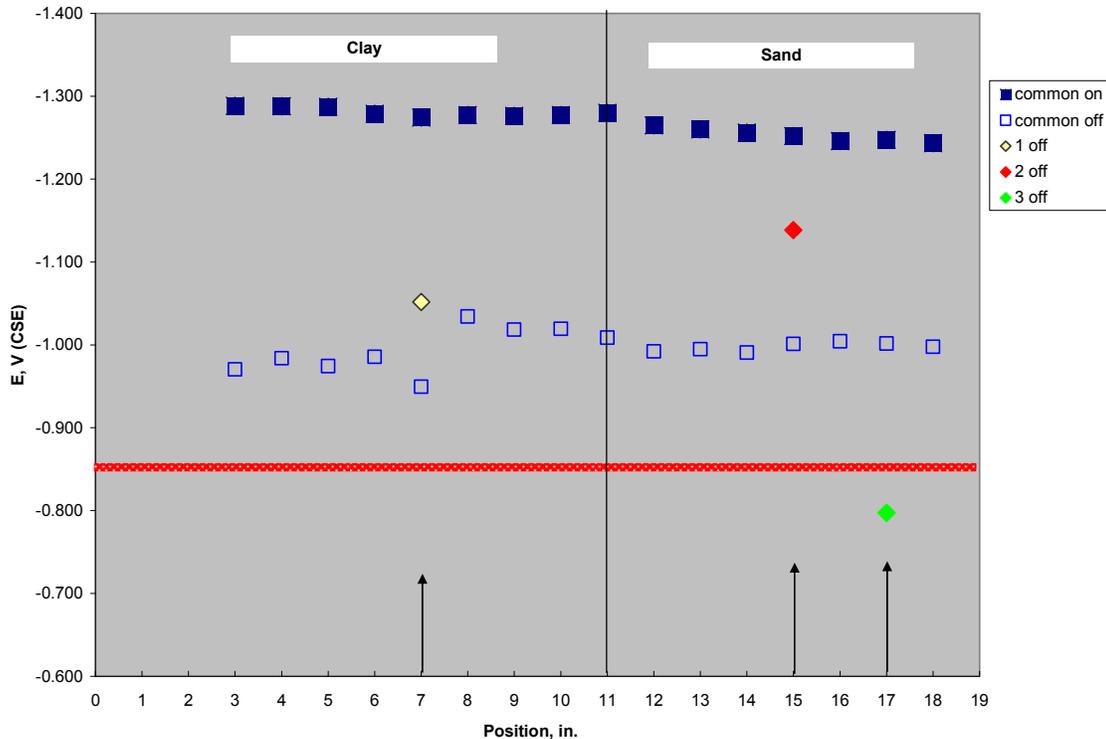
Figure 38. DC CIS profile in clay/sand.

The results varied depending on how the measurements are taken. The difference in resistance paths from the CP anode to the defects resulted in different polarization (OFF) potentials. Consider the graph shown in Figure 38.

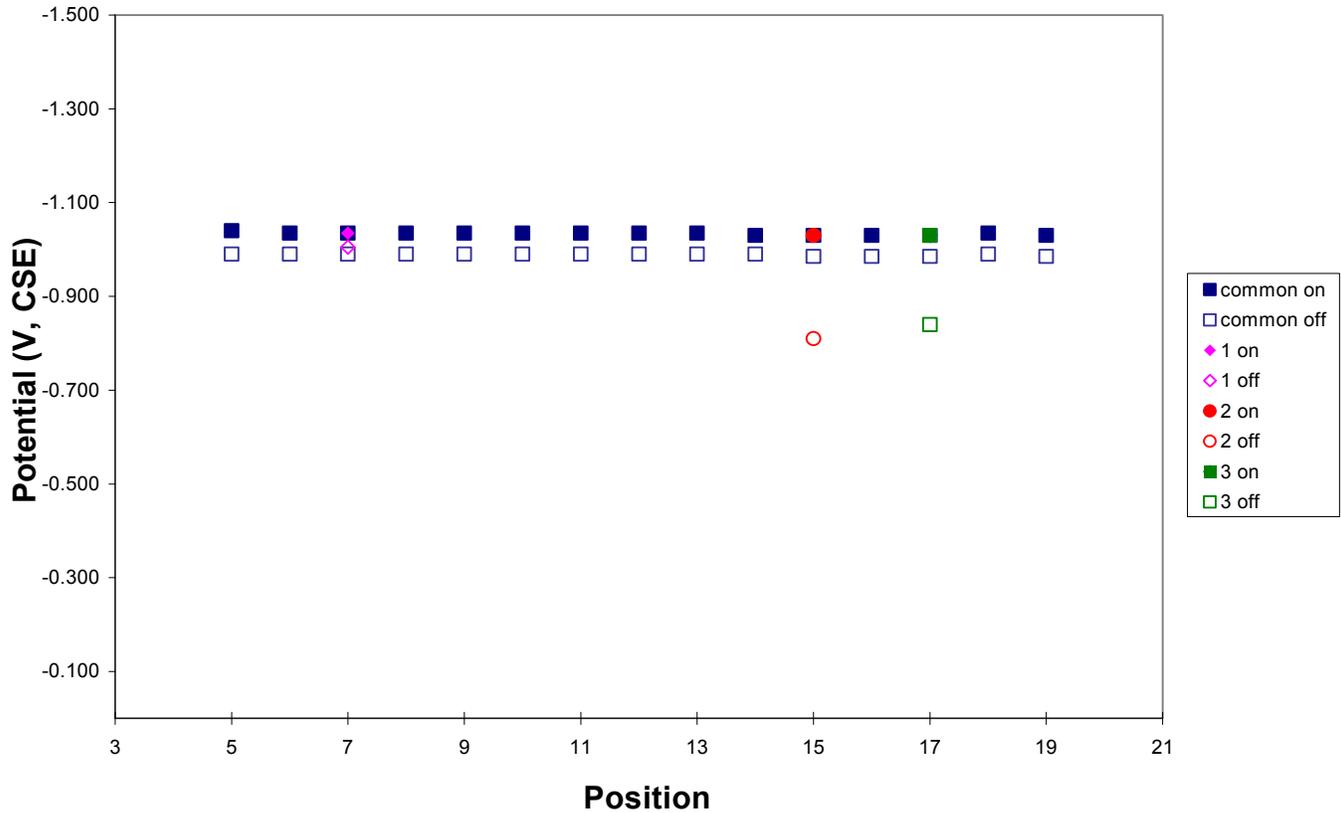
Figure 39. CIS profile (Experiment 1).

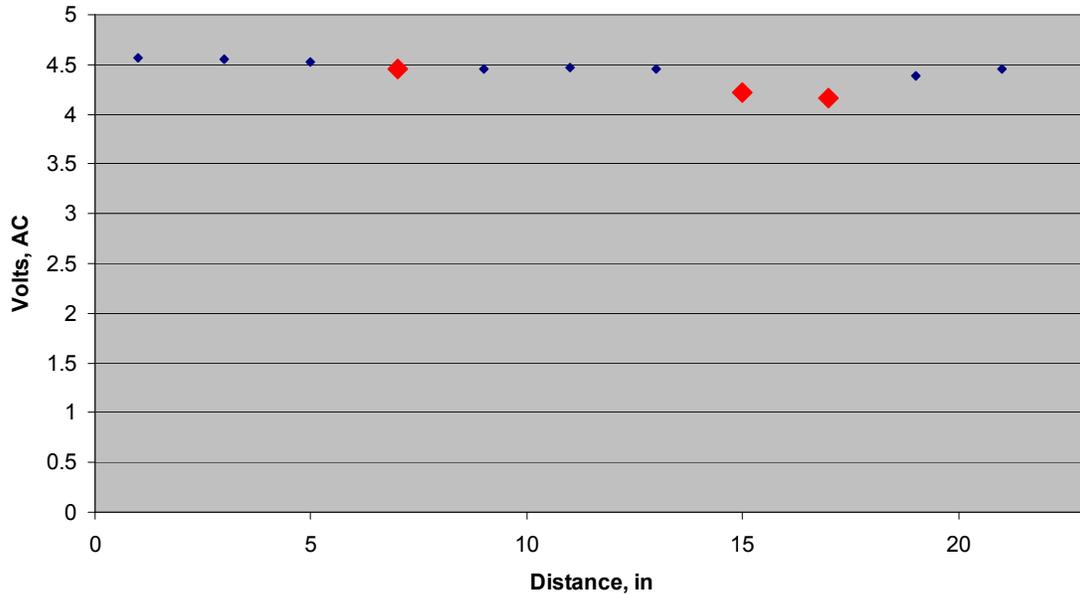
Figure 49. AC CIS profile in sand/clay. Red points denote locations of Defects.

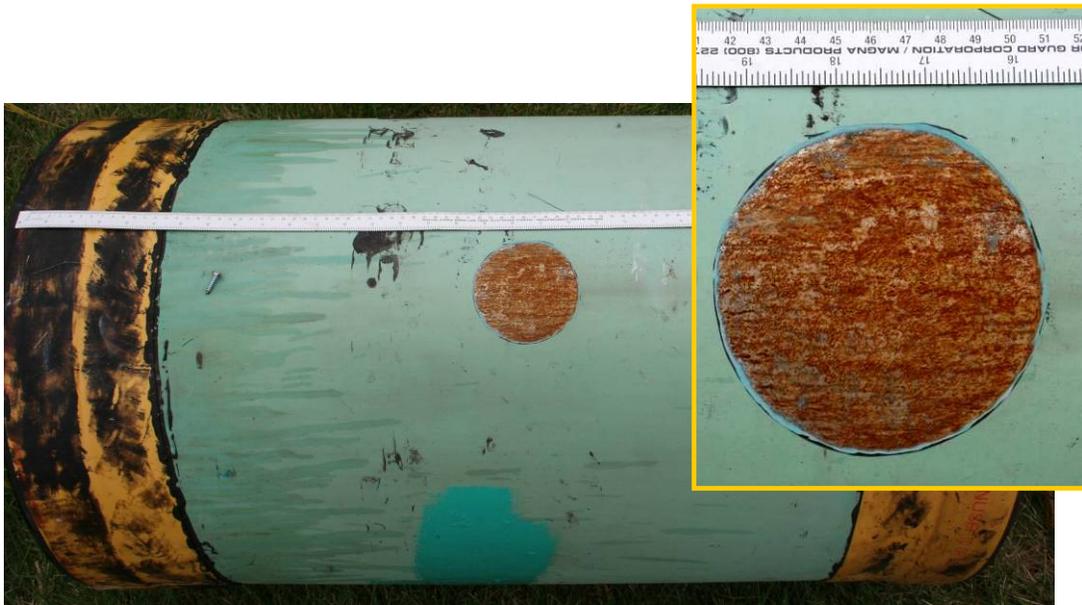
Figure 51. Single centrally positioned 10 sq. inch defect in pipeline section.

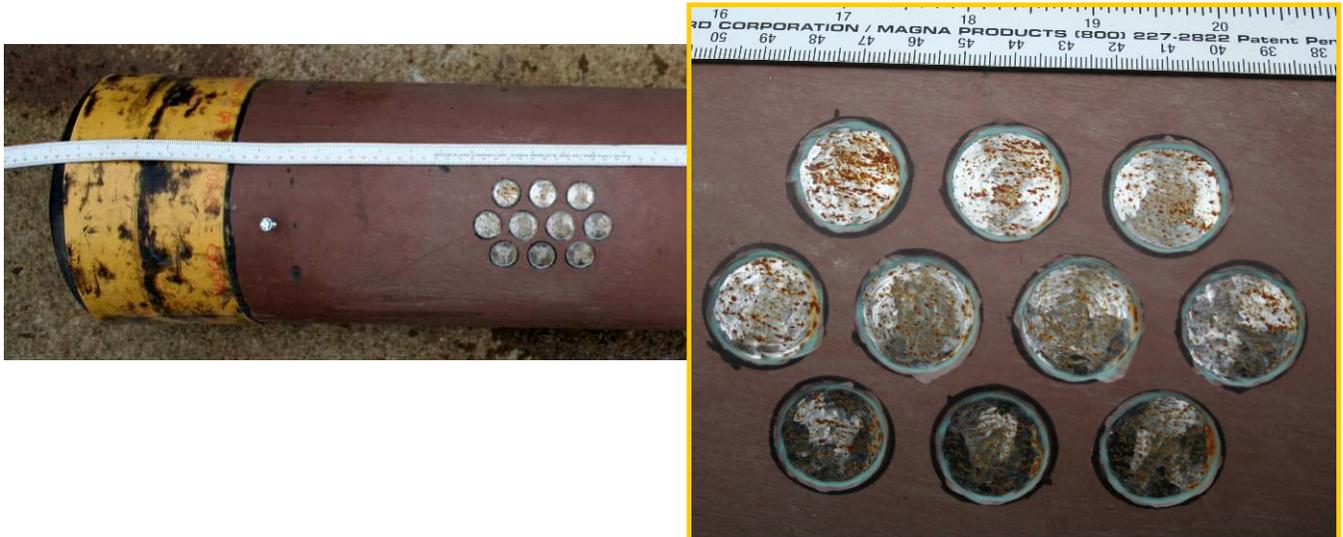
Figure 55. Examples of distributed defects (10 individual 1 sq. inch defects) on 20 inch (top) and 8 inch (bottom) sections.

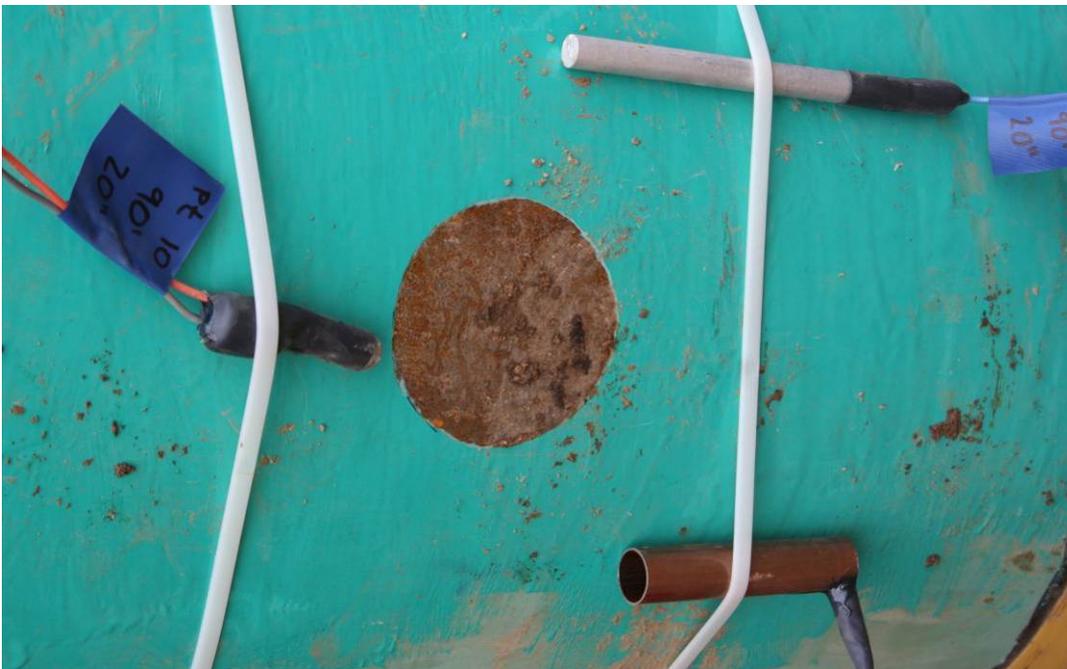
Figure 58. Reference electrode (left), magnesium electrode (upper right) and copper electrode (bottom right) strapped to the 20 inch pipeline section prior to installation.

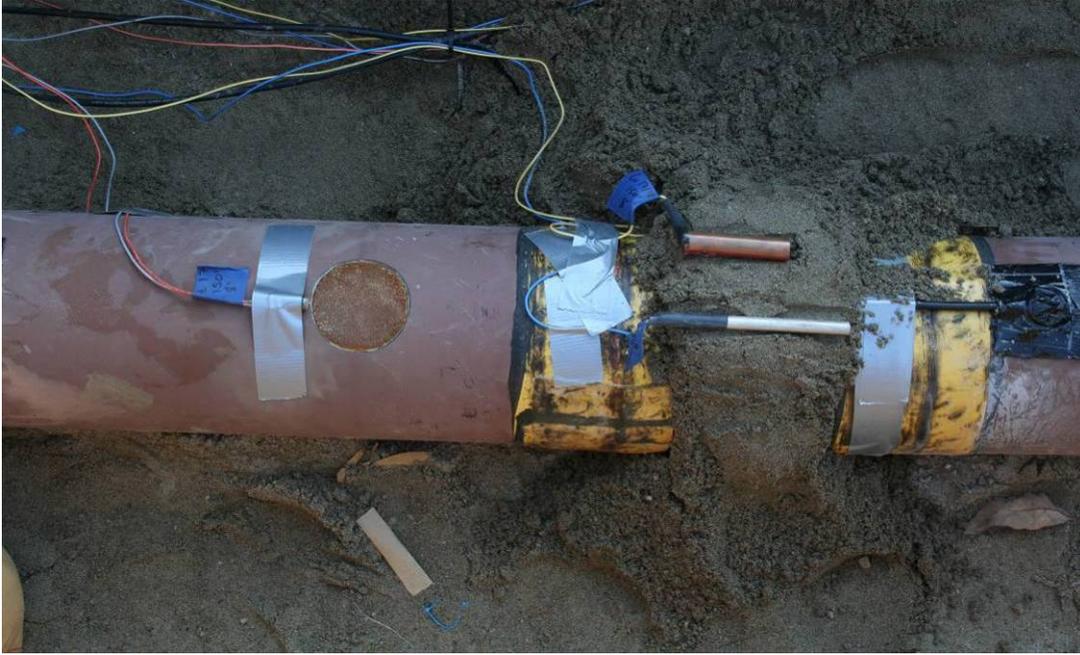
Figure 59. Reference electrode (left) attached next to an off-center 10 sq. inch defect on 8 inch pipeline section; magnesium electrode (right, lower) and copper electrode (right, upper) placed in between two adjacent pipeline sections.

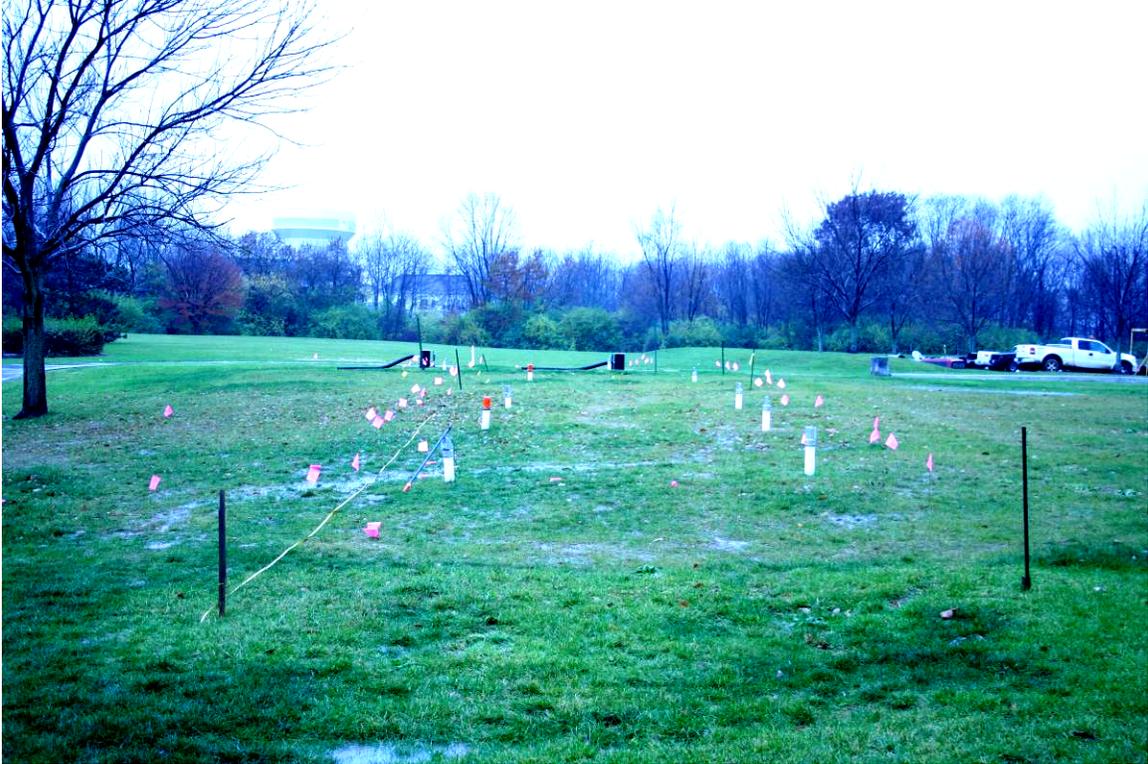
Figure 64. Completed site (red flags show coating holiday locations).

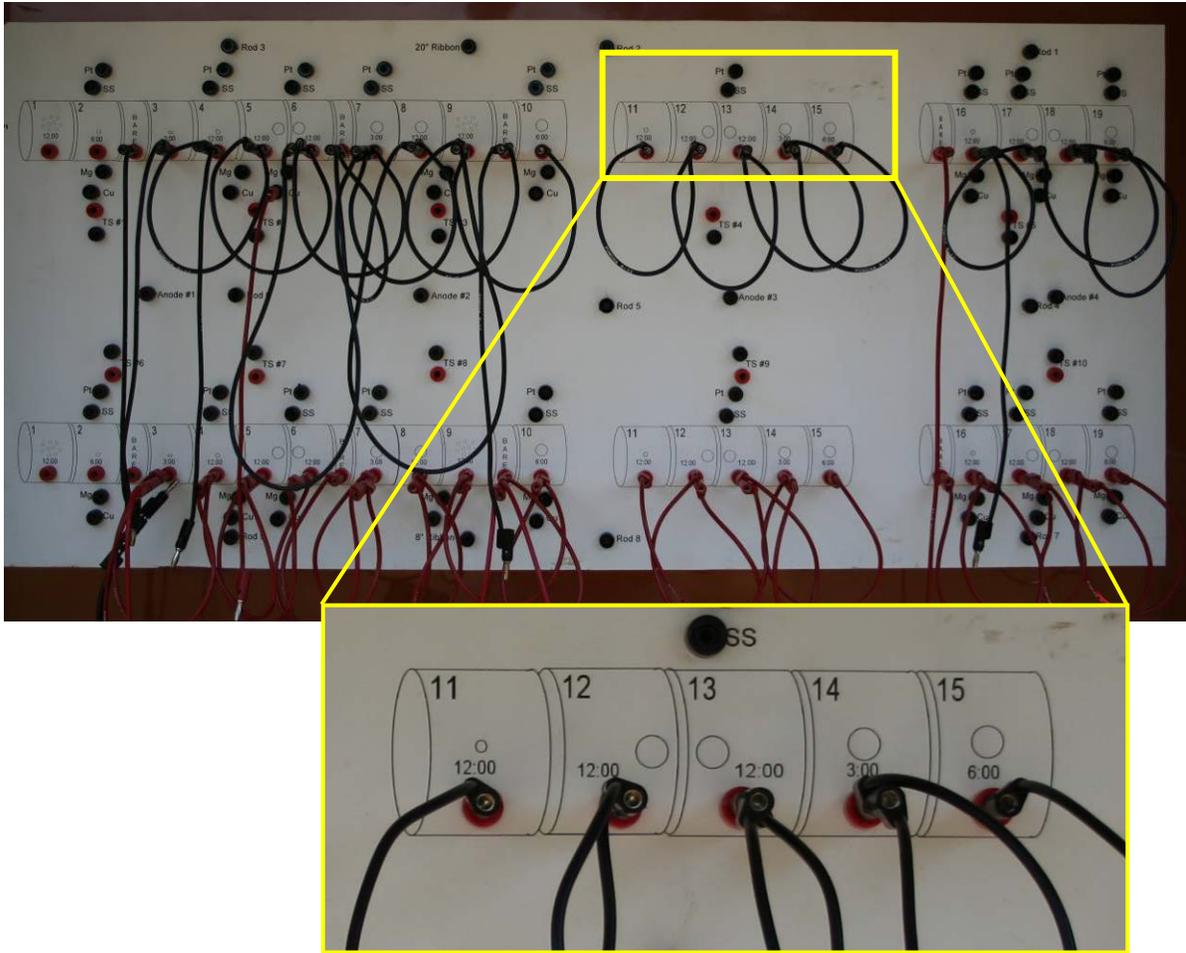
Figure 65. Panel with electrical connections to all large-scale setup components.

The panel with the segments' outline and electrical connections is shown in Figure 65.

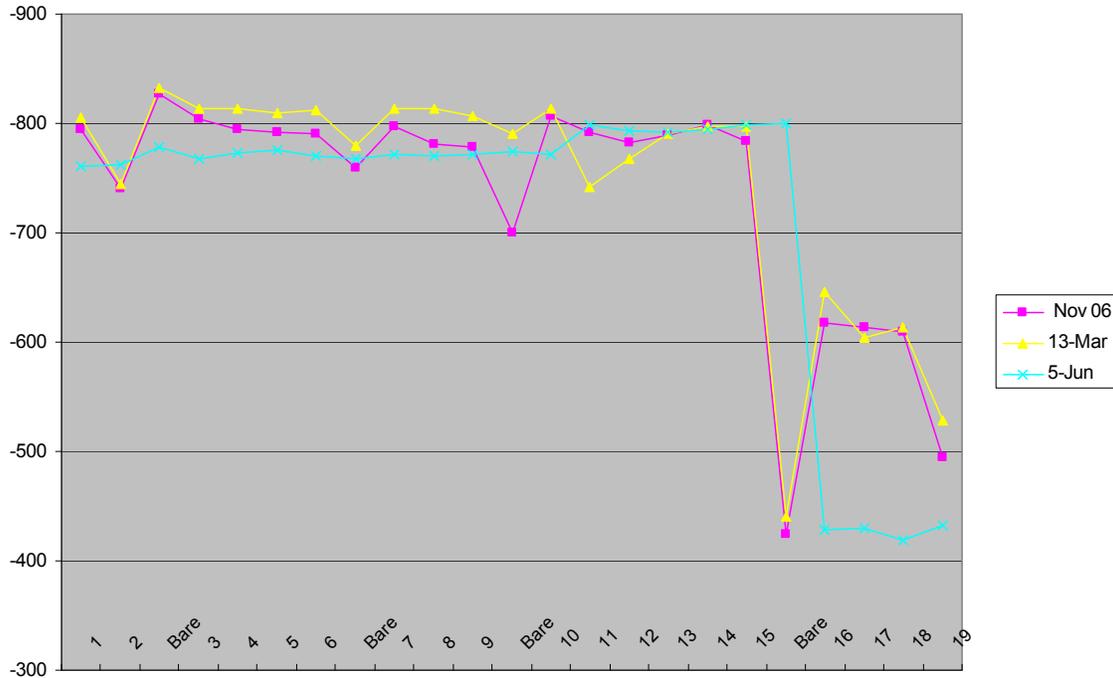
Figure 67. CIS profile of 20 inch pipeline segments (potentials are in mV against copper/copper sulfate reference electrode).

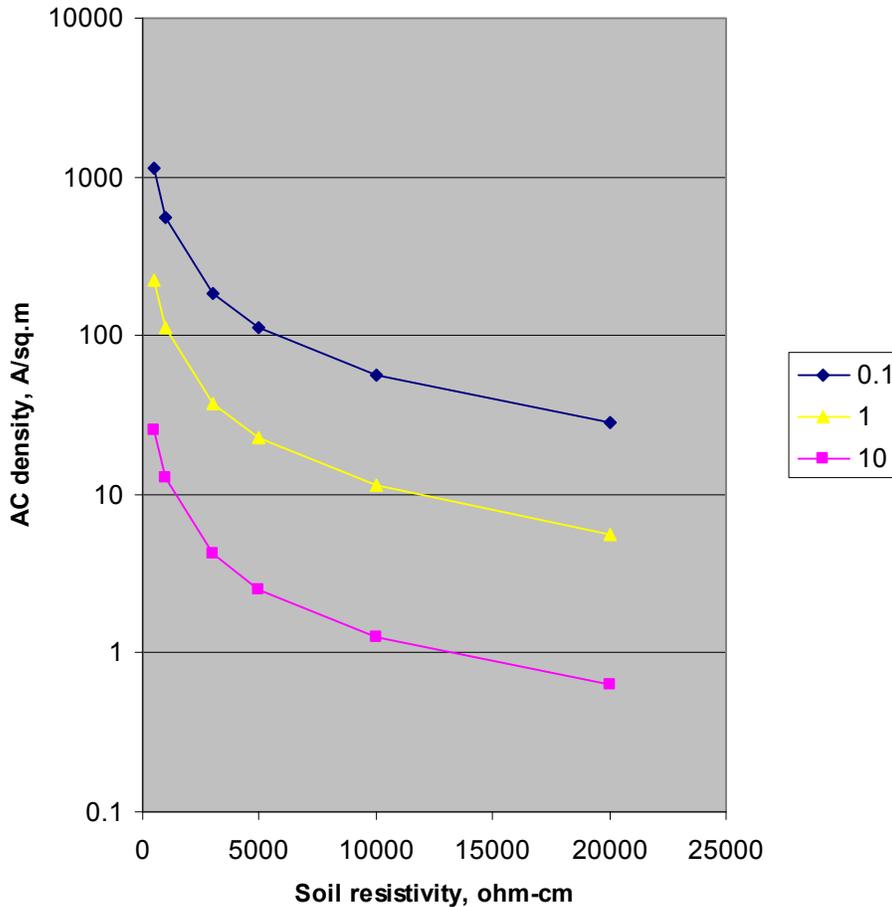
Figure 87. AC current density vs. soil resistivity (AC voltage fixed at 5V).

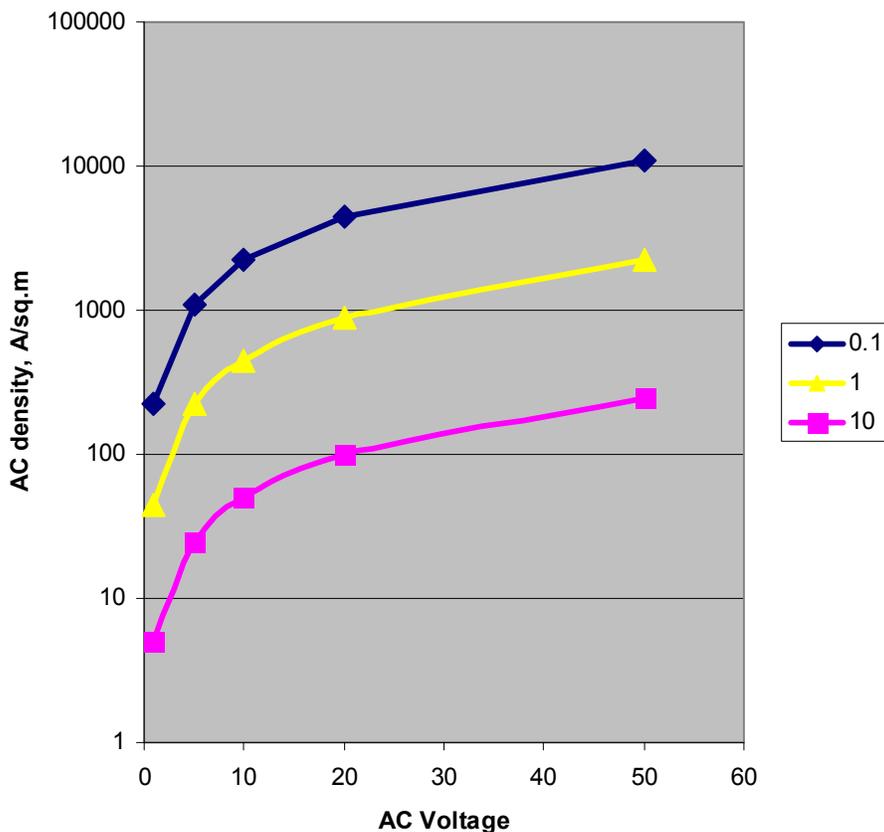
Figure 88. AC current density vs. AC voltage (soil resistivity fixed at 5,000 ohm-cm).

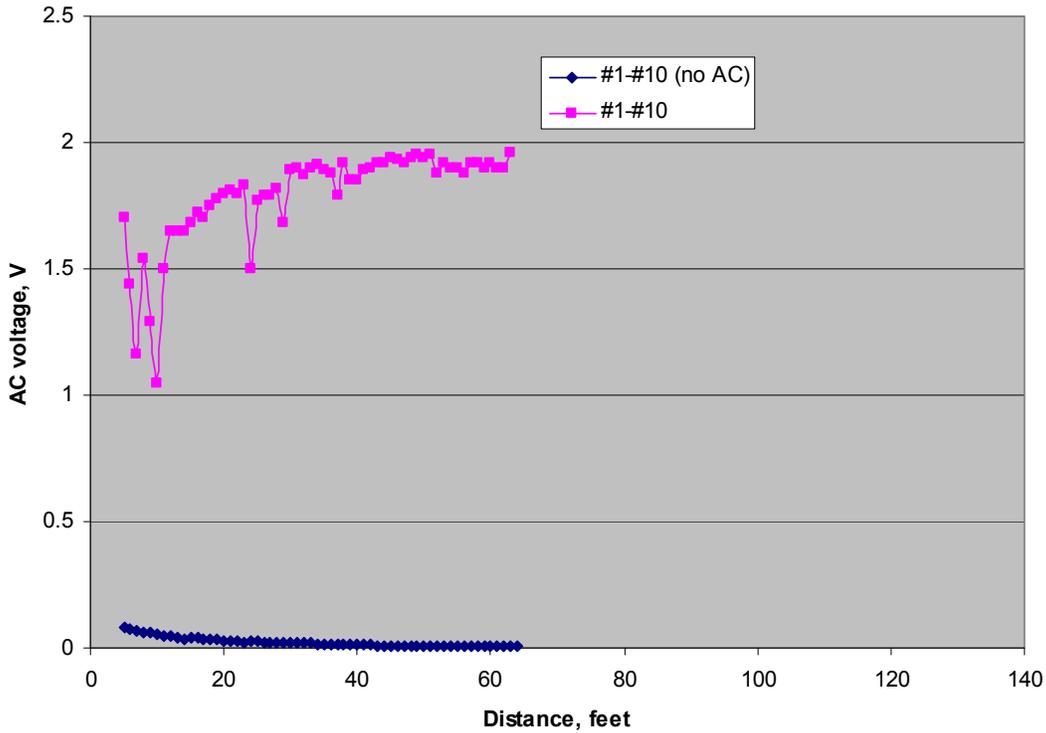
Figure 89. AC current density vs. distance (first pipeline segment, all sections connected).

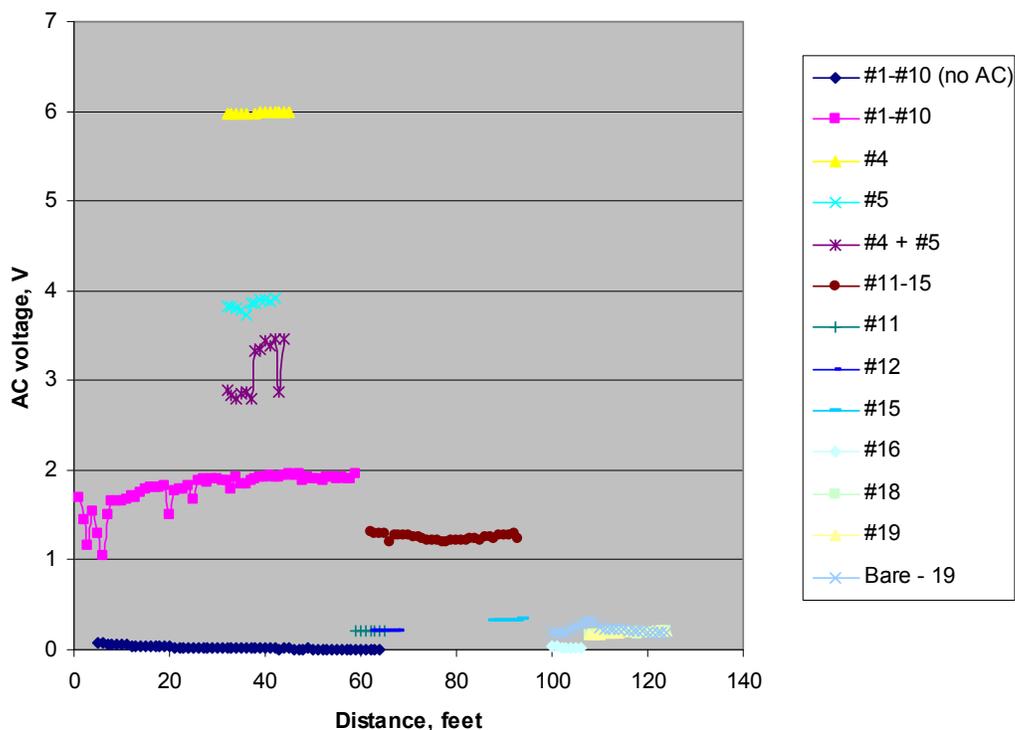
Figure 90. AC current density vs. distance for all surveyed combinations.

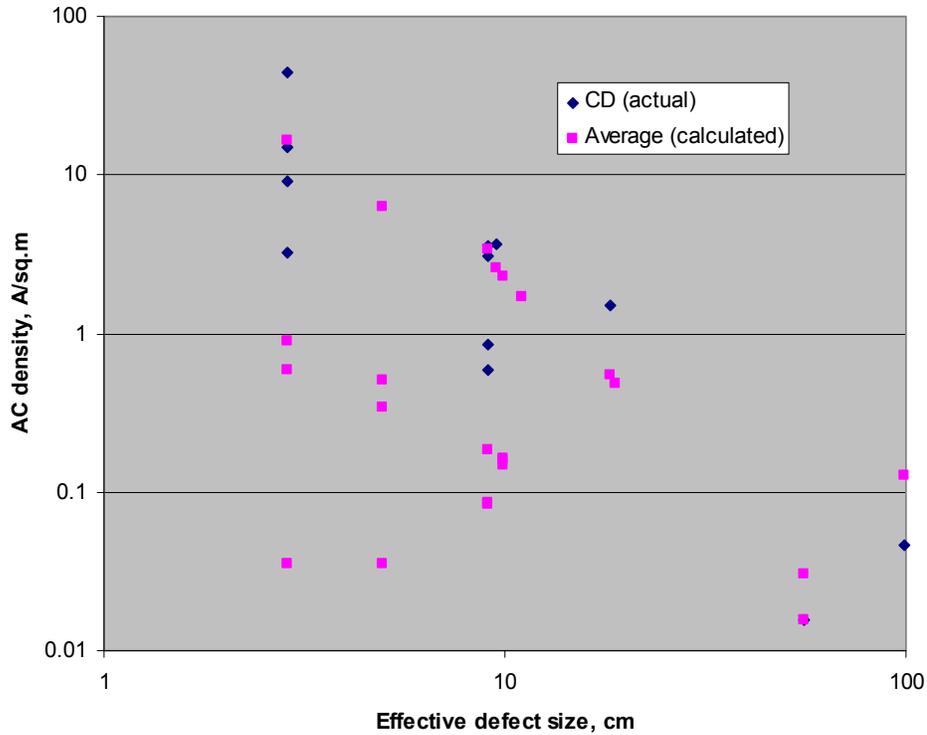
Figure 91. AC current density vs. effective defect size.
