FINAL REPORT

EXTERNAL CORROSION DIRECT ASSESSMENT FOR UNIQUE THREATS TO UNDERGROUND PIPELINES

CONTRACT NO. DTPH56-06-T-0012

**PREPARED BY
CC TECHNOLOGIES, INC., A DNV COMPANY
MARK YUNOVICH, MS, MBA, NACE CORROSION SPECIALIST
STEVEN WATERS, BS**

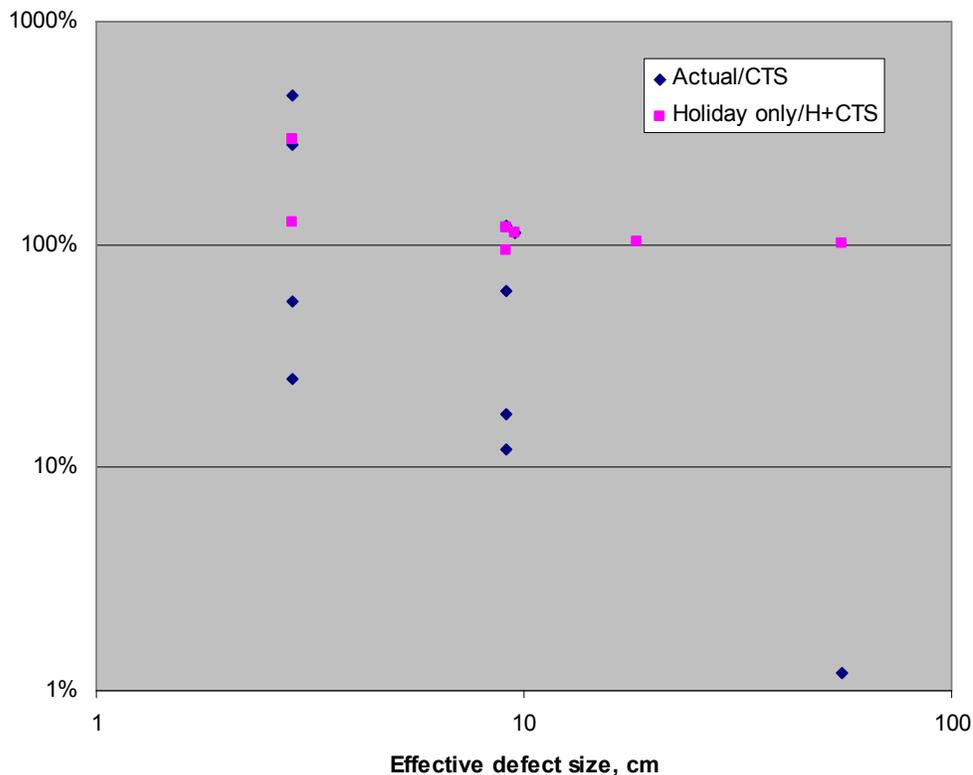
Figure 93. Actual current density vs. calculated current density.

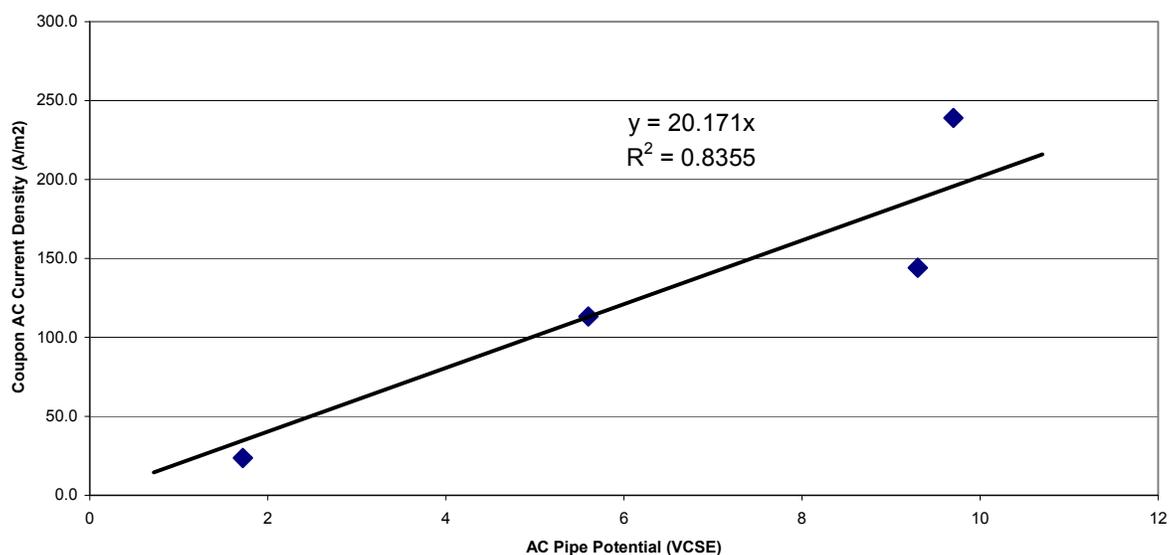
Figure 96. Relationship between measured AC pipe potential and measured coupon current density.³⁴

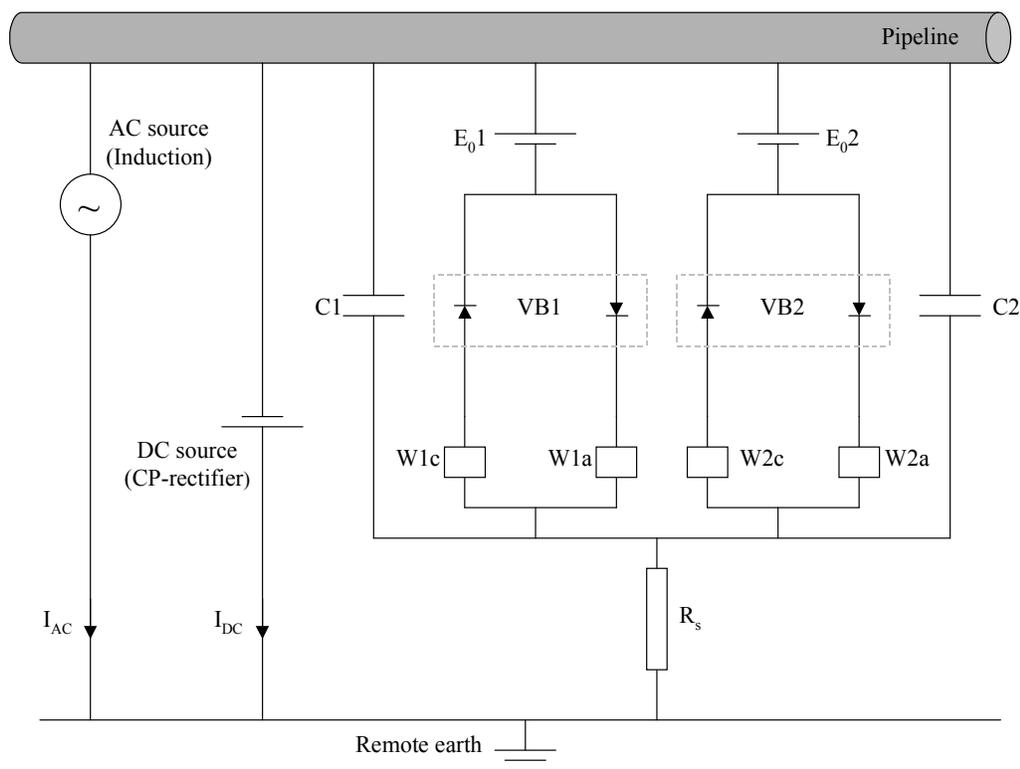
Figure 99. Schematic of a proposed AC corrosion equivalent circuit.²⁵

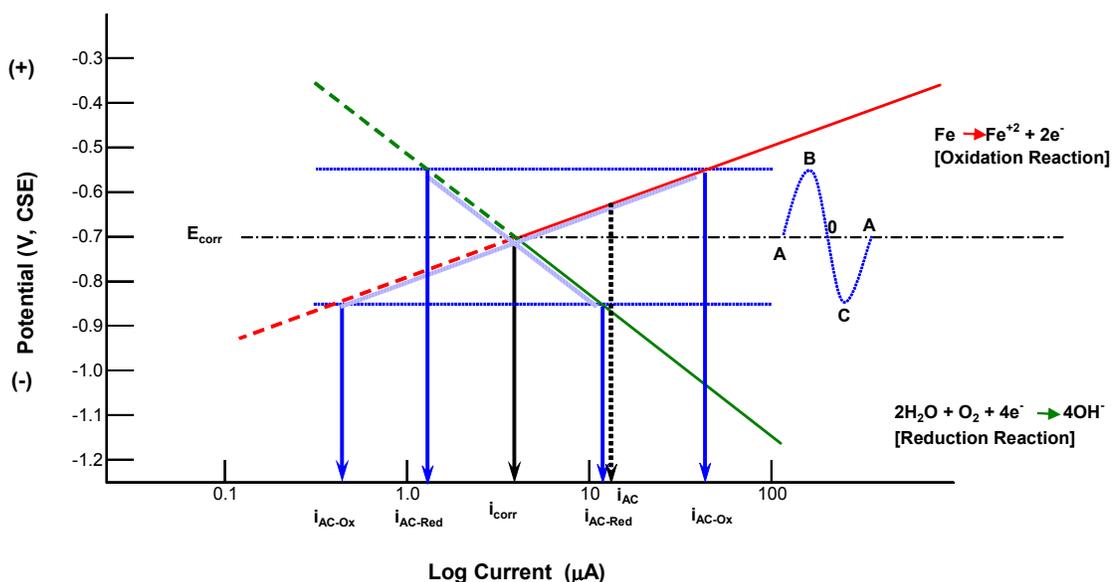
Figure 101. Schematic of proposed mechanism of AC-enhanced corrosion.

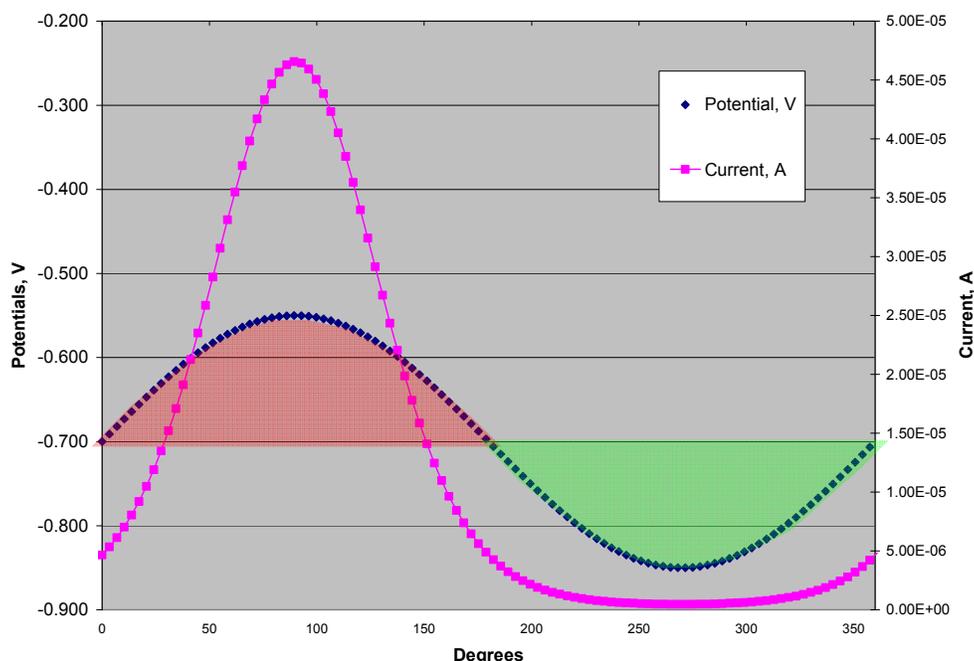
Figure 102. Potential and current shifts for a single period of 60-Hz current producing 150 mV of potential shift.

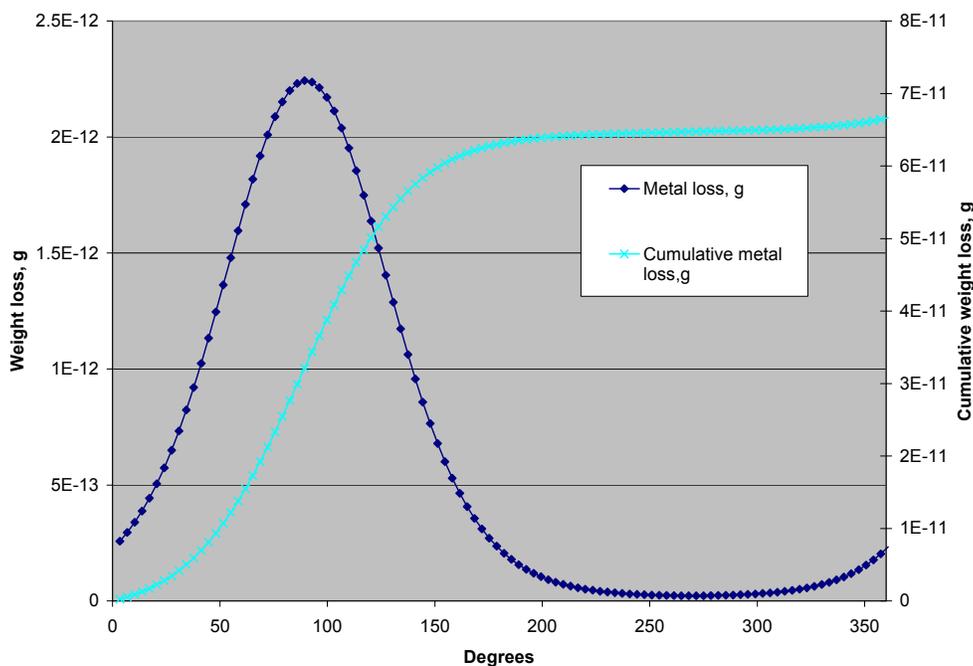
Figure 103. Instant and cumulative metal loss for a single period of a 60-Hz AC producing 150 mV of potential shift.

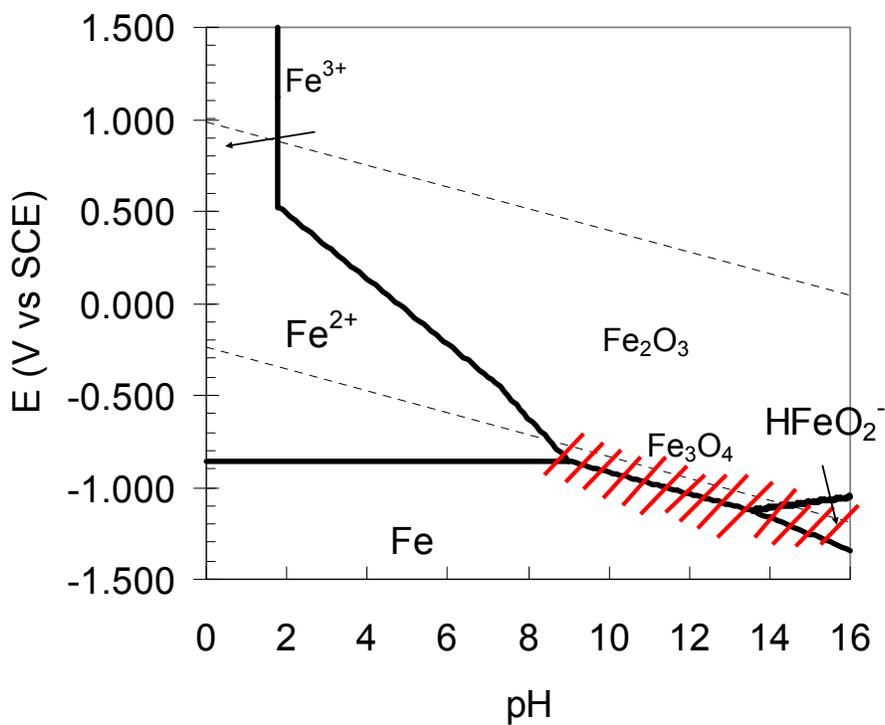
Figure 105. Pourbaix diagram showing unsafe region with respect to AC corrosion.

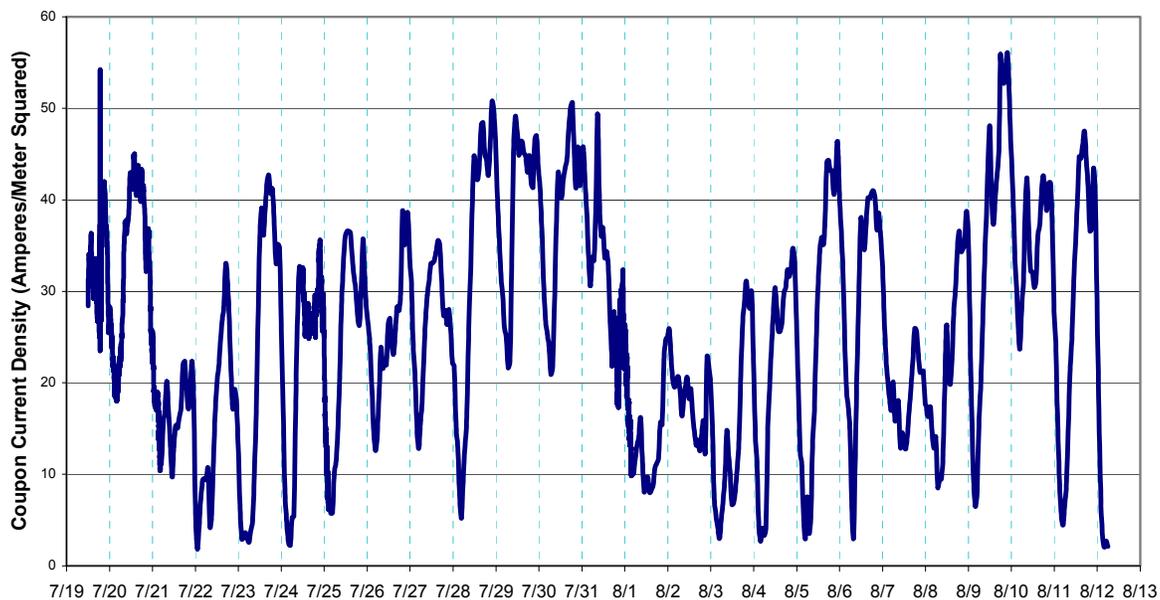
Figure 112. AC density at a coupon over 20 days July/August 2006.

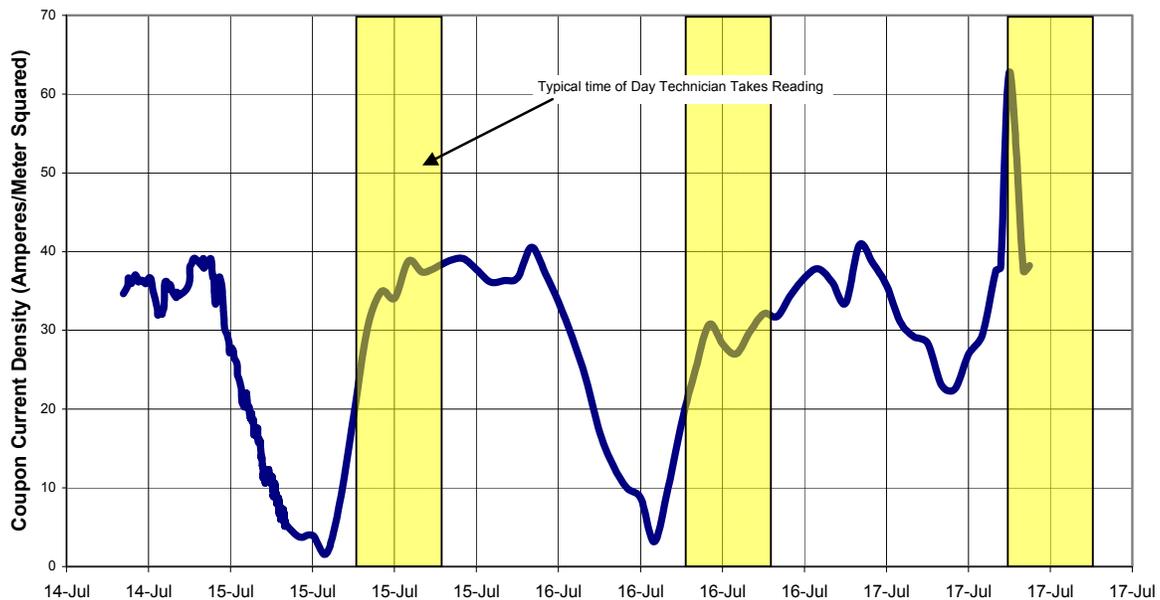
Figure 113. AC density at a coupon over 3-day period in July 2006.

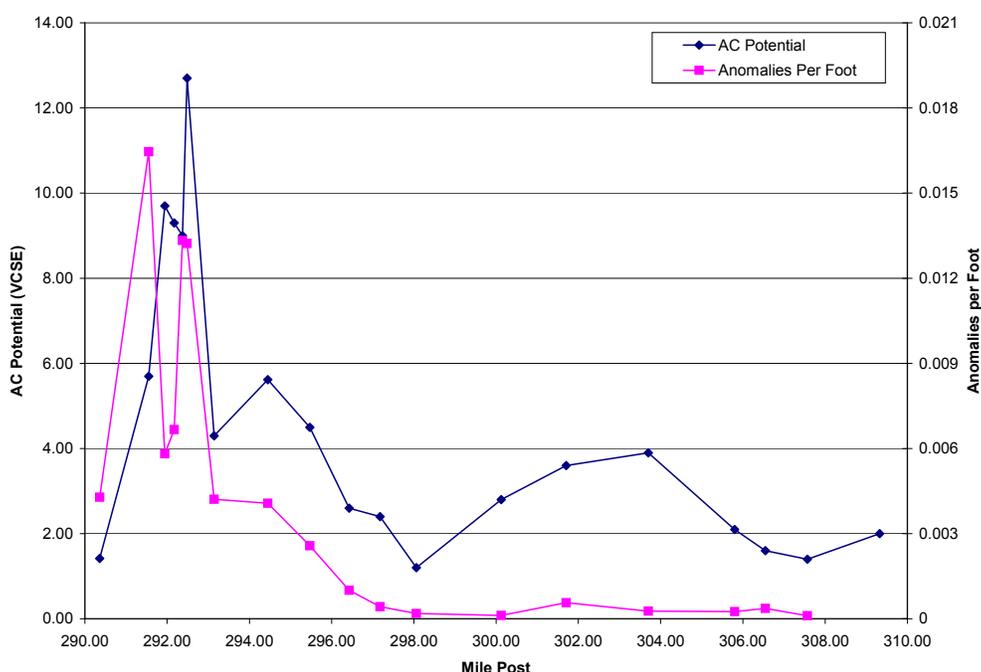
Figure A2. AC potentials and “defect density” (anomalies per linear foot of pipe).
1 ft = 0.3048 meter

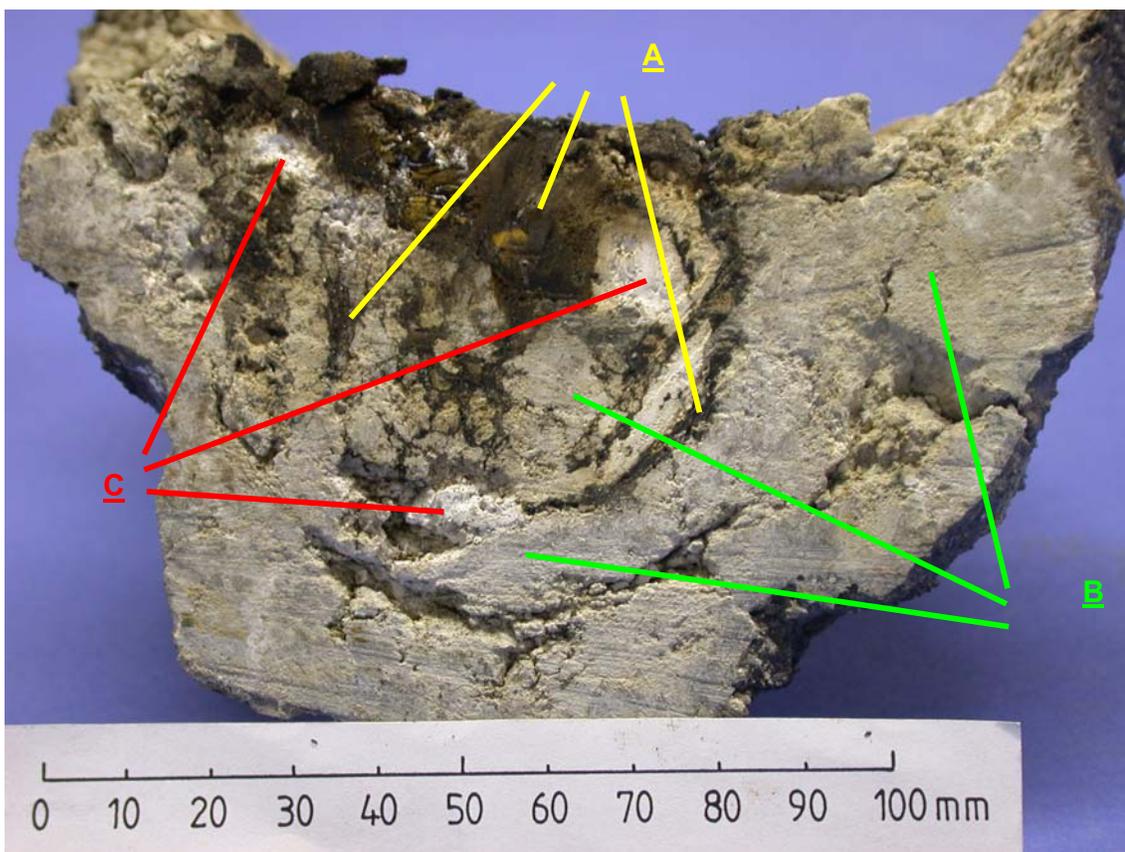
Figure A10—View of the cross section of the soil cap, in direction of the pipe’s axis. The letters indicate different types of material.
