**FINAL REPORT**

**MWM-ARRAY DETECTION AND CHARACTERIZATION OF DAMAGE  
THROUGH COATINGS AND INSULATION**

**By JENTEK Sensors, Inc.  
110-1 Clematis Avenue  
Waltham, Massachusetts 02453-7013  
(781) 642-9666  
[jentek@shore.net](mailto:jentek@shore.net)**

**February 28, 2011**

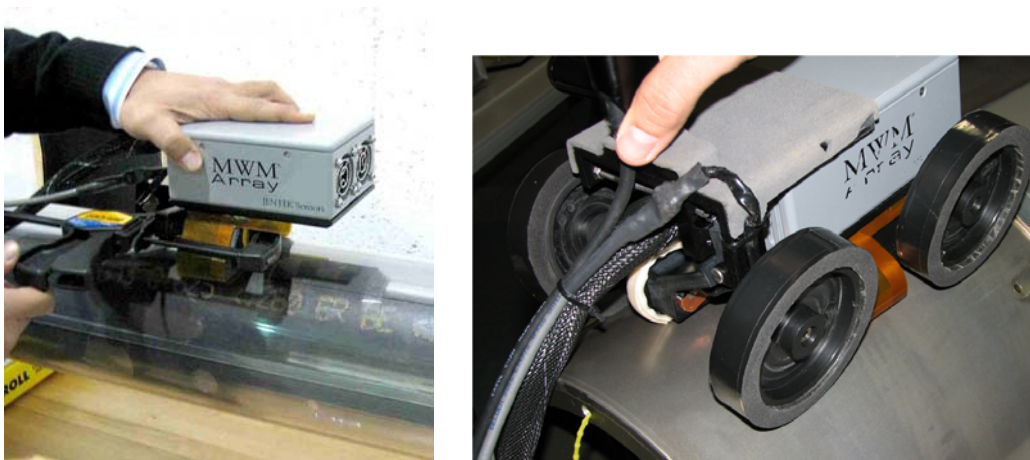
In the effort to provide field support equipment for the scanning arrays, several types of scanning fixtures were investigated. The first type of fixture is shown in Figure 13 and is suitable for use with small MWM-Arrays, such as the FA28 or FA24, for damage imaging through very thin or thin coatings. The sensor array is wrapped around a rigid plastic and foam support layer and positioned underneath the probe electronics. A position encoder is used to record the array position during a scan and, depending upon the configuration, one or more wheels are used to hold the sensor array near the test material surface.

Figure 13. Photographs of a single-sided scanner for use with an FA24 and smaller MWM-Arrays.

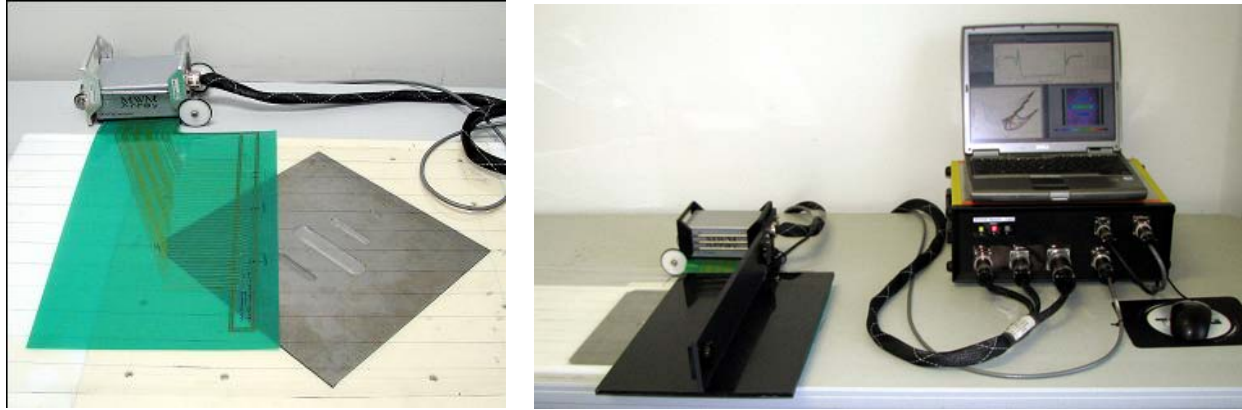
*Figure 18. (Left) Photograph of the medium-sized FA122 and a machined steel plate. (Right) Photograph of the instrument and FA122 MWM-Array mounted to a scanning fixture. Note that the FA122 is underneath the plastic scanner fixture.*

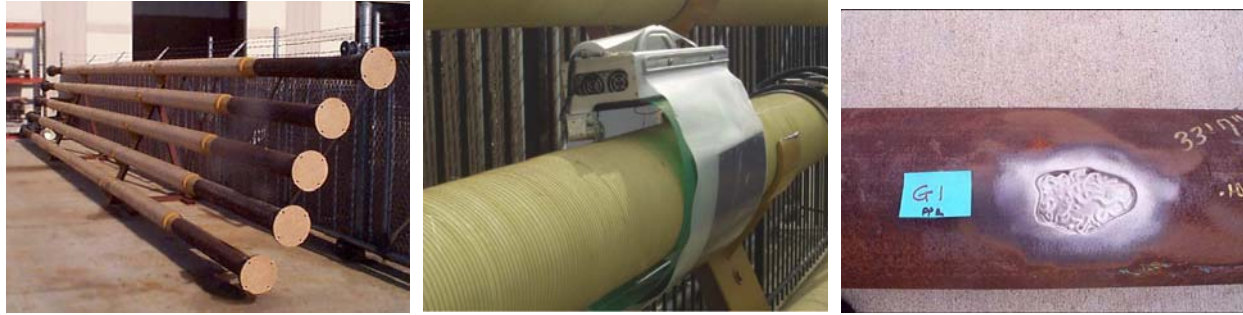
Figure 54. (Left) Simulated pipeline riser sections with embedded corrosion defects. (Center) Photograph of a prototype external scanner. (Right) Photograph of one of the defects.

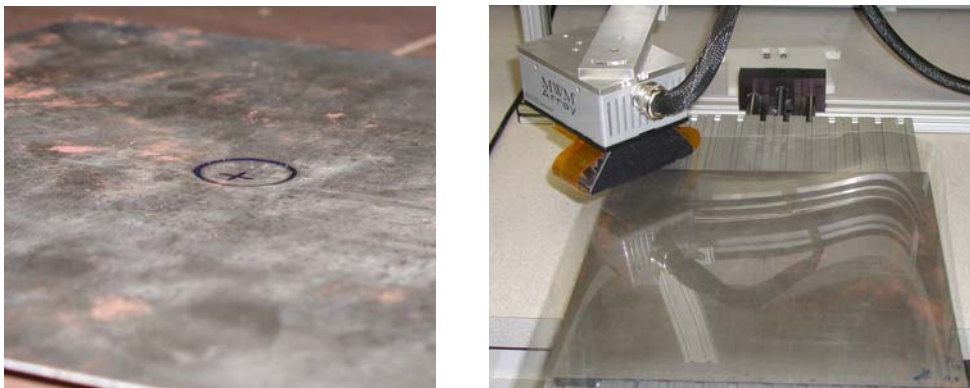
Figure 65. (Left) A dented steel plate. (Right) Plate with an FA24 MWM-Array and a 0.020-in. plastic sheet.

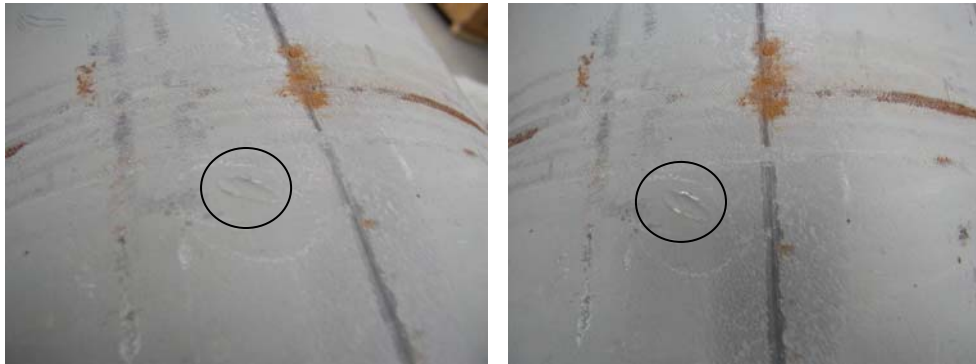
Figure 69. Area of mechanical damage on the external section of a pipe section.

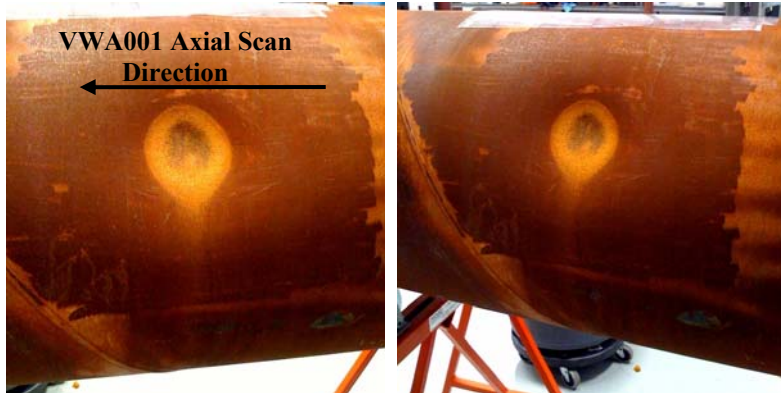
Figure 71. 24-in. diameter pipe section with plain dent. The scan directions for the VWA001 and FA24 MWM-Arrays are indicated.

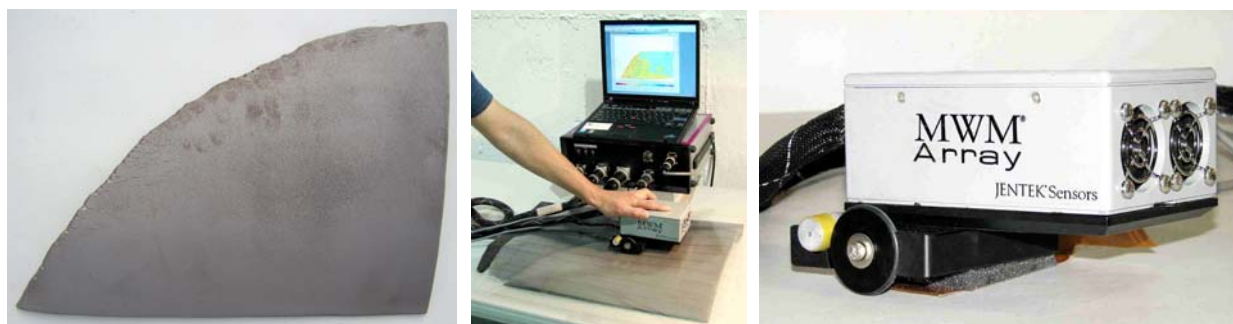
Figure 77. Photographs of (left) the steel pipeline section having clusters of SCC damage, (middle) the scanning setup, and (right) the MWM-Array sensor cart assembly.

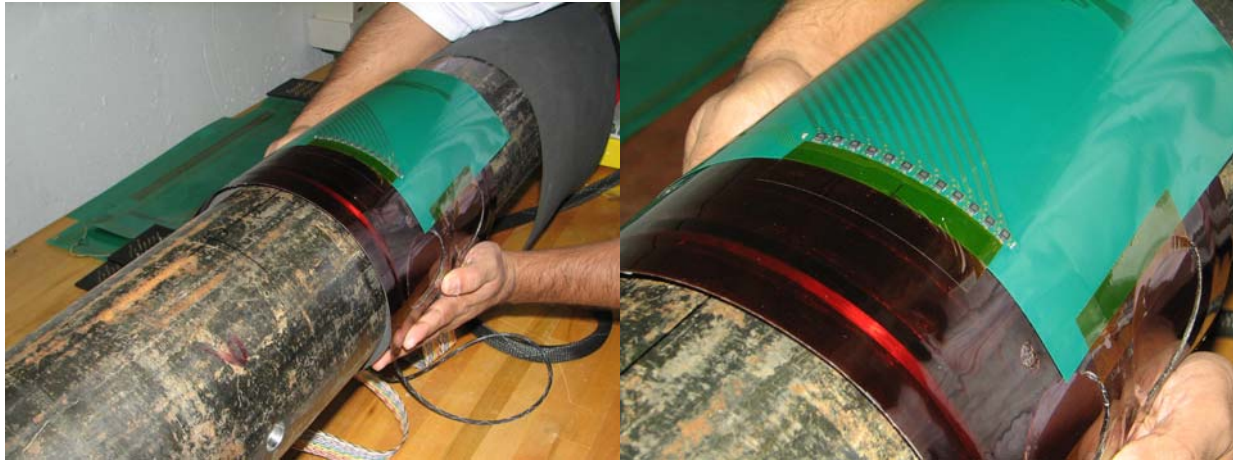
*Figure 93. Photographs of the flexible MR-MWM-Array wrapped around a 6-in. diameter pipe section with several 25.4 mm (1-in.) diameter flat-bottom regions machine out of the inner surface.*

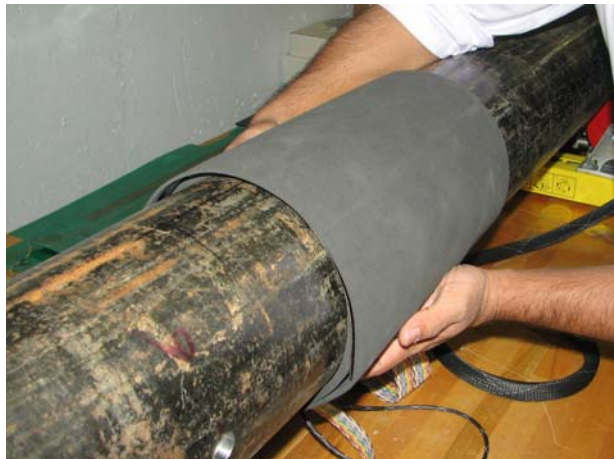
*Figure 94. Photograph of the flexible MR-MWM-Array wrapped around a 6-in. diameter pipe section with an extra layer of 0.25-in. thick Neoprene wrapped around the sensor array.*

For measurements with the MR-MWM-Array on the pipe section, an extra layer of 0.25-in. thick Neoprene was wrapped around the sensor array to hold it in place as shown in Figure 94. A suitable scanning fixture was not fabricated for this prototype array so an image of the pipe properties was obtained by taking a set of measurements at discrete intervals of approximately 6.35 mm (0.25-in.) over the pipe surface. Frequencies from 30Hz to 1kHz were again used for the inversion, along with an air calibration. This data is also undergoing further analysis to support follow-on work.
