Field Trial Activities

This section contains a day-by-day description of field trial activities from June 5, 2009 through June 18, 2009.

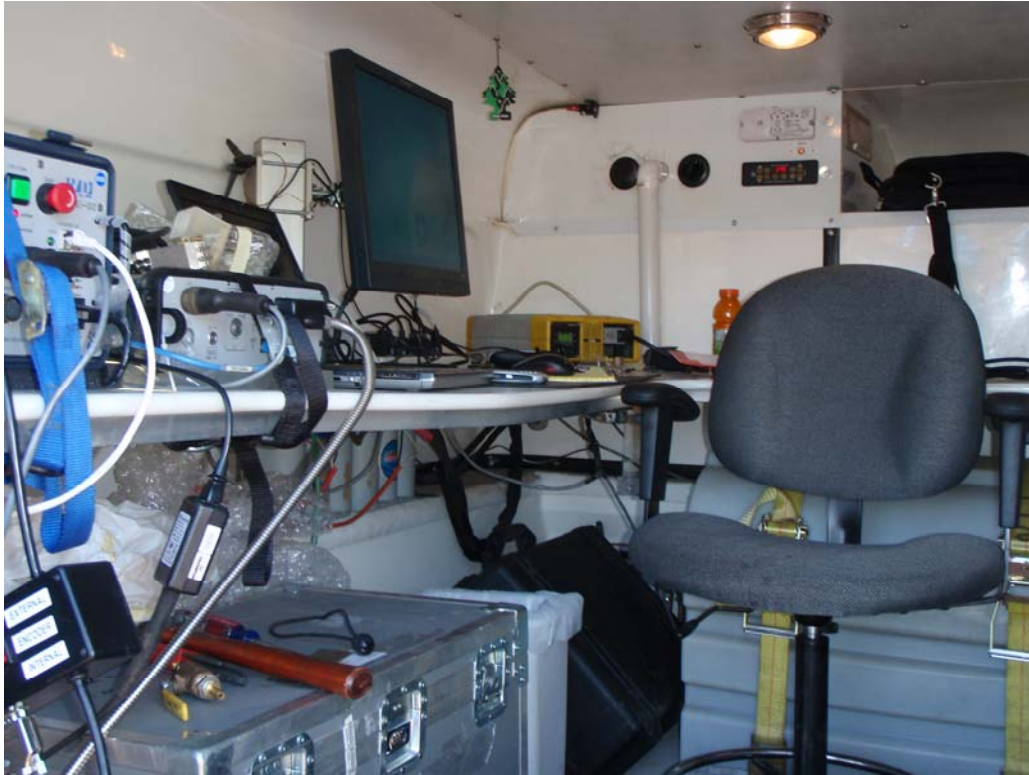
Figure 2. Interior of UTQ Truck with EWI Equipment Installed

Prior to Mr. White and Mr. Eff arriving in Canada, EWI shipped the scanning equipment to the UTQ Quality (UTQ) facilities in Edmonton. UTQ assisted EWI with customs associated with shipping the EWI scanning equipment to and from Canada. When the equipment arrived at UTQ, it was unpacked and loaded on a truck provided by UTQ (Figure 1). Figure 2 is a photo of the inside of the UTQ truck loaded with the EWI phased-array (PA) equipment. Additionally, UTQ provided a driver to transport the equipment and EWI staff to and from the field trial site every day of the field trial period.

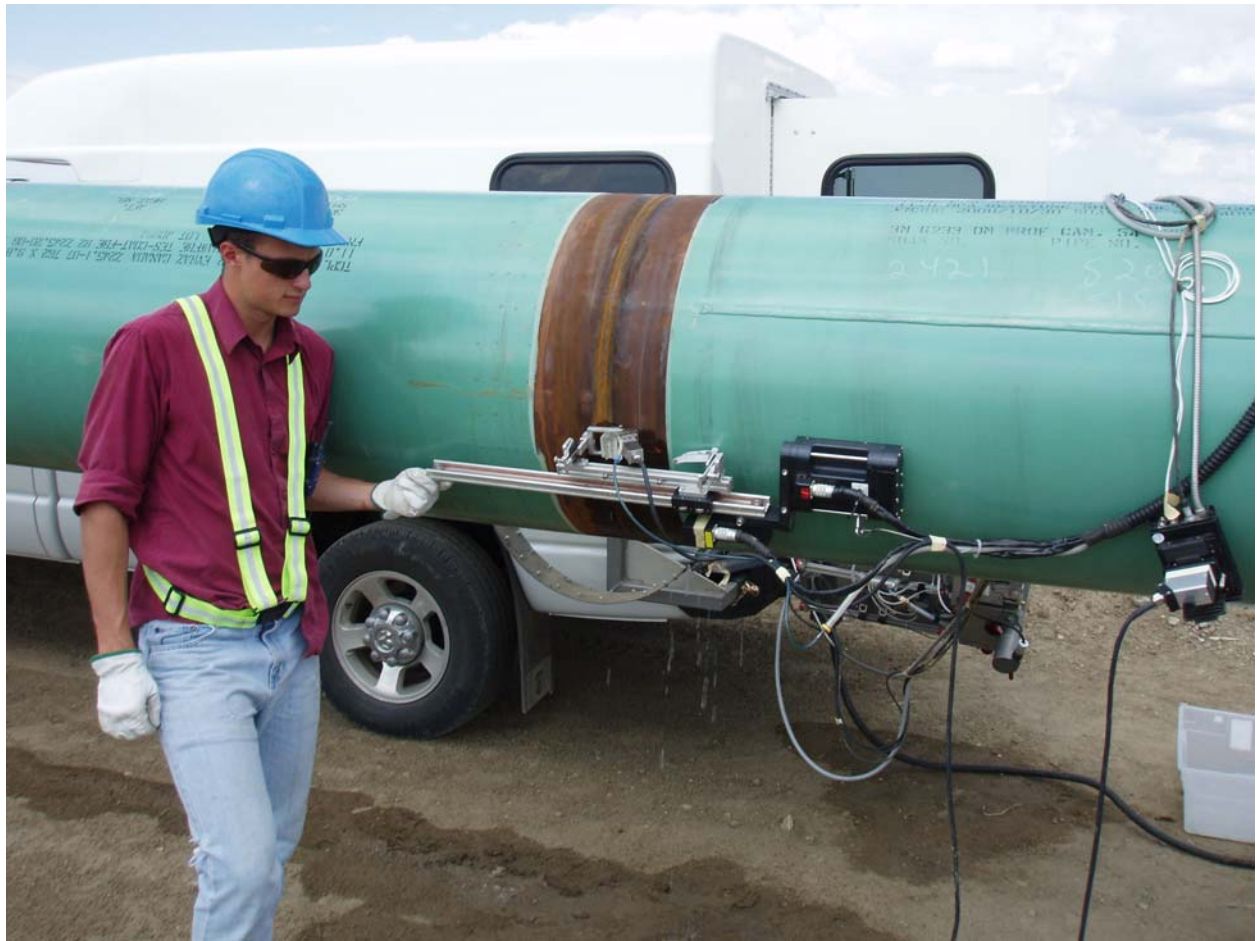
Figure 3. Mike Eff with LPA Scanner

At the UTQ facility in Edmonton, the linear phased array (LPA) set up was verified with the new EWI calibration block using a manual non-encoded technique. After set up was complete, the equipment was broken down and secured for transport to the remote field location in Hardisty. Figure 3 shows the EWI LPA scanning equipment mounted on a pipe section.

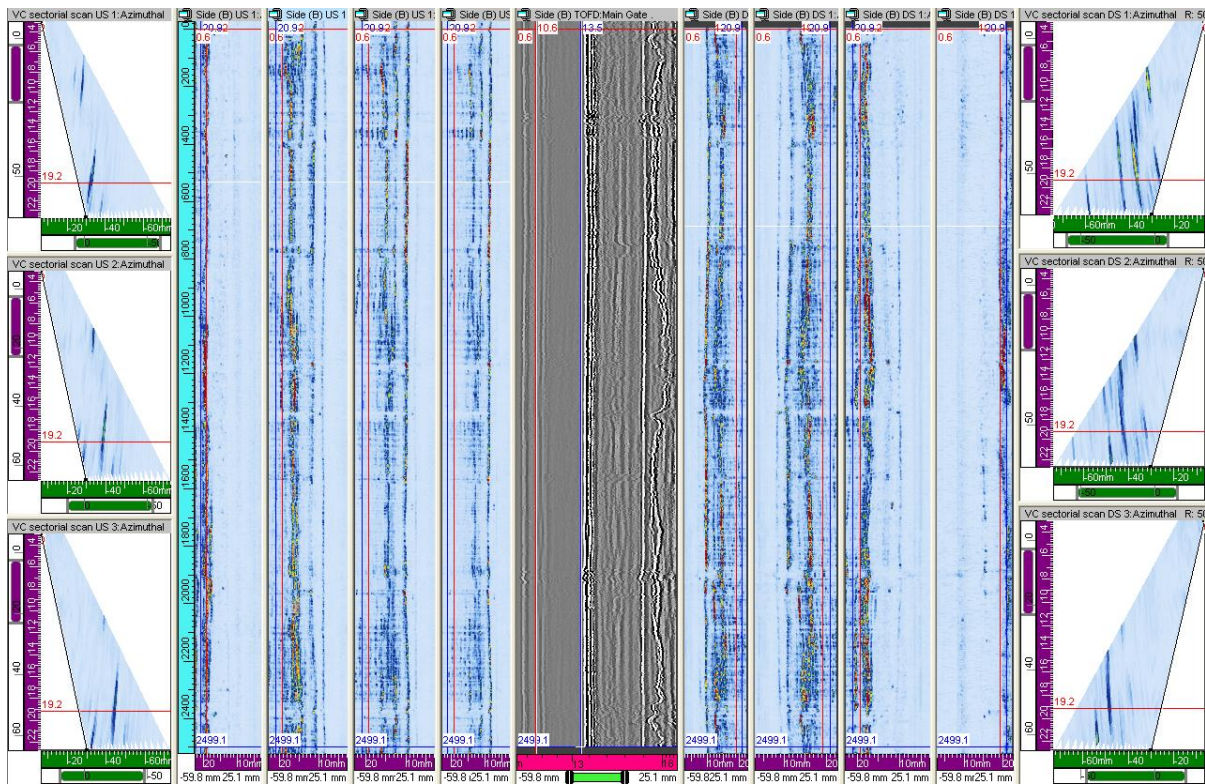
After safety training was complete, two welder qualification welds WT-003 and WT-004 were available for scanning. Both samples consisted of 9.8-mm wall pipe welded with a semi-automated gas metal arc welding (GMAW) process. Both WT-003 and WT-004 were known to be acceptable welds with no rejectable defects; they were scanned for informational purposes only. Figure 5 is a screen capture from the scan of WT-003 using EWI's prototype LPA scanner with the non zonal technique. Figure 6 is a screen capture from the scan of WT-004 using EWI's prototype LPA scanner with the non-zonal technique.

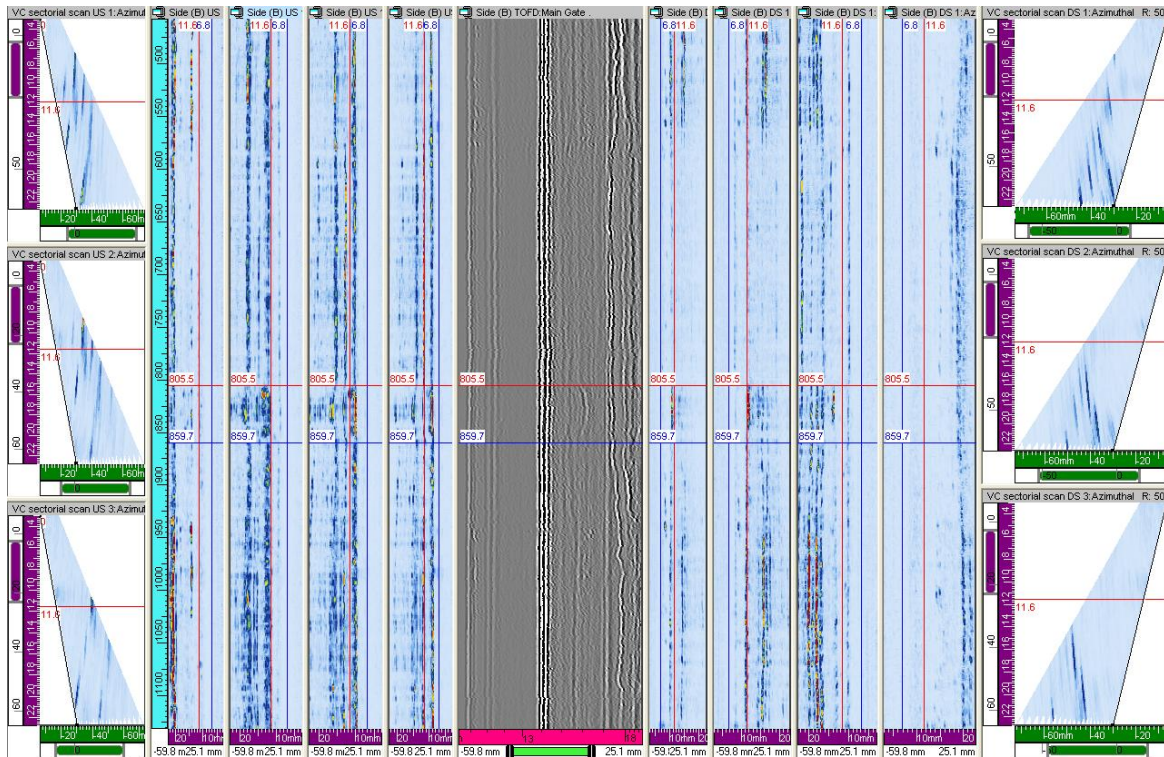
Figure 8. Weld WT-004 - EWI LPA Scan Screen Capture

Using the EWI LPA non-zonal technique, WT-004 was found to have a small geometry indication on the upstream (US) side (Figure 8). WT-004 was also scanned with matrix phased array (MPA). Figure 9 contains the screen capture of the MPA US scan that shows a 780- to 880-mm geometry indication. Figure 10 contains the screen capture of the MPA downstream (DS) scan that shows 780- to 880-mm geometric indication. All MPA scans are in the Field Trial report for DOT project *Enhanced Defect Detection and Sizing Accuracy Using Matrix Phased Array Ultrasonics Tools Program* (DTPH56-08-T-000002).

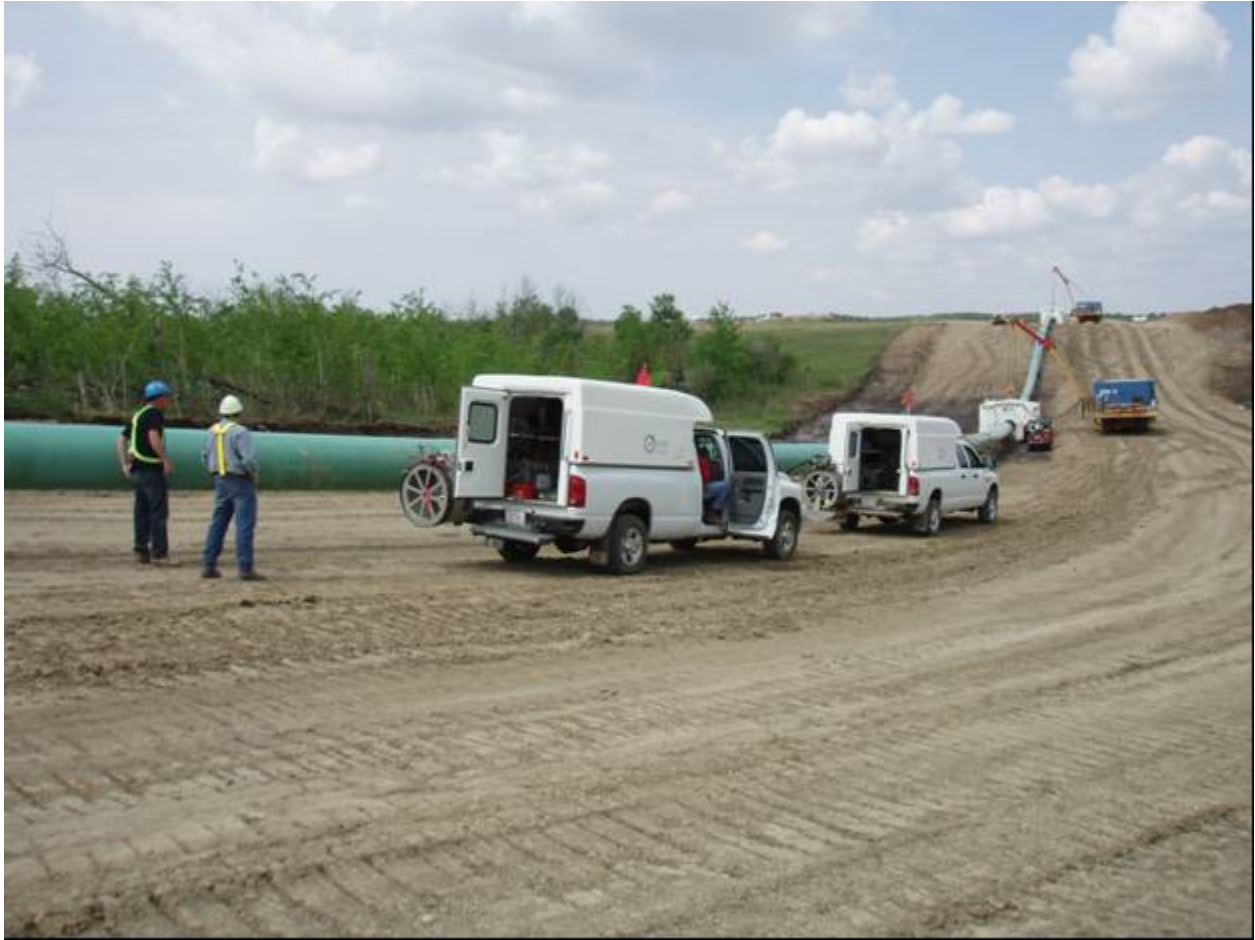
Figure 12. EWI Truck Following UTQ Truck Performing AUT Scans for TCPL

After arriving back in Hardisty, EWI and TCPL personnel went directly to the right of way where the Keystone Pipeline was located. UTQ is the inspection company hired by TCPL to inspect all production welds on the site where the field trials took place. The approach for the field trial was simple. When UT Quality discovered a significant weld defect, EWI was to step in and do a LPA scan (for DTPH56-07-T-000002). When that scan was complete, EWI was to change the scanner equipment to do a MPA scan (for DTPH56-08-T-000002). This was anticipated to be the best approach to gather data in the most efficient manner with minimal interruption to the TCPL production schedule. Figure 12 shows the EWI truck (provided by UTQ) following the UTQ truck with the crew that was performing the AUT inspections for TCPL.

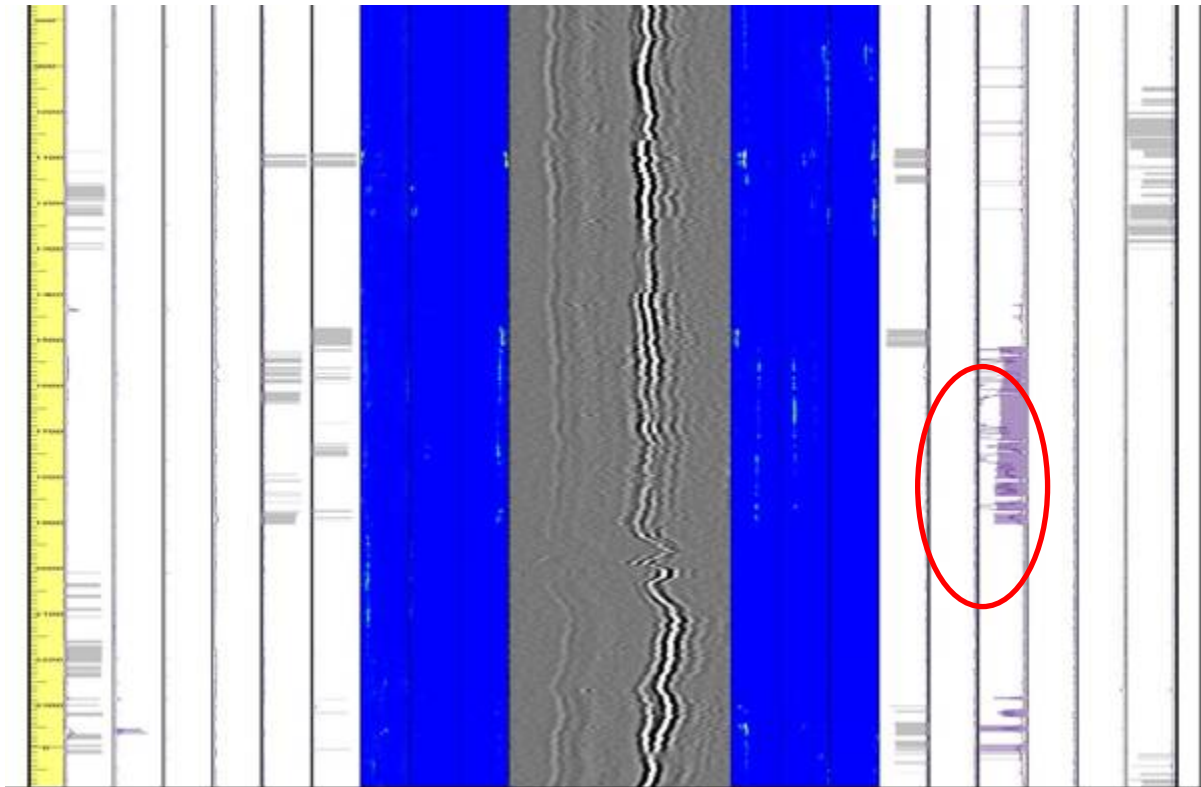
Figure 13. Weld MLA 4530 - UTQ Scan Screen Capture

Scanning activities resumed on weld MLA 4530, which was rejected by UTQ using the zonal discrimination method for an indication exceeding allowable dimensions per the governing acceptance criteria. The zonal discrimination UTQ scan is shown in Figure 13. EWI's LPA non-zonal scan is shown in Figure 14. Figure 15 shows the EWI scan on the DS side with S-Scans and volume corrected side view (B-Scans). There was good agreement between the UTQ zonal discrimination method and the EWI LPA non-zonal method.

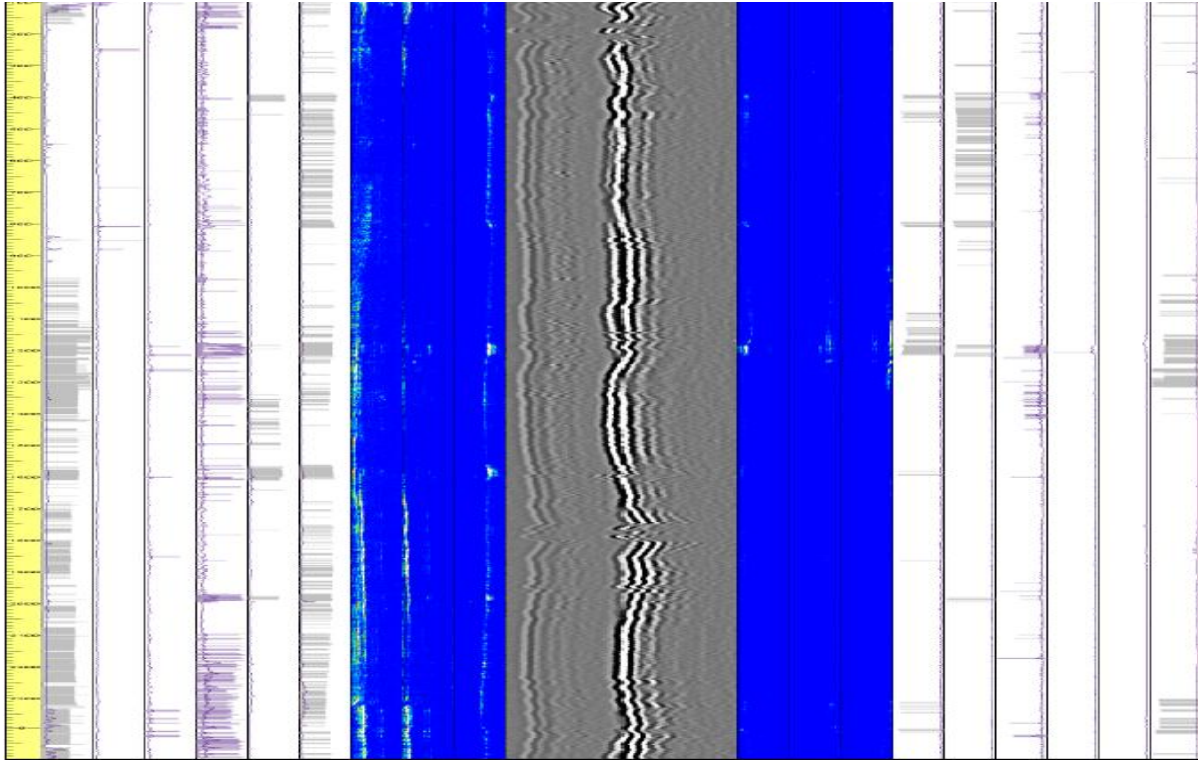
Due to exceptional weld quality on the Keystone project, there were no welds containing rejectable indications on Friday June 12, 2009. Consequently, the team decided to scan good main line welds. Acceptable weld MLA 4568 was scanned to compare techniques. For MLA 4568: the zonal discrimination UTQ scan is shown in Figure 16 and the EWI LPA non-zonal scan is shown in Figure 17. There was good agreement between the UTQ zonal discrimination method and the EWI LPA non-zonal method.

Figure 16. Weld MLA 4568 - UTQ Screen Capture

Figure 17. Weld MLA 4568 - EWI LPA Screen Capture

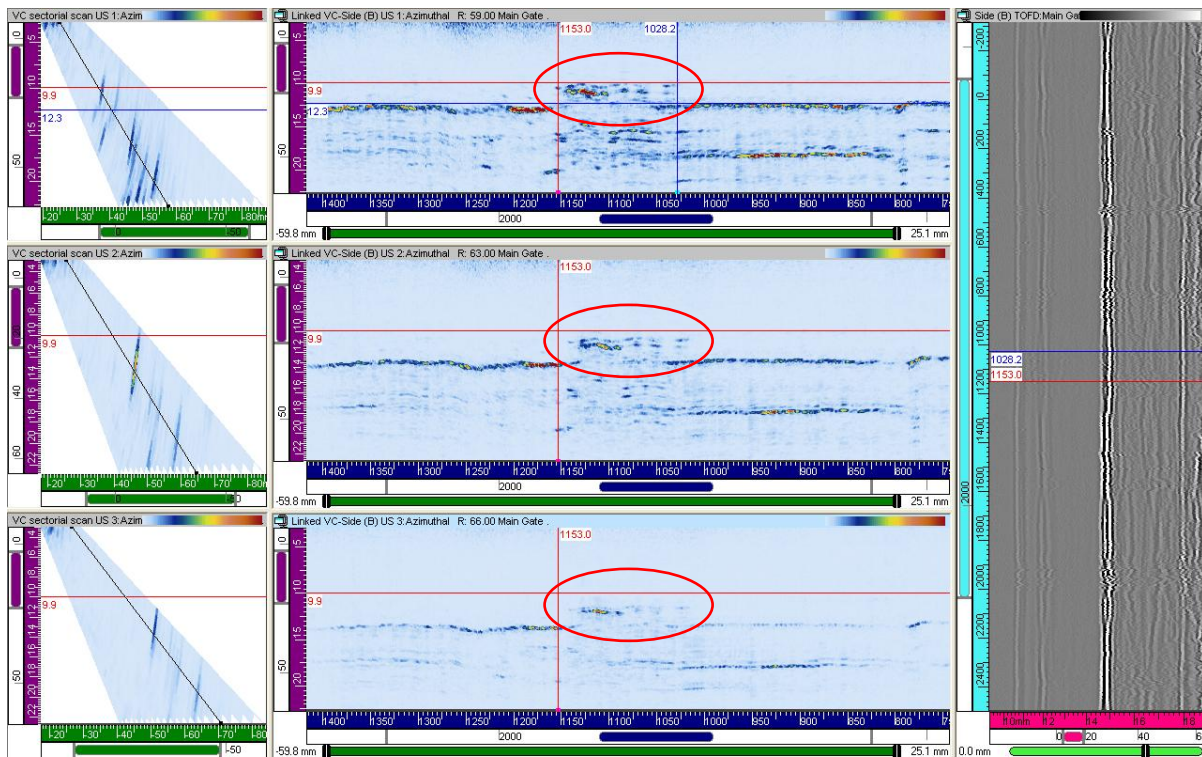
Weld MLA 4685 was scanned, as it was found to contain one rejectable indication that could be used for technique comparison. For MLA 4685 the zonal discrimination UTQ scan is shown in Figure 21. The EWI LPA non-zonal scan is shown in Figure 22. The EWI scan on the US side with S-scans and volume corrected side view (B-scans) is shown in Figure 23. There was good agreement between the UTQ zonal discrimination method and the EWI LPA non-zonal method.

Figure 21. Weld MLA 4685 - UTQ Scan Screen Capture

Figure 22. Weld MLA 4685 - EWI LPA Scan Screen Capture1

Figure 23. Weld MLA 4685 - EWI LPA Scan Screen Capture2 (US)

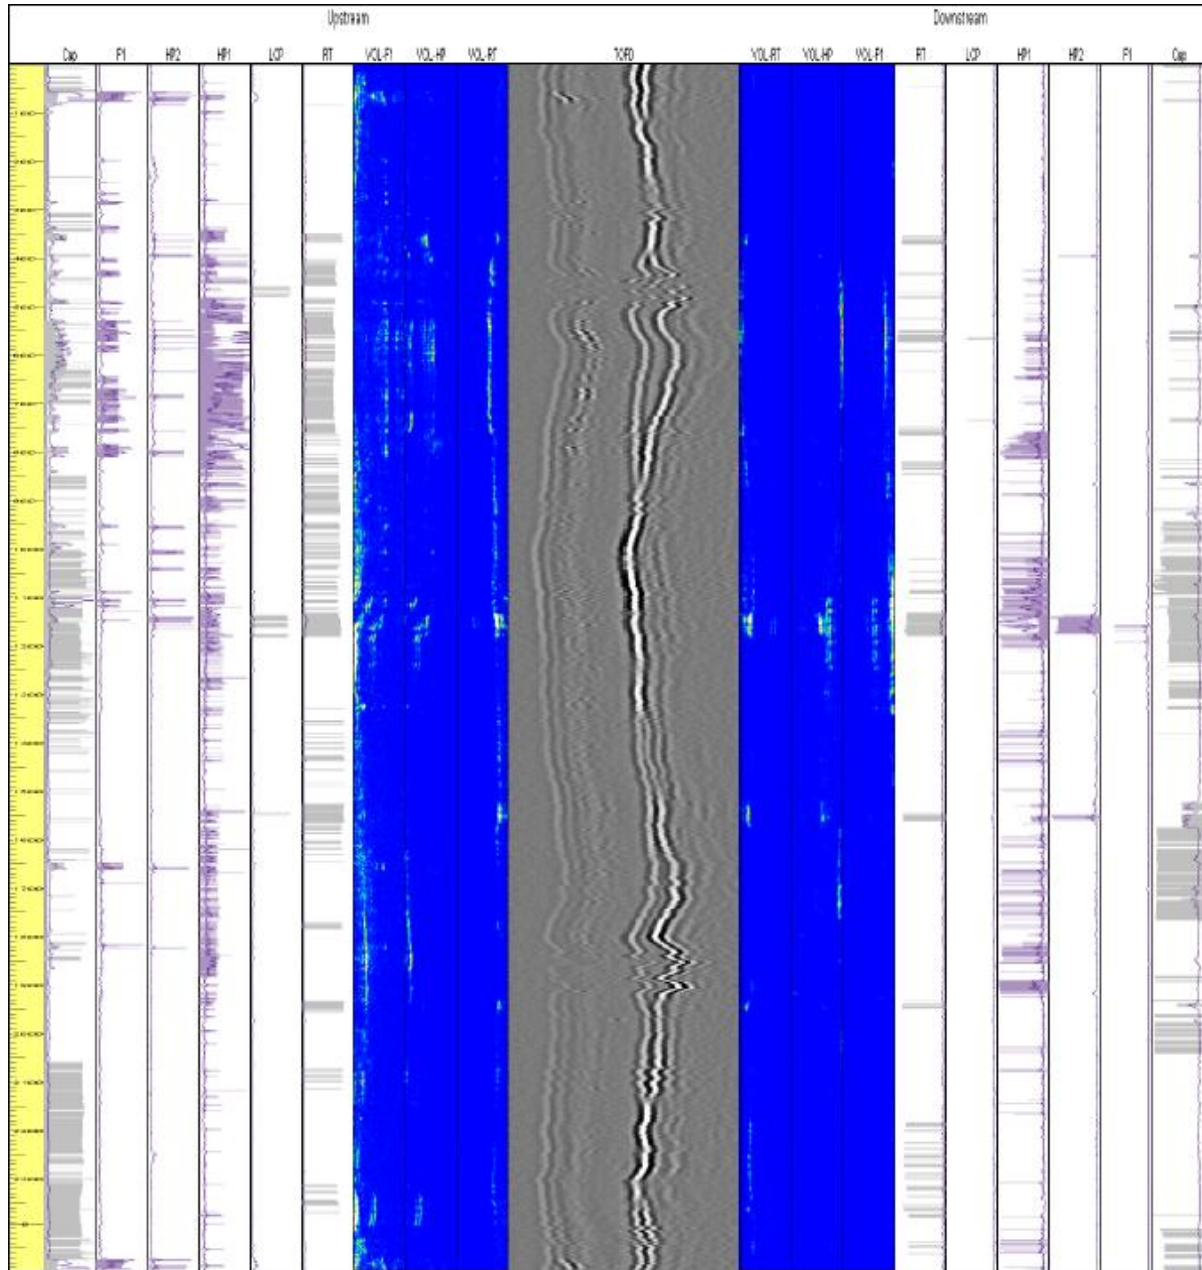
Due to exceptional weld quality on the Keystone project, there was only one weld containing rejectable indications on Saturday June 13, 2009. Consequently, the team decided to scan good main line welds. For MLA 4698: the zonal discrimination UTQ scan is shown in Figure 24 and the EWI LPA non-zonal scan is shown in Figure 25. There was good agreement between the UTQ zonal discrimination method and the EWI LPA non-zonal method.

Figure 24. Weld MLA 4698 - UTQ Scan Screen Capture

Figure 25. Weld MLA 4698 - EWI LPA Scan Screen Capture

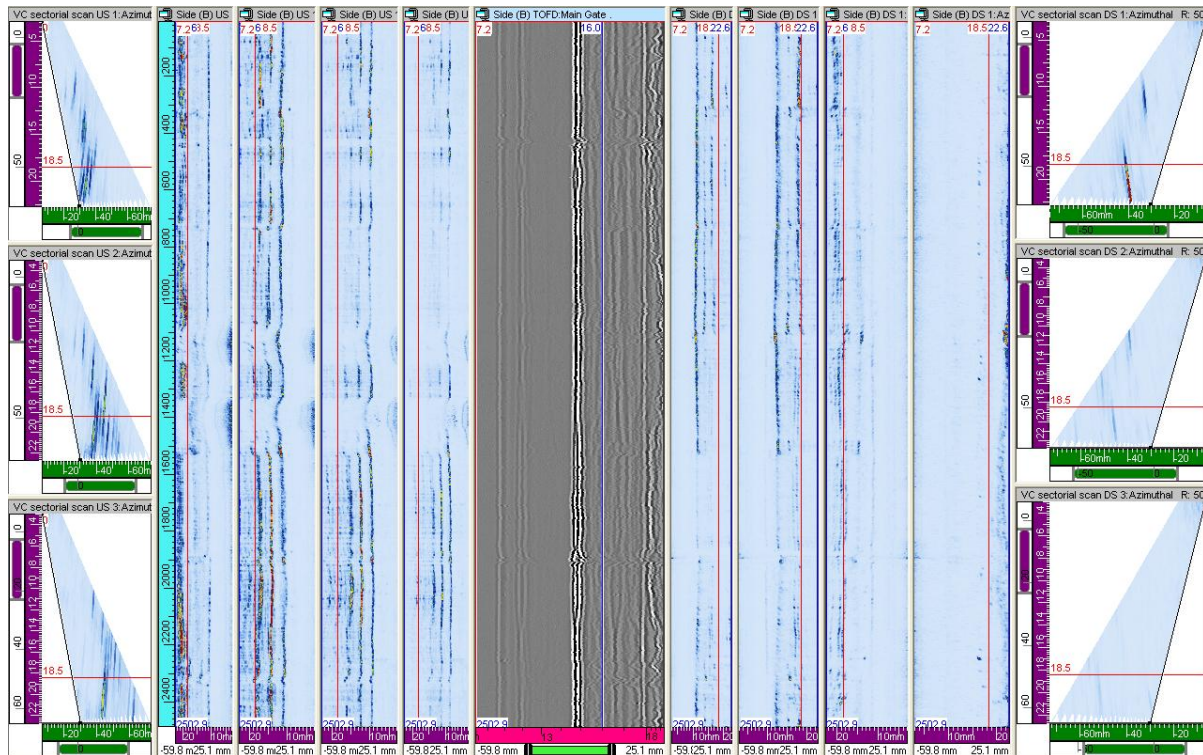
For MLA 4591: the zonal discrimination UTQ scan is shown in Figure 26 and the EWI LPA non-zonal scan is shown in Figure 27. There was good agreement between the UTQ zonal discrimination method and the EWI LPA non-zonal method.

Figure 26. Weld MLA 4591 - UTQ Scan Screen Capture

Figure 27. Weld MLA 4591 - EWI LPA Scan Screen Capture

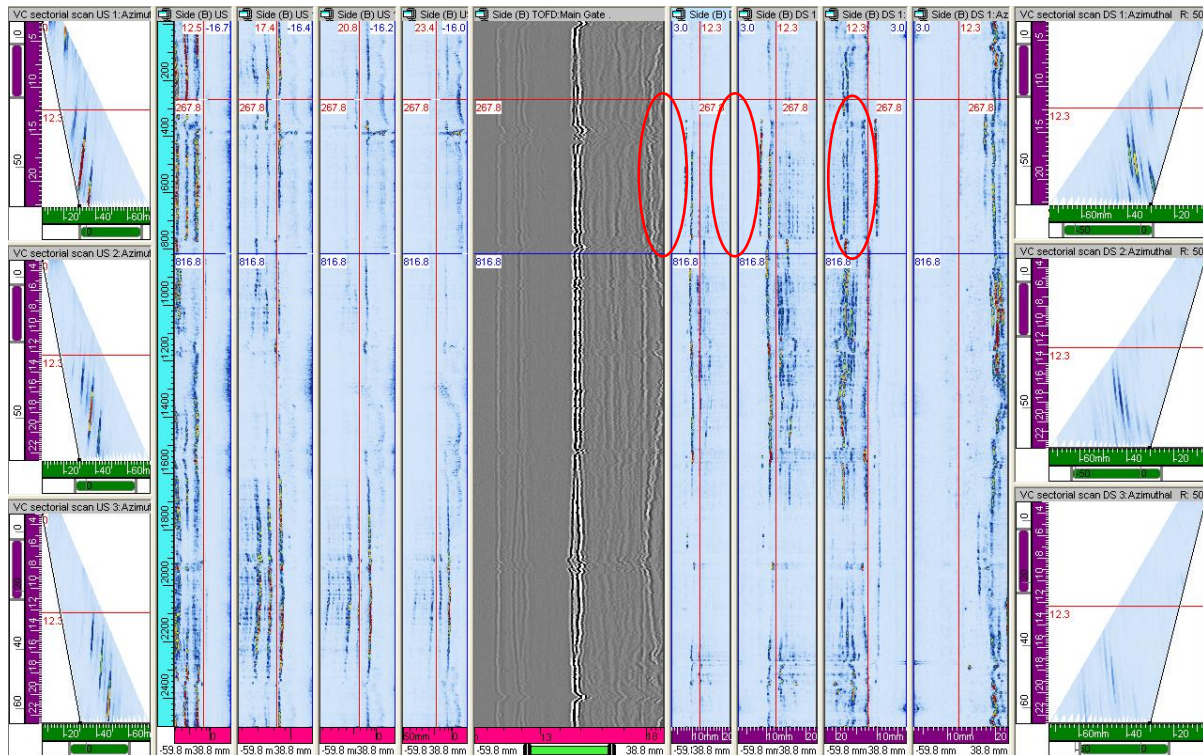
Weld MLA 4887 was scanned, as it was found to contain one rejectable indication that could be used for technique comparison. For MLA 4887 the zonal discrimination UTQ scan is shown in Figure 36. The EWI LPA non-zonal scan is shown in Figure 37. The EWI scan on the DS side with S-scans and volume corrected side view (B-scans) is shown in Figure 38. There was good agreement between the UTQ zonal discrimination method and the EWI LPA non-zonal method.

Figure 36. Weld MLA 4887 - UTQ Scan Screen Capture

Figure 37. Weld MLA 4887 - EWI LPA Scan Screen Capture 1

Figure 38. Weld MLA 4887 - EWI LPA Scan Screen Capture 2 (DS)

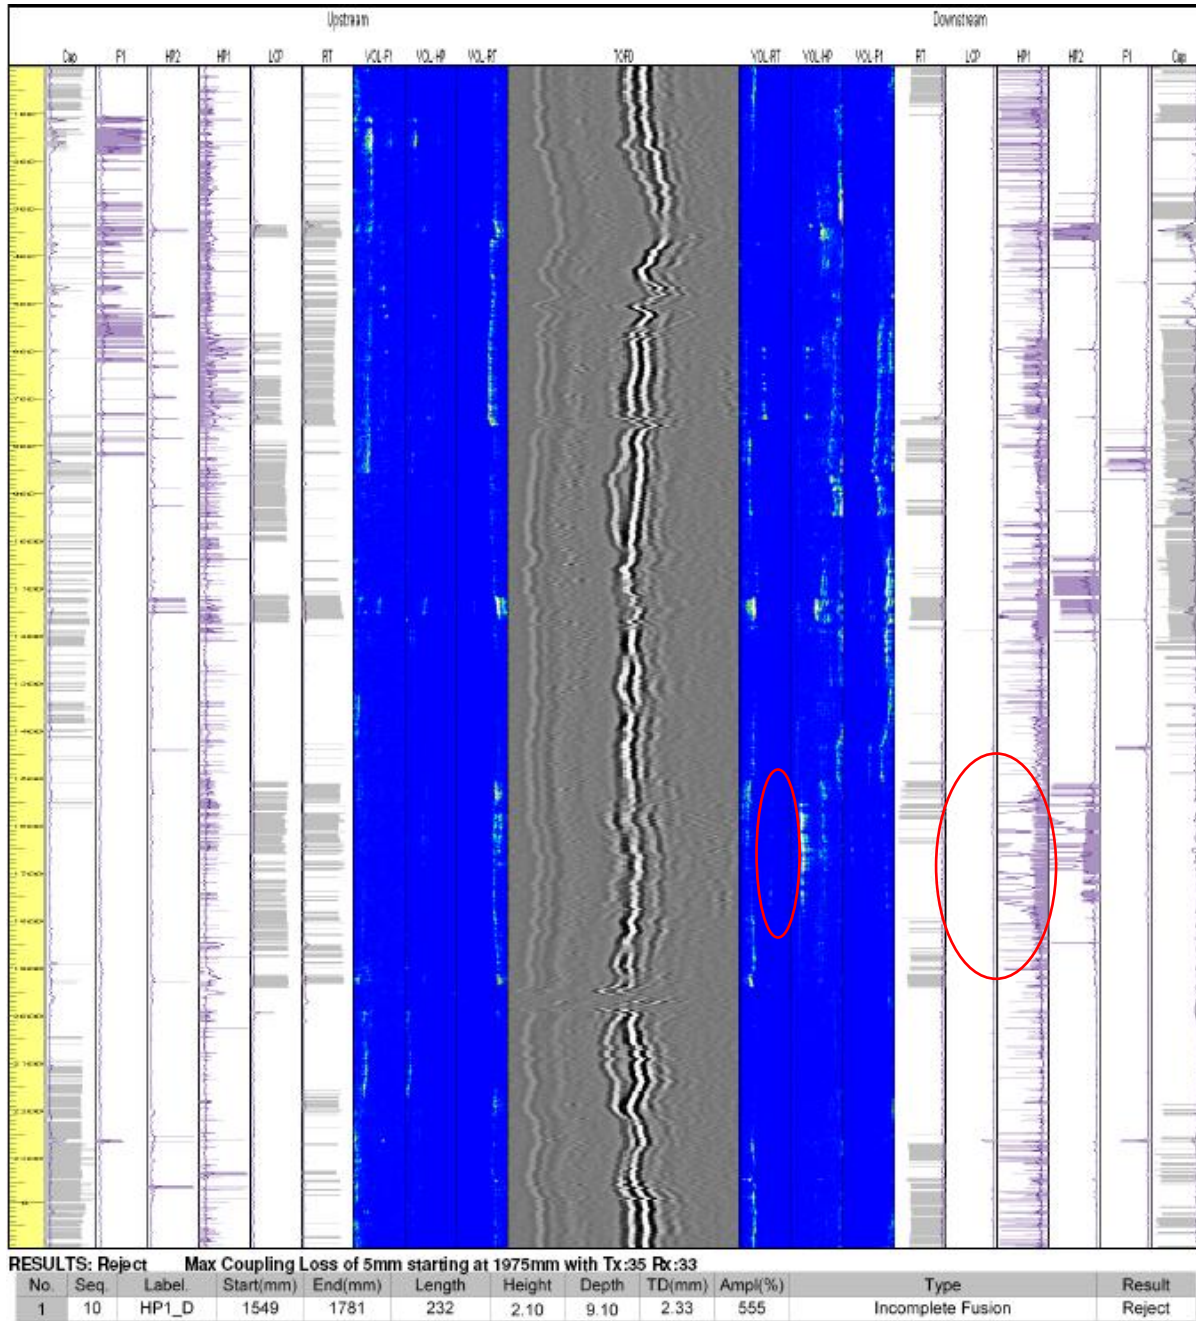
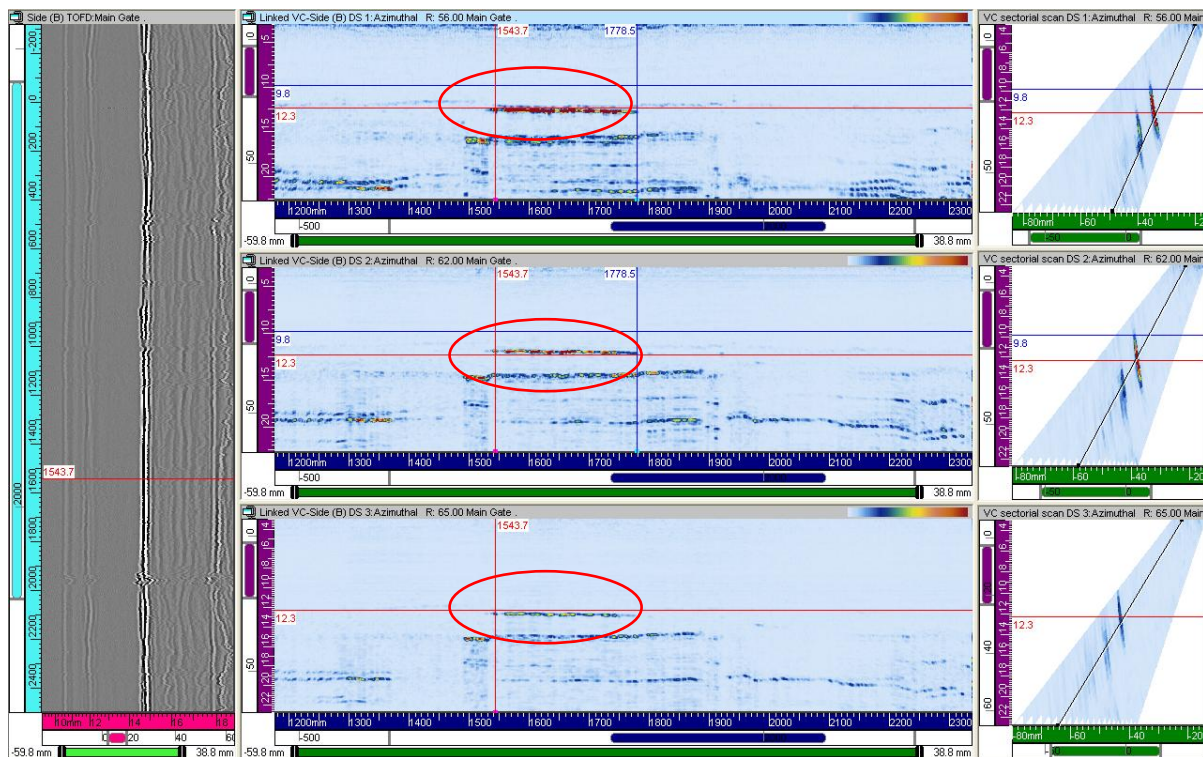
Weld MLA 4890 was scanned, as it was found to contain one rejectable indication that could be used for technique comparison. For MLA 4890 the zonal discrimination UTQ scan is shown in Figure 39. The EWI LPA non-zonal scan is shown in Figure 40. The EWI scan on the DS side with S-scans and volume corrected side view (B-scans) is shown in Figure 41. There was good agreement between the UTQ zonal discrimination method and the EWI LPA non-zonal method.

Figure 39. Weld MLA 4890 - UTQ Scan Screen Capture

Figure 40. Weld MLA 4890 - EWI LPA Scan Screen Capture 1

Figure 41. Weld MLA 4890 - EWI LPA Scan Screen Capture 2 (DS)
