Final Report

Date of Report: April 15, 2011

Project Title: "Understanding Magnetic Flux Leakage (MFL) Signals from Mechanical Damage in Pipelines"

Understanding Magnetic Flux Leakage (MFL) Signals from Mechanical Damage in Pipelines – Phase III

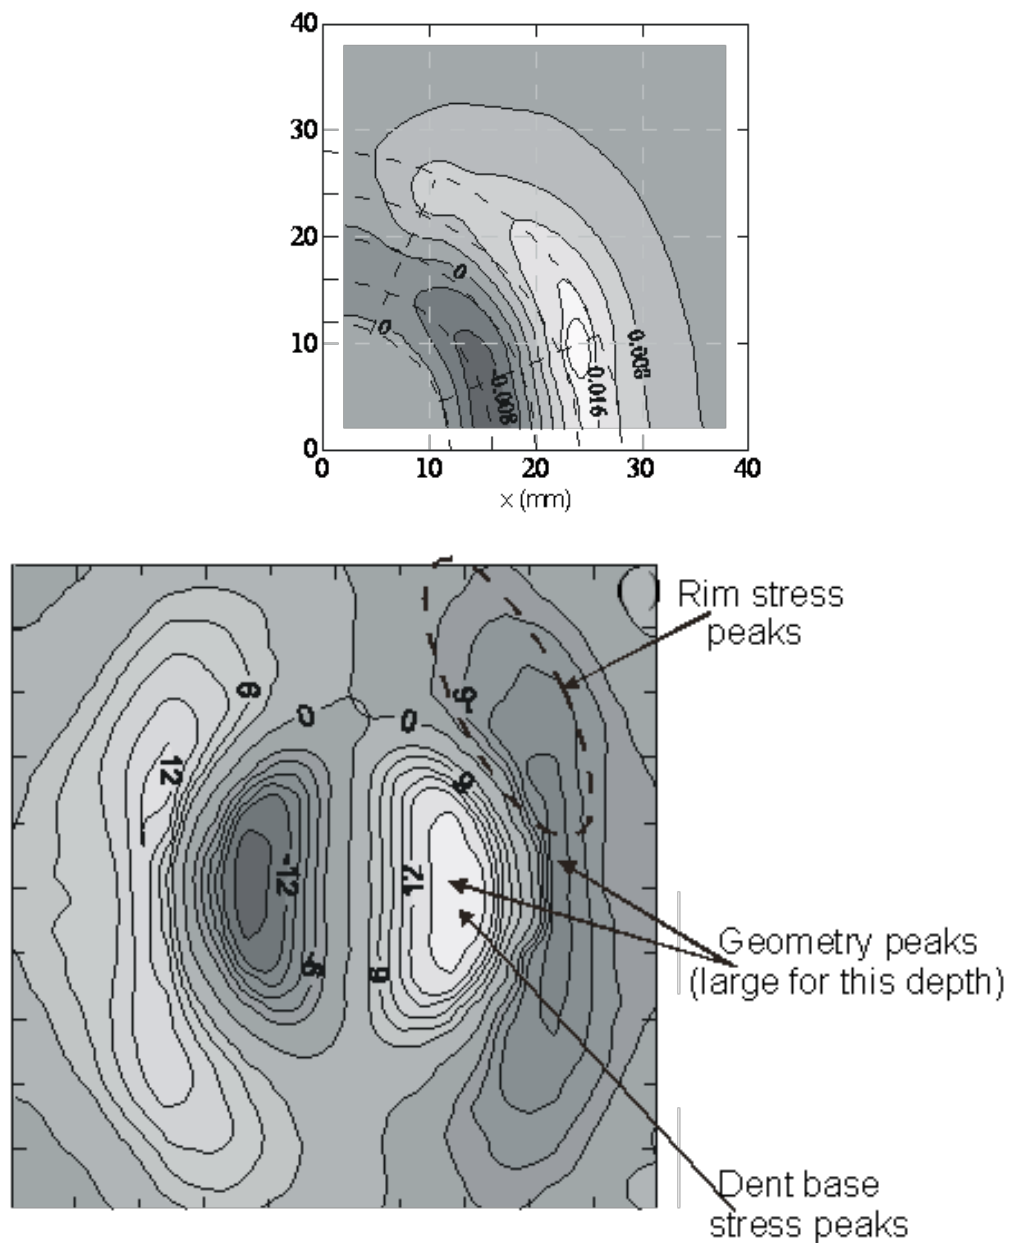
Figure 2-2: (Top) Quarter-model magnetic FEA result for the MFL signal (radial component) shown as a contour plot. This corresponds to the upper right-hand quadrant of the experimental signal shown in Figure 2.3. Both stress and geometry contributions to the MFL signal are included. (Bottom) The FEA modeled result shown in Figure 2.2 enabled the individual features of this MFL result to be associated with either geometry or stress as indicated in the diagram. (Note that the peak polarity is reversed compared with Figure 2.2 because the field is applied in the opposite direction.)

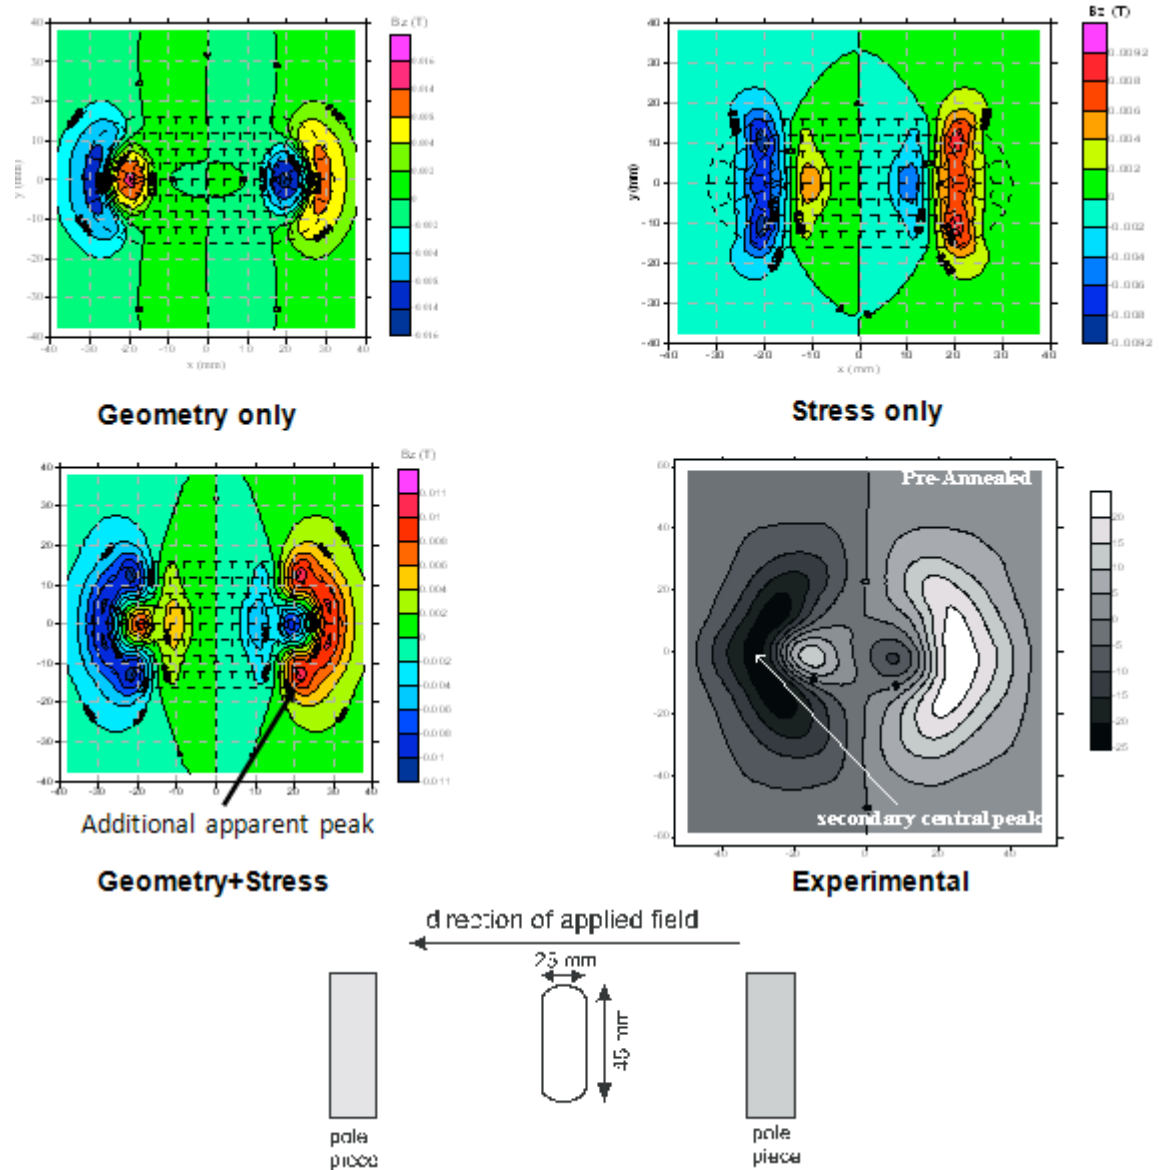
Figure 2-5: MFL_{radial} result for a circumferentially elongated 2:1 dent, 6mm deep. The relative dent and applied field orientation are shown in the schematic at the bottom. The three color photos show the modeled result – the two at the top are the separate contributions of geometry and stress, respectively, and the bottom color plot is the combined modeled result. The experimental result is shown on the bottom right, with good agreement apparent.

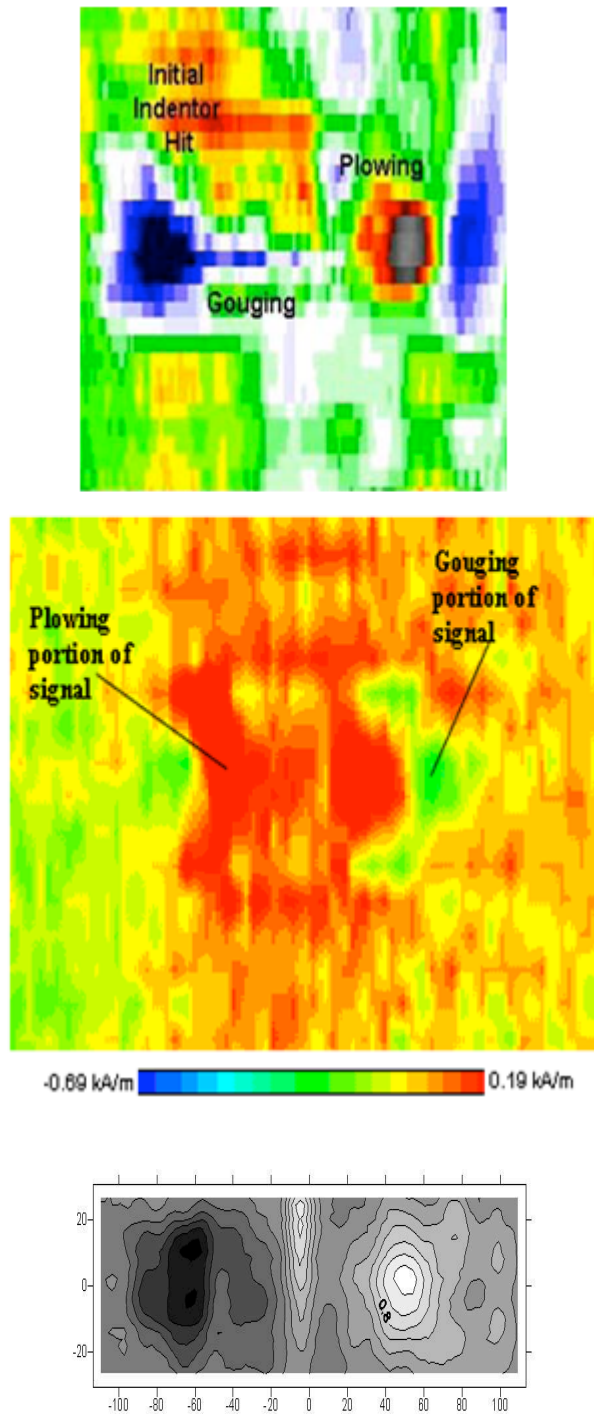
Figure 5- 1: MFL(axial) signals obtained from earlier work. In general these results suggest that a “dipole” signals is characteristic of the MFL(axial) signal for gouges – with one end of the dipole associated with the “plowing” end of the gouges and the other with the “gouging” end. Top: from Battelle (ref 11) Middle: from Rosen (ref 10) Bottom: from measurements as part of Phase II of the current contract – sample from GdF Suez.

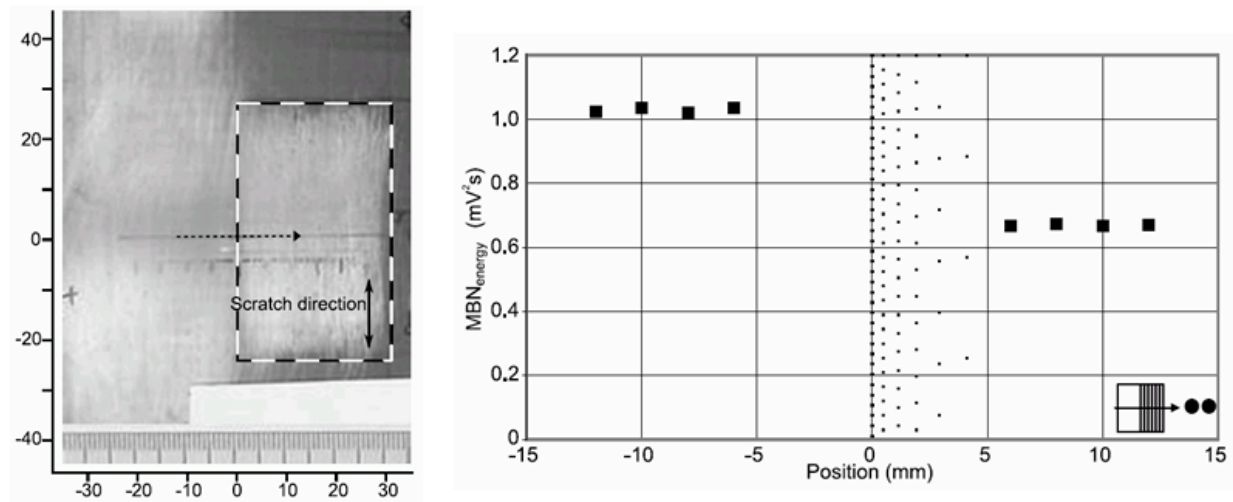
Figure 5- 3: Photo of the 80 grit SiC scratched region (left) and the result of the MBN probe scan across this region (right). Glyph at lower right hand side indicates scan direction and direction of probe field compared to scratch direction (perpendicular).

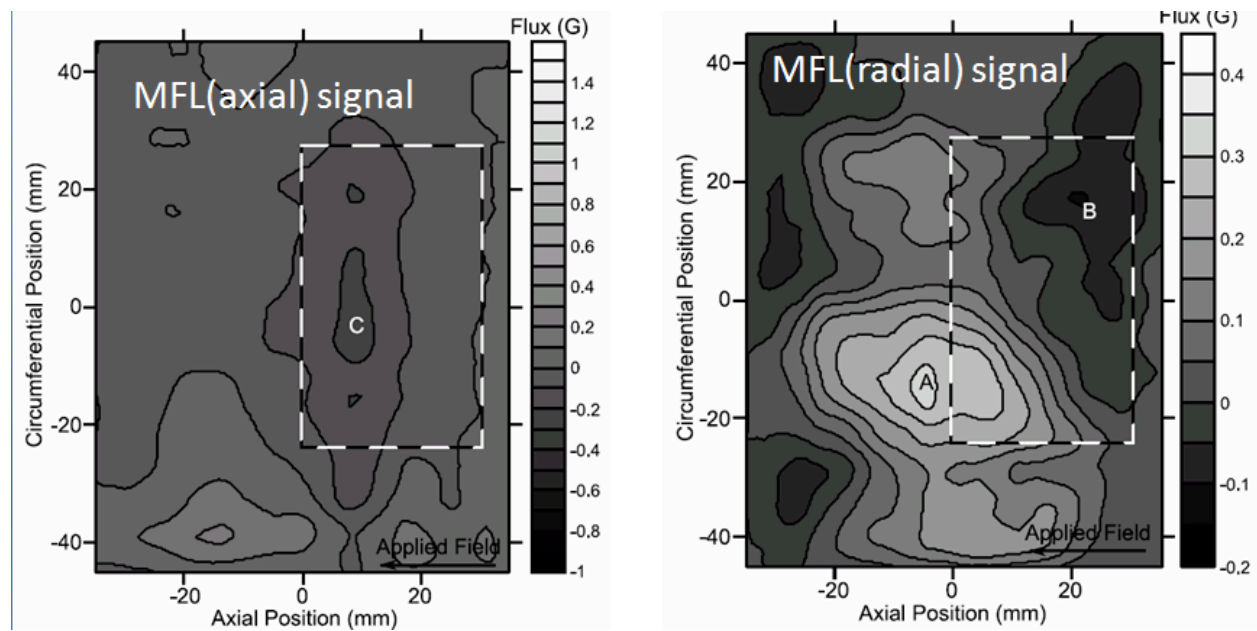
Figure 5- 4: MFL (axial) and MFL (radial) component signals taken from the top surface. The MFL and MBN field are both applied opposite to the direction of the scratches.

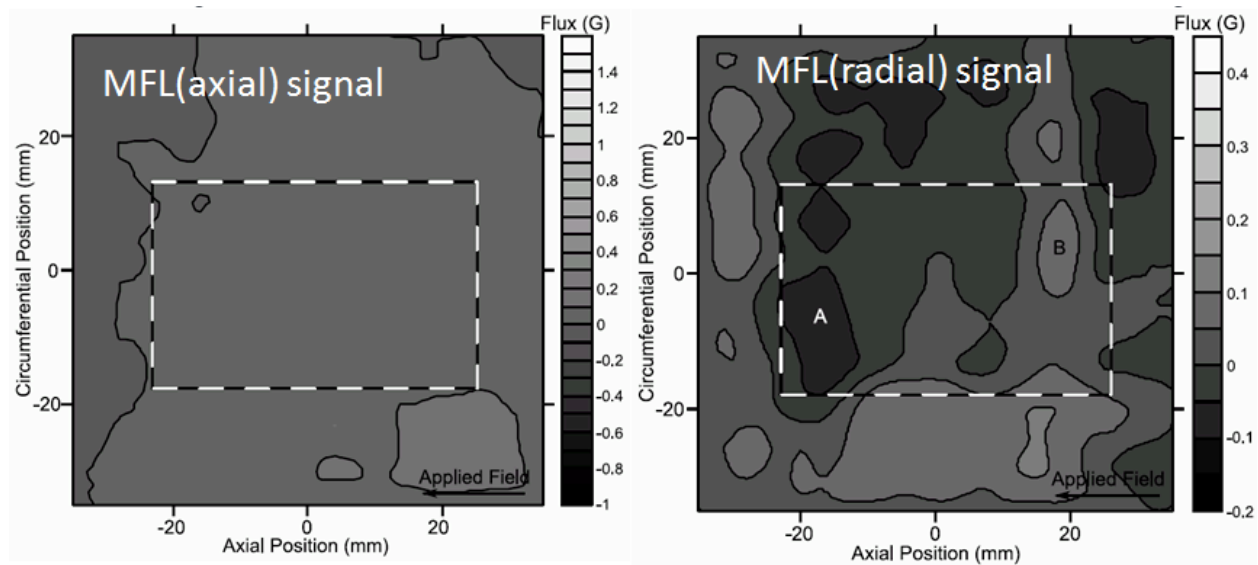
Figure 5- 6: MFL (axial) and MFL (radial) component signals taken from the top surface. The MFL and MBN field are both applied in the same direction as the scratches.

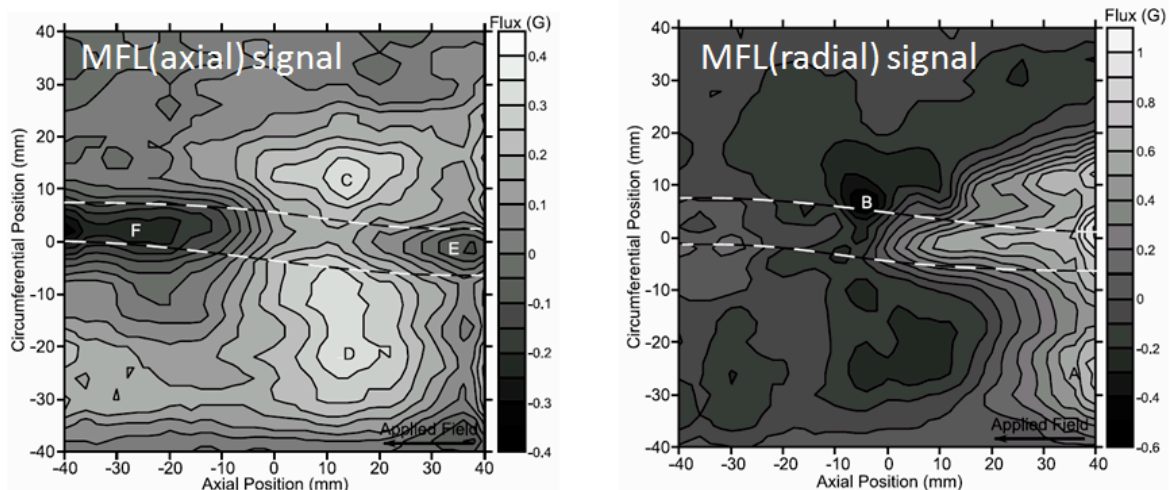
Figure 5- 10: MFL (axial) and MFL (radial) component signals taken from the top surface. The MFL field here has been applied parallel to the scratch direction.

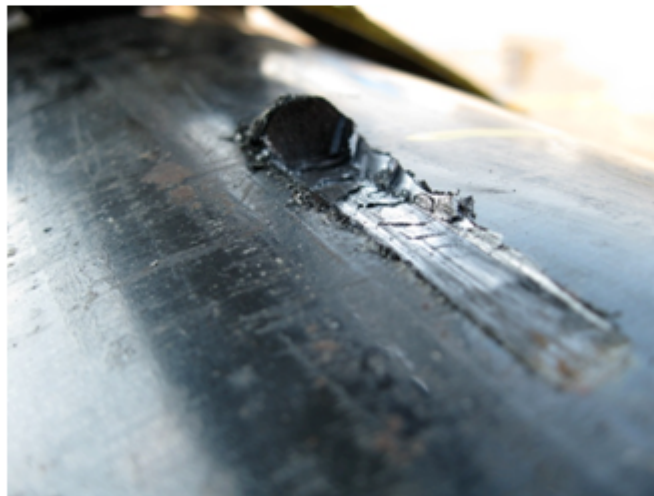
Figure 6- 2: Two examples of typical gouge geometries produced using the SES gouging apparatus, shown at different angles. The length of the gouge is approximately 5cm. Note that the gouging process did not produce this gouge geometry in the Pipe 1 samples – in fact the samples appeared barely scratched.

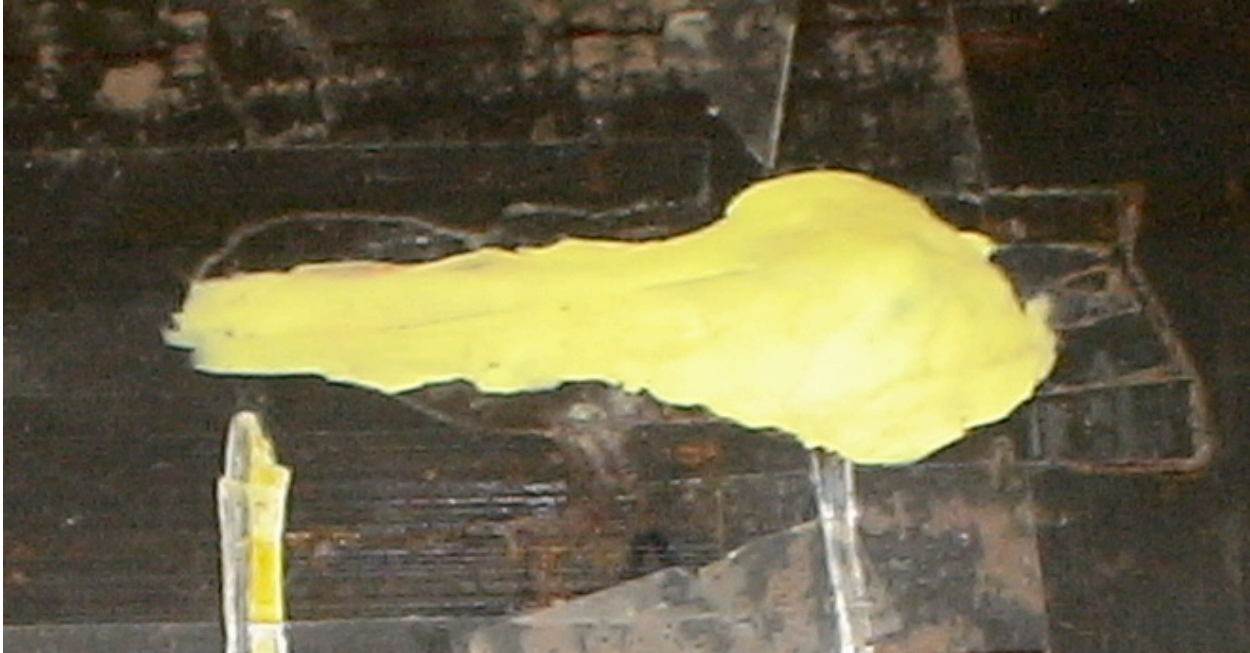
Figure 6- 3: Photograph of the gouge defect 5B, which has been covered with clay to allow a smooth path for the MFL detector probe.

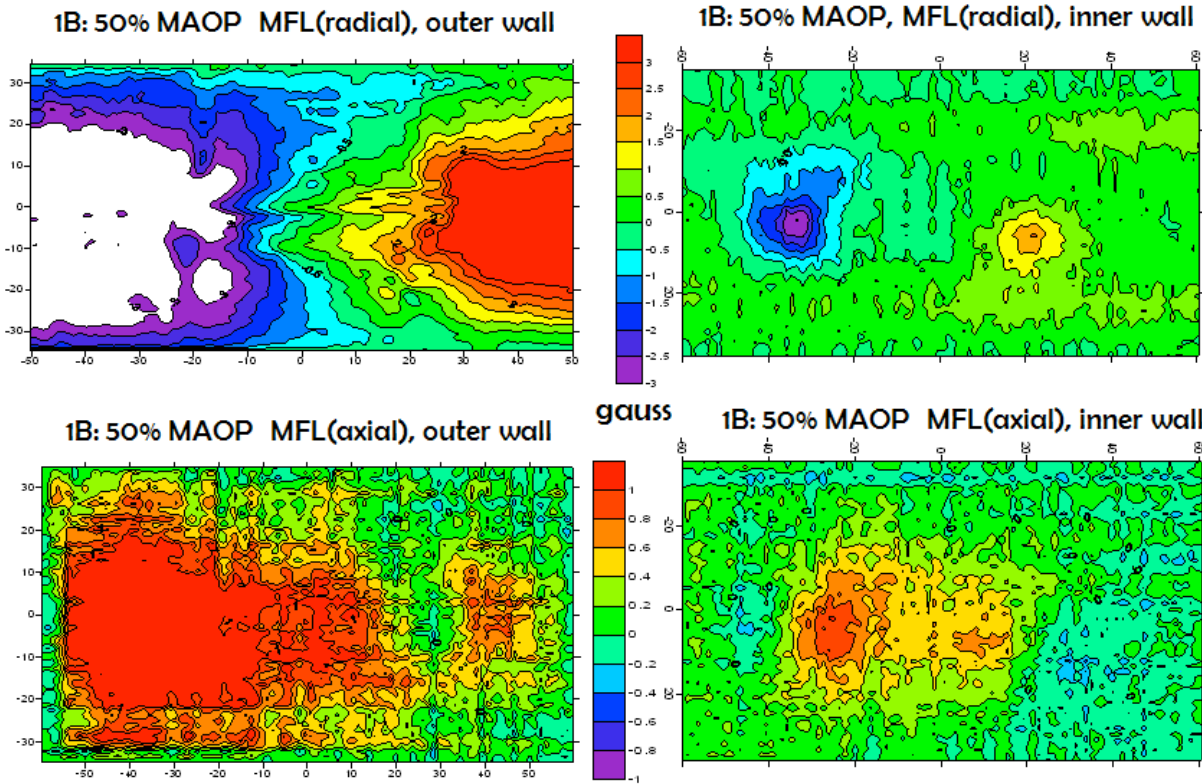
Figure 6- 7: Pipe 1 defects, no visible gouging. Comparison of outer wall MFL signals (left) versus inner wall MFL signals (right) for MFL radial component (top plots) and also MFL axial component (bottom plots). Note that the MFL axial component signals are smaller (since the probe is necessarily further from the surface) so the bottom plots are on a smaller scale. The white areas in the plots indicate where the signal is off scale.

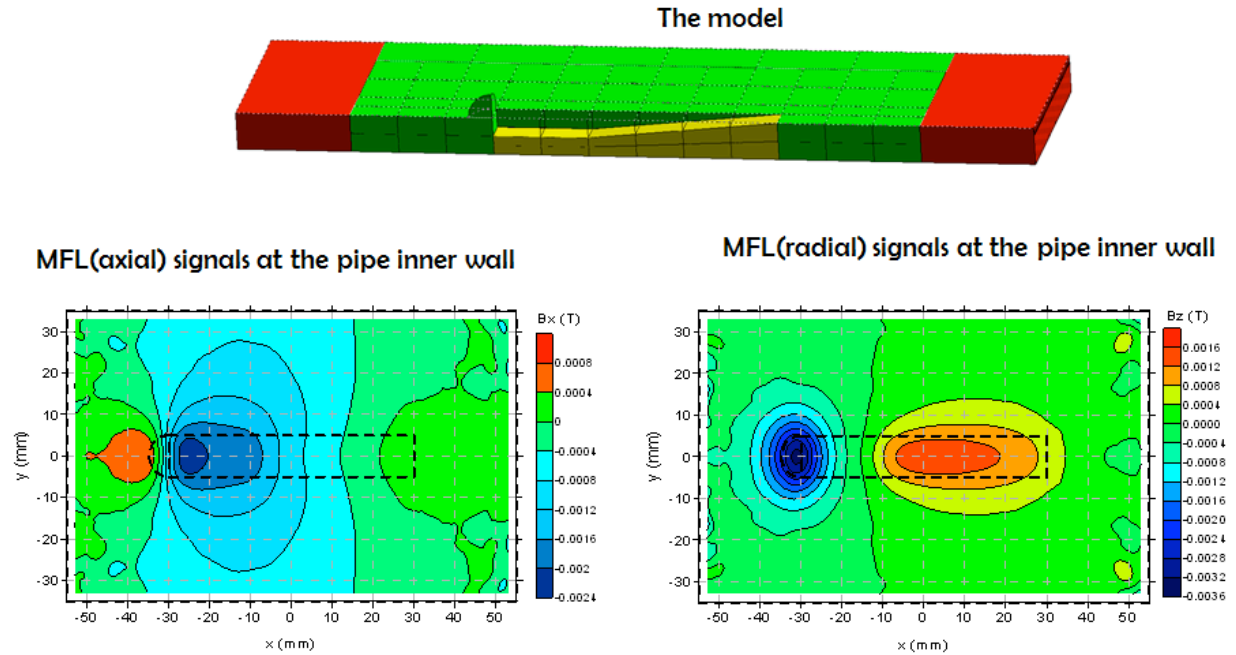
Figure 6- 9: Geometry-only magnetic model for the gouges observed in the present study. The top diagram shows the model itself – a half-model can be used because of the symmetry. The red regions at the end are the magnets. Note that the model does not include a dent – typical MFL signals from dent geometries are shown in Figure 6.10. No stresses are included in the model since stresses are difficult to predict for gouges. Also the model results below are shown for the inner wall. The measured outer wall results were done on top of the clay overlay and this detector trajectory was not modeled at this time.

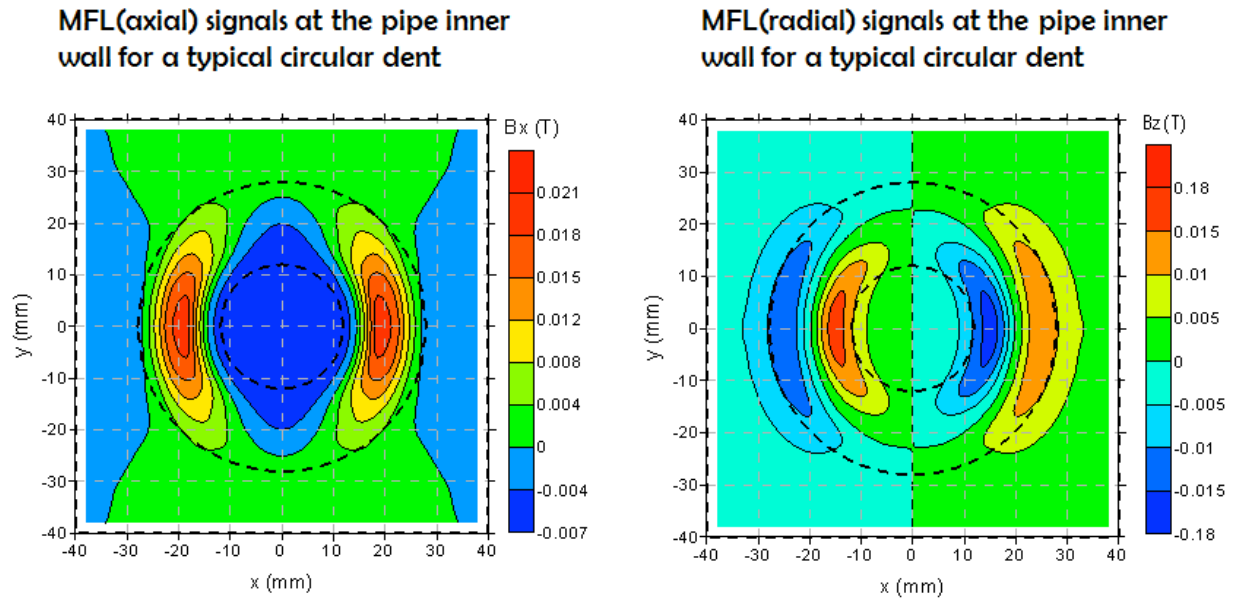
Figure 6- 10: Geometry-only magnetic model results for typical circular dents, taken from earlier work. Of the gouges created in the present study, gouges 4B and 5B exhibited noticeable dents. These dents were manifest as inner wall “bumps” associated with the tool entry end of the gouge.

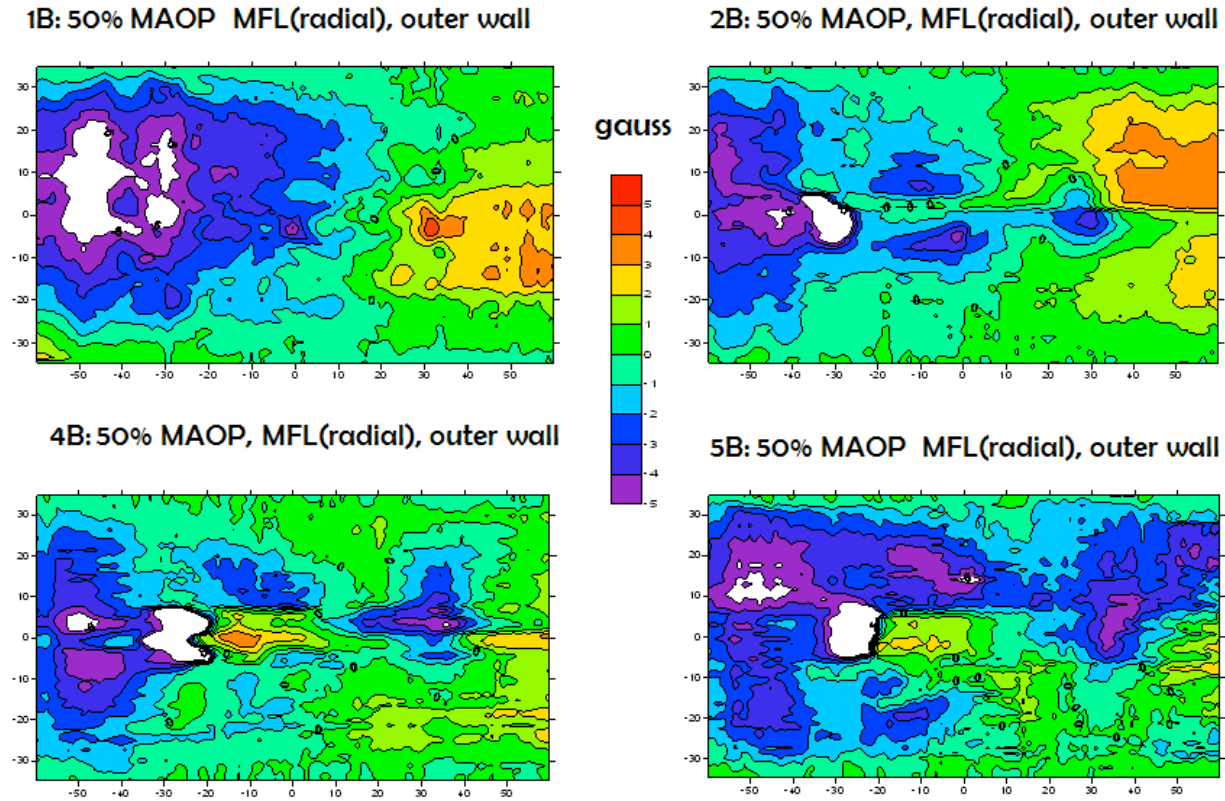
Figure 6- 14: Change in outer wall MFL (radial) signal as gouges get progressively deeper. Data shown is for the gouges produced at 50% MAOP. Note that the scale is from -5G to +5G. The white areas in the plots indicate where the signal is off scale.

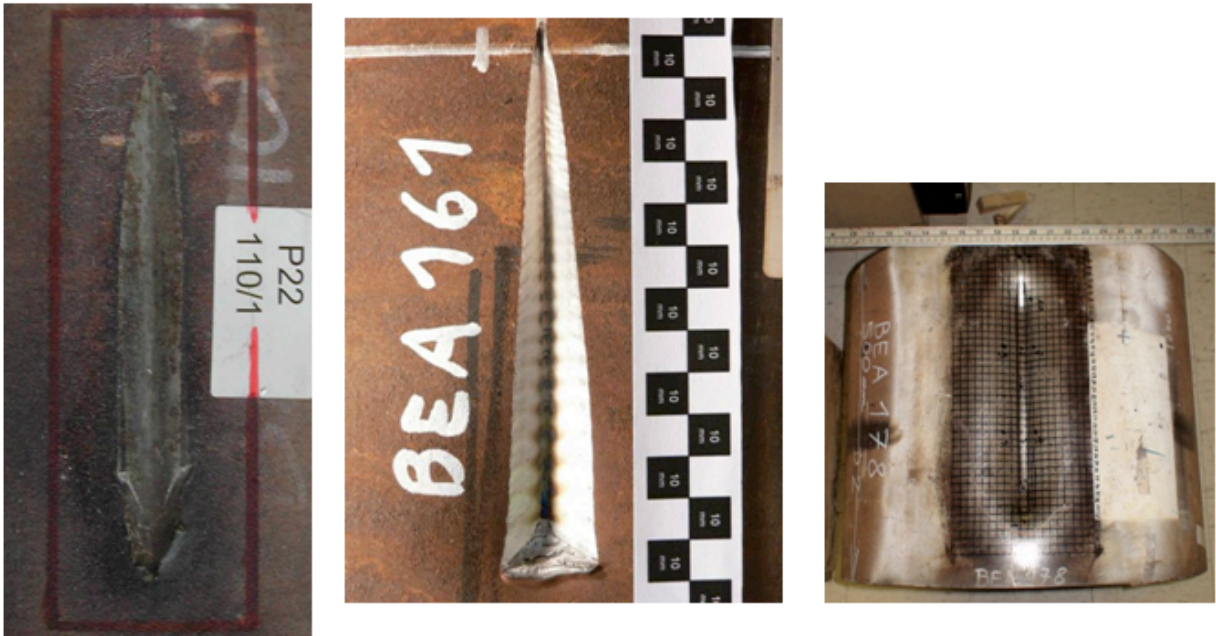
Figure 7-2: The three gouges examined using neutron diffraction. Sample P22 (left) is a coupon sample containing a 17 cm gouge (tool entry at top end). Sample BEA161 (center) is a 13 cm long wedge-shaped gouged contained in a 60 cm long, 60cm diameter pipe ring of X52 steel (tool entry at top end) . Sample BEA178 (right) is also a pipe ring sample (X52 steel) containing a long gouge with a significant associated dent.

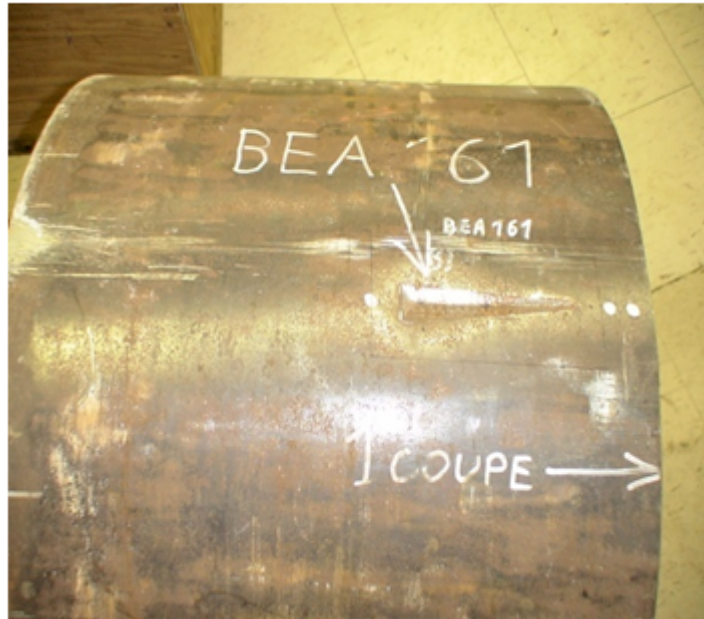
Figure 7-13: Pipe section containing showing gouge BEA161 location

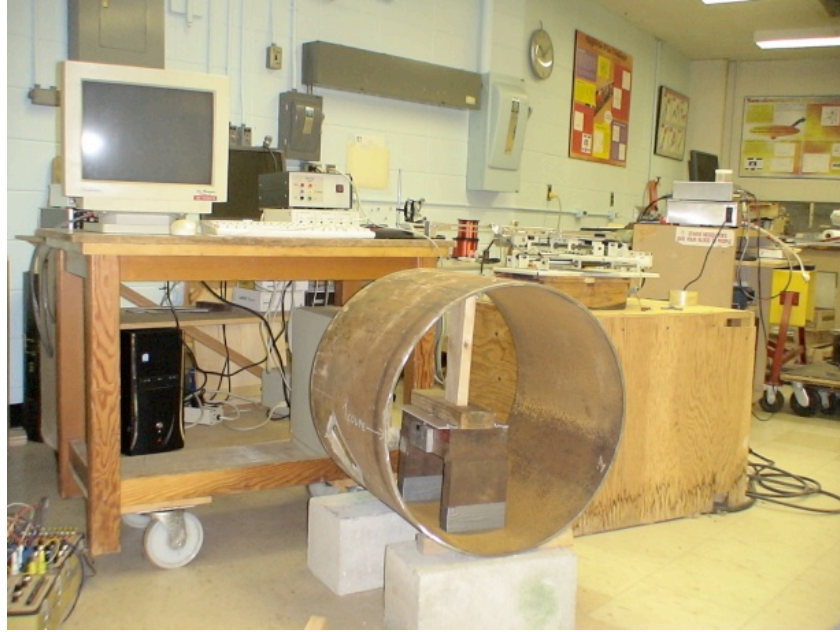
Figure 7-14: Pipe section BEA161 with MFL magnetic inside

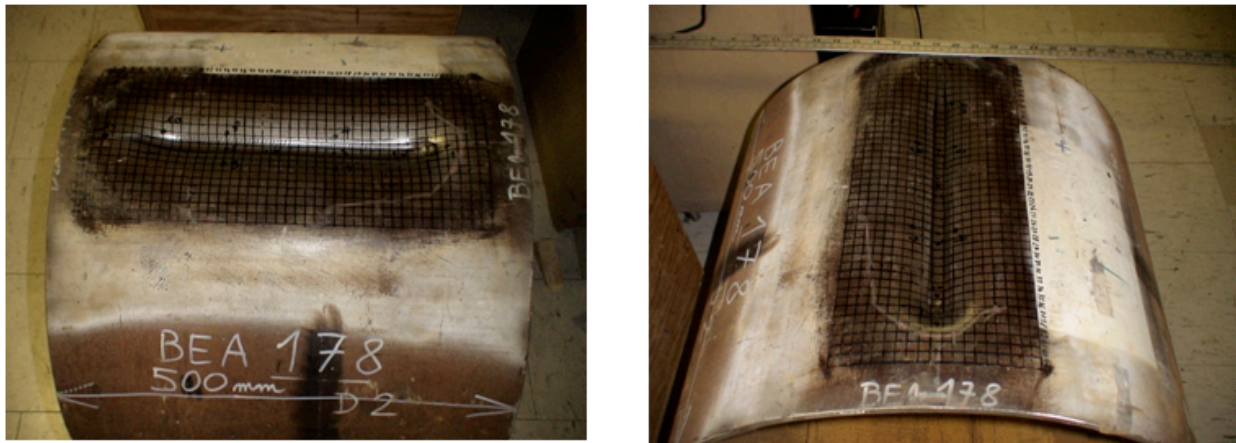
Figure 7-19: Photographs of gouge+dent BEA178 in pipeline section sent to NIST for residual strain measurements.

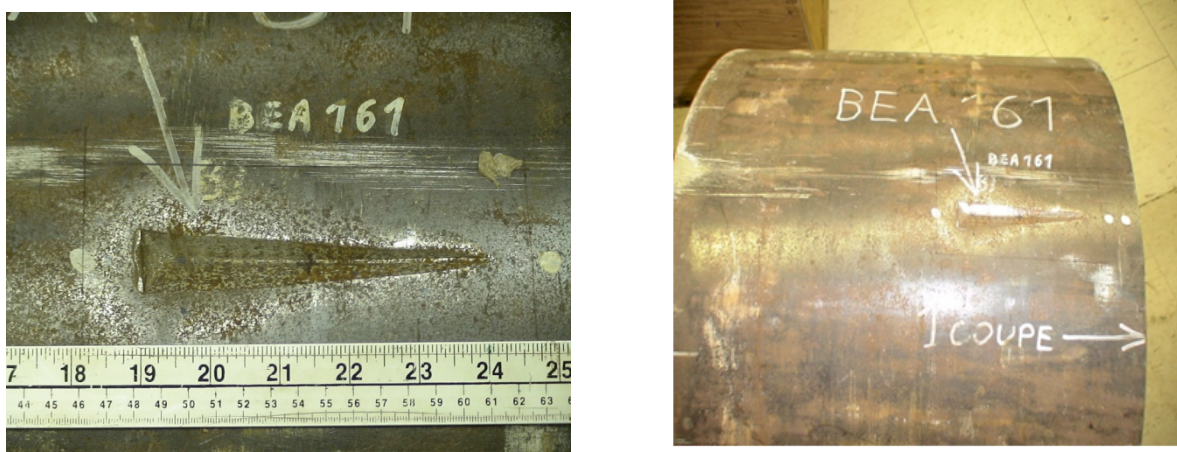
Figure 8- 1: Photographs of BEA161 – on the left is a closeup of the gouge, with a ruler indicating the size. On the right is shown the pipe ring that was sent to NIST and Queen’s which contained the gouge. Note the close proximity of the gouge to the end of the pipe ring - this was done deliberately to facilitate neutron diffraction measurements at NIST.
