# **Radio Frequency Identification (RFID) Smart Corrosion Coupon**

## **CAAP Final Report**

**Contract Number: DTPH56-13-SN-000002**

**CAAP, PHMSA, U.S. DOT**

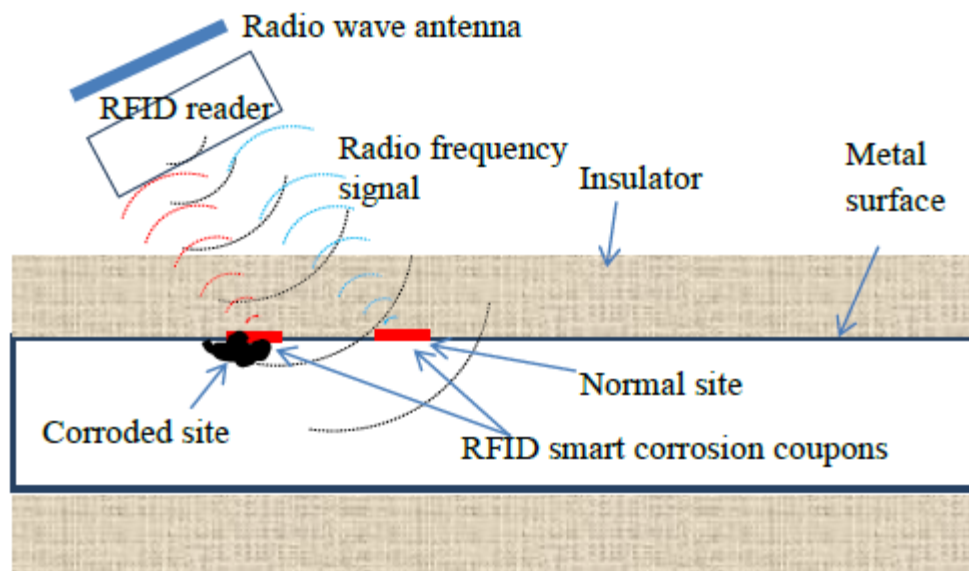
**Figure 1.** Conceptual representation of using integrated radio frequency identification (RFID) corrosion coupon for corrosion monitoring under insulation.

Figure 1 illustrates the conceptual representation of using integrated radio frequency identification (RFID) corrosion coupons for corrosion monitoring under insulation. The black wave represents the incoming radio wave from the radio wave emitting antenna, the RFID tag antenna picks up the signal and powers the microchip. The microchip at a normal site then responds with a normal radio frequency signal (green color); the microchip at the corroded site either responds with a different radio frequency signal (red color) or does not respond. The change in responding signal allows corroded sites to be detected. A description of the technical tasks as defined in the award documents and the status updates are provided in the following section.

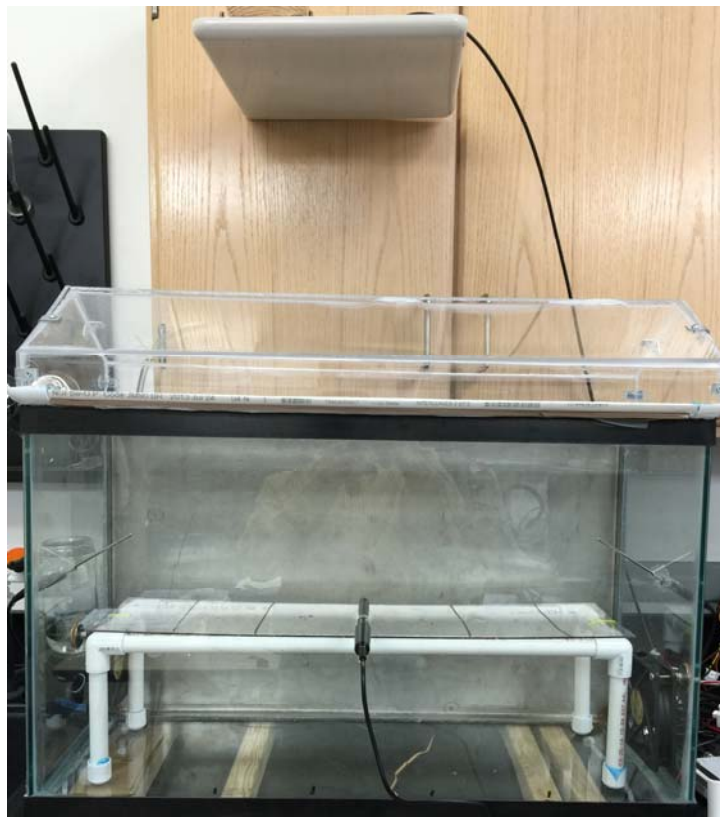
**Figure 3.** Front view of the environment chamber.

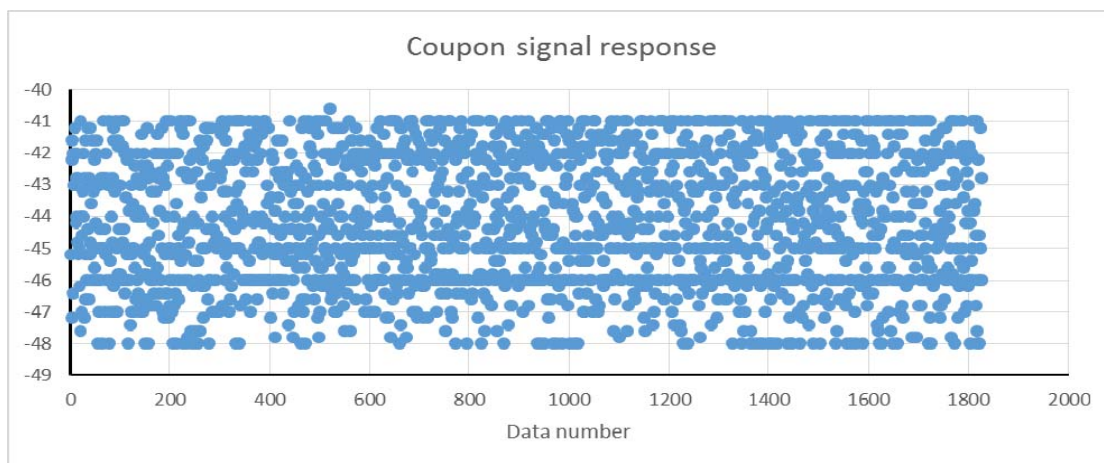
**Figure 8.** RFID coupon signal response

**Observation 1:** The RFID reader implements FCC mandated frequency hopping in the 902-928 MHz band which causes slight variations in signal reading. Figure 8 shows a typical signal response in the experiment. In this experiment, the mean, the standard deviation and the range of the data is recorded.

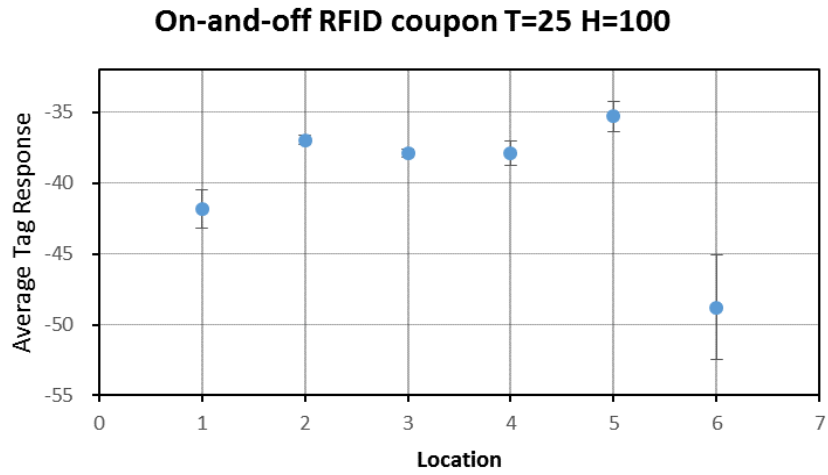
**Figure 9.** The signal of on/off RFID smart coupons in 6 locations.

**Observation 2:** Multiple experiments show that the signal right below the reader (location 2-4) shows a smaller variance. Figure 9 shows an example of the mean and variance information of the on/off RFID smart coupon in six locations.

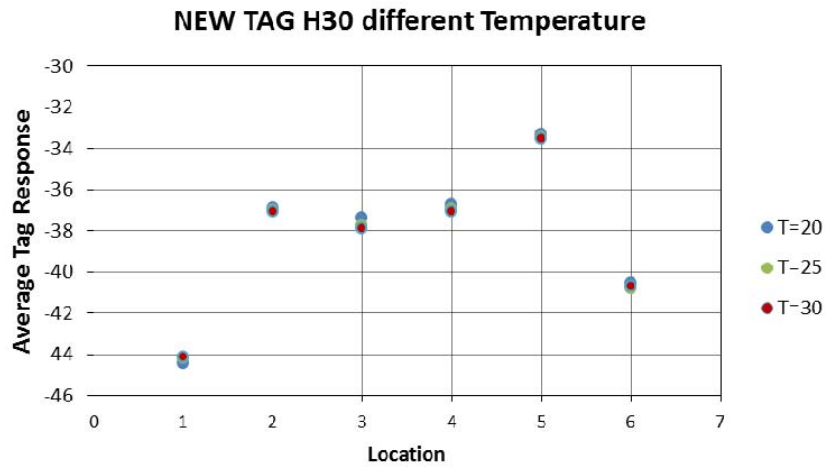
**Figure 11.** Signal of on/off RFID smart coupon in different temperature

**Observation 4:** Temperature has no statistically significant effect on the reading in the range of 20-35°C. Humidity has minor influence in the range of (30%-100%). Figure 10 and Figure 11 show the reading of on/off RFID smart coupons in different humidity and temperature.

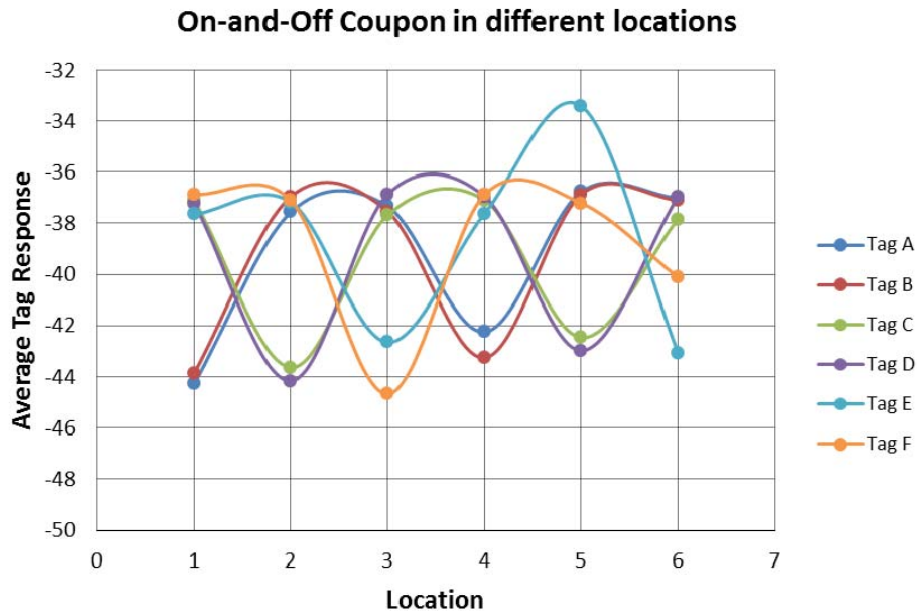
**Figure 12.** On/off RFID smart coupon in different locations.

**Observation 5:** The signal response of the same coupon in different locations shows that location can affect the signal but the influence from the location is very random. In Figure 12, six coupons give six different trends when location changes. In the beginning of this project, the signal strength of the RFID coupon was expected to be correlated with the length and thickness of the antenna. However, since location affects the signal, the correlation becomes less useful because the reader will be moving around to detect the signal of different coupons in the real application. A signal change caused by location could not be differentiated from a change caused by corrosion. This is another main reason that the first generation RFID coupon design was revised to an on/off design.

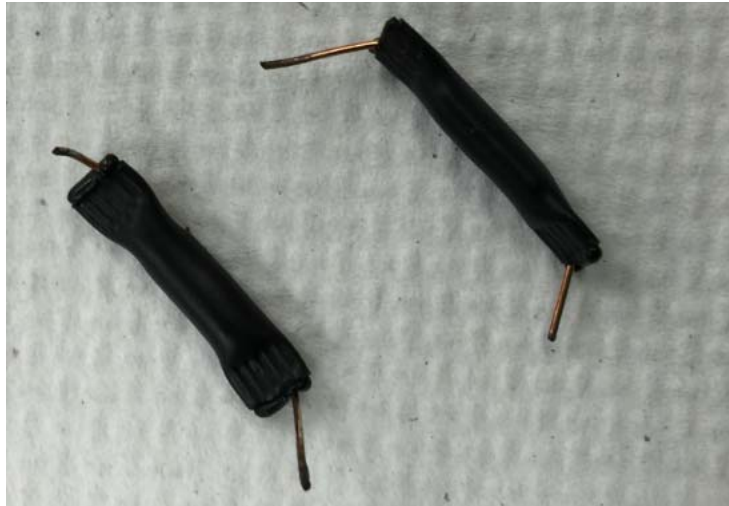
**Figure 13.** Corroded on/off RFID smart coupons.

**Observation 8:** The corrosion test of the on/off RFID smart coupons in acid solutions showed that the coupons in 5% acid solution were killed in about 52~53 hours, and the coupons in 2.5% acid solution

were killed in about 96-100 hours. The coupons in water showed evidence of corrosion but there were still signal readings after 150 hours. Figure 13 shows the pictures of two corroded on/off RFID smart coupons. The on/off RFID smart coupon buried in acidified soil could still be detected after 31 days.

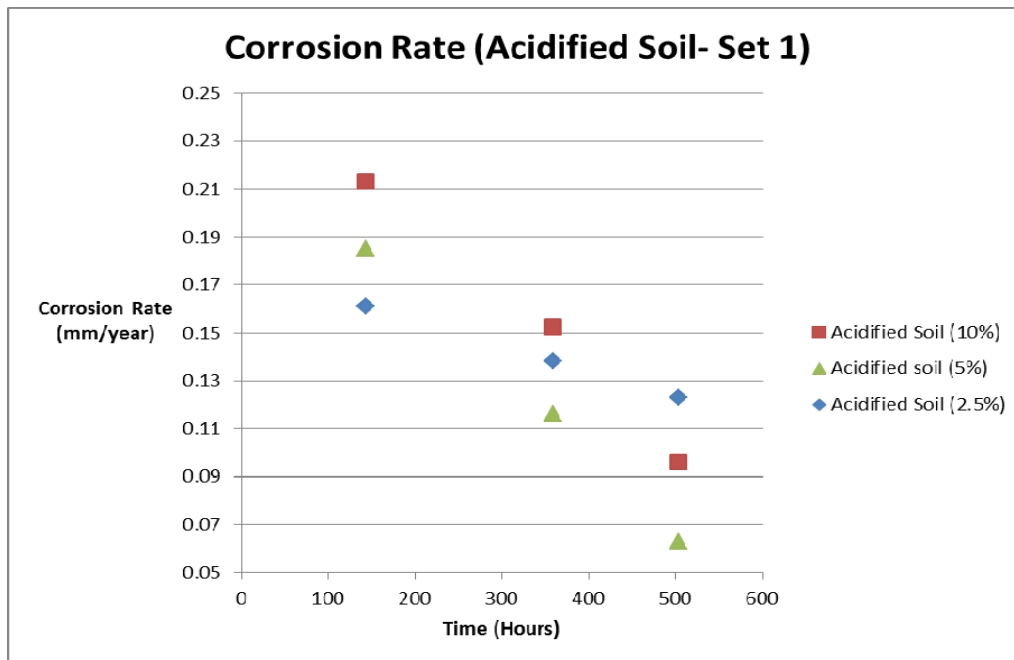
**Figure 18.** The corrosion rate of metal coupon plotted against time (Set 1).

Figure 18 represents the variation of corrosion rate with time. It is observed that there was a general decrease in the corrosion rate with time for all the three concentrations in the acidified soil. This may be attributed to the consumption of the more corrosive substances in the soil and also to the formation of a passive protective film. However, it should be noted that the samples were left in the soil with no mechanical vibration and in a stable environment. In the real world, many of the pipelines maybe buried under road or rail ways and be subjected to cyclical vibrations which may not allow for the passive layer or the corrosion product layer to stay on, thus eroding the surface away with time. Moreover, as mentioned in the previous section, the corrosion was highly non-uniform, hence even

though the aggregate rate of corrosion may decrease, deep pits and indentation on the sample will occur, which in the case of an actual pipeline may lead to a pinhole. Also it is noted that there is no cathodic protection or coating applied on the metal coupons, which are the most commonly used methods to protect pipelines in the industry. Hence the rate of corrosion is more representative of unprotected metal.
