TECHNOLOGY TRANSFER, DEMONSTRATION, & POST- MORTEM TESTING OF CIPL FOR CAST IRON AND STEEL PIPE

CIPL Workshop, Roosevelt Hotel, NYC

August 20, 2015

Presented by: David W. Merte, PE

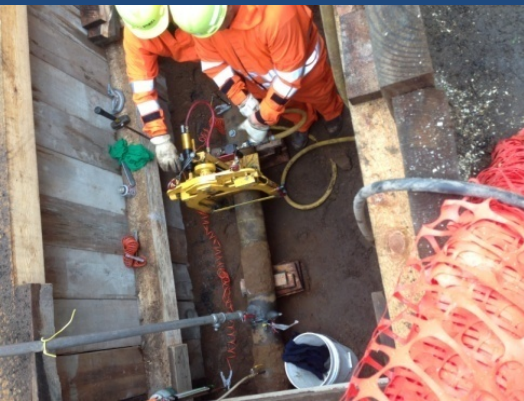
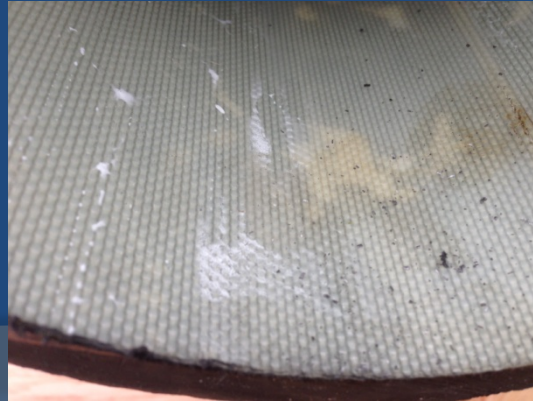
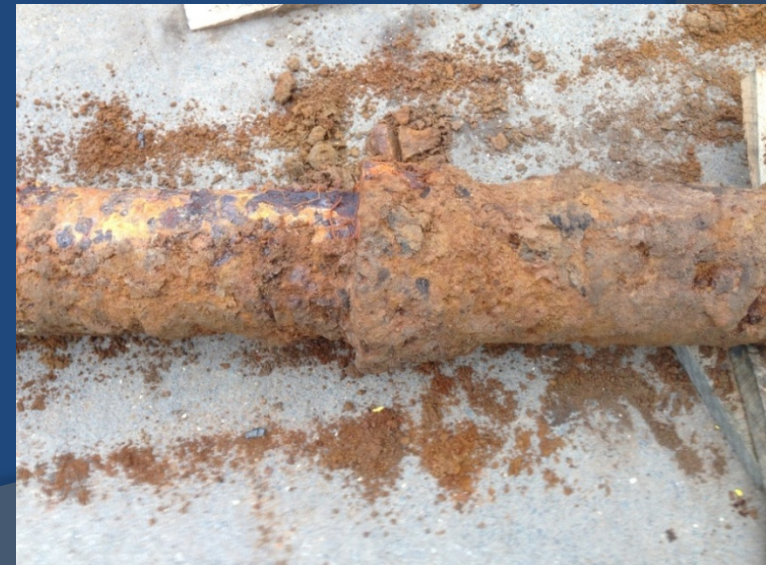
FIELD AGED CIPL EXTRACTION – PSE&G

- After a thorough review of funder CIPL in-service pipe segments >10 years old
 - Elmwood Park (Palsa Avenue, N.J.) selected
 - 6" (low pressure) CI installed in 1949
 - Lined with Starline®2000 in 1998
 - Cement/Jute joints (2)
 - 8' segments removed

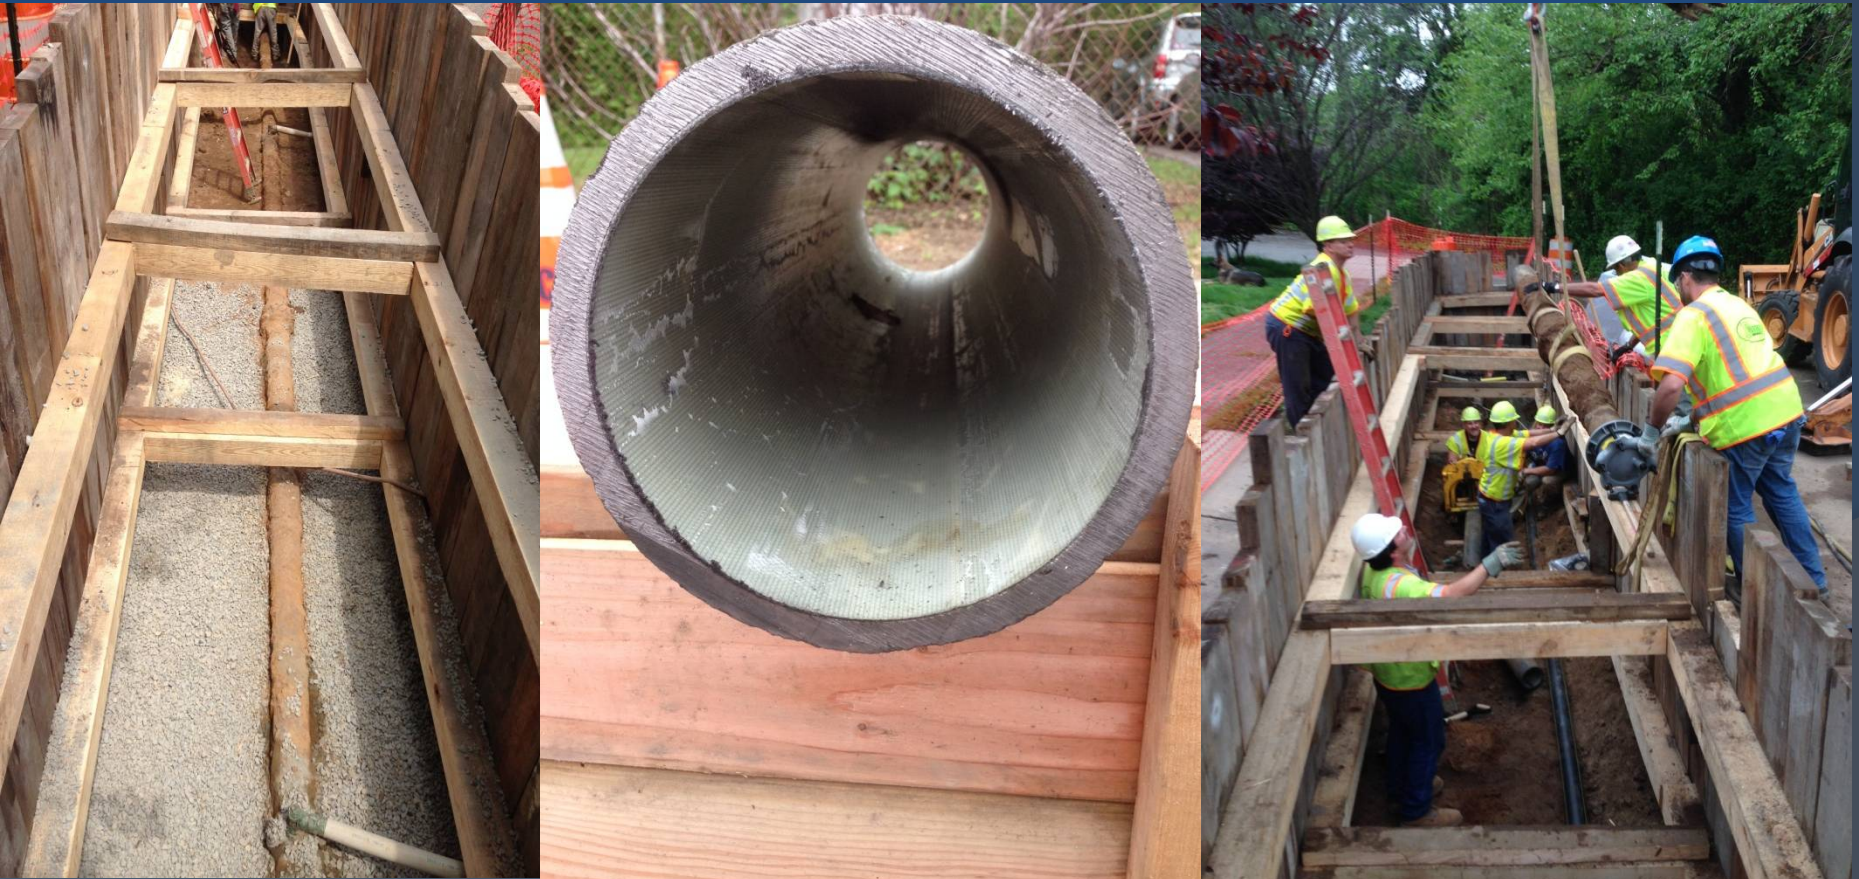
FIELD AGED CIPL EXTRACTION – PSE&G

- 16 years of active field service
- Two 6" CI cement/jute joints

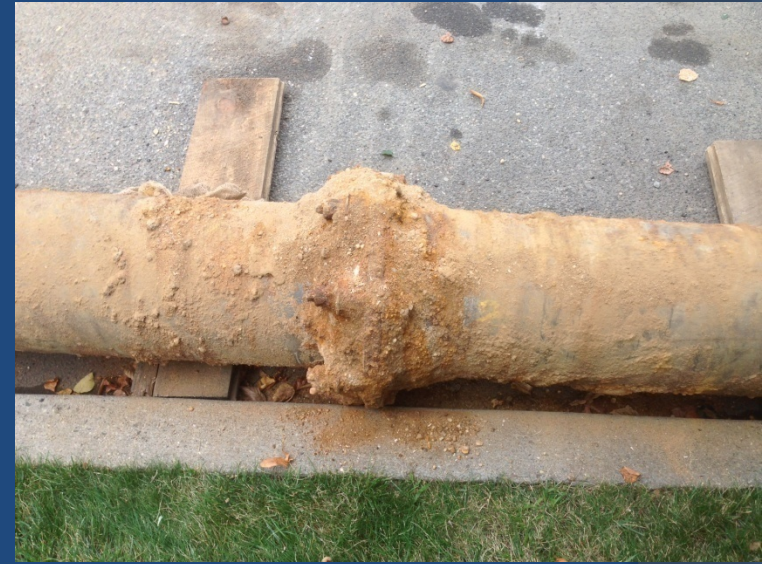
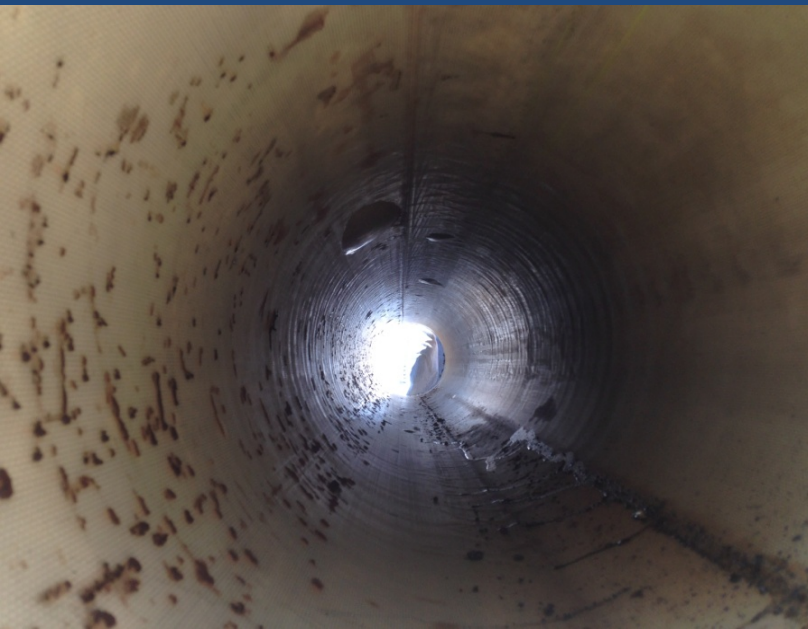
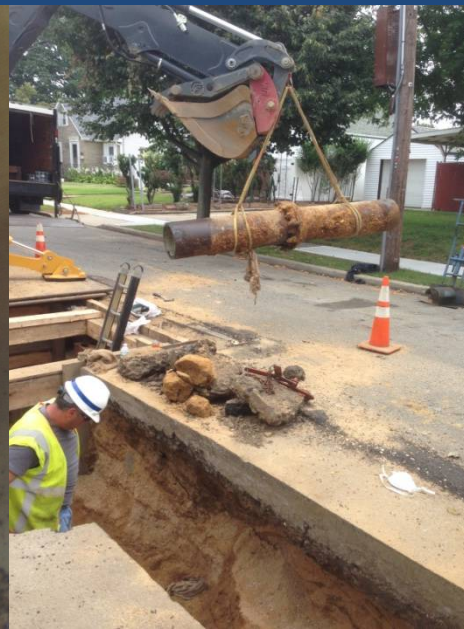
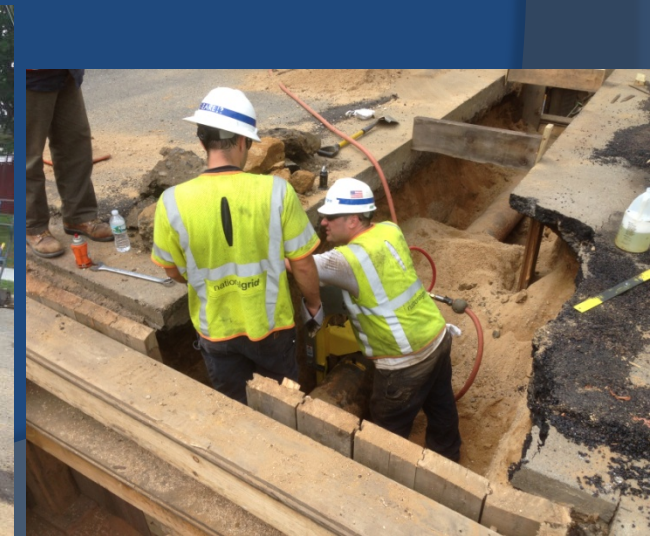
FIELD AGED CIPP EXTRACTION – NATIONAL GRID

- Garden City South, N.Y.
 - Main selected on 5th Place S.
 - 12" (60 psig) CI installed in 1951
 - Lined with Starline®2000 in 2004
 - Mechanical joints (2)
 - 8' segments removed

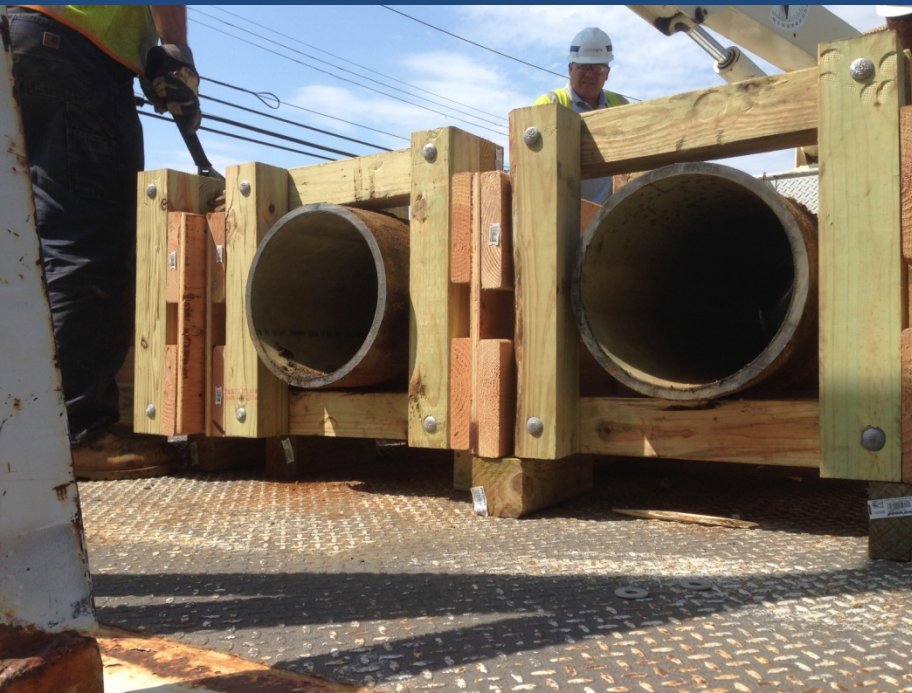
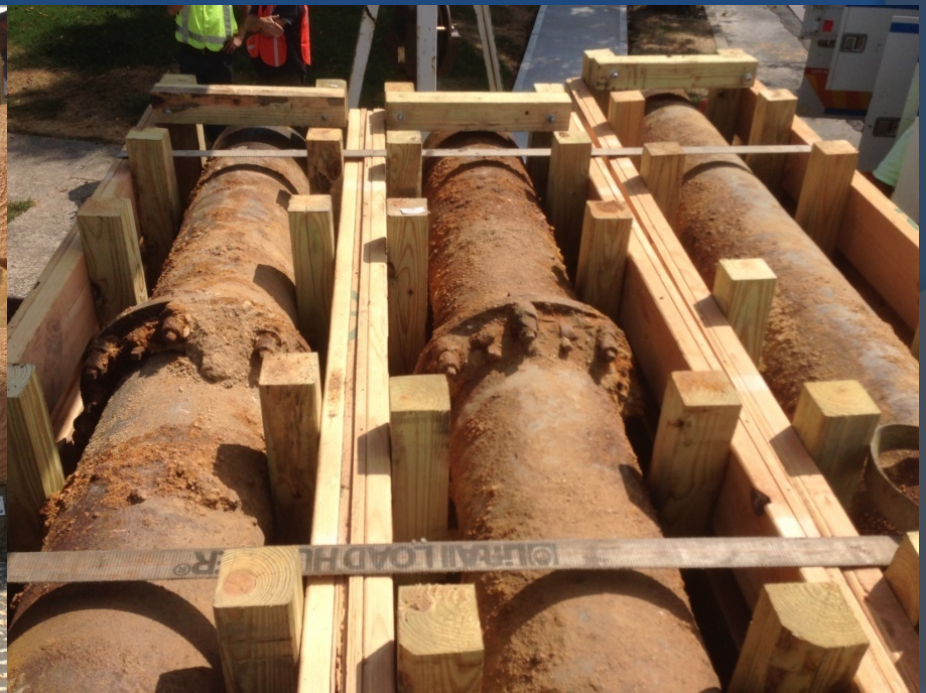
FIELD AGED CIPP EXTRACTION – NATIONAL GRID

- 10 years of active field service
 - Two 12" mechanical joints
 - One section w/o joint
 - Crated and shipped to Cornell University

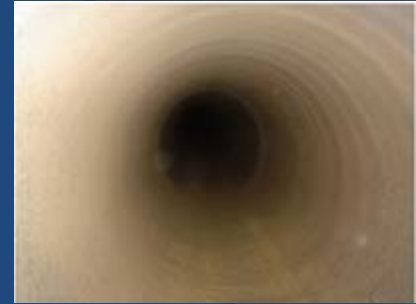
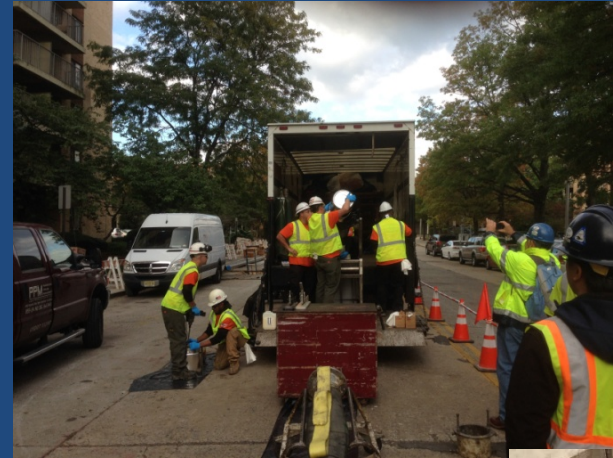
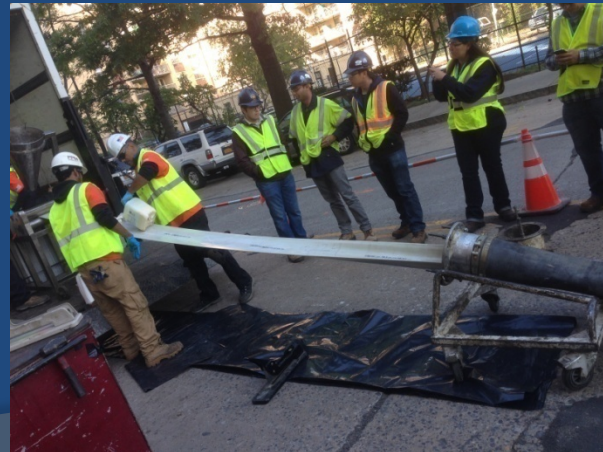
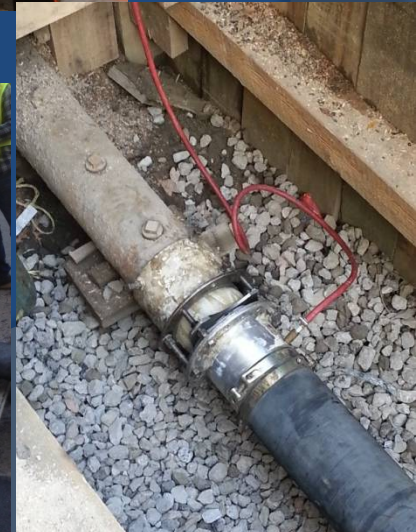
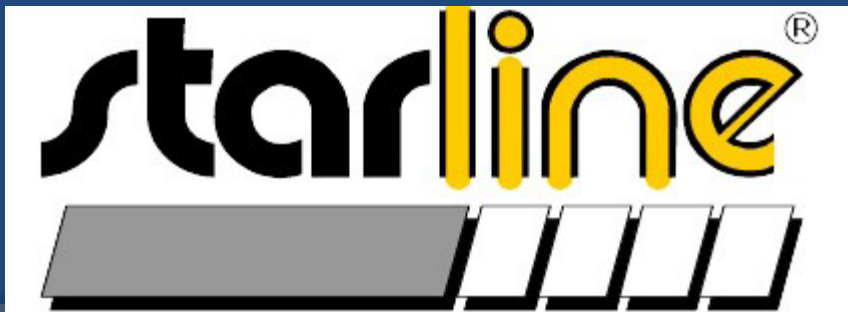
LIVE DEMONSTRATION

- **Conducted on October 21 at Con Edison**
- Access pit & pipe preparation
- Initial pipe inspection
- Surface preparation
- Post cleaning inspection
- Adhesive preparation
- Liner wet-out/adhesive application
- Liner inversion
- Curing & pressure monitoring
- Post Lining Inspection
- 8" and 6" low pressure cast iron

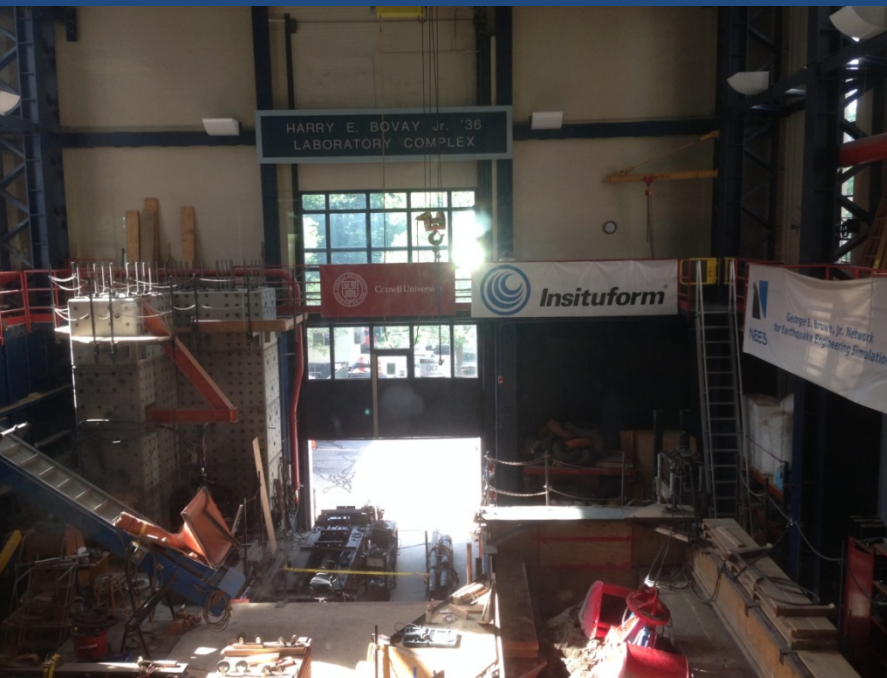
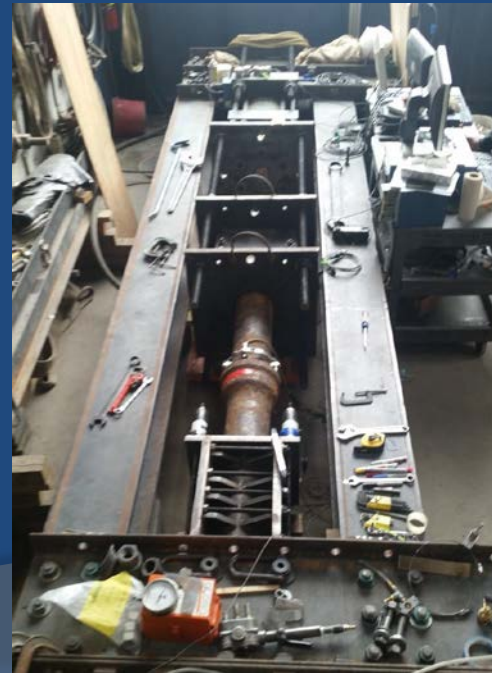
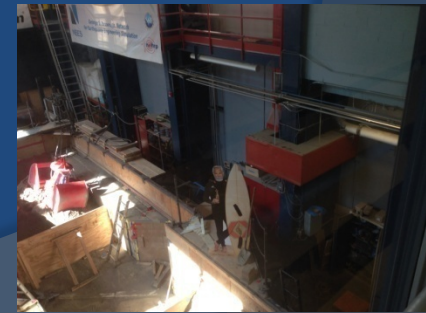
Cornell Mechanical Aging

- Traffic cycle loading
 - 1,000,000 cycles (50 years)
 - 100,000 cycles subsequent to undermine/backfill event
 - Thermal push/pull cycles (50 years)
 - Repeat above testing (100 year field service equivalent)

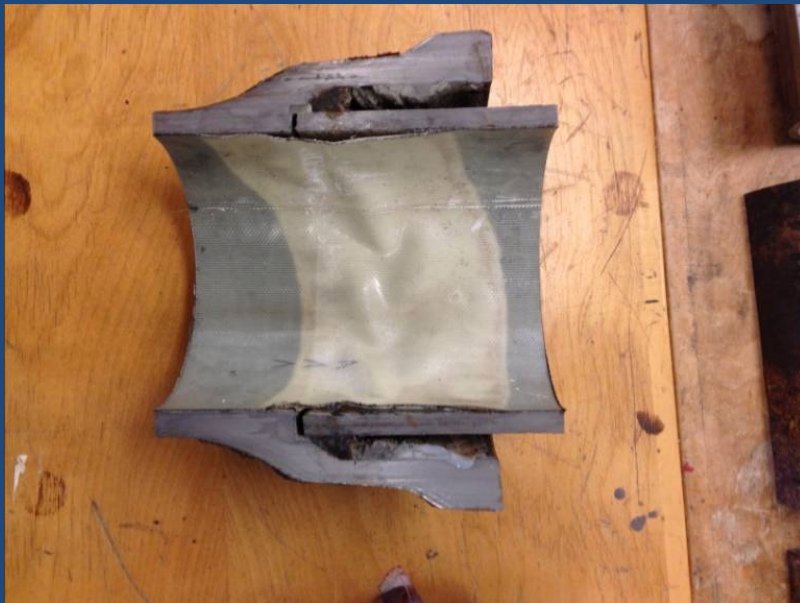
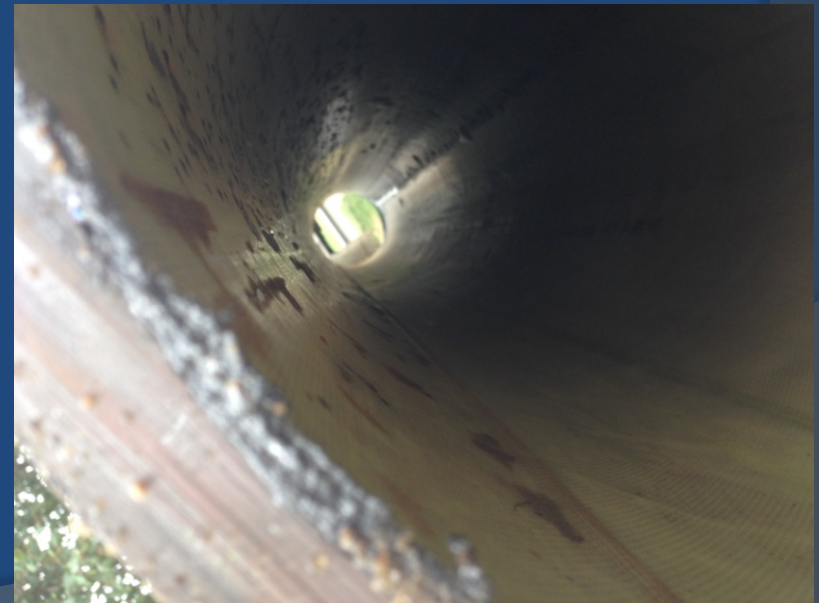
Cornell Liner Testing

- Each segment liner destructively tested after field extraction
- Each segment liner destructively tested in high stress joint area after all heavy traffic, undermine events, and thermal push/pull cycles

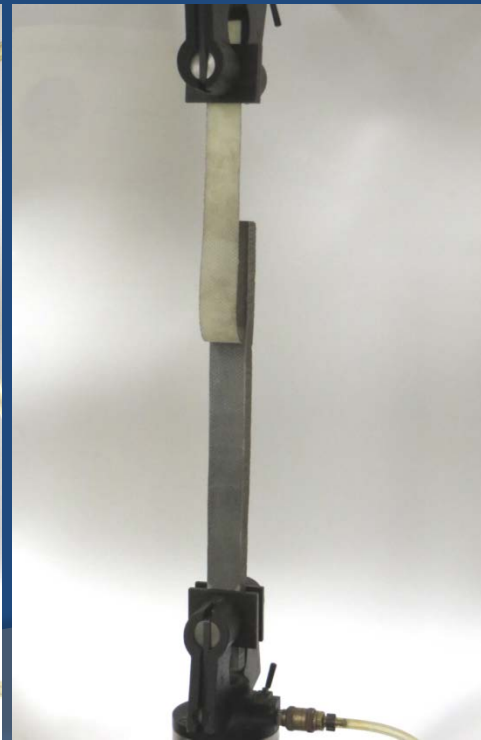
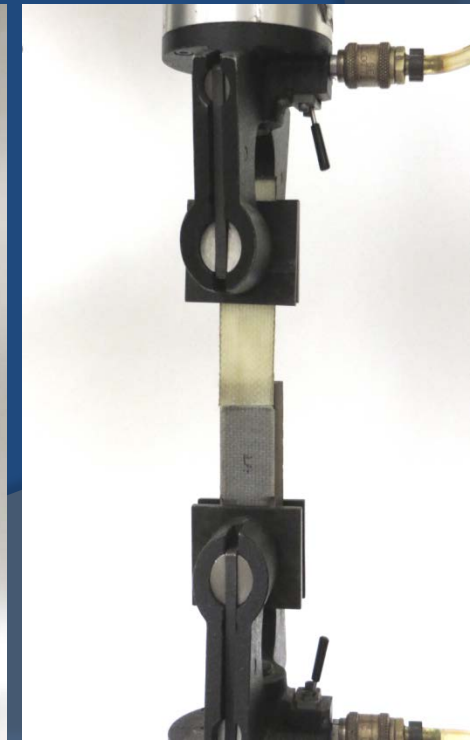
Cornell Liner Testing

- Tension (longitudinal and transverse directions)
 - High stress joint area
 - Bonded and de-bonded
- Lap Shear (primary adhesion test)
- Peel (longitudinal direction – secondary adhesion test)

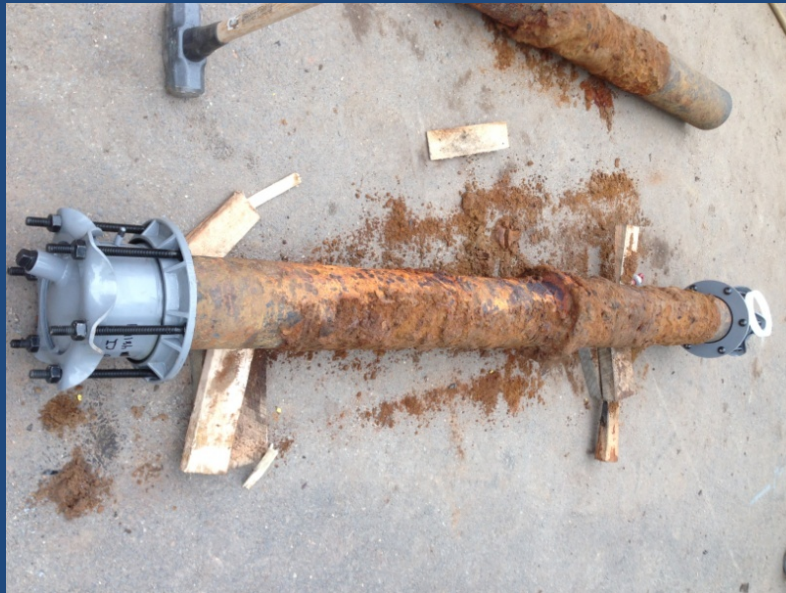
Cornell Pressure Testing

- Dresser 711 end caps utilized for 6" Low pressure CI (not available for 12")
- Smith Blair EBR end caps utilized for 12" CI- 60 psig MAOP restraint

- All four segments under pressure during all mechanical aging tests and tested to 90 psig (1.5 X MAOP) after >100 yr. aging
