# **CIPL PROJECT WORKSHOP: Results of Mechanical Aging & CIPL Materials Property Tests**

**Cornell University  
Northeast Gas  
Association**

# **Mechanical Aging and CIPL Property Tests of Field-Aged Lining Systems**

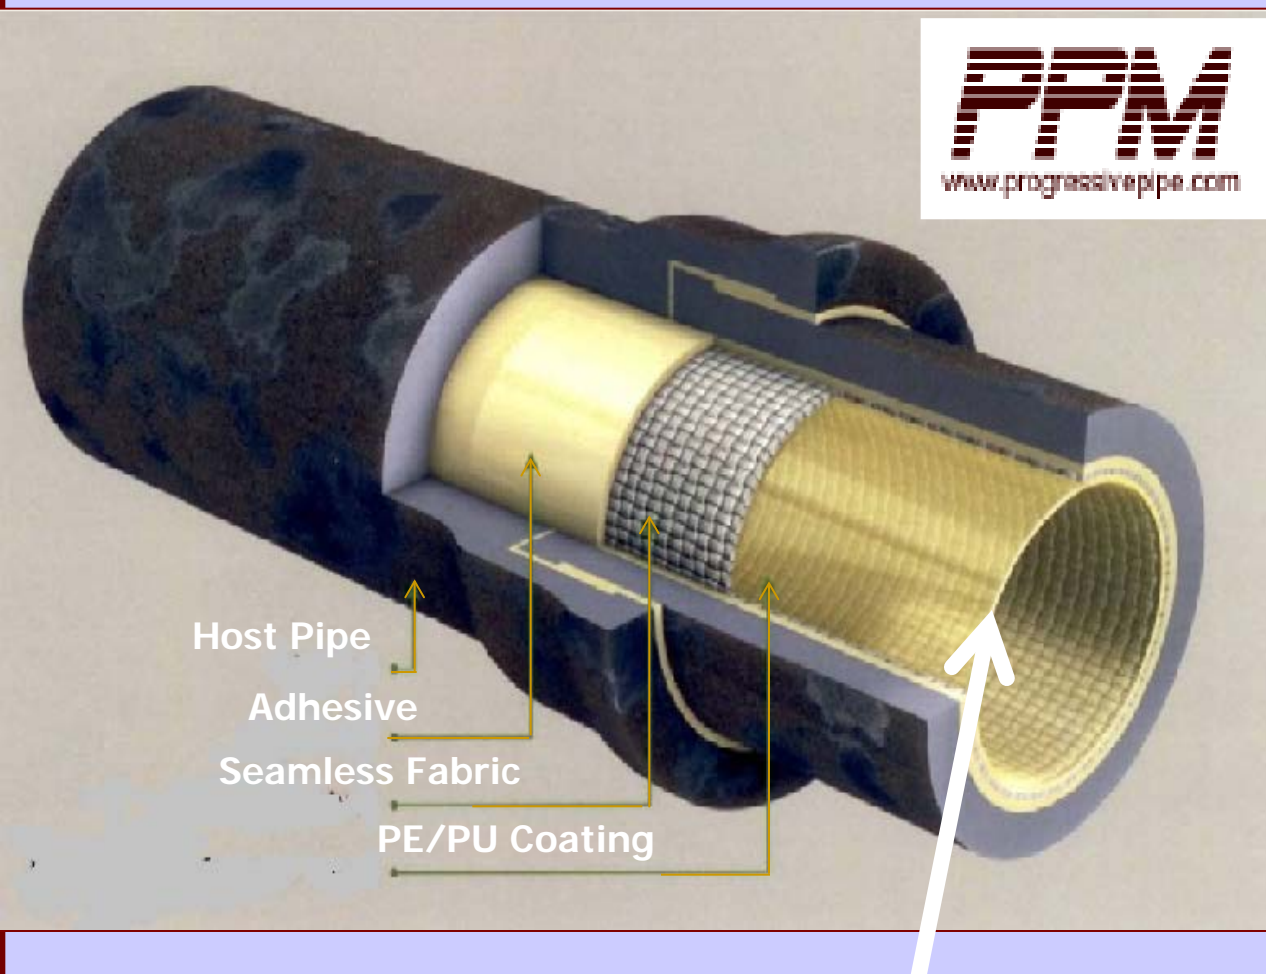
# CIPP LININGS: STARLINE

Diameter Range	4 - 48 in. & services
Pipe Section Length	2500 ft maximum
Bends	YES
Host Pipe	Cast Iron, Ductile Iron, & Steel
Thickness	0.05 - 0.1 in.

**Tough, impervious polyurethane membrane**

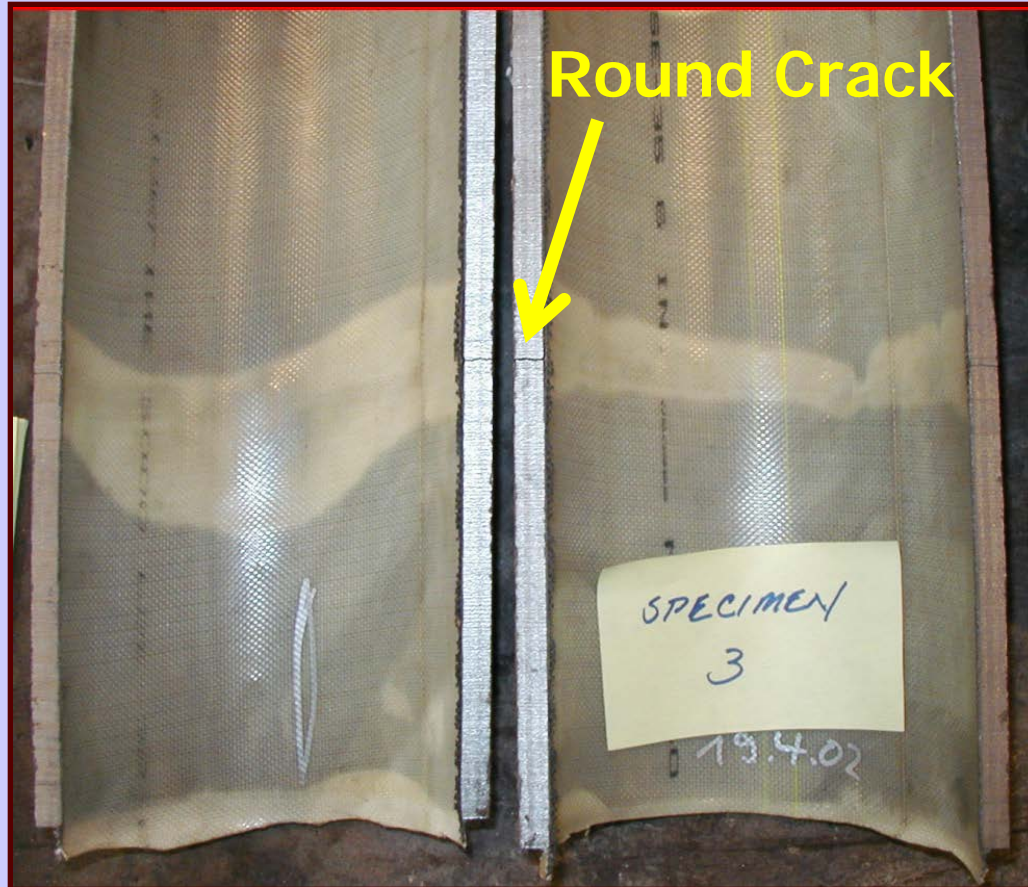
# KEY CIPP RESEARCH FINDING

- Local de-bonding required to accommodate movement at cracks & weak joints
- De-bonding confined to a distance of one diameter from crack
- Installation engineered for local de-bonding

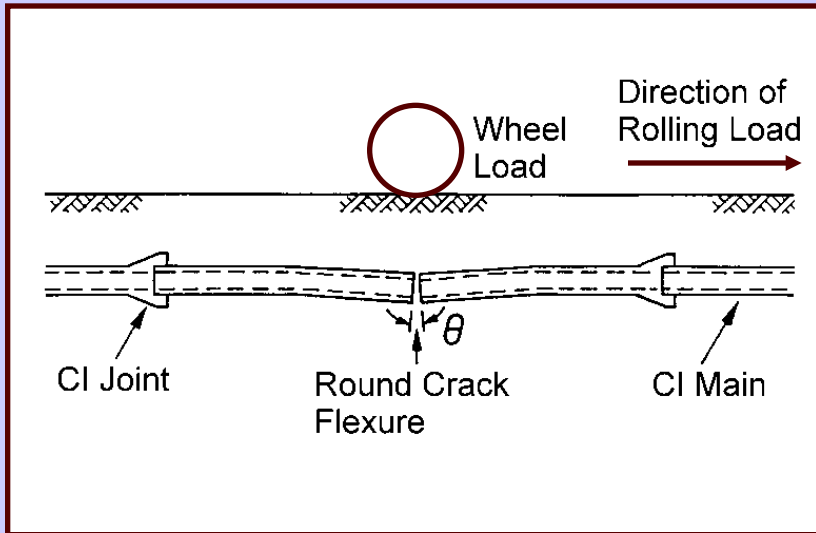
# REPETITIVE HEAVY TRAFFIC LOADING

- Heaviest double tandem axle loads permitted in NYS
- Number of axle loadings over 50 years determined from traffic surveys
- **Vehicular speed  $\approx$  40 mph**
- 780,000 axle loads over 50 years, rounded to 1 million
- Finite element simulations to set repetitive deflections
- Simulations validated by full-scale field tests in U.S. and U.K.

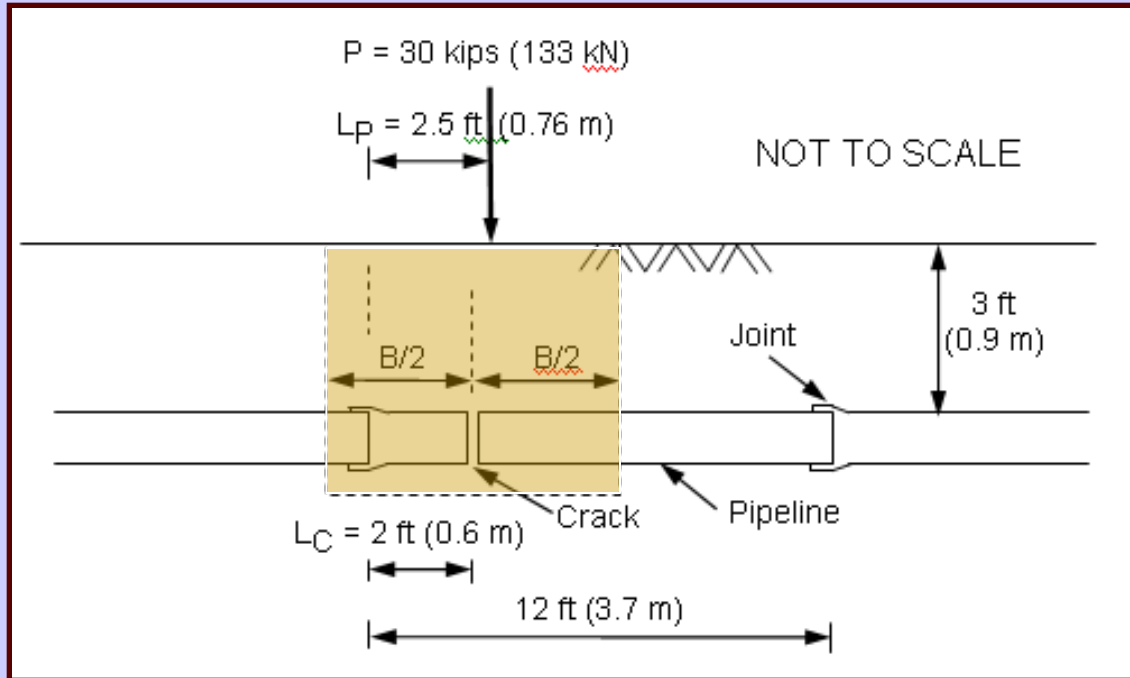
# UNDERMINING & BACKFILLING

- Undermining widths: 4-12 ft
- Lightly compacted backfill
- Single Axle Load: 30 kips
- Deflection from simulations: 0.35 in. &  $0.5^\circ$
- 100,000 cycles

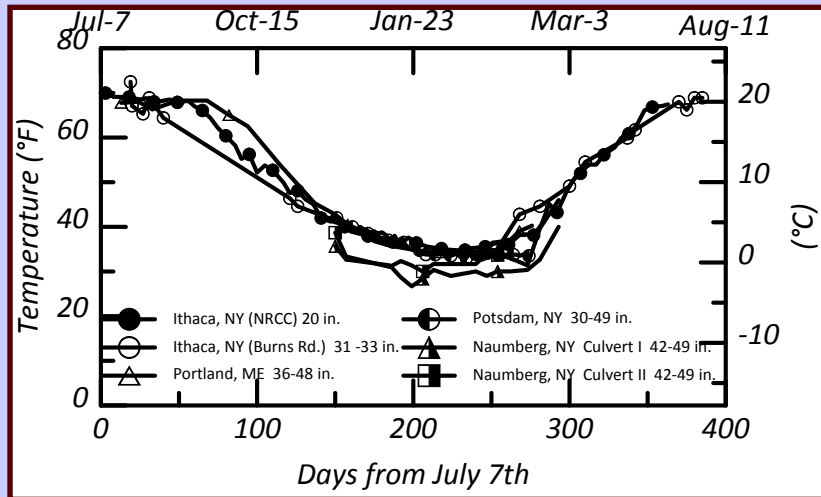
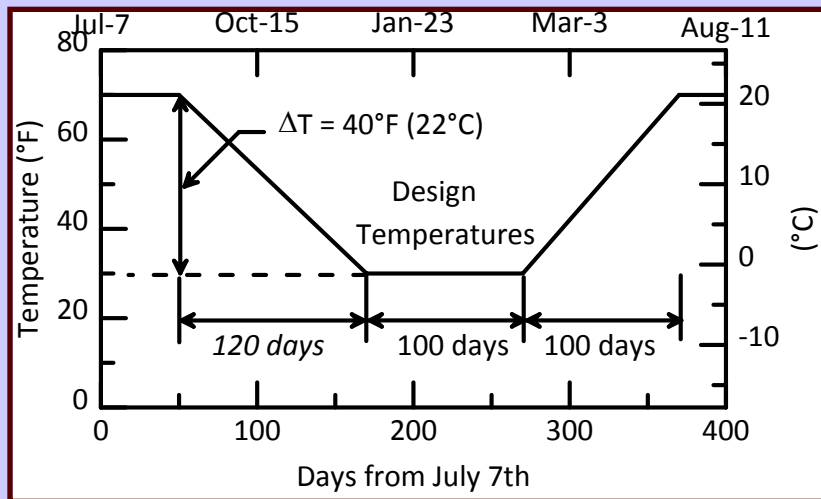
# THERMAL CONTRACTION & EXPANSION

- Subsurface year-long temperature measurements in New York State
- Closed-form subsurface thermal contraction & expansion analytical model
- Assumes liner provides negligible resistance to contraction/expansion
- Upper bound on axial liner displacement
- Rate of loading > 1000x faster than occurs in the field

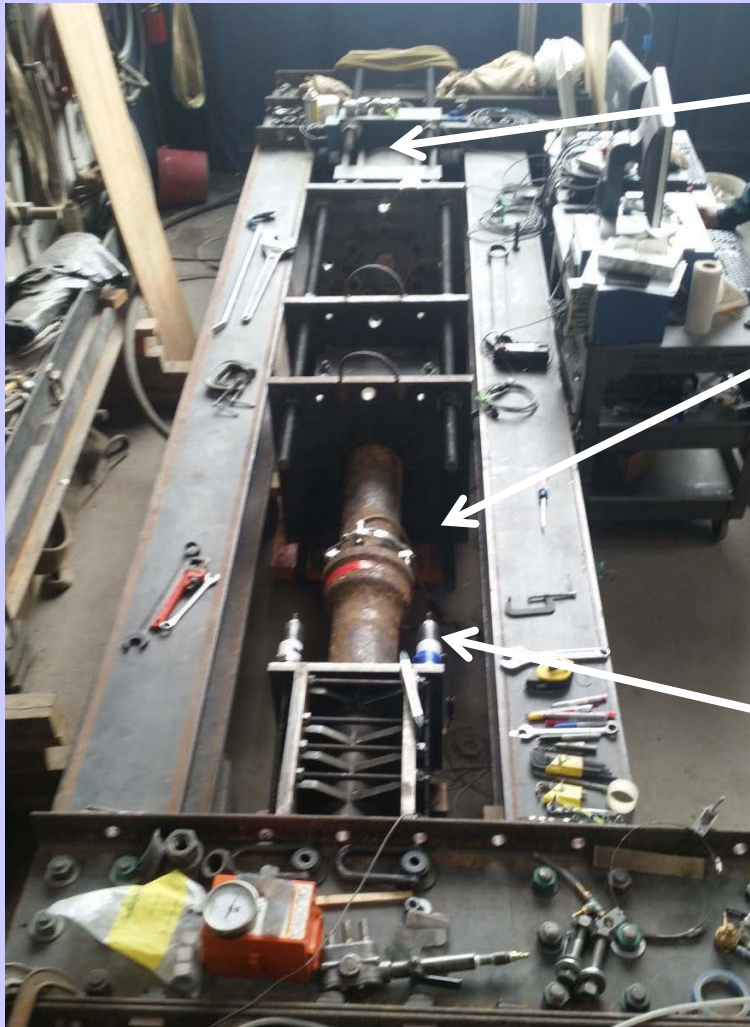
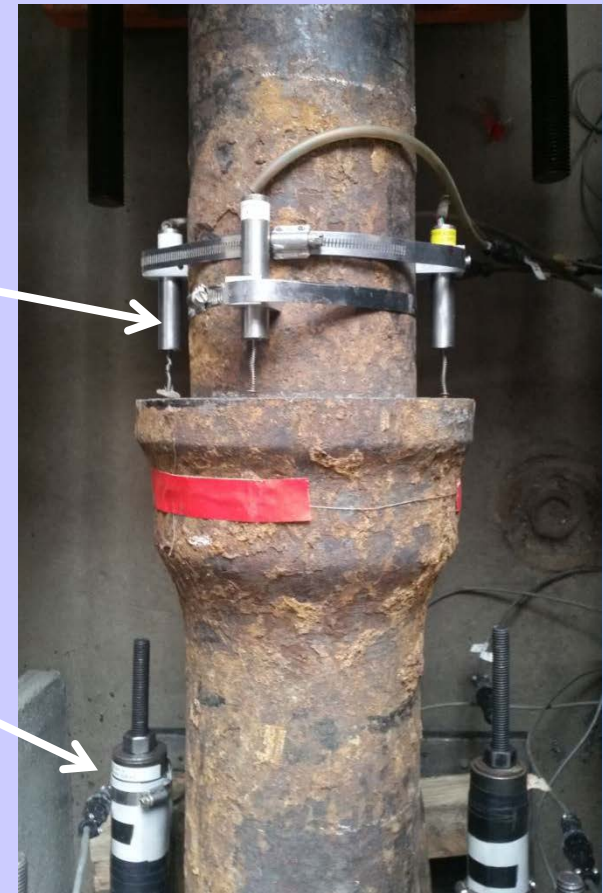
# LABORATORY TESTING FOR THERMAL CYCLES

Experimental Setup Overview

Actuator

DCDTs

Load  
Cells

Top View of the Joint,  
Bovay Laboratory Complex, Cornell University

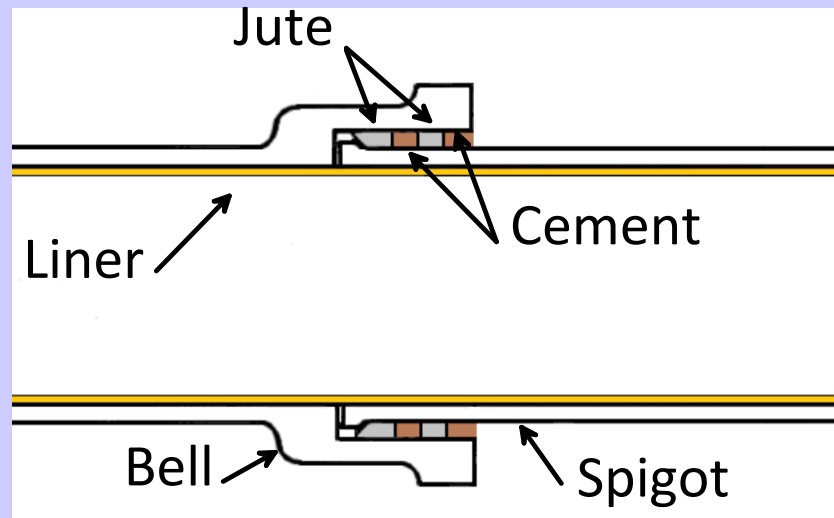
# 6 in. Lined Cast Iron Joints

- Initially Cement Caulked
- Removal of Cement to Weaken Joint after 1<sup>st</sup> 50 Years Vehicle Loading
- Further Weakening after Thermal Cycles

The cement/jute caulking was mostly removed in to provide a weak joint condition.  
During mechanical aging the internal pressure was N<sub>2</sub>, pressure verification used water.

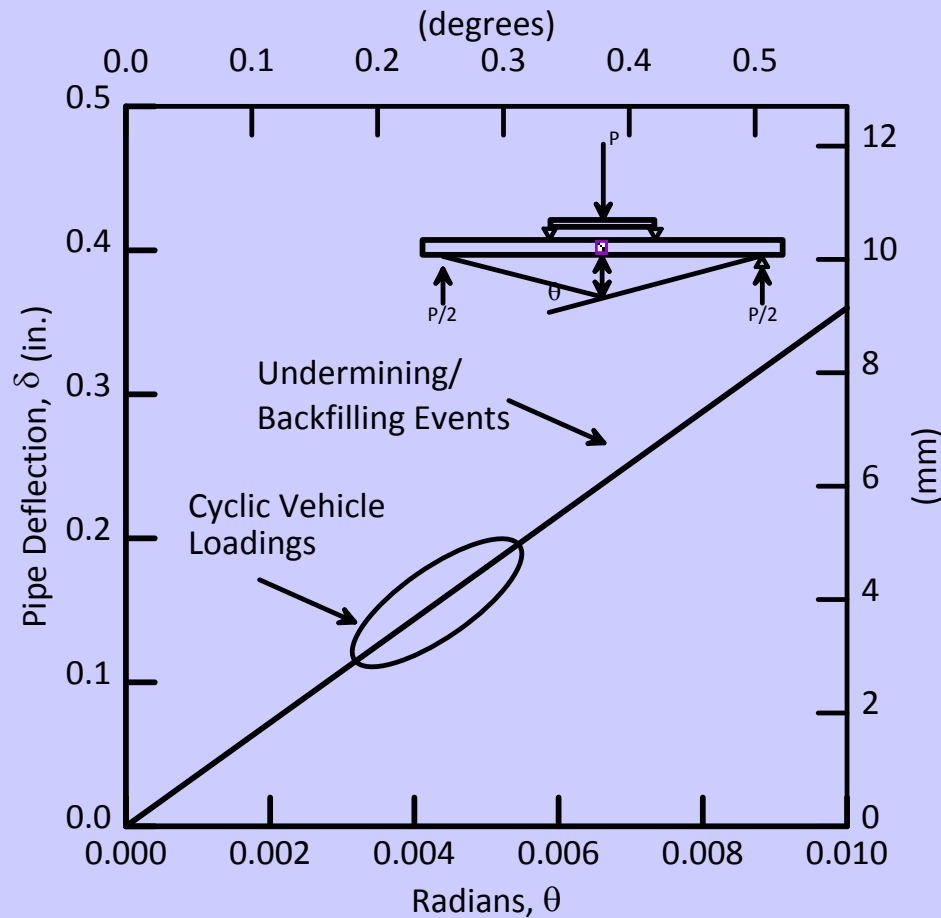
# Mechanical Aging due to Vehicle Loading

Deflections and Rotations are Small

Can Determine Moment-Rotation Relationships

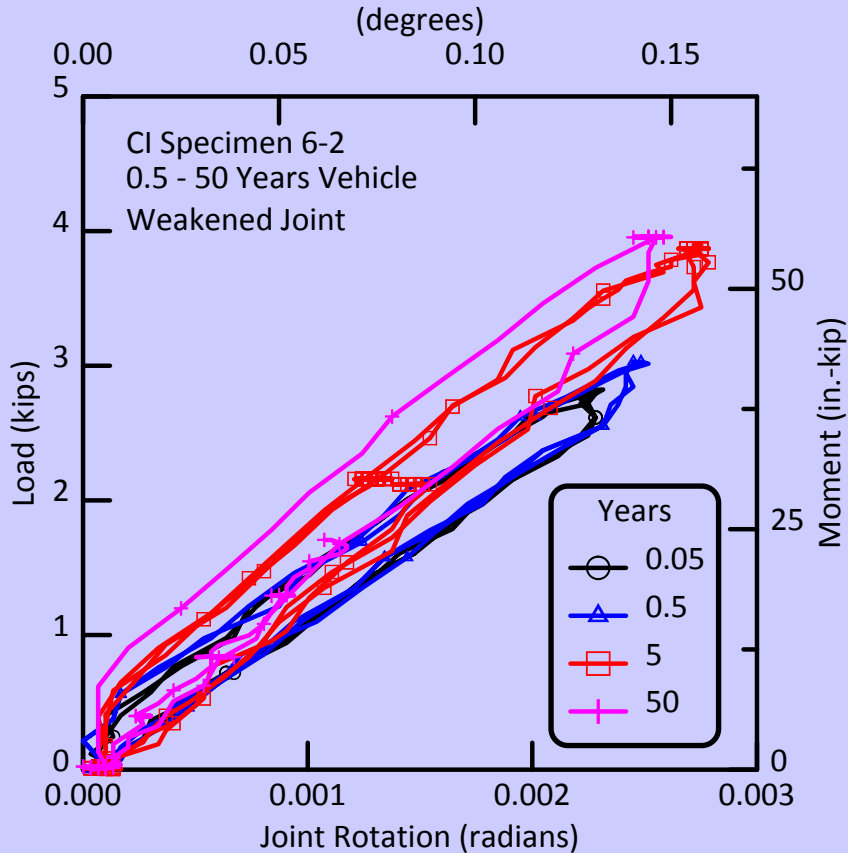
### Vehicle Loadings

## First 50 Years Vehicle Loading

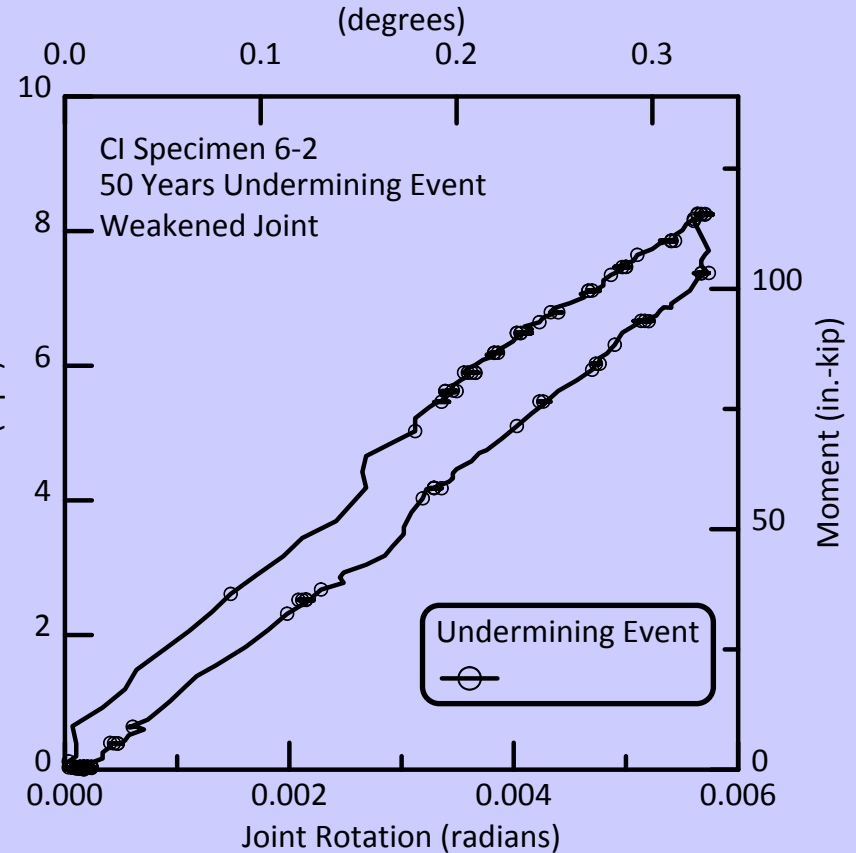
### Undermining Event

(note scale change)

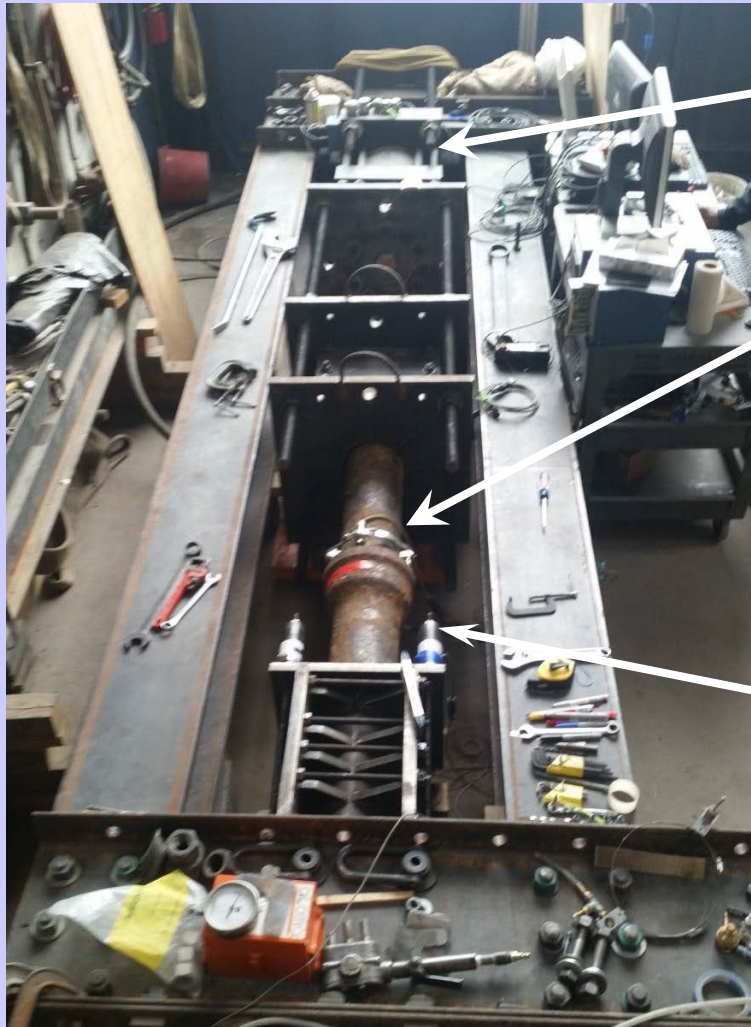
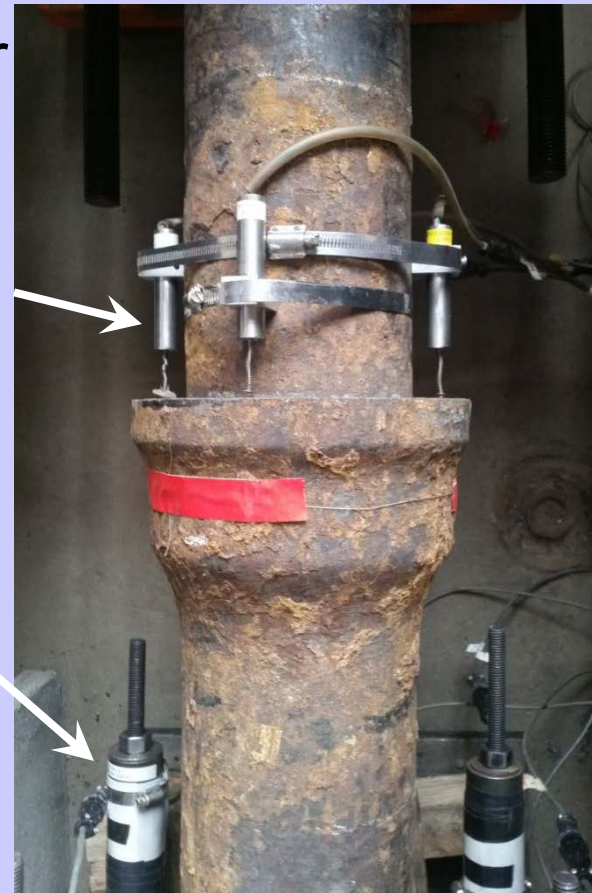
# 6 in. Lined Cast Iron Joints – Thermal Cycles

Experimental Setup Overview

Actuator

DCDTs

Load  
Cells

Top View of the Joint,  
Bovay Laboratory Complex, Cornell University

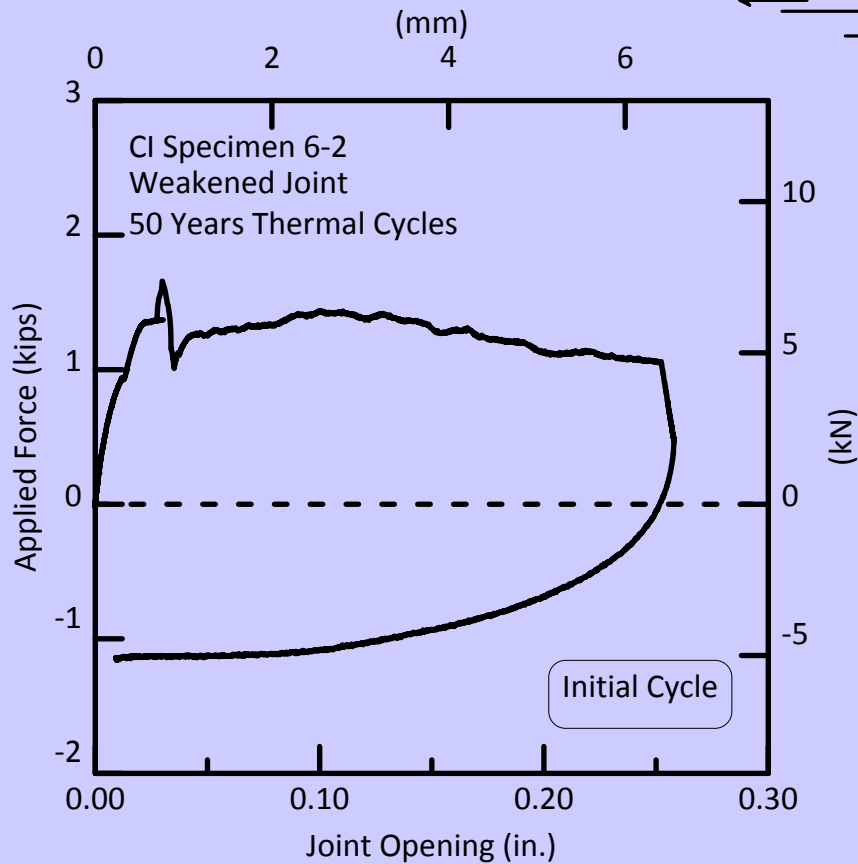
## Initial Cycle

# 6 in. Lined Cast Iron Joints First 50 Years Thermal Cycles

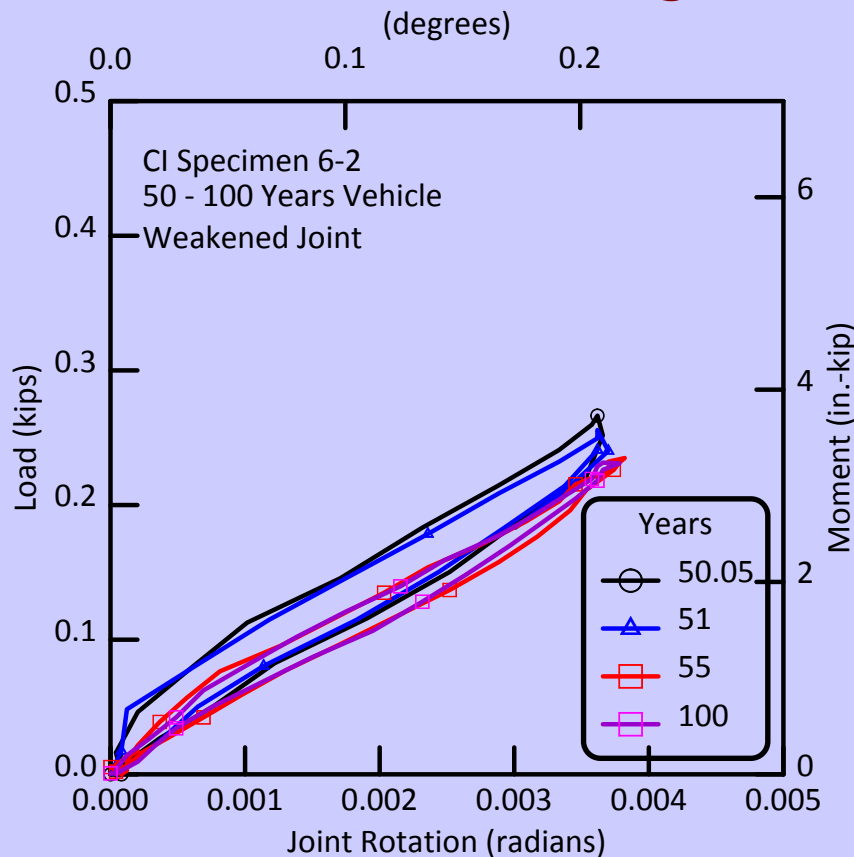
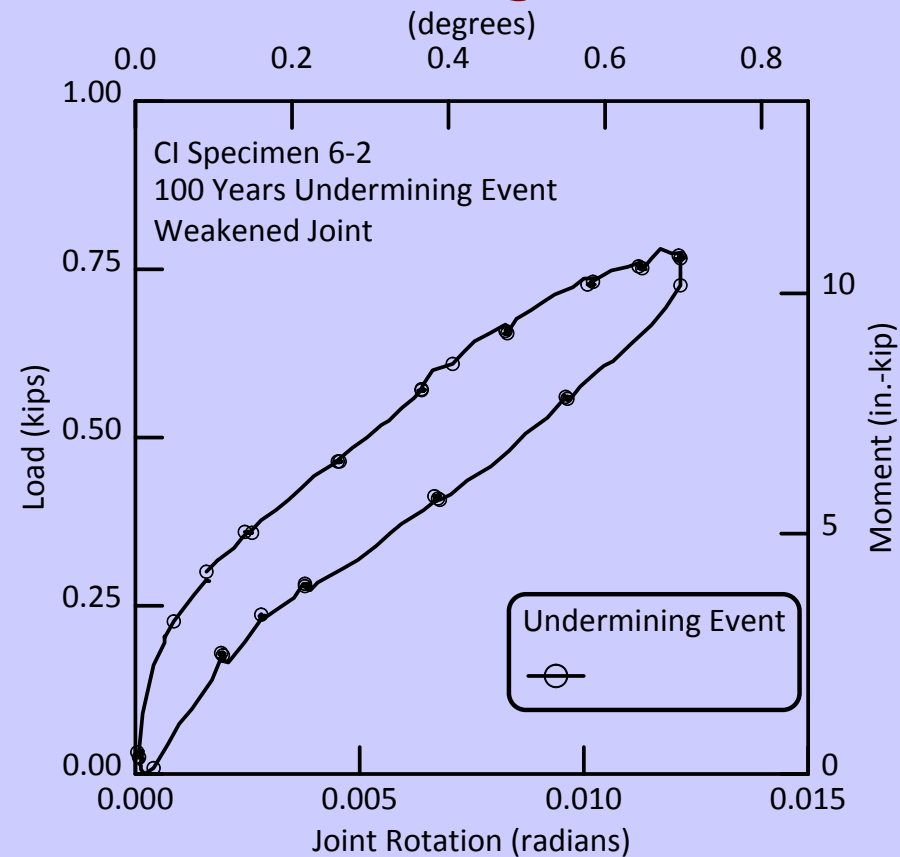
## 50 - 100 Years Vehicle Loading

## Undermining Event

(note scale change)

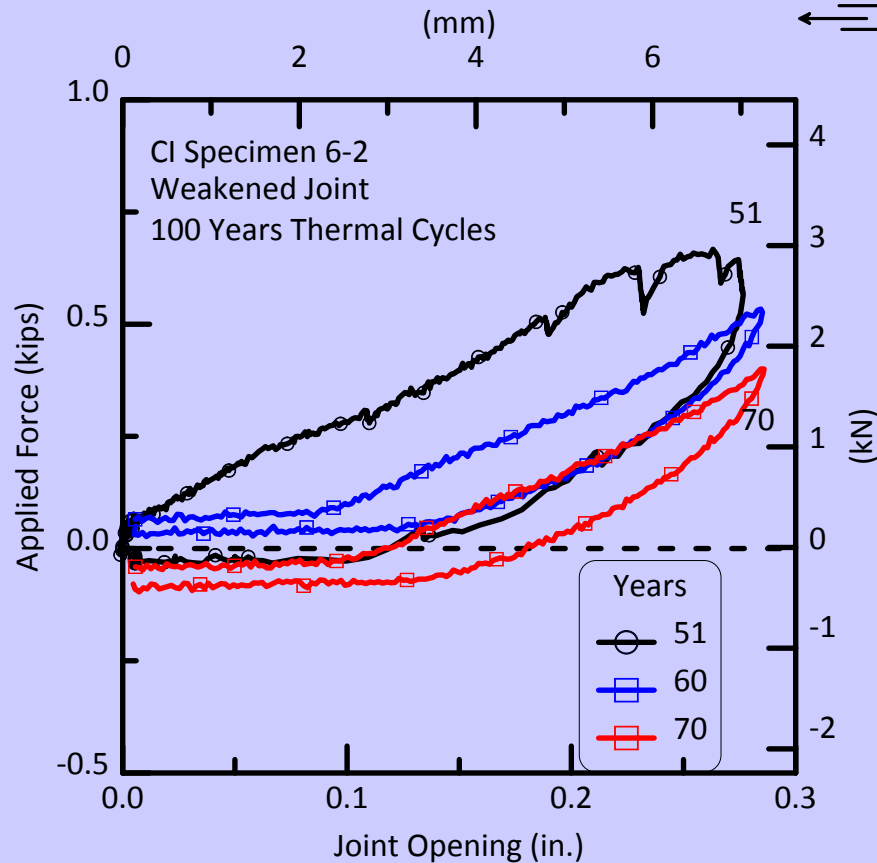
Years 51 - 70

## 51 - 100 Years Thermal Cycles

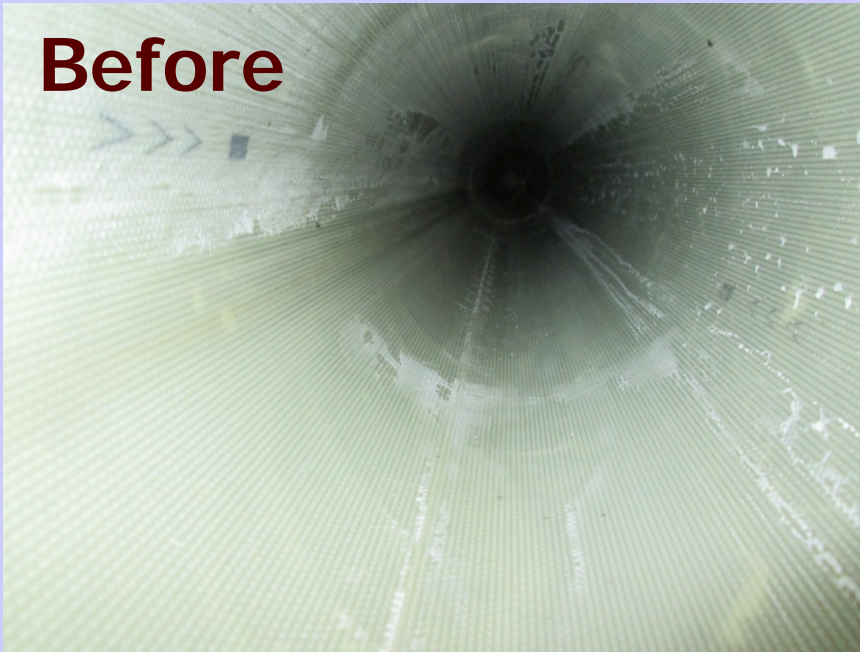
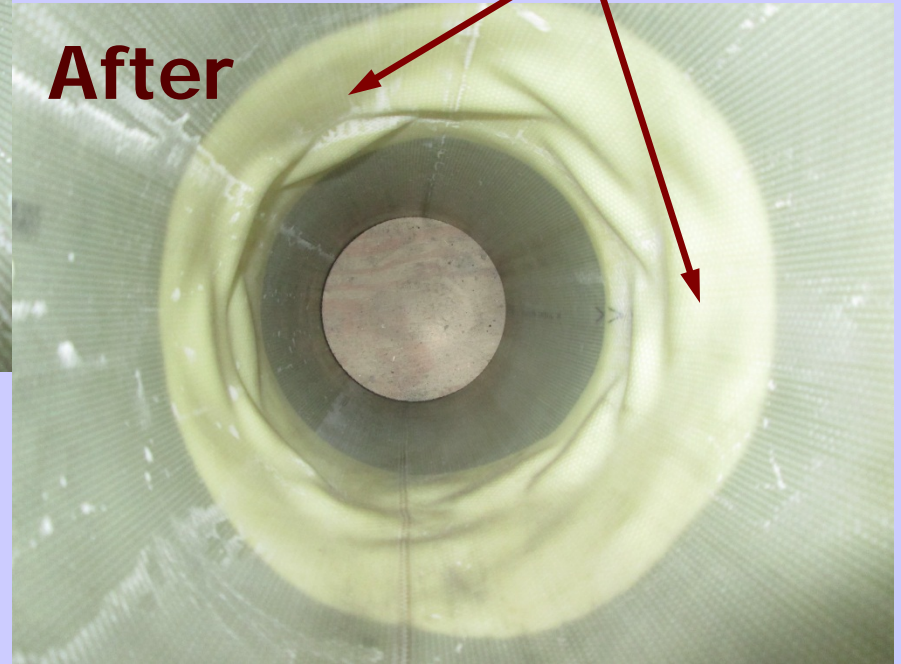
# 6 in. Specimen

**Before**

**De-Bonding**

**After**

**No Leakage, No Liner Damage**

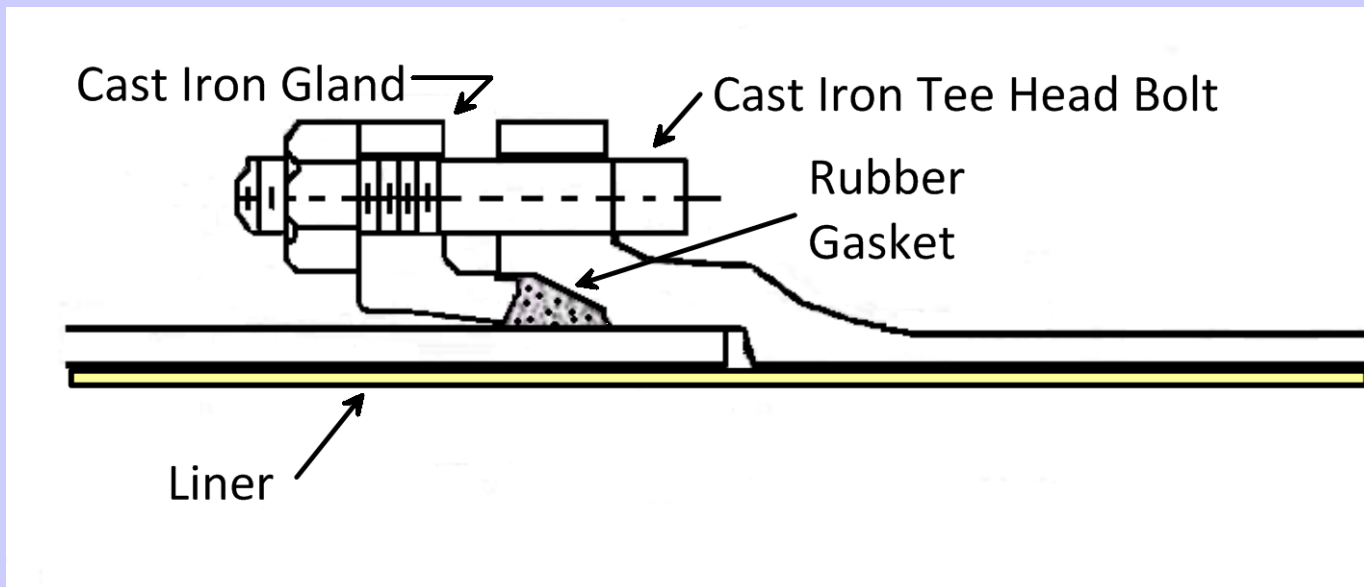
# 12 in. Lined Cast Iron Joints

- Mechanical Joint
- Inner-Tite (or similar) with Clamp

12 in. CI had Inner-Tite mechanical joints.  
All internal pressurization used N<sub>2</sub>.

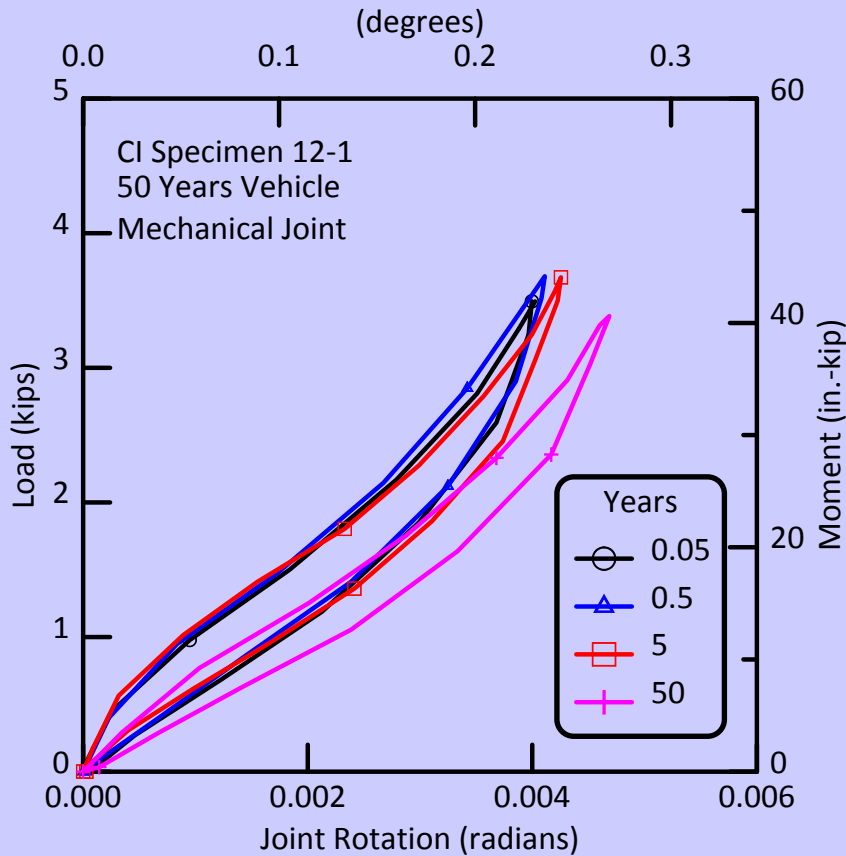
### Vehicle Loadings

## First 50 Years Vehicle Loading

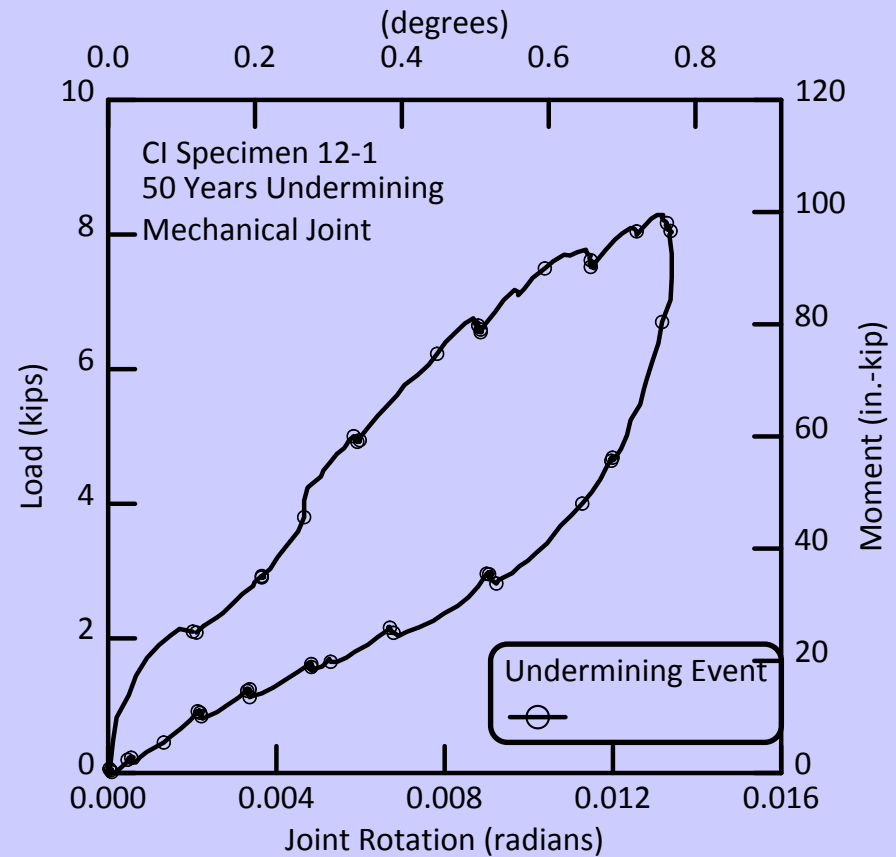
### Undermining Event

(note scale change)

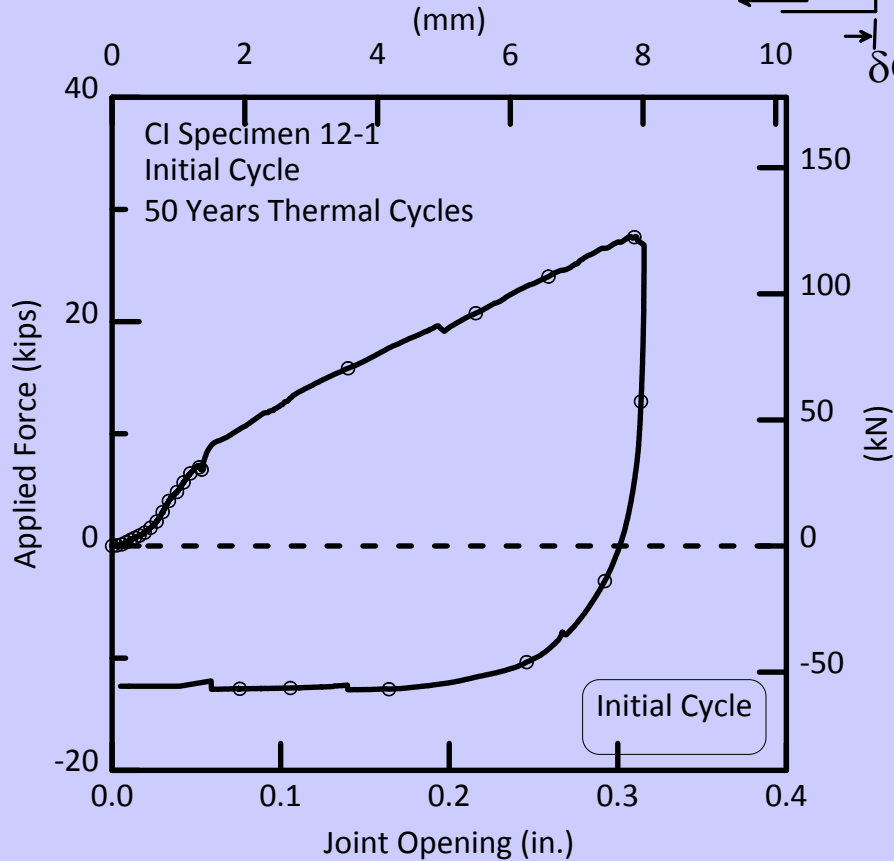
## Initial Cycle

# 12 in. Lined Cast Iron Joints First 50 Years Thermal Cycles

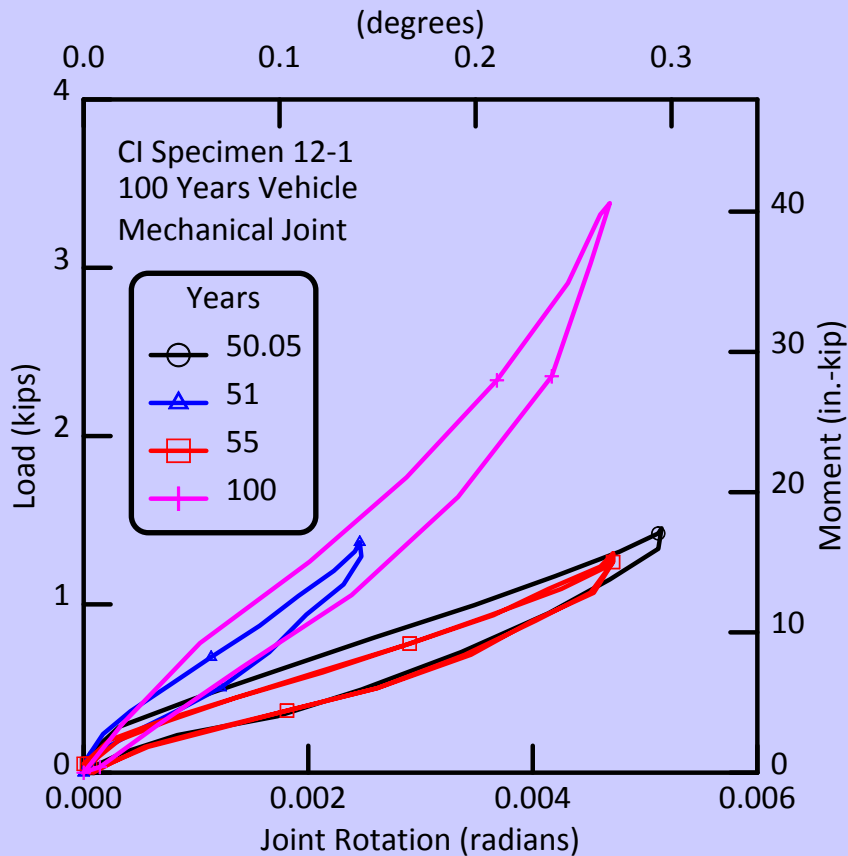
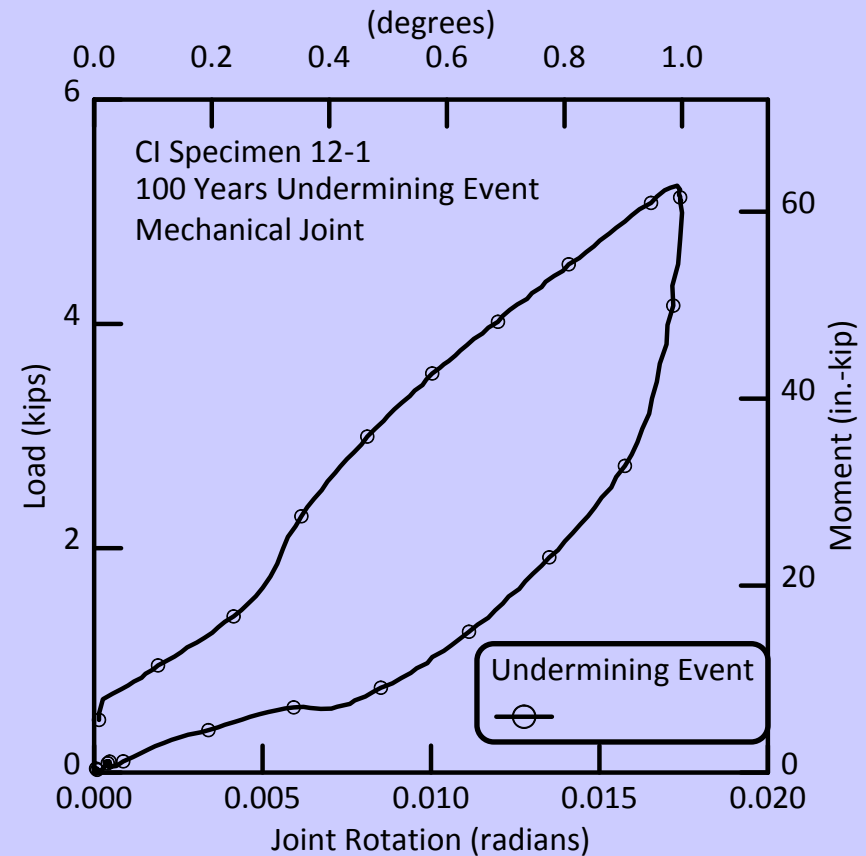
## 50 - 100 Years Vehicle Loading

## Trenching Event

(note scale change)

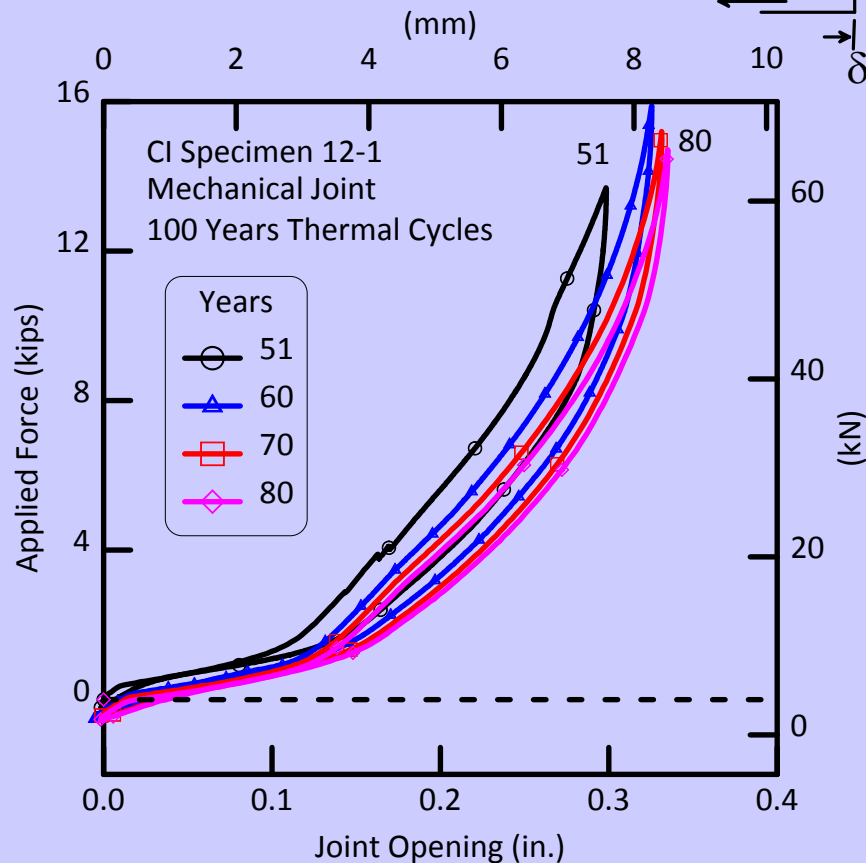
Years 51 - 80

## 100 Years Thermal Cycles

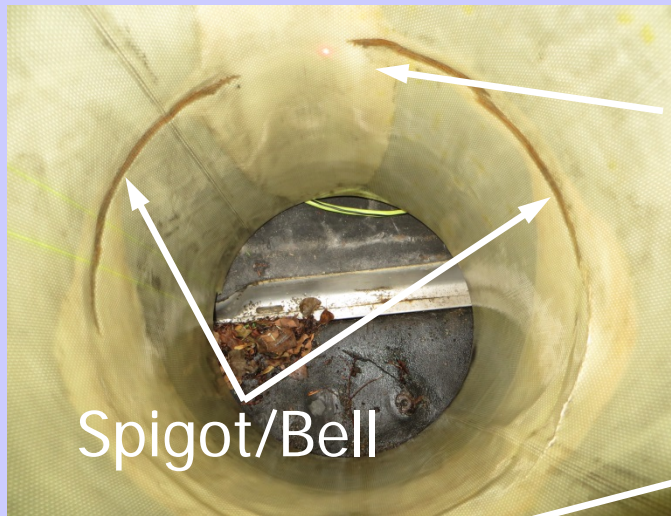
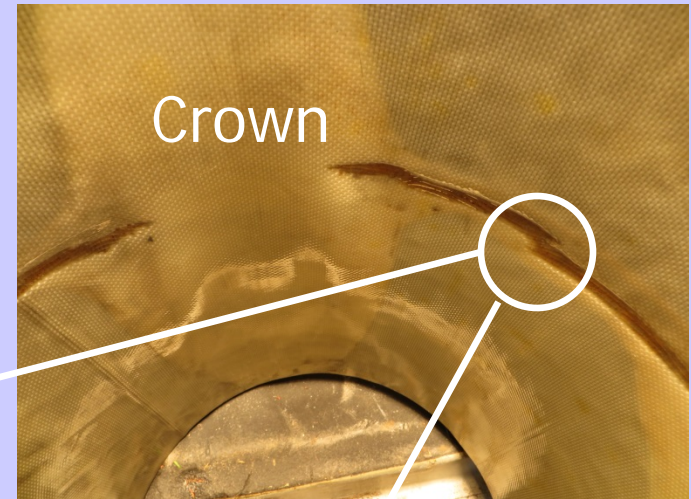
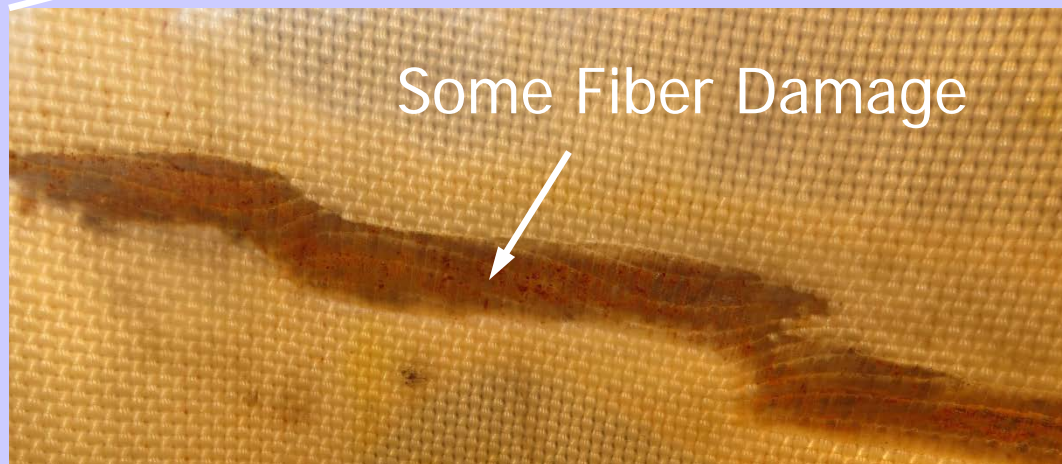
# 12 in. CI Lined Pipe Joint

## Post-Mechanical Aging Tests

**No Leakage, Some Liner Damage**

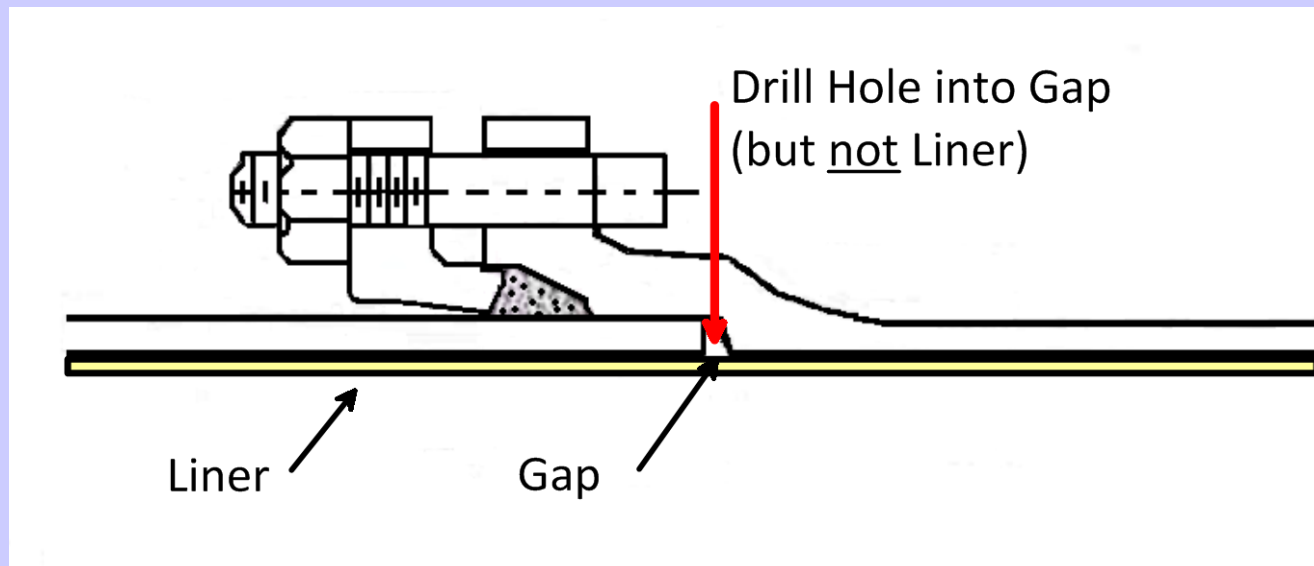
## Drill Hole into Gap

- Drill hole through CI into bell/spigot gap but not liner
- Fill with soapy water
- Pressurize in 5-psi steps to 90 psig
- Hold each pressure 30 minutes

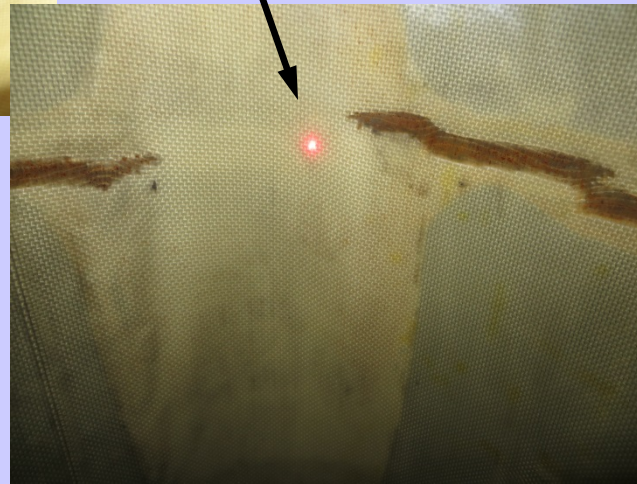
After Pressurization with Hole into Gap

Laser Beam Shining  
through Drilled Hole

- 90 psig
- No Leaks
