# **CIPL PROJECT WORKSHOP: Results of Mechanical Aging & CIPL Materials Property Tests**

**Cornell University  
Northeast Gas  
Association**

# **Mechanical Aging and CIPL Property Tests of Field-Aged Lining Systems**

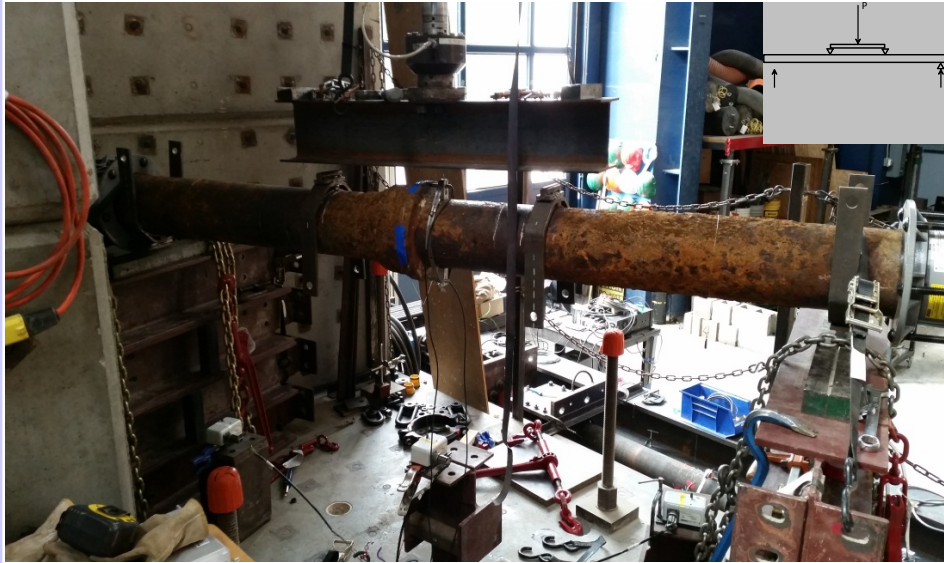
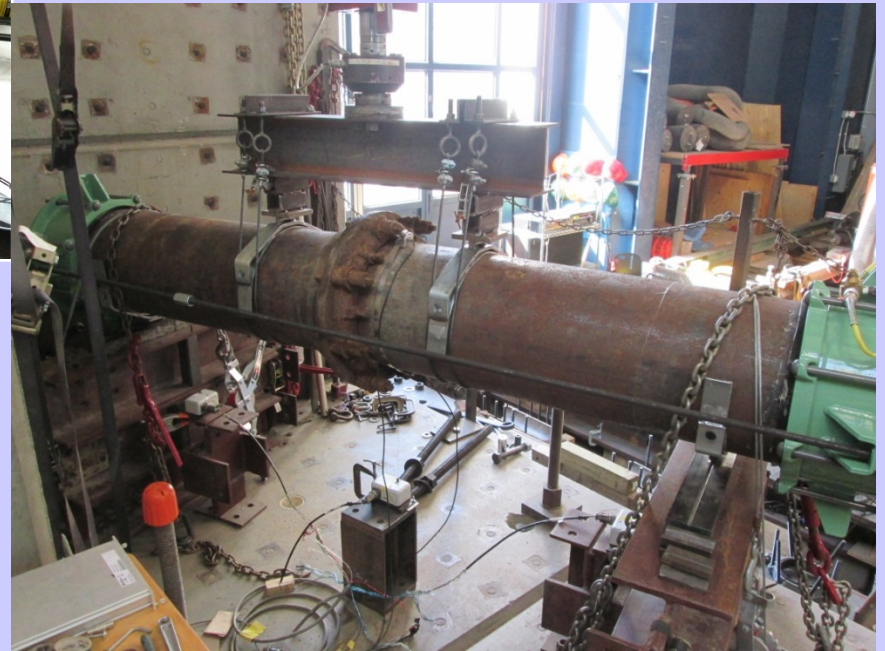
# Vehicle Cycles

2 M Cycles

100 Years

- **Mechanical Aging - Lab Testing**
  - **Vehicular Loading**
    - 40 kip Tandem Axle with Impact Factor of 1.5
    - 780,000 per 50 Years Rounded to 1M
    - 100 Years = 2M cycles
  - **Undermining Events (1 every 50 Years)**
    - Excavation and Backfill with Disturbed Soil
    - Additional Vehicle Load Directly over Crack
  - **No Leakage**

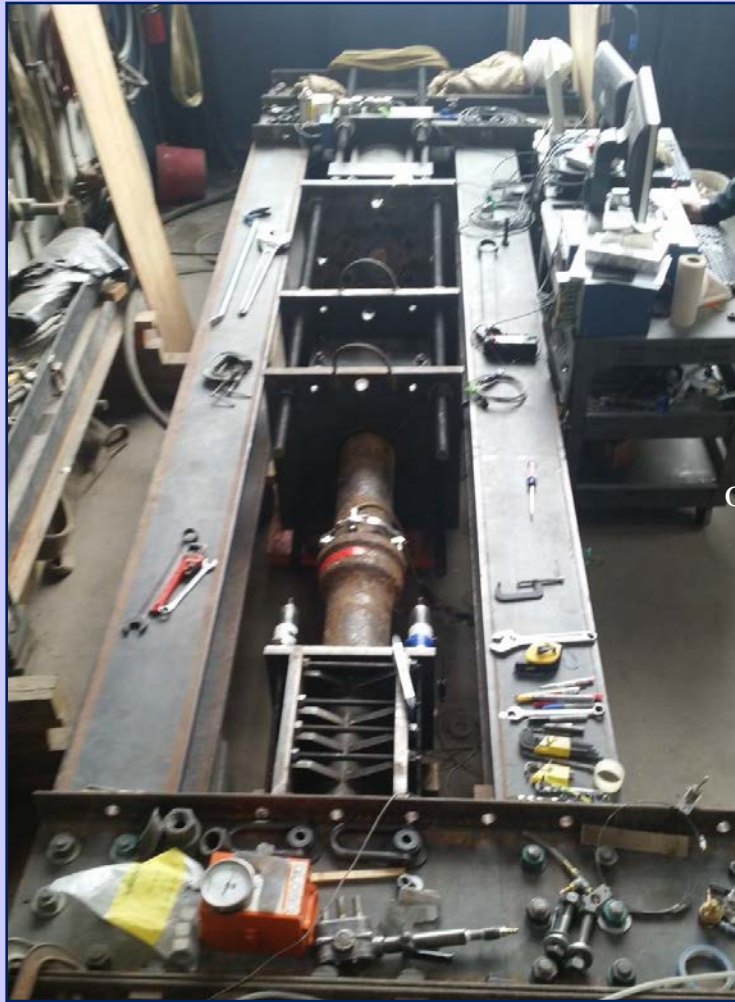
# Thermal Cycles

$\Delta T = 40^{\circ} \text{ F}$   
( $22^{\circ} \text{ C}$ )

100 Cycles  
100 Years

De-Bonding  
on Cycle 1

- **Mechanical Aging - Lab Testing**
  - **Thermal Cycles**
    - $\Delta T = 40^{\circ}\text{F}$  ( $22^{\circ}\text{C}$ )
    - Two 50 Years Cycle Sets = 100 Years
    - Weakening on First Cycle
  - No Leakage
