Test Results for the Field Aged & Mechanically Aged Composite Liner System

Starline® 2000

Xia Zeng and Anil N. Netravali

Cornell University

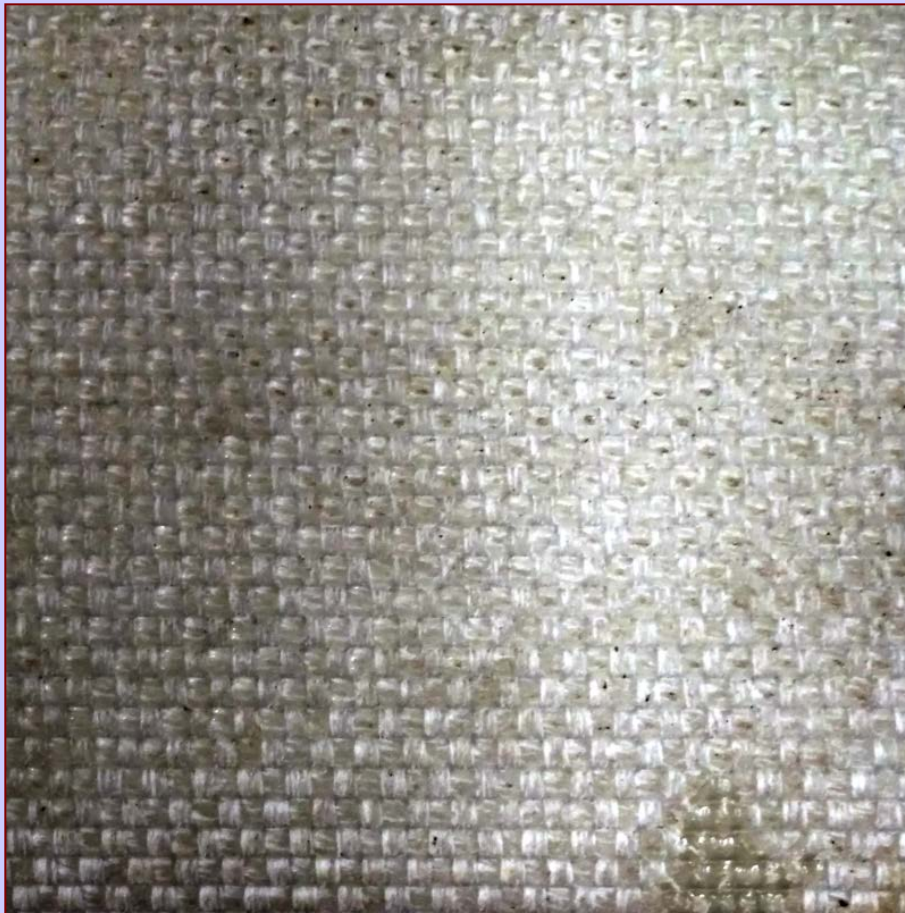
Image of a Typical Composite Liner

Longitudinal Direction

Thread Count:

21.03 per inch for 6" pipe

16.31 per inch for 12" pipe

Transverse (Hoop)

15.96 per inch for 6" pipe

16.68 per inch for 12" pipe

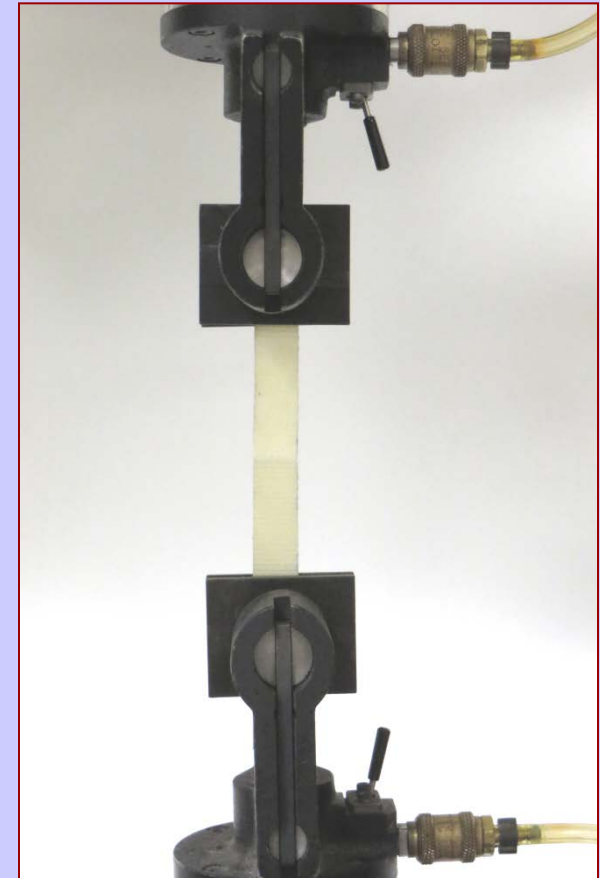
Composite Liner Tension Test in Longitudinal Direction

(Impregnated Composite Liner – 6 in. CI Pipe)

Test parameters*

Gauge Length (mm)	Crosshead Speed (mm/min)	Width (mm)	Thickness (mm)	Length (mm)
60	20	15	~1.25	200

*Same parameters were used in 2002-2003 tests on Starline® 2000 Composite Liner

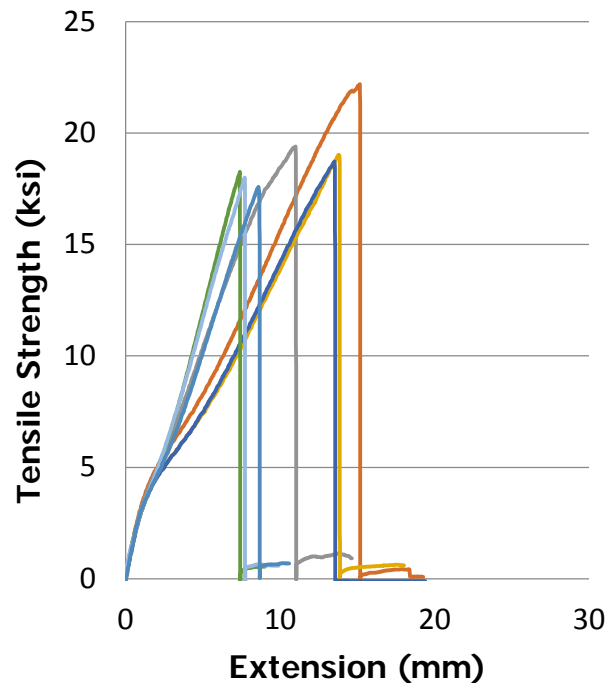
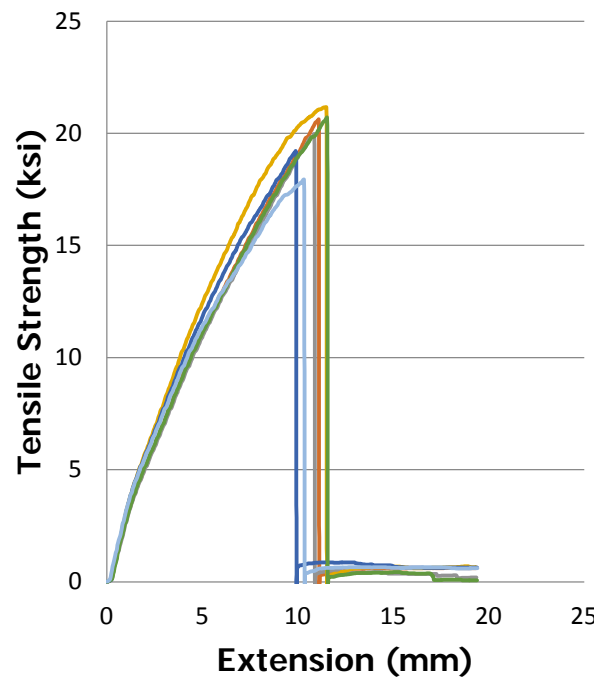
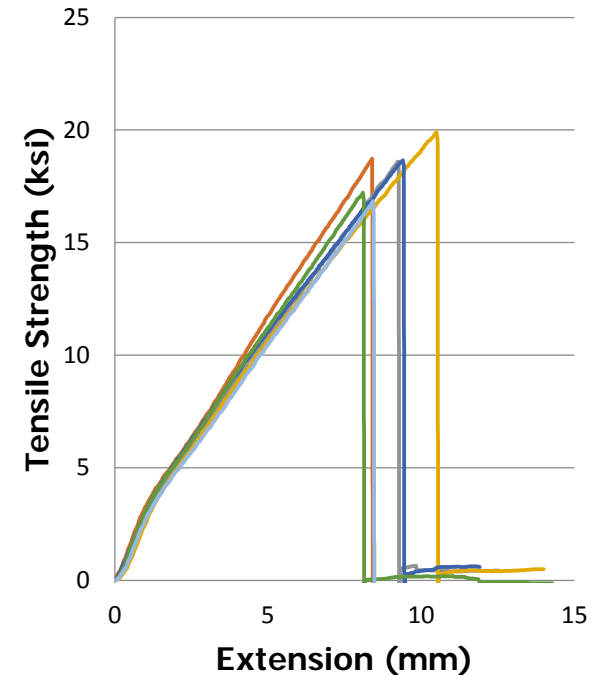
Composite Liner Tension Test

Longitudinal Direction

(Impregnated Composite Liner – 6 in. CI Pipe)

Field Aged: FA
(Bonded)

Field + Mechanically
Aged: FMA
(De-Bonded) No. 1

Field + Mechanically
Aged: FMA
(De-Bonded) No. 2

FA = Field aged for 16 yrs

FMA = Mechanically aged @ Cornell (equivalent to 100 yrs of traffic and 100 yrs of thermal cycling)

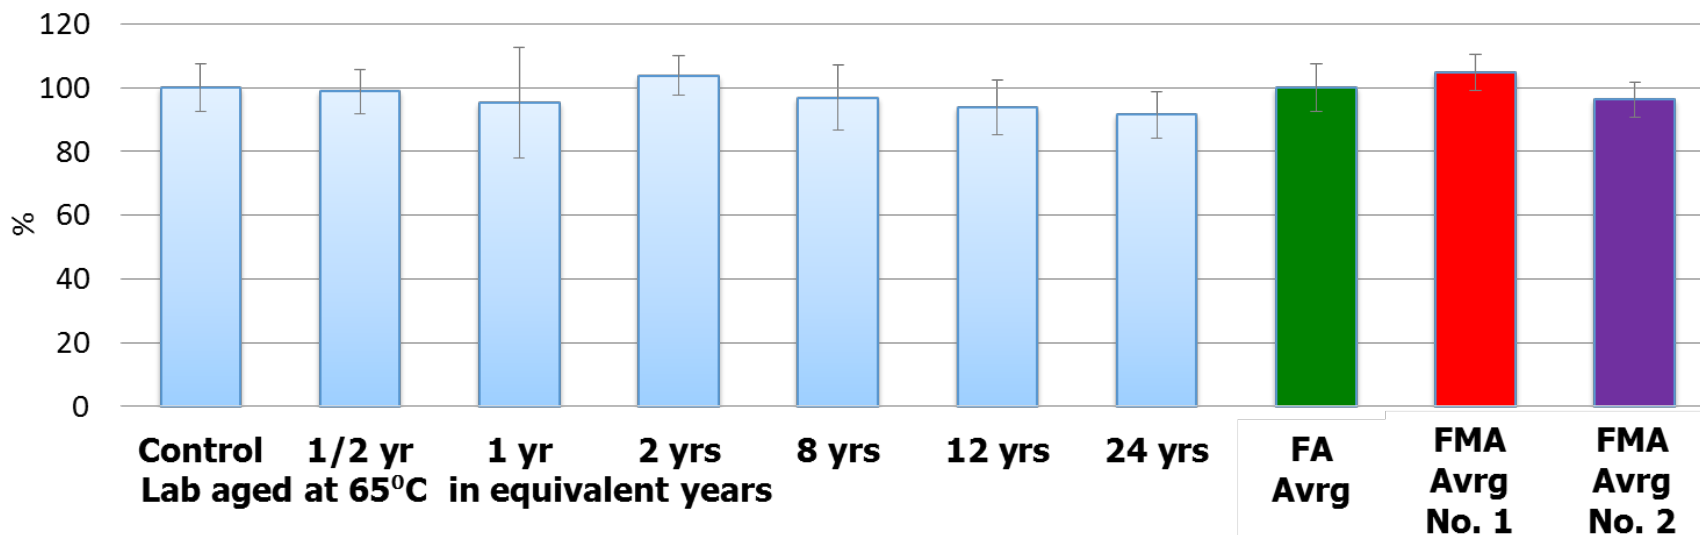
Composite Liner Tension Test in Longitudinal Direction

(Not debonded Composite Liner FA and De-Bonded FMA – 6 in. CI Pipe comparison)

Average 6 in. Pipe (FA)	Average 6 in. Pipe (FMA) De-Bonded No. 1	Average 6 in. Pipe (FMA) De-Bonded No. 2
ksi	19.03	19.94	18.33
CV %	7.44	5.46	5.59

No change is seen after mechanical aging at Cornell University

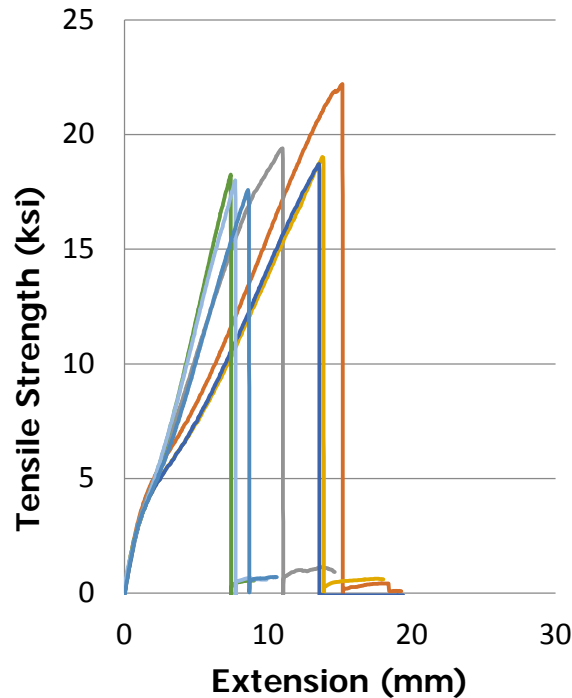
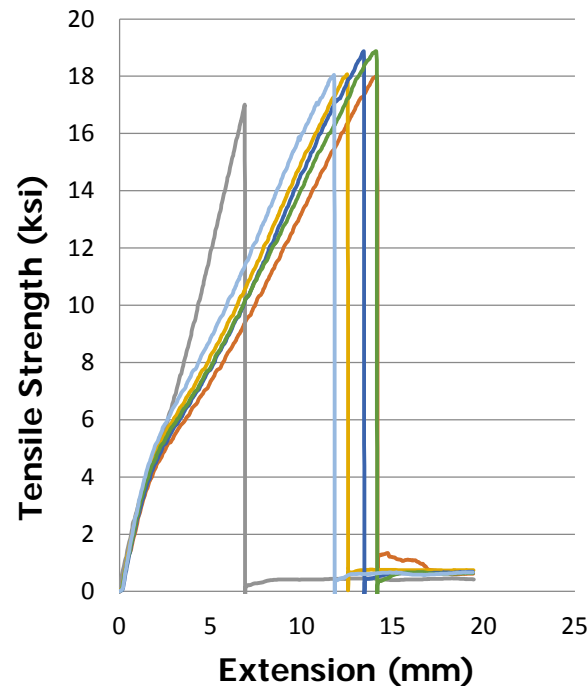
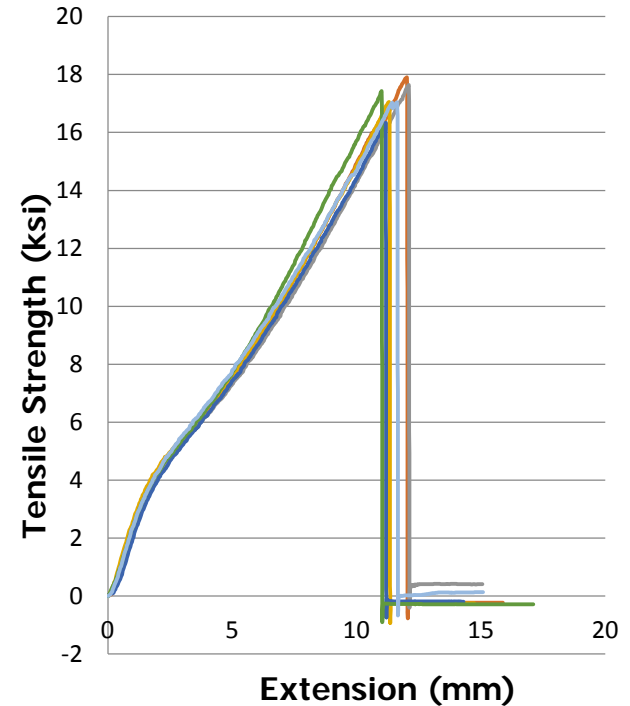
Composite Liner Tension Test in Longitudinal Direction

(Impregnated Composite Liner – 6 in. CI Pipe)

Field Aged: FA
(Bonded)

Field + Mechanically
Aged: FMA
(Bonded) No. 1

Field + Mechanically
Aged: FMA
(Bonded) No. 2

FA = Field aged for 16 yrs

FMA = Mechanically aged @ Cornell (equivalent to 100 yrs of traffic and 100 yrs of thermal cycling)

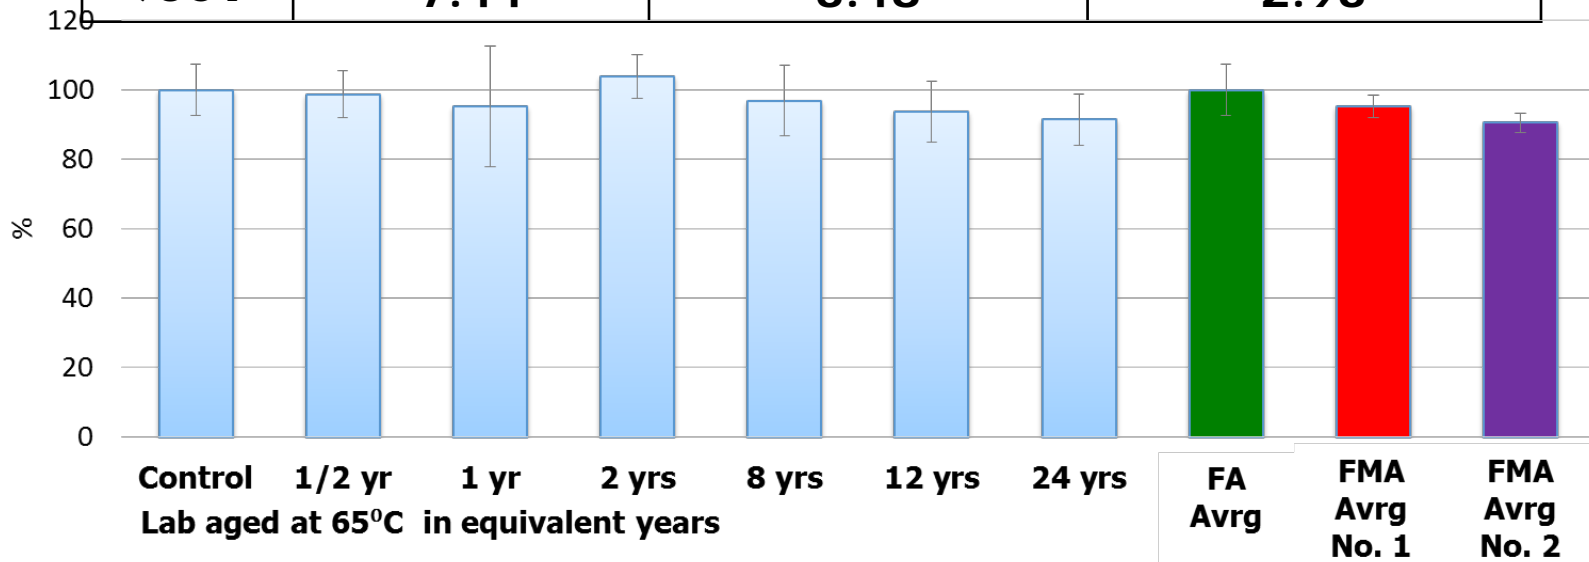
Composite Liner Tension Test Longitudinal Direction

(Impregnated Composite Liner FA and Bonded-FMA – 6 in. CI Pipe comparison)

Average 6 in. Pipe (FA)	Average 6 in. Pipe (FMA) Bonded No. 1	Average 6 in. Pipe (FMA) Bonded No. 2
ksi	19.03	18.15	17.23
%CV	7.44	3.48	2.93

Negligible change is seen after mechanical aging at Cornell University

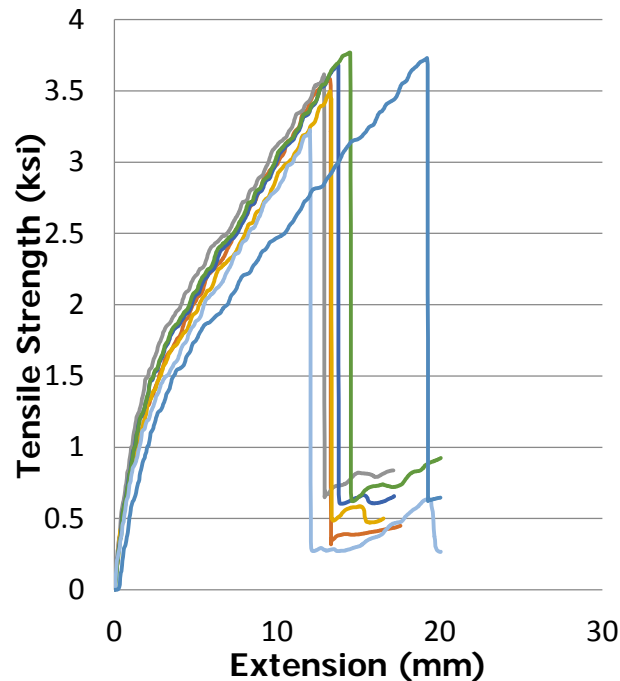
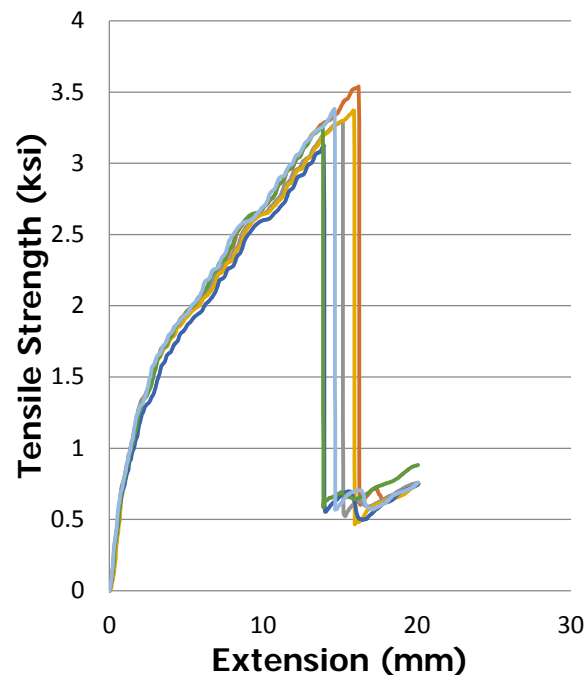
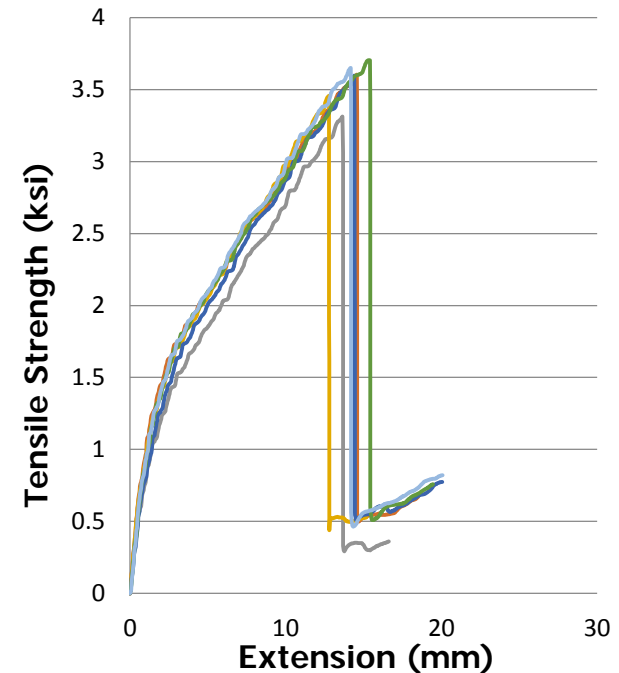
Composite Liner Tension Test Transverse (Hoop) Direction

(Impregnated Composite Liner – 6 in. CI Pipe)

Field Aged: FA
(Bonded)

Field + Mechanically
Aged: FMA
(Bonded) No. 1

Field + Mechanically
Aged: FMA
(Bonded) No. 2

FA = Field aged for 16 yrs

FMA = Mechanically aged @ Cornell (equivalent to 100 yrs of traffic and 100 yrs of thermal cycling)

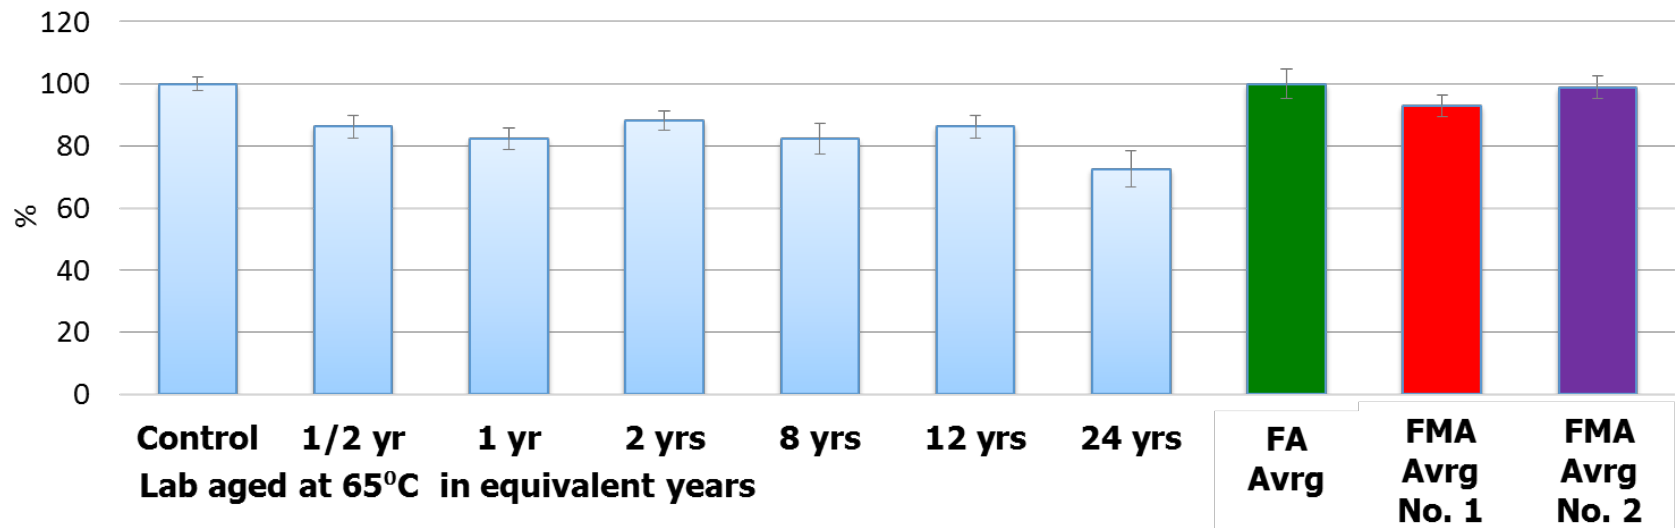
Composite Liner Tension Test Transverse (Hoop) Direction

(Impregnated Composite Liner FA and Bonded FMA – 6 in. CI Pipe comparison)

Average 6 in. Pipe (FA)	Average 6 in. Pipe (FMA) Bonded No. 1	Average 6 in. Pipe (FMA) Bonded No. 2
ksi	3.59	3.33	3.55
%CV	4.74	3.75	3.72

Negligible change is seen after mechanical aging at Cornell University

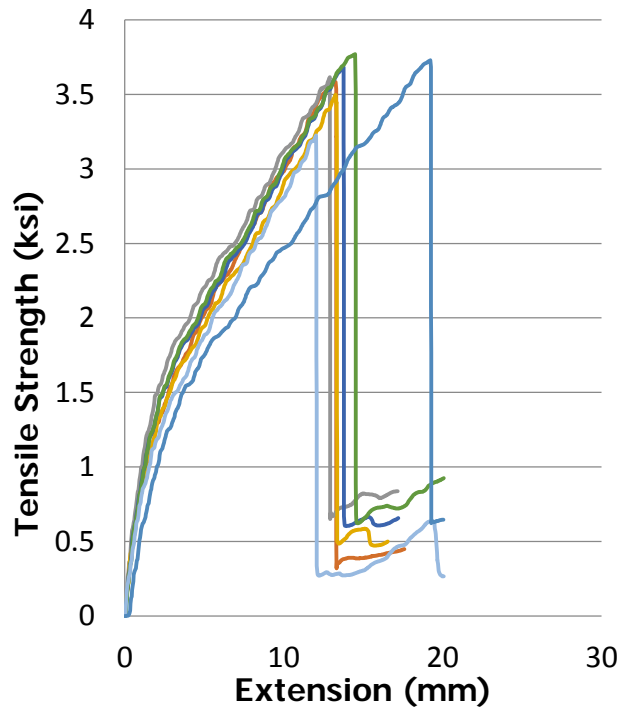
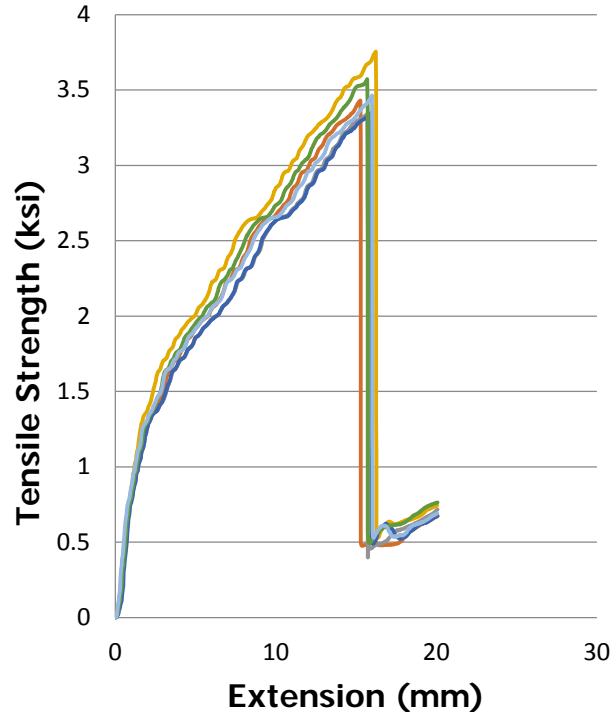
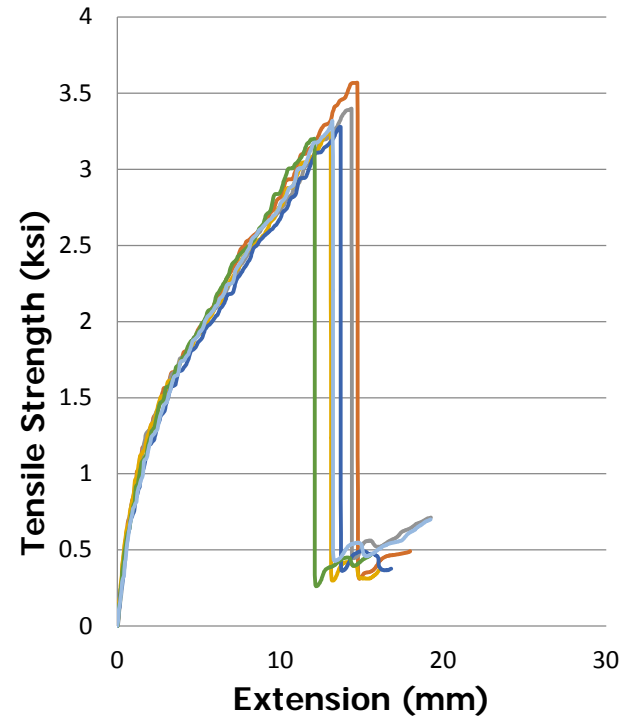
Composite Liner Tension Test Transverse Direction

(Impregnated Composite Liner – 6 in. CI Pipe)

**Field Aged: FA
(Bonded)**

**Field + Mechanically
Aged: FMA
(De-Bonded) No. 1**

**Field + Mechanically
Aged: FMA
(De-Bonded) No. 2**

FA = Field aged for 16 yrs

FMA = Mechanically aged @ Cornell (equivalent to 100 yrs of traffic and 100 yrs of thermal cycling)

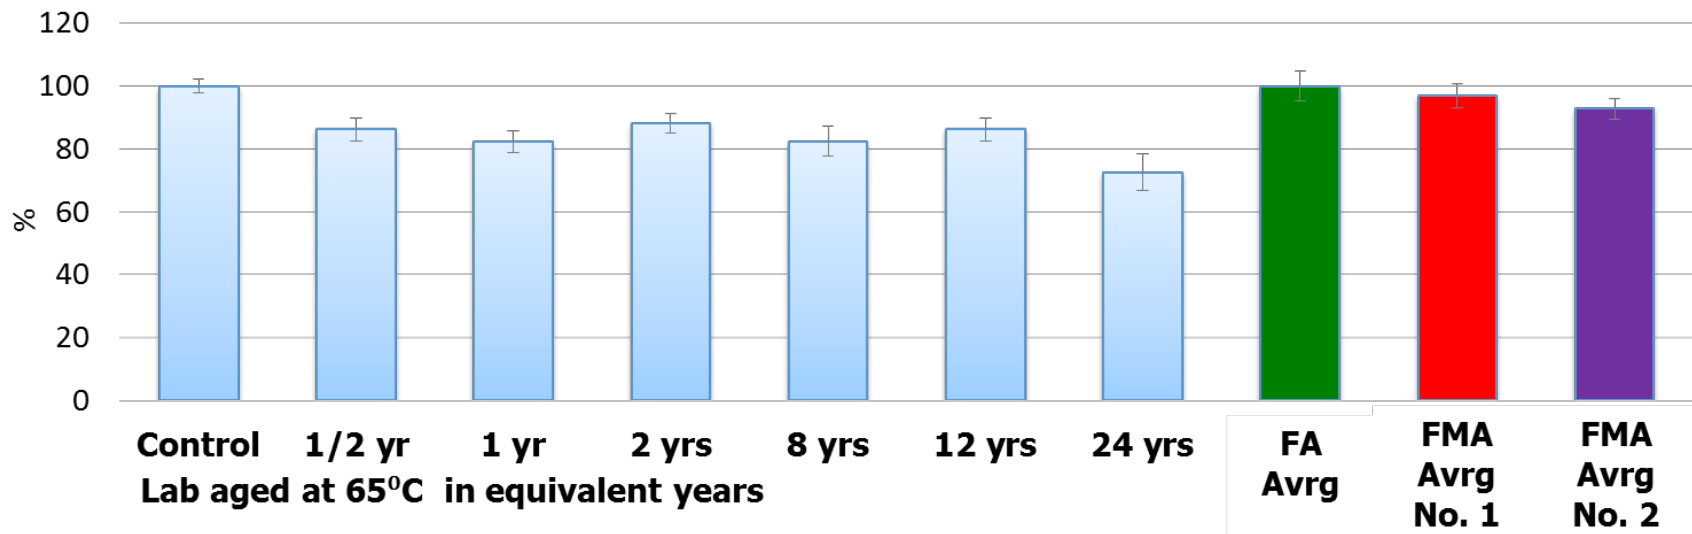
Composite Liner Tension Test Transverse Direction

(Impregnated Composite Liner FA and De-Bonded FMA – 6 in. CI Pipe comparison)

Average 6 in. Pipe (FA)	Average 6 in. Pipe (FMA) De-Bonded No. 1	Average 6 in. Pipe (FMA) De-Bonded No. 2
ksi	3.59	3.48	3.33
CV %	4.74	4.11	3.66

Very small change is seen after mechanical aging at Cornell University

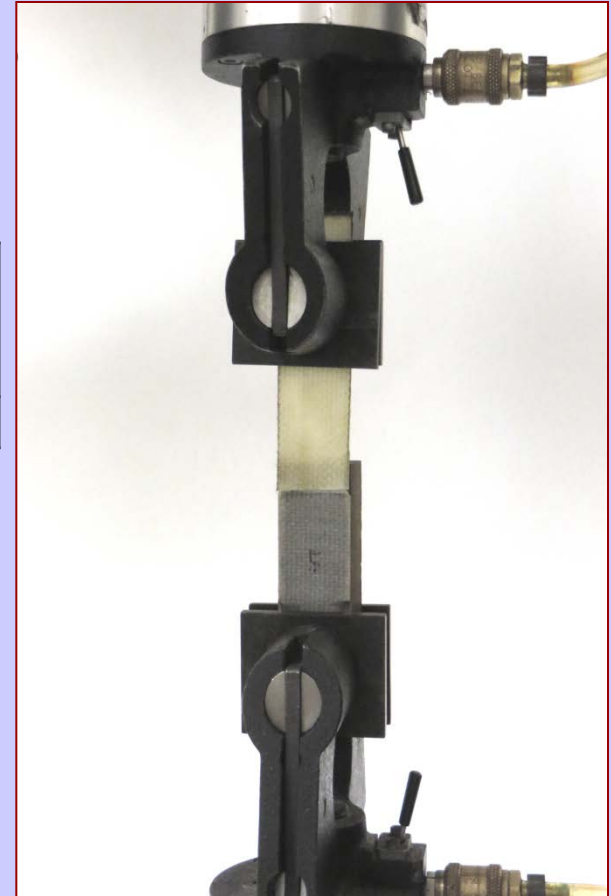
Lap Shear Test

(Impregnated Composite Liner– 6 in. CI Pipe)

Primary Test for Adhesion

Test parameters

Gauge Length (mm)	Crosshead Speed (mm/min)	Width (mm)	Thickness (mm)	Length (mm)	Overlap (mm)
80	10	25.4	~ 1.25	152.4	8

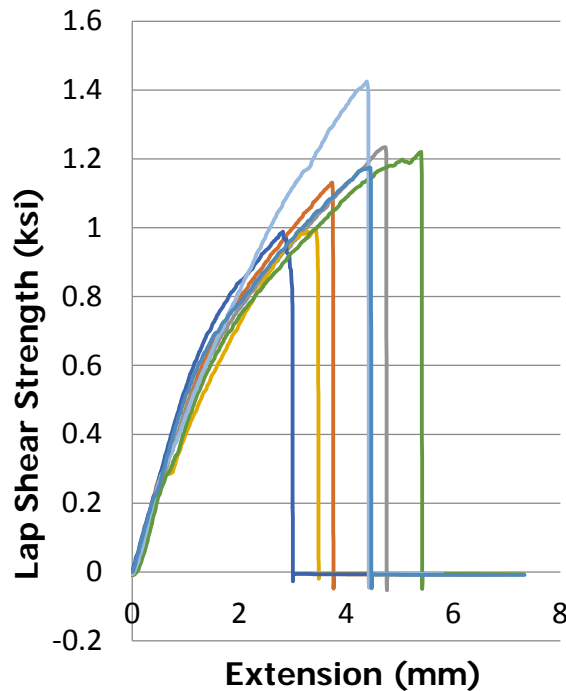
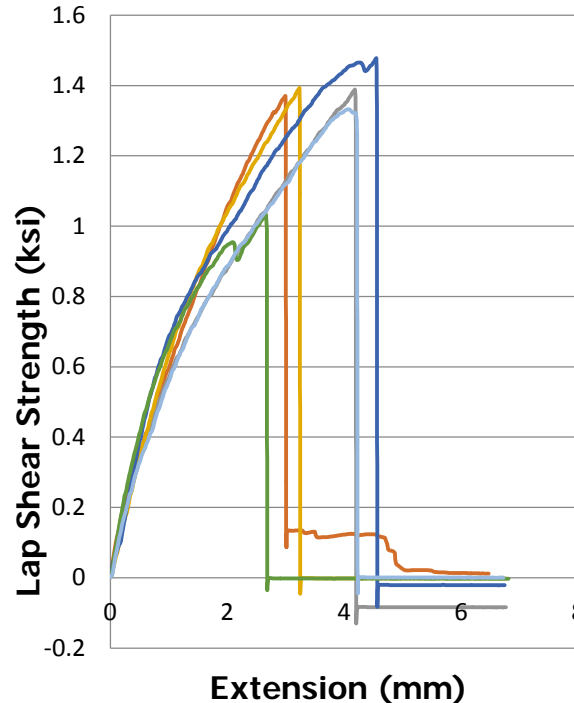
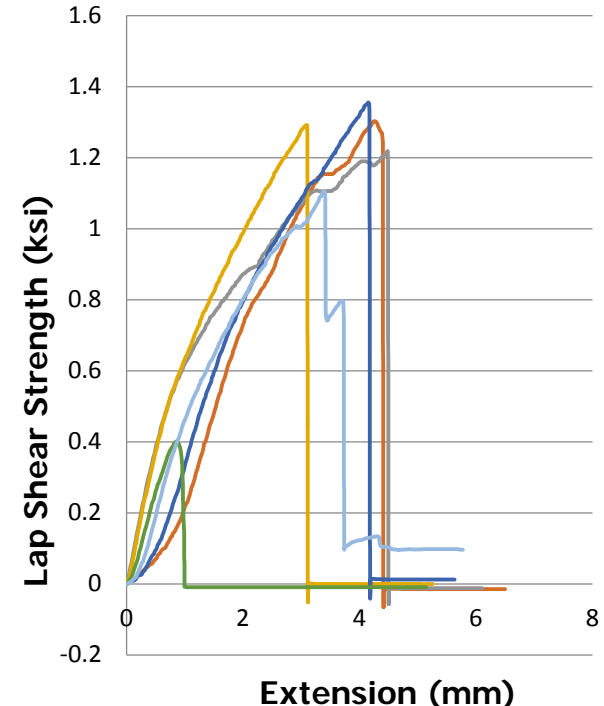
Lap Shear Test

(Impregnated Composite Liner – 6 in. CI Pipe)
(Individual Results)

Field Aged: FA
(Bonded)

Field + Mechanically
Aged: FMA
(Bonded) No. 1

Field + Mechanically
Aged: FMA
(Bonded) No. 2

FA = Field aged for 16 yrs

MA = Mechanically aged @ Cornell (equivalent to 100 yrs of traffic and 100 yrs of thermal cycling)

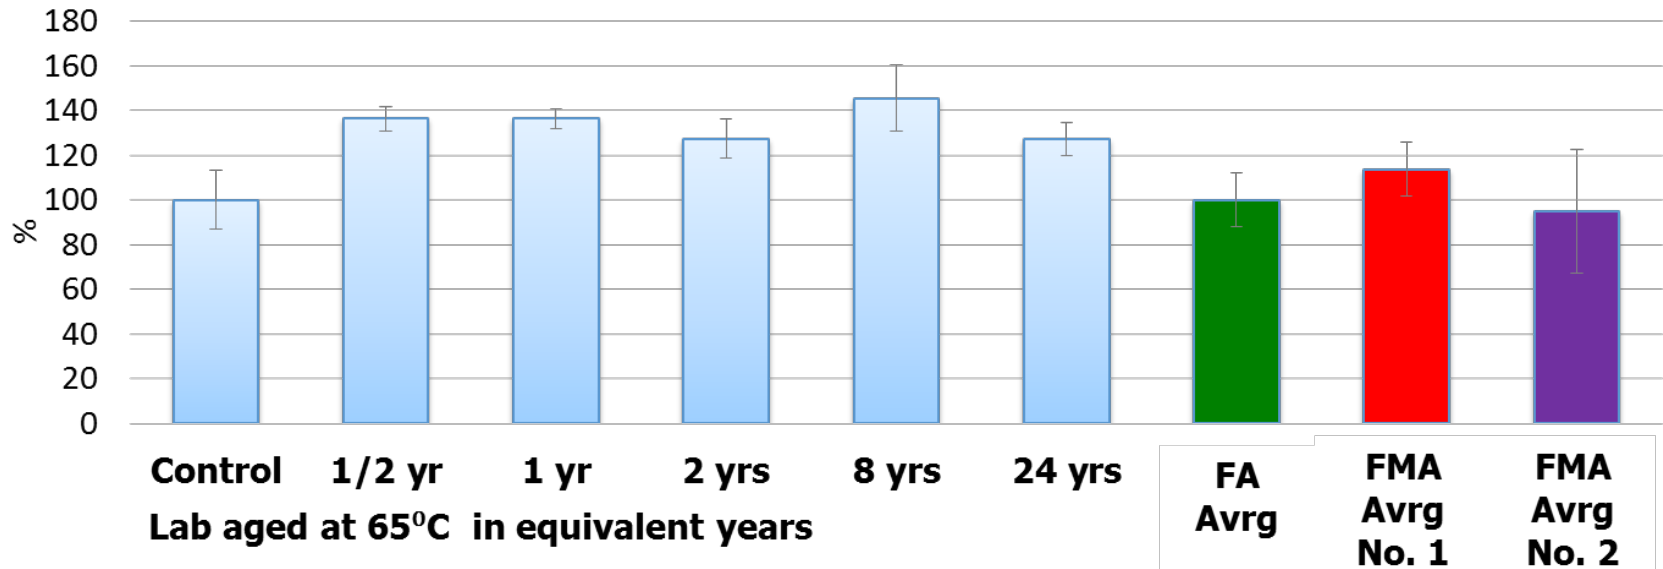
Lap Shear Test

(Impregnated Composite Liner FA and Bonded FMA – 6 in. CI Pipe comparison)

Control	48 weeks	Average 6 in. Pipe (FA)	Average 6 in. Pipe (FMA) Bonded No. 1	Average 6 in. Pipe (FMA) Bonded No. 2
ksi	1.1	1.4	1.17	1.33	1.11
%CV	13.2	5.7	11.91	10.56	29.41

No change is seen after mechanical aging at Cornell University

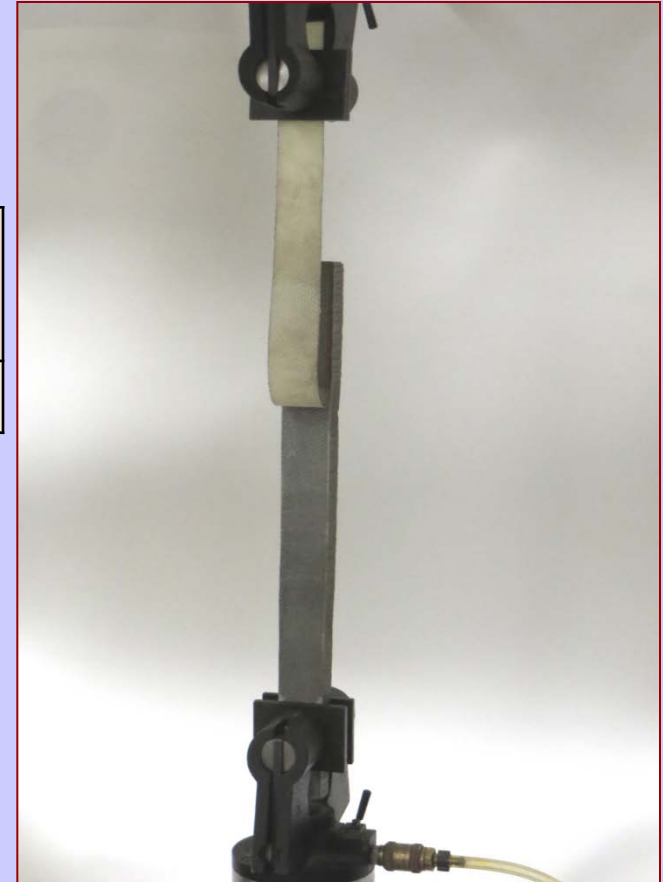
Peel Test in Longitudinal Direction

(Impregnated Composite Liner– 6 in. CI Pipe)

Secondary Test for Adhesion

Test parameters

Gauge Length (mm)	Crosshead Speed (mm/min)	Width (mm)	Thickness (mm)	Length (mm)
260	150	25.4	~ 1.25	300

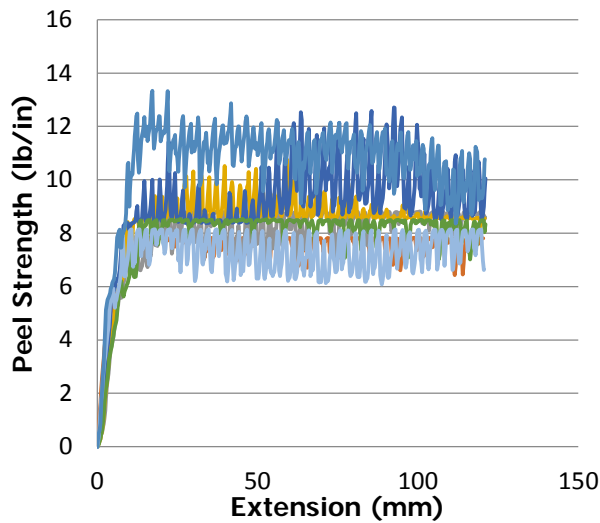
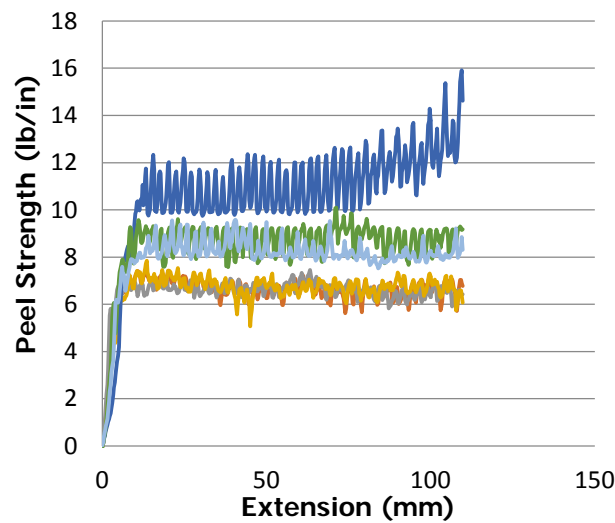
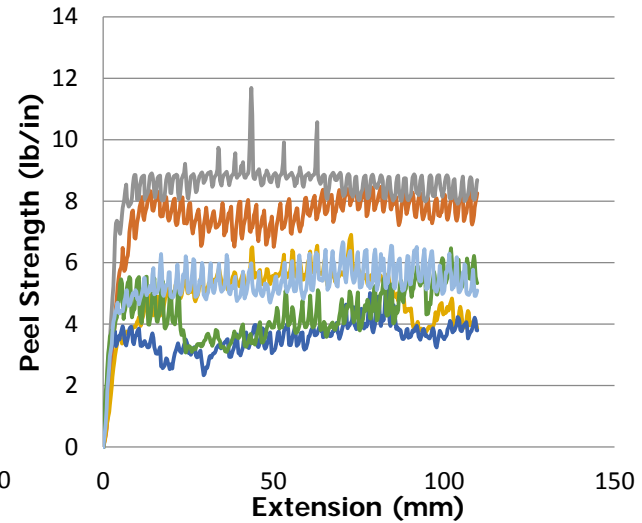
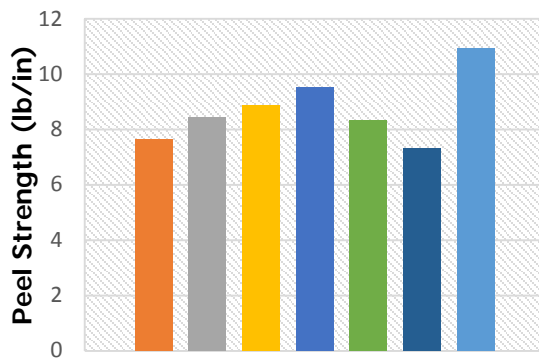
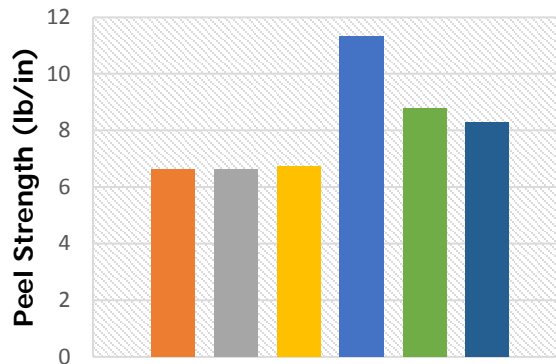
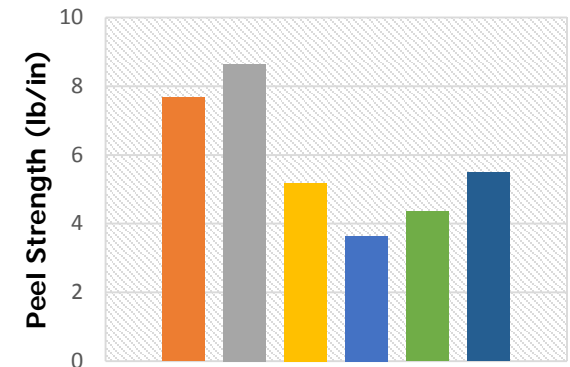
Peel Test in Longitudinal Direction

(Individual Results)

Field Aged: FA
(Bonded)

Field + Mechanically
Aged: FMA
(Bonded) No. 1

Field + Mechanically
Aged: FMA
(Bonded) No. 2

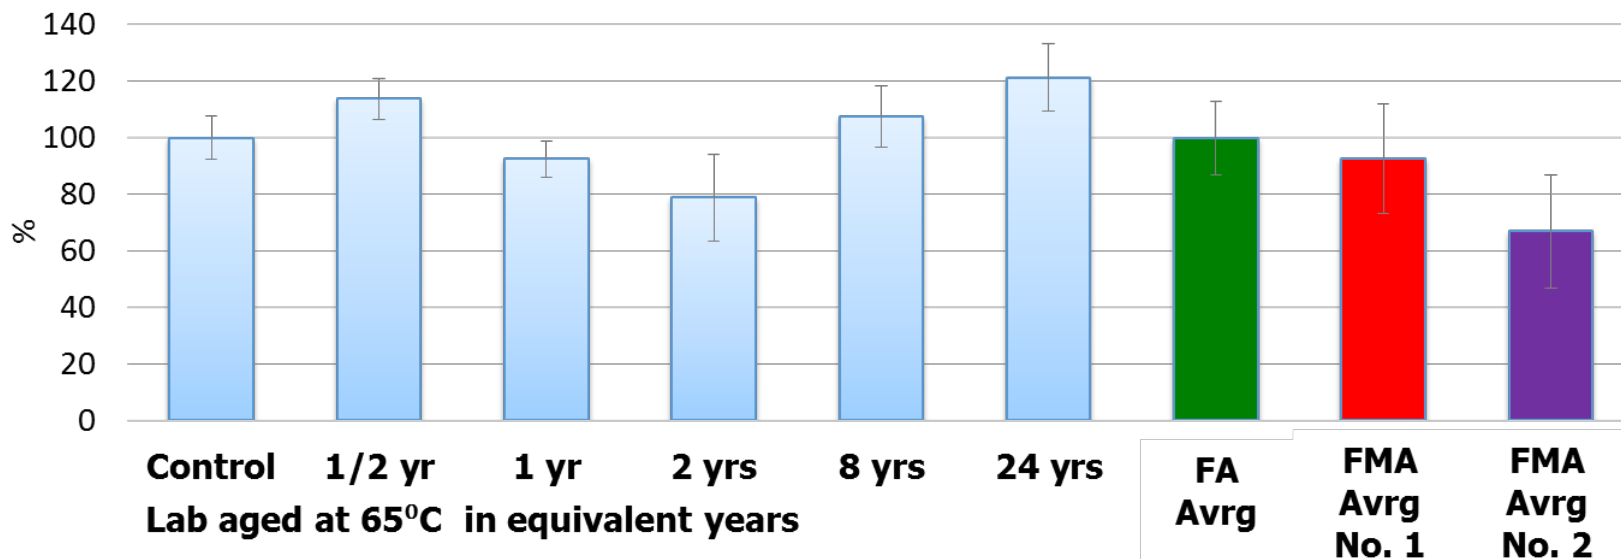
Peel Test in Longitudinal Direction

(Impregnated Composite Liner FA and Bonded FMA – 6 in. CI Pipe comparison)

Control	48 weeks	Average 6 in. Pipe (FA)	Average 6 in. Pipe (FMA) Bonded No. 1	Average 6 in. Pipe (FMA) Bonded No. 2
ksi	8	9.7	8.72	8.06	5.83
%CV	7.6	9.9	12.96	21.01	30.08

Small change is seen after mechanical aging at Cornell University
 - **Large inherent variation**

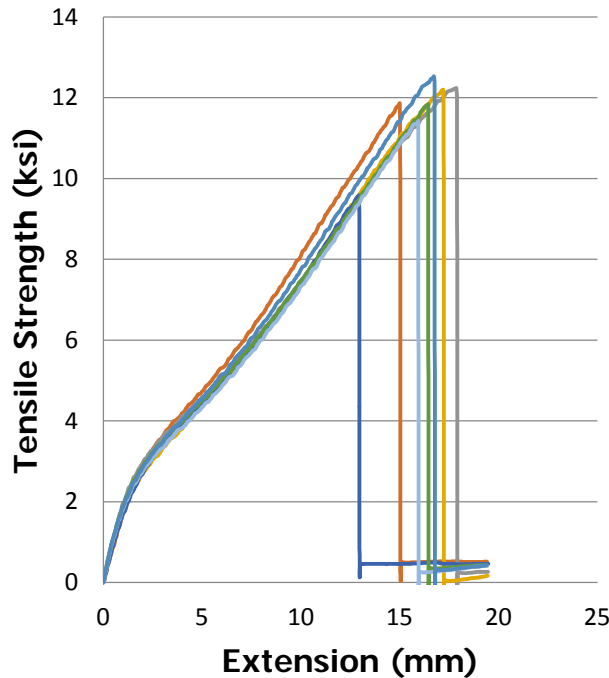
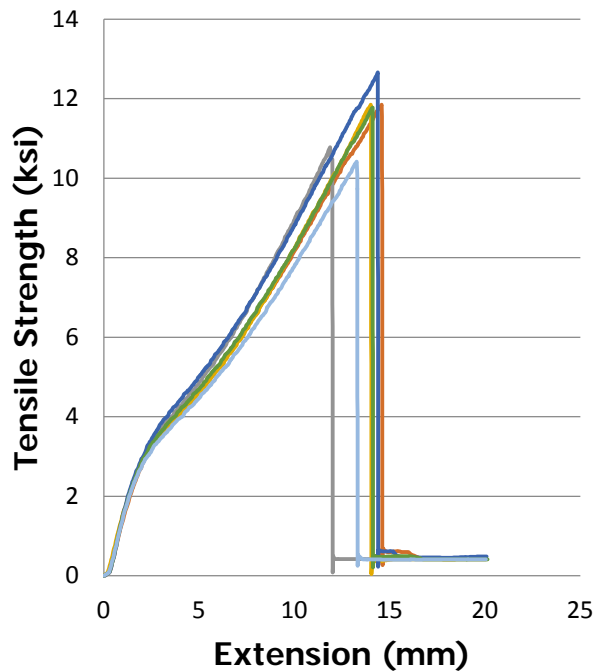
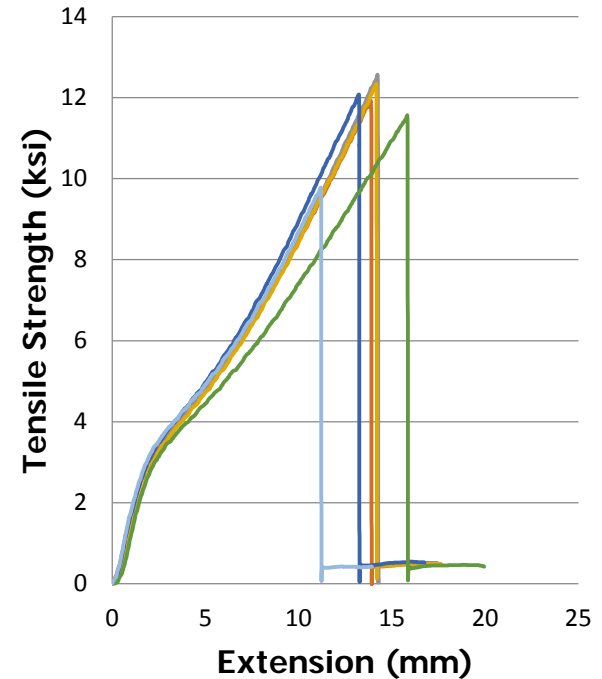
Composite Liner Tension Test

Longitudinal Direction

(Impregnated Composite Liner – 12 in. CI Pipe)

Field Aged: FA
(Bonded)

Field + Mechanically
Aged: FMA
(De-Bonded) No. 1

Field + Mechanically
Aged: FMA
(De-Bonded) No. 2

FA = Field aged for 11 yrs

MA = Mechanically aged @ Cornell (equivalent to 100 yrs of traffic and 100 yrs of thermal cycling)

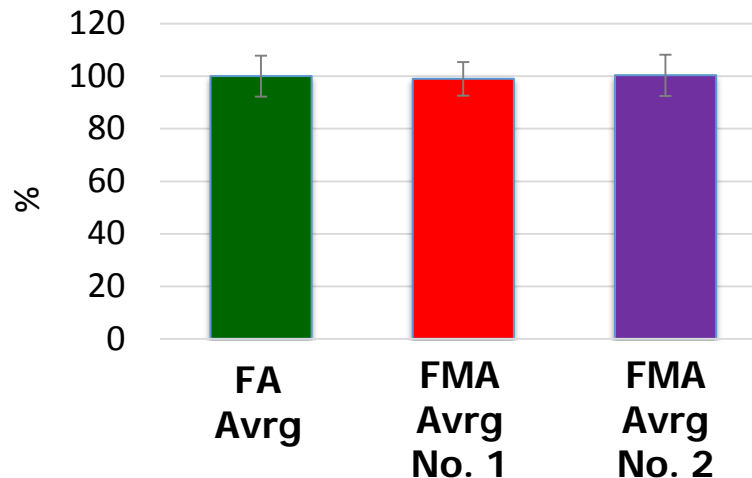
Composite Liner Tension Test in Longitudinal Direction

(Impregnated Composite Liner FA and De-Bonded FMA – 12 in. CI Pipe comparison)

Average 12 in. Pipe (FA)	Average 12 in. Pipe (FMA) De-Bonded No. 1	Average 12 in. Pipe (FMA) De-Bonded No. 2
ksi	11.67	11.55	11.71
%CV	7.82	6.45	7.84

No change is seen after mechanical aging at Cornell University

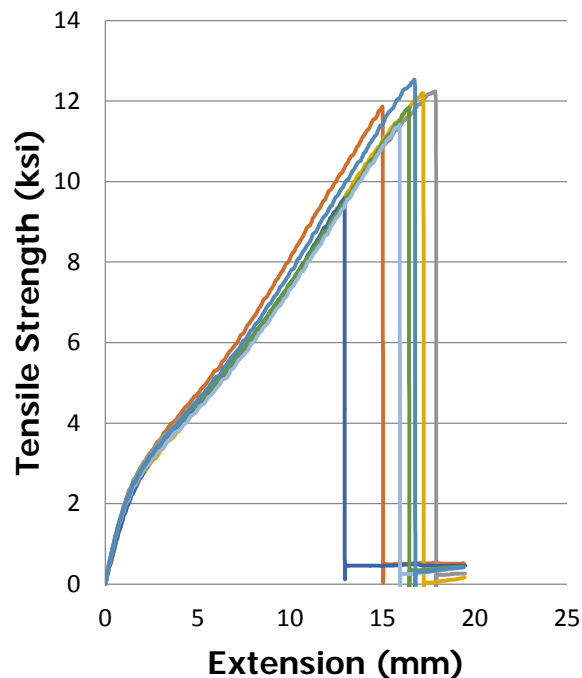
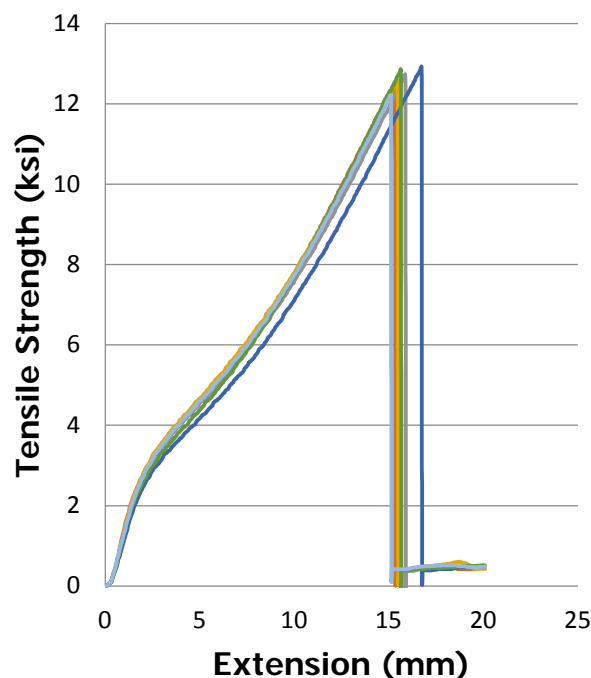
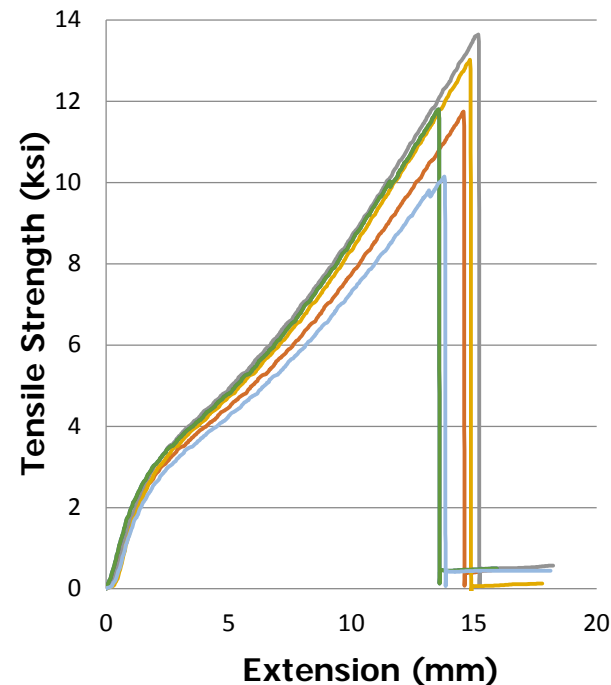
Composite Liner Tension Test in Longitudinal Direction

(Impregnated Composite Liner – 12 in. CI Pipe)

Field Aged: FA
(Bonded)

Field + Mechanically
Aged: FMA
(Bonded) No. 1

Field + Mechanically
Aged: FMA
(Bonded) No. 2

FA = Field aged for 11 yrs

MA = Mechanically aged @ Cornell (equivalent to 100 yrs of traffic and 100 yrs of thermal cycling)

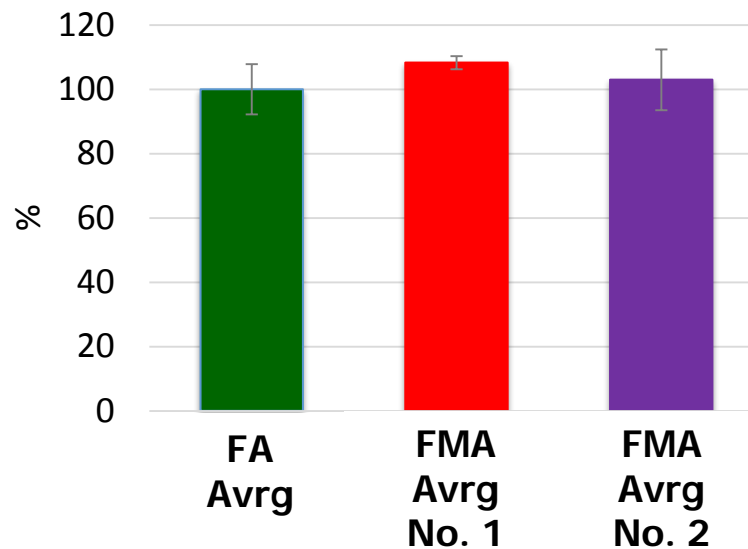
Composite Liner Tension Test Longitudinal Direction

(Impregnated Composite Liner FA and Bonded-FMA – 12 in. CI Pipe comparison)

Average 12 in. Pipe (FA)	Average 12 in. Pipe (FMA) Bonded No. 1	Average 12 in. Pipe (FMA) Bonded No. 2
ksi	11.67	12.64	12.02
%CV	7.82	1.86	9.19

No change is seen after mechanical aging at Cornell University

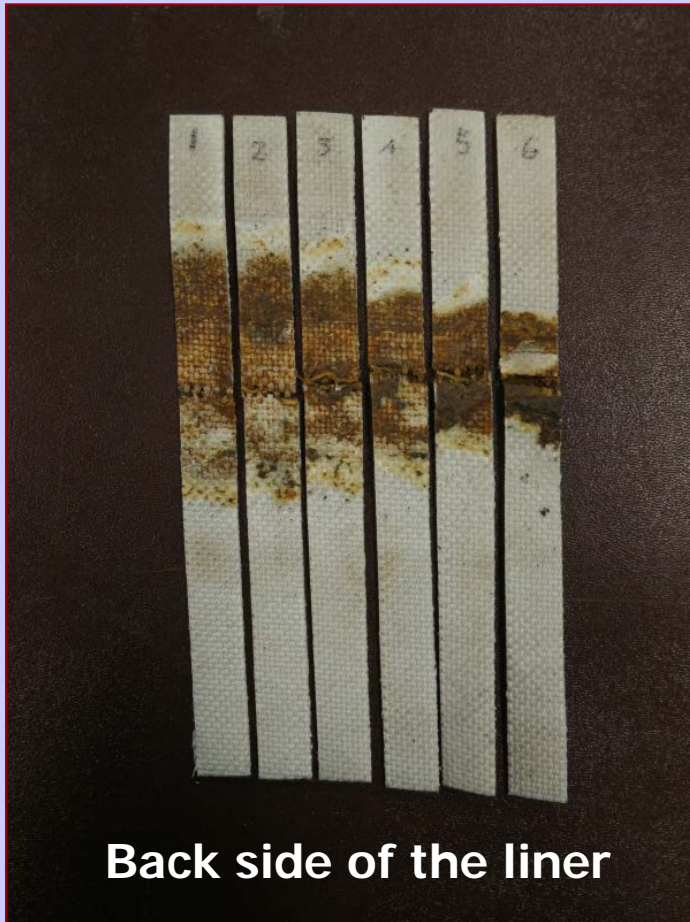
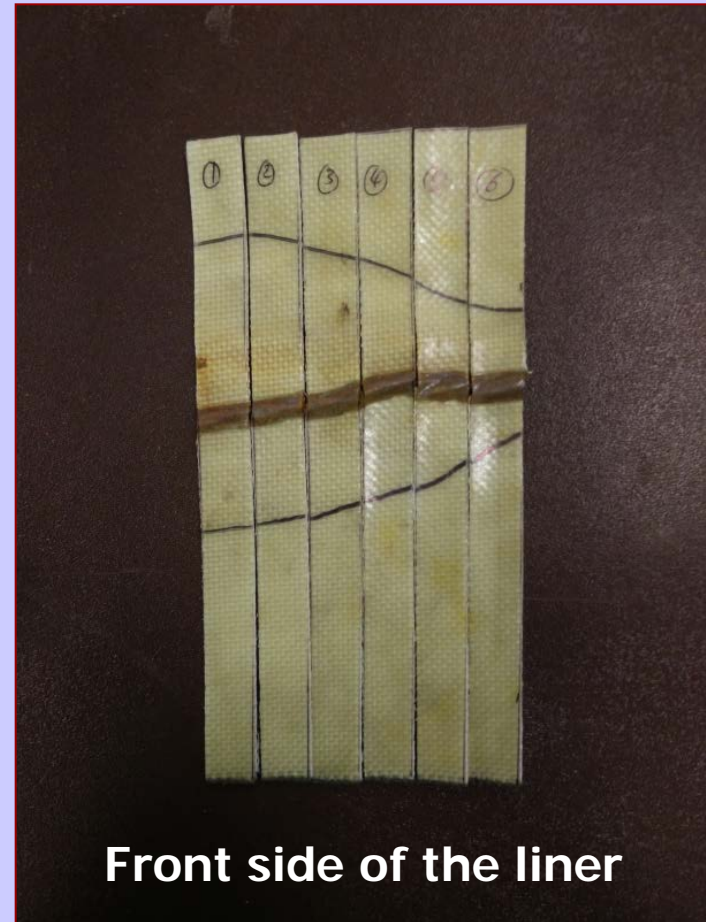
Composite Liner Tension Test in Longitudinal Direction for Partially Damaged Section

(Impregnated Composite Liner – 12 in. CI Pipe)

Back side of the liner

Front side of the liner
