Test Results for the Field Aged & Mechanically Aged Composite Liner System

Starline® 2000

Xia Zeng and Anil N. Netravali

Cornell University

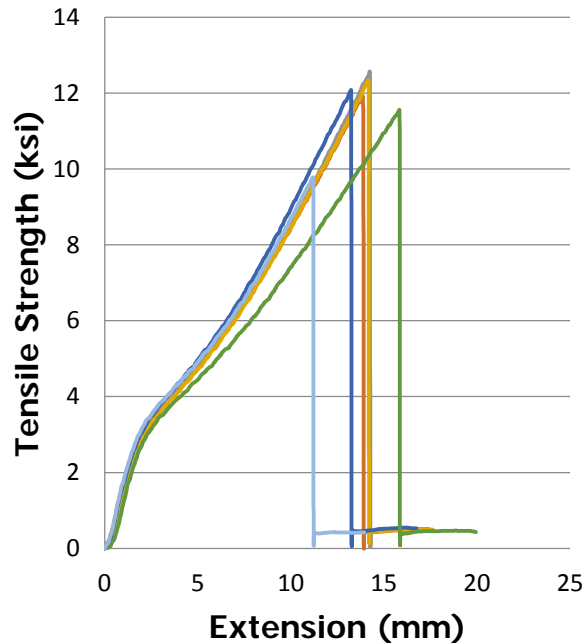
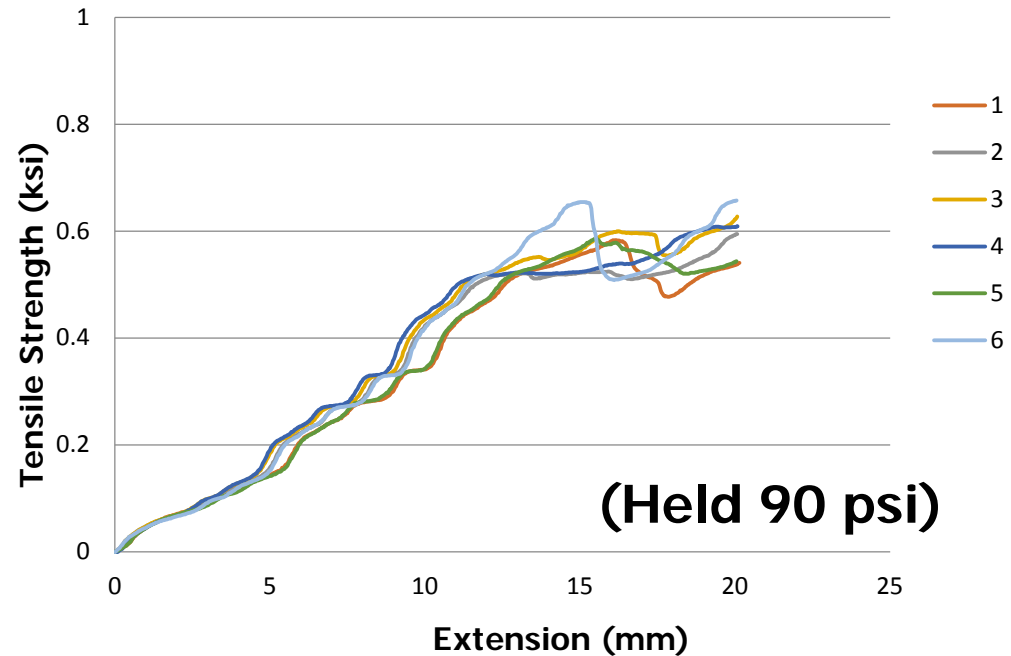
Composite Liner Tension Test in Longitudinal Direction for Partially Damaged Section

(Impregnated Composite Liner – 12 in. CI Pipe)

Field + Mechanically
Aged: FMA (De-Bonded)
12 in. pipe No. 2

Field + Mechanically Aged:
FMA (De-Bonded) 12 in. pipe
No. 2 **Damaged Section***

*Plots indicate the properties of the PU membrane

Conclusion: Liner tensile strength is not affected by 100 years mechanical aging for 6-in. pipe specimens. Local strength reduction for 12-in. pipe specimens.

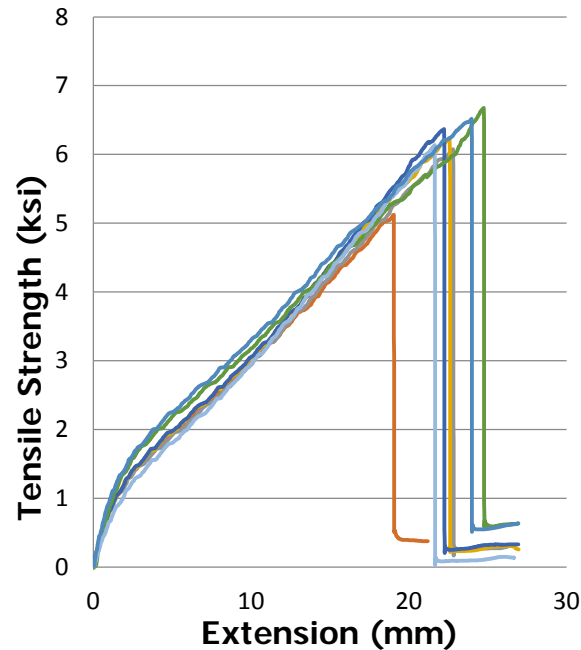
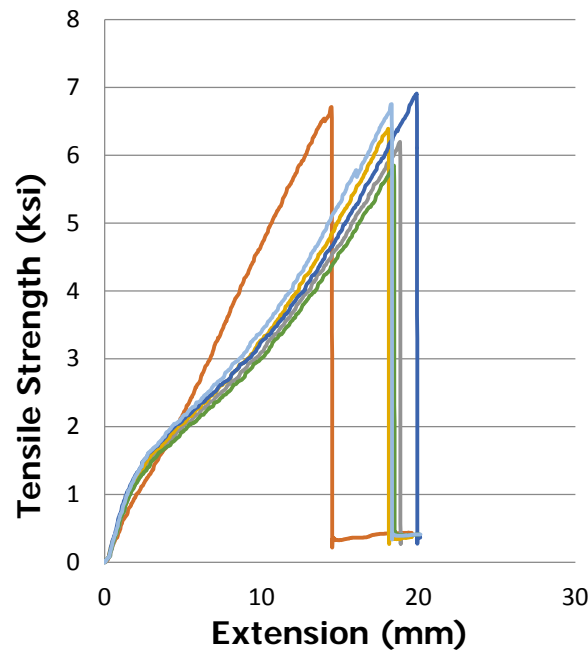
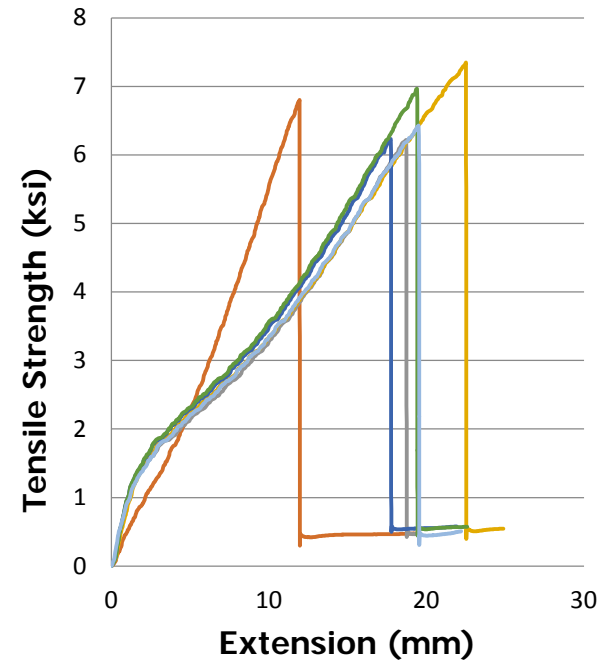
Composite Liner Tension Test Transverse Direction

(Impregnated Composite Liner – 12 in. CI Pipe)

Field Aged: FA
(Bonded)

Field + Mechanically
Aged: FMA
(Bonded) No. 1

Field + Mechanically
Aged: FMA
(Bonded) No. 2

FA = Field aged for 11 yrs

FMA = Mechanically aged @ Cornell (equivalent to 100 yrs of traffic and 100 yrs of thermal cycling)

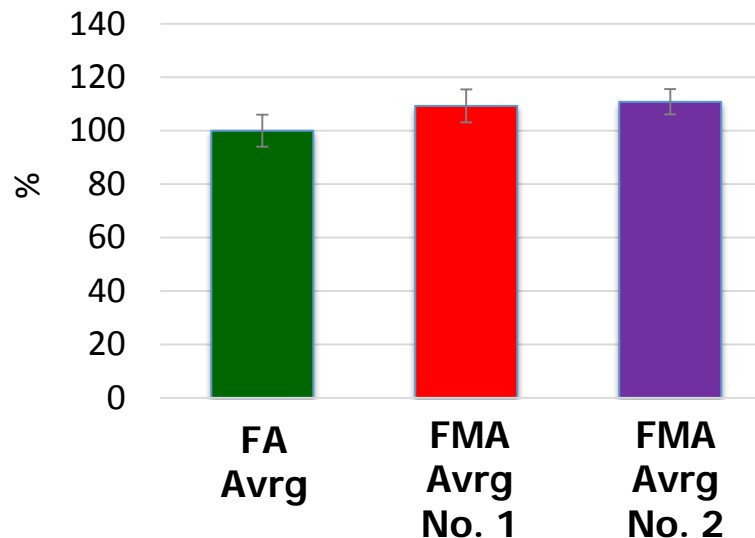
Composite Liner Tension Test Transverse Direction

(Impregnated Composite Liner FA and Bonded FMA – 12 in. CI Pipe comparison)

Average 12 in. Pipe (FA)	Average 12 in. Pipe (FMA) Bonded No. 1	Average 12 in. Pipe (FMA) Bonded No. 2
ksi	5.92	6.47	6.56
%CV	6	5.63	4.3

No change is seen after mechanical aging at Cornell University

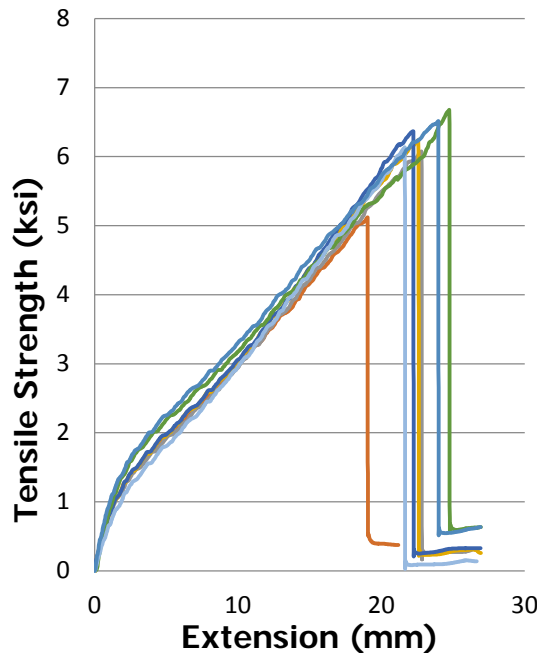
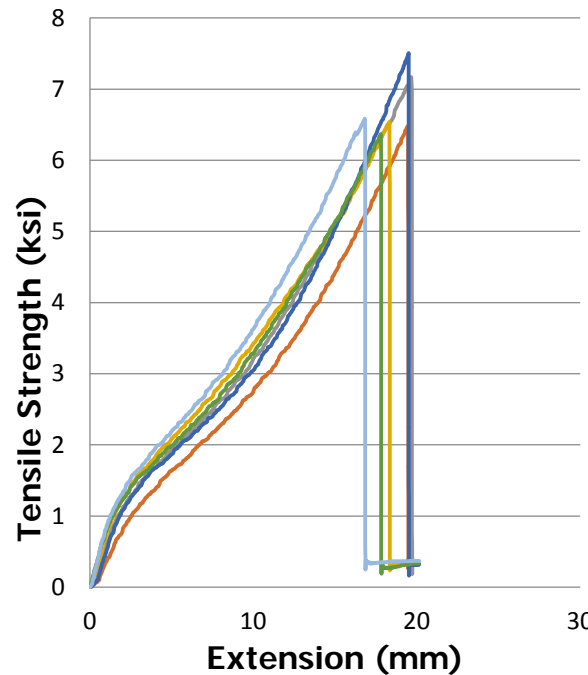
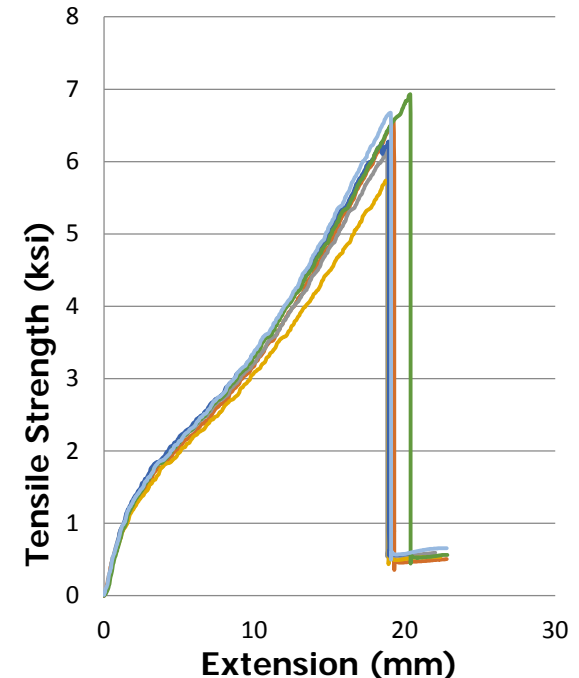
Composite Liner Tension Test Transverse Direction

(Impregnated Composite Liner – 12 in. CI Pipe)

Field Aged: FA
(Bonded)

Field + Mechanically
Aged: FMA
(De-Bonded) No. 1

Field + Mechanically
Aged: FMA
(De-Bonded) No. 2

FA = Field aged for 11 yrs

FMA = Mechanically aged @ Cornell (equivalent to 100 yrs of traffic and 100 yrs of thermal cycling)

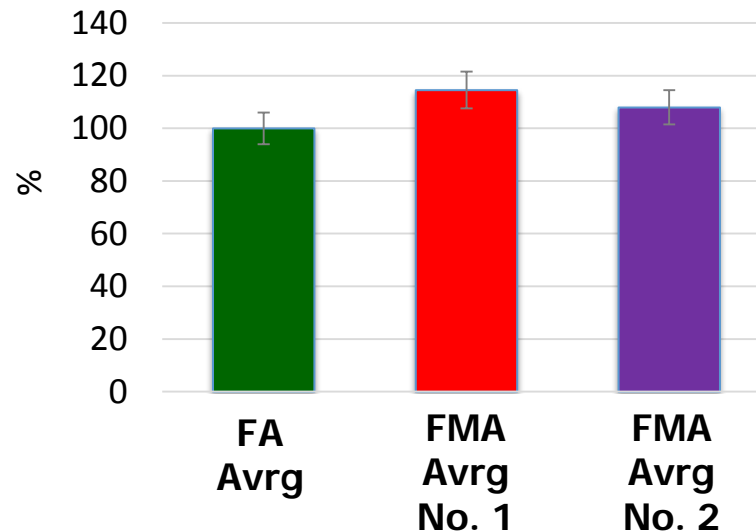
Composite Liner Tension Test Transverse Direction

(Impregnated Composite Liner FA and De-Bonded FMA – 12 in. CI Pipe comparison)

Average 12 in. Pipe (FA)	Average 12 in. Pipe (FMA) De-Bonded No. 1	Average 12 in. Pipe (FMA) De-Bonded No. 2
ksi	5.92	6.78	6.39
CV %	6	6.14	6

No change is seen after mechanical aging at Cornell University

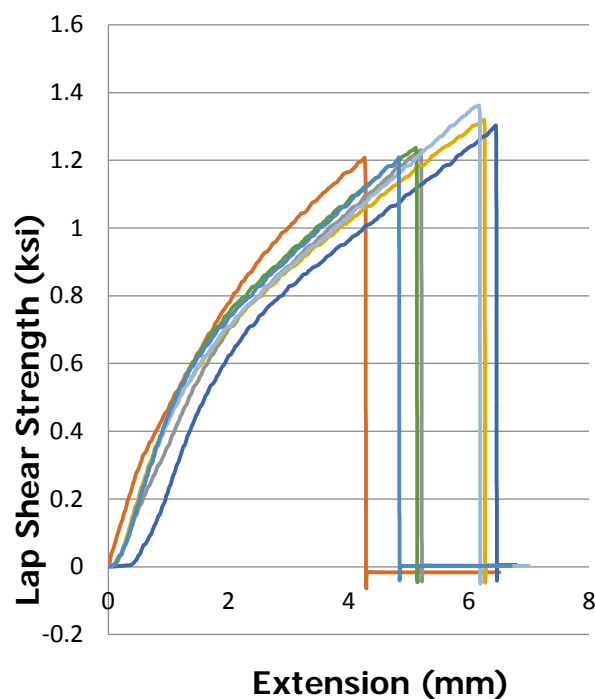
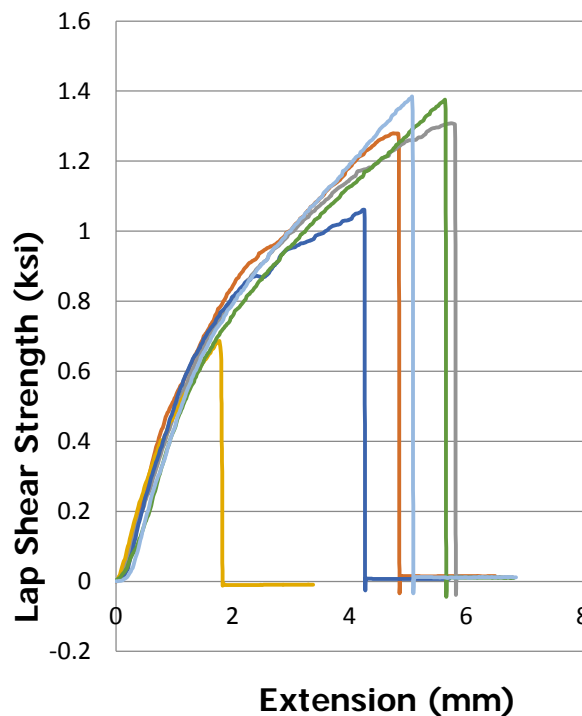
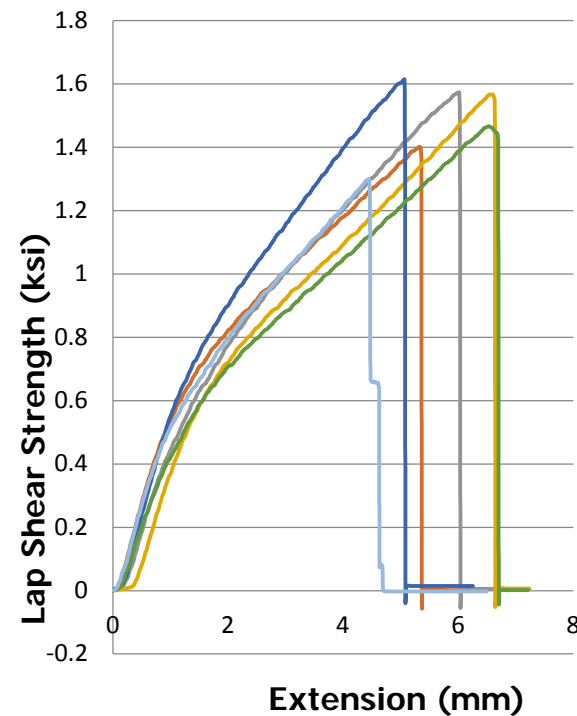
Lap Shear Test

(Impregnated Composite Liner – 12 in. CI Pipe)
(Individual Results)

**Field Aged: FA
(Bonded)**

**Field + Mechanically
Aged: FMA
(Bonded) No. 1**

**Field + Mechanically
Aged: FMA
(Bonded) No. 2**

FA = Field aged for 11 yrs

FMA = Mechanically aged @ Cornell (equivalent to 100 yrs of traffic and 100 yrs of thermal cycling)

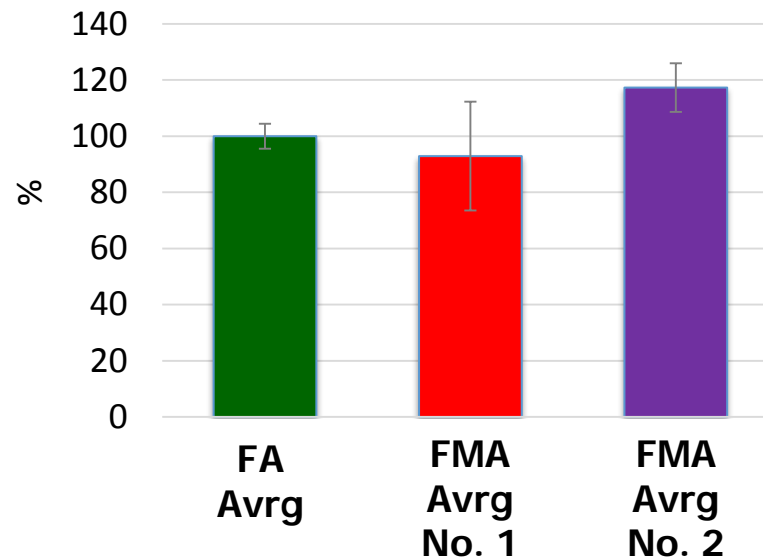
Lap Shear Test

(Impregnated Composite Liner FA and Bonded FMA – 12 in. CI Pipe comparison)

Control	16 weeks	Average 12 in. Pipe (FA)	Average 12 in. Pipe (FMA) Bonded No. 1	Average 12 in. Pipe (FMA) Bonded No. 2
ksi	1.1	1.6	1.27	1.18	1.49
%CV	13.2	10.1	4.46	20.82	7.4

No change is seen after mechanical aging at Cornell University

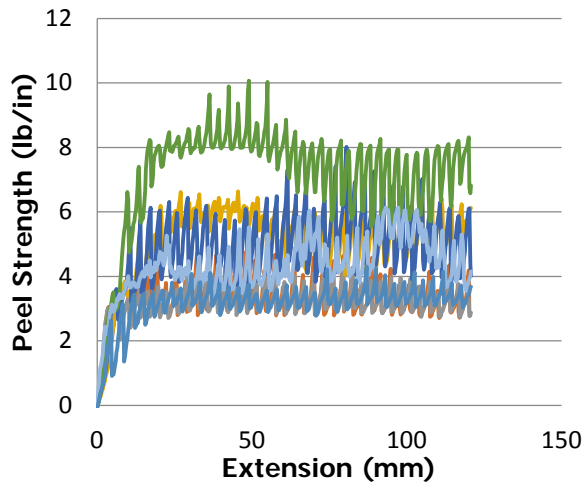
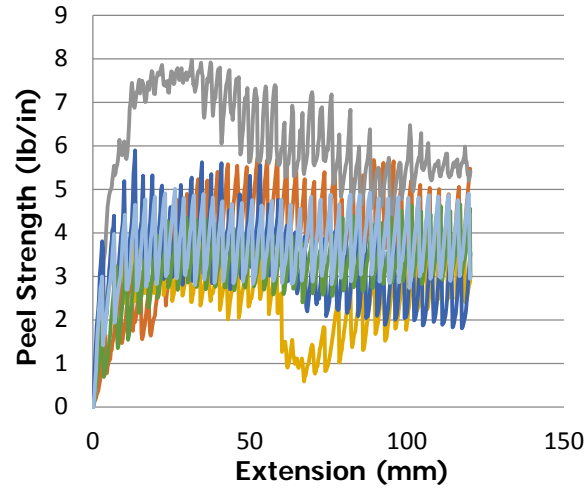
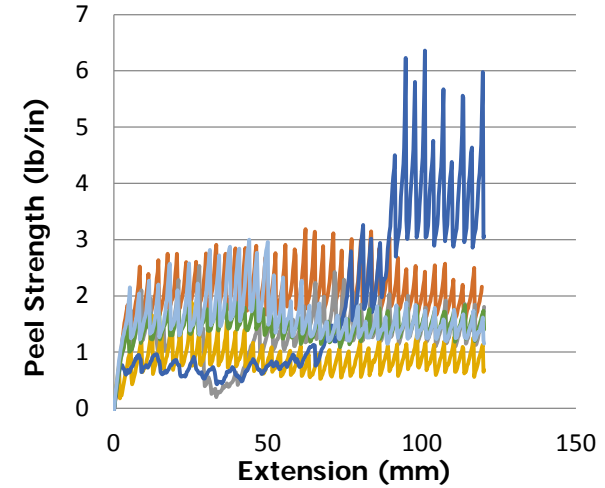
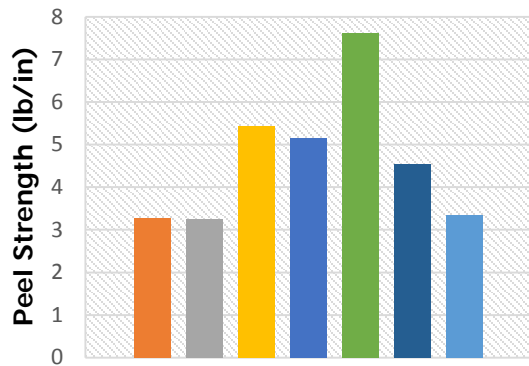
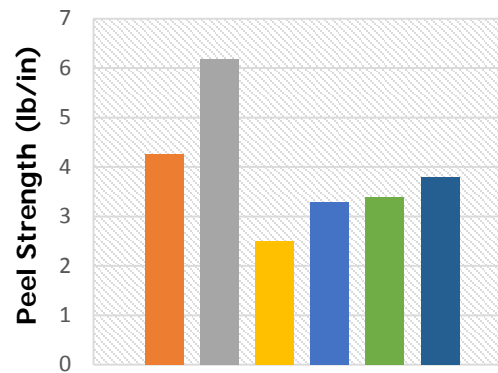
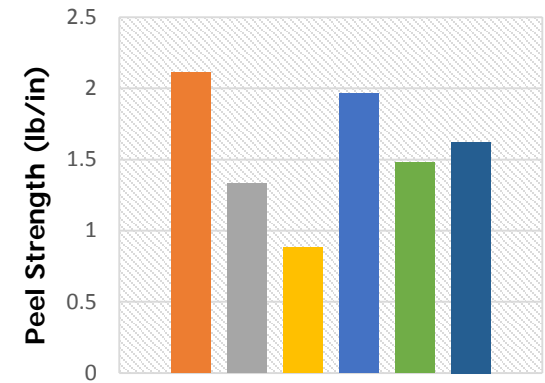
Peel Test in Longitudinal Direction

(Individual Results)

Field Aged: FA
(Bonded)

Field + Mechanically
Aged: FMA
(Bonded) No. 1

Field + Mechanically
Aged: FMA
(Bonded) No. 2

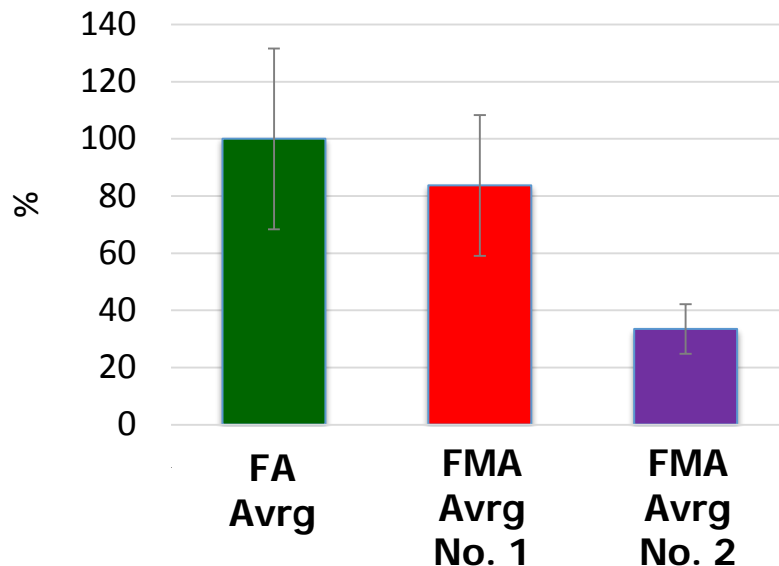
Peel Test in Longitudinal Direction

(Impregnated Composite Liner FA and Bonded FMA – 12 in. CI Pipe comparison)

Control	16 weeks	Average 12 in. Pipe (FA)	Average 12 in. Pipe (FMA) Bonded No. 1	Average 12 in. Pipe (FMA) Bonded No. 2
ksi	8	8.6	4.66	3.9	1.56
%CV	7.6	10	31.61	29.48	25.88

Small change is seen after mechanical aging at Cornell University
- Large inherent variation

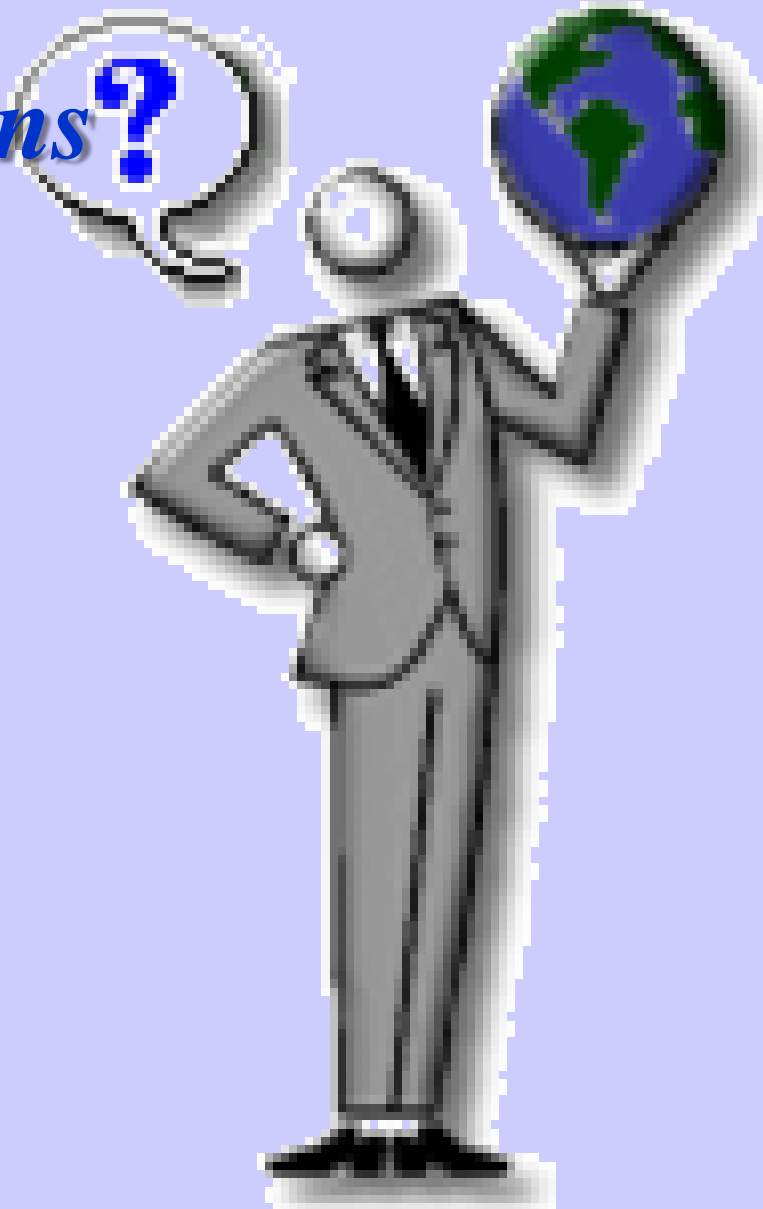
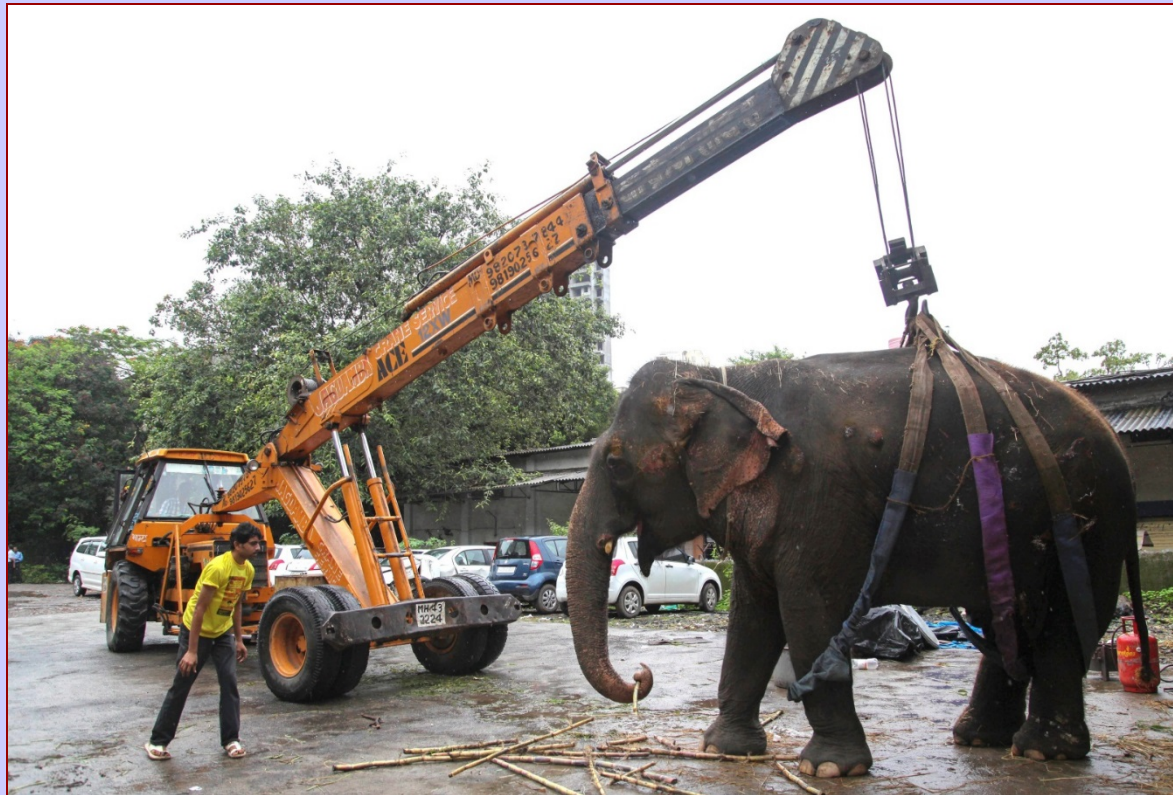
A single composite liner bonded to just 1" around the circumference of 6 in. pipe could lift a three 10,000 lb elephants without de-bonding
