CHENIERE ENERGY, INC.

Bolted Joint Integrity Program, Standards and Application

February 2020

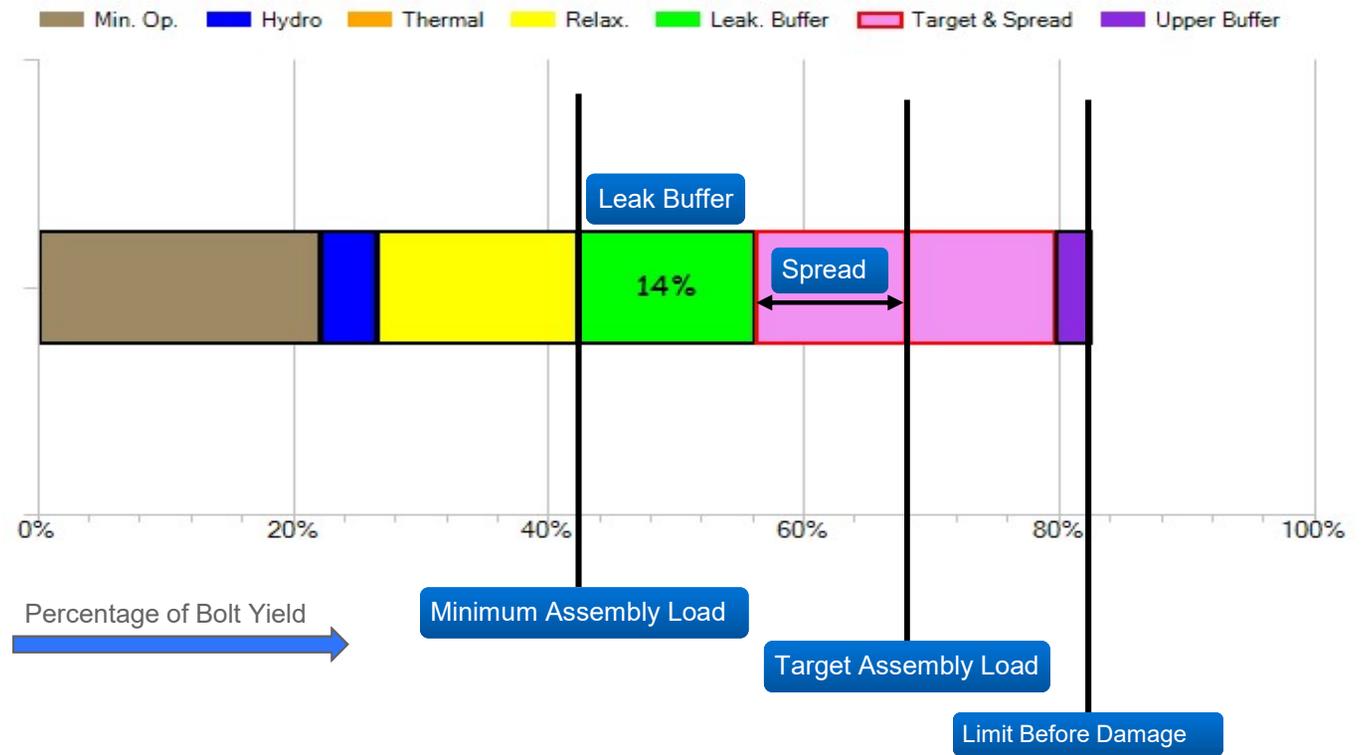
Appendix O Concept

10" 150# 304SS

- Torque: 270 ft-lbs
- Gasket Stress: 12.3 ksi
- Bolt Stress: 54.2 ksi
- Design Temp: -265°F
- Design Press: 150 psig

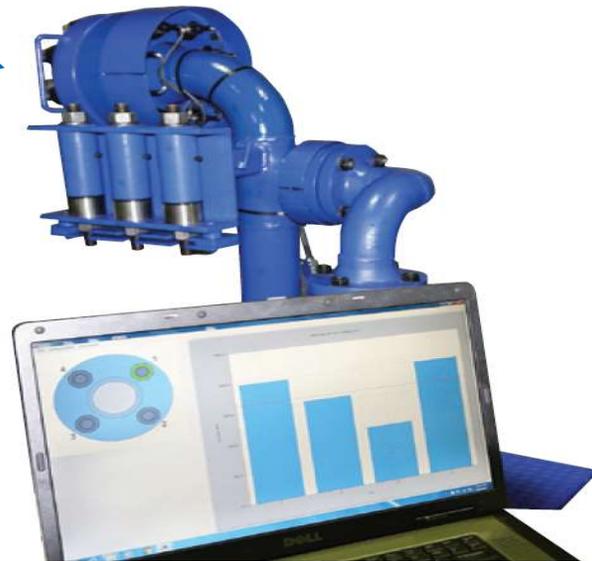
- Training program for all personnel involved with BFJ assembly
 - Appendix-A based competency qualification
- Utilize Demonstration of Effective Bolting (DEB)
 - Hands on learning tool
 - On-boarding of maintenance personnel
 - Before T/A's or major construction activities

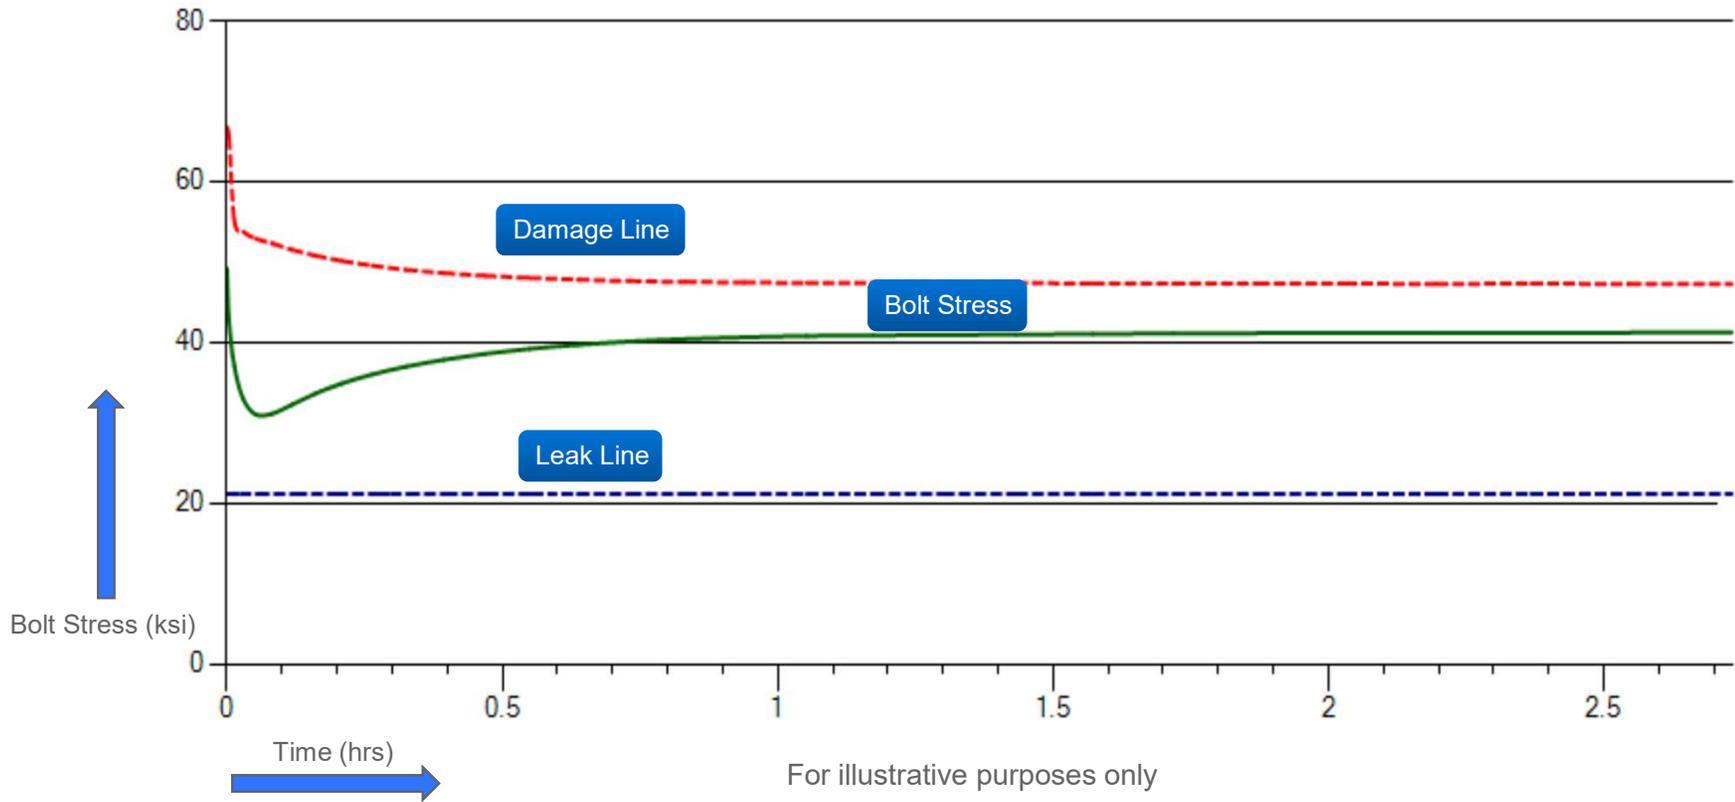
Thermal Transient Effects (70 to 405°F)

For illustrative purposes only

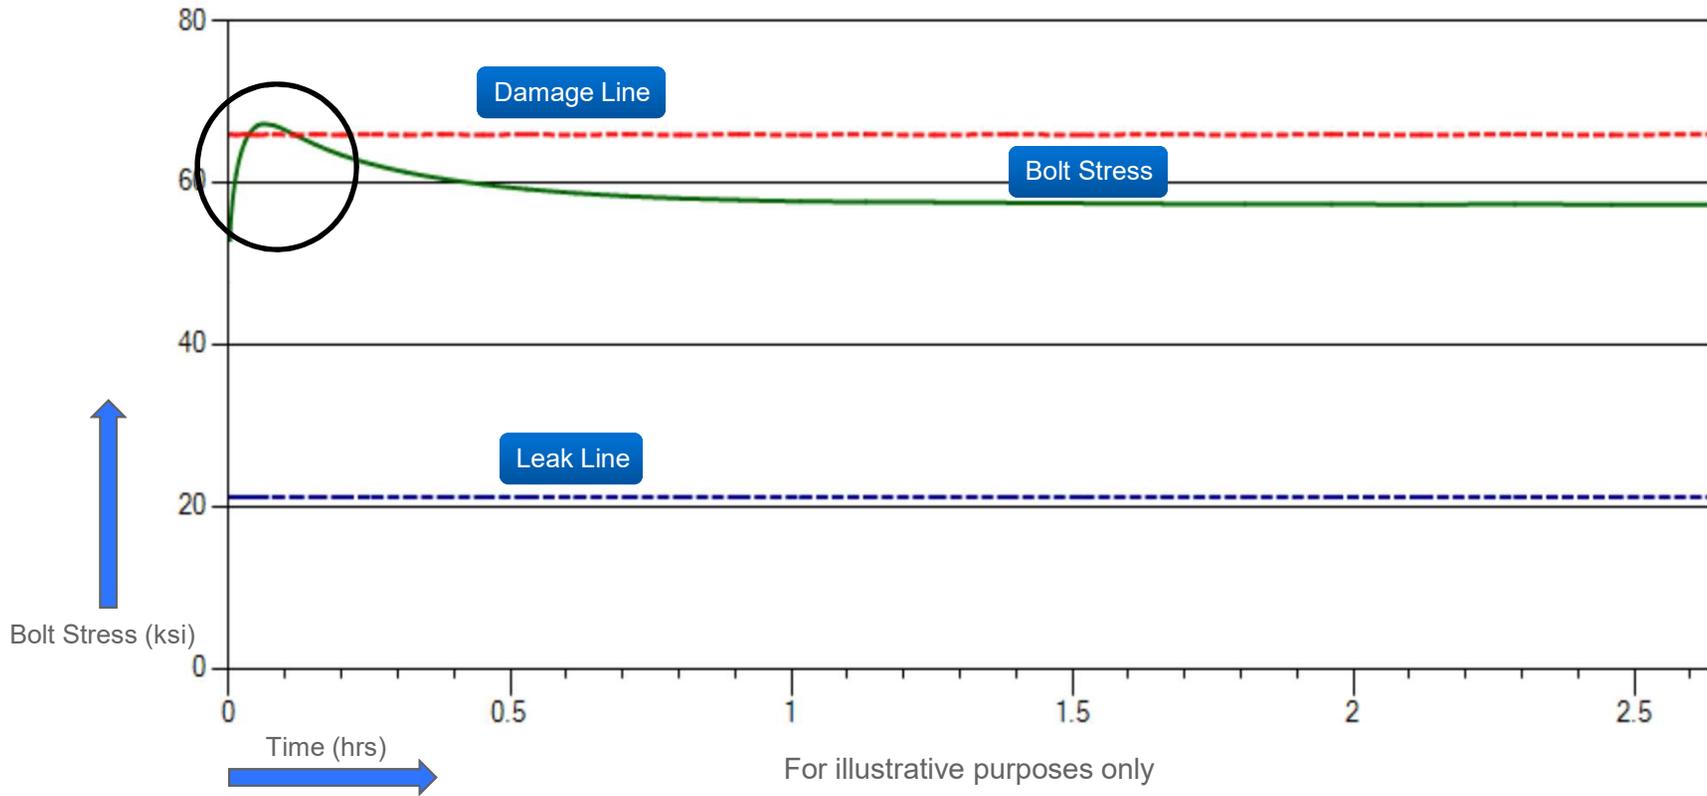
Thermal Transient Effects (70 to -265°F)

For illustrative purposes only

Cryogenic applications will benefit from further study

- Calculating thermal effects difficult without software
 - WRC 510 outlines methodology
- Accuracy of predicted flange rotation
- Boundary conditions – Need actual field data
 - Instrument flanges with strain gauges
- Cheniere is pursuing this with a view to improve bolted joint performance in cryogenic applications and share findings with the Industry.

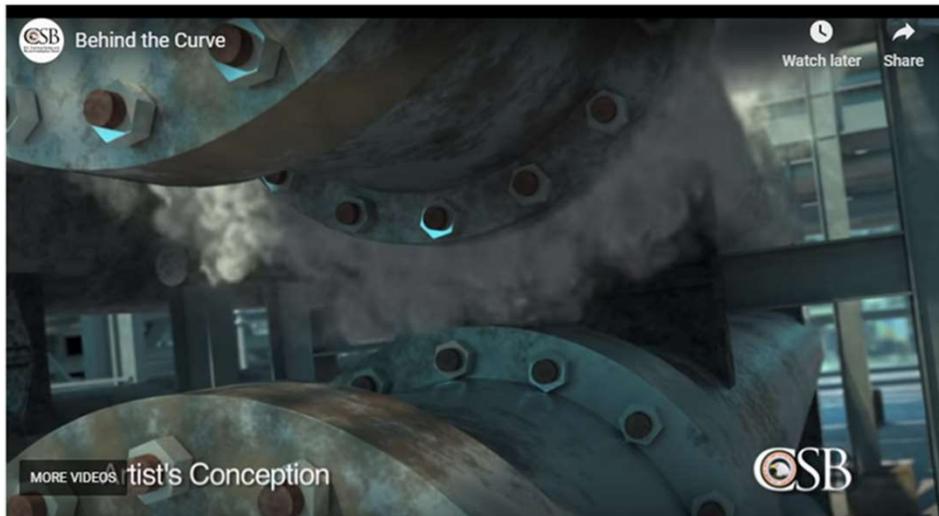
Tesoro Anacortes - 2010

Heat Exchanger Leak

- Personnel using steam lance to mitigate “bad actor” during startup
- Leaking flange not root cause, but placed personnel in close vicinity of the exchanger.
- Leaks treated as normal occurrences
- 7 fatalities
