# PHMSA R&D FORUM

Preventing and Mitigating Geo-Forces on Pipelines & Facilities

Pete Barlow

February 19, 2020

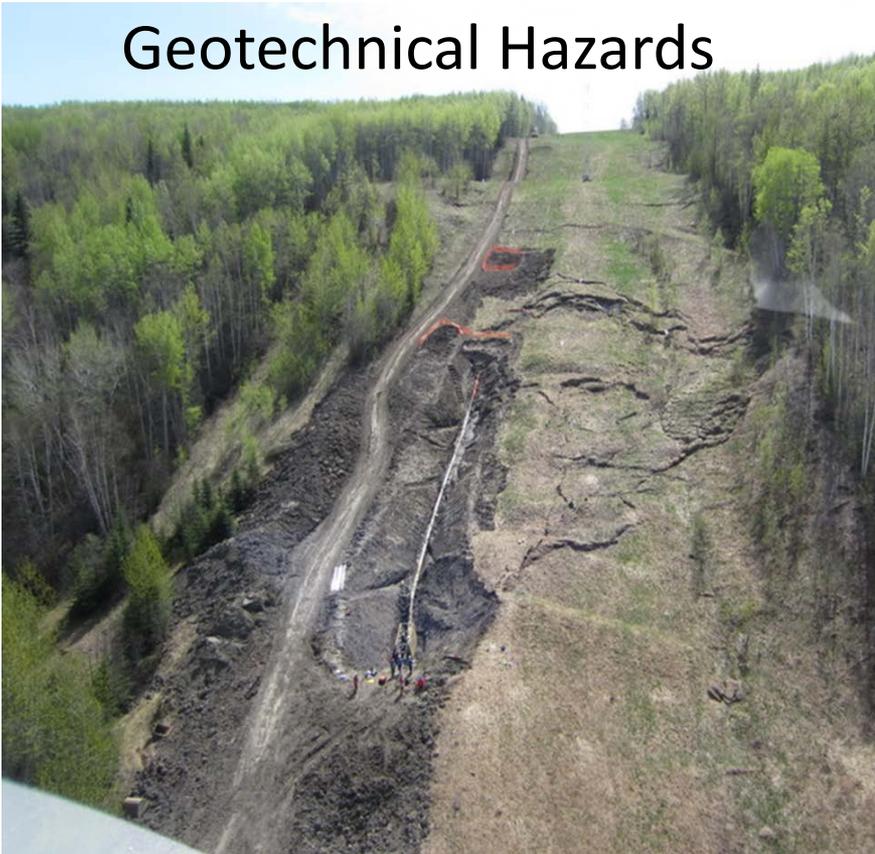
Geotechnical Hazards

Geotechnical hazards pose the most significant geohazard threats to pipeline integrity and are responsible for more ruptures & pipeline damage

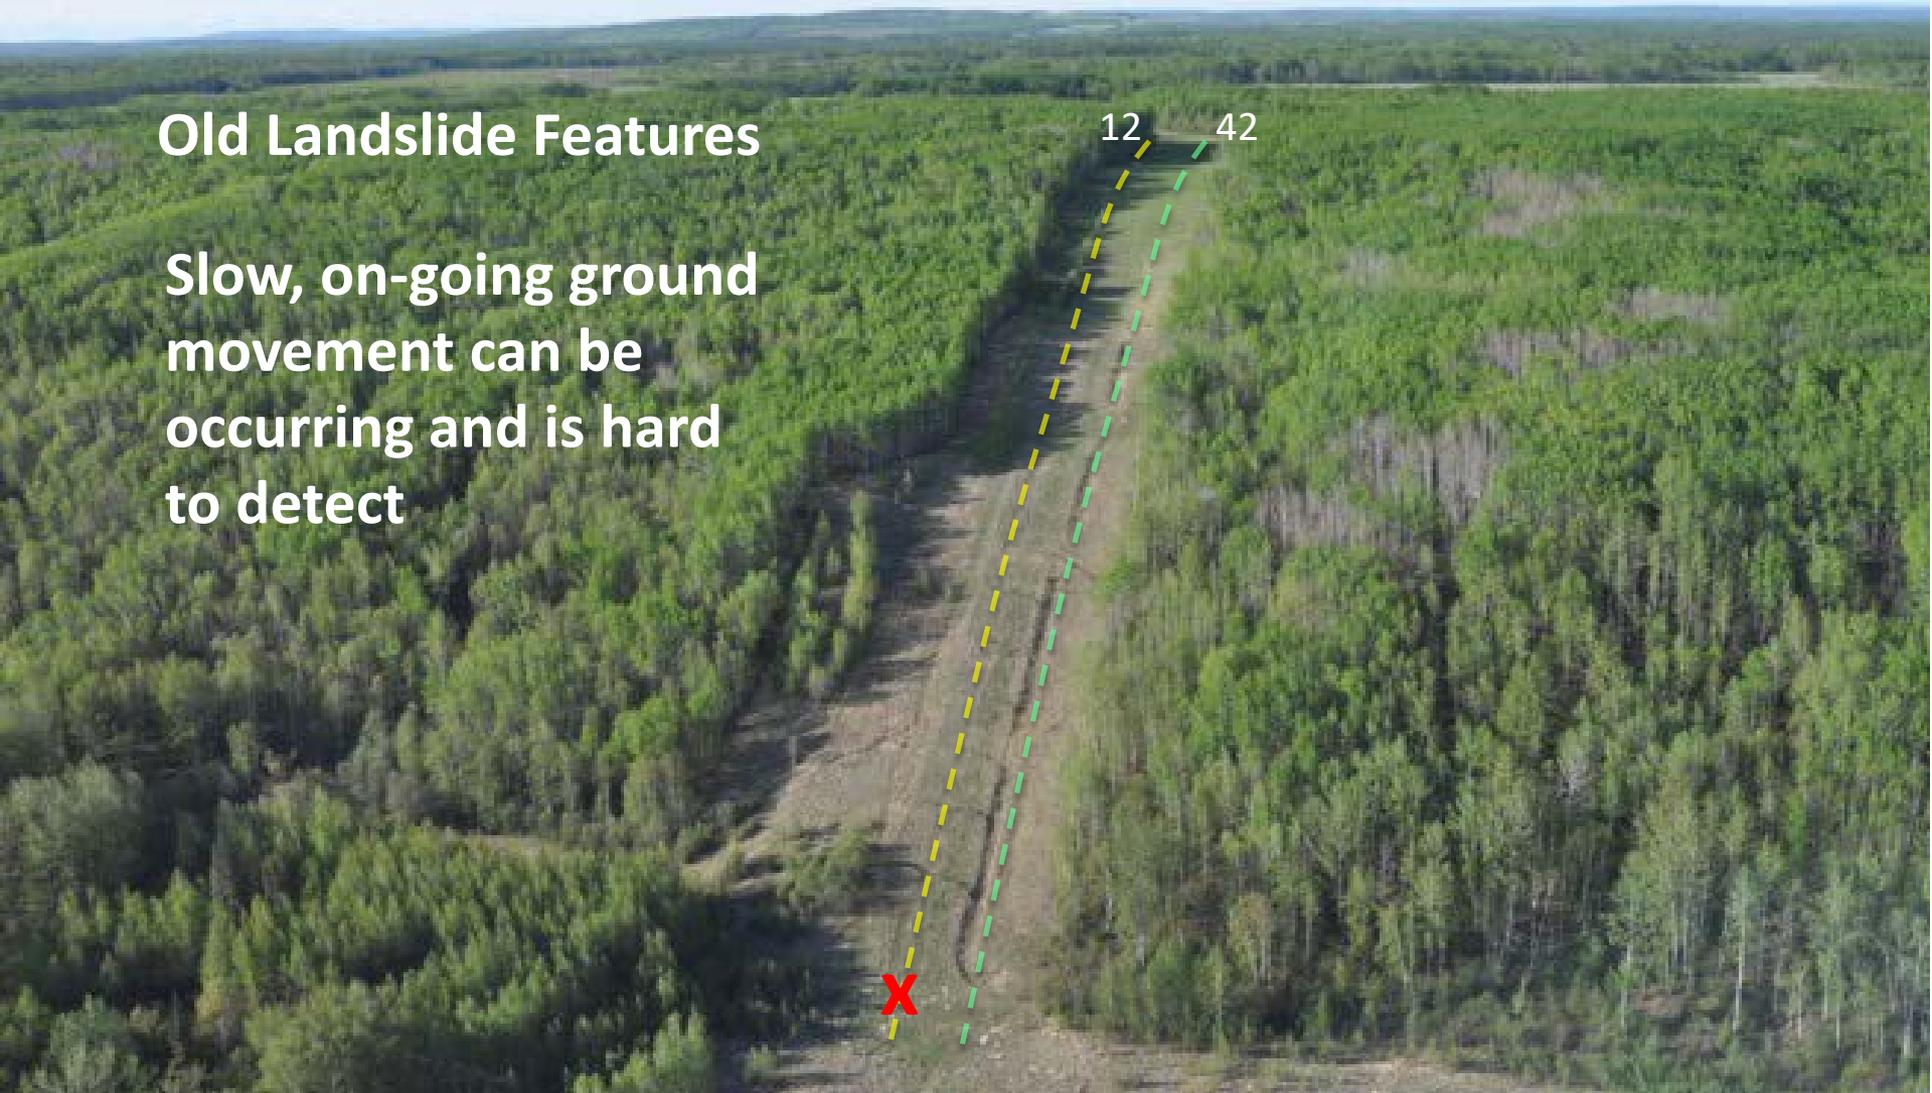
## Old Landslide Features

Slow, on-going ground movement can be occurring and is hard to detect

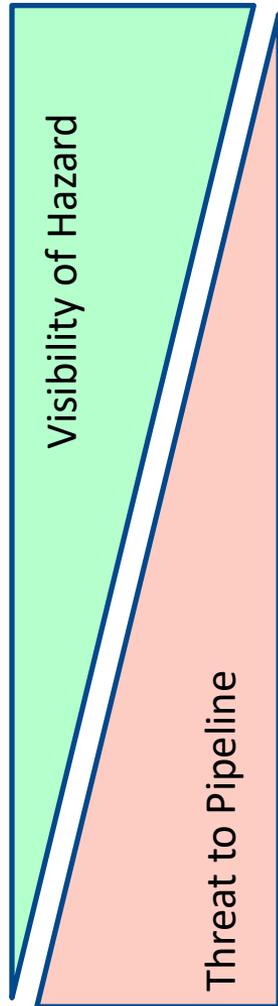
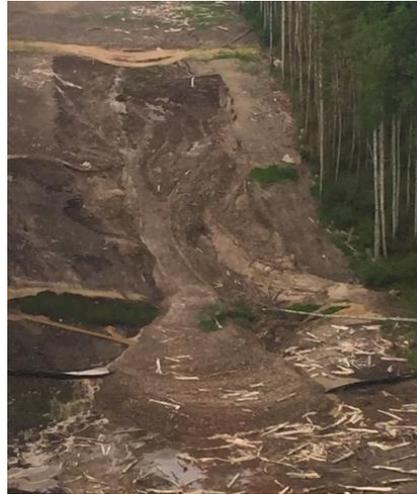
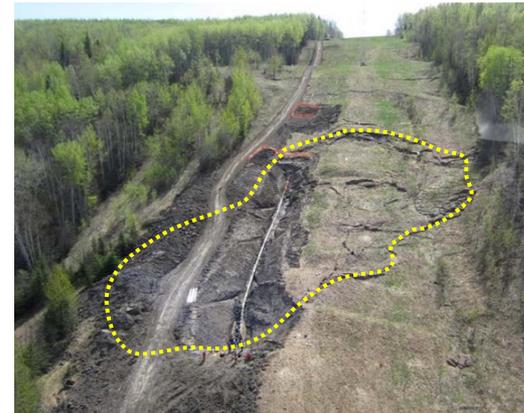
# Perception of hazard and actual pipeline vulnerability to hazard can be very different

Flow Slide  
Shallow & only upper portion involves loss of ground

Shallow Earth Slide  
(*Translational*)

Deep Seated Landslide  
(*Translational*)

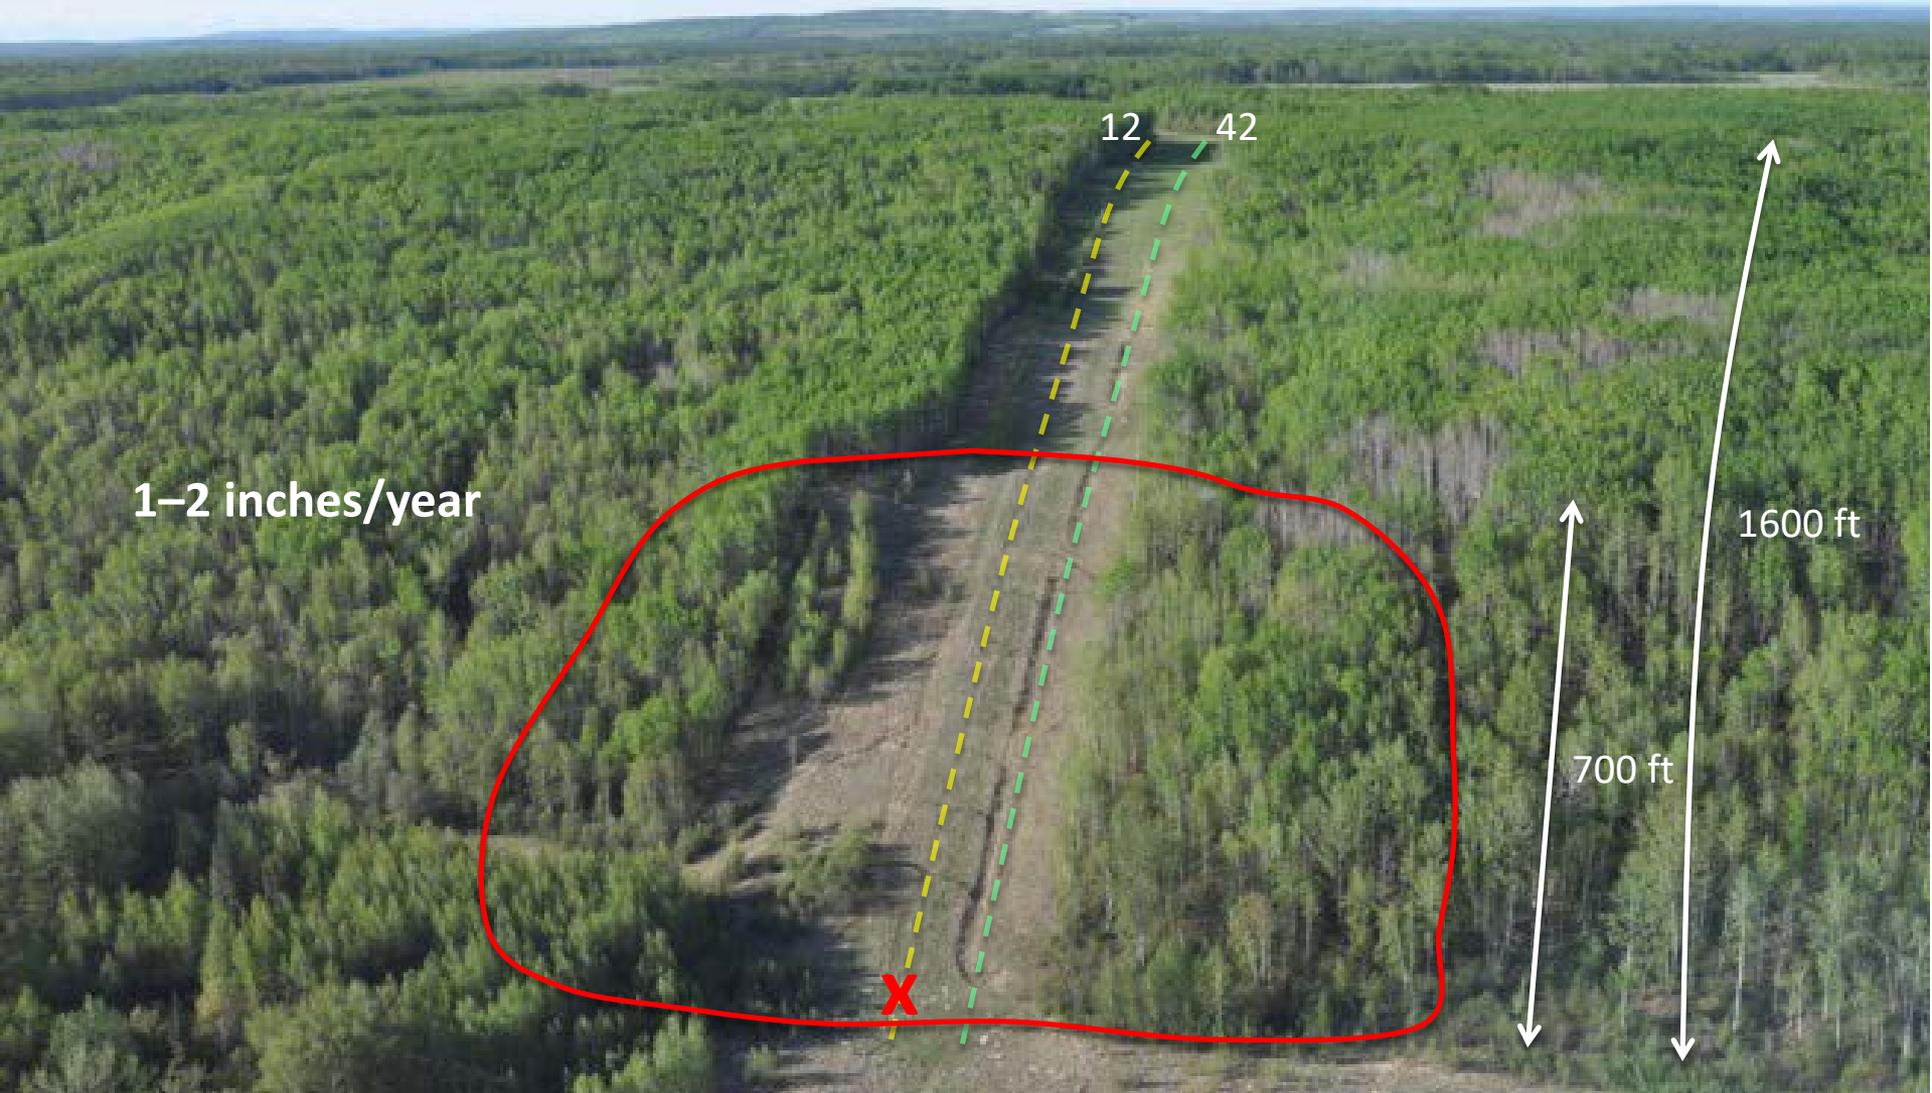
Many of the old landslide features on a route can be benign, but it can be challenging to tell

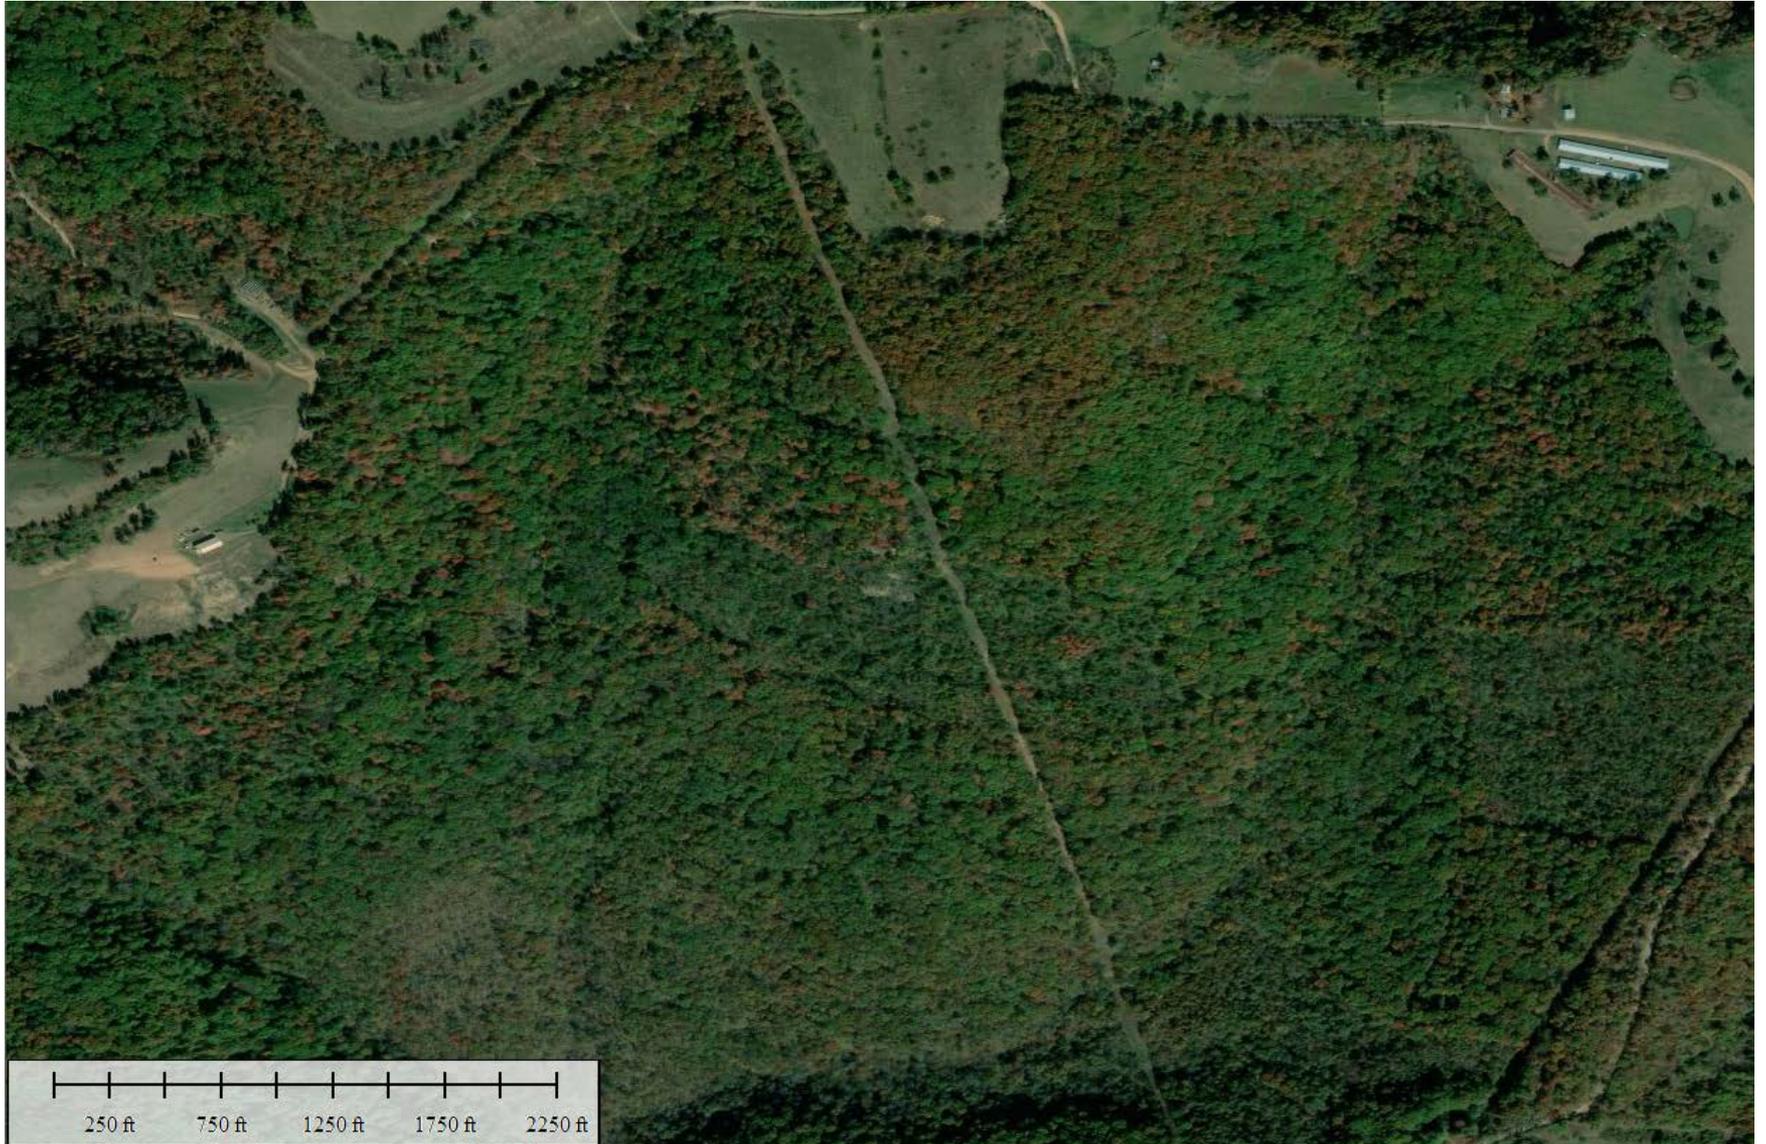
# Publicly available aerial imagery

Publicly available LiDAR Imagery (same image as previous) can be a powerful and often under-utilized data source for hazard identification

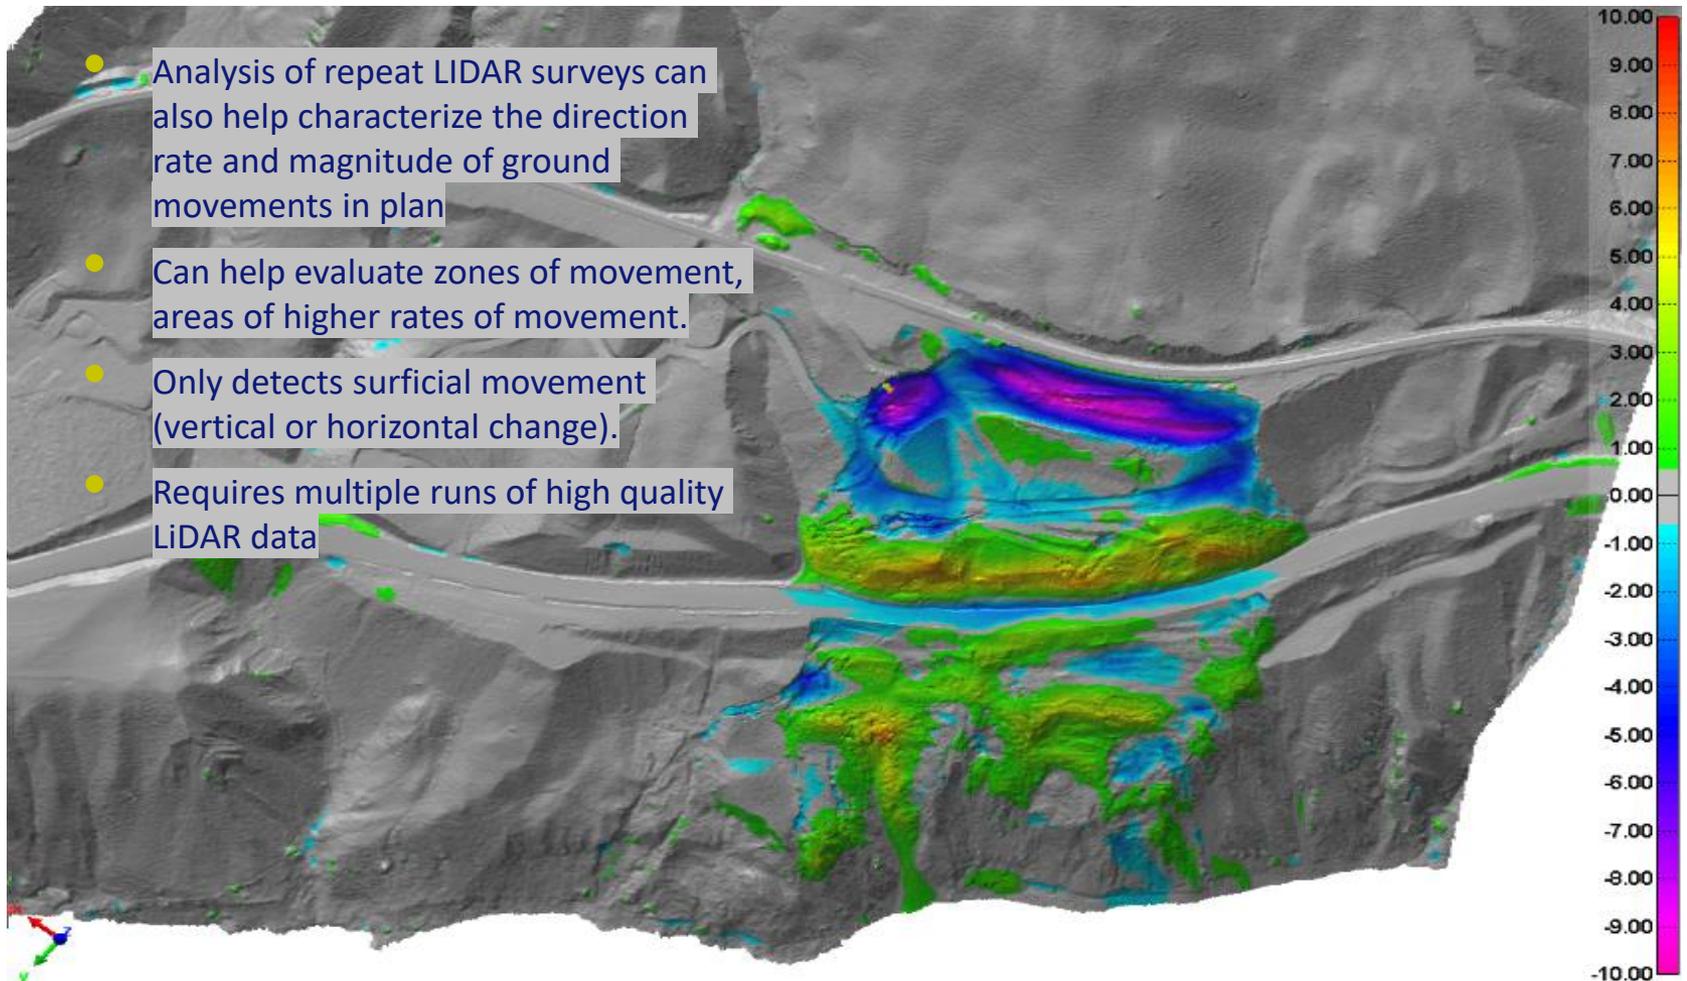
## Monitoring Slope Conditions – LiDAR Change Detection

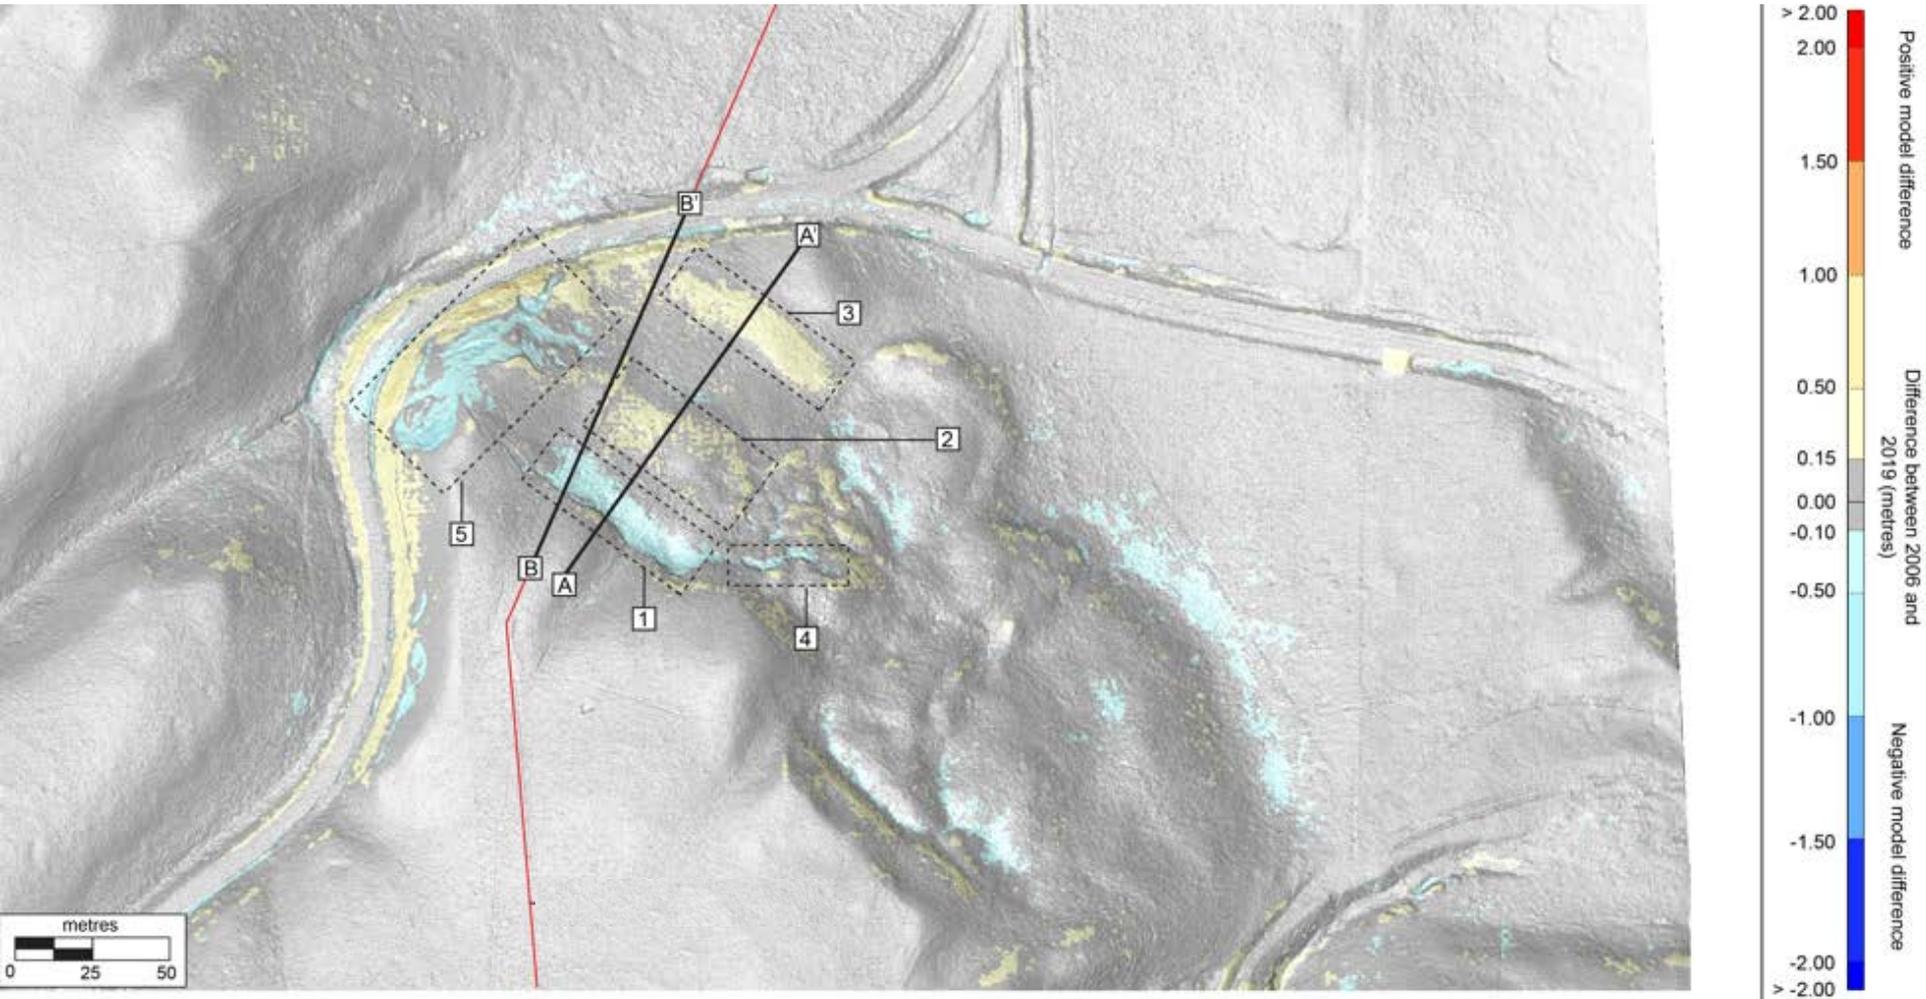
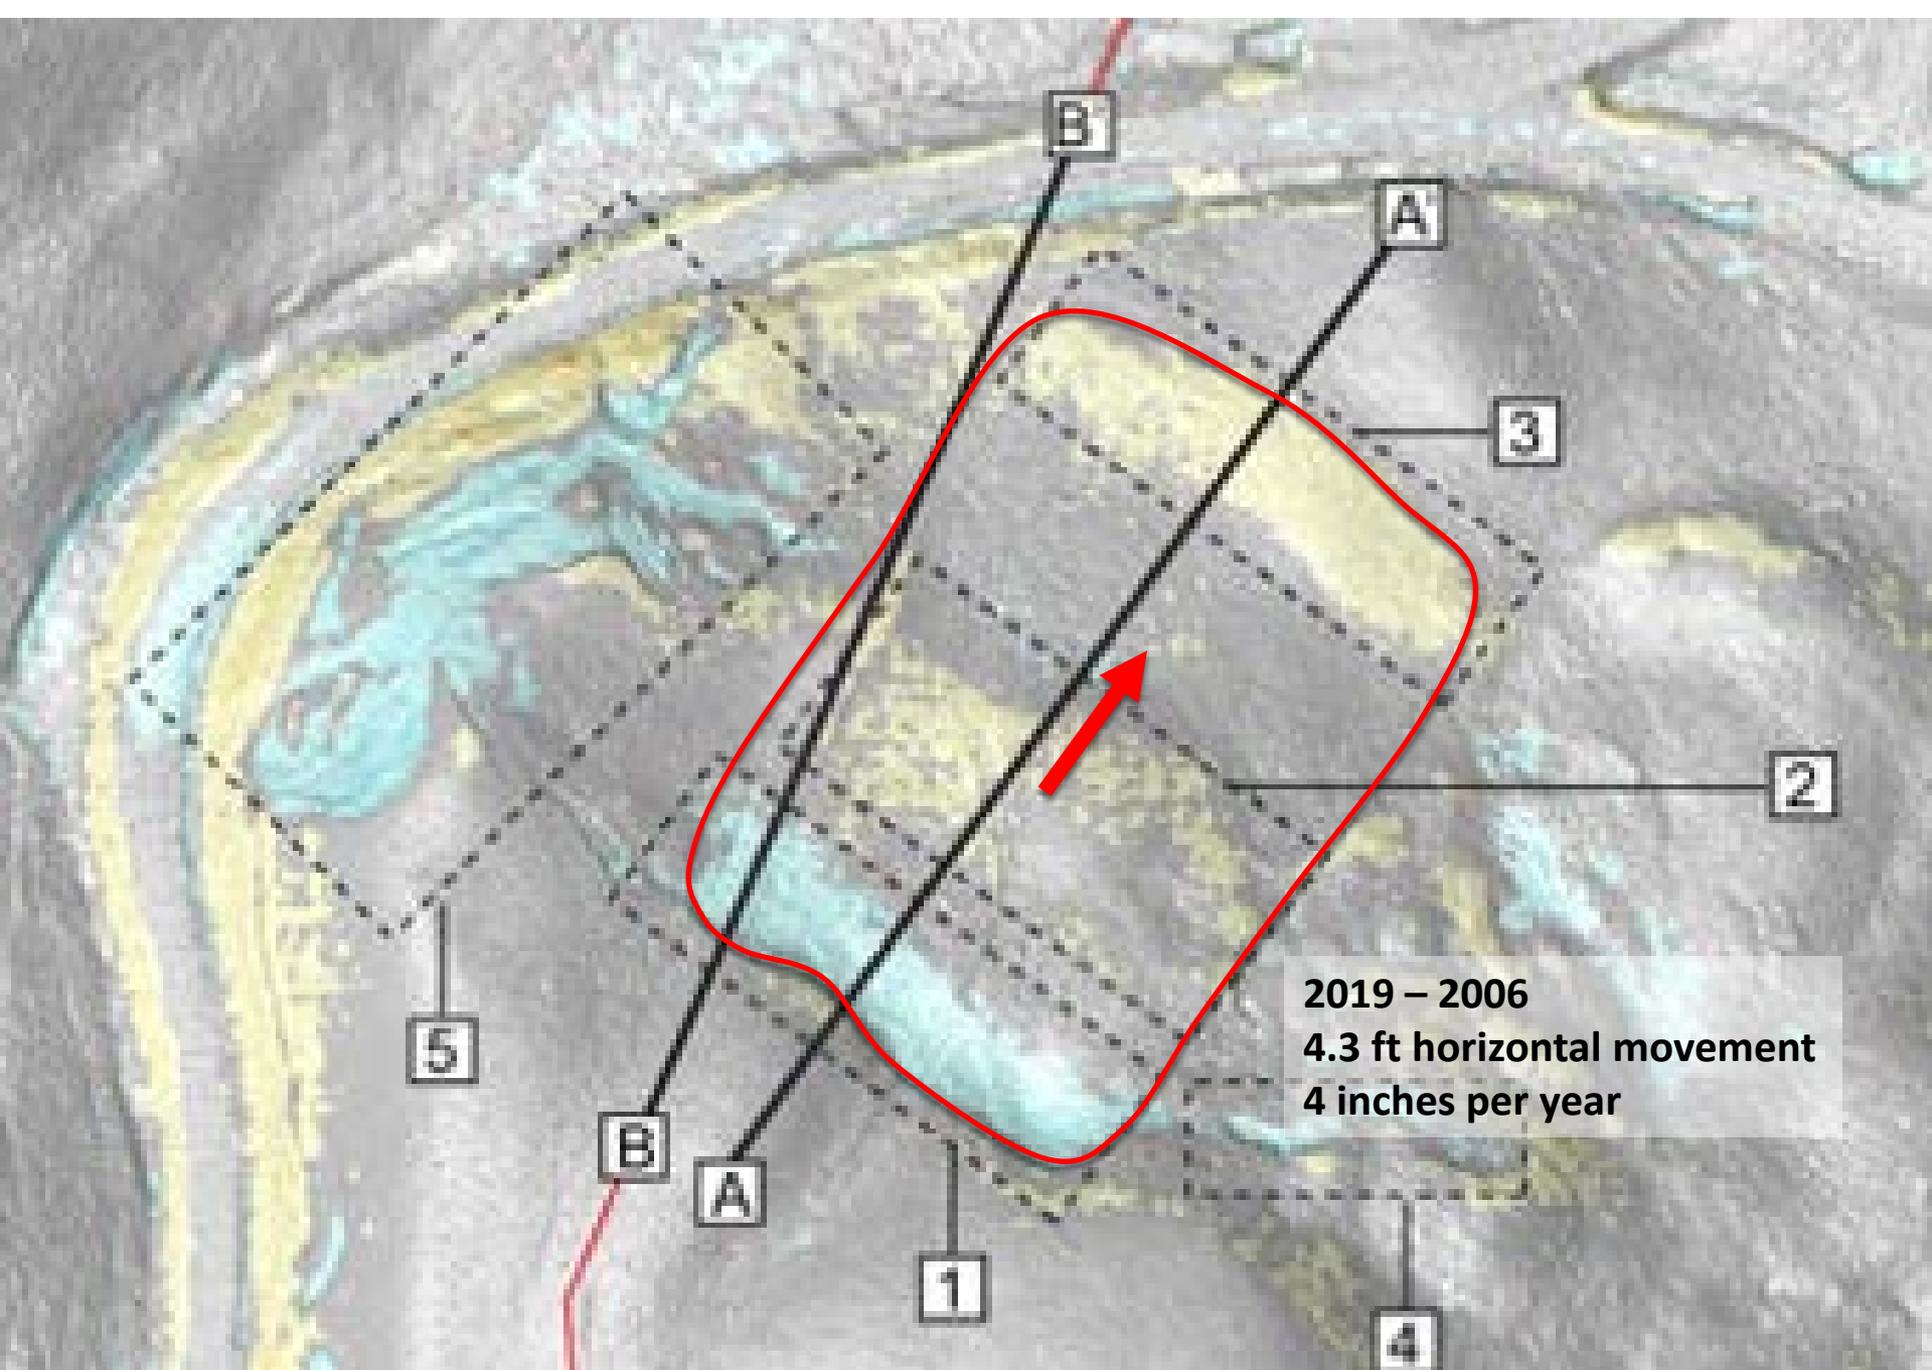
# Deep seated landslide movements picked up by LiDAR change detection

2019 - 2006  
4.3 ft horizontal movement  
4 inches per year

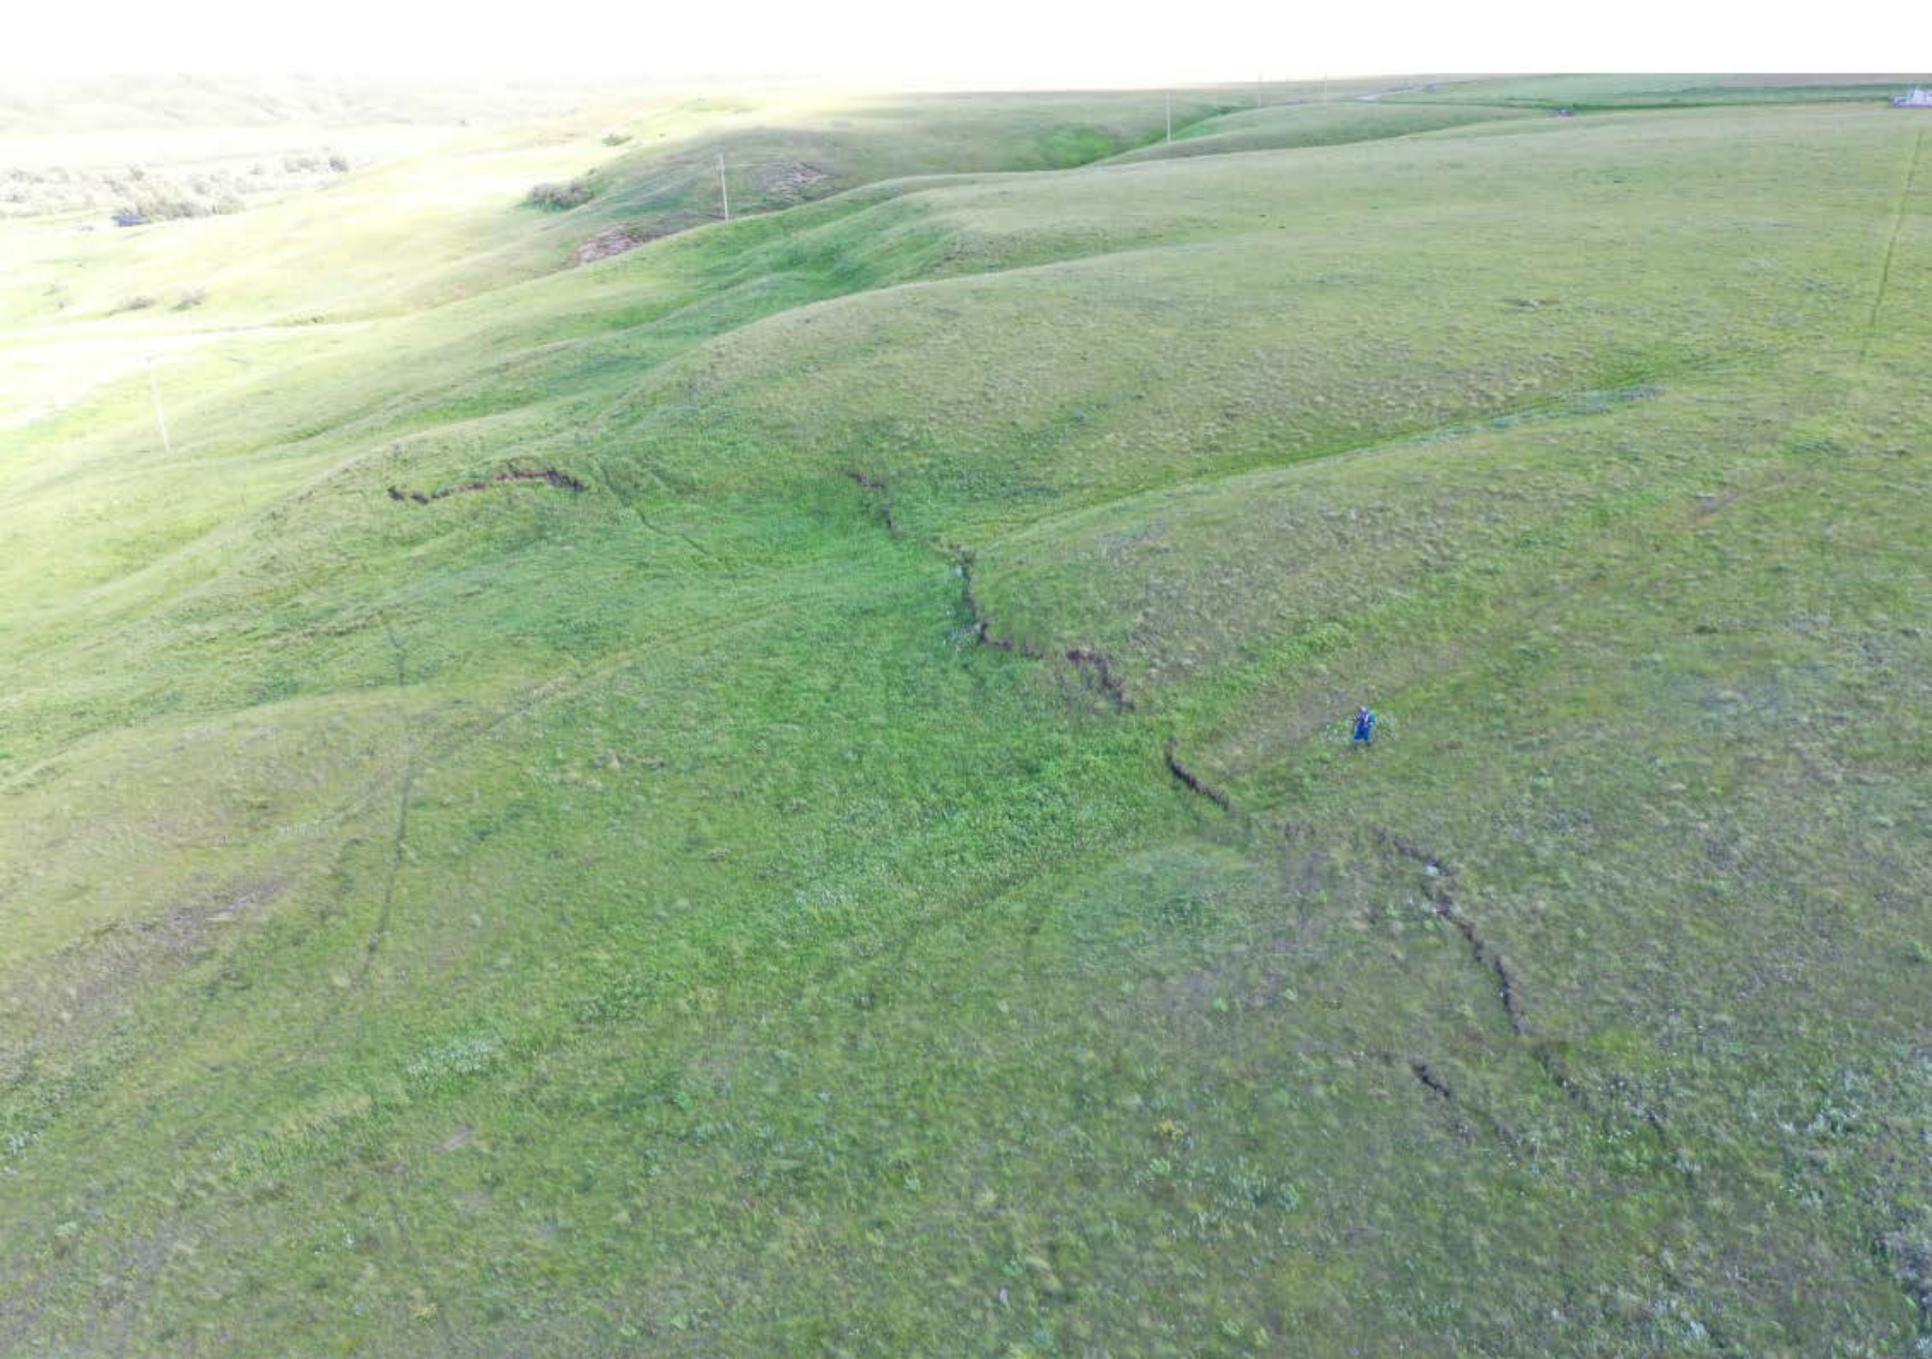
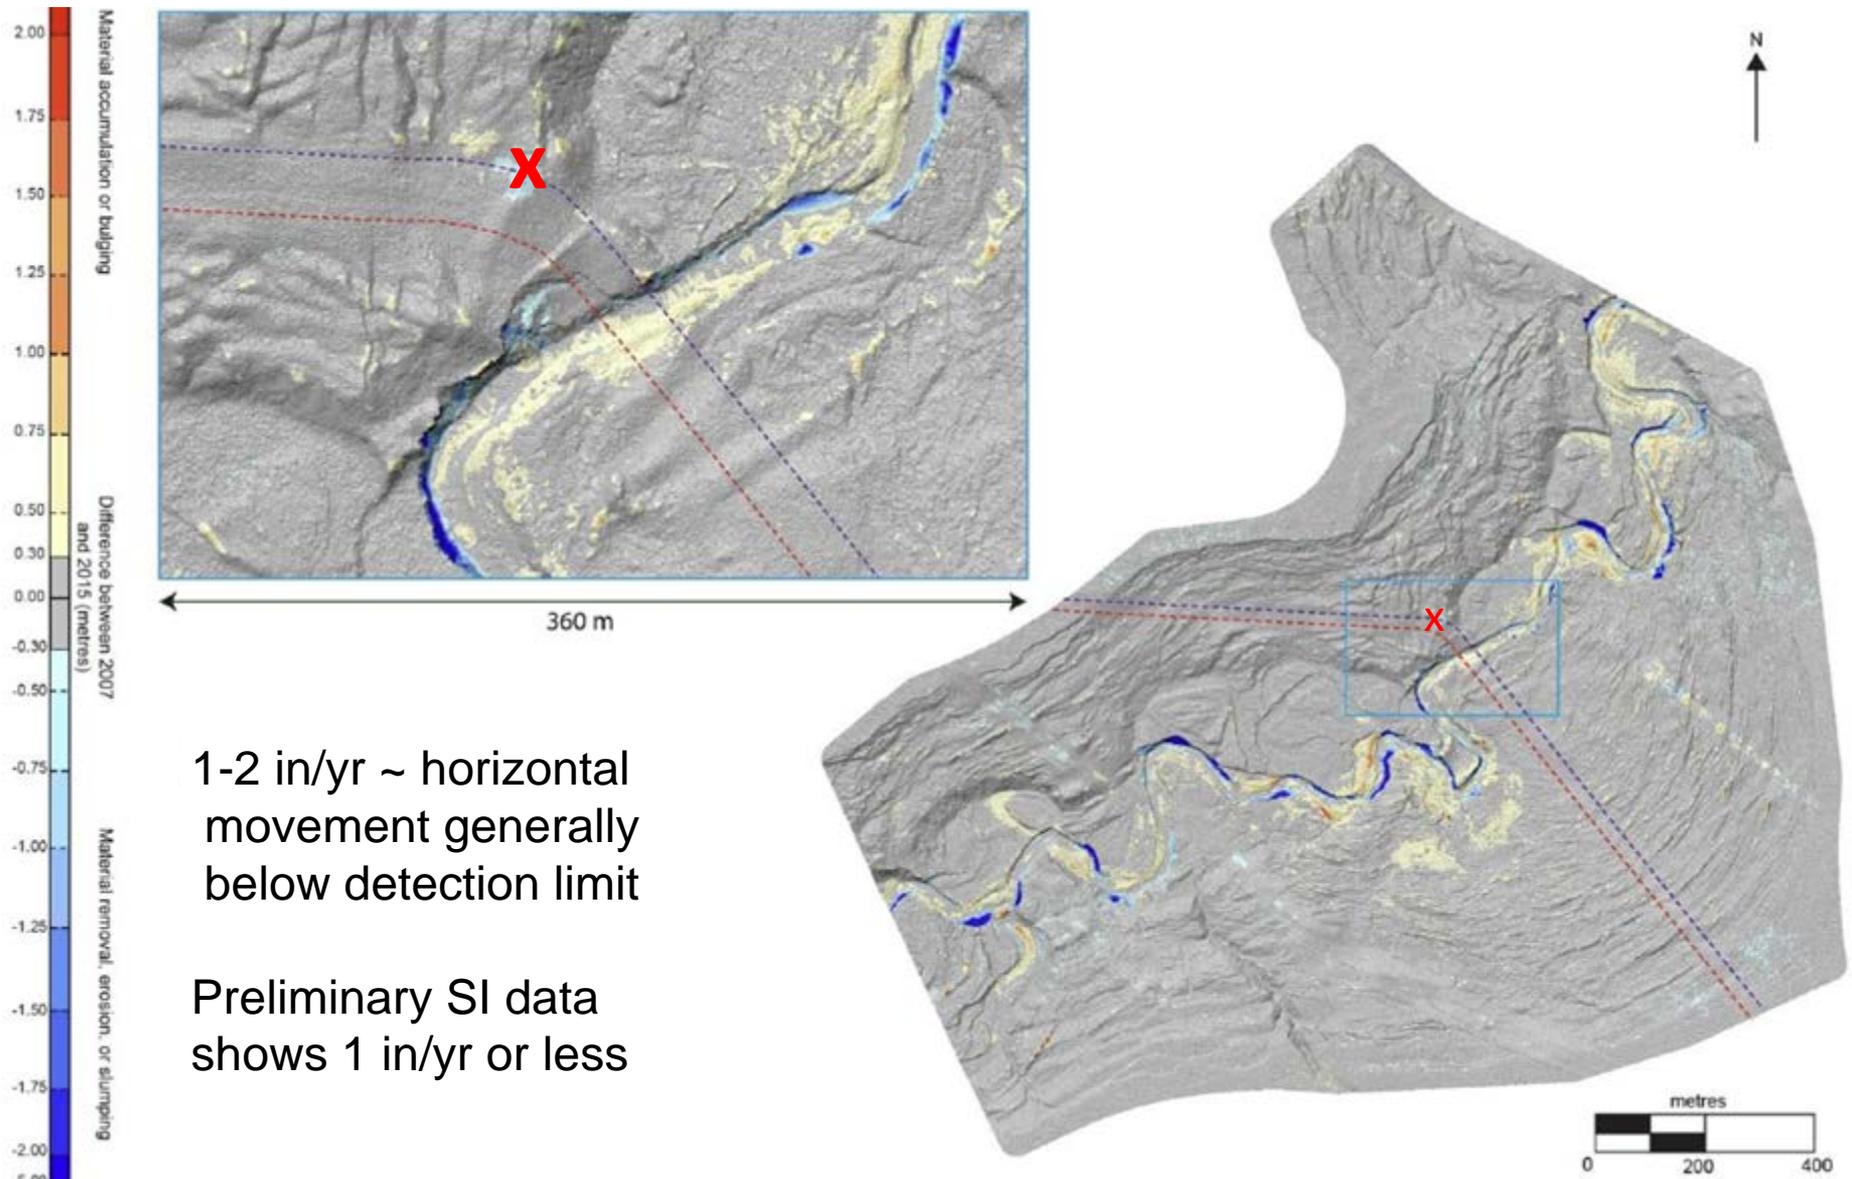
LiDAR change detection is a valuable and low cost means to identify movement over large area but can miss slow, creeping slide activity

1-2 in/yr ~ horizontal movement generally below detection limit

Preliminary SI data shows 1 in/yr or less

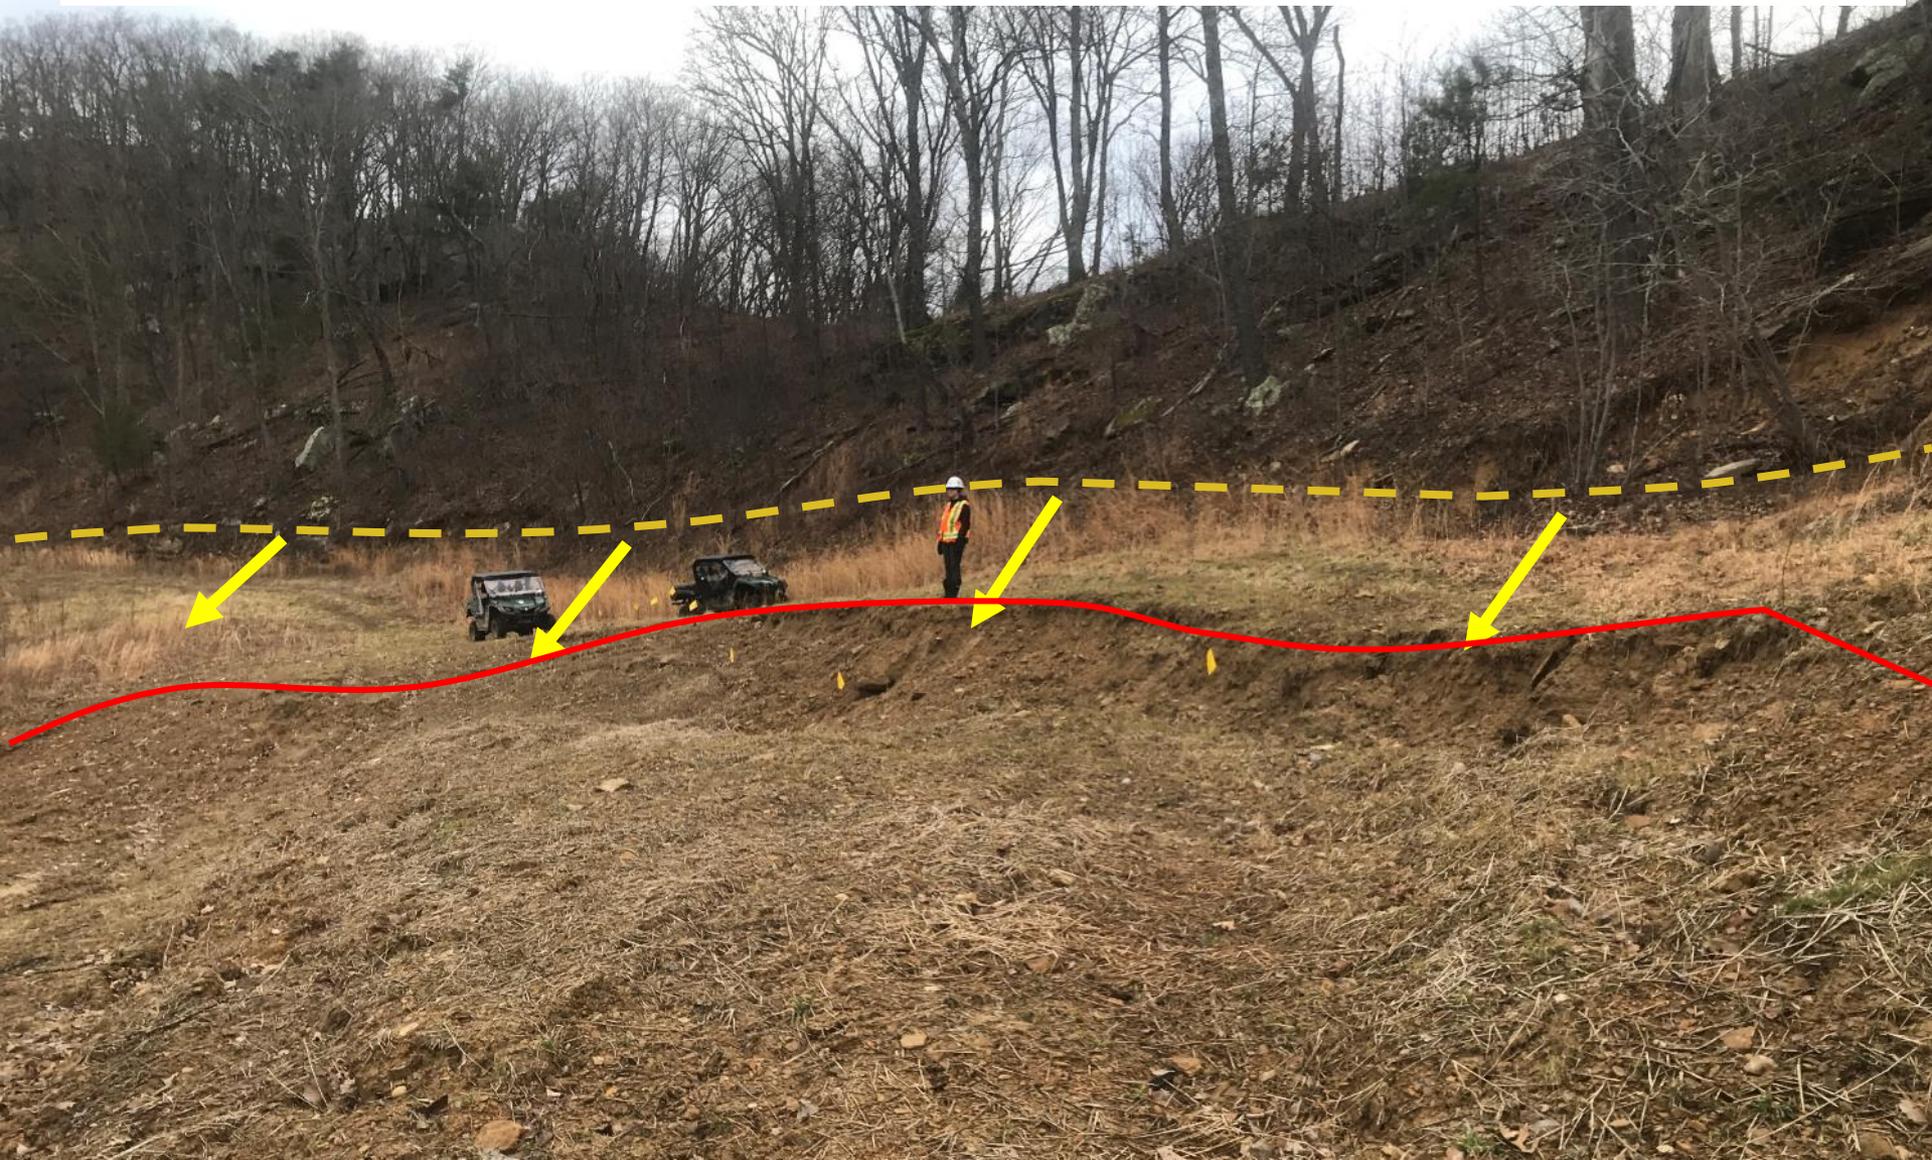
IMU data from In-Line Inspection can be an effective tool at revealing sites where on-going slow ground movement is deforming the pipeline

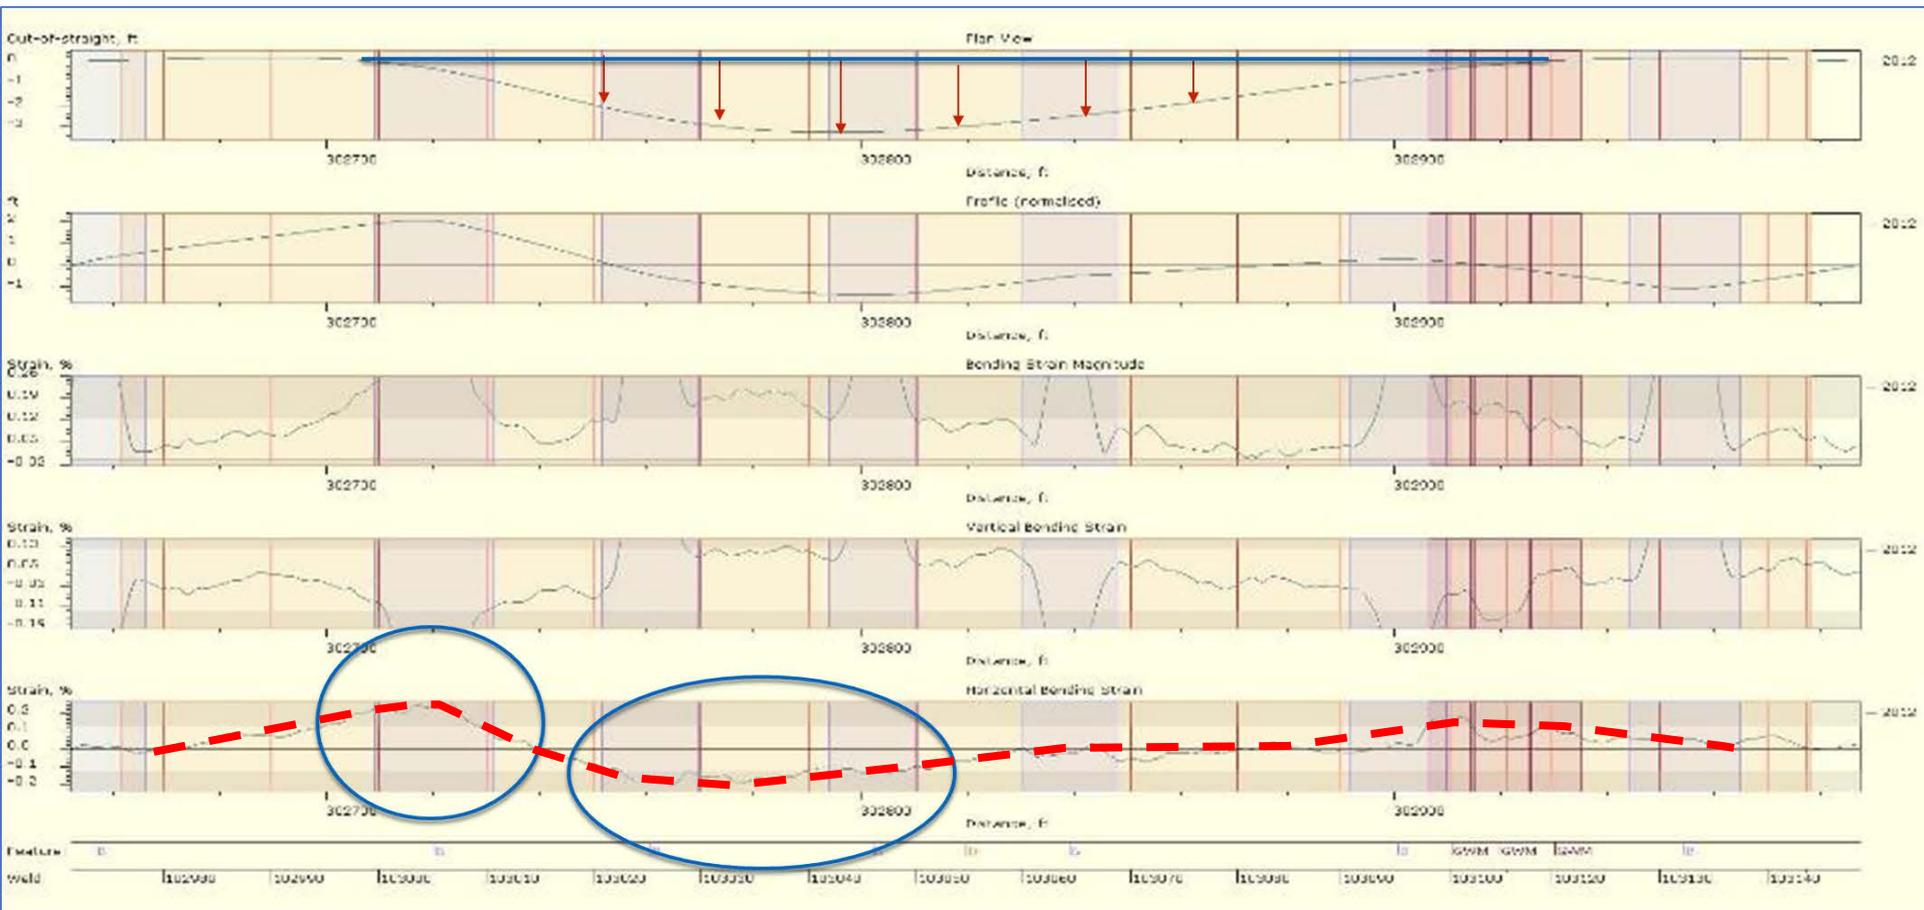
Slope movements that are engaging the pipeline can be detected by the irregular bending strain signatures they cause
