# PHMSA R&D FORUM

Preventing and Mitigating Geo-Forces on Pipelines & Facilities

Pete Barlow

February 19, 2020

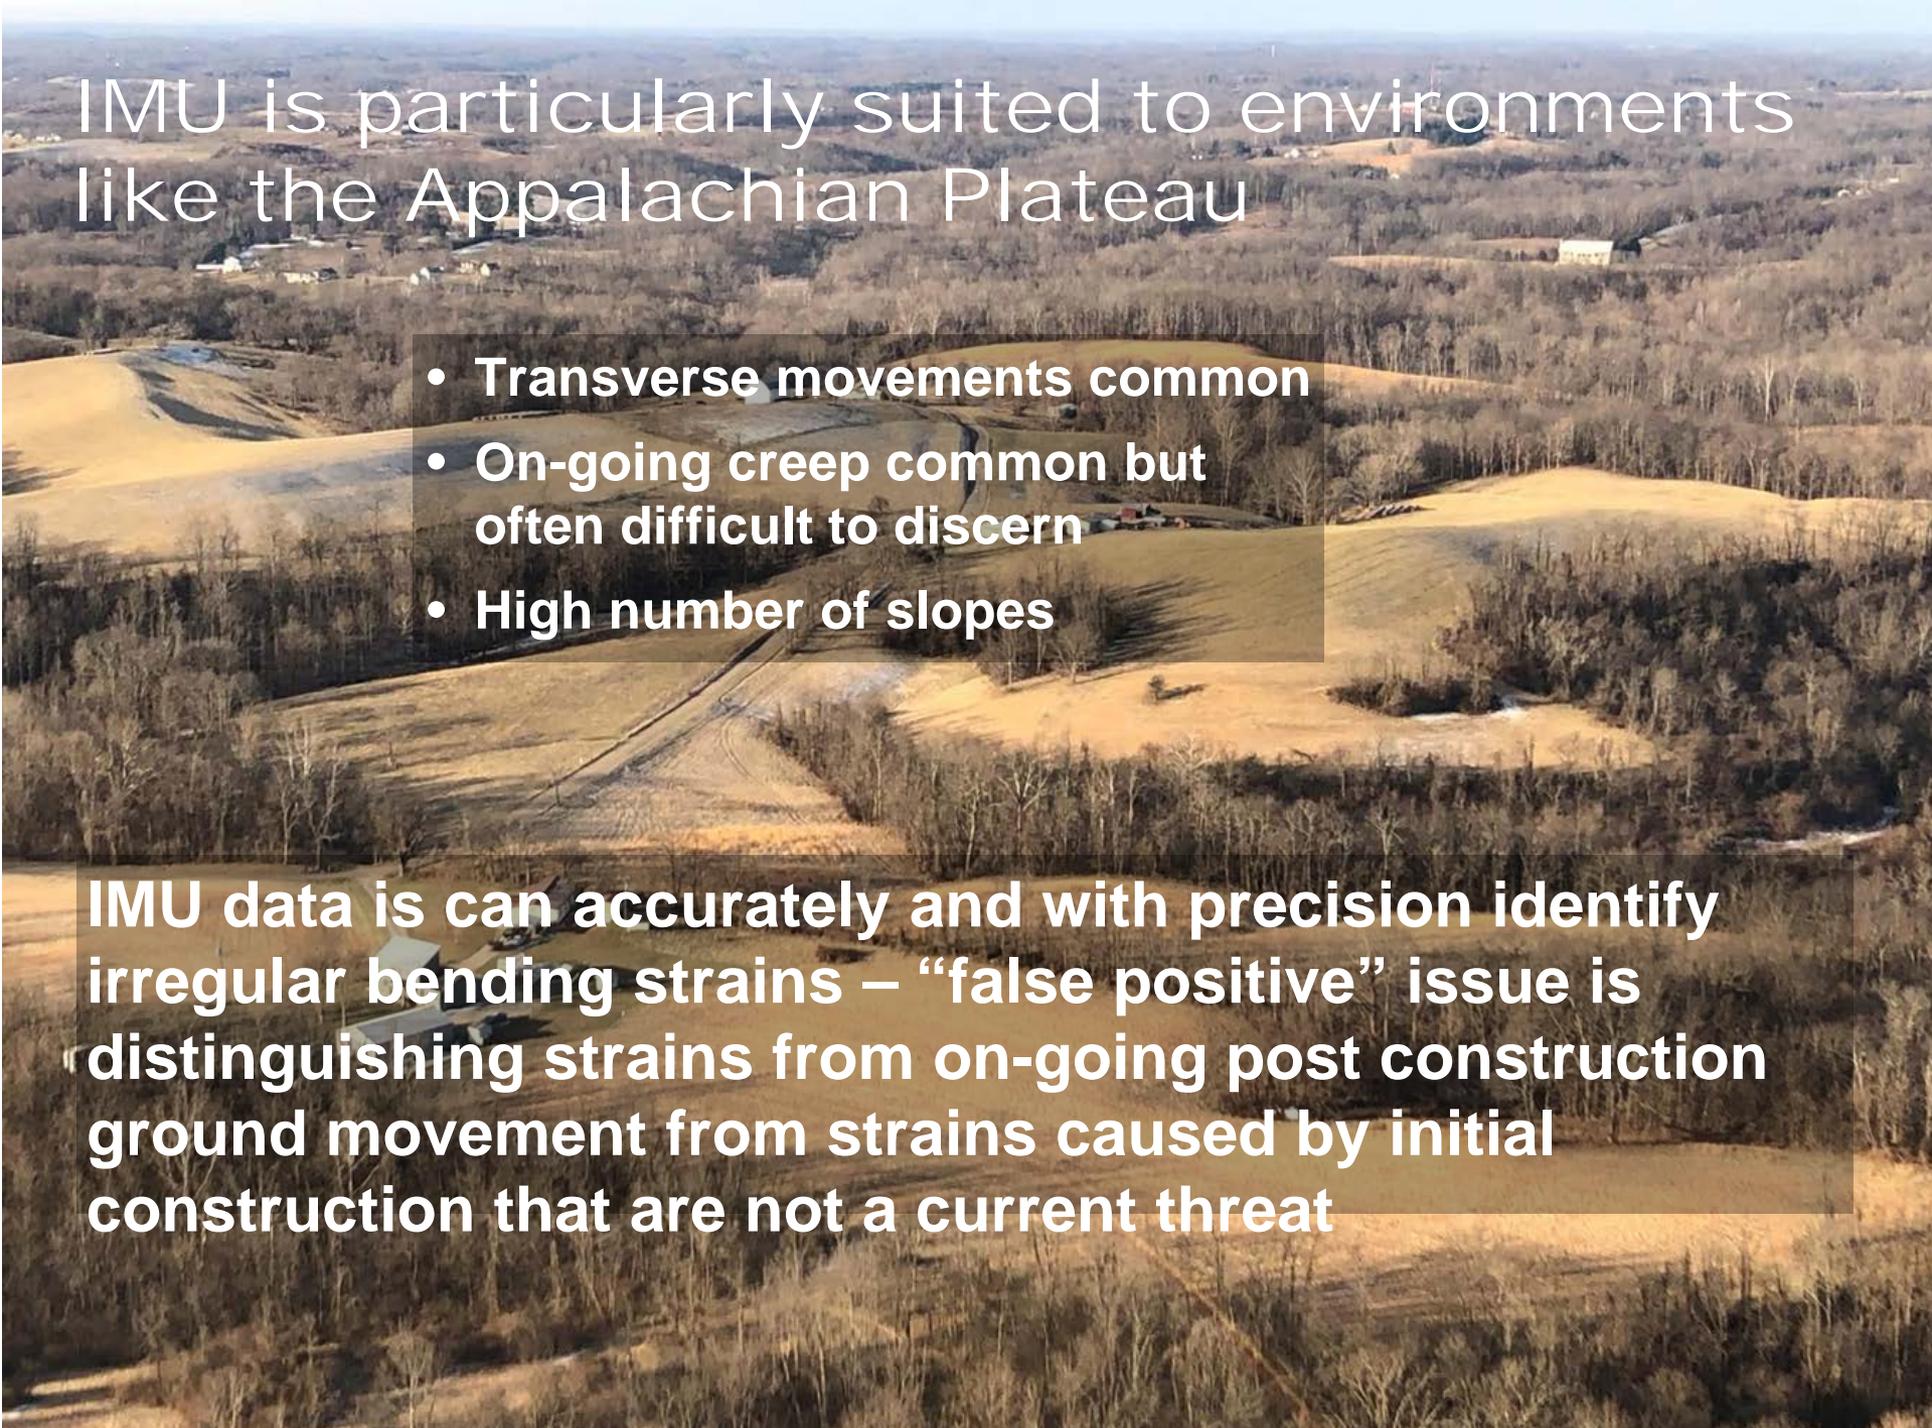
An aerial photograph of a rural landscape in the Appalachian Plateau region. The terrain is characterized by rolling hills and valleys. A prominent feature is a winding road or path that cuts through the landscape, surrounded by fields and patches of bare trees. In the distance, there are small clusters of buildings, likely farmsteads or small villages. The overall scene is a mix of natural and agricultural land.

IMU is particularly suited to environments like the Appalachian Plateau

**IMU data is can accurately and with precision identify irregular bending strains – “false positive” issue is distinguishing strains from on-going post construction ground movement from strains caused by initial construction that are not a current threat**
