#### **GTI Field Applied Coatings Research Program**

Presented to OPS Advanced Pipeline Coatings Workshop

June 9, 2005

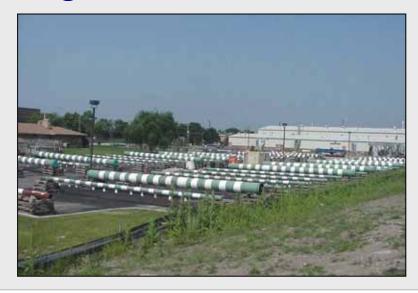
FBE Coated Pipes Covered in Tyvek and Awaiting Final Holiday Testing

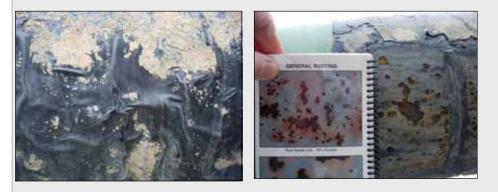
#### **Failure Analysis**

In some cases, the failure investigation revealed serious deficiencies in the coating system that resulted in severe rusting and pitting on the substrate, under the coating
