Research on Detection and Assessment Gas Technology Institute

Pipeline Research and
Development Forum

11 December 2003

Albert Teitsma
Program Manager

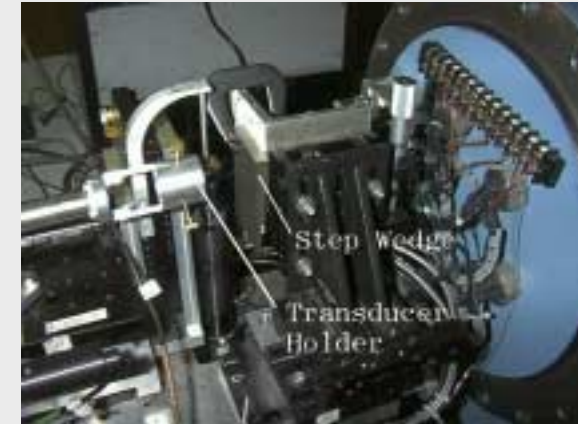
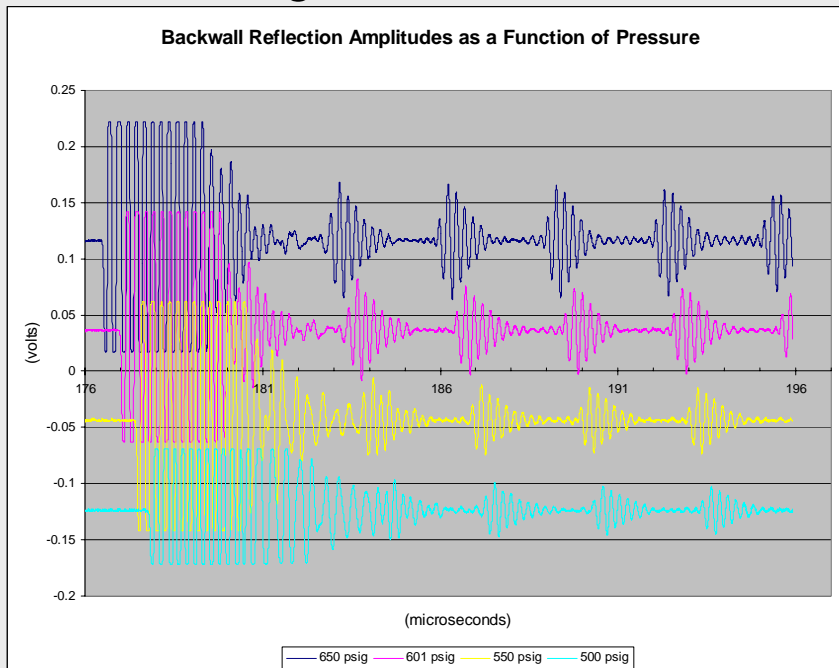
Gas Coupled Ultrasonics

- Direct measurement of wall thickness to a couple of percent
- Direct measurement of crack depths
- Already in use for non contact monitoring of burn victims

- Reduced sensitivity to material properties
- No liquids or wheels and not sensitive to stand off

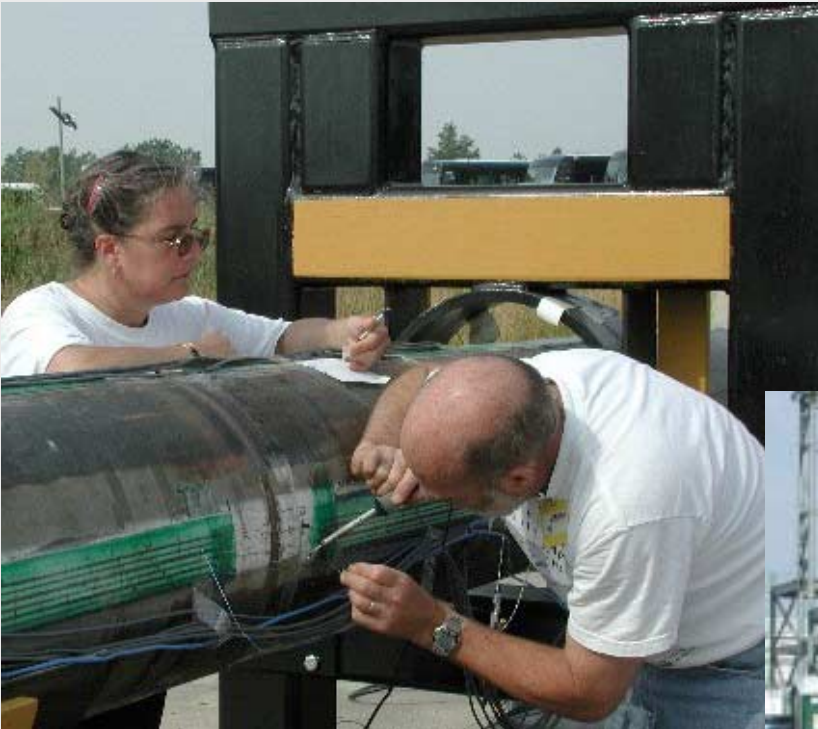
Smart Pipe

- Joint project with INEEL
- Measure stress and stress location
