Dent Assessment Natural Gas Pipelines Perspective

September 11, 2018

TransCanada Dent Assessment Process

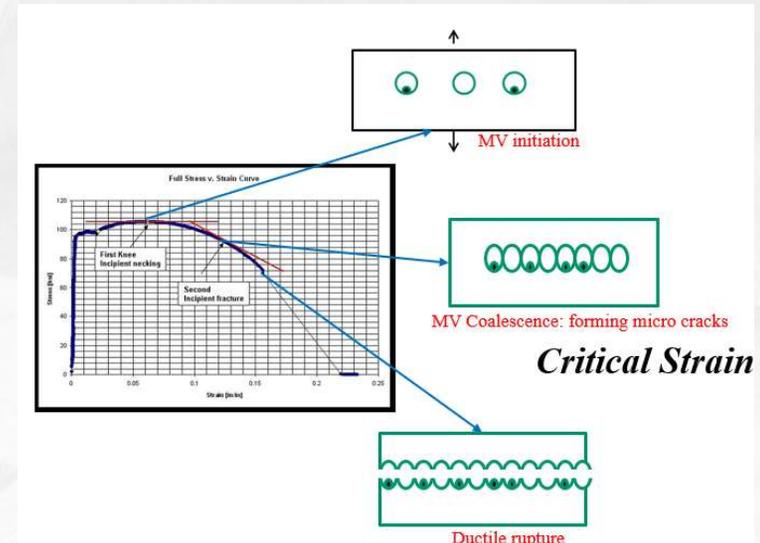
- ASME B31.8 (2003 Edition) – Introduced 6% strain limit for plain dents (empirical)
- Limitations of ASME B31.8 criterion
 - Plastic strain level of 12% for cracking is below the actual measured strain limit for cracking for most line pipe steels.
 - One strain limit for all steel grades is not appropriate.
- Critical-strain-based Ductile Failure Damage criterion
 - Quantify progressive damage limit for avoiding onset of failure in ductile materials.
 - Ductile Fracture Damage Index (DFDI) Criteria
 - DFDI >1 is onset of cracking
 - Conservative Screening criteria DFDI >0.6
 - DFDI = $\varepsilon_{eq}/(\varepsilon_0/1.65)$ --- simplified for screening

$$DFDI = \frac{1}{1.65\varepsilon_c} \int_0^{\varepsilon_{eq}} \exp\left(\frac{3\sigma_m}{2\sigma_{eq}}\right) d\varepsilon_{eq} \text{ or}$$

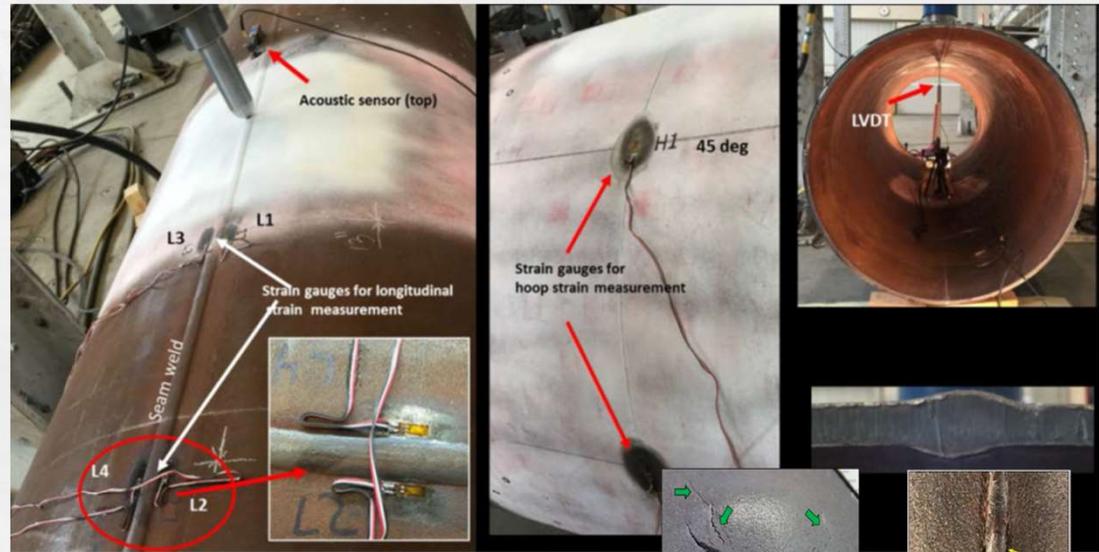
Denting (NPS 34, X52, 1.5" Dia. Indenter) – Pipe body and weld (seam/girth) Test Setup

- MTS Hydraulic Actuator with Indenter
- LVDT for displacement measurement (OD%)
- Strain gages for strain measurement
- Video camera for real time monitoring and recording
- In-situ Laserscan for real time strain measurement
- Acoustic sensor was mounted close to the dent deformation area to monitor the cracking sound if any during the test

Test #	Pipe Specimen	Dent Location	Max. Equv. Strain	Upper bound DFDI	DFDI ≥ 1 Criterion	Comments
1	NPS 34; X52 grade; 2.5"/1.5" indenter	Pipebody	30.1%	0.98	Yes. Validated	Several small cracks were found between 12% to 15% OD depth
2			37.5%	1.22	Yes. Validated	Wide-open transverse crack formed at 17.5%OD with several small cracks
3			34.9%	1.136	Yes. Validated	Several micro cracks were found
4	NPS 36; X65 grade; 1.5" indenter		31.2%	0.88	Not validated	Pipe was severely ovalized. Test abandoned & no crack found
5	NPS 34; X52 grade; 1.5" indenter	Seam weld	31.8%	1.05	Yes. Validated	Cracks formed in seam weld/HAZ region at 6%OD
6	NPS 36; X65 grade; 1.5" indenter	Girth weld	31.5%	0.96	Yes. Validated	Cracks formed in girth weld region at 6%OD

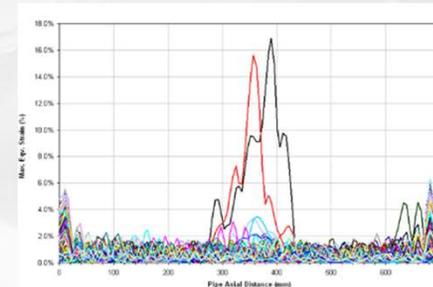
- When characterizing the MFL signals in combination with the dent strain level, some new insight is gained into unique features of the signals that may be associated with ML in a dent:
 - Rule #1: A single strong MFL signal and located at the dent apex or highest strain spot in the dent, then the metal loss feature is most likely to be a crack.
 - Rule #2: Many general metal loss signals distributed within the dent area, then it is most likely to be corrosion.
 - Rule #3: A strong metal loss feature signal oriented circumferentially and located at dent apex or highest strain spot, then it is probably associated with gouge.
 - Rule #4: a strong metal loss feature signal located at dent apex or highest strain spot surrounded with general shallower metal loss features, then it is probably either a gouge or crack.

DFDI = 0.93

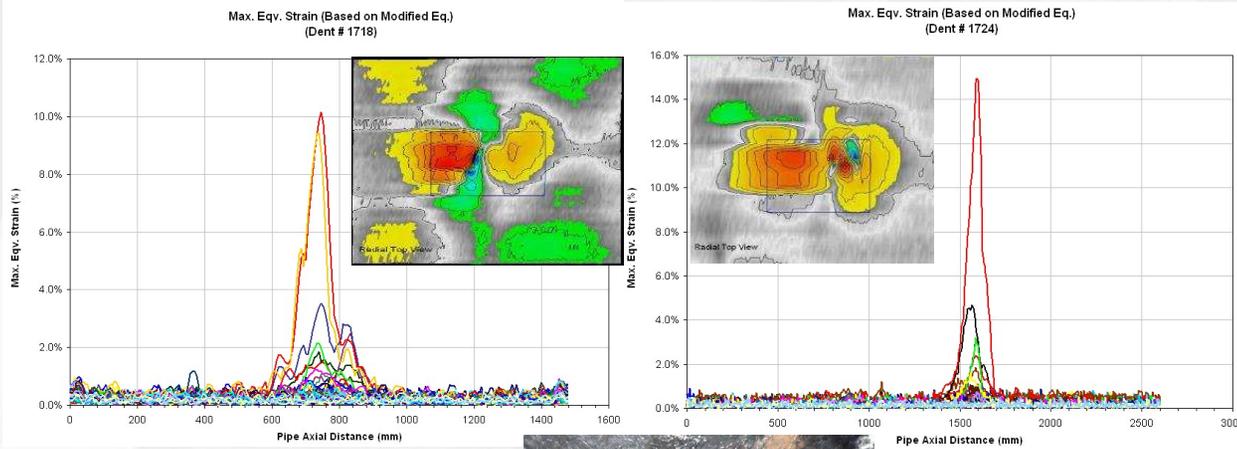
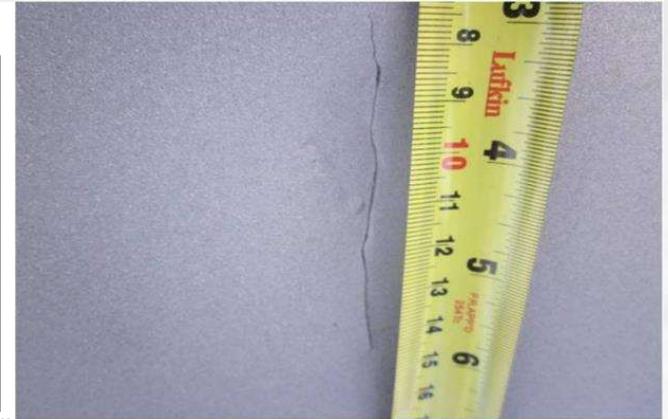
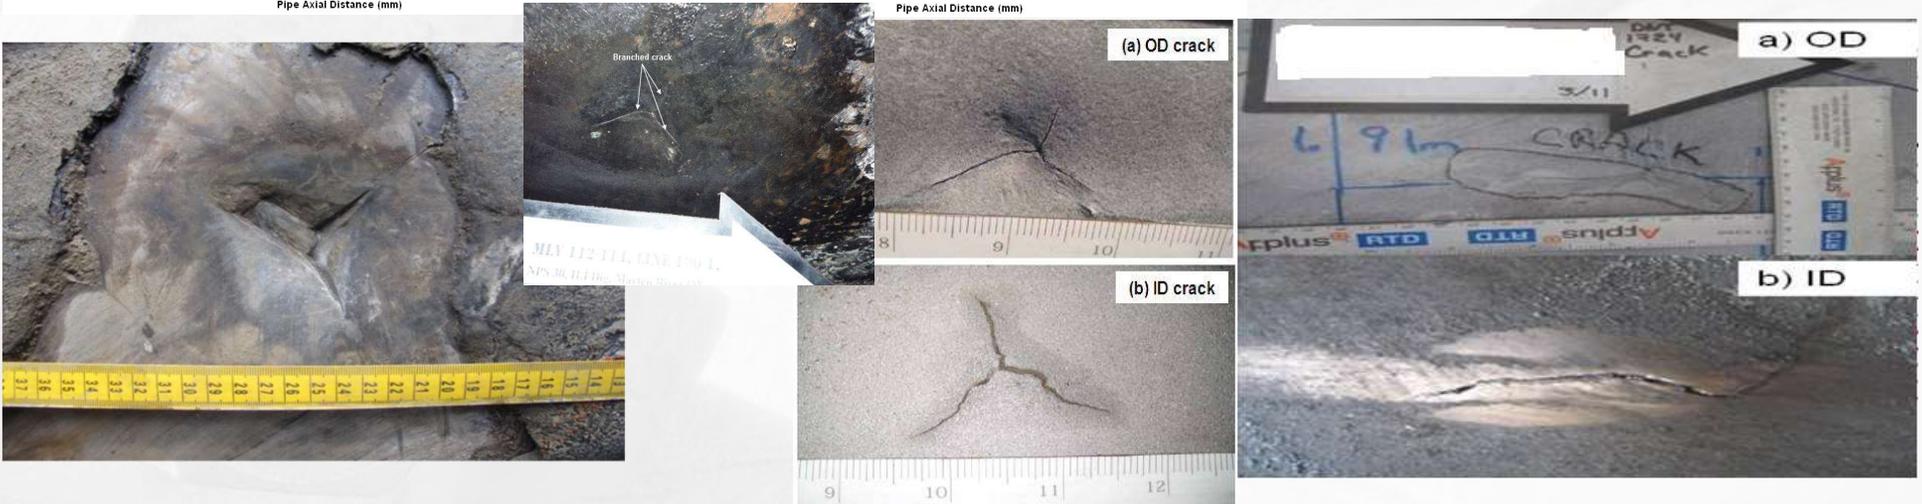
Examples of Findings – Further Validation

- Three pipeline segments with combo ILI reporting 6361 dents, 150 selected using screening method.
- Strain, DFDI and MFL analyses identified 15 dents for further validation.
 - Model prediction
 - 7 dents crack or gouges
 - 8 dents metal loss
- Excavation Results:
 - 7 dents with cracks or gouges.
 - 8 dents, corrosion or manufacturing defects (negative-negative)

Case +S+ O6:T20	ε_{eq}	Upper bound	Prediction	Excavation	Prediction- Excavation
	(%)	DFDI			
1	10.20%	0.6	Possible crack	Through wall crack	Positive-positive
2	15.00%	0.8	Possible crack	Through wall crack	Positive-positive
3	16.90%	0.9	Possible crack and gouge	Gouge	Positive-positive
4	13.00%	0.7	Low confidence of possible crack	ID crack	Positive-positive
5	31.00%	1.7	Crack with gouge	Gouge	Positive-positive
6	17.60%	1	Possible crack	ID / OD crack	Positive-positive
7	11.50%	0.6	Possible crack	Through wall crack	Positive-positive
8	6.80%	0.4	no crack	6% ML dent on rock	Negative-negative
9	7.10%	0.4	no crack	16% ML dent on rock	Negative-negative
10	10.50%	0.6	no crack	12% ML dent on rock	Negative-negative
11	9.90%	0.5	no crack	16% ML dent on rock	Negative-negative
12	5.00%	0.3	no crack	36% OD corrosion	Negative-negative
13	9.00%	0.5	no crack	10% ML dent on rock	Negative-negative
14	7.80%	0.4	no crack	15% OD corrosion	Negative-negative

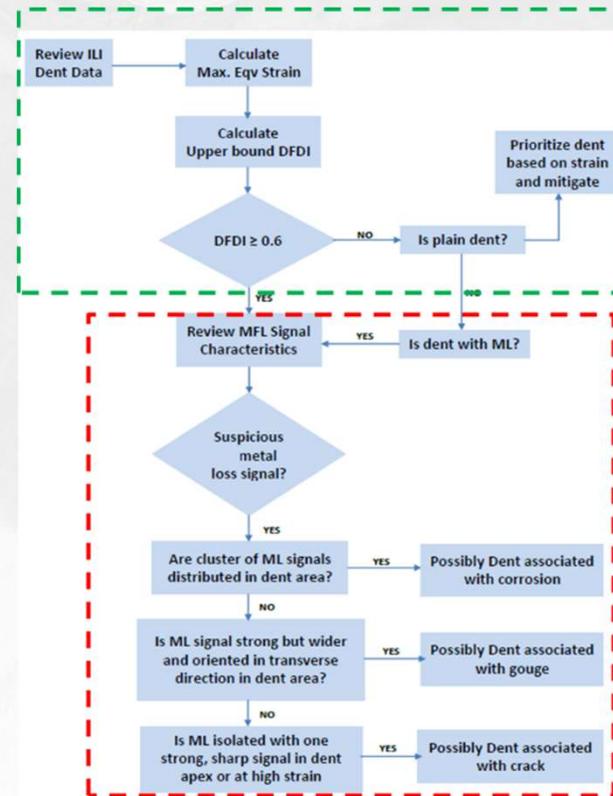
- Follow code requirements and complement with the combined approach to identify critical features:
 - DFDI assessment using geometric strain
 - Assess MFL data when DFDI greater than 0.6
- EPRG fatigue analyses check (no FEA strain required)
- If the above filtering identifies the dent then -Excavate to repair or perform an ECA

1. Plastic Strain
Damage
Assessment

2. MFL Signal
Characterization

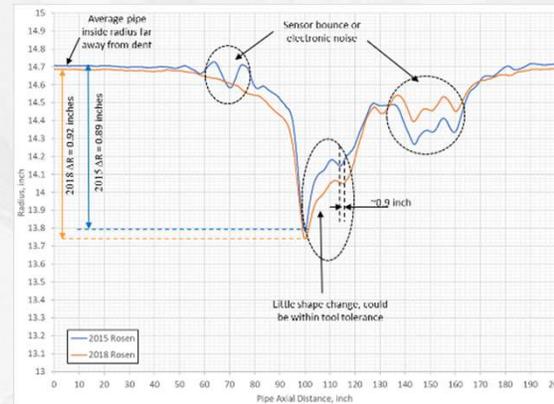
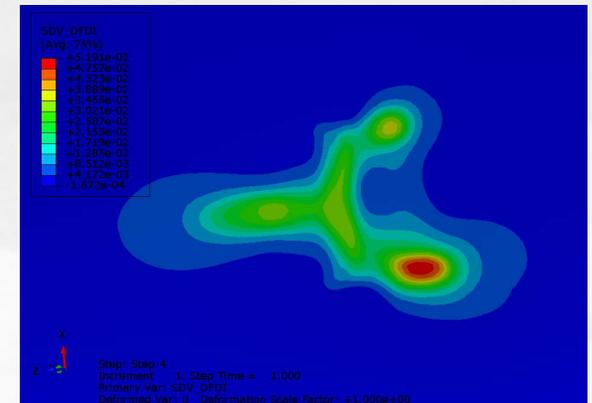
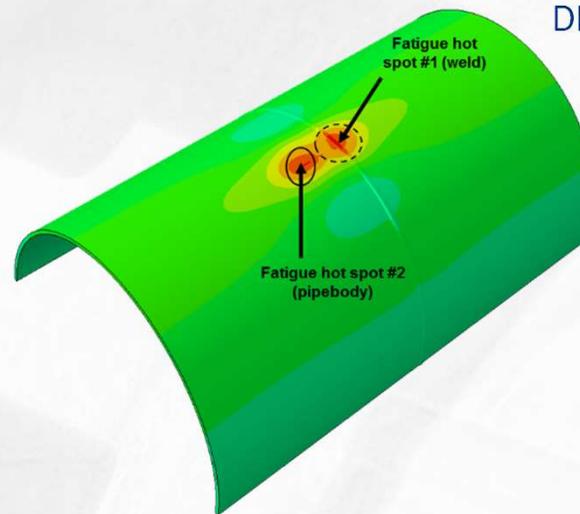
- Assess ILI data in detail + run comparison
- Identify all loads on the dent (welds, external and other local deformation)
- Geometric & FEA strain
- DFDI analyses
- If the above identifies dent then perform detailed fatigue analyses with FEA strain:
 - Apply the pressure differential
 - Obtain strain differential
 - Strain differential used for estimating fatigue life
 - Lowest fatigue life between Markl and SWT is used

DFDI = 0.18 to 0.19

API 1156 – 111,816 cycles

Markl – 19,921 to 2621 cycles

SWT – 66,740
