**ConocoPhillips
Pipe Line Company**

RE: CPF No. 5-2009-5013

Item.1 §195.54 Accident reports.

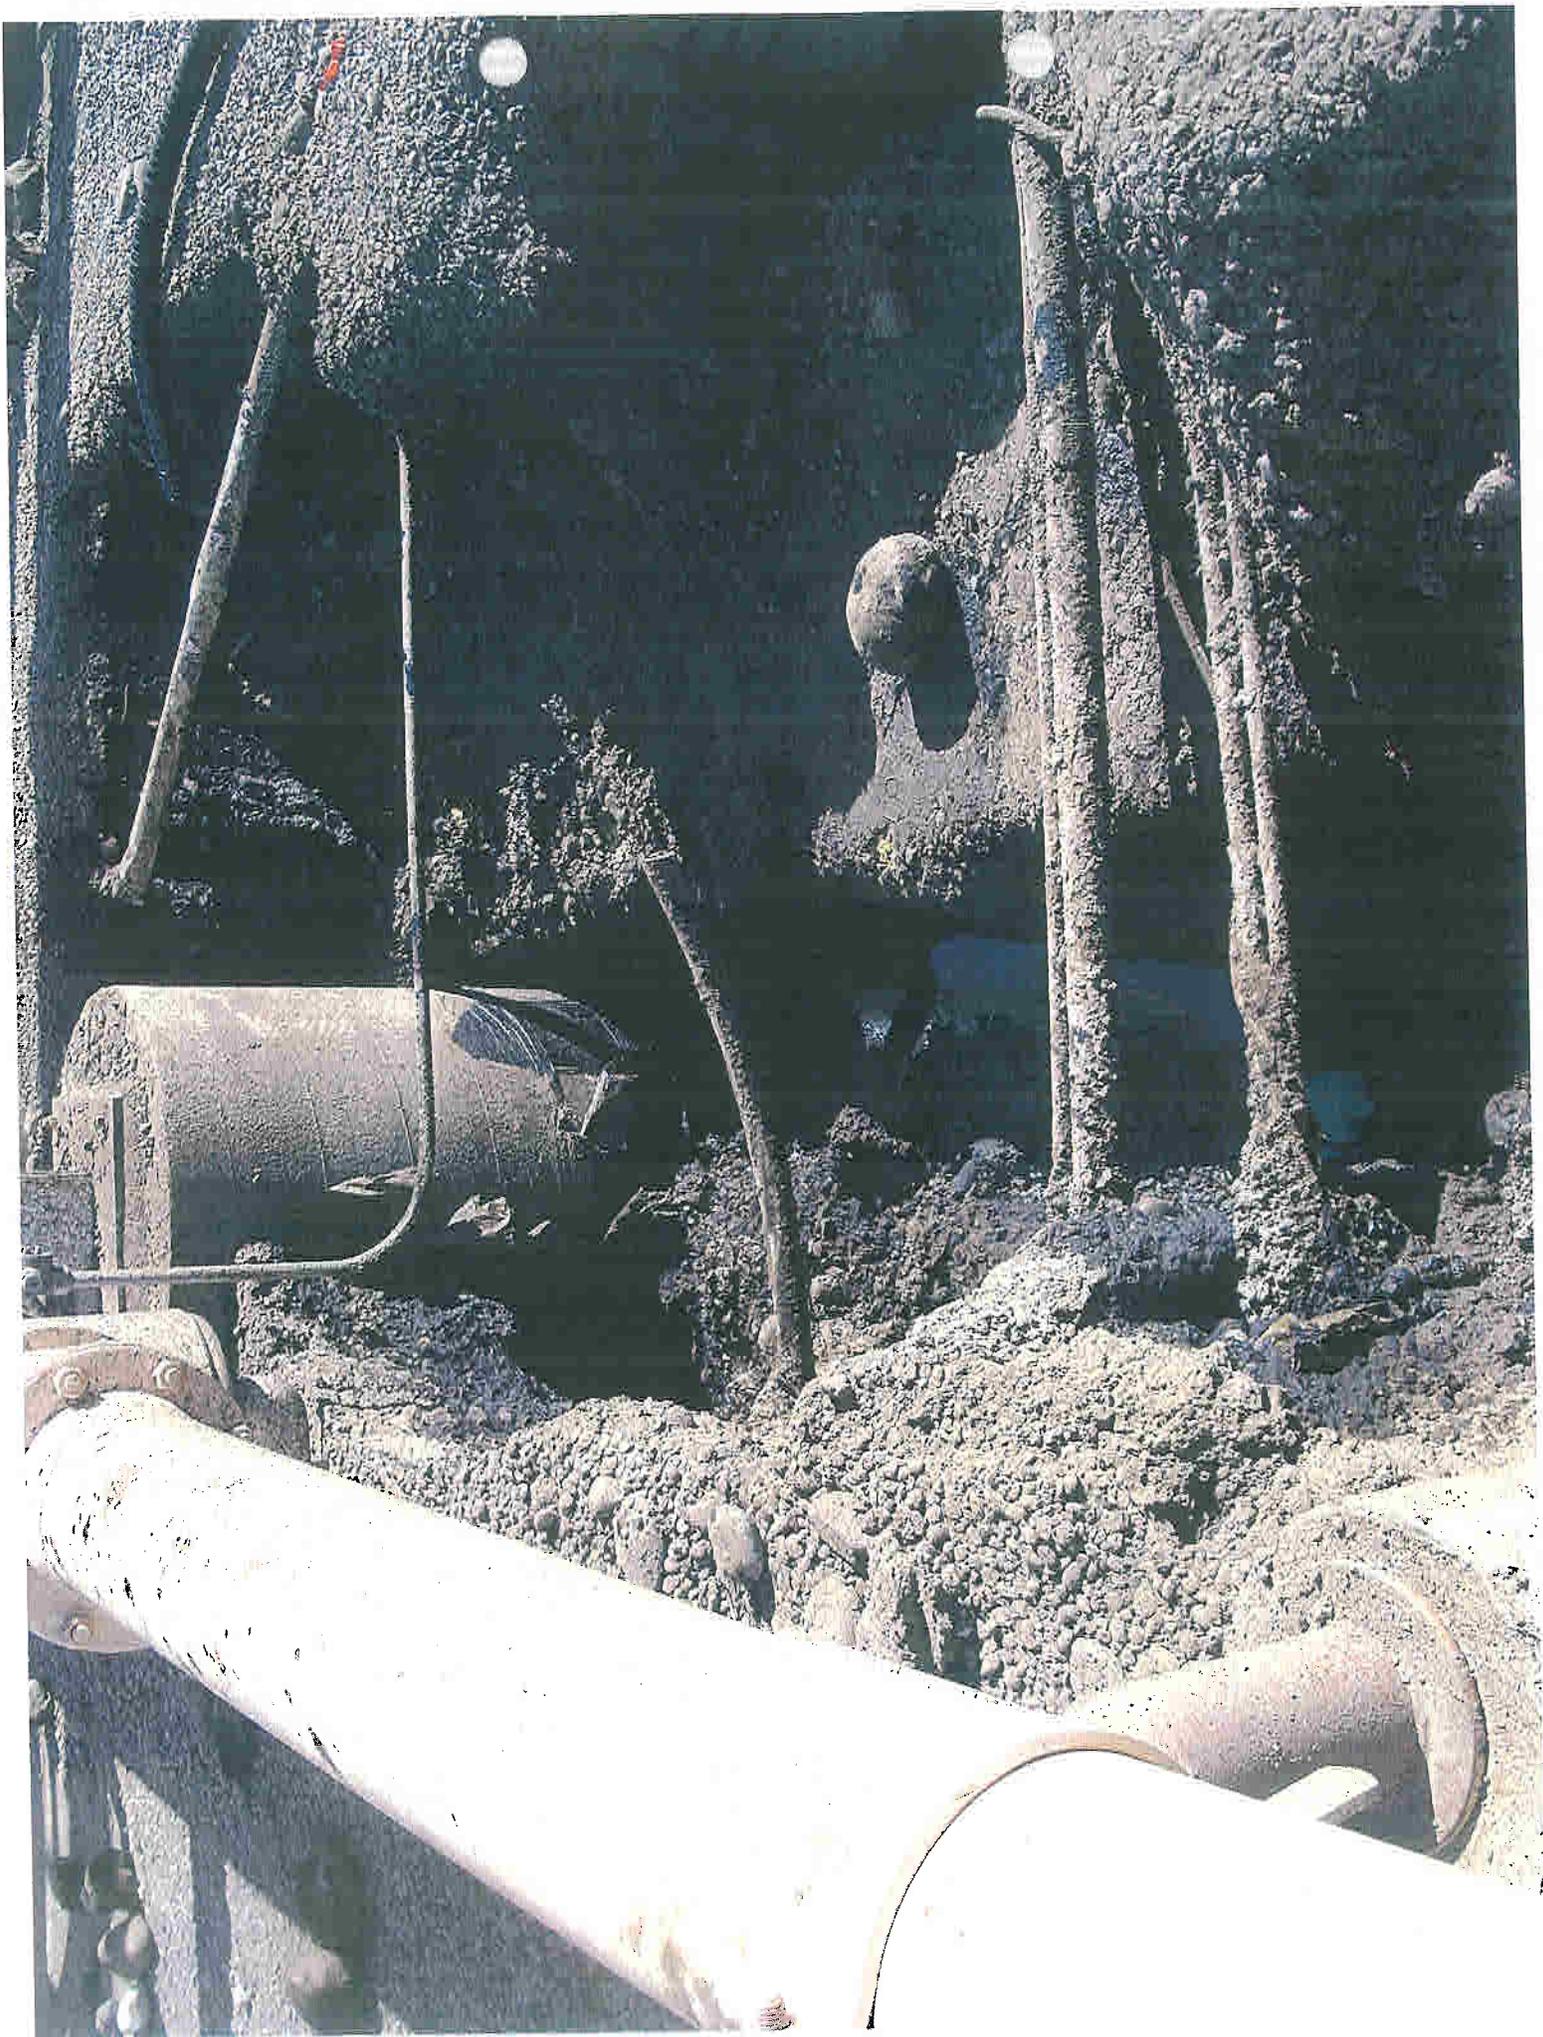
Regarding Item 1, CPPL did attempt to complete a site evaluation to determine the cause of the leak. CPPL hydro-vaced the area in several places to determine the approximate location of the source and the relief line suspected to be leaking. The pipeline systems in the area were shut down and a leak test was performed and confirmed the leak to be in the relief line. At that time, CPPL was unable to excavate the area to determine the exact cause of the leak due to the significant congestion of other pipes, cement piers, and conduits in the area. Also, immediately above the relief line, there is a 1'X3'X100' concrete slab from historical refinery operations that made access to the leak very unsafe for personal to dig any farther in that area to determine the exact cause of the leak. CPPL felt that the risk of sustaining an injury out weighed the importance of finding the exact cause of the leak. At that time, CPPL filled the line with grout and put another line in service as the relief line for the Glacier Pipeline System. CPPL agrees that identifying the cause of leaks is very important, but due to the safety and congestion circumstances mentioned above, CPPL was unable to go any farther in determining the exact cause of this leak. Attached to this letter are photos that demonstrate the congestion at the location and risks/dangers that would have been involved if CPPL would have exposed the relief line any farther.

CPPL believes that the relief line likely developed an external corrosion leak based on the extreme congestion of the area and presence of a containing concrete slab, electrical conduits, and permanent structures built on and near the piping. Due to these activities, the pipe coating was likely compromised allowing the cathodic protection to leave the pipe. CPPL will update the 7000-1 report to reflect external corrosion as the suspected cause of the leak, upon approval of the Western Region office.

36" Peir for overhead piping

Pipe
